CANOPY WALKWAY INSPECTION, MAINTENANCE AND TRAINING

FINAL REPORT

Program Title: Strengthening Sustainable Ecotourism in and around Nyungwe National Park

Project Maintenance Report Greenheart Canopy Walkway Nyungwe, Rwanda

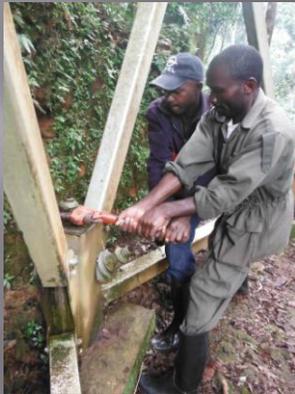
Tower bases were checked to
verify level and all bolts were
tightened.

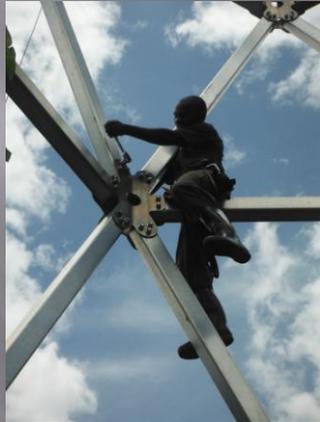
Each tower was climbed,
inspected and bolts tightened.

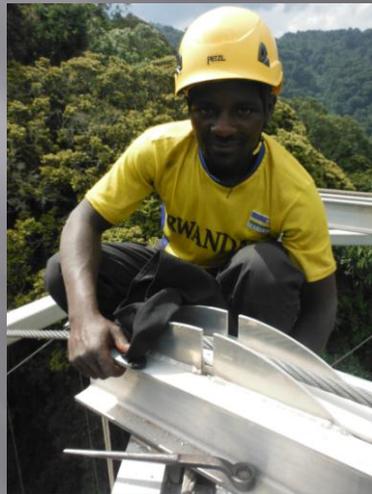
All saddle bolts were inspected
and tightened.

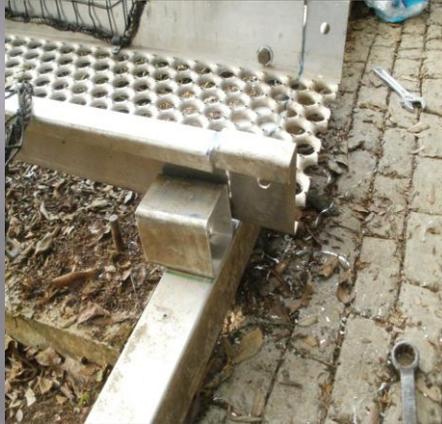
ENTRANCE BRIDGE

The bridge connection for the entrance bridge to the tower was moved from the concrete pad to the tower beam.

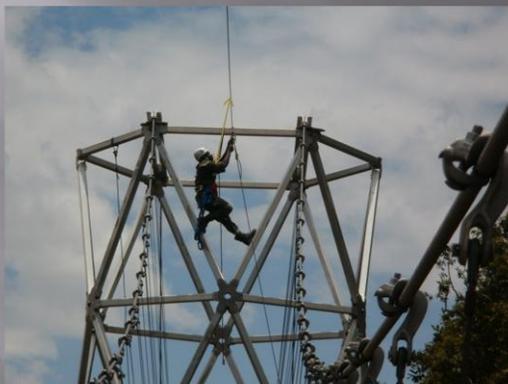
ENTRANCE BRIDGE

Working cable for bridge one was inspected and tensioned.

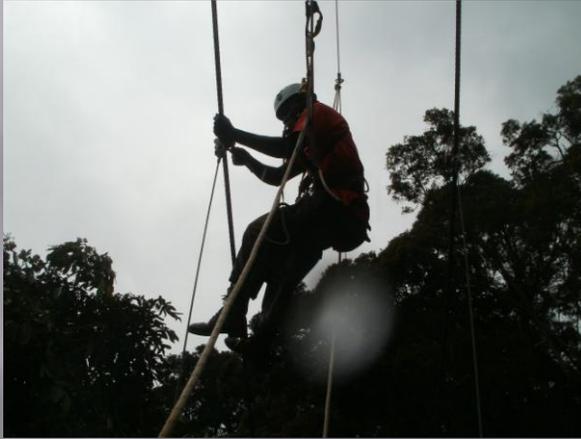
ENTRANCE BRIDGE

Hanger cables were checked,
adjusted and tightened.

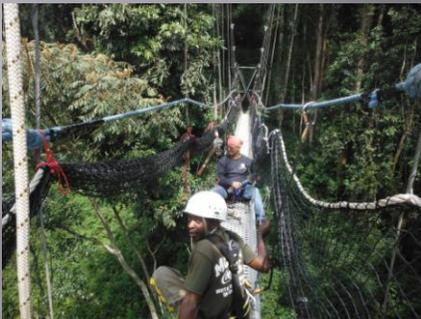
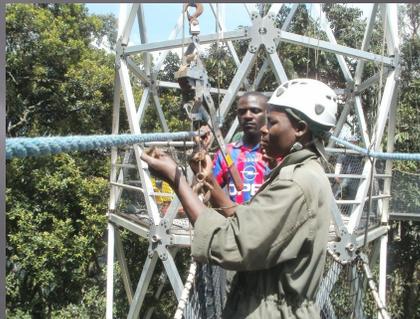
ENTRANCE BRIDGE

The entrance bridge was aligned
and nets adjusted.

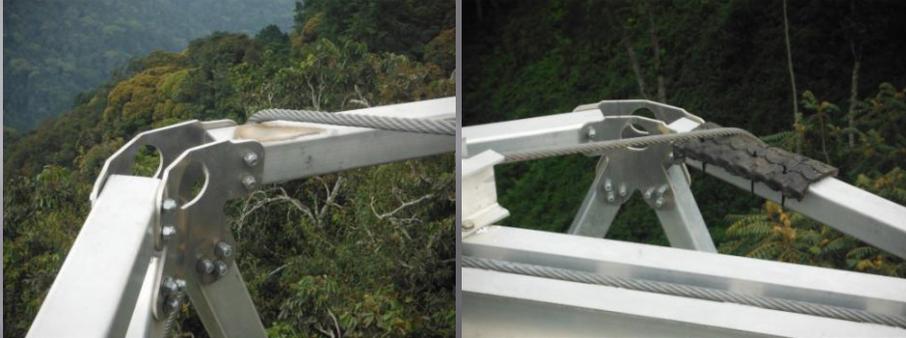
ENTRANCE BRIDGE

Bridge cables for bridge #1 were checked and new buffer pad installed.

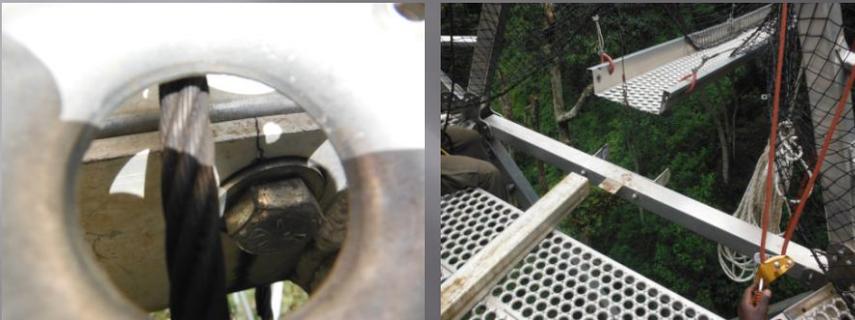
TOWER # 1

The beam and connection for the bridge to tower #1 were replaced with a new beam.

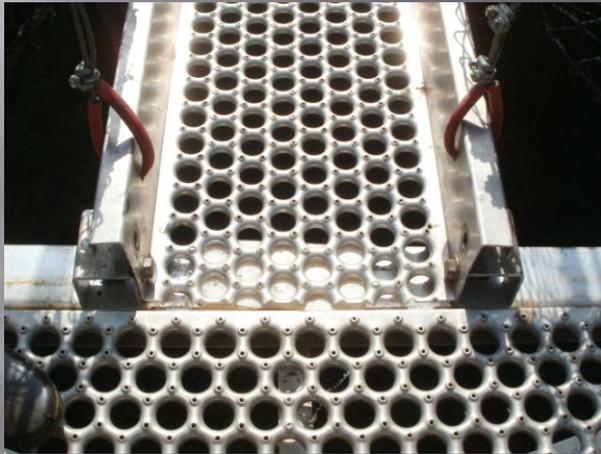
TOWER # 1

New beam in place.

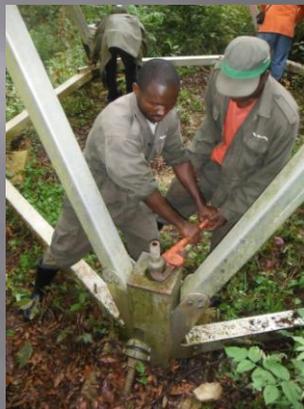
TOWER # 1

The tower base nuts were checked and
tightened.

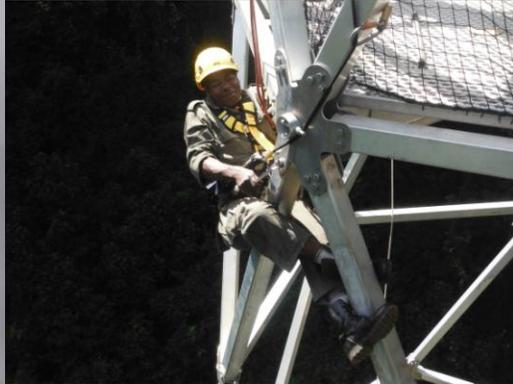
TOWER # 1

Bolts were checked and tightened.

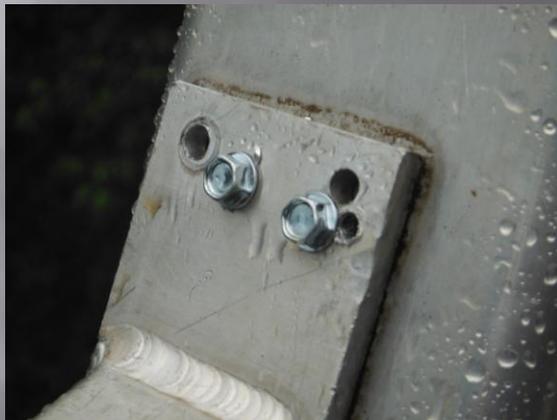
TOWER # 1

Several of the handrails on tower 1 were loose and required re-drilling and new screws.

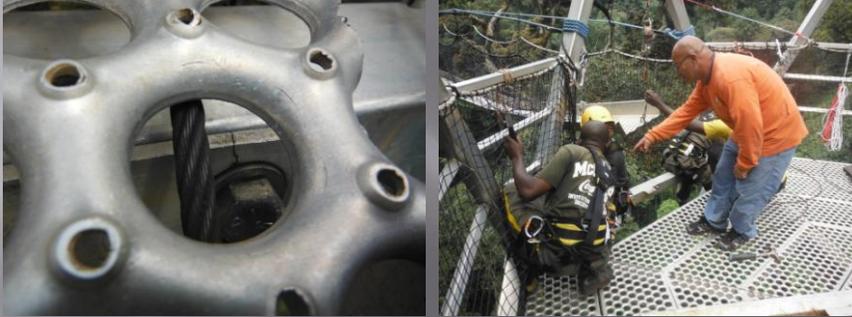
TOWER # 1 TO BRIDGE 2

The bridge connection for tower #1 to bridge 2 was replaced and a new beam installed.

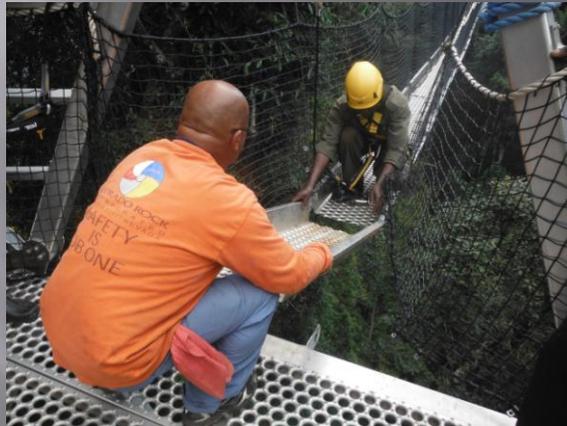
TOWER # 1 TO BRIDGE 2

The first bridge section on bridge 2 was replaced.

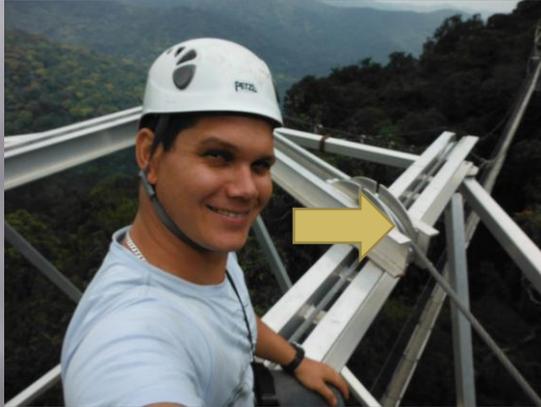
TOWER # 1 TO BRIDGE 2

Bridge saddles were checked and adjusted.

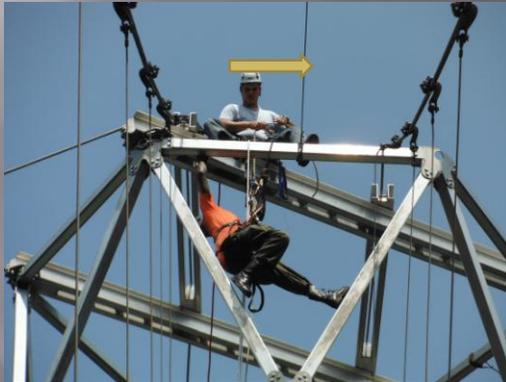
BRIDGE 2 AND CENTER SPAN

Adjusted and tensioned safety cable
for bridge #2.

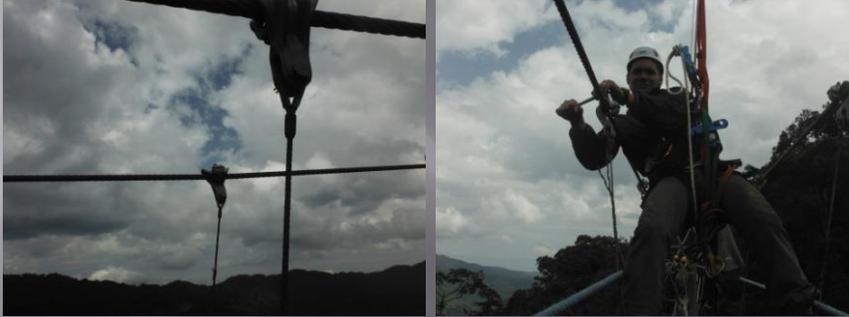
BRIDGE 2 AND CENTER SPAN

Hanger cables for bridge number 2 were checked and the bridge aligned.

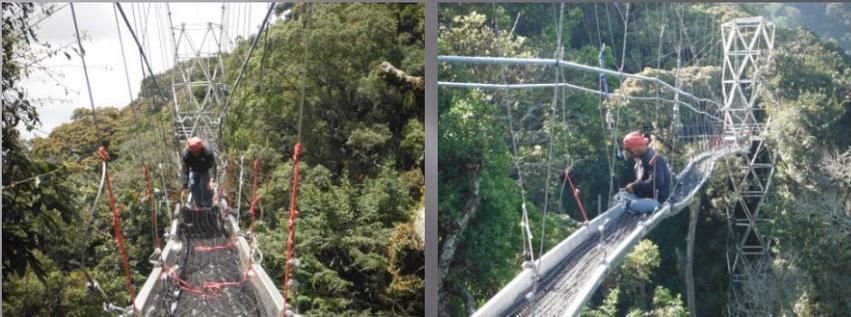
BRIDGE 2 AND CENTER SPAN

Nets were removed, inspected and re-set after bridge alignment.

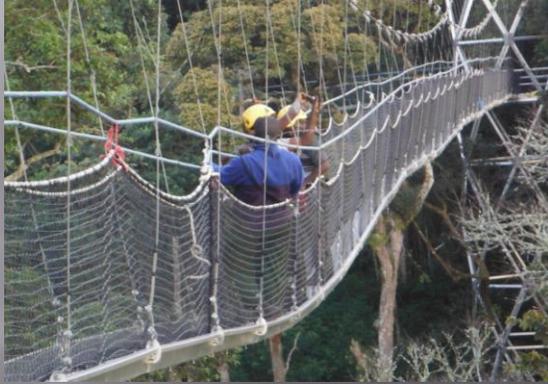
BRIDGE 2 AND CENTER SPAN

Bridge level was set and nets re-set.

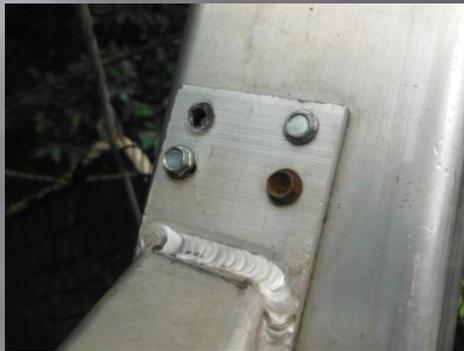
TOWER # 2

Some of the bolts securing the
handrails on tower 2 were replaced.

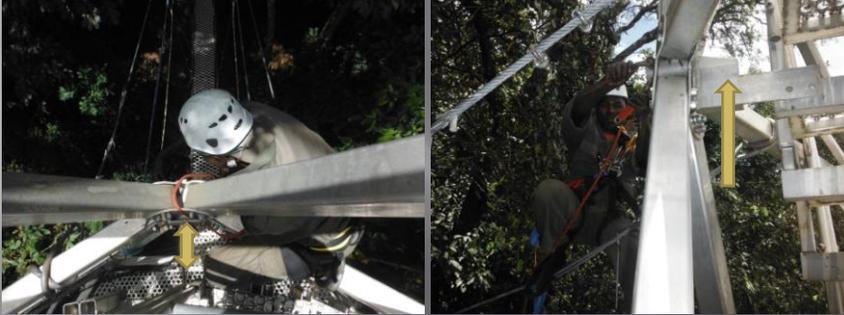
TOWER # 2

Stairs on tower #2 inspected and adjusted.

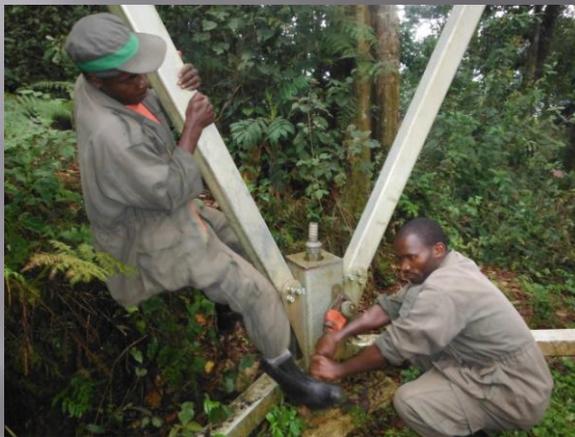
TOWER # 2

Tower #2 based was checked and bolts tightened.

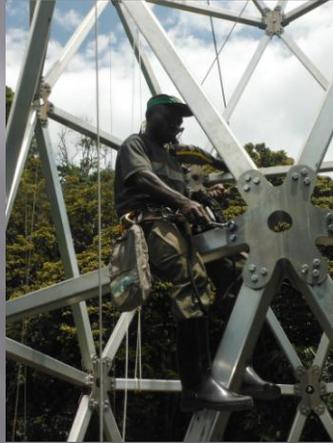
TOWER # 2

Tower #2 structure was inspected and bolts tightened.

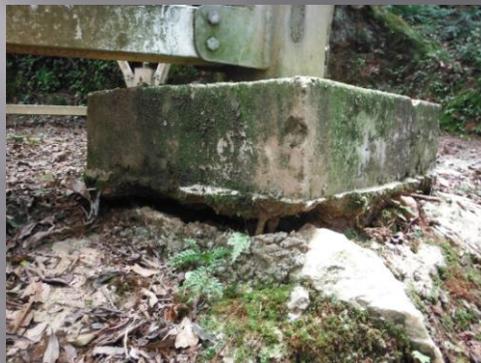
TOWER # 2

Soil erosion was found under all of the bases of tower number 2. It was recommended that new footings be set and poured. The tower remains level and the local maintenance crew were advised to carry out this procedure.

One area that requires further attention is the stabilization of the soil and control of water flow around and under the tower bases. There are signs of erosion and exposure of the tower footings. It is recommended that the tower footings be re-set and poured and ground cover or geo-fabric be added to the base area to limit erosion.

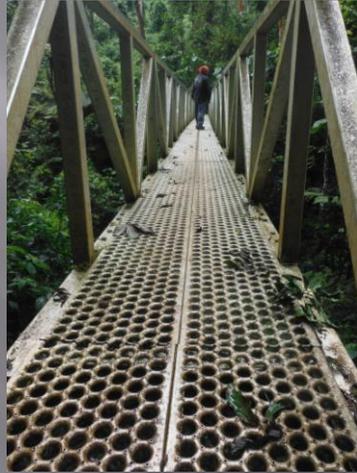
TRUSS BRIDGE

Conducted truss bridge inspection and re-installed tech screws to secure the decking.
