ARCE Groundwater Lowering Response Project, Luxor

“Conservation at Karnak Temple”

Existing Condition Survey and Overview of Additional Work Recommended for the Khonsu Temple

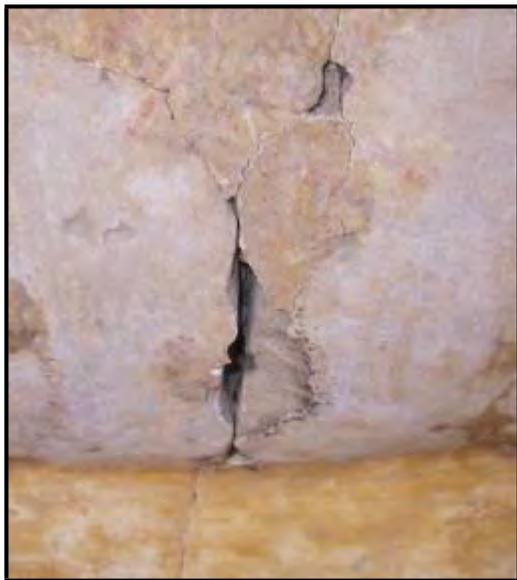
Figure 1.

Fills tend to be completed in only the larger areas of loss, smaller voids and cracks are often not filled (Figure 1). Many areas that were gently tapped upon examination of the wall sounded hollow, indicating detachment of stone, plaster or both (Figure 2). Also, there are several cases where damaged sections of plaster jut out on an angle from the stone surface (Figure 3). The edges of many damaged areas have not been protected with a fill material to secure them in place (Figure 4).

- **Additional fill materials are required for areas where detached stone and/or plaster are at risk for further damage, where there are large cracks or where additional edging protection is needed.** Some sections may require additional stabilization and the smaller areas will require a fill material other than mortar (e.g. a mix of glass microballoons, Paraloid B44, acetone and sand). The fill material can often be injected into the area requiring stabilization and can be tinted to an appropriate color using earth pigments. In some cases it may be possible to apply gentle pressure to the detached section using a metal spatula so it re-adheres to the surface. The methods and materials used for these treatments should be left to the discretion of the ARCE conservation staff. The higher sections of the temple (including the corners and sections of the ceiling) are in poor condition. Re-attachment and stabilization of thick plaster sections may be necessary in these areas (Figures 18 and 19).

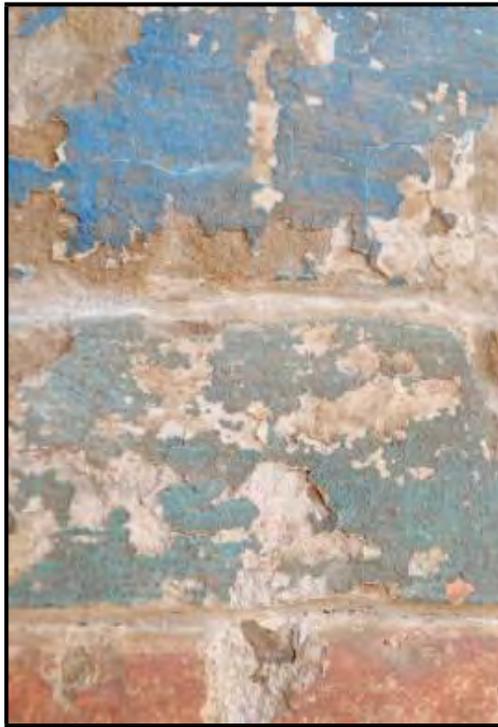
Figure 5.

Some consolidation work has been completed on friable areas of plaster and paint. However, there are sections where additional consolidation is needed and vulnerable areas that have not been fully stabilized (Figure 5). When touched, there are several paint flakes that move due to detachment from the surface of the plaster. Examples of this can be seen on the curved sections of the columns (Figure 6). Darkening of the surface is one risk with consolidation. Therefore, the consolidant should be tested beforehand and, regardless of the adhesive that is used, it should be a dilute solution (e.g. 3% Paraloid B72 or B44 in acetone).

- **Consolidation is necessary for several sections of the walls and columns; some areas that have been previously consolidated should be evaluated as they may require additional treatment.** Care needs to be taken when applying the consolidant. When too much or too concentrated of a solution is applied, the area can become significantly darker. Excess consolidant has been noticed in some areas and should be removed with an appropriate solvent (e.g. acetone) and small cotton swabs.

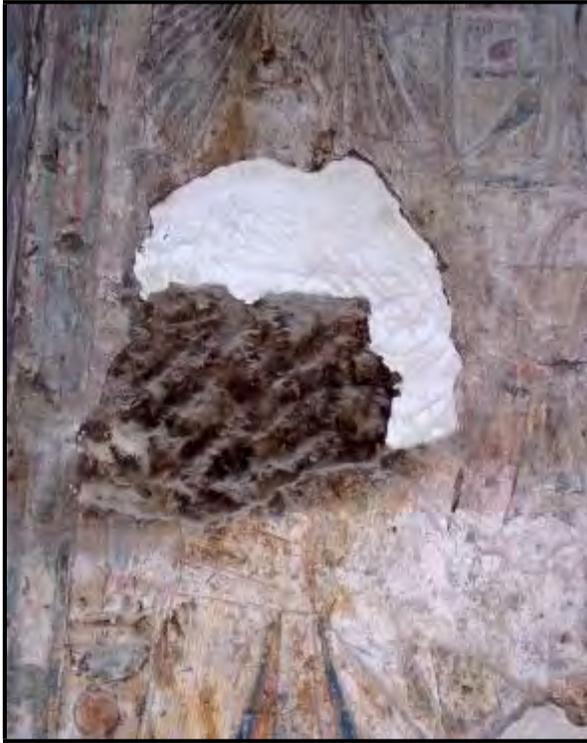
Figure 7.

Although the mortar work has improved since the last examination of the temple by ARCE staff in early May, additional work is recommended. There are some sections along the South Wall which have not been filled or have only been partially filled. In a few areas, the first layer of mortar is visible with scoring on the surface (Figure 7). There are also uneven and unsmooth

- **Additional mortar work should include:**
 - 1) Completion of unfinished areas and voids
 - 2) Removal of any old cement fills and replacing this material with lime mortar

- 3) Smoothing of any uneven mortar surfaces and building up of sections that need additional mortar for stabilization purposes.
 - 4) Do additional grouting around the existing mortar fills, making sure the first layer of mortar is not visible.

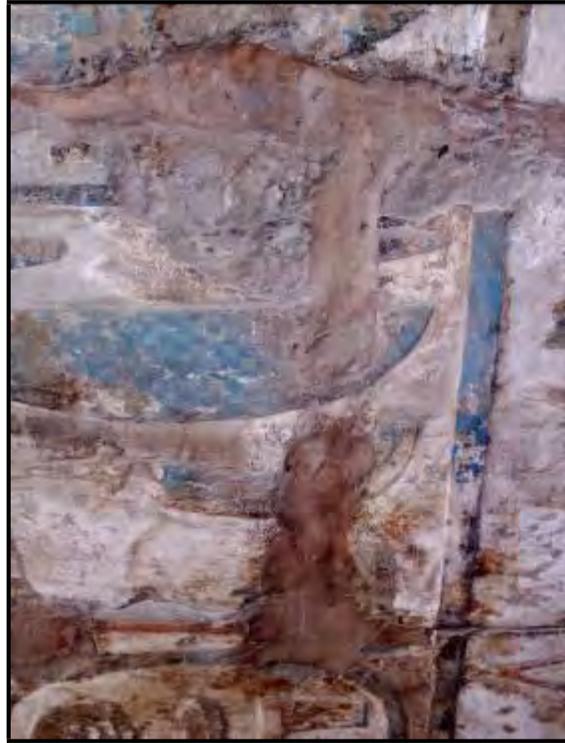
Figure 8.

mortar surfaces and some areas where the old mortar has not been removed (Figure 8). There are also a few mortar patches (previously applied) that are a different color from the recent patches. The latest mortar work in Khonsu Temple was completed by SCA staff, not the ARCE field school. In general, there should be a more consistent approach to the mortar work.

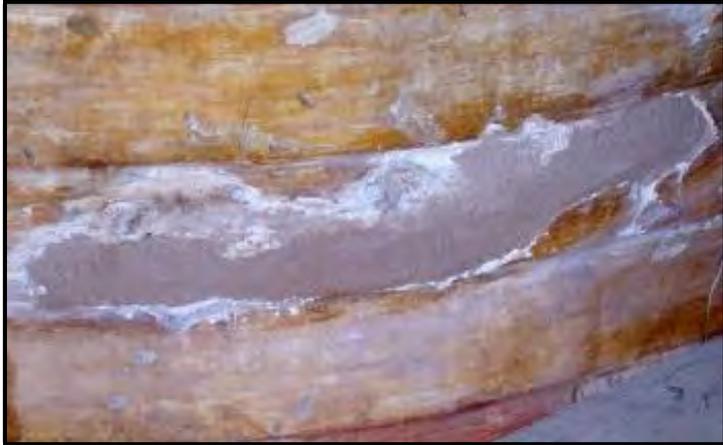
Figure 9.

The edges and grouting of smaller voids need further attention. In many sections the mortar work appears unfinished, particularly around the edges of the fills (Figure 9). Care also needs to be taken to apply the mortar neatly so as not to leave the first layer visible in any section or smudge the mortar outside of the fill (Figure 10). Some fills also need to be built up higher in relation to the original wall surface.

- 5) Clean off any excess mortar or smears around the edges of the fills.
- **Investigate the dark, stained areas to determine if this occurred in antiquity or if it could be the result of recent cleaning, consolidation or water used during the mortar application.** Some cleaning tests should be completed, using different solvents or poultices, to see if it is possible to remove or reduce some of the staining. The tests

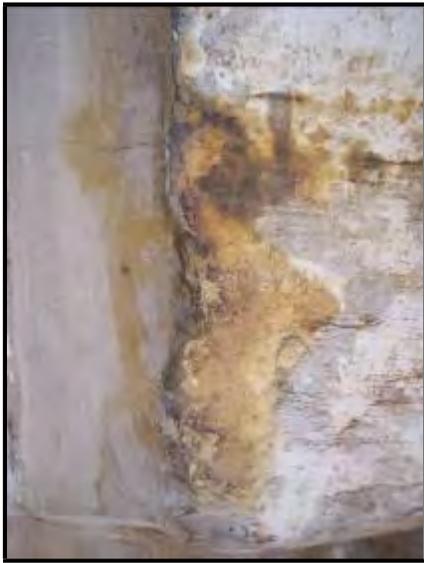
Figure 11.

There are many areas where staining is present on the surface of the walls and columns (Figure 11). Some sections of the surface are much darker and have a yellow, oily appearance. One possibility is that the staining has resulted from iron inclusions within the original stone that have migrated to the surface with the application of any water or solvents (either during the cleaning process or during the mortar application). On some of the columns there is staining which looks as if it might have formed around the edges of something square that was applied to the surface (Figure 12). Large rolls and squares of cotton have been used for cleaning in the temple, so this possibility should be investigated further. The staining may have occurred in antiquity or some of the darker, oily areas may be a result of using too much consolidant. Whatever the cause, stains are present on several sections of the walls, columns and around the edges of many fills.

and any treatment that follows should be left to the discretion of the ARCE conservation staff.

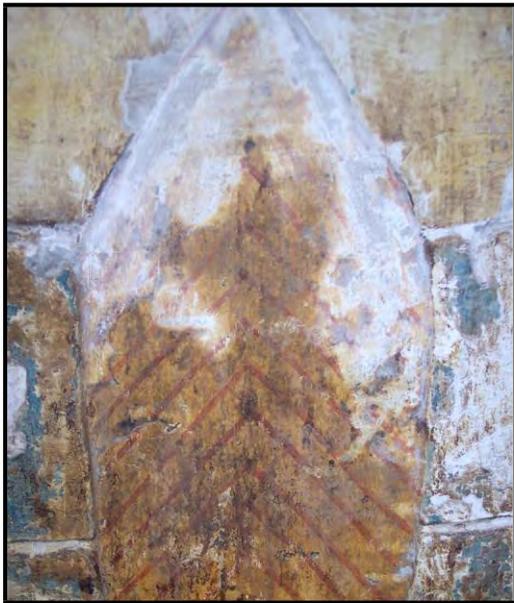
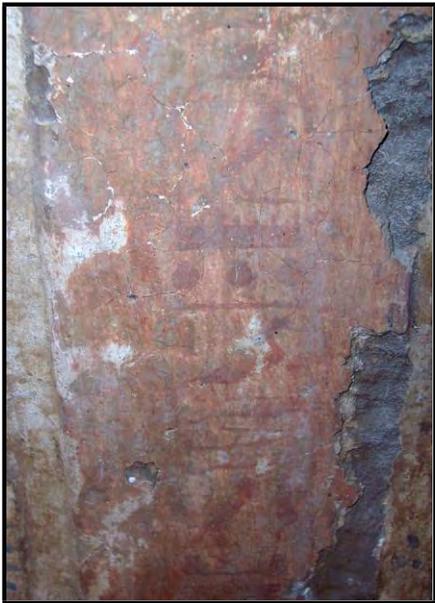
Overall, the cleaning that has been completed in the temple is inconsistent. Some of the plastered and painted areas do not appear clean enough (Figures 13 and 14). There are several instances where mortar and other chemical drips have been left on the surface of the wall (Figures 15 and 16). Cleaning is not as crucial as the issues that have been previously discussed in this survey and can be a lower priority for next season's work.

- **Dry and alternate wet cleaning methods should be trialed as these could allow for more control and result in a more thoroughly cleaned surface.** Smaller areas should be cleaned at a time, avoiding the use of large squares of cotton saturated with solution. Once again, decisions about an alternate cleaning method should be discussed, tested and decided upon by ARCE conservation staff.

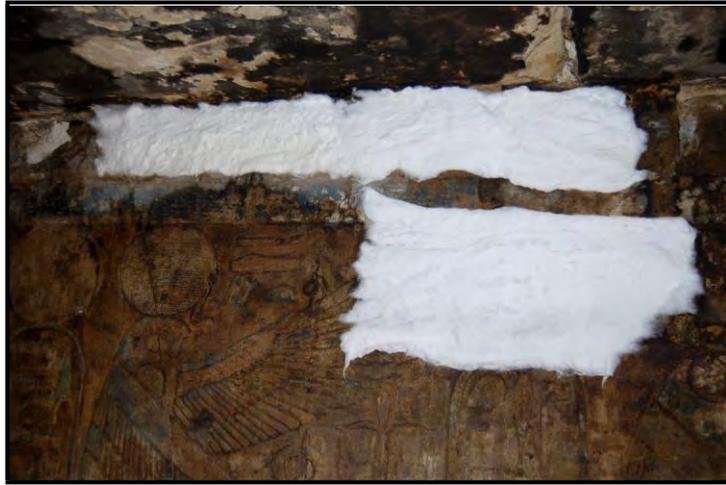
Figure 17.

However, in the long-term, it seems in the best interest of the temple to alter the cleaning methods. The current technique involves placing large sheets of cotton on the surface (Figure 17) and then saturating the cotton with the following solution: ammonium carbonate, ethylenediaminetetraacetic acid (EDTA) and distilled water. Alternate methods of cleaning which allow for more control and do not saturate the surface as much should be trialed.
