FINAL REPORT

ASLP Project No. RU10-009

Leakage Detection Survey of the Qaraoun Dam, Lebanon using Remotely Operated Vehicle

Leakage Detection Survey of the Qaraoun Dam in Lebanon April 20-26, 2010

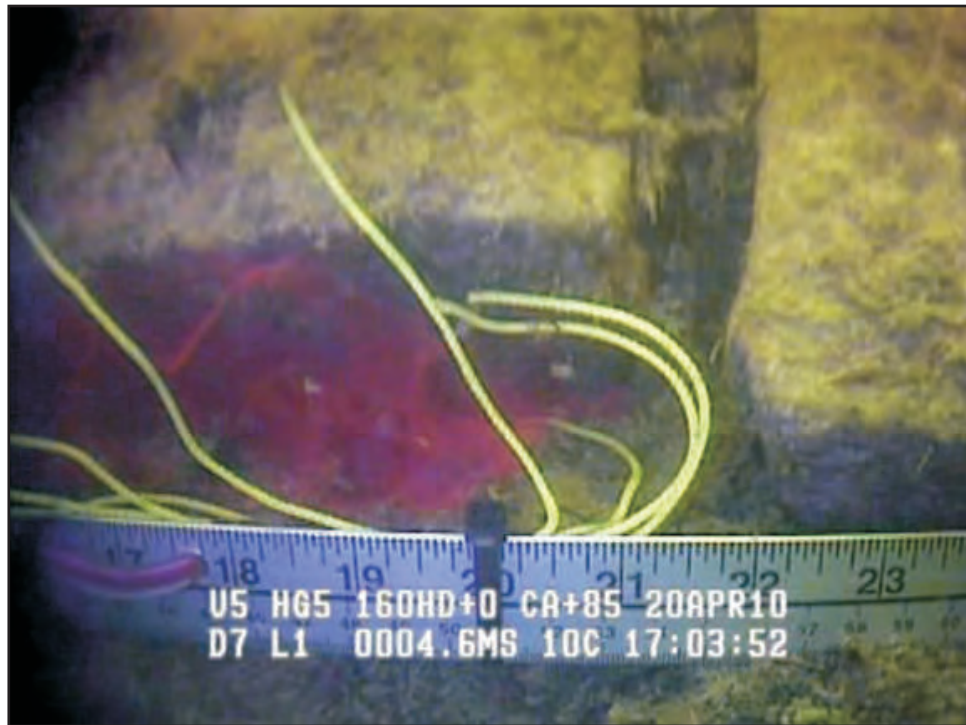
Image 1-1: 2010-04-20-1703 - Joint offset at joint O9 and upper horizontal joint.

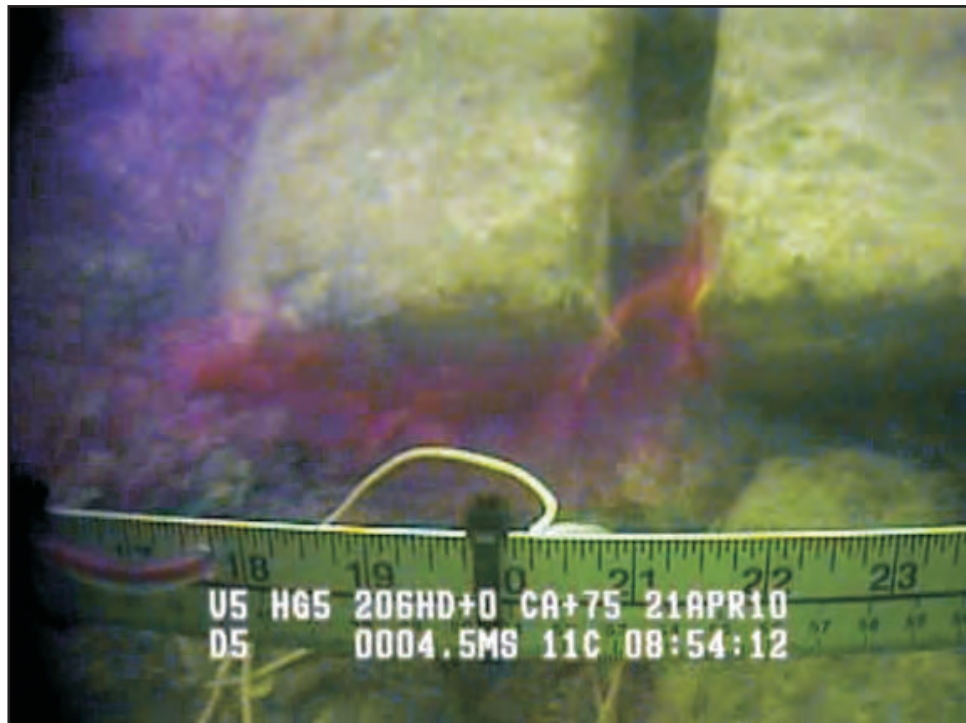
Image 1-2: 2010-04-21-0854 - Joint intersection at joint O6 and upper horizontal joint.

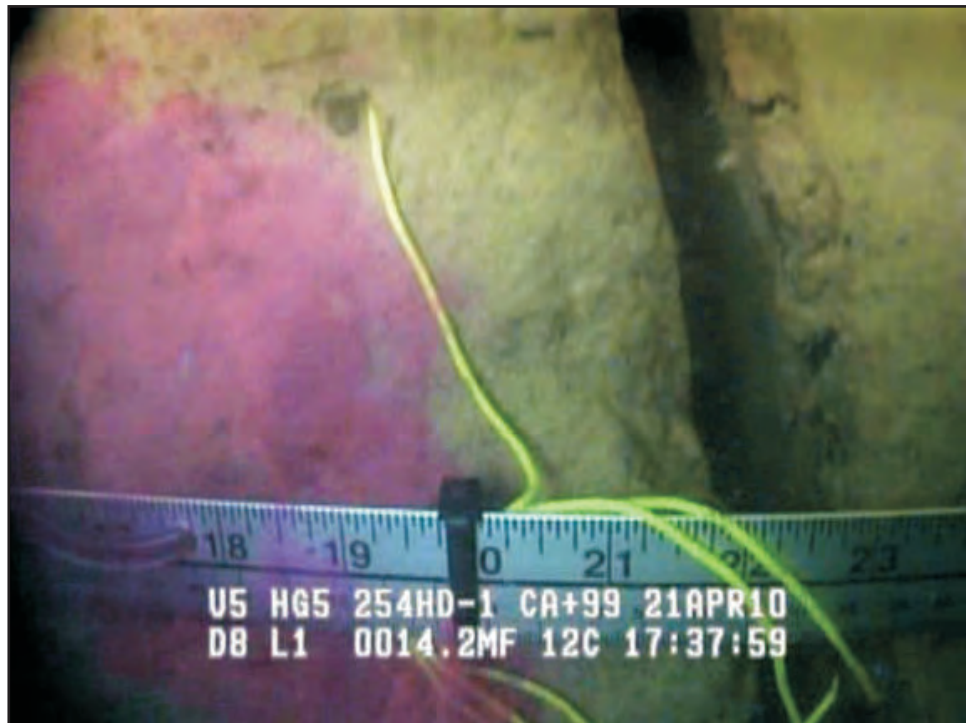
Two leaks were identified in this section; one along Joint 29 at elevation 840.1. The second, a large leak at 831.3 m elevation along Joint 24. This second leak was recorded on April 22 at 16:16 and was observed to be less than 1 m in length with an opening 2 cm wide. A high velocity of flow was noted through this opening, evident by the clean concrete surrounding the leak.

Image 1-4: 2010-04-21-1737 - Leak in vertical joint 29.

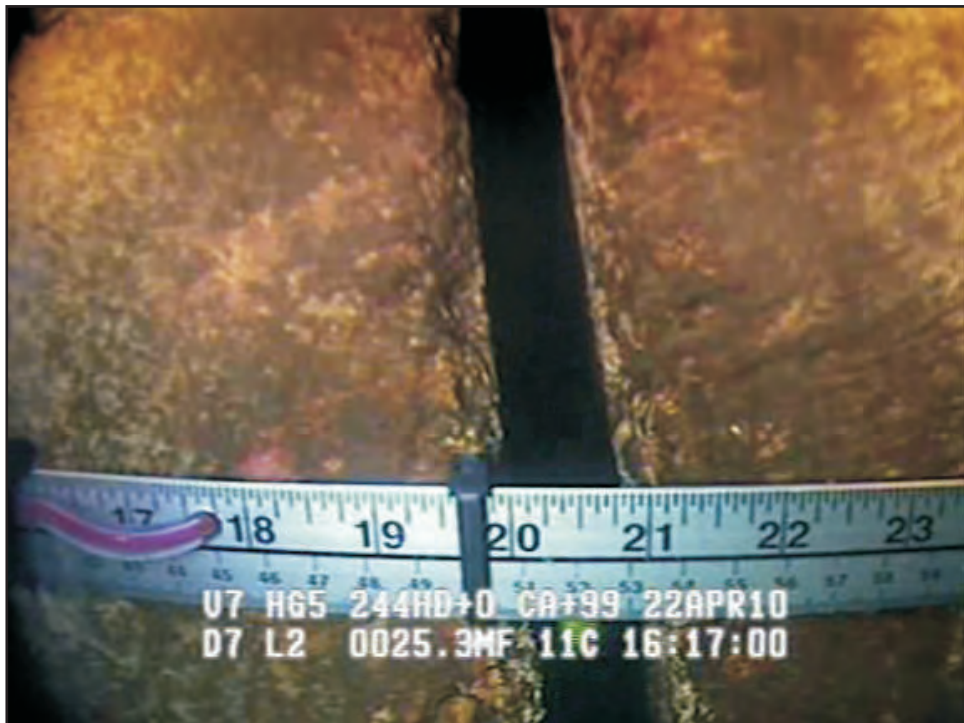
The first major leak was located at Vertical Joint 24 at 831.3 m elevation. This leak was on the vertical joint below the third horizontal joint. The leak had a high volume of flow through an opening 2 cm wide and less than 1 m high, found on April 22 at 16:16. (See Image 1-6 & 1-7 in Appendix 1.)

Image 1-6: 2010-04-22-1617 - Large leak closeup at joint 24.

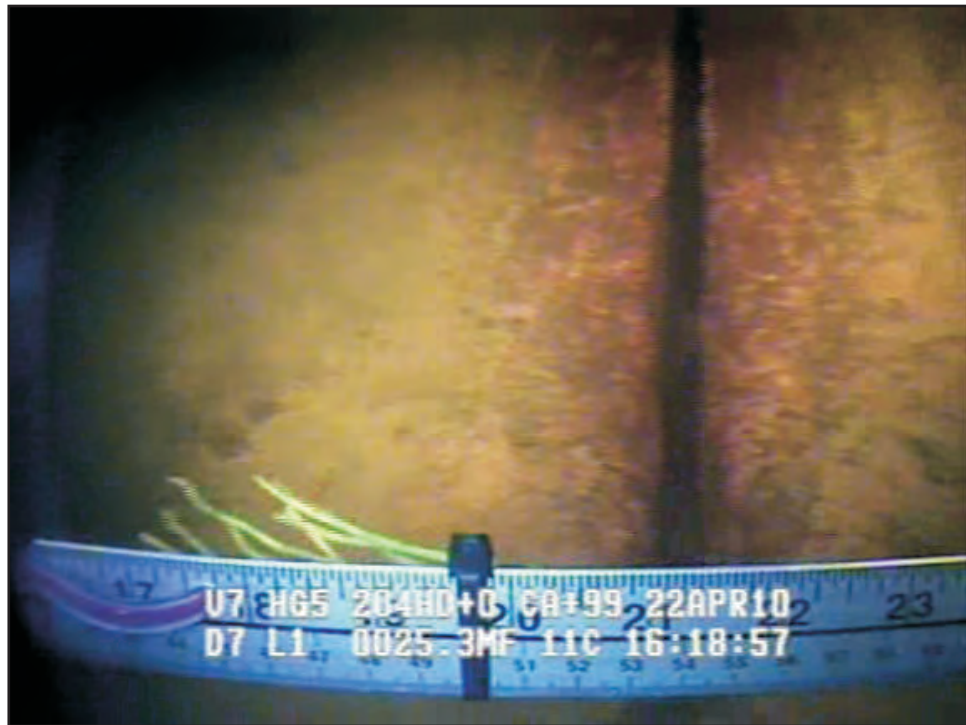
Image 1-7: 2010-04-22-1618 - Large leak in vertical joint 24 at 831.3 m elevation.

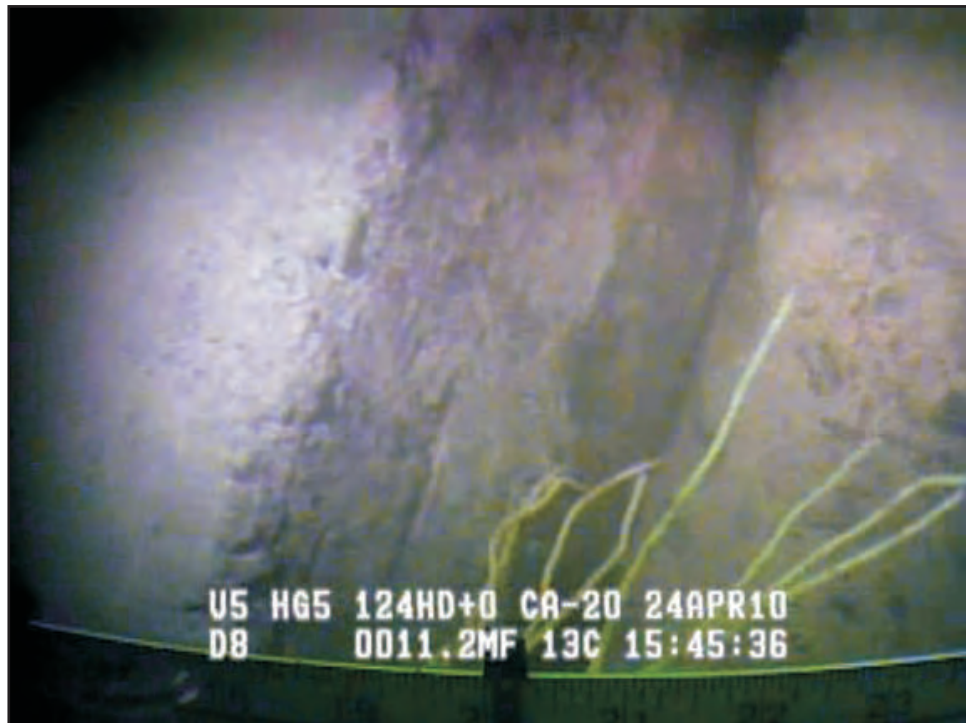
Image 1-8: 2010-04-24-1545 - Raised slab at joint O2.

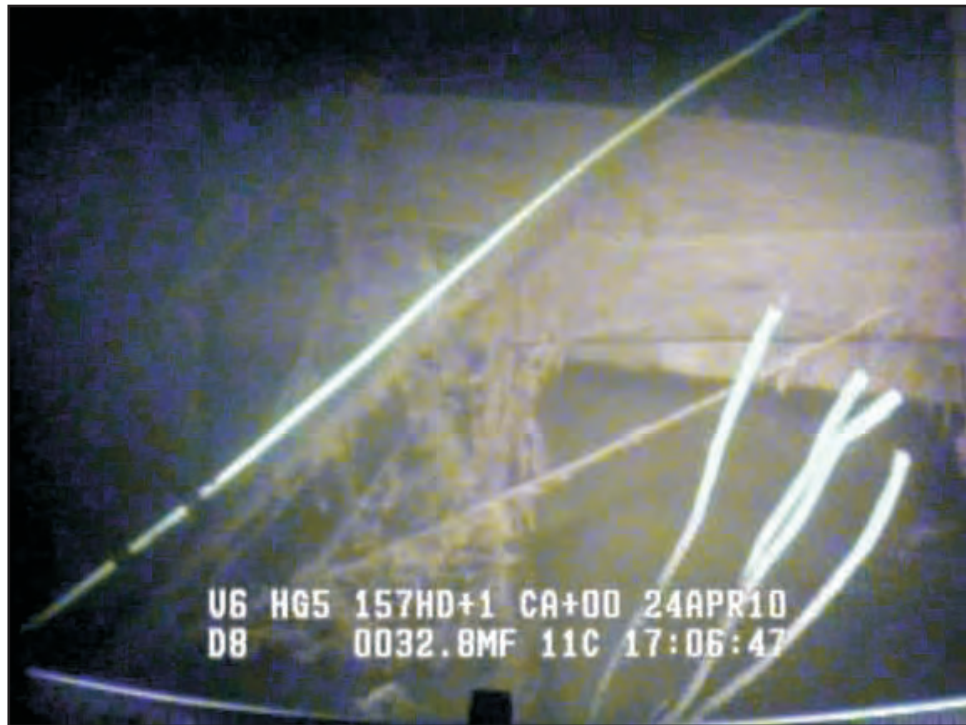
Image 1-9: 2010-04-24-1706 - Net, ropes and debris hanging on platform near joint 10 at elevation 815 m.

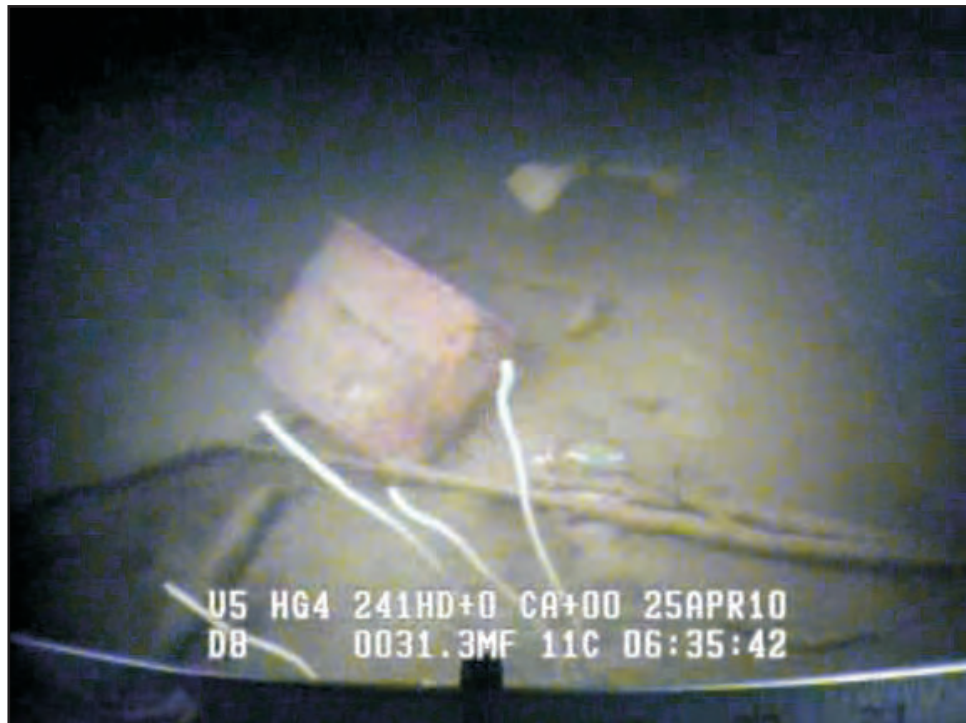
Image 1-10: 2010-04-25-0635 - Debris at bottom of abutment.

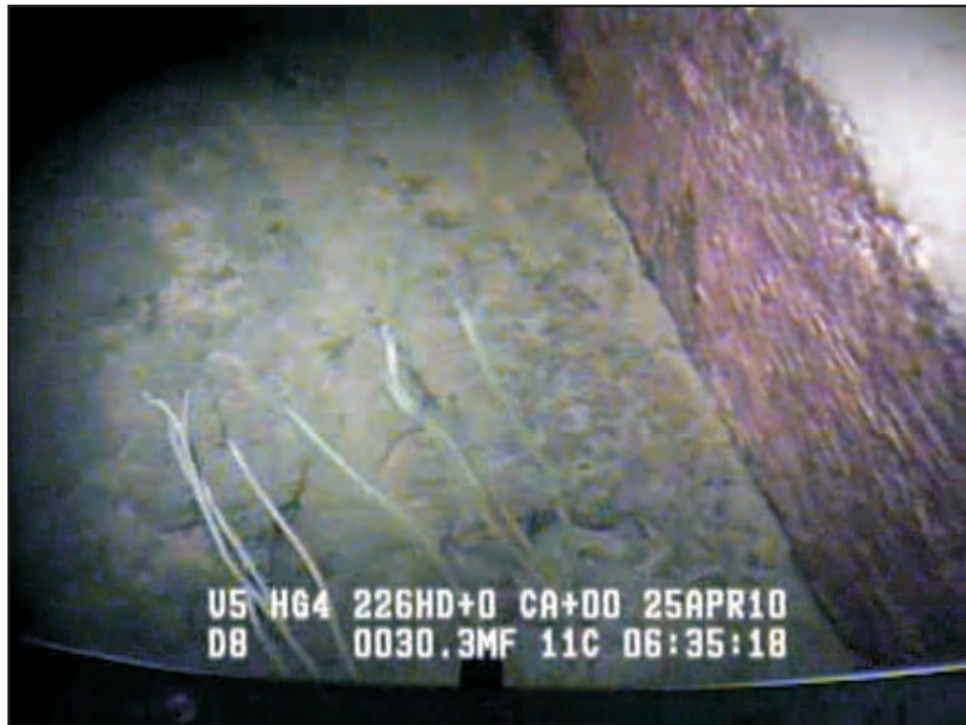
Image 1-11: 2010-04-25-0635 - Raised slab along joint C.

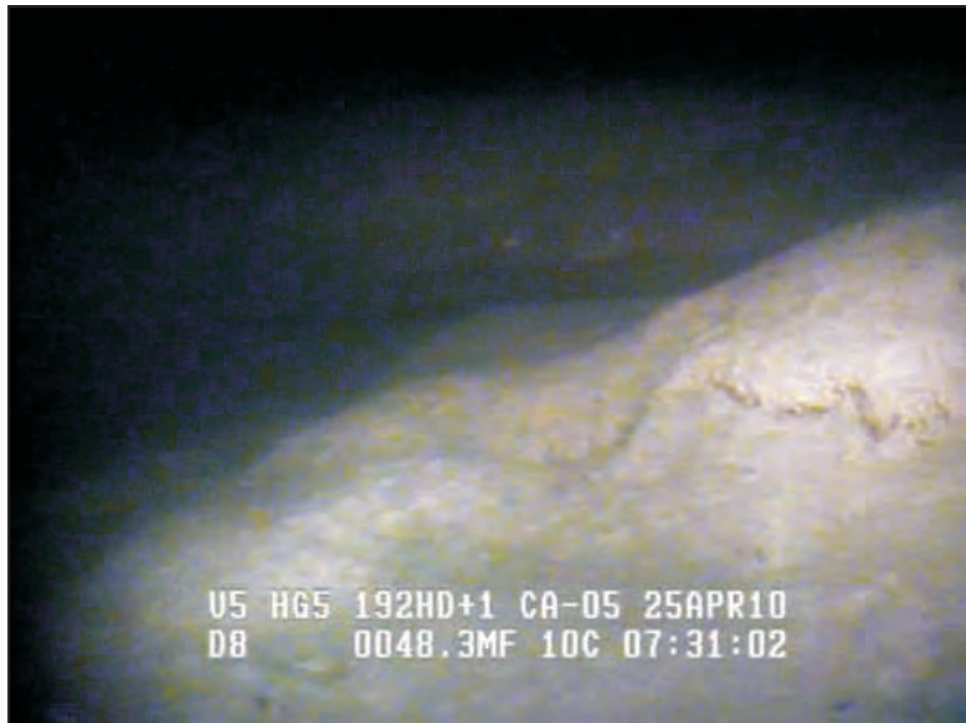
Image 1-12: 2010-04-25-0731 - Silt at floor of power tunnel inlet.

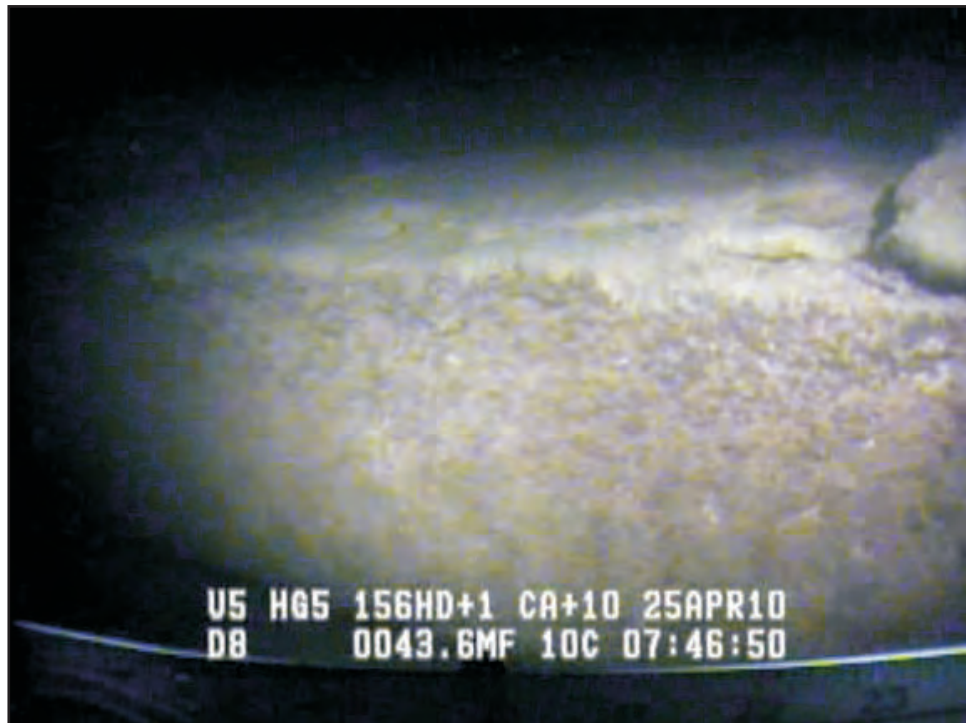
Image 1-14: 2010-04-25-0746 - Silt on vane in inlet.

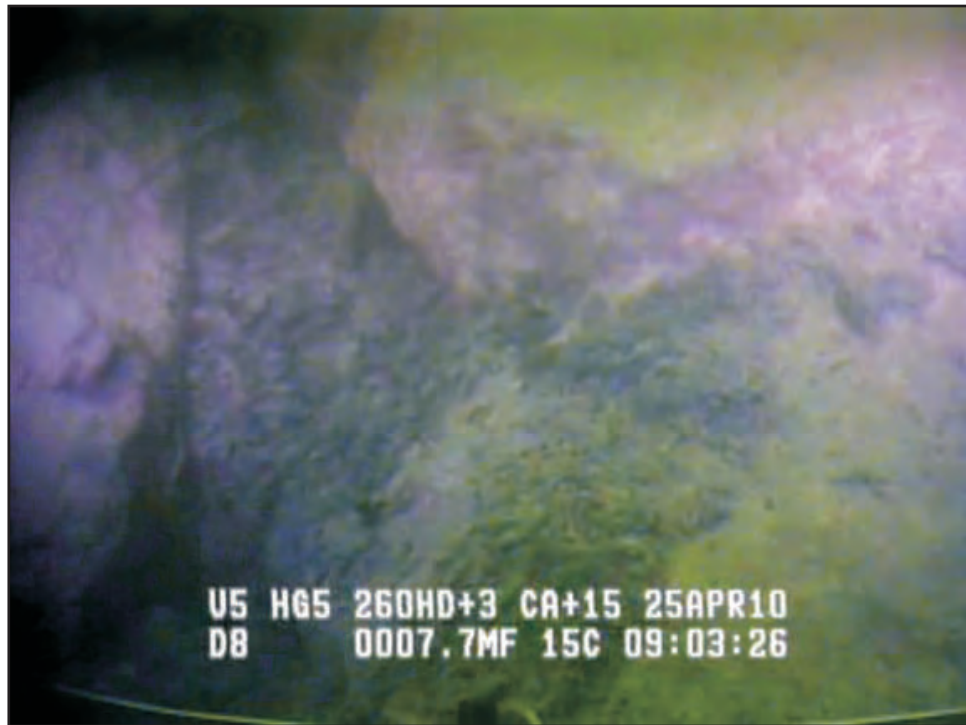
Image 1-15: 2010-04-25-0903 - Broken edges of slab at joint 2.

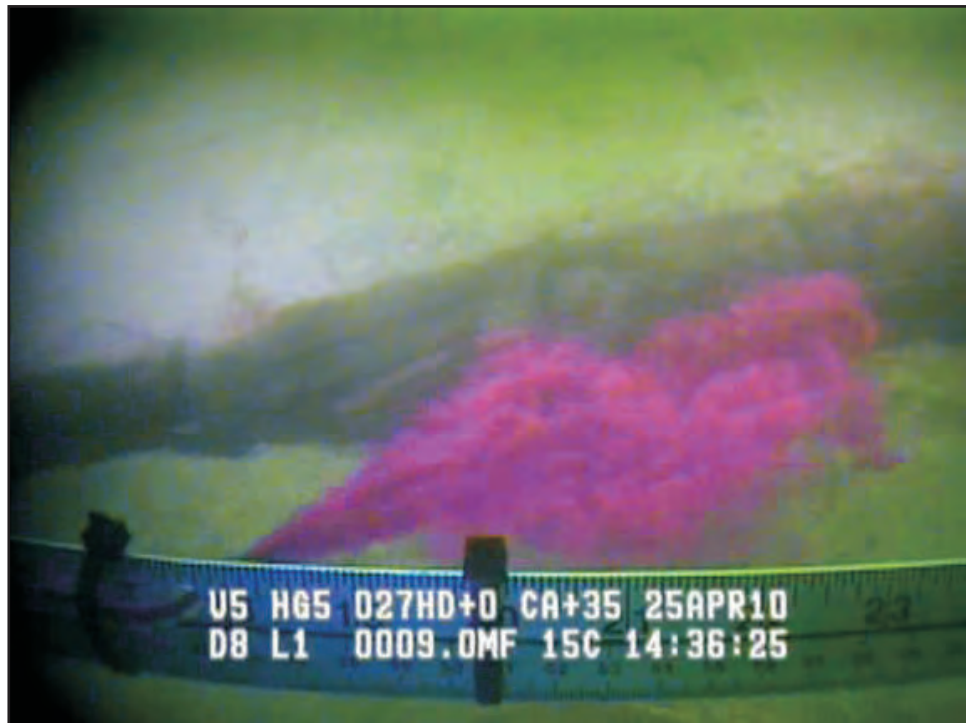
The second area with a large volume leak was detected at Vertical Joint O1 just above the abutment at elevation 847.4 m. It appeared two leaks in the same proximity were identified here on April 25 at 14:09 and 14:35. This area had been reported by LRA as repaired on August 14, 2009. On April 26, 2010, 1.5 liters of dye was injected here to aid in locating the path of the leak (shown in Image 1-22, Appendix 1).

Image 1-16: 2010-04-25-1436 - Dye being pulled in to large leak in joint O1

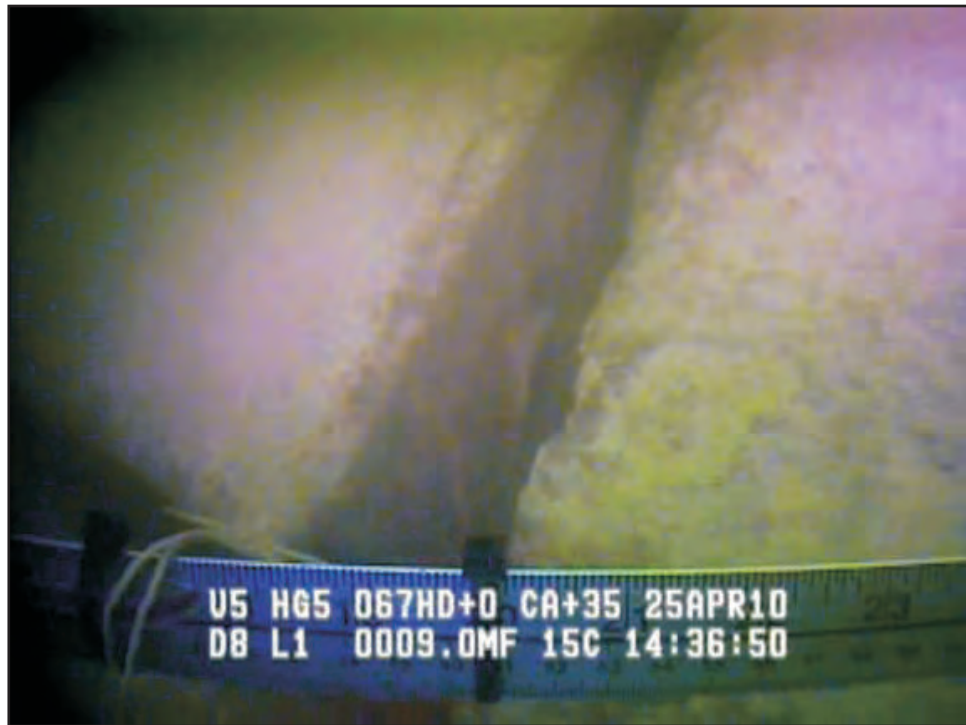
A large leak was observed at Vertical Joint O1 on April 25 at 14:35. This leak appeared to be present in two locations near the third horizontal joint down. This was an area that had been repaired in August of 2009. Another possible leak was identified just above this large leak on Joint O2 and below at elevation 834.8 m. Some other possible leaks were noted at Joint O8 at 854.6 m and at Joint O10 at elevation 855.7 m.

Image 1-17: 2010-04-25-1436 - Leak at joint O1.

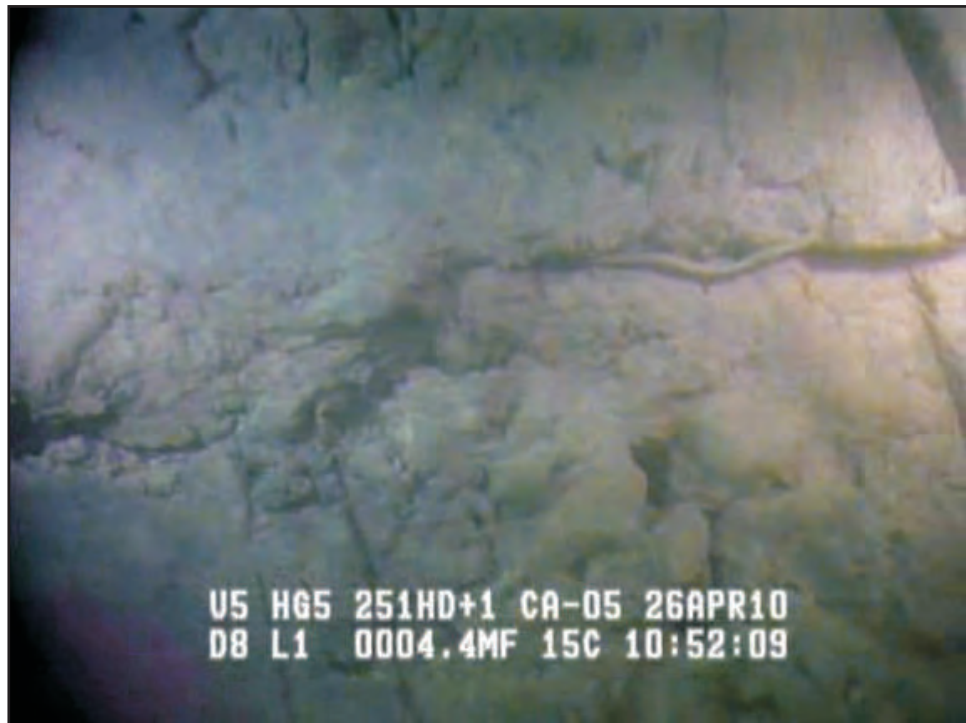
The reservoir spillway structure is north of Vertical Joint 23 about 50 m from the dam. An inspection of this structure was requested by LRA for the locating of leaks. The ROV was tended from the structure while operated from the dam. The south side was inspected, where a notable number of patches of rough concrete forming were observed. The underside edge of the overflow flume was rough with small holes present (Image 1-18, Appendix 1). No leaks were positively identified by the ROV.

Image 1-18: 2010-04-26-1052 - Porous concrete interface on spillway.

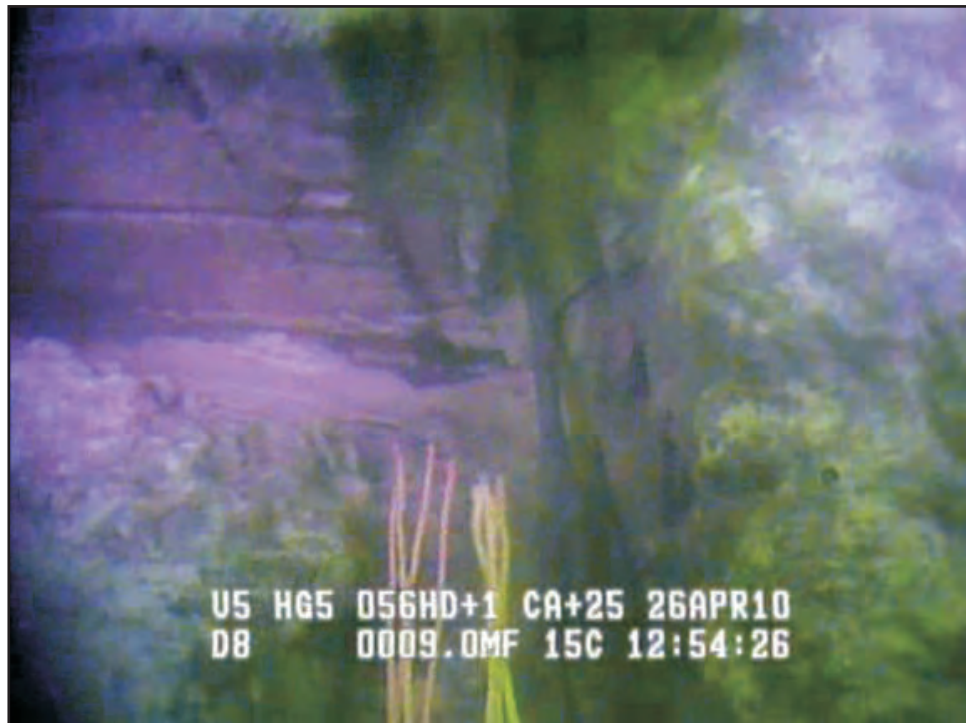
Image 1-22: 2010-04-26-1254 -Injecting dye into large leaks at O1.

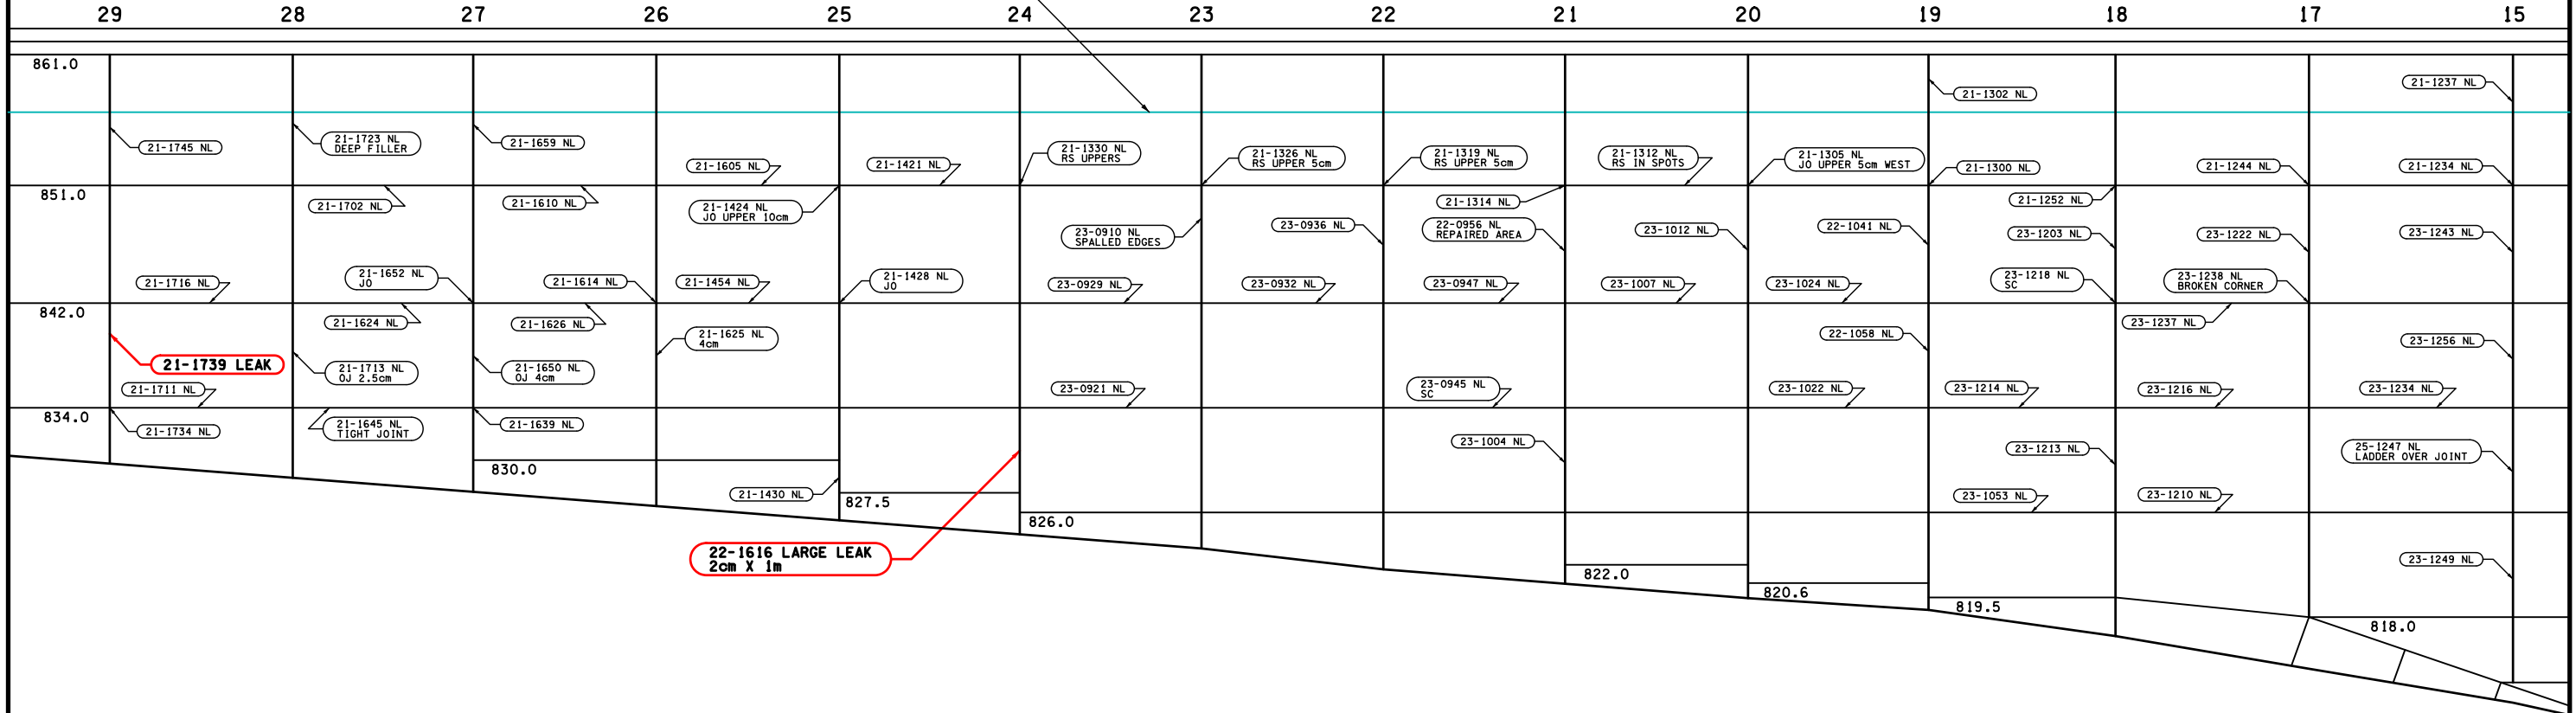
APPENDIX REF.
NUMBER:
2 - 3
SHEET 03 OF 07

Sheet 3 covers the area from Joint 29 through to Joint 15. At Vertical Joints 27 and 24 offsets were noted at the top of the dam above the water line. Along the upper horizontal joint in this section the upper slabs were generally raised. Numerous areas with shifts and offsets were noted.

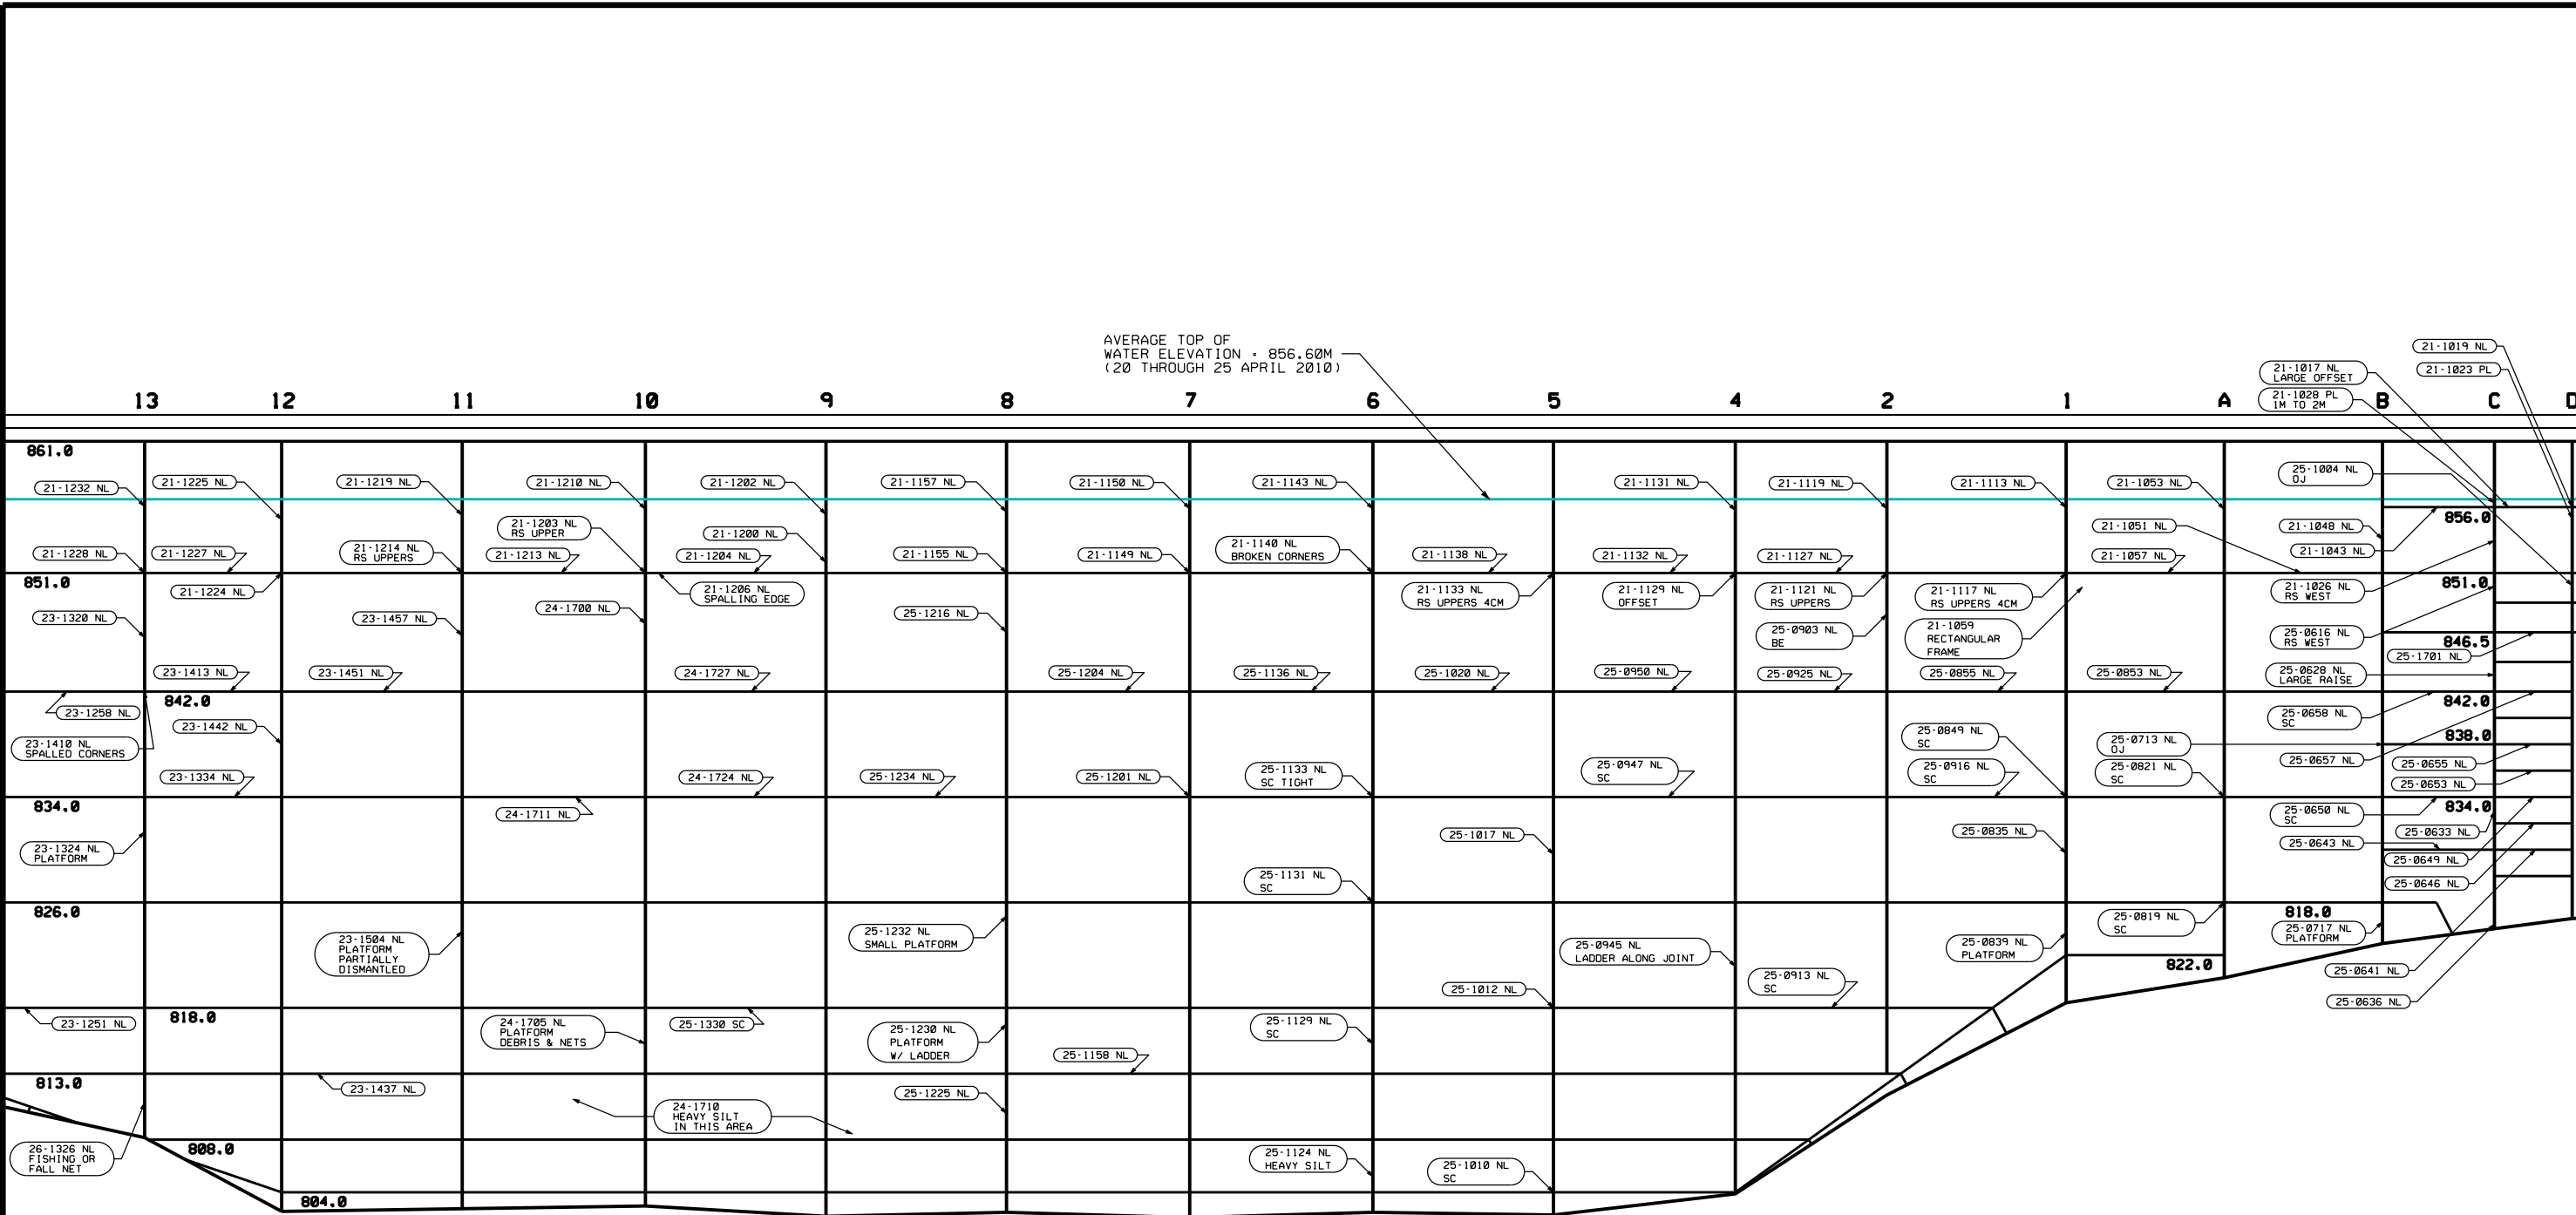
APPENDIX REF.
 NUMBER:
 2 - 4
 SHEET 04 OF 07

In Sheet 4, the deepest section of the dam is covered from Vertical Joint 13 to Vertical Joint D. The dam appeared to have few offsets and misaligned joints in this area. Across the upper horizontal joint at 851 m a continuous offset where the upper panels were raised above the second row of panels was observed. Near the area east of the abutment at Vertical Joint C, larger offsets were noted where the east panels were lower than those adjacent to the abutment.

In a few areas spalling was noted on joint edges including: Joint 13 at 842 m, Joint 6 at 851 m and Joint 2 below 851 m. In the deeper section of the dam several more rows of scaffold bracketing were observed below each horizontal joint. In some areas ladders were present along the vertical joints. Rope, netting and other debris were attached or present on and around the scaffold sections, shown in Image 1-9 in Appendix 1. On the bottom a thick layer of silt was present generally obstructing a view of the horizontal joints. A variety of natural and artificial debris was present on the reservoir floor.

Along Vertical Joint C and D, both at 855 m elevation a possible leak was observed.

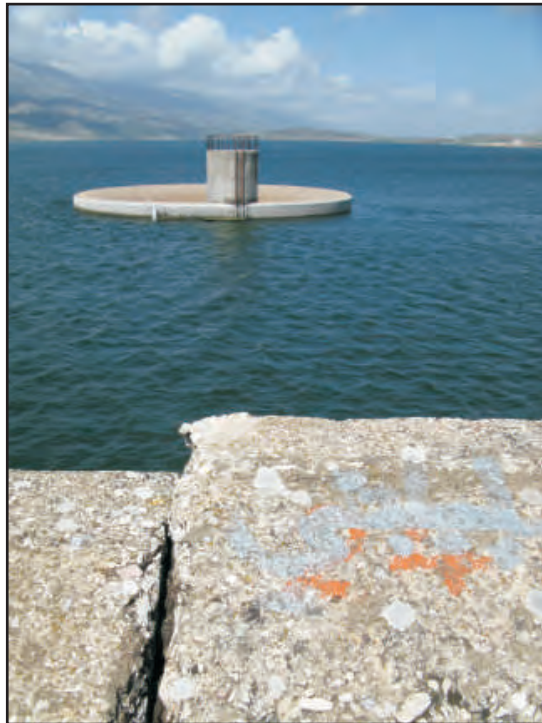
Image 4-4: Spillway and offset at joint 24.

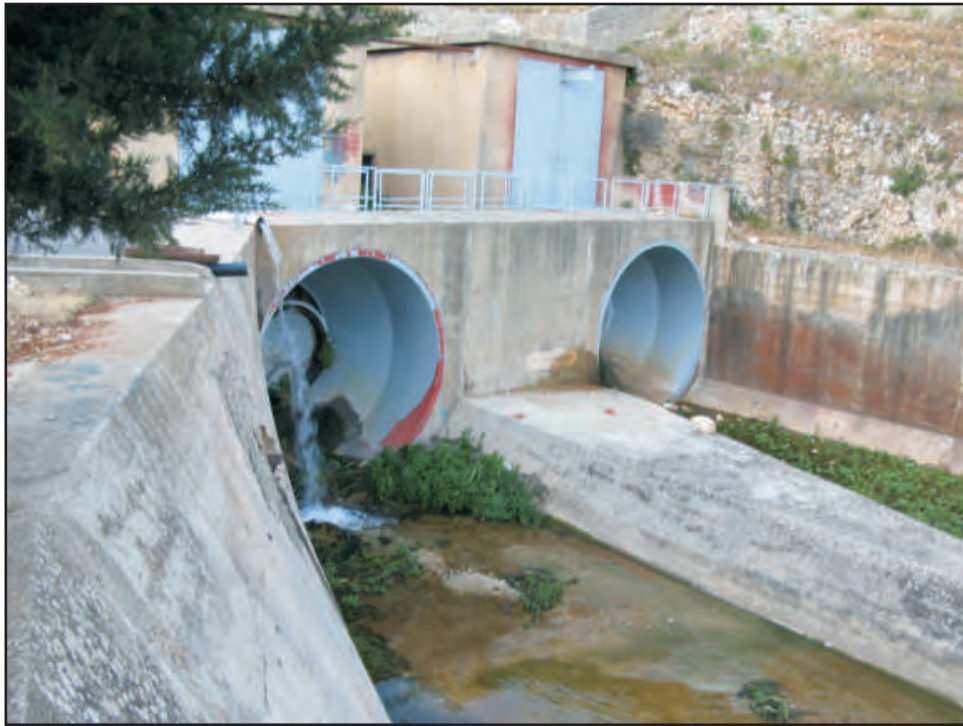
Image 4-7: Drainage outlets with combined leaks in small conduit.
