LITANI RIVER BASIN MANAGEMENT SUPPORT PROGRAM

ROVER TRAINING AND QARAOUN DAM INSPECTION

April 2012

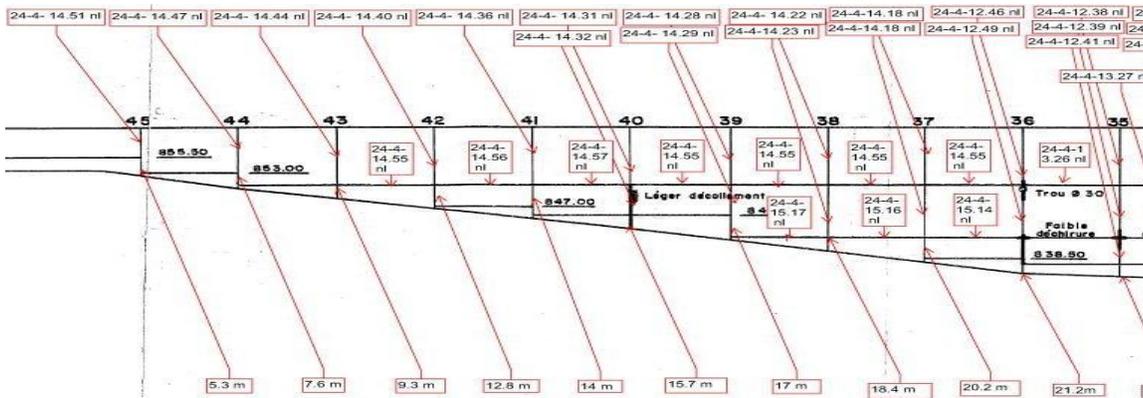
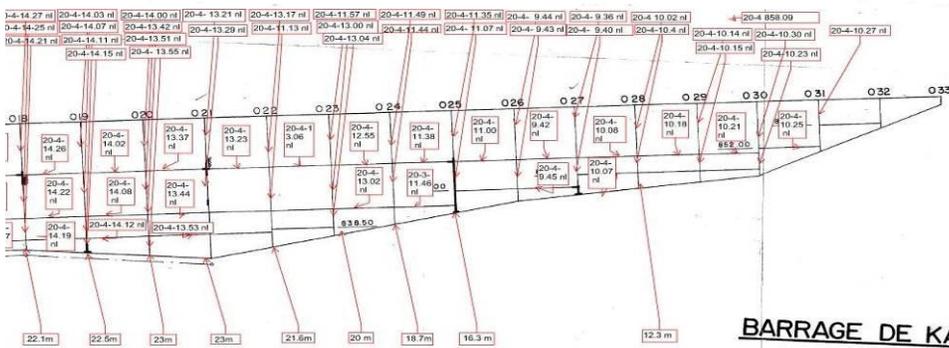
4.1. INSPECTION LOGS

After each joint, or series of joints, the date, time, and condition of that joint was marked on a diagram of the dam face. Areas that could not be inspected were also labeled. The diagram is intended as the primary recording of inspection data, and the only accurate reference. Wireless headsets were obtained on the second day of inspection, and some of the video contains the audio of the operators and the tether tender during the operation. If needed, this audio could be used to verify the data recorded on the diagram.

The majority of all joints on the upstream dam face were visually inspected. LRBMS employees observed the inspection and noted no noticeable damage or features of concern. Leak detection was also performed regularly, and at no location was there a noticeable flow of water into the joints. Special attention was given to areas which previously had leaks. Again, no flow of water into the previously leaking areas was observed. This shows that the repairs carried out end of 2010 by LRA after the previous rover inspection were very effective.

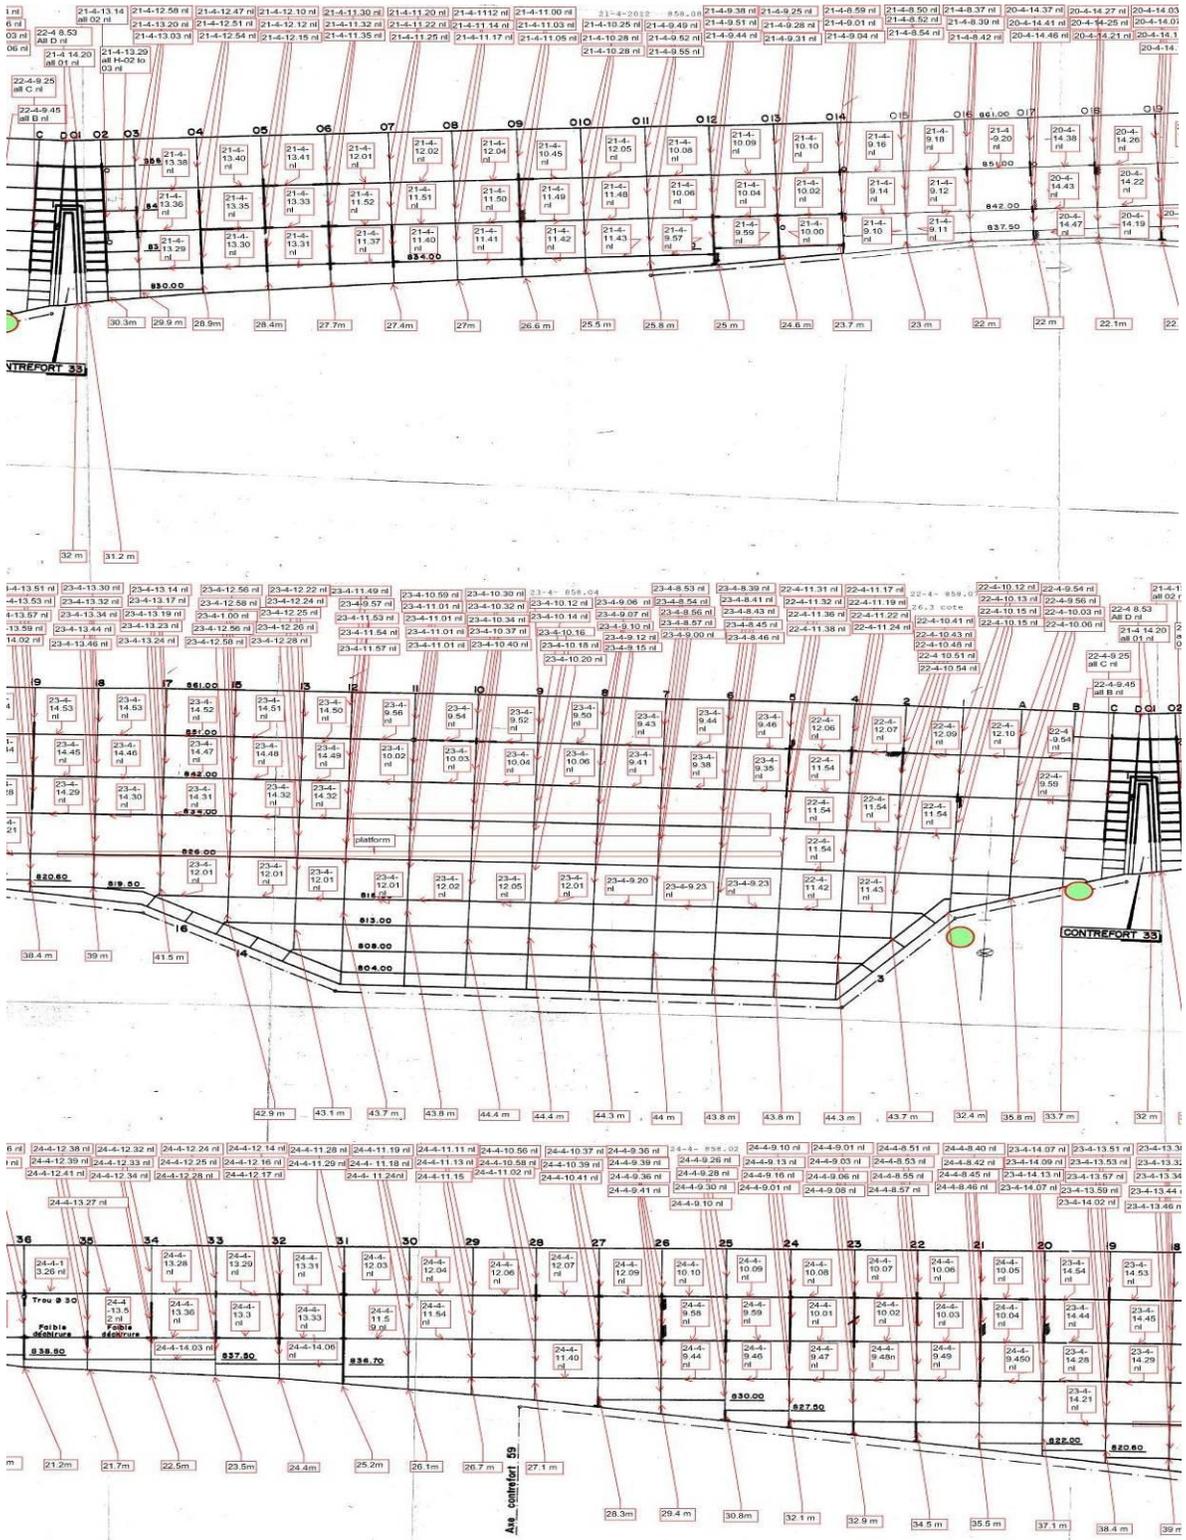
Découpage du Masque

Drawing showing joint layout and joint areas that were repaired. This was included in the 1980 inspection report.
