## Kandahar Helmand Power Project (KHPP)

**CONTRACT: 306-C-00-11-00506-00**

**Kajaki Hydro Power Plant Transmission and  
Distribution Facility Assessment Report - DRAFT**

**March 17, 2011**

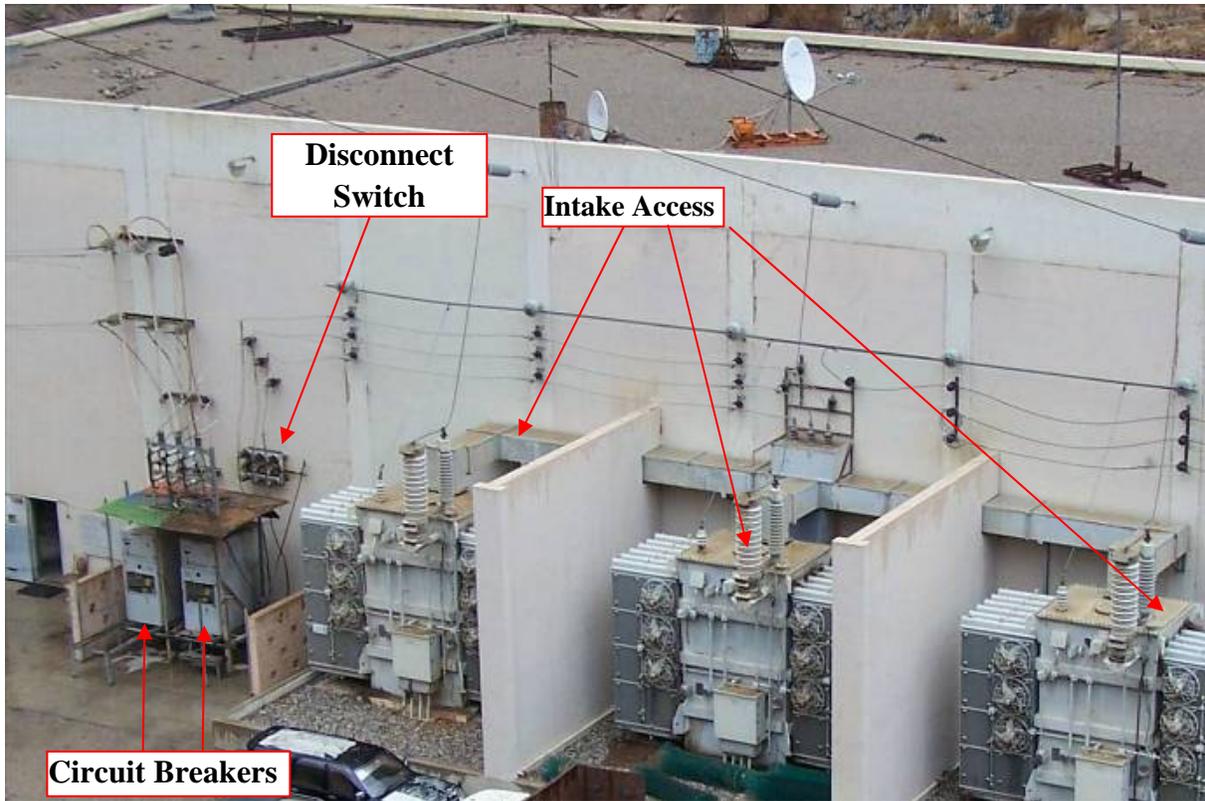
**Figure 4-1 Existing Configuration at KHPP**

The existing configuration consists of two overhead 13.8 kV feeders leaving the powerhouse and directly connected to an extension of the 13.8 kV generator bus-duct feeding the 13.8/110 kV generator step-up (GSU) transformers as shown below in Figure 4-1

The two overhead circuits were originally protected via the two indoor-rated circuit breakers, housed outdoors under only a shed roof, with a non-load break gang-operated switch. One of the circuit breakers is inoperable and the remaining circuit breaker is bridged to both feeders and is providing limited protection for all of the 13.8 kV bus.

The non-load break gang-operated switch, connecting cables and insulators are in extremely poor condition and subject to arc flash-over during even the lightest precipitation.

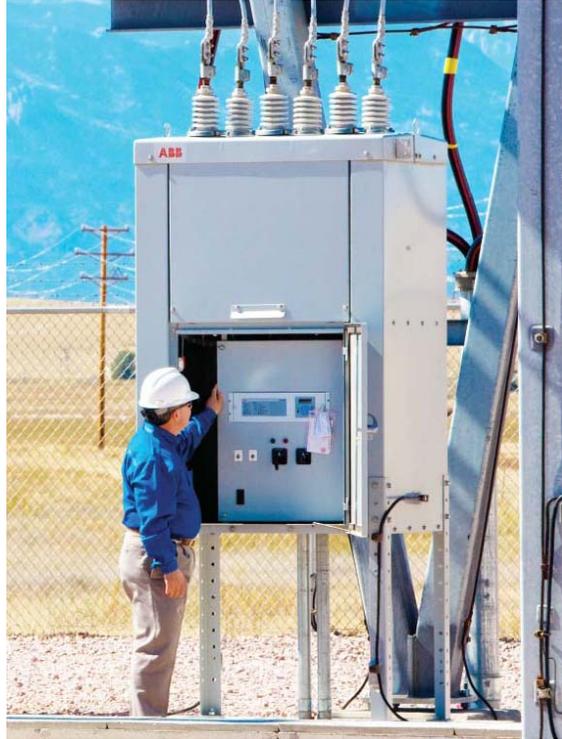
**Figure 4-2 R-MAG Vacuum Circuit Breaker**

The 13.8 kV distribution circuit leaving KHPP should be isolated from the generator bus via an R-MAG magnetically actuated dead tank outdoor vacuum circuit breaker show below in Figure 4-2. The medium voltage vacuum circuit breaker is relatively small in size and has the following features which adequately fit the application at the KHPP:

The R-MAG breaker will be equipped with the REF615 feeder protection relay. The 59G ground voltage relay element will be set to operate faster than the 64G relay to provide coordination with the generator ground fault protection so as to protect better units 1 and 3 against ground faults. As part of the 13.8 kV isolation, it is also recommended the existing disconnect switch be replaced due to its extremely poor condition.

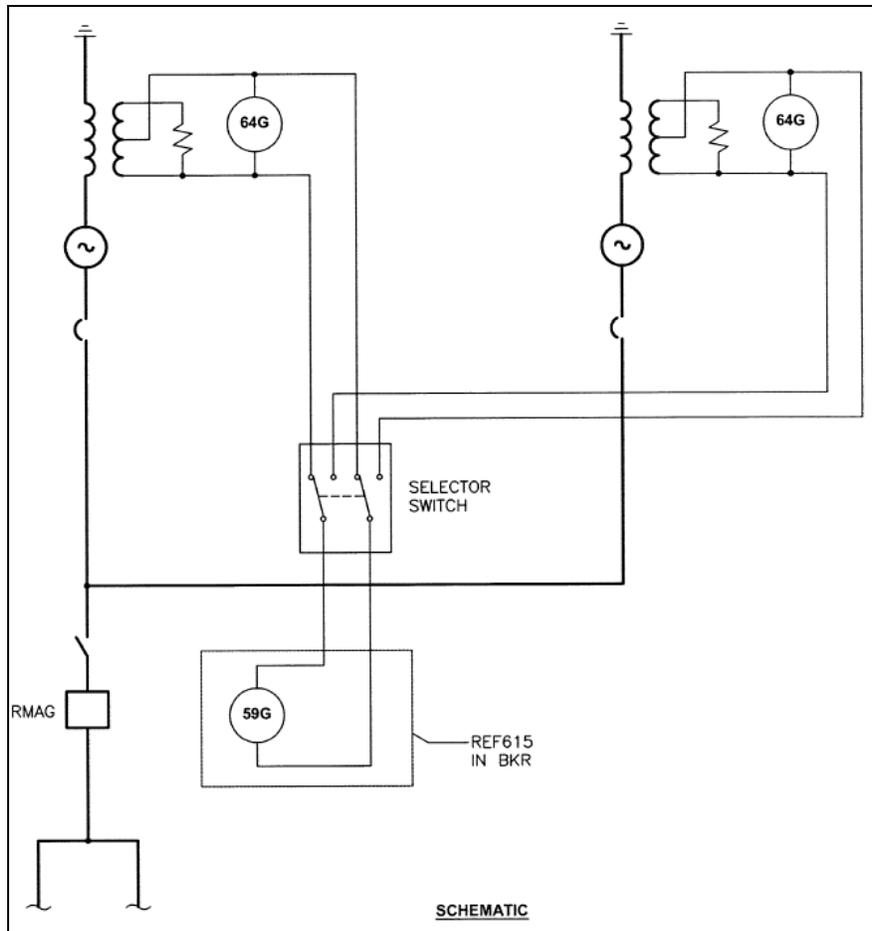
**Figure 4-3 R-MAG and REF615 Protection One Line Diagram**

A protection one line diagram depicting the R-MAG and REF615 design is shown below in Figure 4-1. This recommendation will not address the issue of the generator governors not responding to load rejection and tripping on over/under speed. Recommendations addressing governor response is included in the *Kajaki Dam Unit 2 Hydro Inventory and Condition Assessment Report-DRAFT* study previously submitted to USAID.

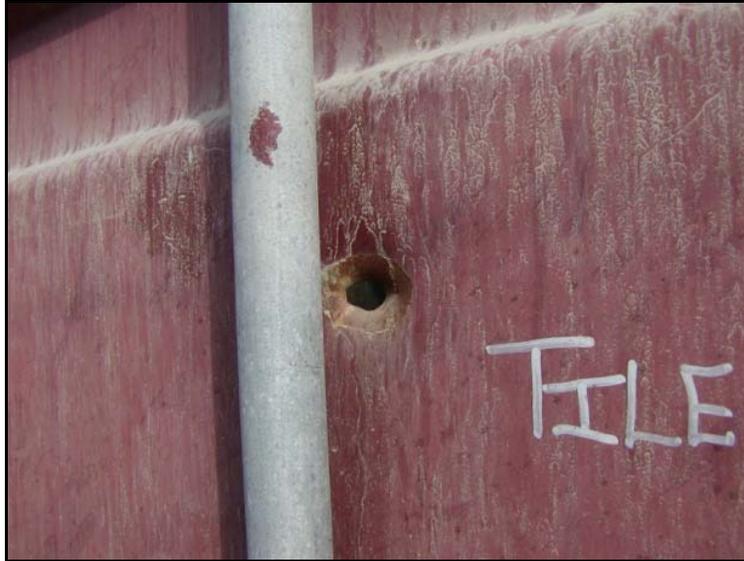
The transformer's shipping container has signs of small fire arm damage as shown below in Figure 5-1 and Figure 5-2; however, none of the fire arm damage penetrated the transformer's tank.

**Figure 5-1 Tangi Distribution Transformer External Damage #1**

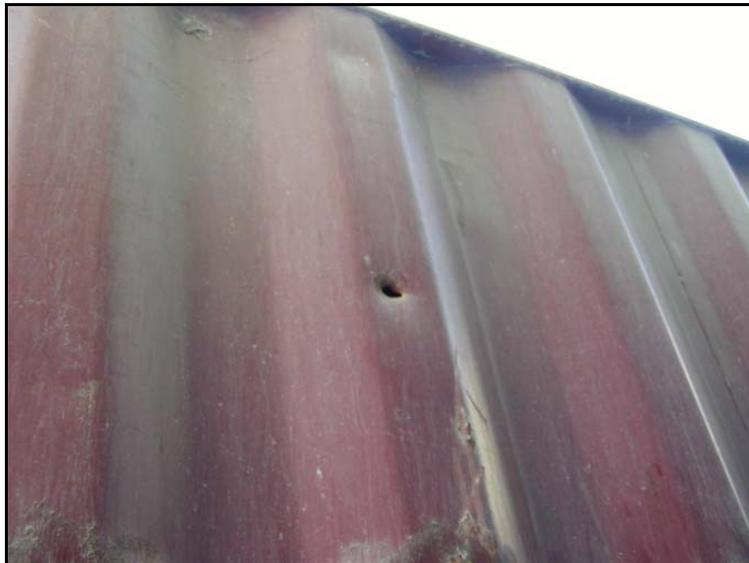
**Figure 5-2 Tangi Distribution Transformer External Damage #2**

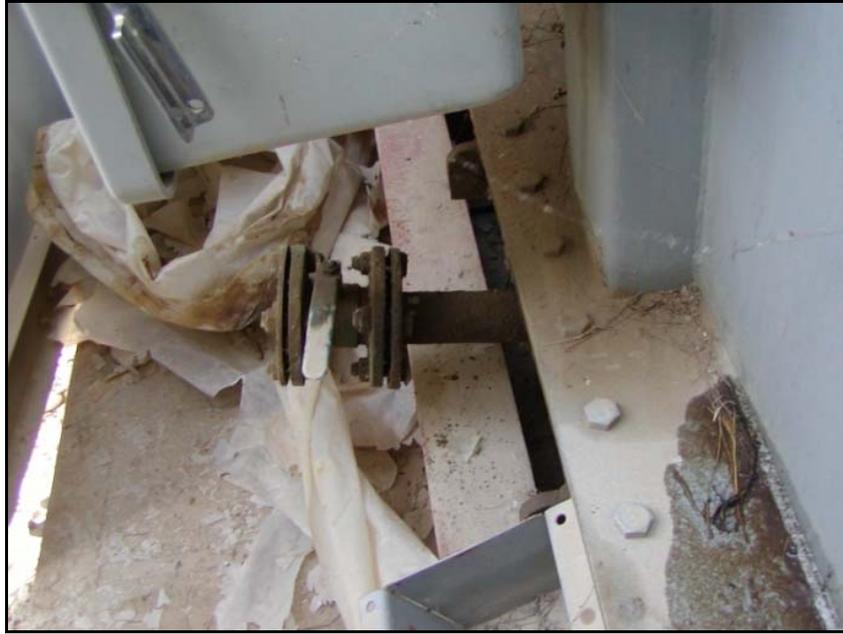
Inspecting the transformer's physical body showed damages to drain valve and auxiliary piping. These damages are illustrated below in Figure 5-3, Figure 5-4 and Figure 5-5.

**Figure 5-3 Tangi Distribution Transformer – Bent Drain Valve**

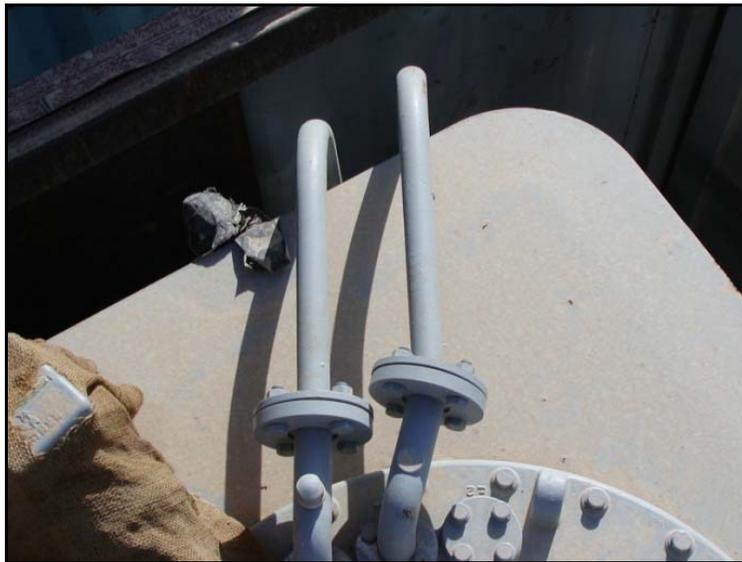
**Figure 5-4 Tangi Distribution Transformer – Bent Auxiliary Piping**

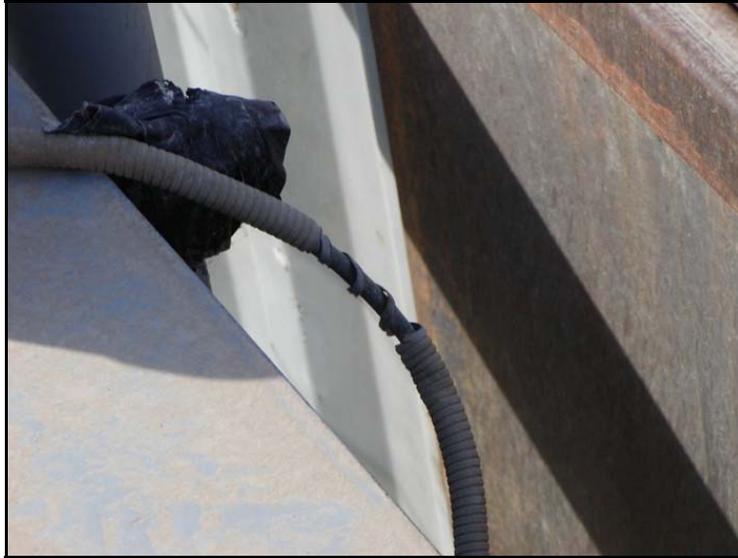
**Figure 5-5 Tangi Distribution Transformer – Damaged Flex Conduit**

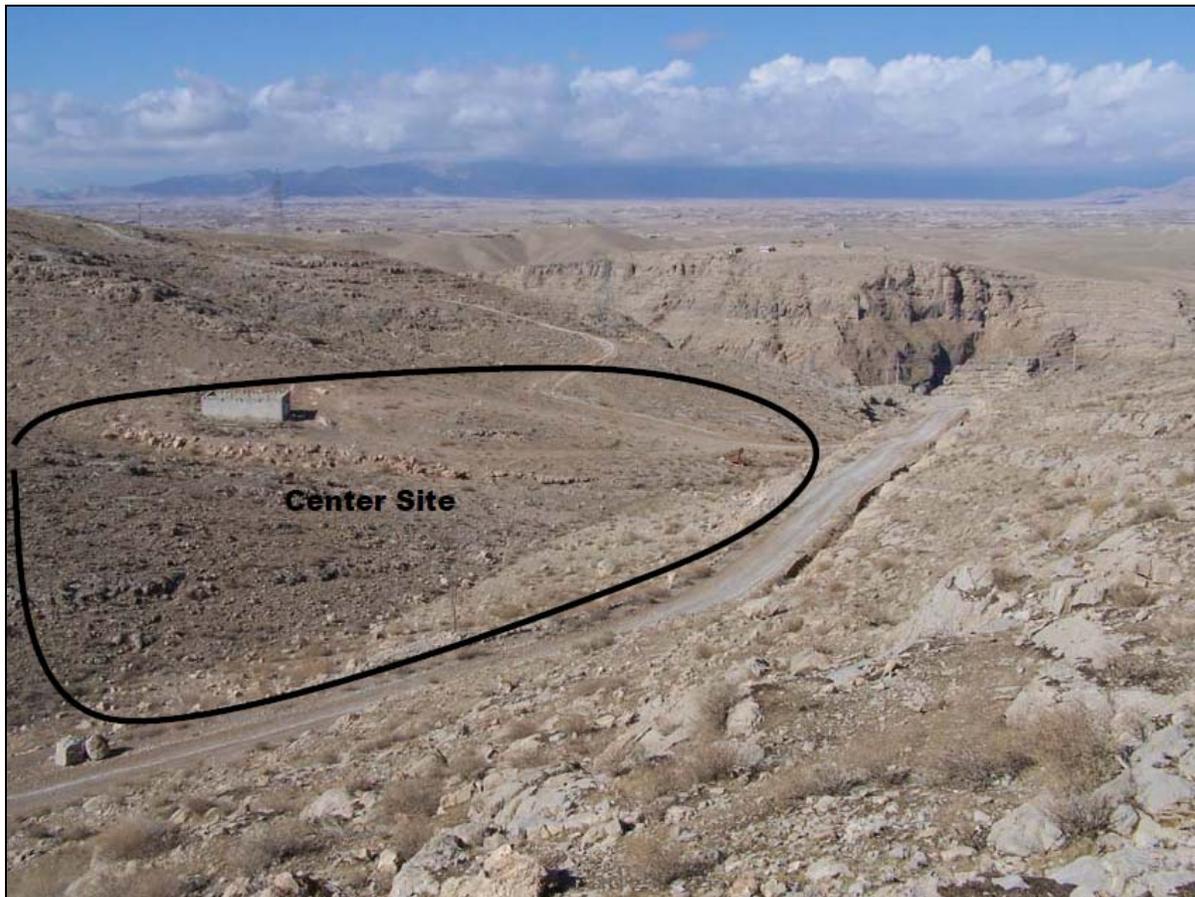
**Figure 6-2 Kajaki New 110 kV Substation Proposed Site**

The proposed site is located in a saddle/valley south of the existing powerhouse 110 kV substation. The entire site is located over exposed Triassic limestone dolomite bedrock. The limestone and dolomites are expected to have unconfined compressive strengths in excess of 150 MPa. An illustration of the proposed 110 kV site is shown below in Figure 6-2.
