CONSTRUCTION MONITORING & EVALUATION PROGRAM

**STRENGTHENING & IMPROVEMENT OF PESHAWAR – TORKHAM
ROAD (N-5), KHYBER AGENCY, FATA**

MONTHLY PROGRESS REPORT # 02

JANUARY 2013

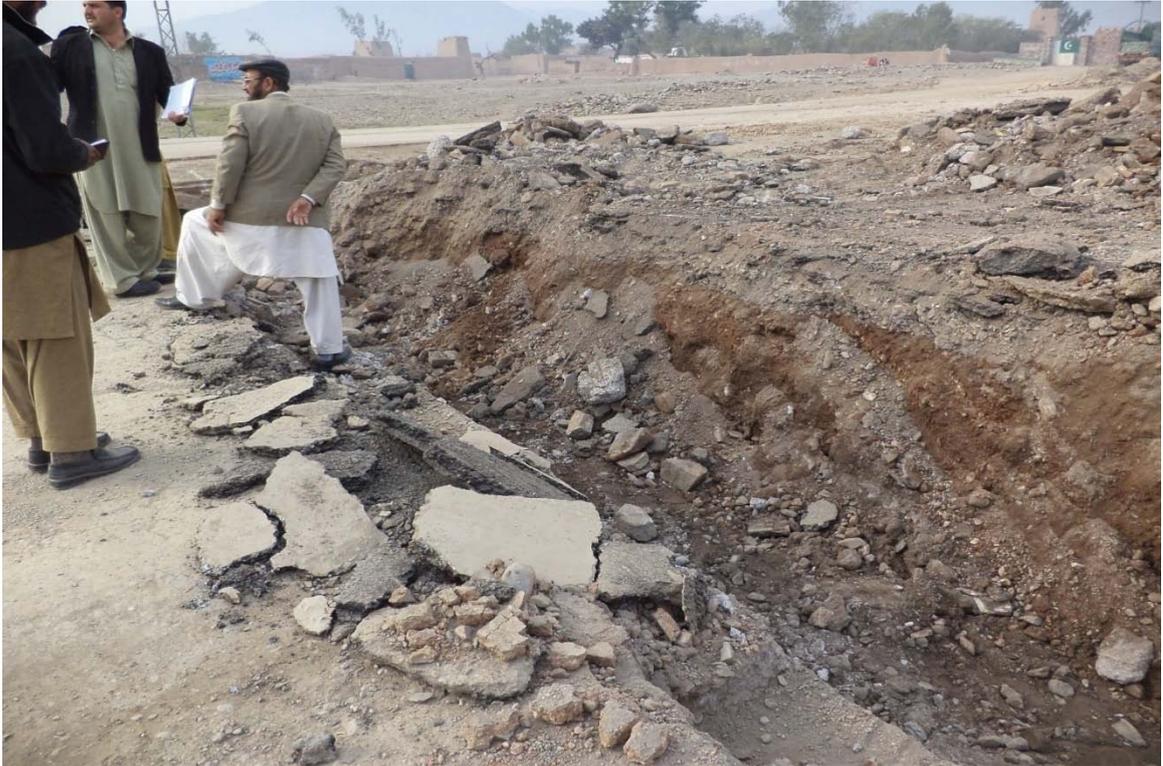
KM: 5 + 210 (Culvert) Structural excavation is in progress

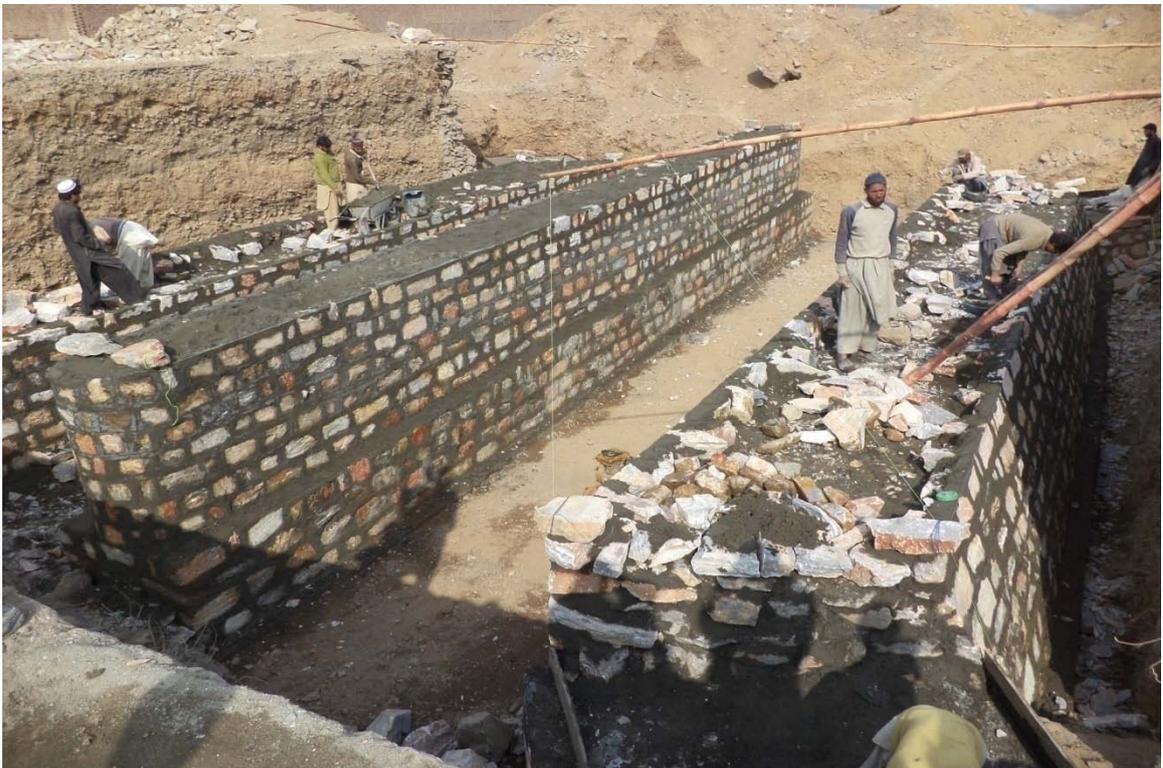
KM: 6 + 191 (Culvert) Stone masonry construction is in progress

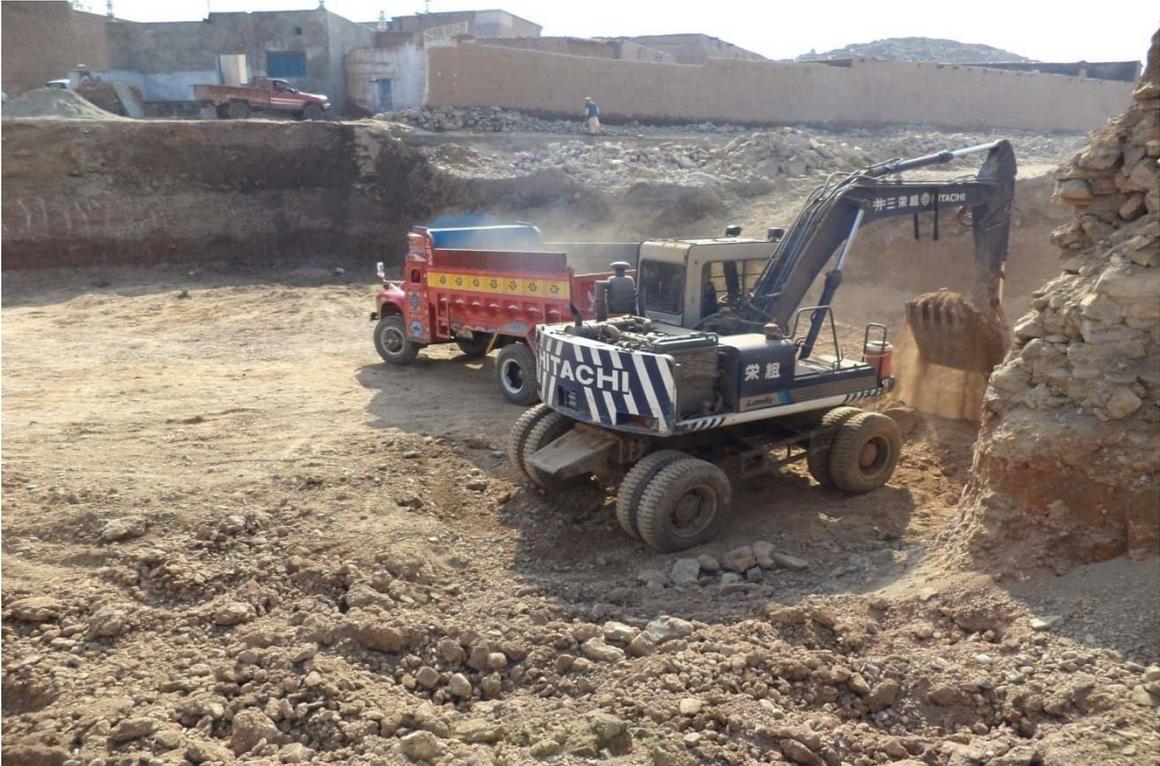
KM 6 + 501 (Culvert) Structural Excavation is in progress

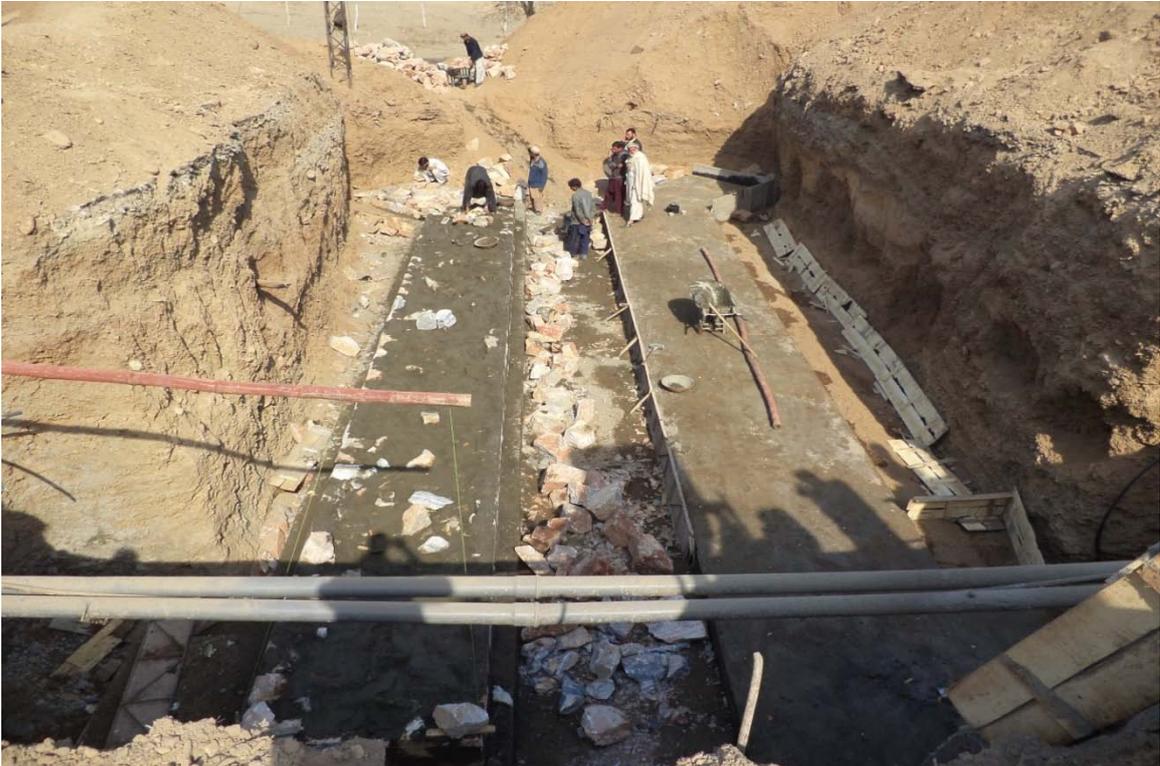
KM: 6 + 648 (Culvert) Stone masonry construction is in progress

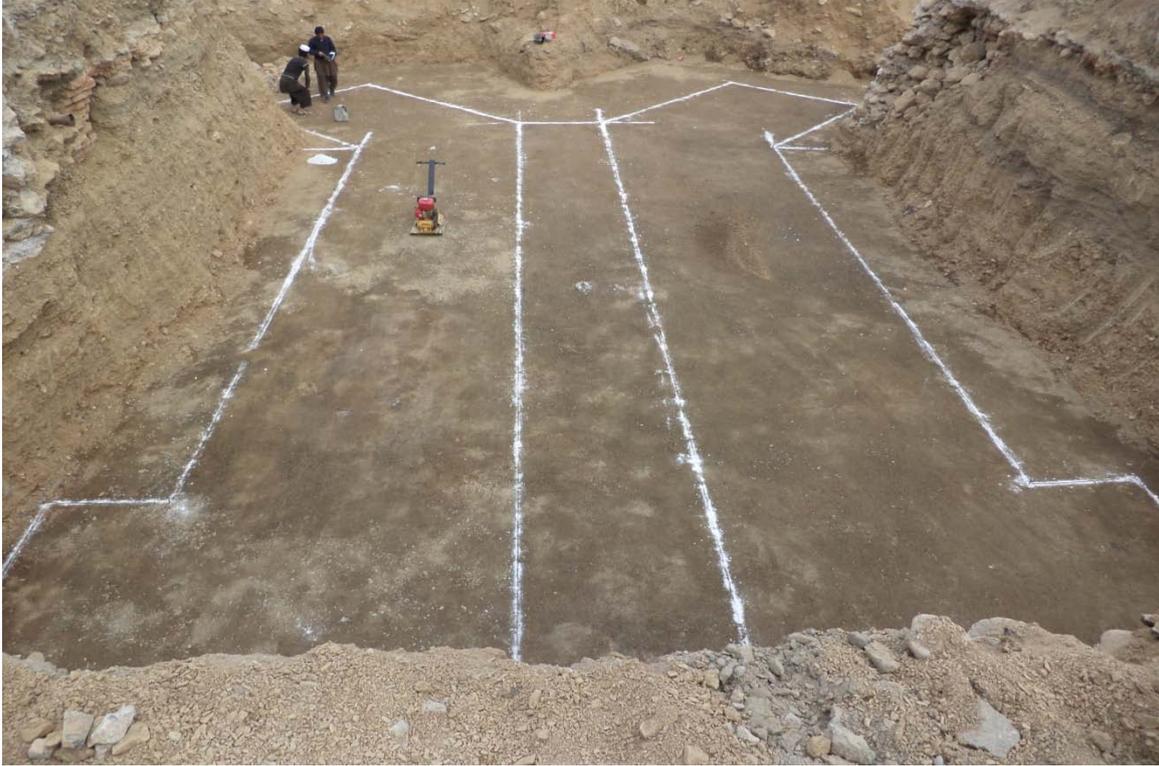
KM: 6 + 883 (Culvert) Layout for lean concrete is in progress

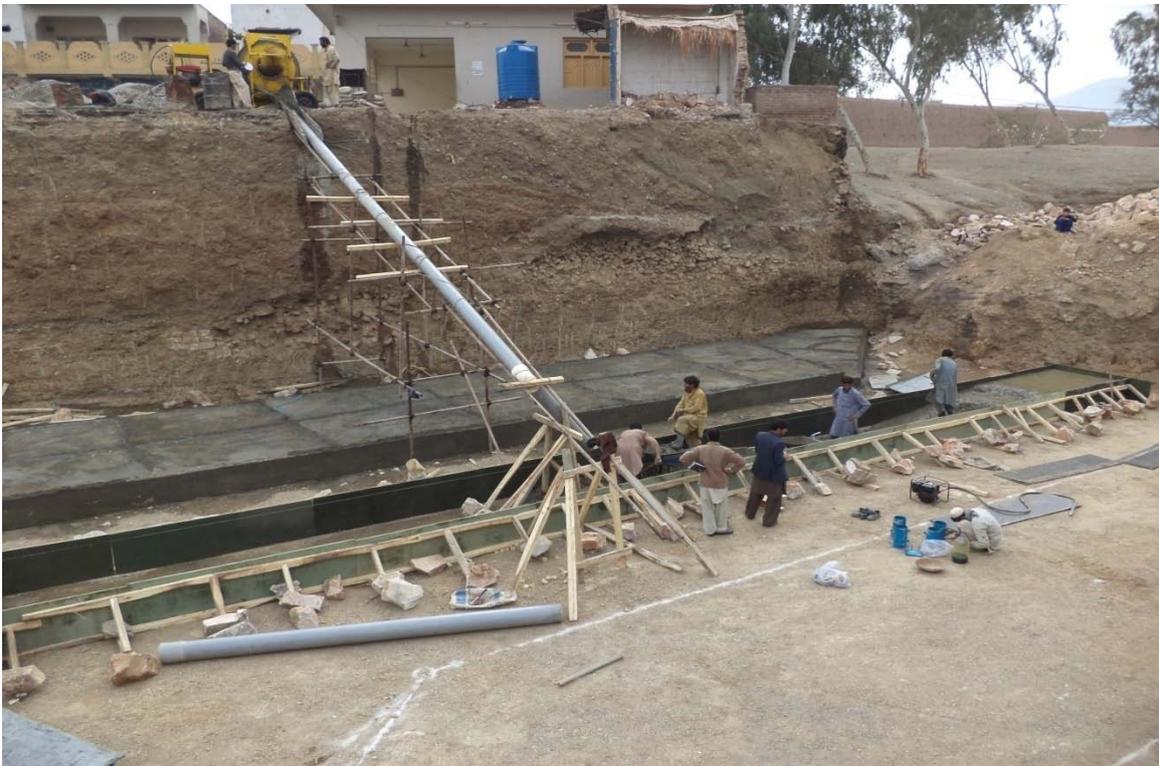
KM: 7 + 386 (Culvert) Lean concrete is in progress

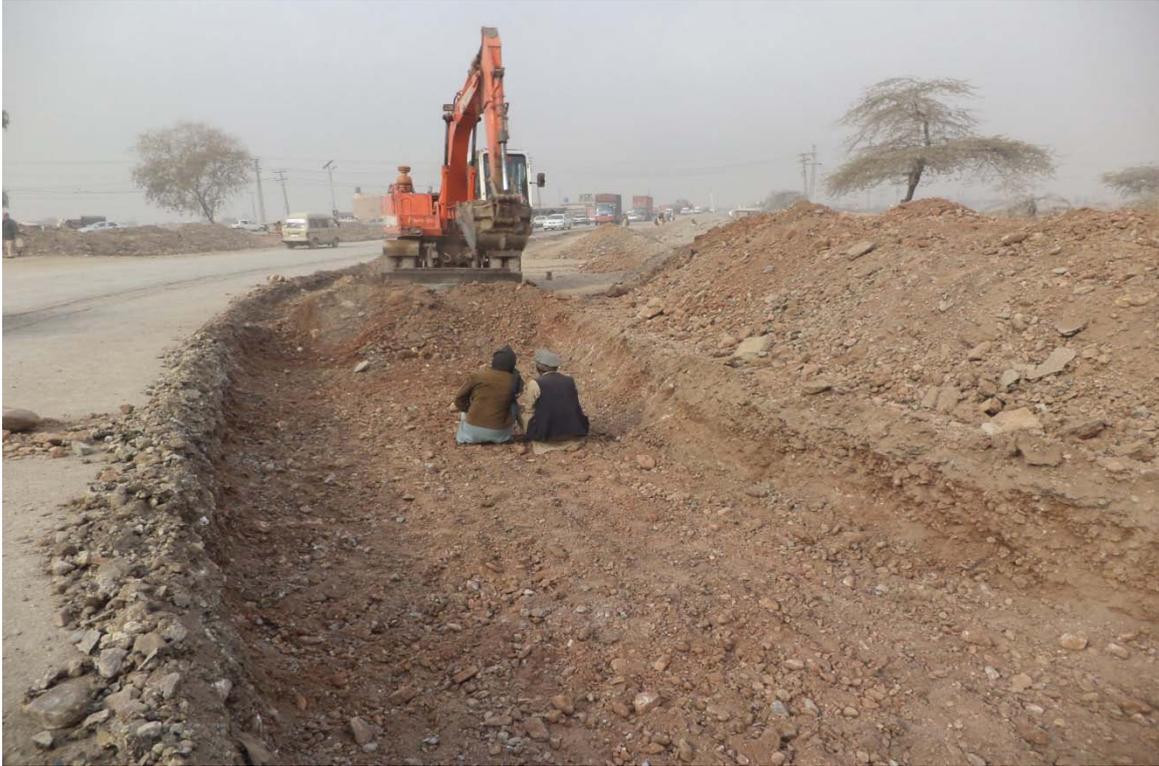
KM: 1 + 850 to 1 + 900 (RHS Shoulder) Excavation for sub grade layer is in progress

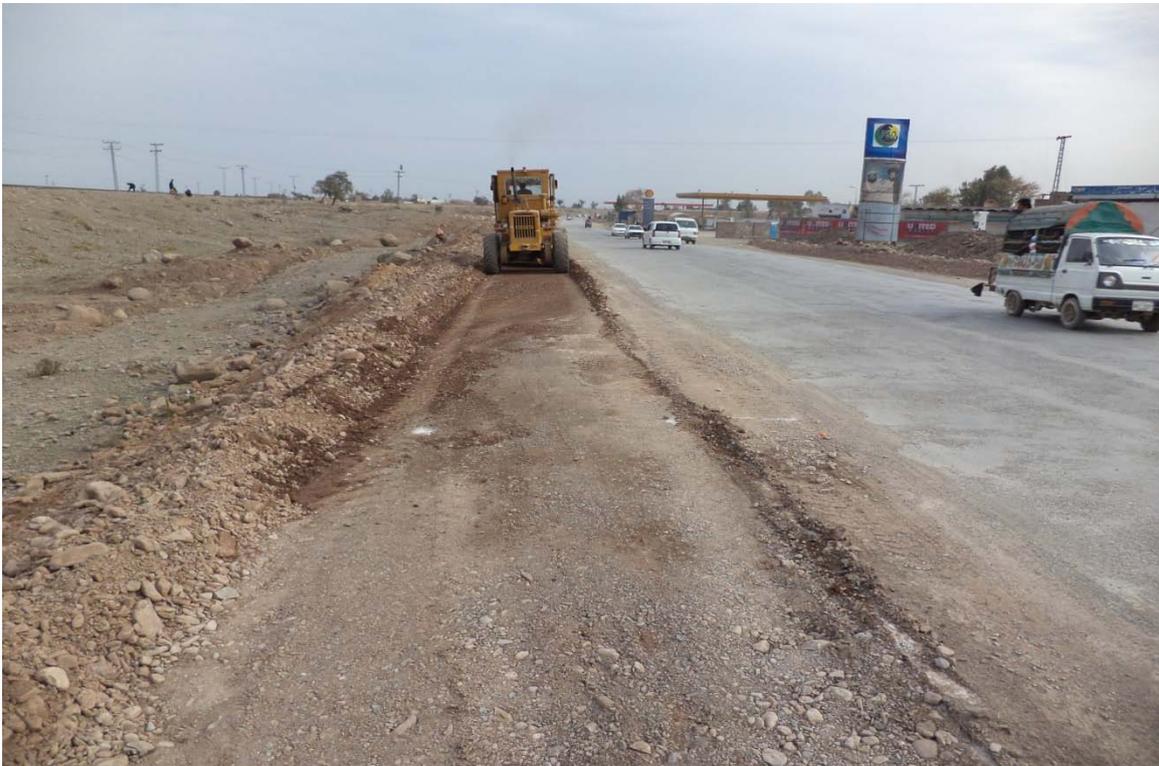
KM: 2 + 850 to 3 + 050 (RHS Shoulder) Sub base 1st layer preparation is in progress

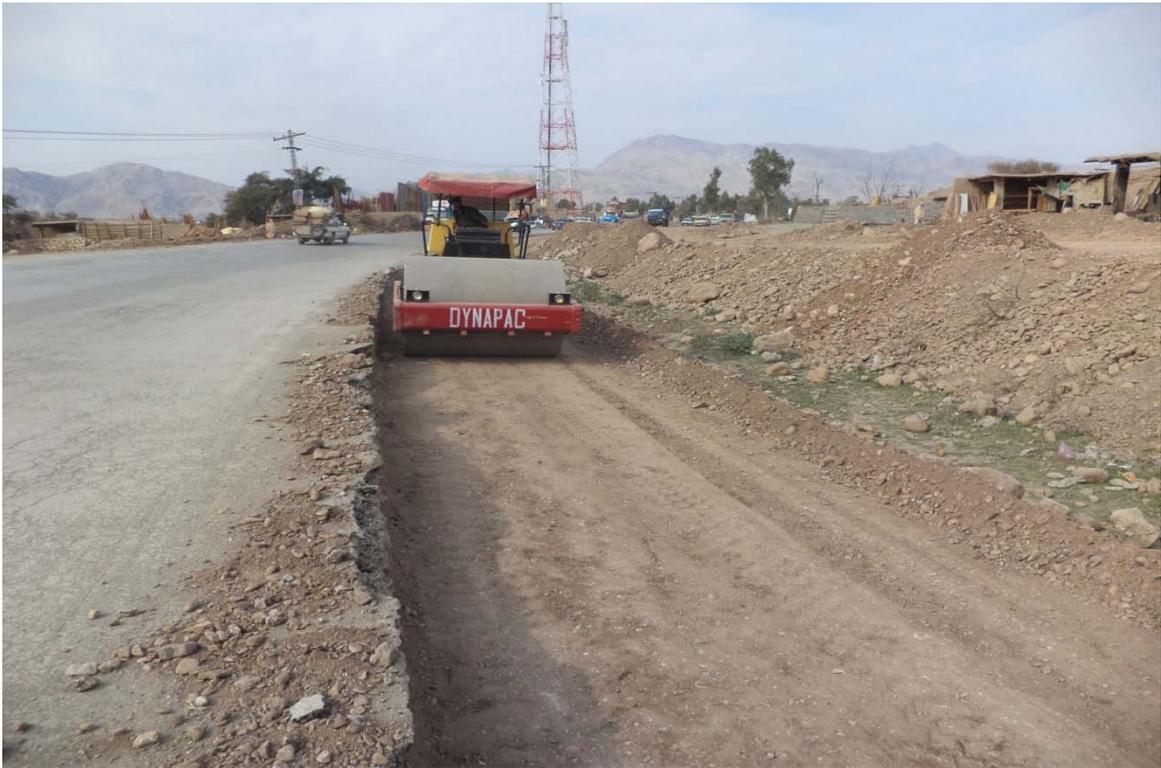
KM: 3 + 200 to 3 + 300 (RHS Shoulder) Sub grade top layer compaction is in progress

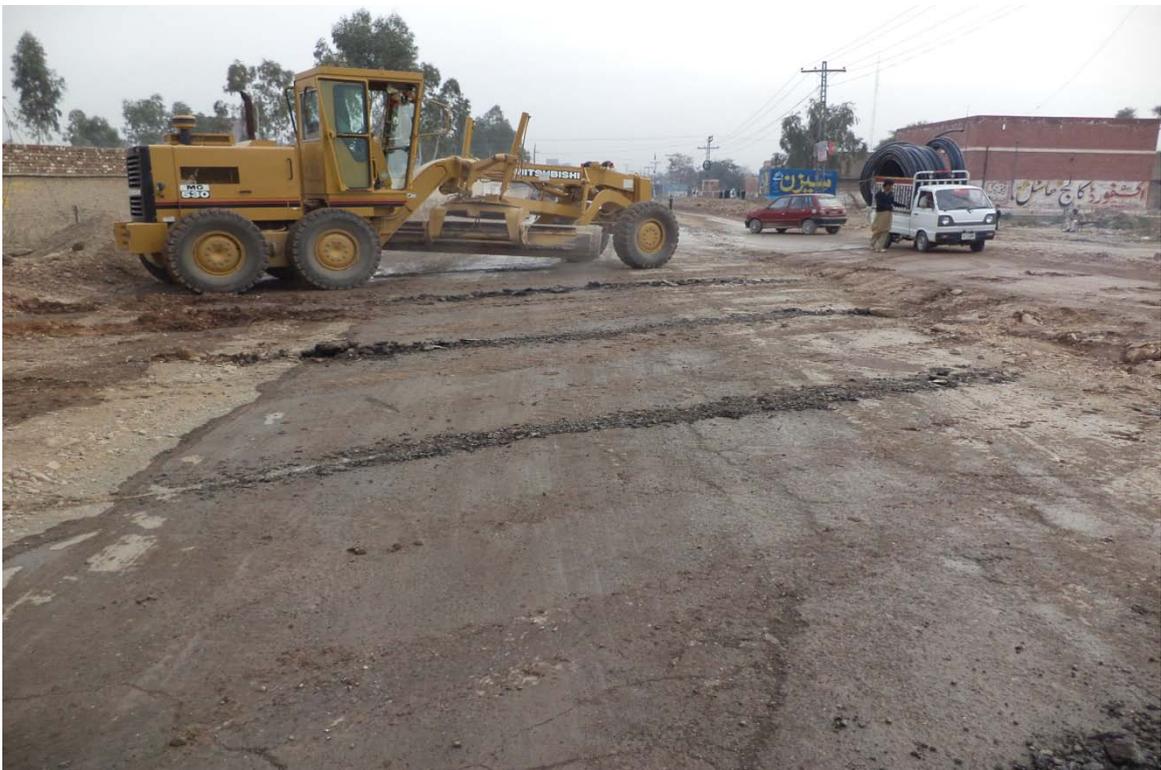
KM: 4 + 600 to 5 + 000 Grooving is in progress

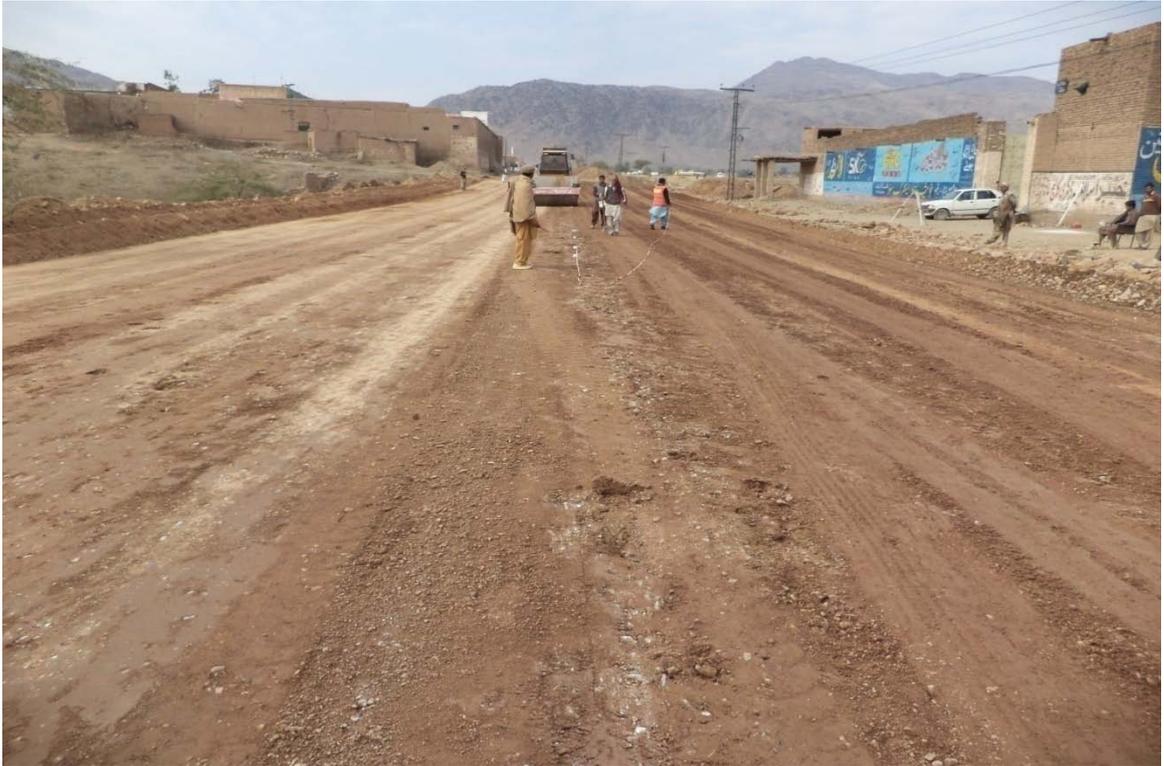
KM: 6 + 325 to 6 + 400 Full width embankment 1st layer preparation is in progress

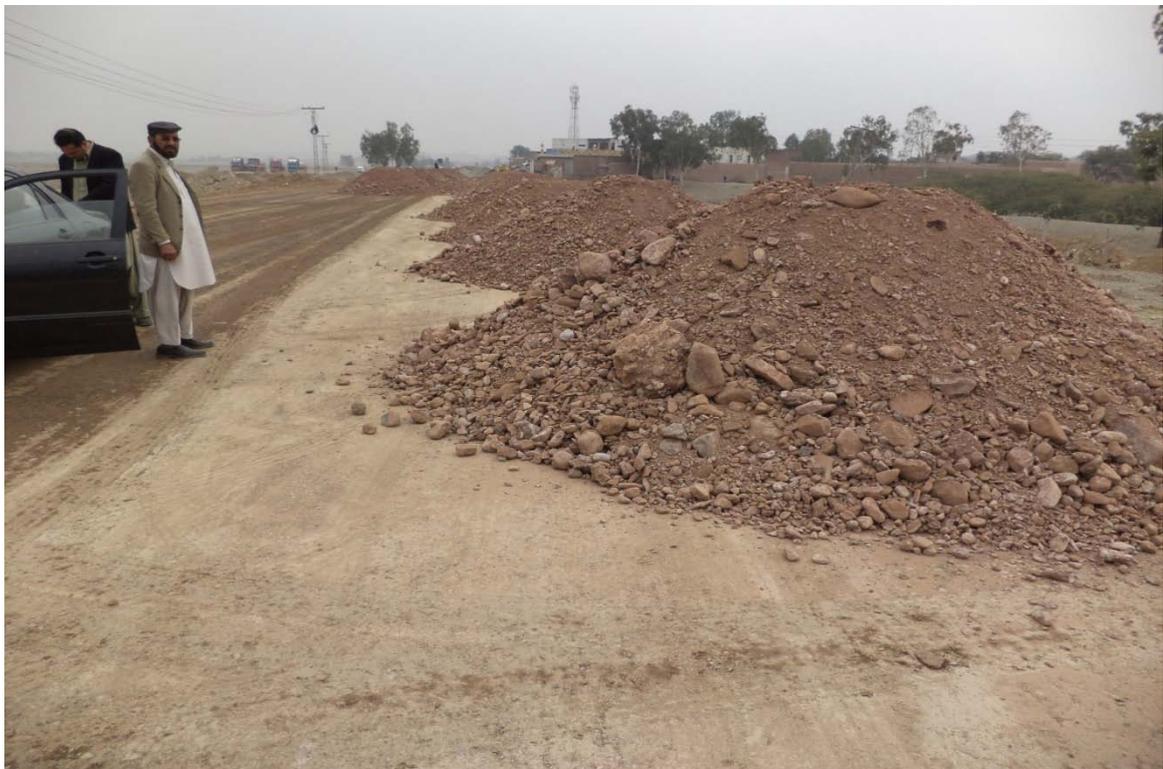
KM: 7 + 450 to 7 + 550 (Full width) Sub grade top layer material has dumped

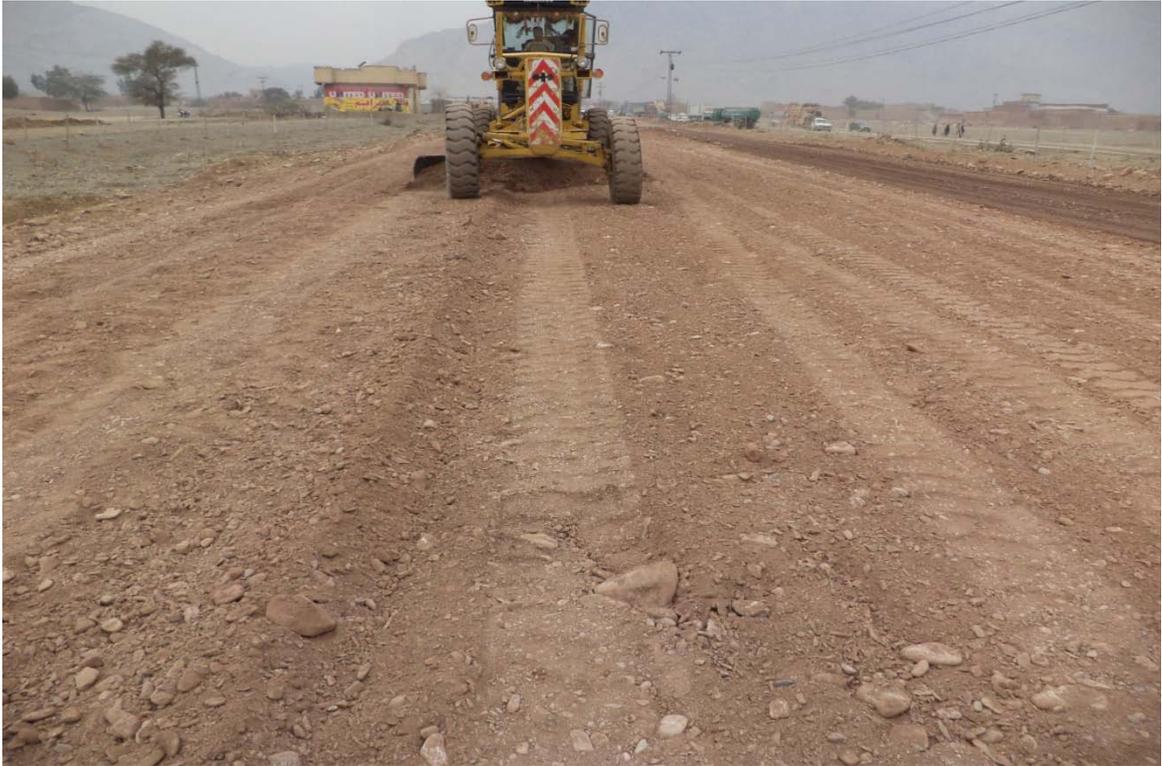
KM: 7 + 575 to 7 + 675 (Full Width) Sub base 1st layer preparation is in progress

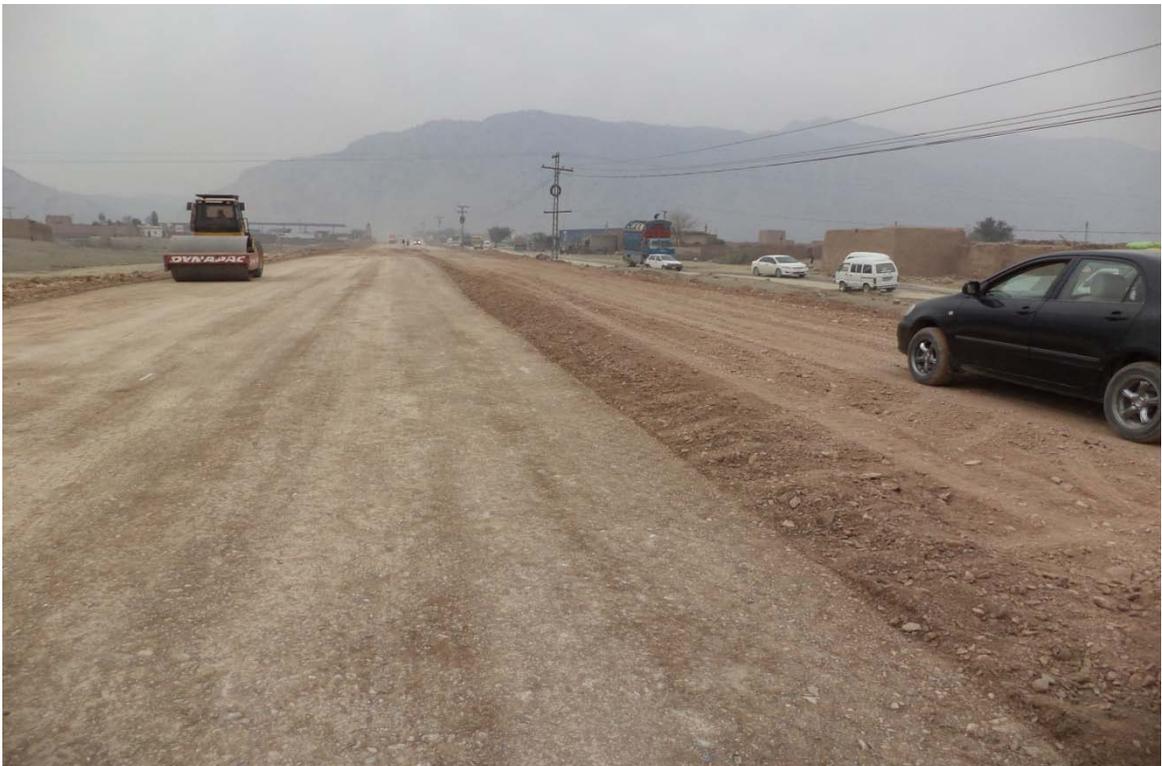
KM: 7 + 750 to 7 + 875 (LHS Full Width) Sub base 1st layer preparation is in progress

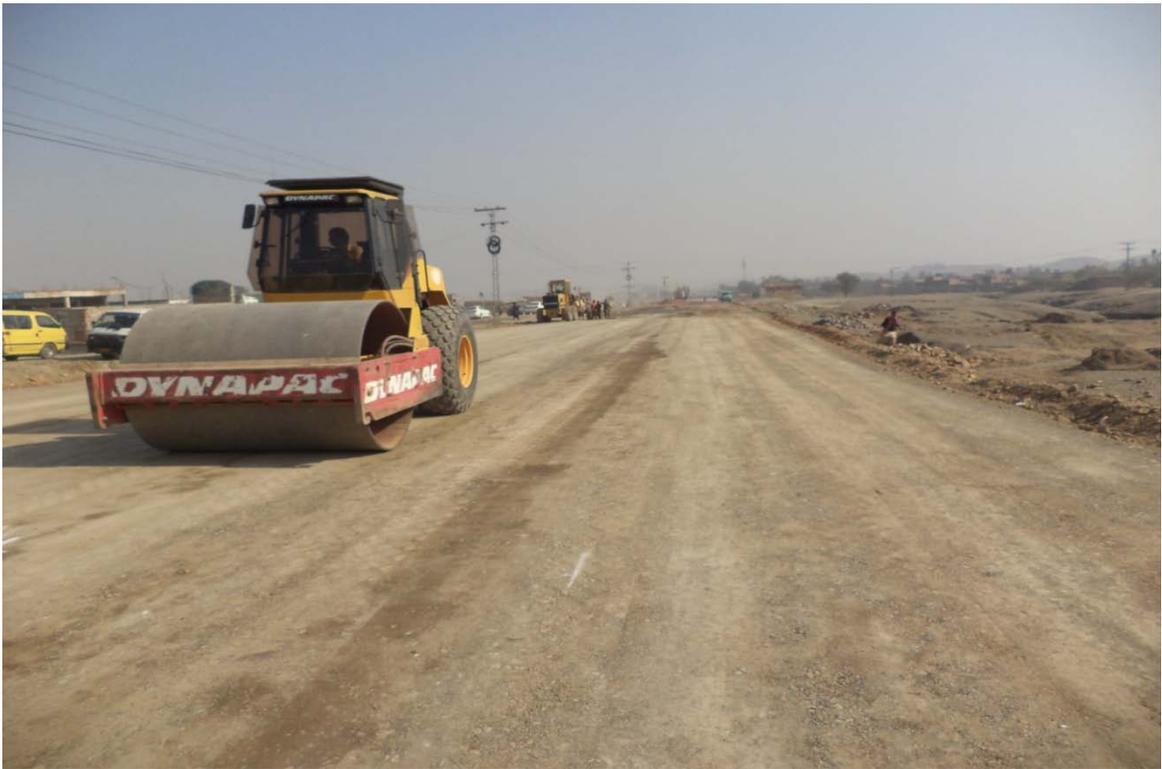
KM: 7 + 950 to 8 + 075 (Full width) Embankment 1st layer preparation is in progress

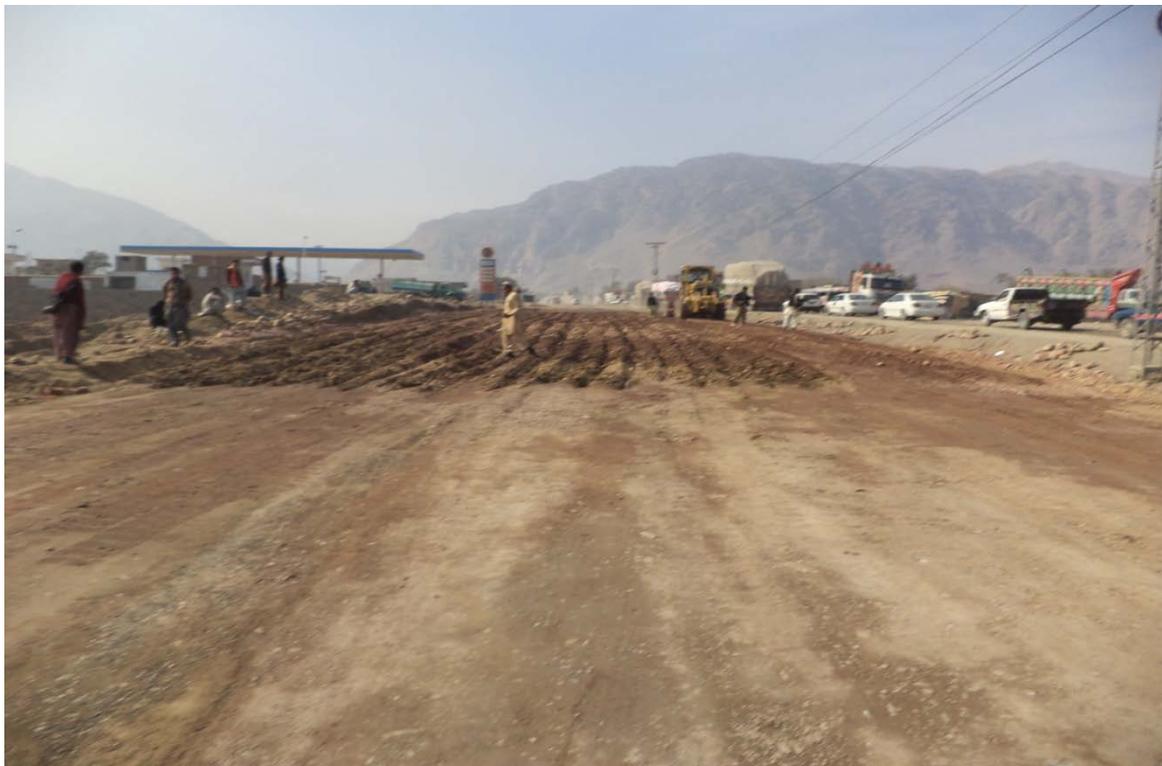
KM: 8 + 075 to 8 + 125 (Full Width) Plowing of sub base 1st layer is in progress

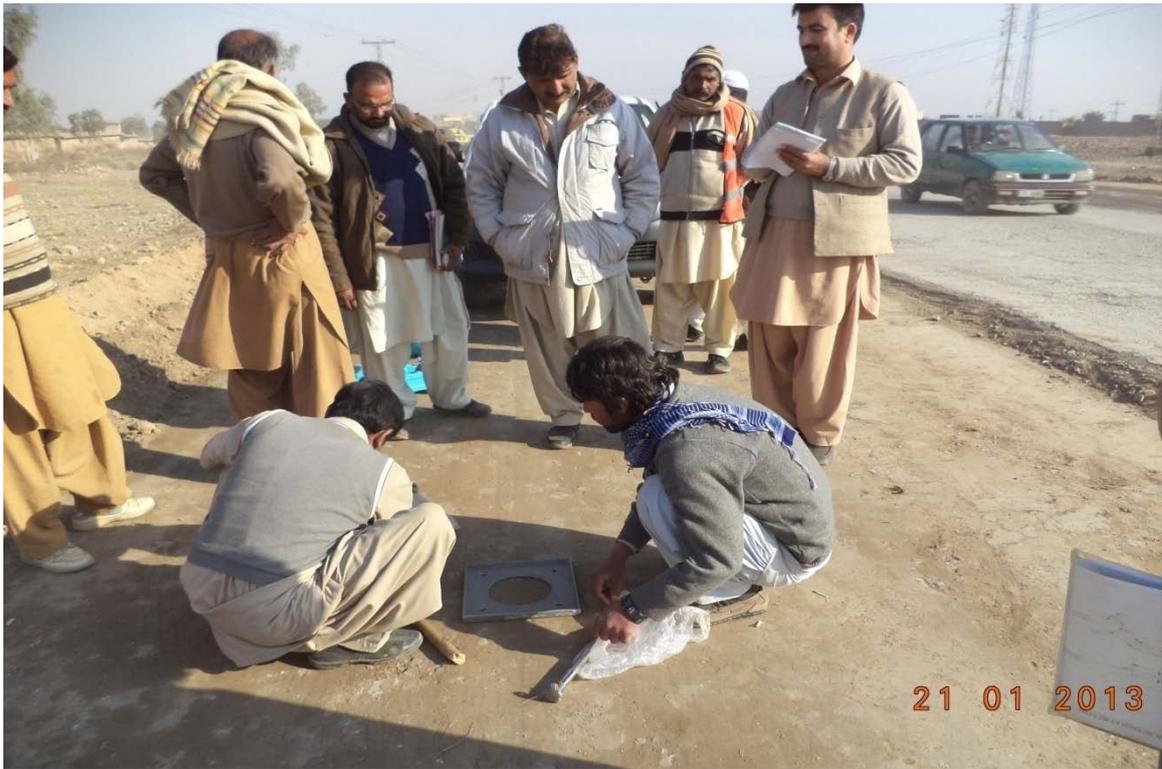
KM: 4 + 655 (LHS Shoulder) FDT Test for NGC is in progress in the presence of M & E Material Engineer

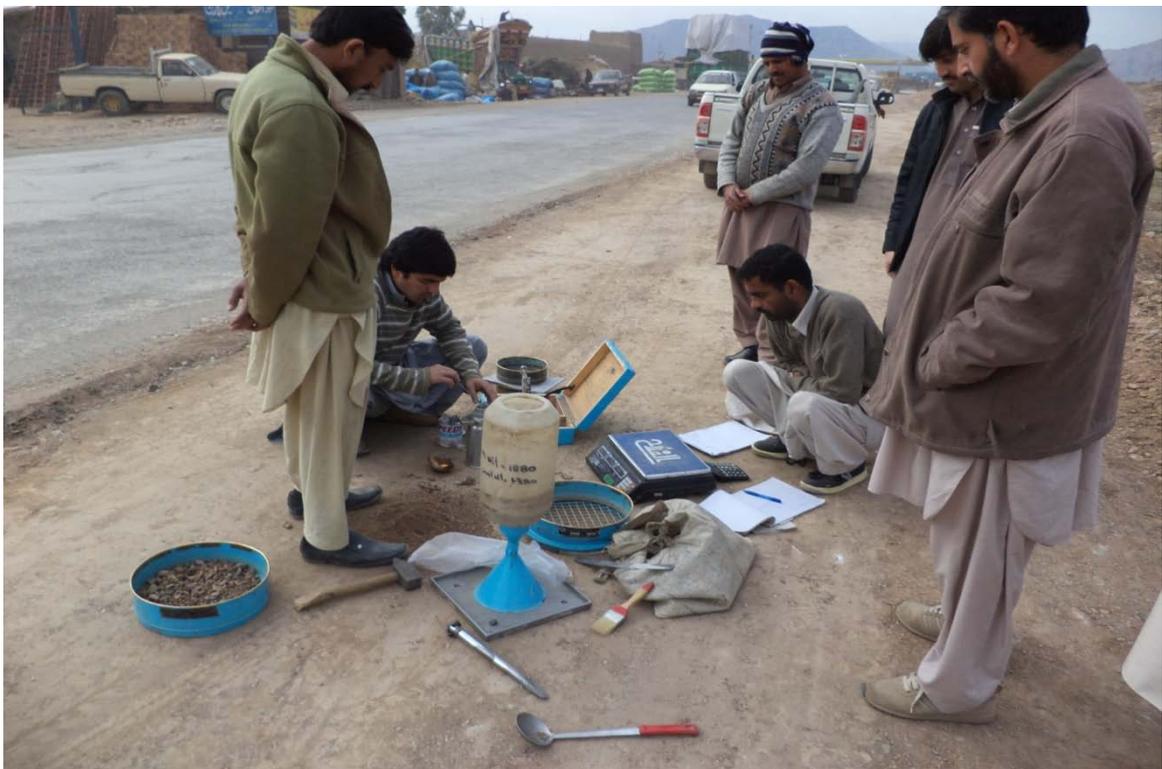
KM: 3 + 050 to 3 + 125 (RHS Shoulder) FDT test on NGC is in progress in the presence of M & E lab staff

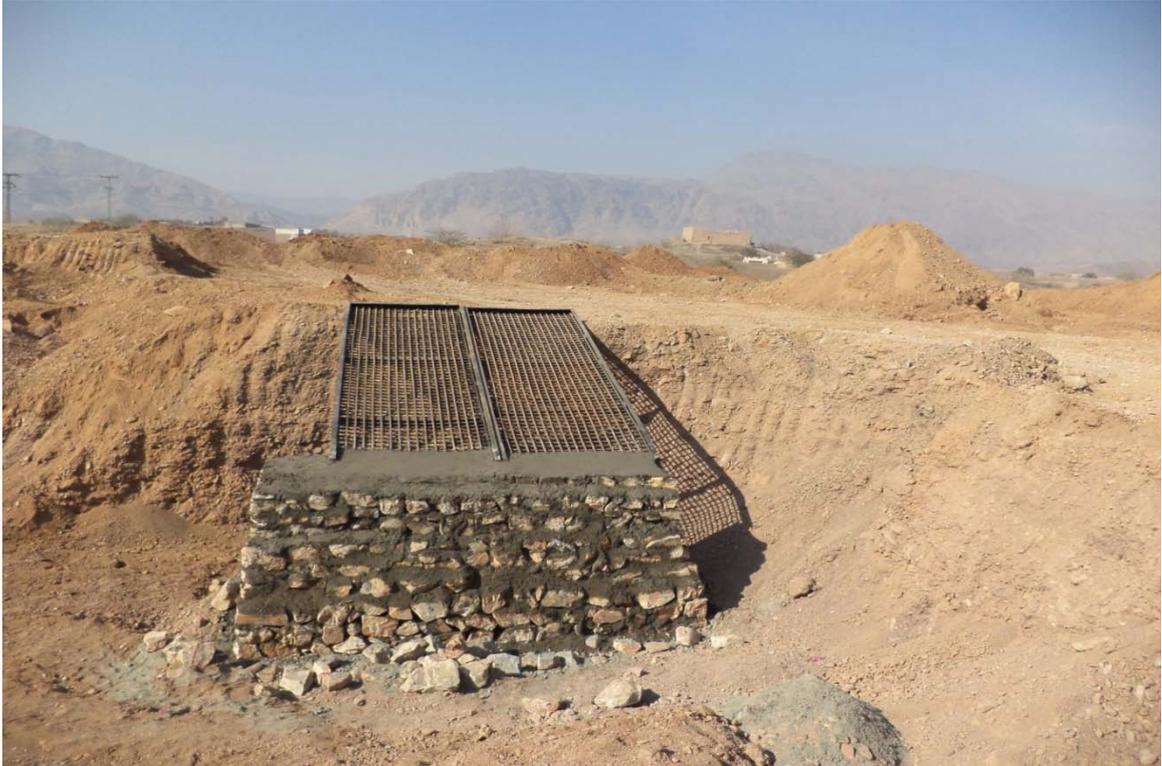
KM: 6 + 000 Pit # 1 screen for sub base

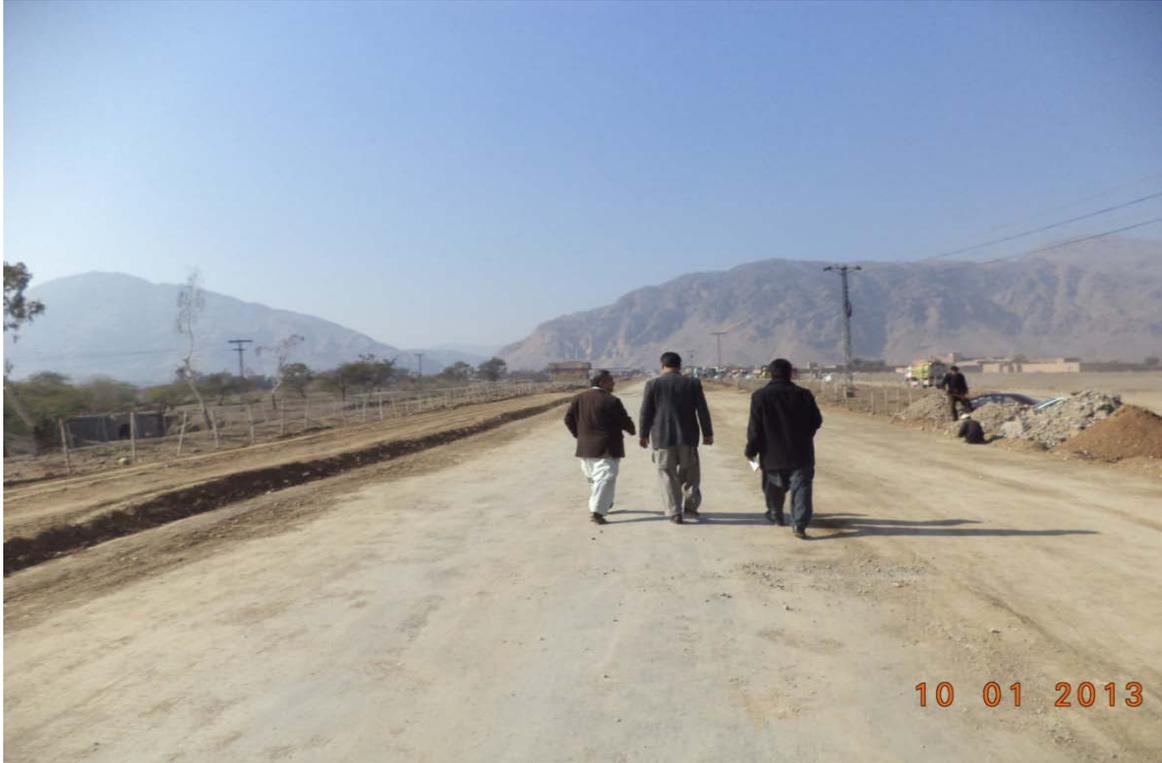
(KM: 7+375 & onward) earthwork on both side shoulders

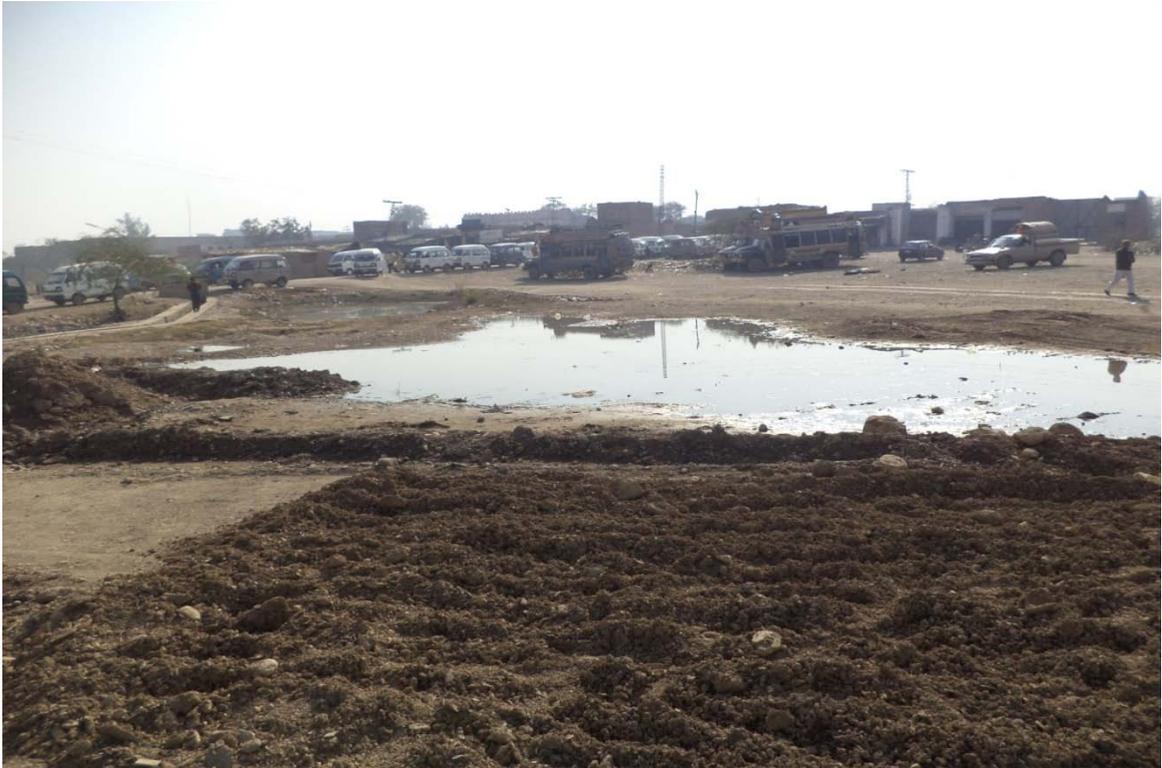
❖ Good	<input type="checkbox"/>
❖ Satisfactory	<input checked="" type="checkbox"/>
❖ Poor	<input type="checkbox"/>
9. **Issues:** Damages to PTCL Telephone cables at RD 5+560, dumping of excavated material in graveyard, Standing water and drainage problems at RD 5+905, dig pits at quarry area near RD 7+400

Photo (1): Standing water due to no temporary drainage arrangement at RD 5+905

Recommendation/Instructions: Advised to contact PTCL department before excavation at any site, where telephone cables pass, drainage problem should be resolve as per guidance at site (RD 5+905), the land should be leveled and fill the pits with the same material at quarry areas.

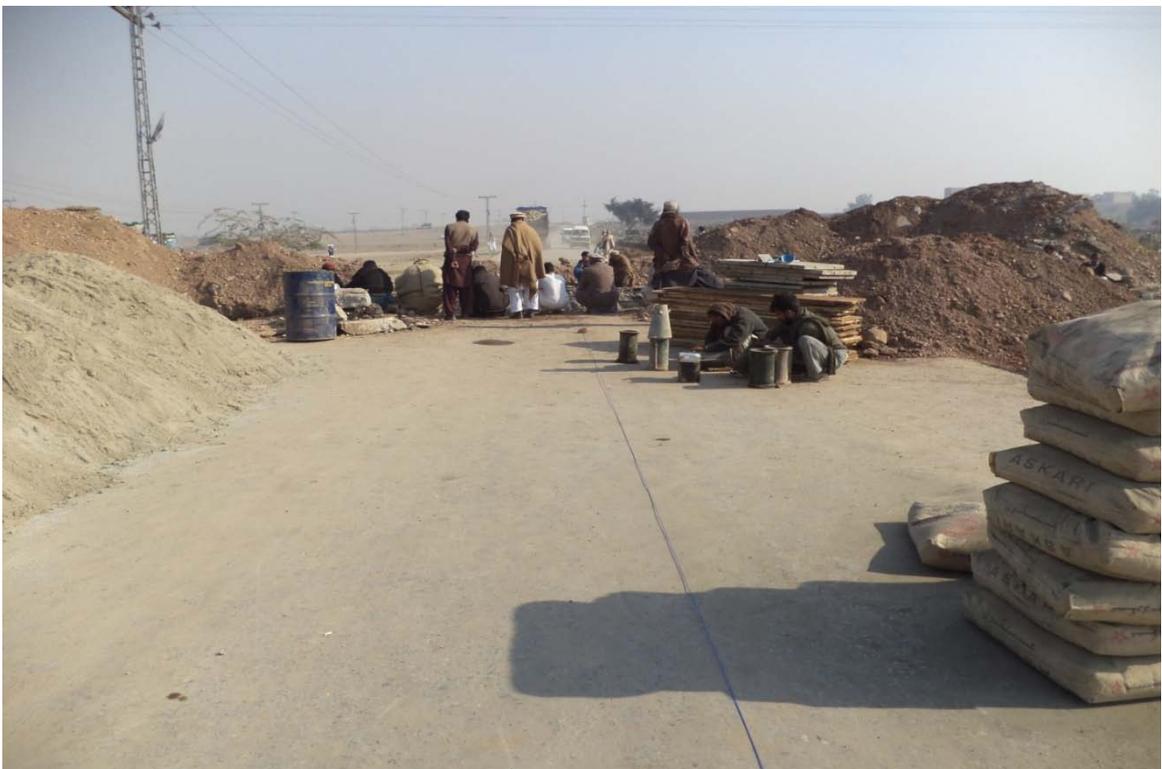
Photo (2): Reconstruction of culvert.

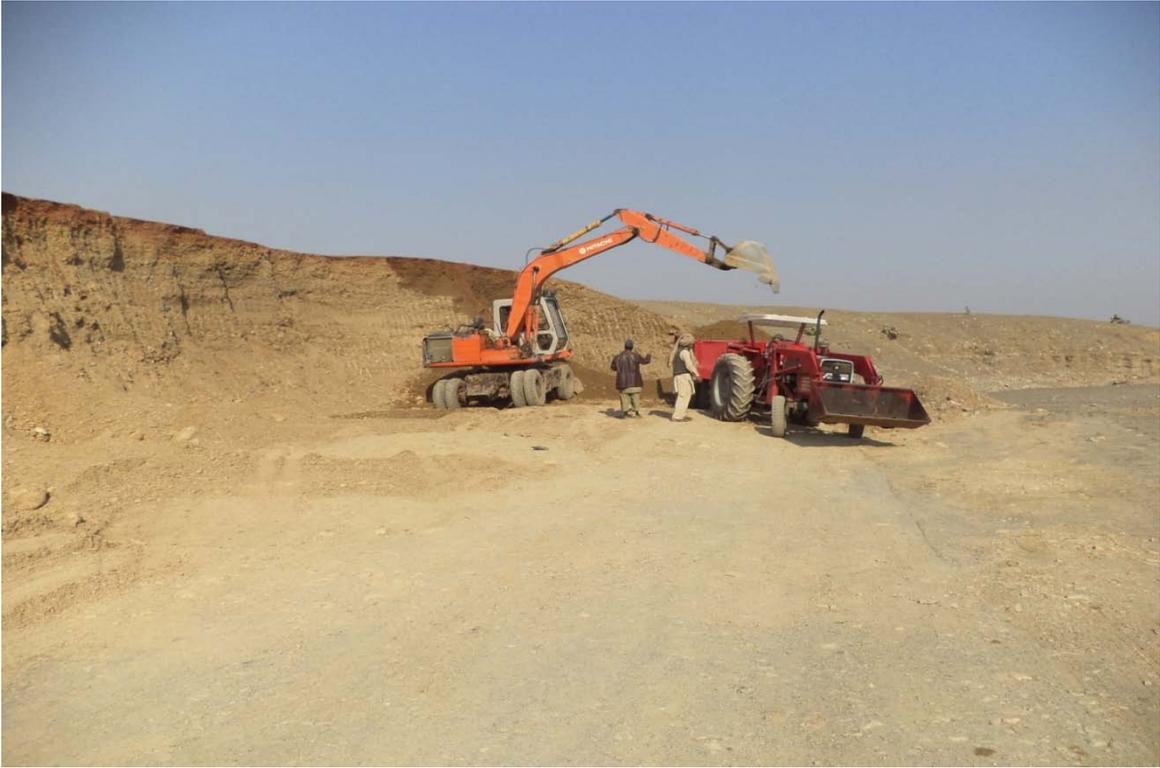
Photo (9): Quarry area near RD 7+400

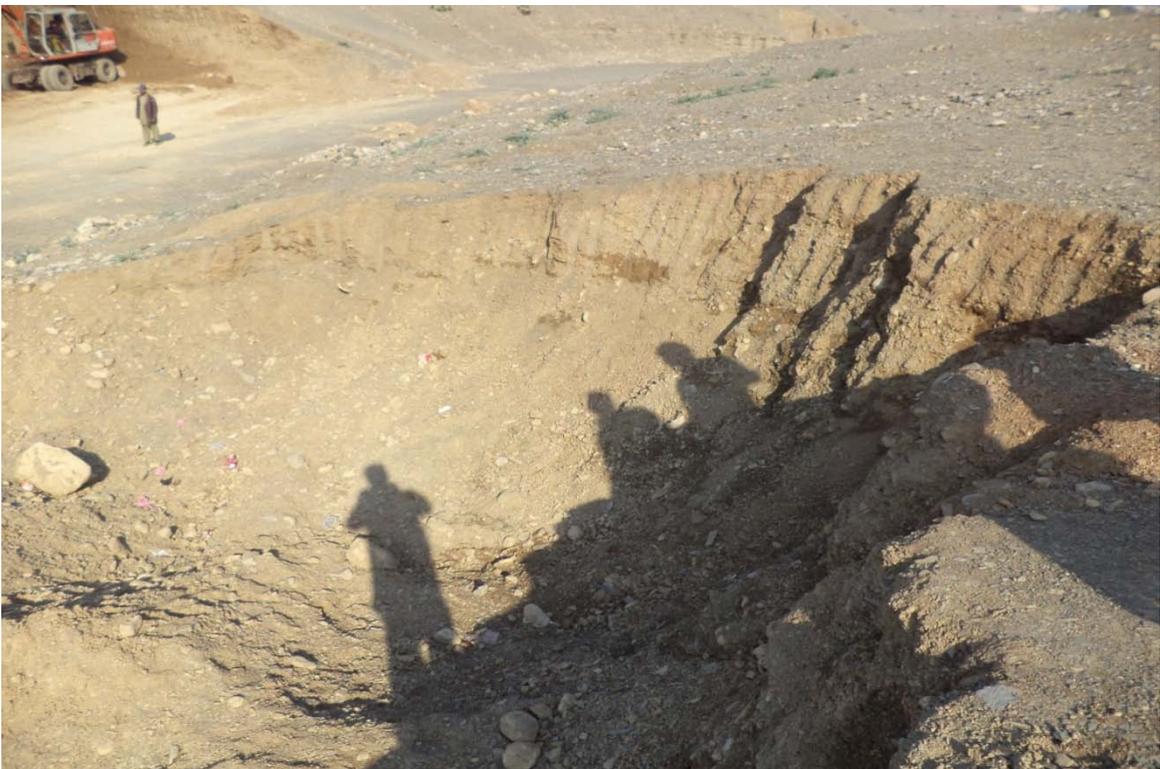
Photo (10): Dig pit at Quarry area near RD 7+400

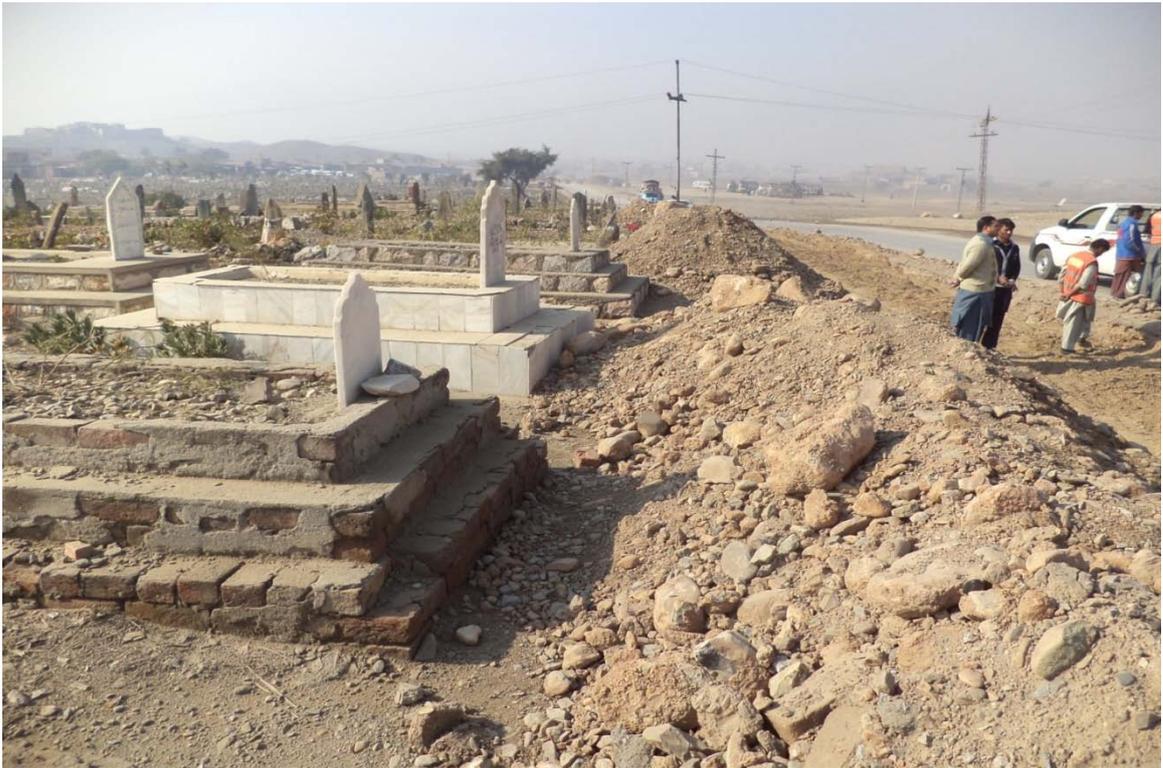
Photo (11): Excavated Material dumped in graveyard
