CONSTRUCTION MONITORING & EVALUATION PROGRAM

**STRENGTHENING & IMPROVEMENT OF PESHAWAR – TORKHAM
ROAD (N-5), KHYBER AGENCY, FATA**

MONTHLY PROGRESS REPORT # 02

JANUARY 2013

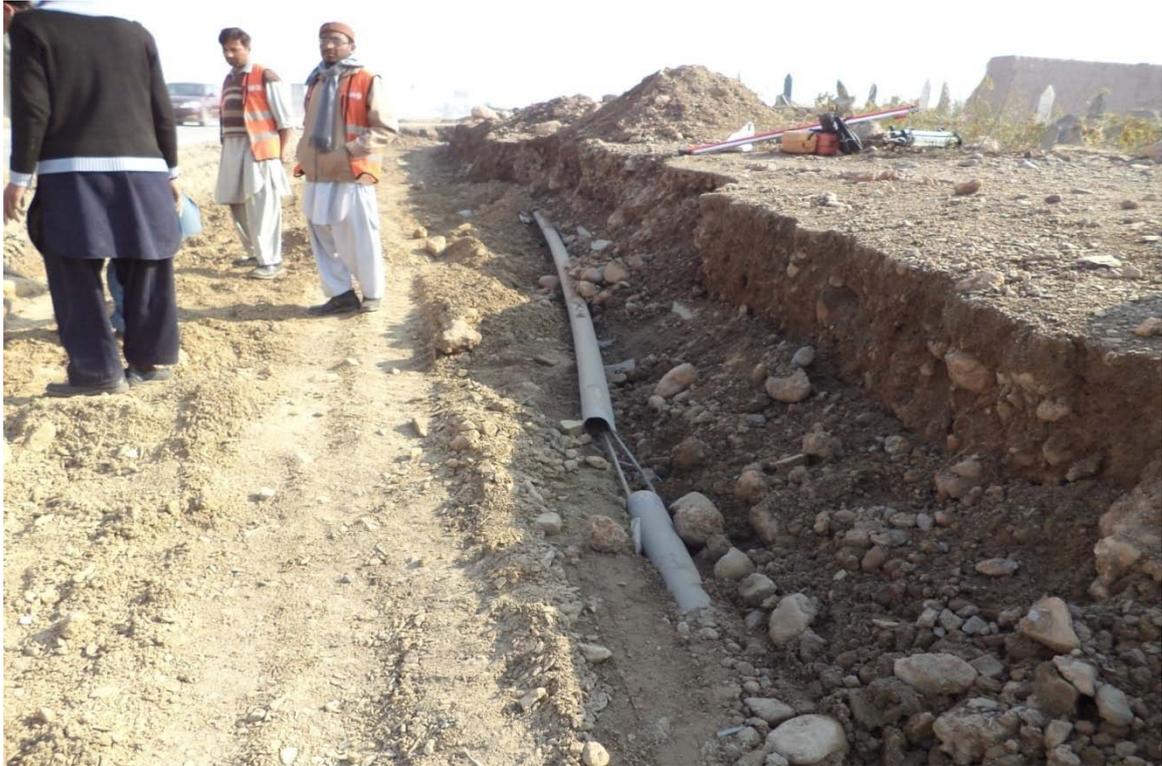
❖ Good	<input type="checkbox"/>
❖ Satisfactory	<input checked="" type="checkbox"/>
❖ Poor	<input type="checkbox"/>
9. **Issues:** Damages to PTCL Telephone cables at RD 5+560, dumping of excavated material in graveyard, Standing water and drainage problems at RD 5+905, dig pits at quarry area near RD 7+400

Photo (13): Exposed Telephone cable at RD- 5+560

Recommendation/Instructions: Advised to contact PTCL department before excavation at any site, where telephone cables pass, drainage problem should be resolve as per guidance at site (RD 5+905), the land should be leveled and fill the pits with the same material at quarry areas.

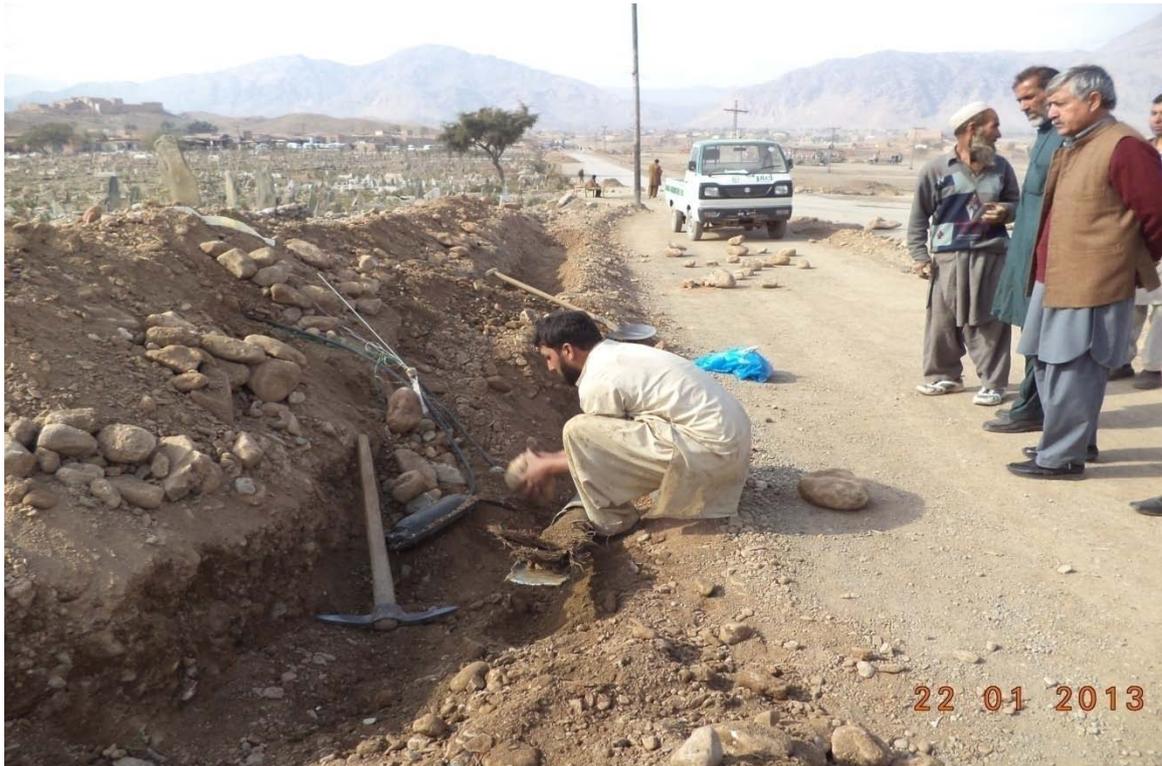
Photo (17): Damage PTCL cable at RD.5+905

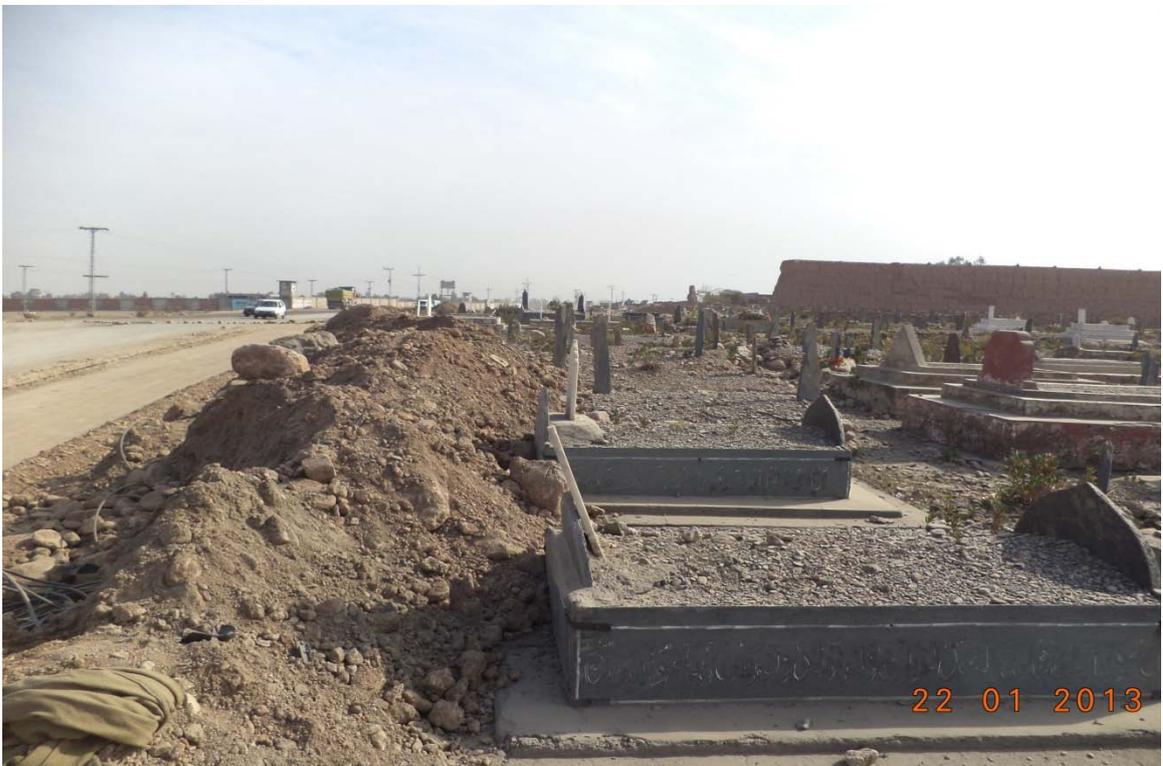
Photo (22): View of Excavating material place at graveyard

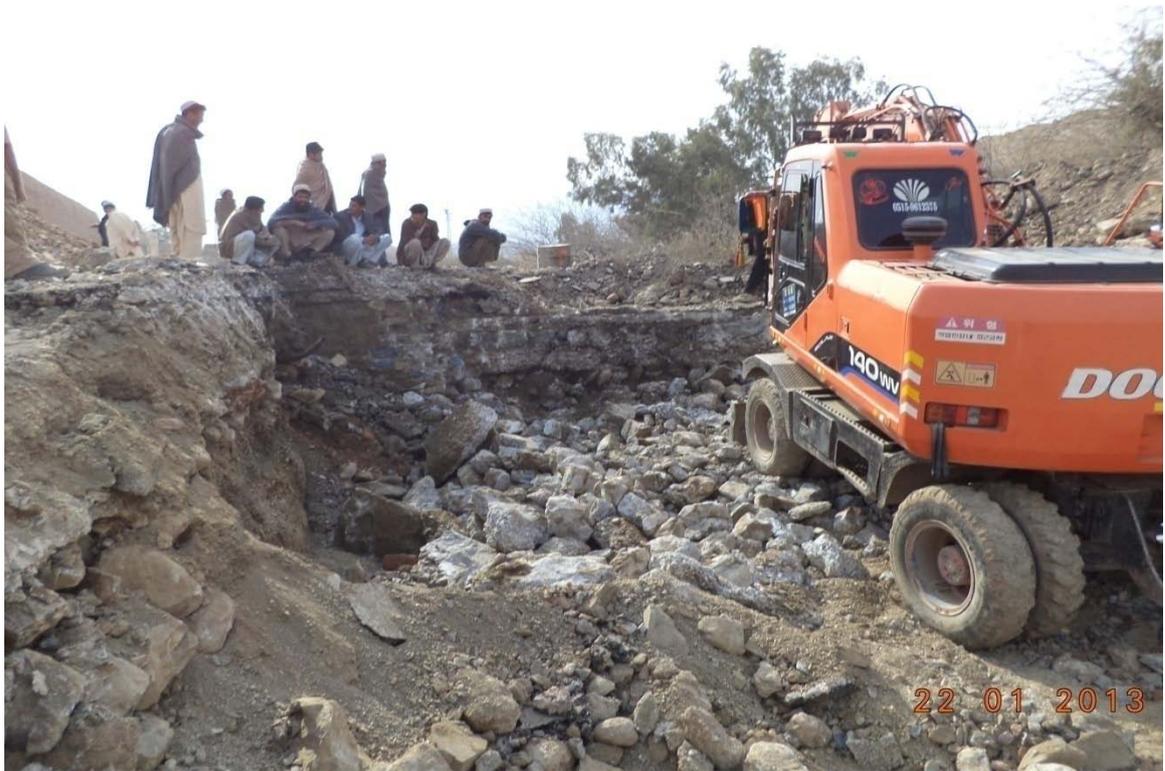
Photo (23): View of Excavation at Culvert without fence.

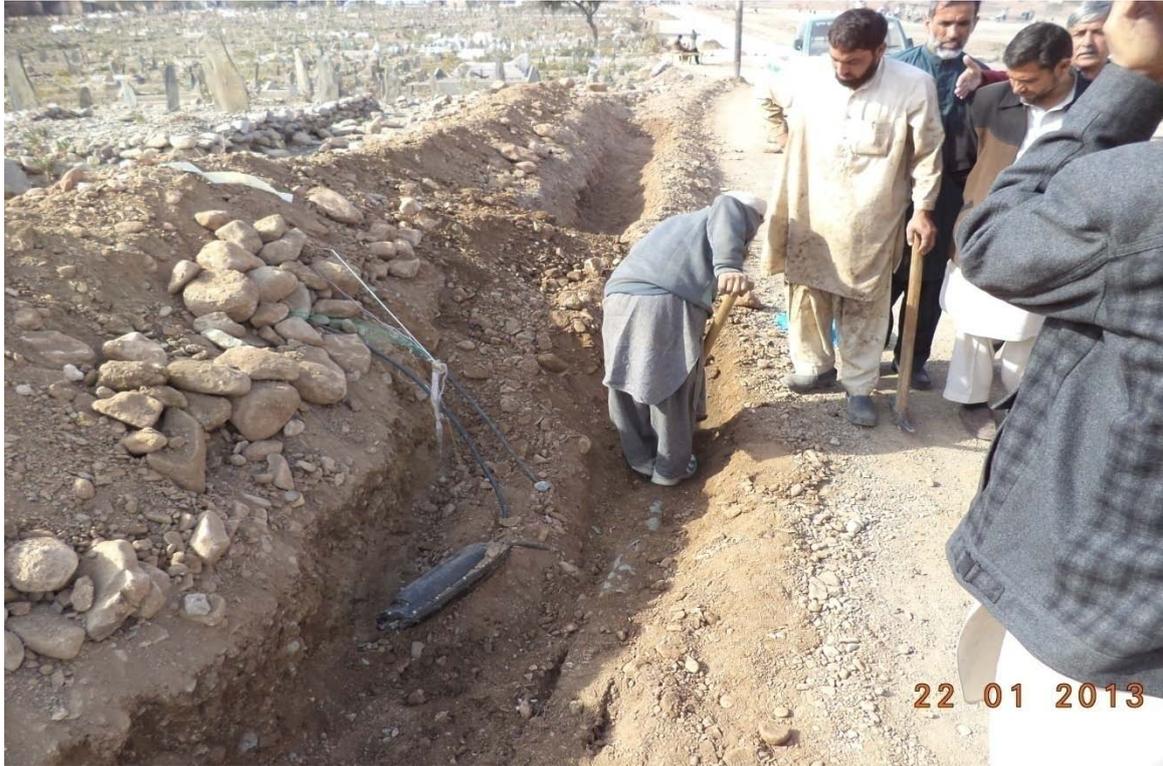
Borrow Areas	These impacts are reversible through a diligent restoration process which must be put in place by the contractor and approved by the Highway Division.	Landscape rugged and interfere with the aesthetics of the area; pose danger to livestock and children; hold stagnant water and they take up agricultural land.	There were no activities at site regarding borrow area use. Moreover, barrow areas are still to be identified, if required.
Damages of existing infrastructure	<ul style="list-style-type: none"> a. Locate different infrastructure on opposite site of road b. Determine locations of water pipes, electricity pylons, etc and design scheme to avoid damage 	Facilities to the locals	<p>Damages to PTCL Telephone cables at RD 5+600, RD 5+905, RD 6+850 and RD 7+384 were noticed and asked FWO official to repair cables. It was also asked to site engineer that in future inform PTCL Department before starting excavation. Later on, in a meeting the overall field in charge informed us that a meeting has already been conducted with PTCL and WAPDA departments for proper care of their cables during construction process.</p> <p>Please see Photo. 25</p>

Photo (25): View of Damaged PTCL cable
