CONSTRUCTION MONITORING & EVALUATION PROGRAM

**STRENGTHENING & IMPROVEMENT OF PESHAWAR – TORKHAM
ROAD (N-5), KHYBER AGENCY, FATA**

MONTHLY PROGRESS REPORT # 03

FEBRUARY 2013

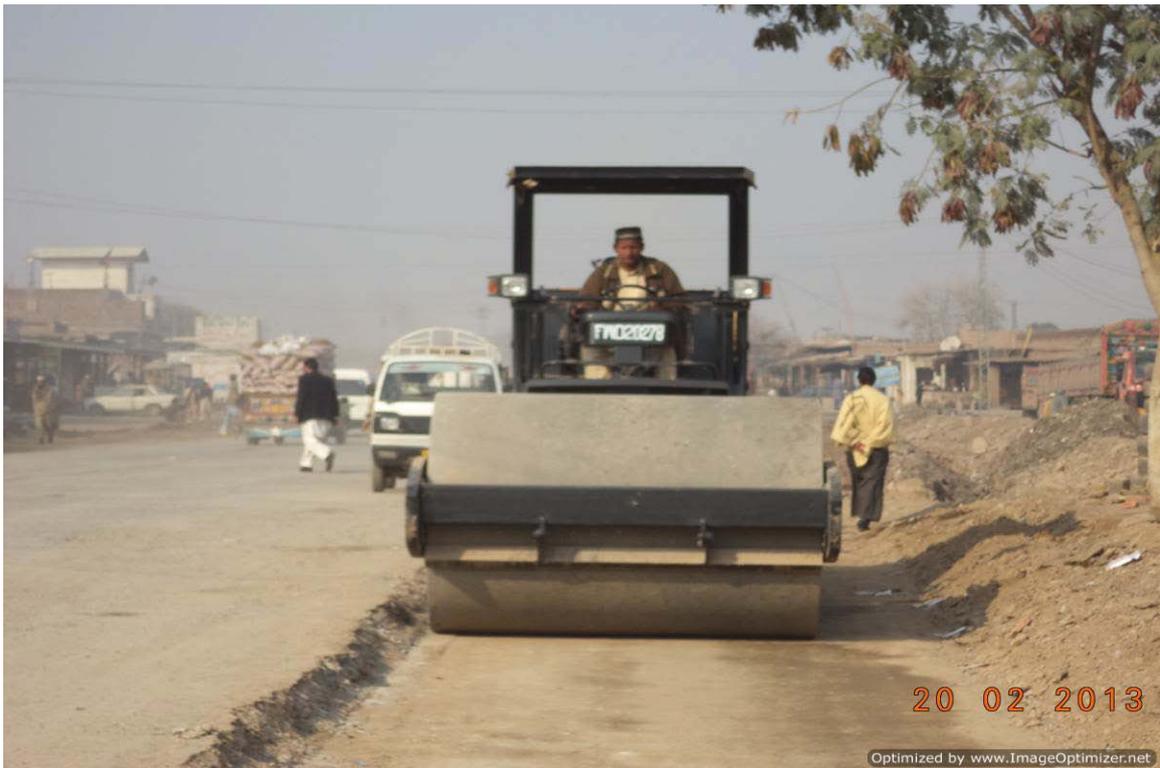
Lat 33; 59; 57.7, Lon 71; 24; 46.1

KM: 0 + 750 To 0 + 800 (RHS shoulder) Sub grade top layer compaction is in progress

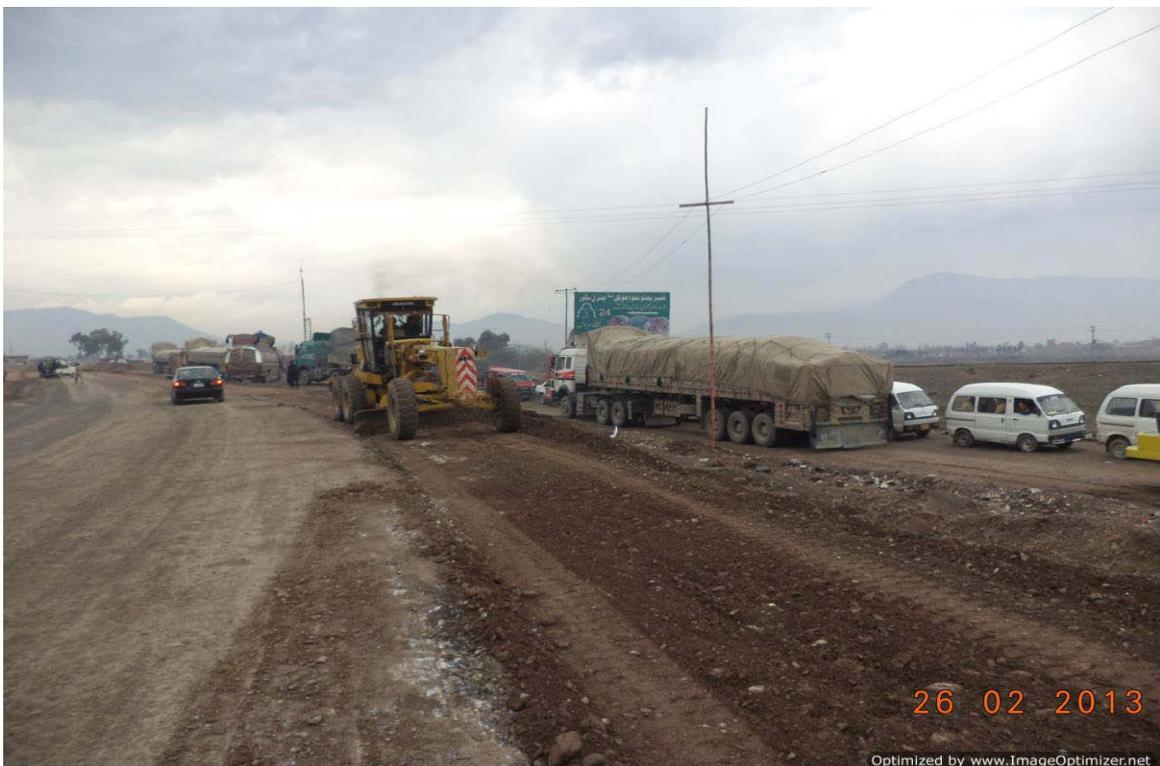
Lat 33; 59; 52.9, Lon 71; 24; 12.1

KM: 1 + 625 To 1 + 775 (RHS Shoulder) Sub grade top layer preparation is in progress

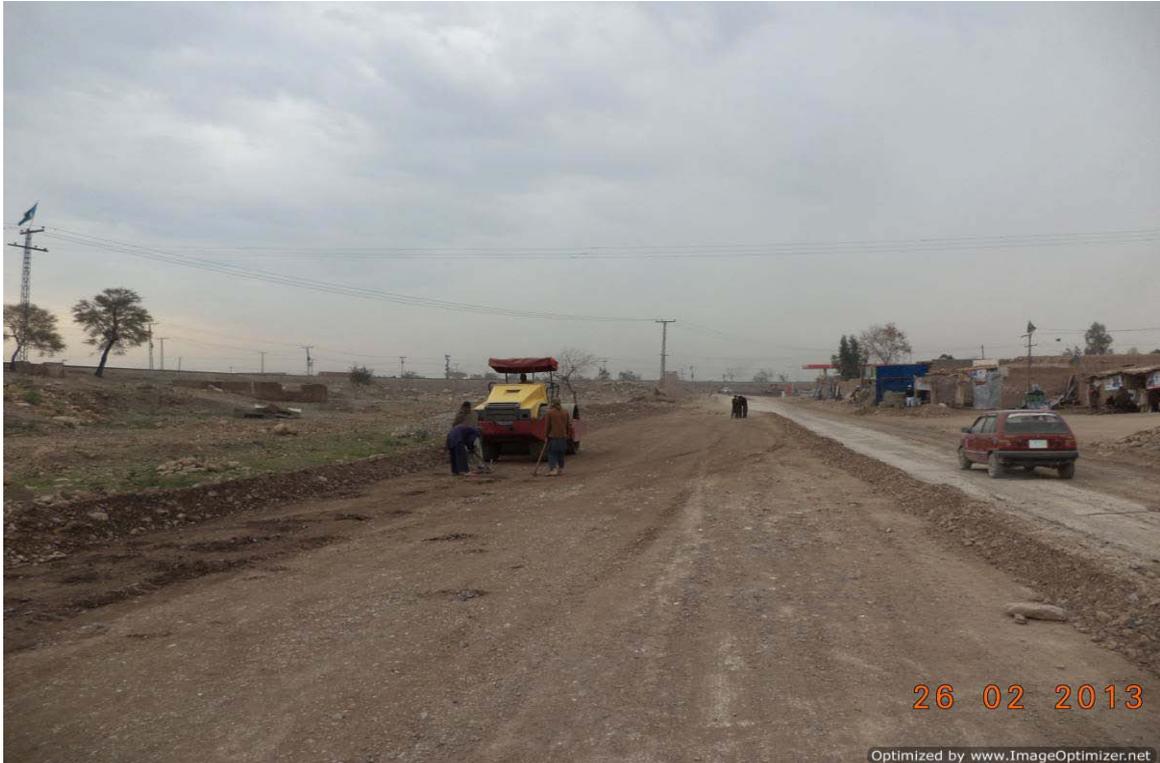
**Lat 34; 0; 2.7, Lon 71; 23; 42
KM: 2 + 900 To 3 + 000 (RHS Half Width) Sub base top layer compaction is in progress**

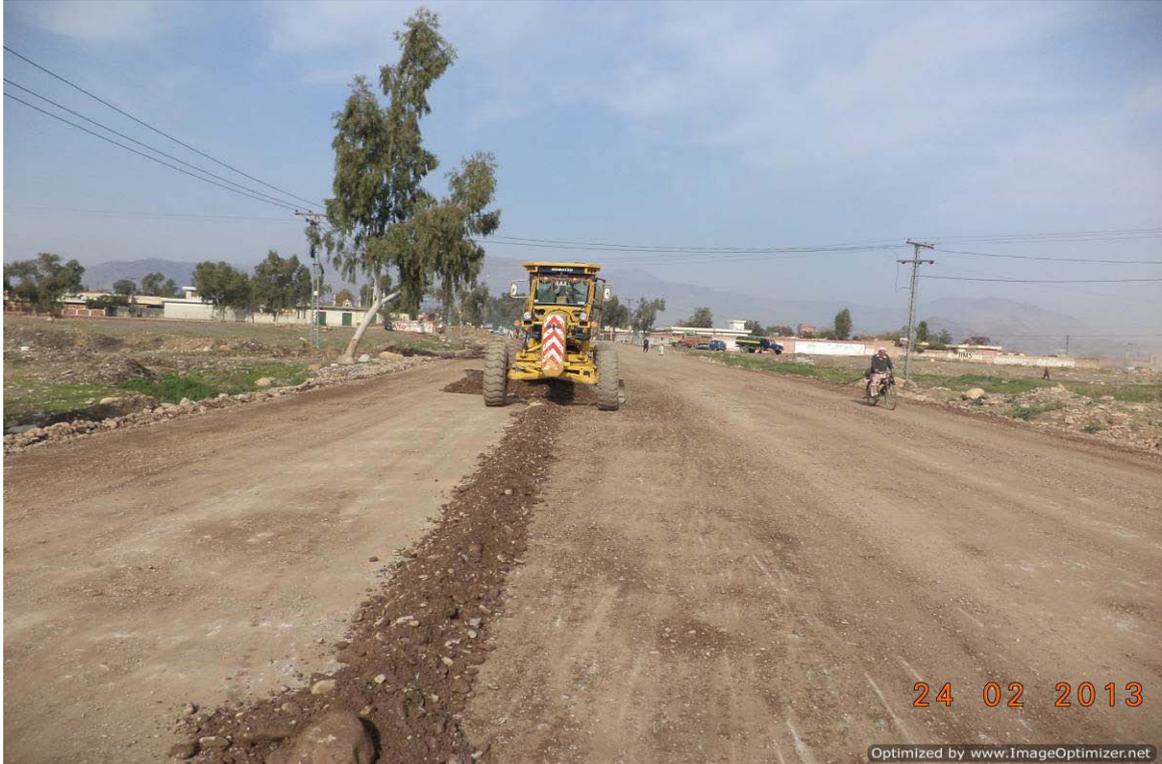
Lat 34; 0; 2.4, Lon 71; 23; 12.5

KM: 3 + 650 To 3 + 750 (Full Width) Sub grade grading is in progress

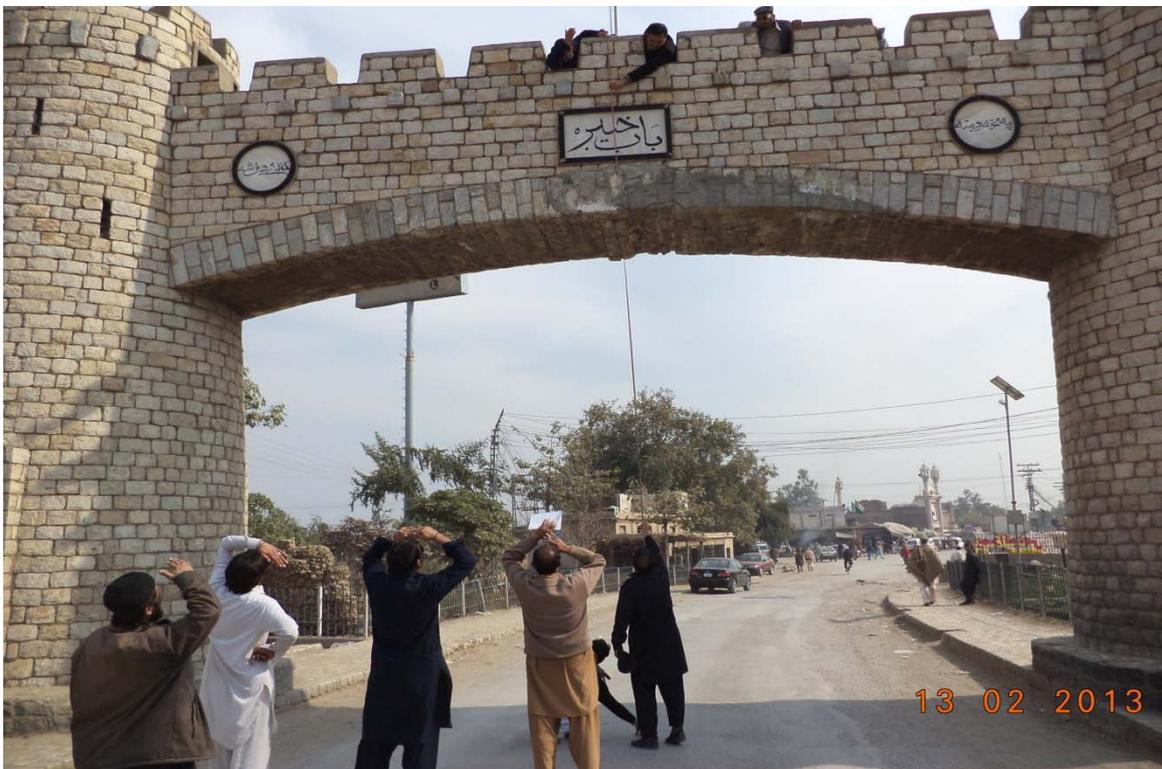
Lat 34; 0; 8.7, Lon 71; 22; 44

The ongoing site activities of full width sub base construction near Bab-e-Khyber monument (between KM: 4 + 500 to KM: 4 + 700) reveals that the vertical clearance b/w the proposed finished road surface and soffit of the famous monument (KM: 4 + 365) will be insufficient for safe passage of Commercial vehicles. The design appears not to be in conformity with the site conditions and AASHTO standard of 5.1 M vertical clearance for National Highways. Insufficient vertical clearance at Bab-e-Khyber may result in severe incidents risking road users, damaging the Monument, and causing serious traffic congestion on this section of the road. Similarly, horizontal clearance between the two pillars of the Monument is insufficient to accommodate the proposed carriageway. FWO / NESPAK should review the design at the above mentioned section, make necessary correction to the measurements and redesign the horizontal as well as vertical alignment.

KM: 4 + 365 M&E Consultants & FWO are measuring clear height of Bab e Khyber

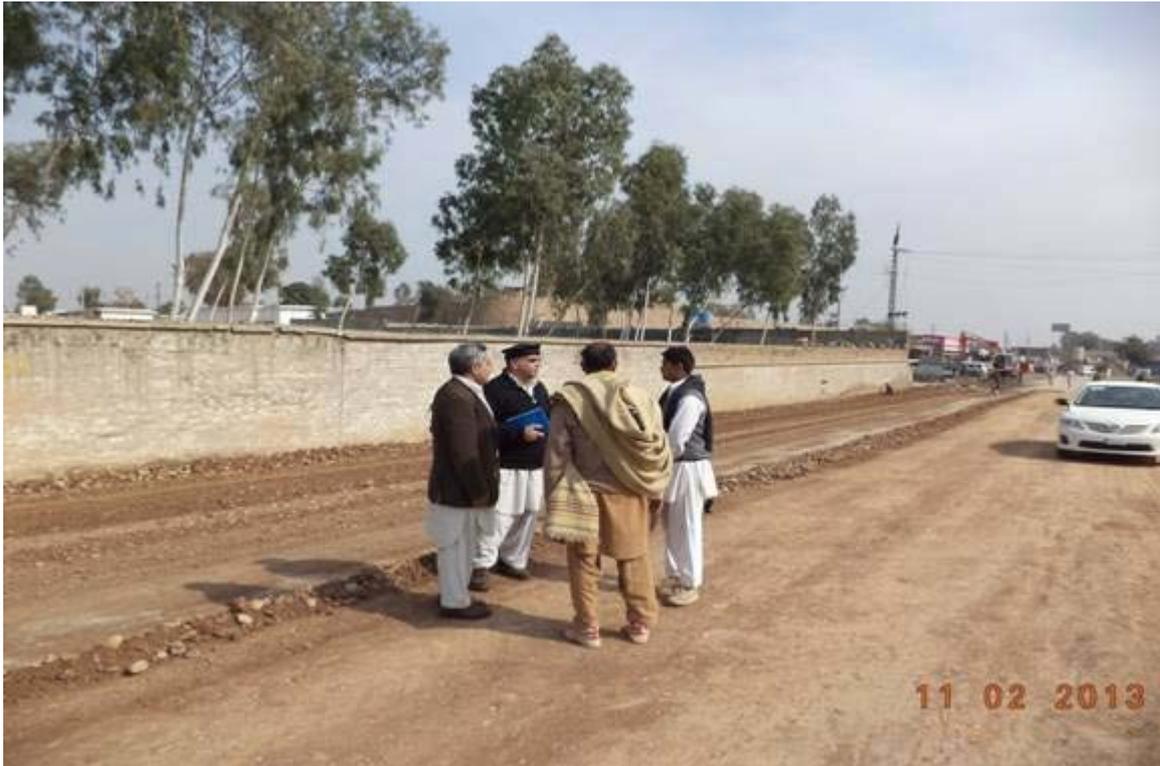
Lat 34; 0; 7, Lon 71; 22; 34.9

KM: 4 + 625 To 4 + 700 (Sub base 1st layer) M&E Consultants inquired about the field control exercised by FWO field staff

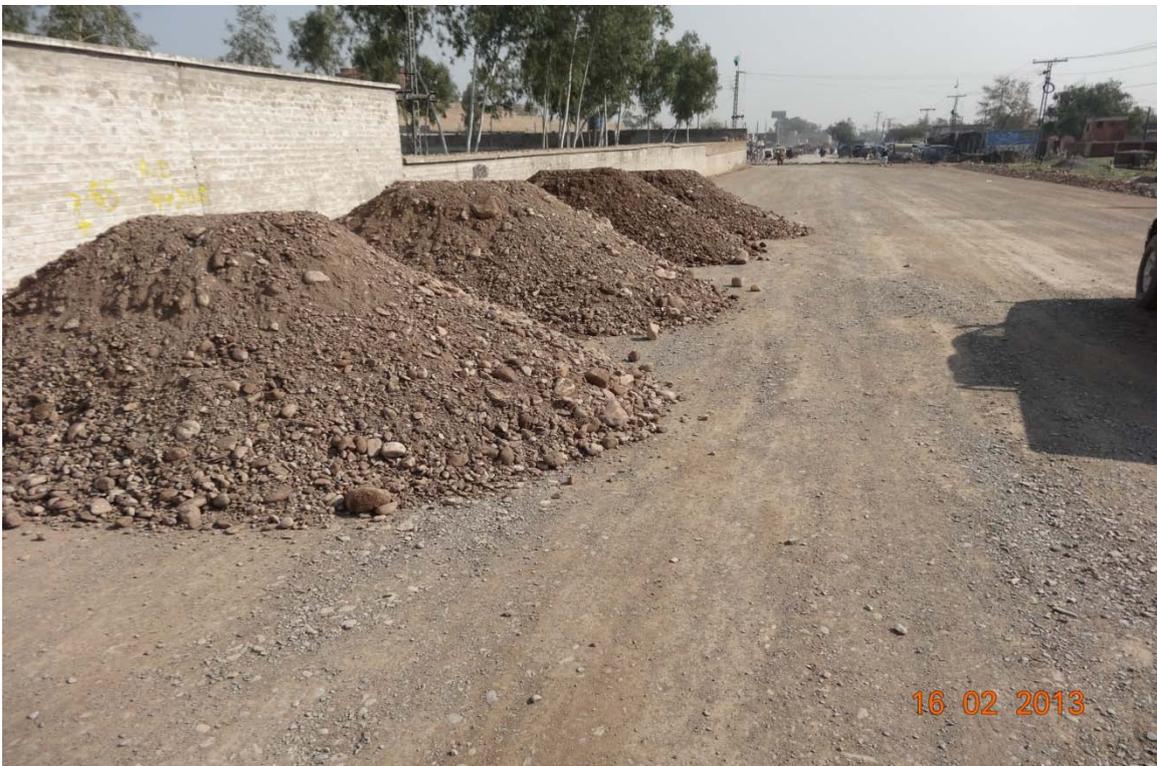
Lat 34; 0; 7, Lon 71; 22; 34.9

KM: 4 + 625 To 4 + 700 (Full Width) Dumping of material for sub base 1st layer is in progress

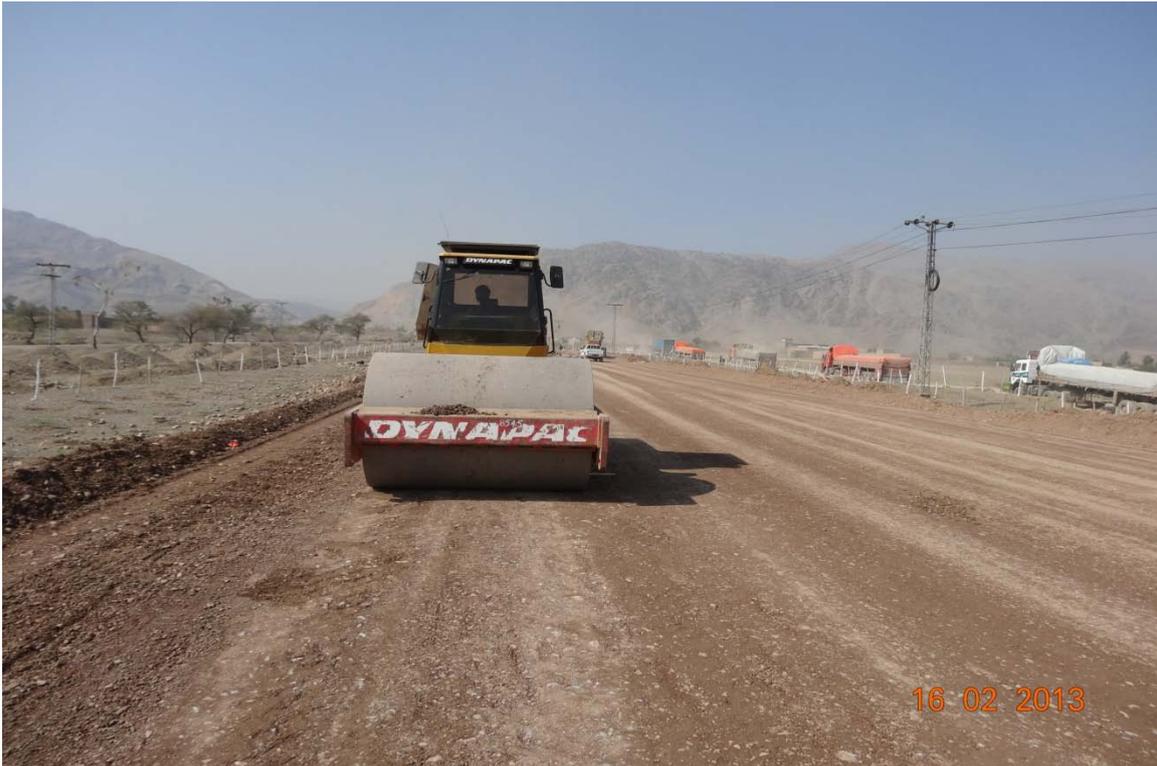
Lat 34; 0; 16.5, Lon 71; 20; 49

KM: 7 + 450 To 7 + 550 (Full width) Sub base 1st layer compaction is in progress

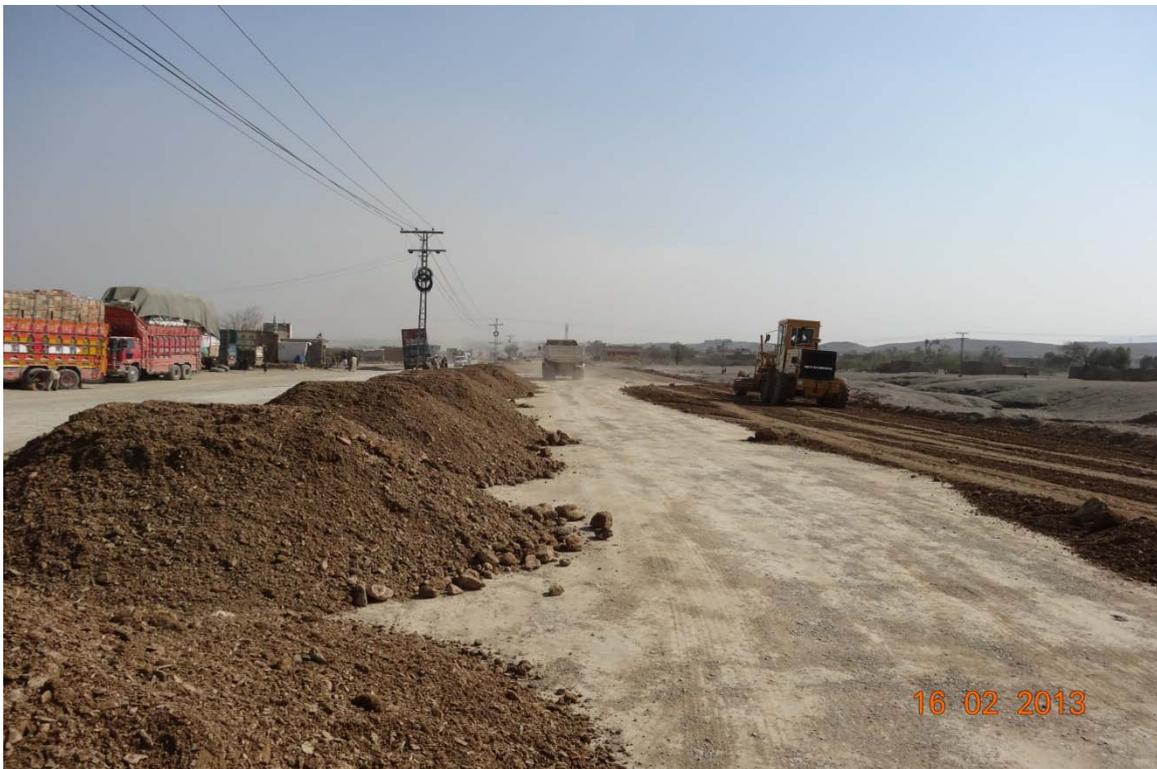
Lat 34; 0; 19.2, Lon 71; 20; 28.6

KM: 7 + 925 To 8 + 075 Dumping/grading of material for sub grade top layer is in progress

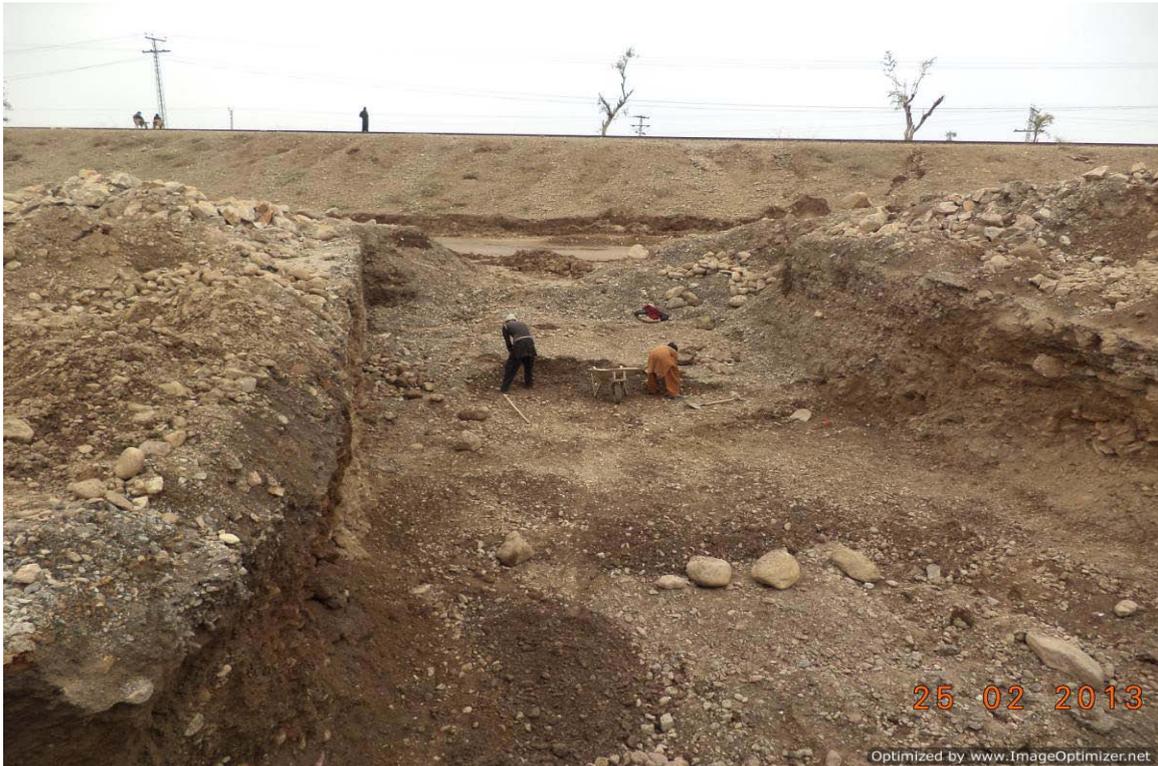
Lat 34; 0; 5.4, Lon 71; 23; 50.9
KM: 2 + 611 (Culvert) Structural excavation is in progress

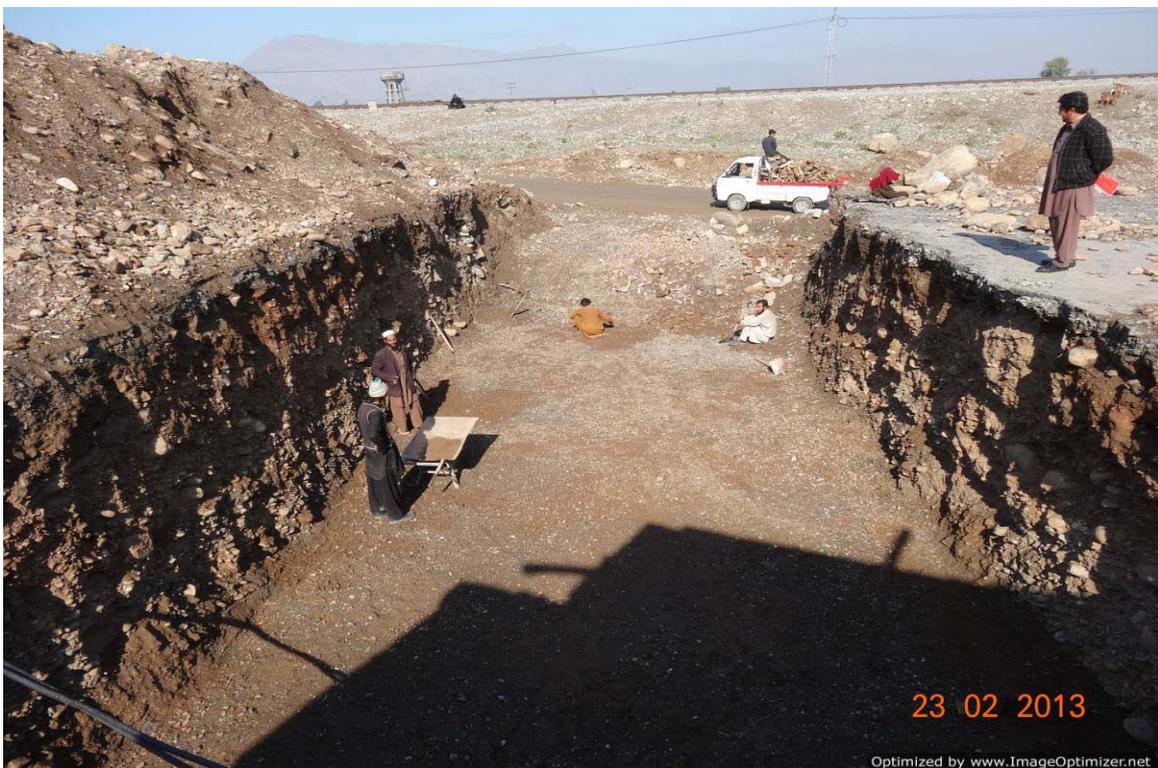
Lat 34; 0; 0, Lon 71; 23; 33.7
KM: 3 + 081 (Culvert) Leveling of foundation bed is in progress

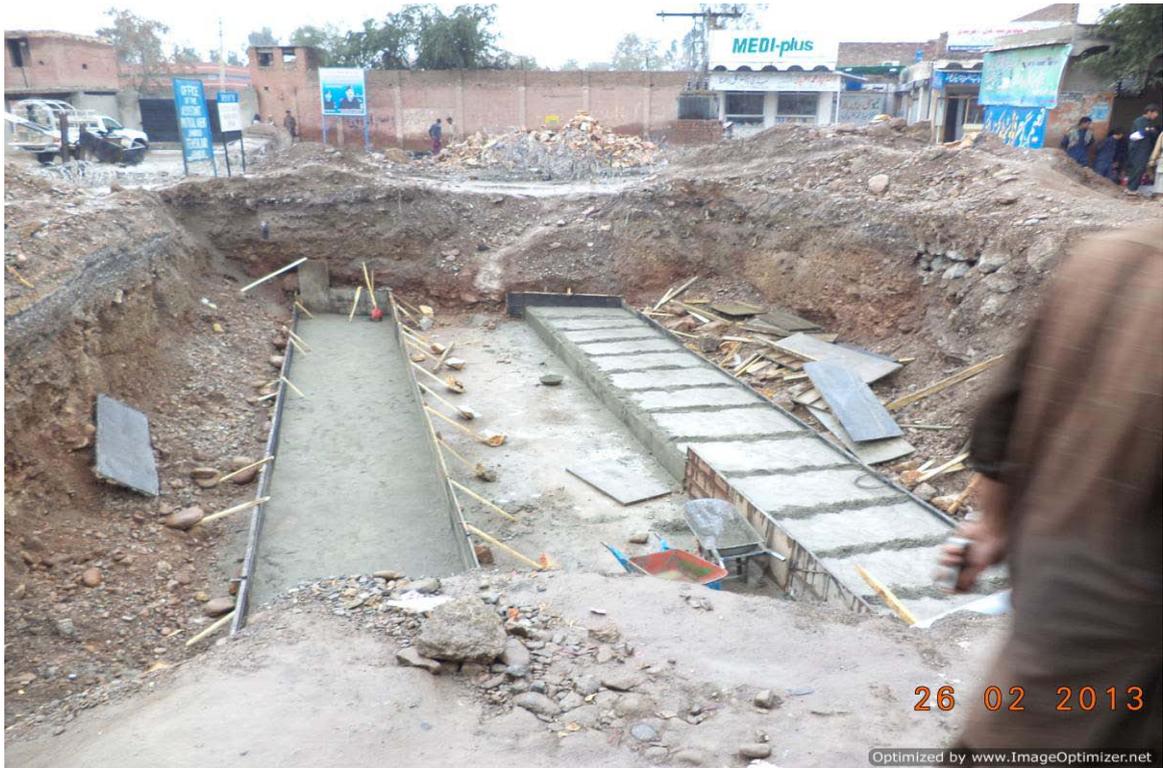
Lat 34; 0; 8.7, Lon 71; 22; 44
KM: 4 + 480 (Culvert) Form work for lean concrete of abutment 2 is in progress

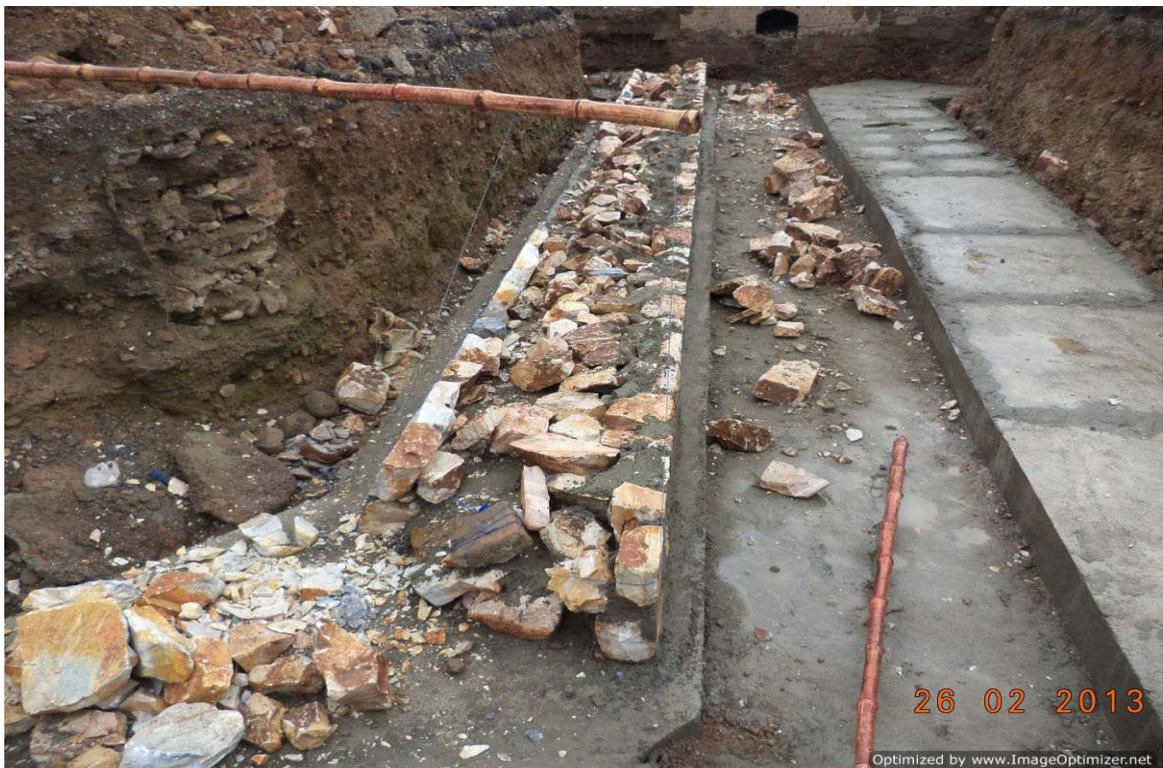
Lat 34; 0; 6.3, Lon 71; 22; 15.7
KM: 5 + 202 (Culvert) Stone masonry construction at abutment 1 is in progress

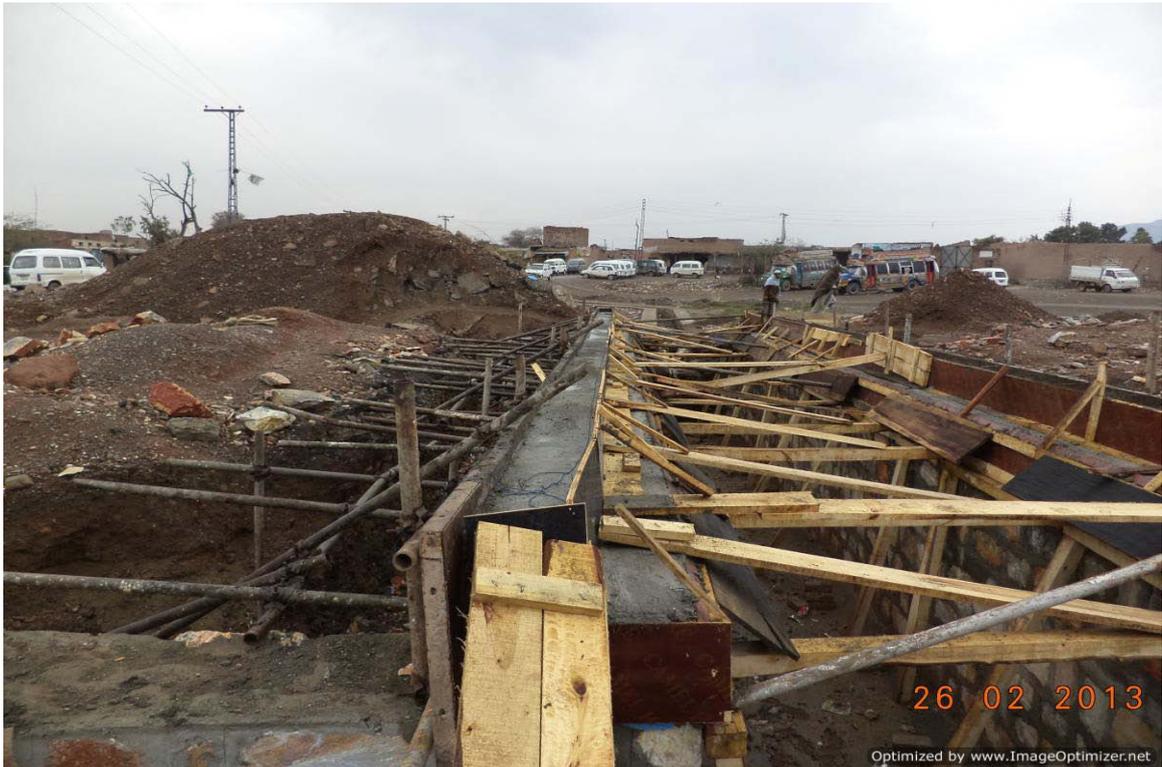
Lat 34; 0; 7.9, Lon 71; 21; 49.2
KM: 5 + 905 (Culvert) View of form work for concrete pad at abutment 1 & 2

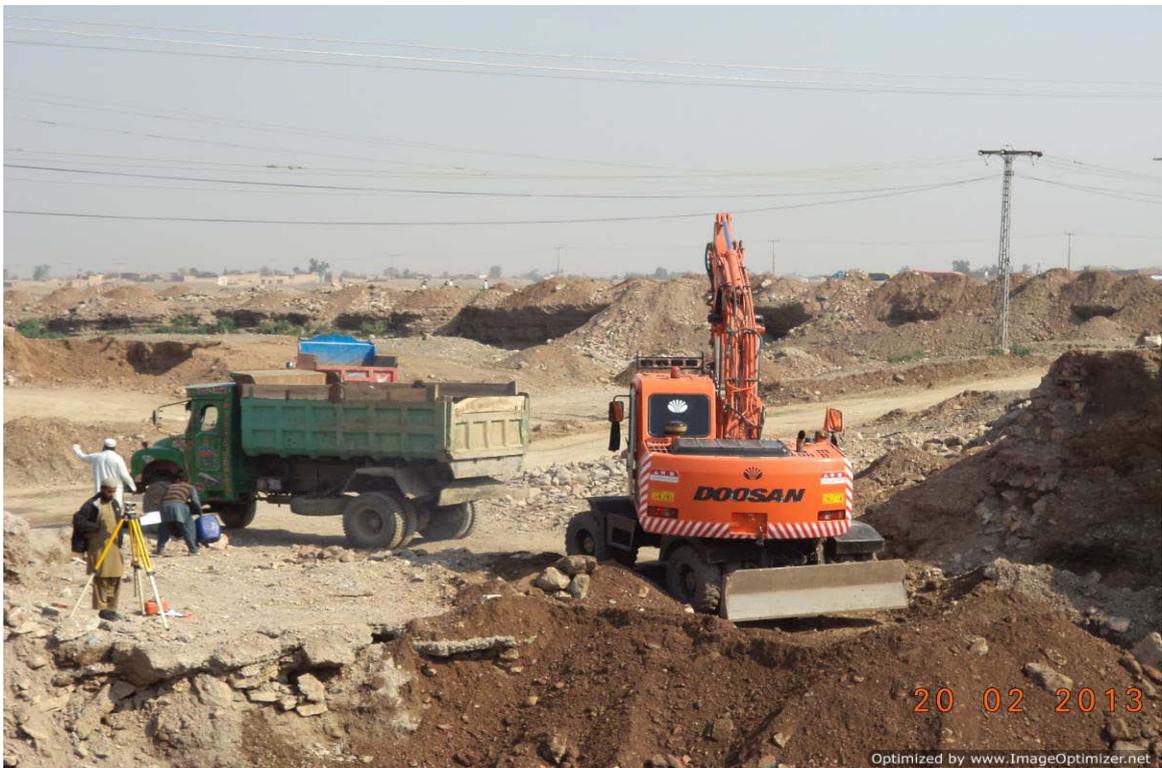
Lat 34; 0; 8.0, Lon 71; 21; 44.0
KM: 6 + 050 (Culvert) Structural excavation is in progress

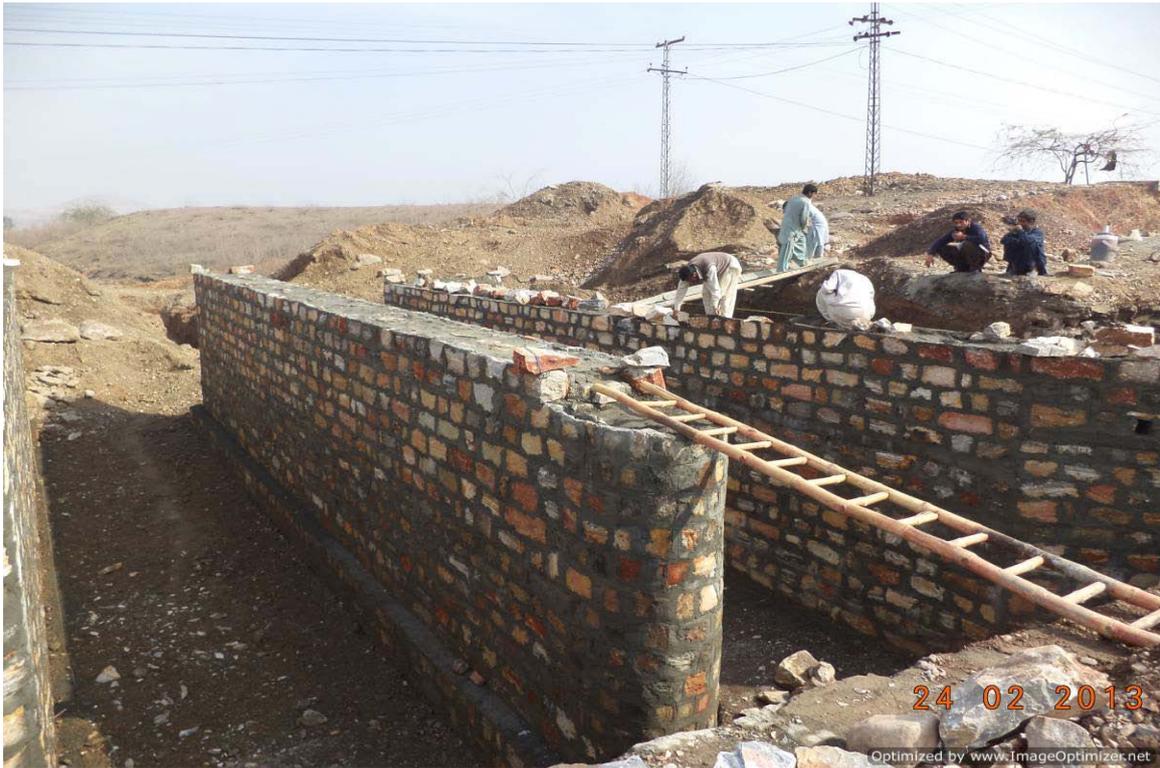
Lat 34; 0; 8.723, Lon 71; 21; 27.733
KM: 6 + 191 (Culvert) Stone masonry construction of abutment 1 is in progress

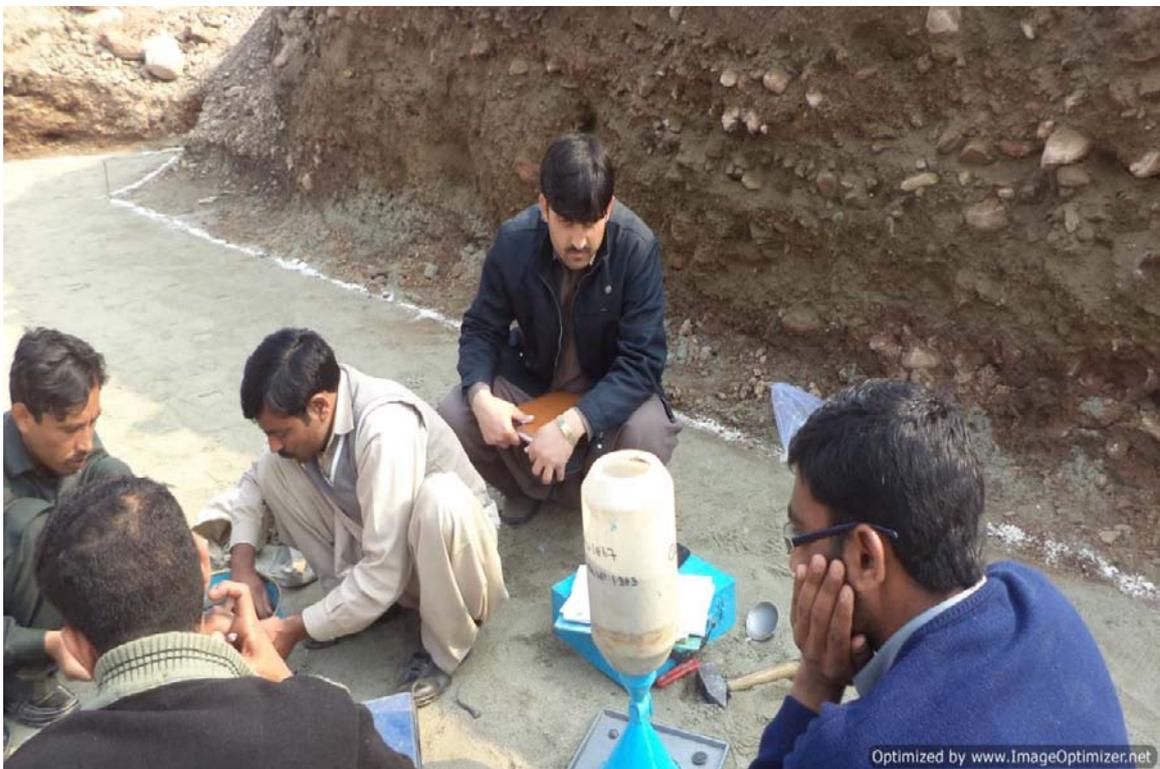
Lat 34; 0; 6.33, Lon 71; 22; 15.785
KM: 5 + 202 FDT Test for Culvert foundation is in progress in the presence of M & E Lab Staff

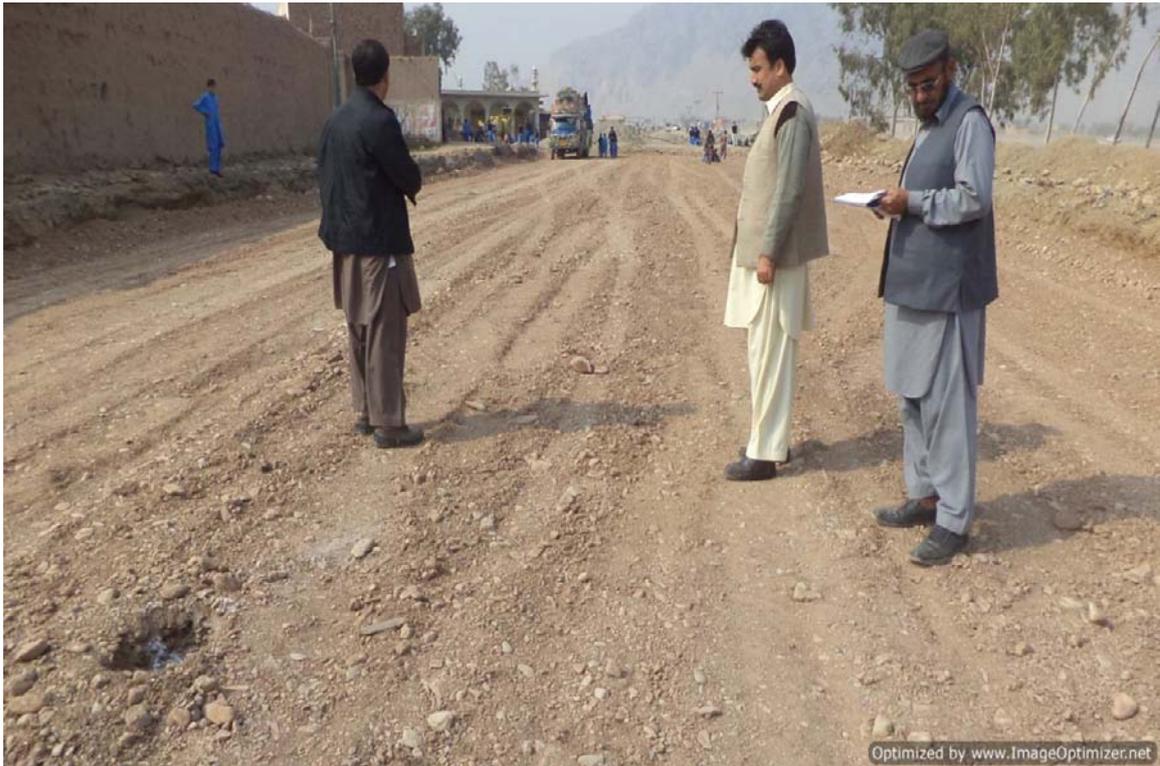
Lat 34; 0; 13.4, Lon 71; 20; 58.7

KM: 7 + 250 To 7 + 350 (Full Width) Inspection of Sub base material by Material Engineer and Field Monitor, M&E Consultants

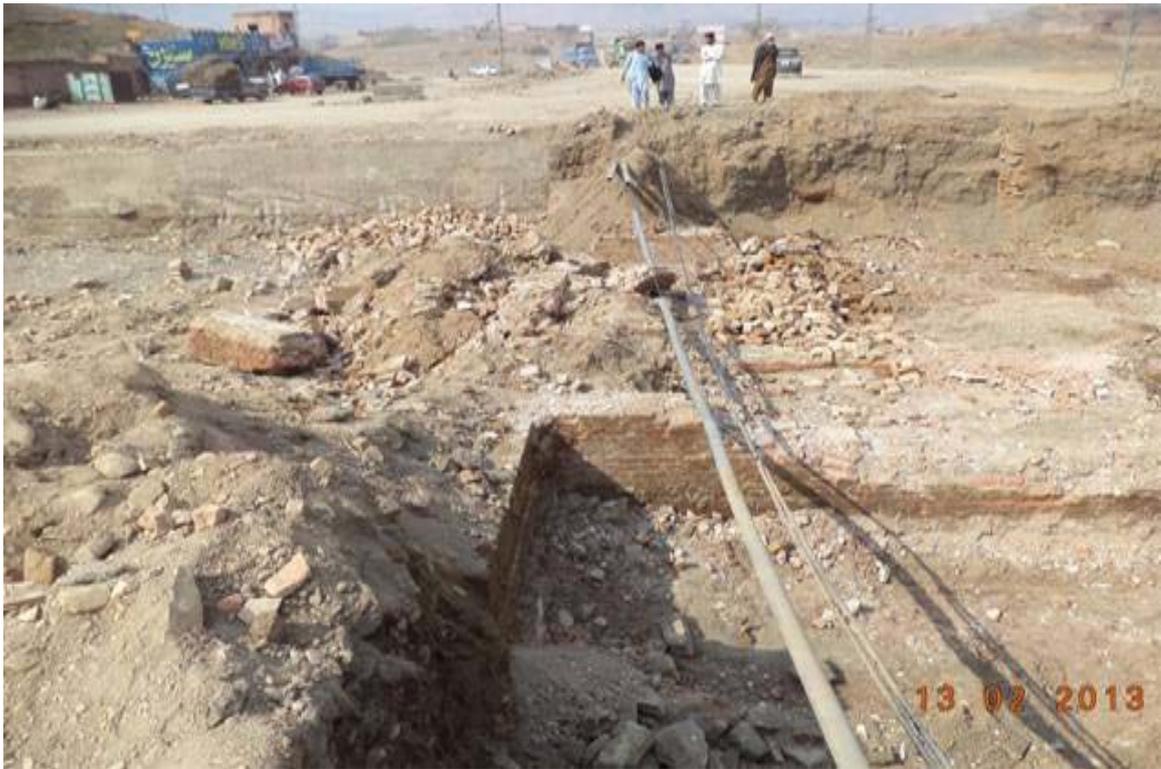
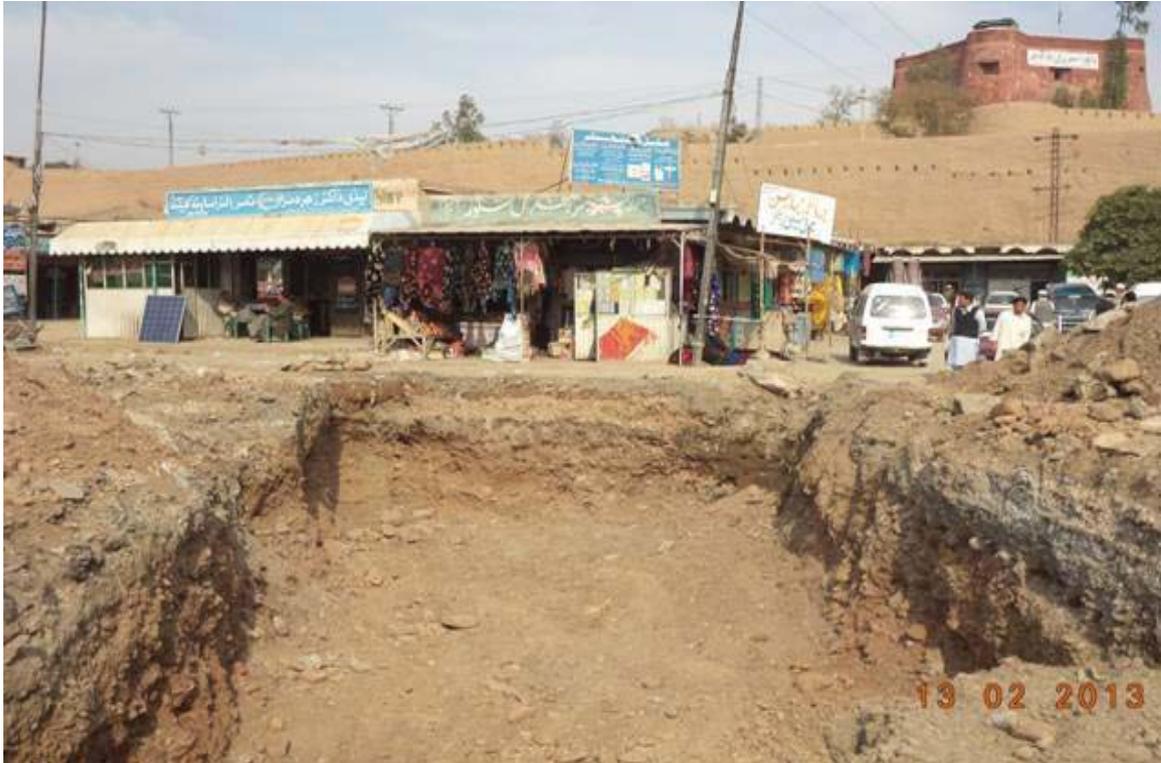
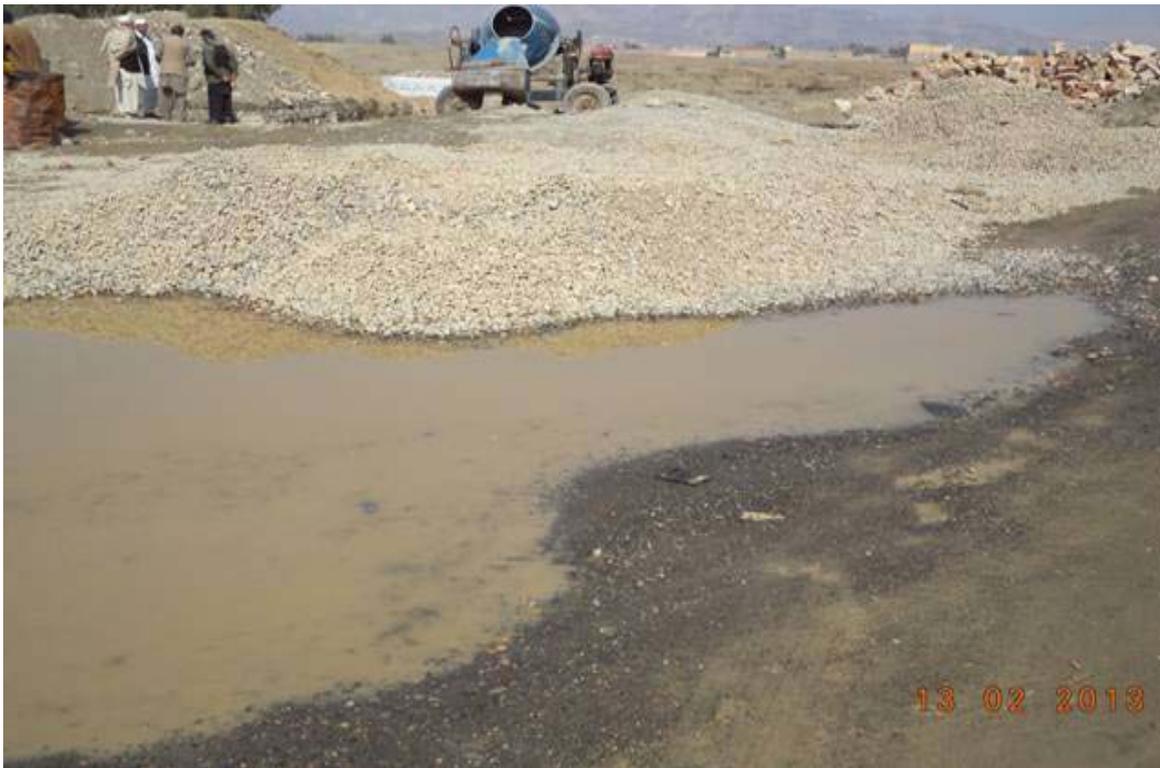
| Activity | Mitigation Measures | Monitoring indicators | Observations |
|---|--|--|--|
| Flood protection | <ul style="list-style-type: none"> a. Culverts should be provided to control flood damages and provision of safety of Embankments. b. Road protection work along the river side. c. Construction of retaining wall d. New causeways for the smooth flow of water during rainy seasons and flooding. | Site inspection | <p>The road construction work has started and works on different types of flood protection measures have also been started like culverts, retaining walls for smooth flow of water during rainy season and sewerage disposal.</p> <p>But it was noticed during site visit that no temporary arrangements have been made for disposal of flood and sewerage water nor any protection measures have been adopted for safety of other infrastructure like telephone cables etc This kind of instruction is repeatedly advised for the last one and a half month.(RD 2+600, 4+625, 5+905, RD 6+191, RD 6+850, RD 7+384)</p> <p>Please see photos(1),(2),(3)</p> |

Photo (1): KM: 6+501 Construction of Culvert

Photo (2): KM: 4 + 600 Construction of Culvert in Jamrud Bazar

Photo (3): KM: 6 + 883 Construction of Culvert

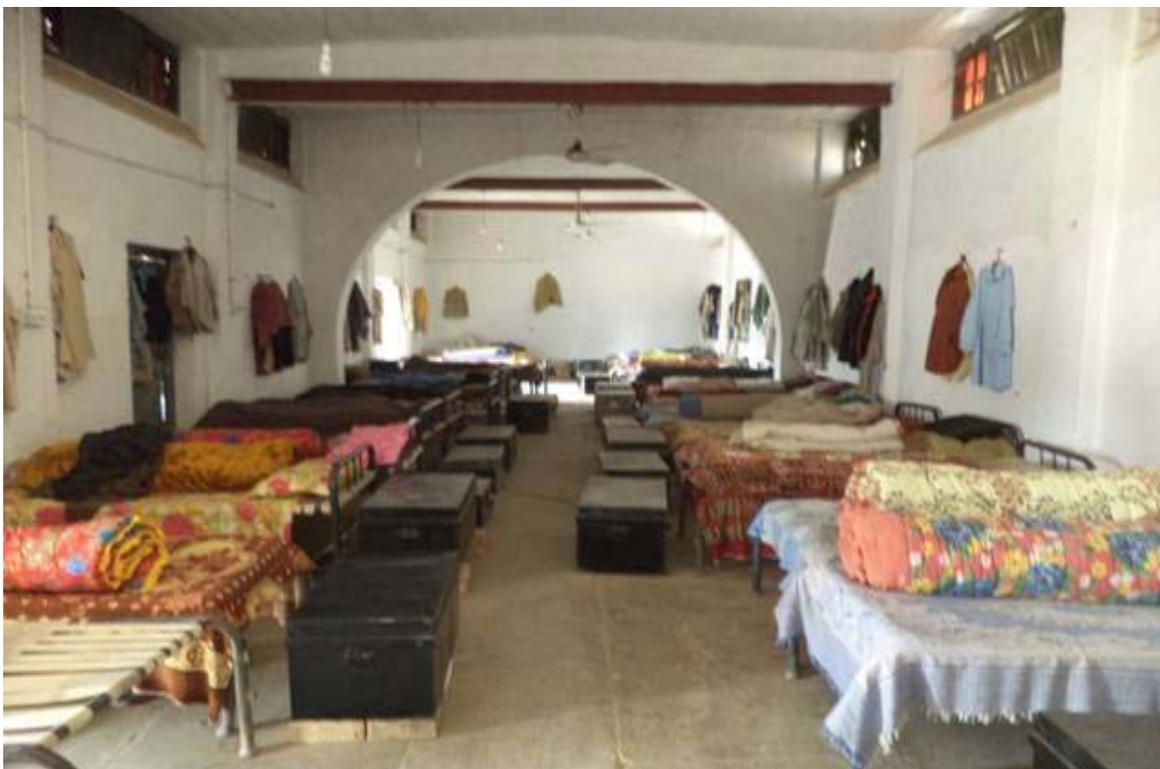
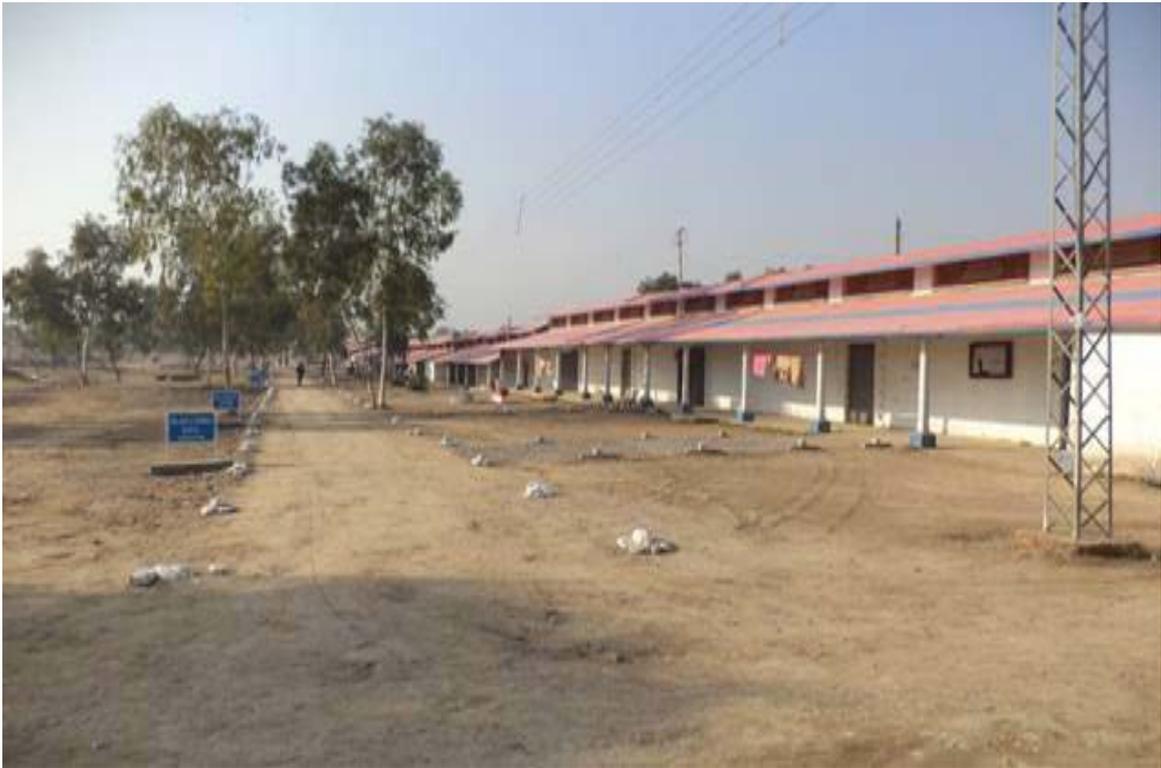
| | <ul style="list-style-type: none"> h. Provide adequate quantities and good quality food and cooking fuel. i. If the water is stored for drinking water should meet the WHO standards and if it is used for construction purpose then it should be clearly demarcated. j. No domestic pets or livestock are allowed on the site. | | <p><u>diagnosis at site observed.</u> FWO staff is educated and follow strict guidelines from their senior to interact with locals. <u>The guidelines for removal of trees have not been provided to be followed as standard procedure. Trees cutting (removal) was noticed earlier and the removed trees were then carried to camps.</u></p> <p>FWO provides good quality food and setting environment for its staff. Domestic livestock can be seen at site off and on, but the camps are away and are protected, so no entrance was seen during site visit.</p> <p>Please see Photos-(4),(5)</p> |

Photo (4): Room inside view of FWO Contractor Labor Camp

Photo (5): View of labor Camp (FWO)

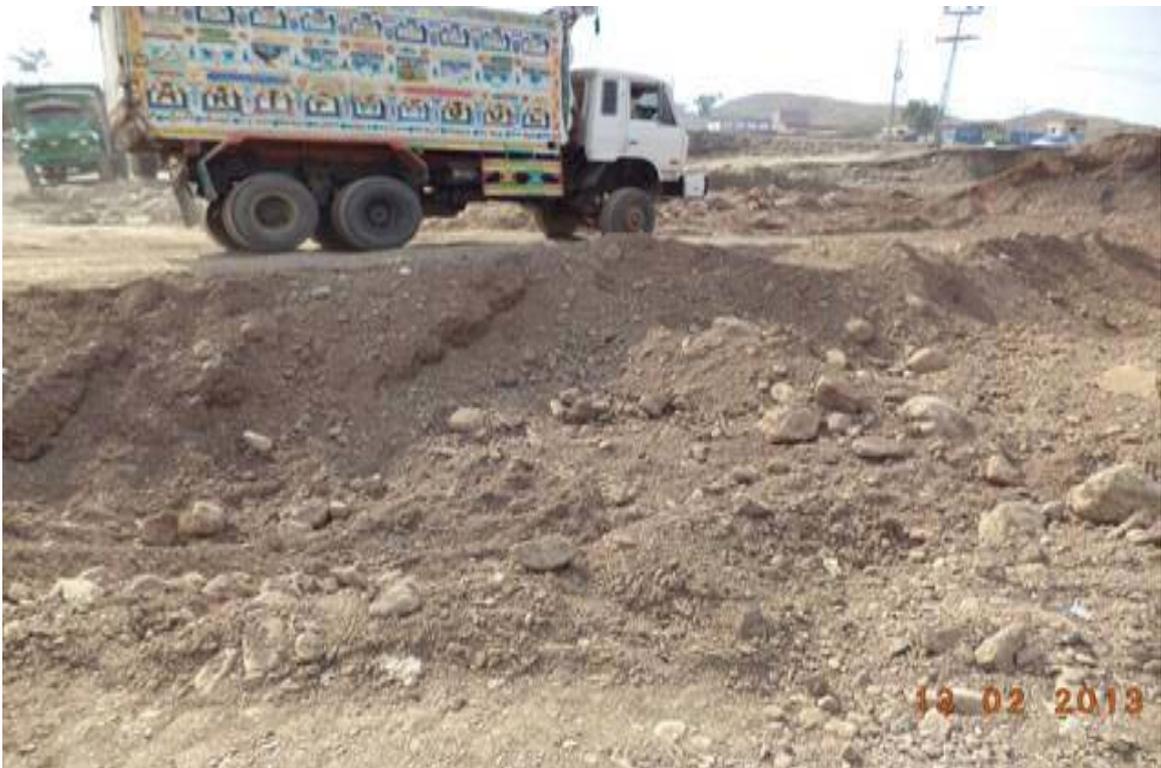
| Source of building materials | <ul style="list-style-type: none"> a. Develop logging, quarrying and borrowing plans that take into account cumulative effects b. Monitor adherence to plans and impacts of extraction practices. Modify as necessary c. Fill in quarries and pits before abandoning d. Control runoff into pit | Damage aquatic ecosystems erosion , siltation, Harm terrestrial ecosystems and vector-borne diseases | <p>At material extraction site near RD 6+50, the area has not been restored and leveled. Asked Mr Fiaz Naik FWO at site for <u>leveling and refilling the adjacent previous quarry sites for sustainable use and for making drainage ways, where applicable.</u></p> <p>The local inhabitants of the area were asked for better use of these quarry are as. During site visit, It was also noticed that no safety protocols being followed.</p> <p>Please see photo.(6)</p> |

Photo (6): KM: 6 + 000 Quarry area
