CONSTRUCTION MONITORING & EVALUATION PROGRAM

**STRENGTHENING & IMPROVEMENT OF PESHAWAR – TORKHAM
ROAD (N-5), KHYBER AGENCY, FATA**

MONTHLY PROGRESS REPORT # 03

FEBRUARY 2013

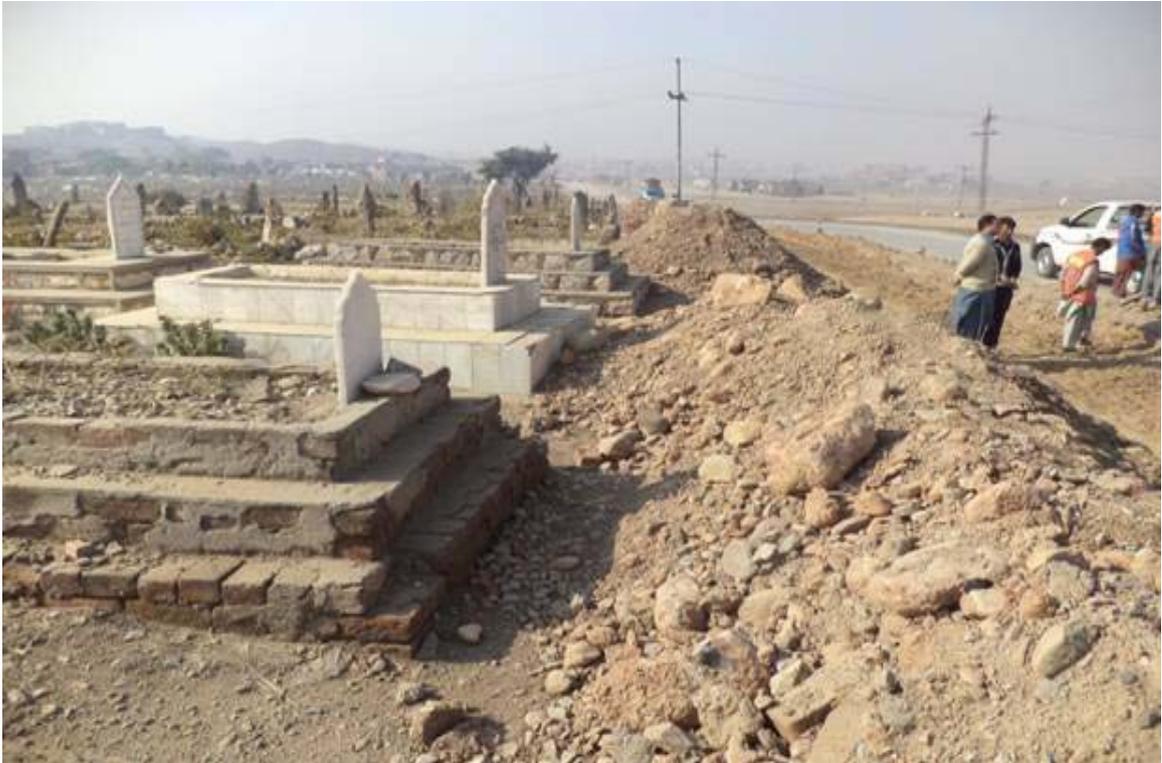
Photo (8): KM: 5 + 630 Excavated Material dumped in graveyard

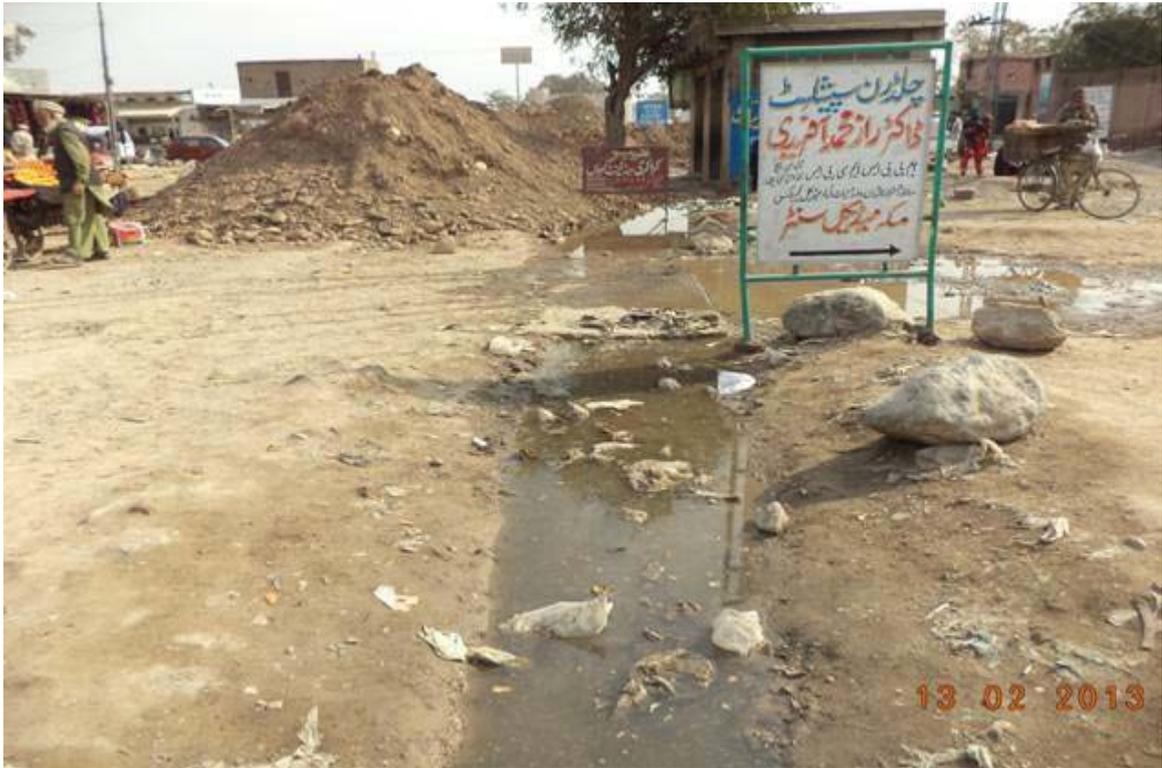
Photo (9): KM: 4 + 600 Standing water and closer of road due to construction of Culvert at Jamrud Bazar

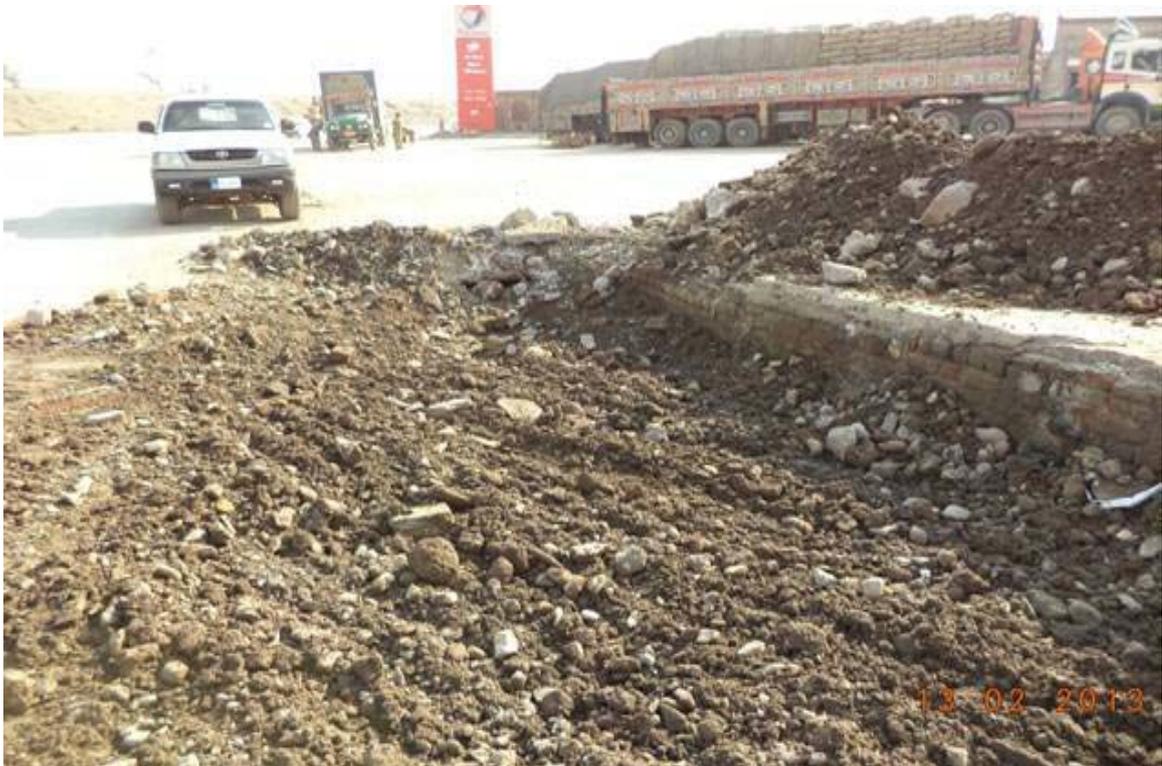
Photo (10): KM 3 + 200 View of excavated shoulder near Total Perol pump

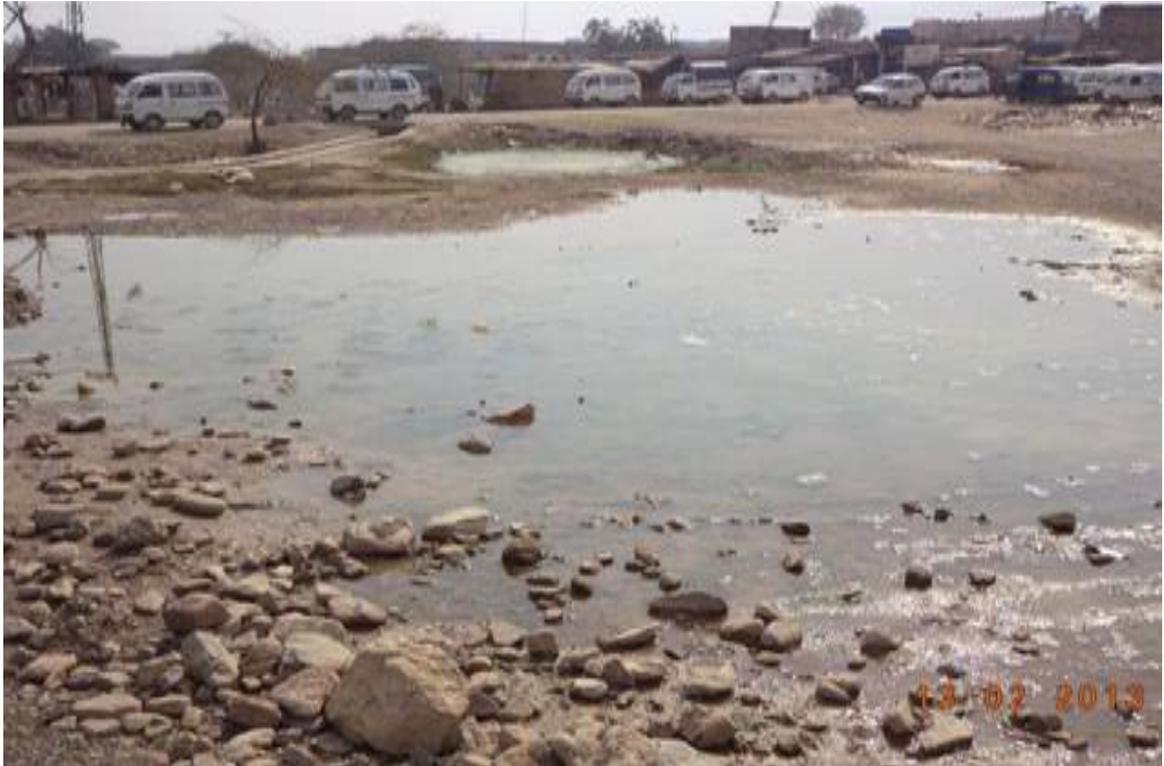
Photo (11): KM: 5 + 905 Stagnant water near Culvert construction

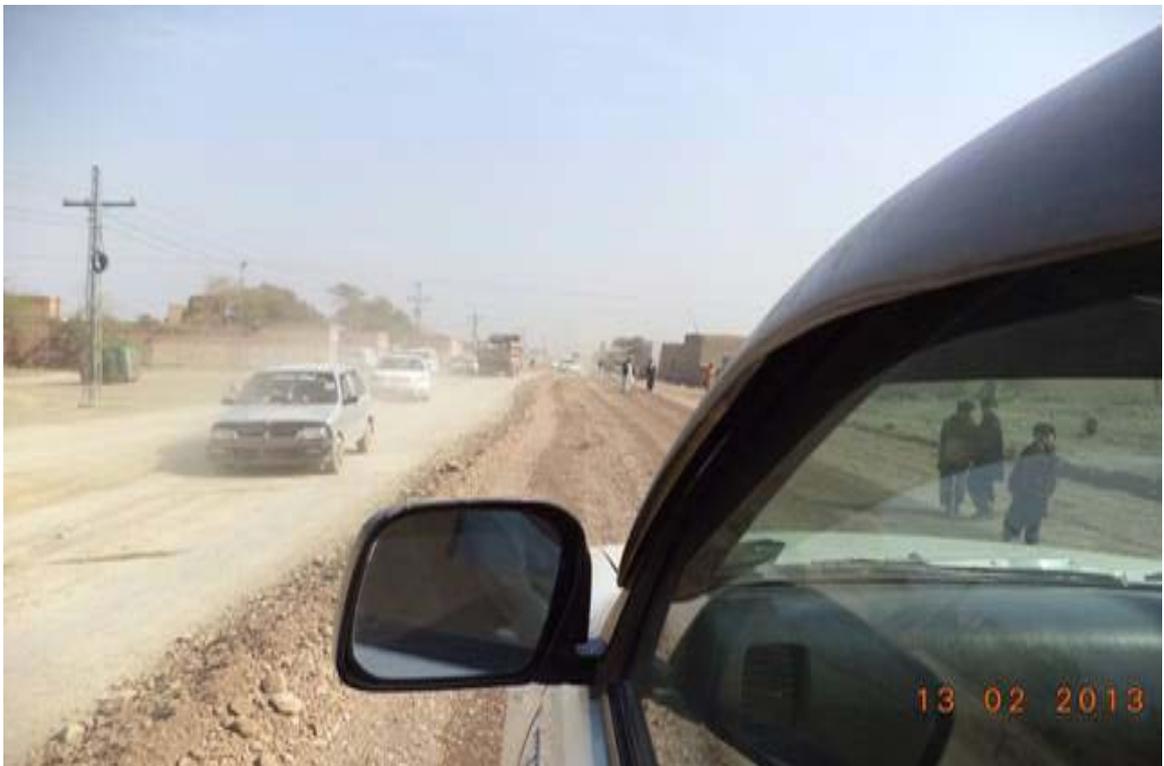
Photo (12): KM: 8 + 900 View of Dust at village Sur Kamar

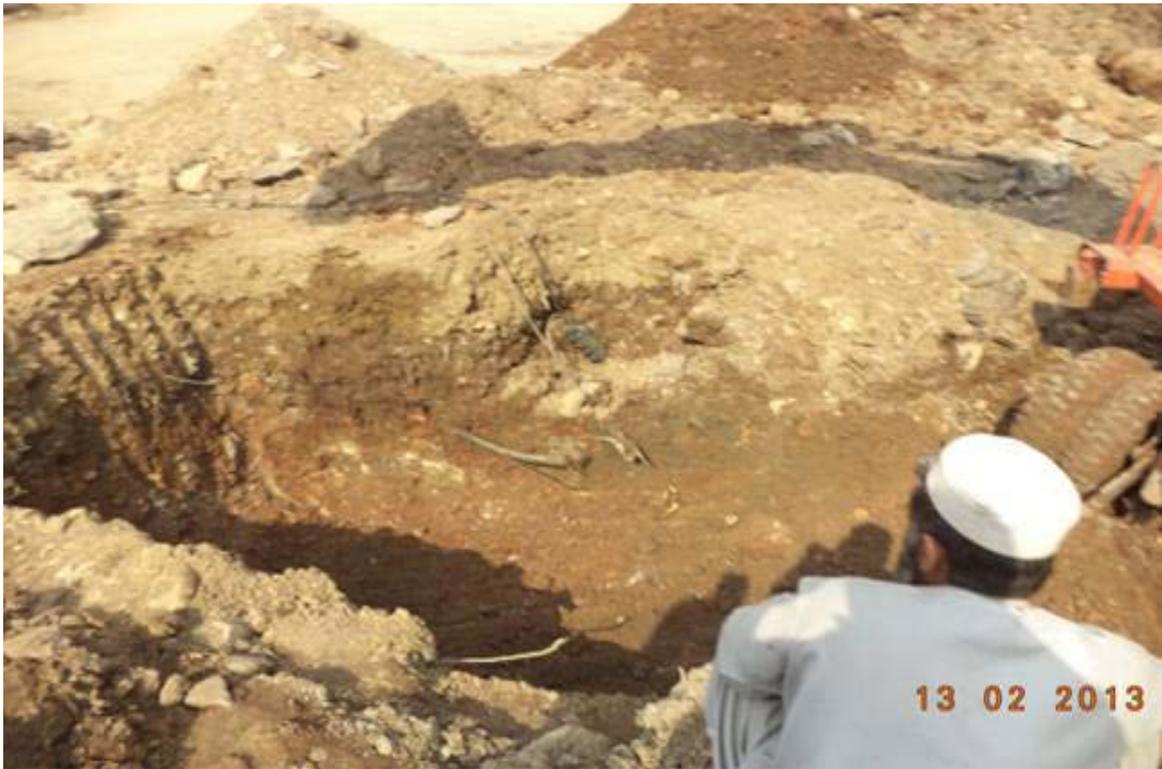
| Damages of existing infrastructure | <ul style="list-style-type: none"> a. Locate different infrastructure on opposite side of road b. Determine locations of water pipes, electricity pylons etc. and design scheme to avoid damages. | Facilities to the locals | <p>PTCL telephone cable was damaged due to excavation for culvert near RD 5+354. A team from PTCL arrived at site. The officials of PTCL and FWO were asked to repair the damaged cable. It was also advised to Site Engineer on spot that in future PTCL Department must be informed before starting excavation activities.</p> <p>Please see Photo. (13)</p> |

Photo (13): KM: 6 + 050 Damaged PTCL cables

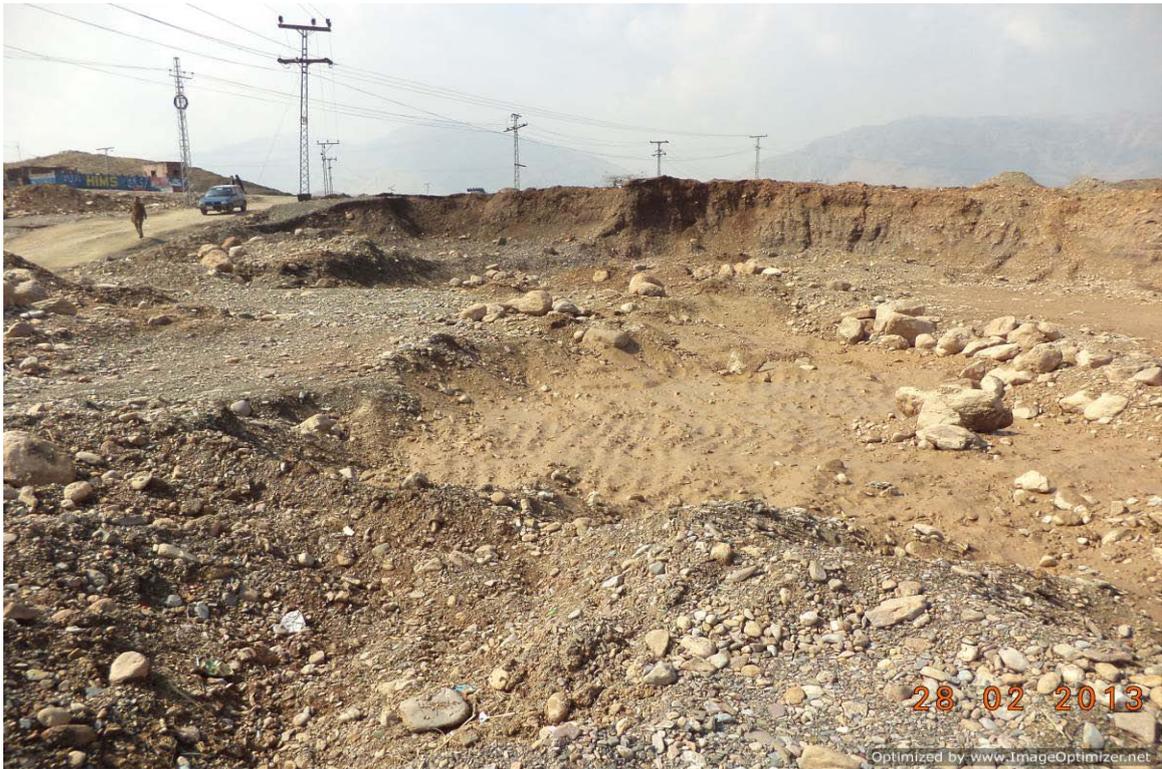
| Source of building materials | <p>a. Develop logging, quarrying and borrowing plans that take into account cumulative effects</p> <p>b. Monitor adherence to plans and impacts of extraction practices. Modify as necessary</p> <p>c. Fill in quarries and pits before abandoning</p> <p>d. Control runoff into pit</p> | Damage aquatic ecosystems erosion, siltation, Harm terrestrial ecosystems and vector-borne diseases | At material extraction site (Quarry) near Km 6+190, the area has not been restored and leveled. Asked FWO person at site for <u>leveling and refilling the adjacent previous quarry sites for sustainable use and for making drainage ways, where applicable.</u> The local inhabitants of the area should be contacted for better use of these quarry are. <u>During site visit, It was also noticed that no safety protocols being followed.</u> Please see photo.(19) |

Photo (19): KM 6+190 View of Quarry area

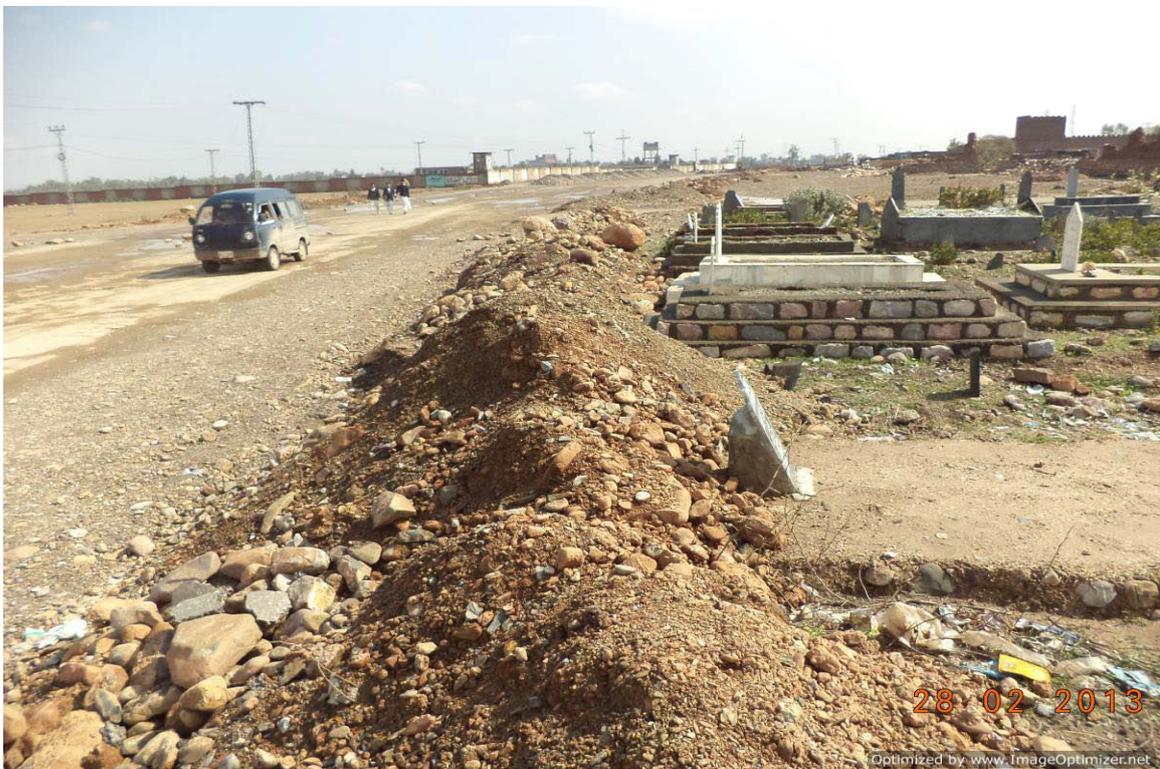
Photo (20): KM 5+630 Excavated Material dumped in graveyard

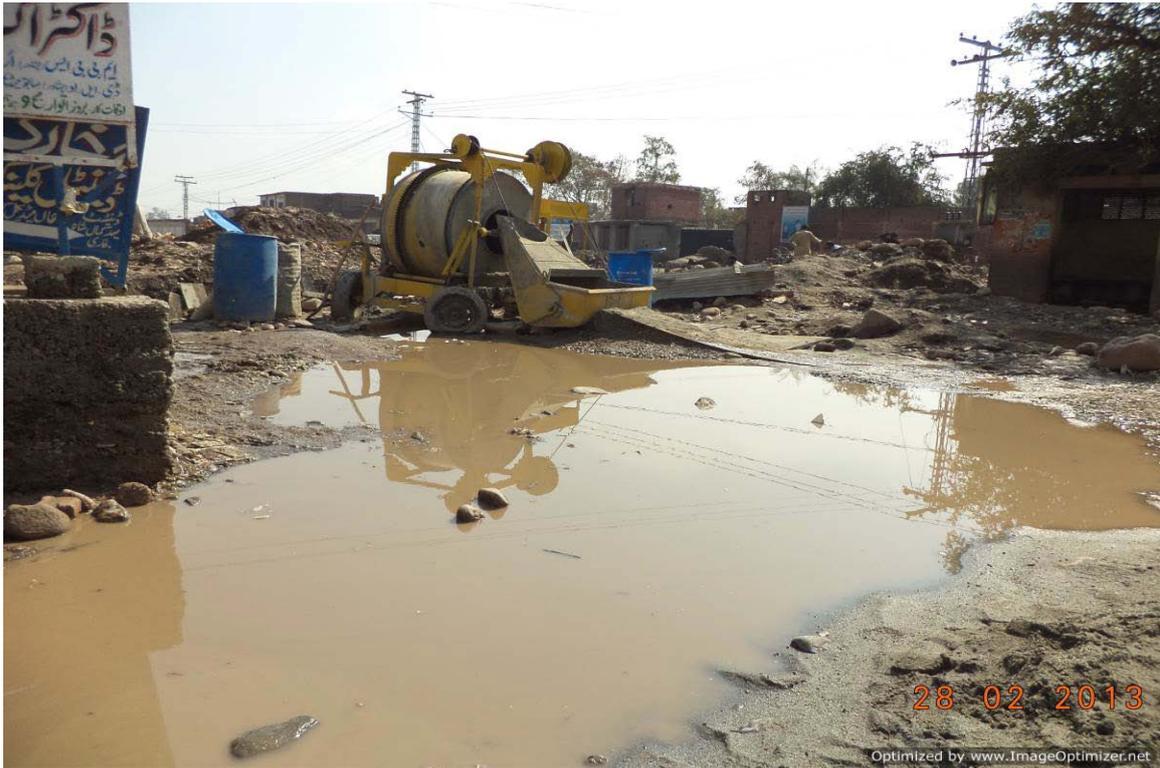
Photo(21): Km..4+600) Standing water and closer of road due to construction of Culvert at Jamrud Bazar

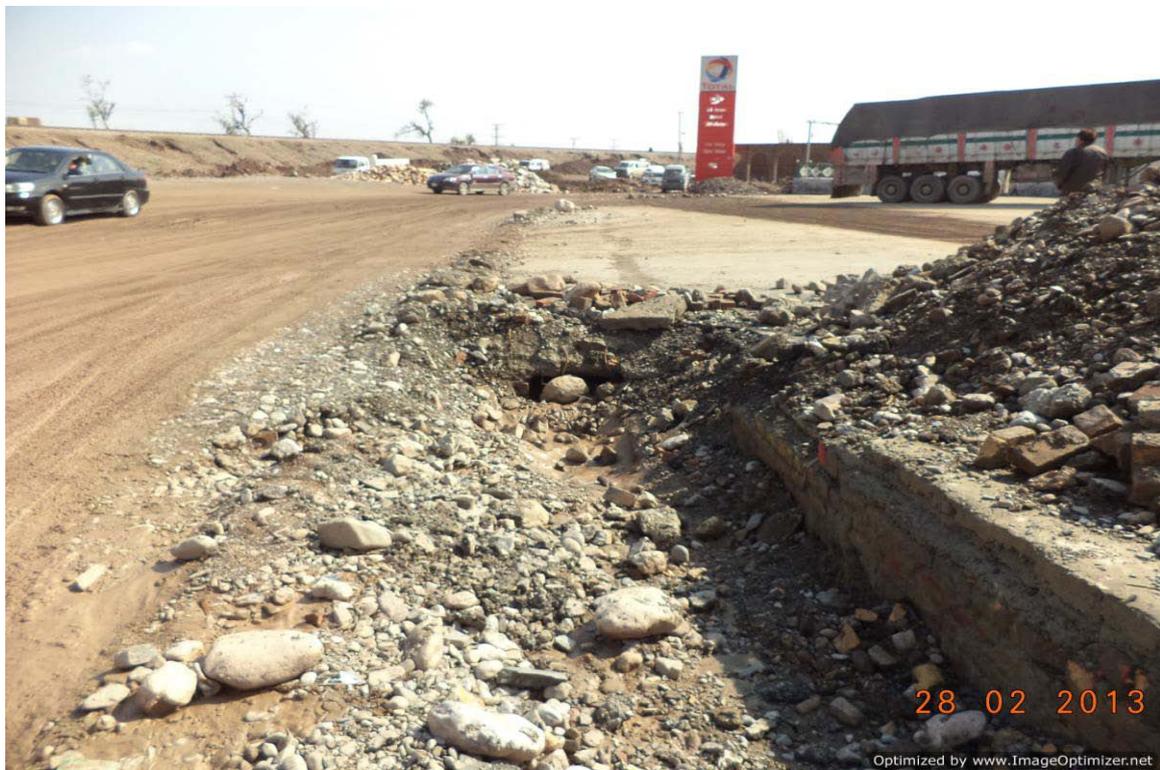
Photo(22): KM 3+200 View of drain blocked near Petrol pump

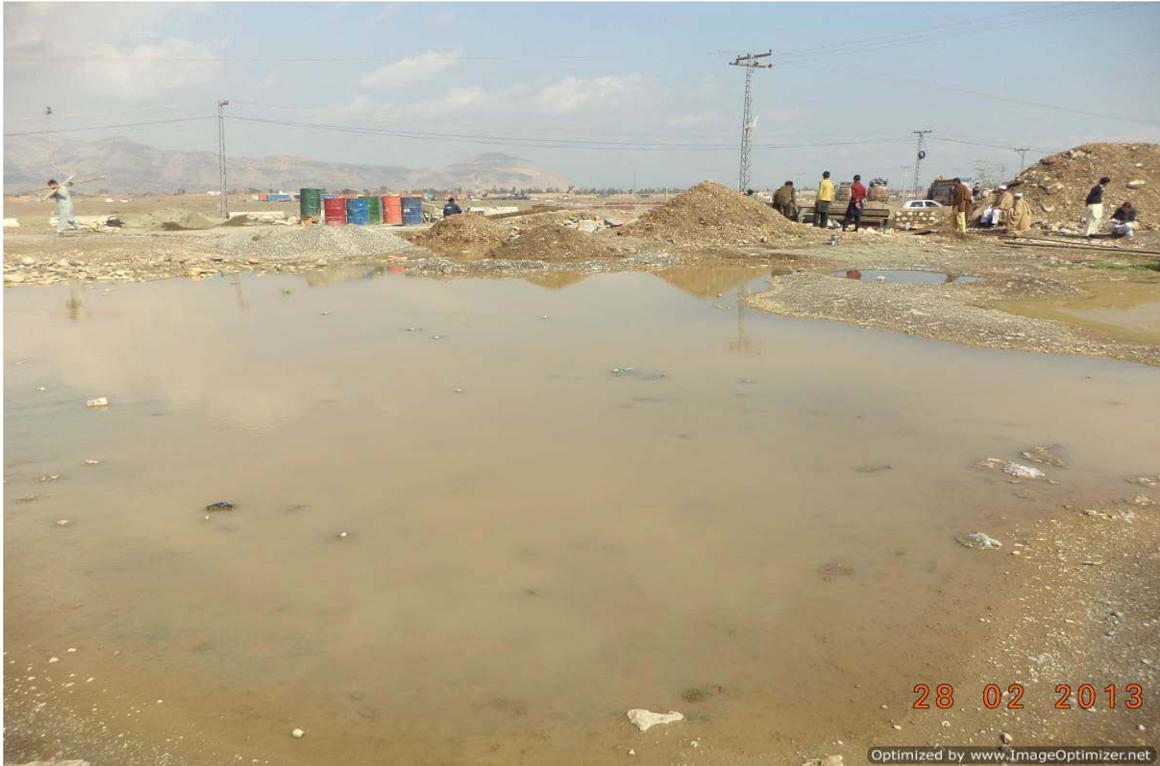
Photo(23): KM 5+905 Stagnant water near Culvert construction

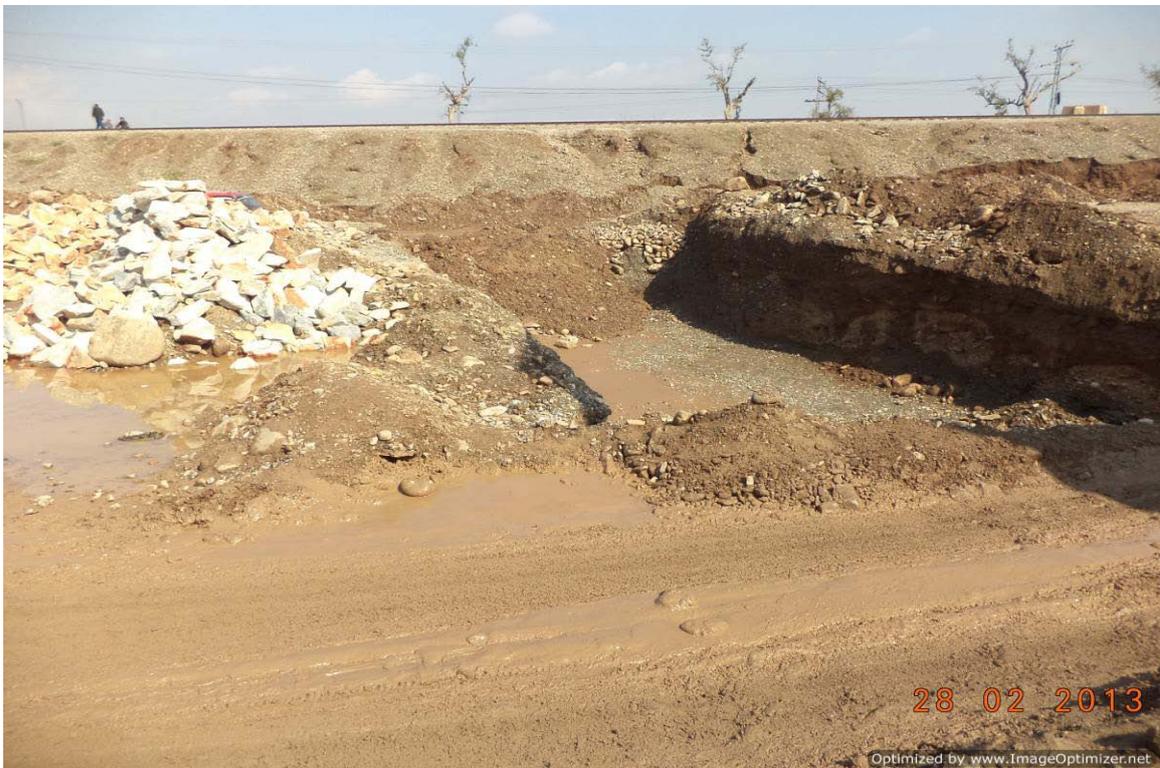
Photo(24) KM 3+200 View of Culvert construction without fence

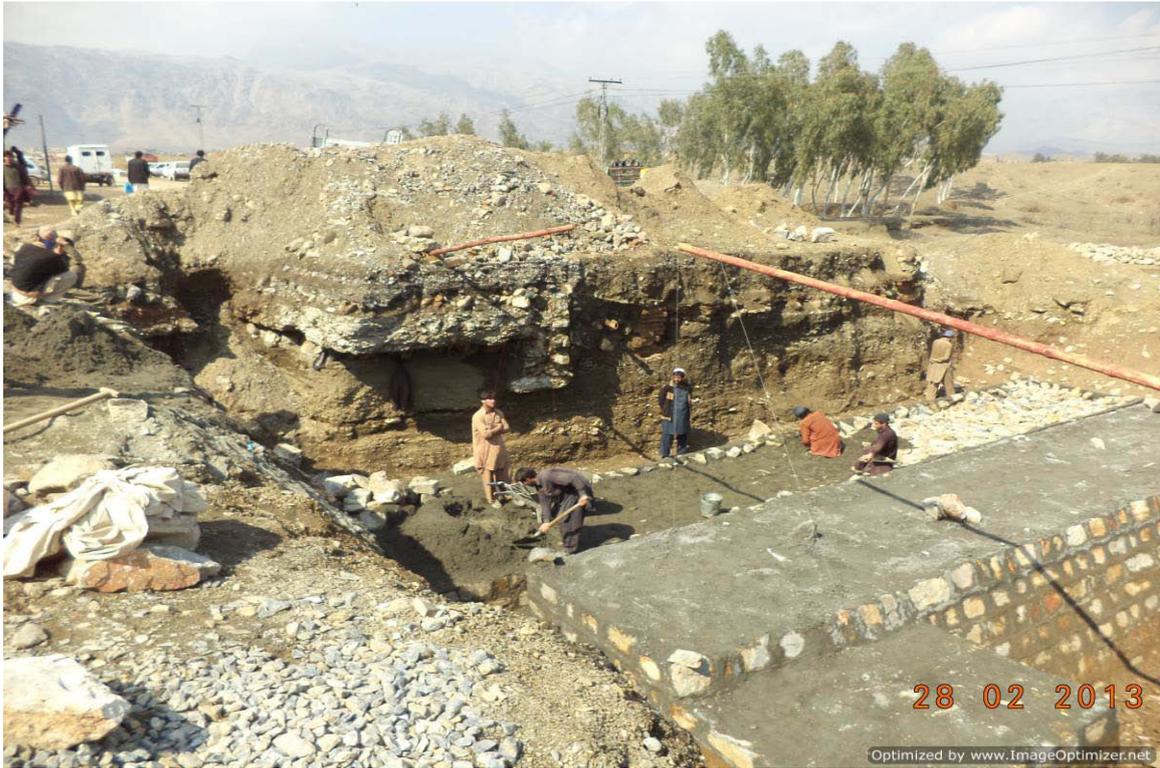
Photo(25) KM 6+883 View of Culvert construction without fence

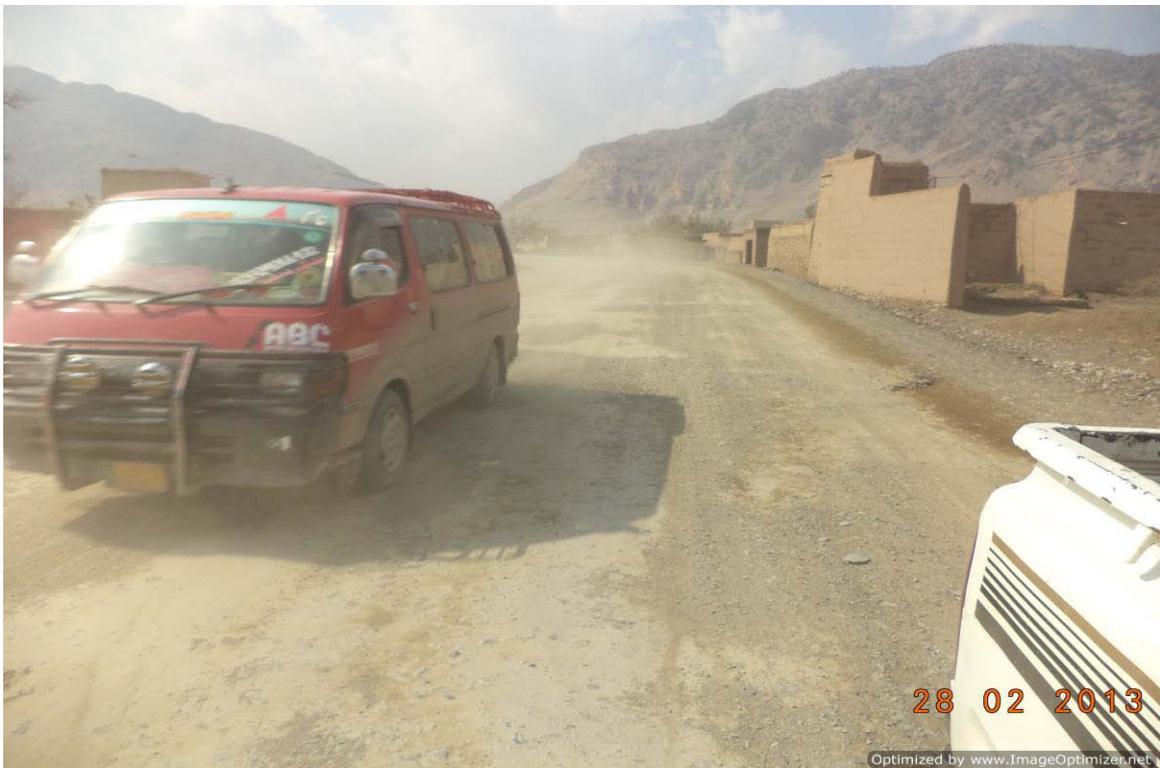
Photo(26): KM: 8+900 View of Dust at village Sur Kamar
