CONSTRUCTION MONITORING & EVALUATION PROGRAM

**STRENGTHENING & IMPROVEMENT OF PESHAWAR – TORKHAM
ROAD (N-5), KHYBER AGENCY, FATA**

MONTHLY PROGRESS REPORT # 04

MARCH 2013

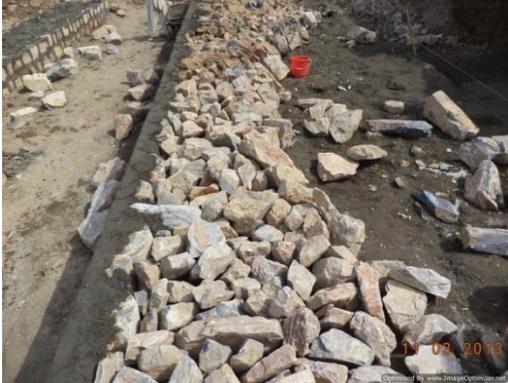
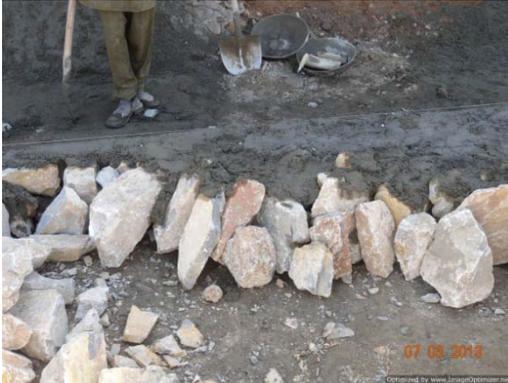
<p>Fig- 01 KM: 6 + 501 (Culvert Abutment wall)</p>

<p>Fig- 02 KM: 6 + 501 (Culvert Abutment wall)</p>	<p>1. QUALITY CONTROL PRACTICES</p> <p>The prime contractor FWO has entrusted local / petty contractors to carry out construction of all proposed cross drainage structures. However, FWO's supervision of the stated works is quite unsatisfactory as evident from the attached photographs. It has been consistently observed that FWO is not fulfilling its responsibility to control the working details of the subcontractor work and to execute the work in accordance with specifications using standard construction practices. Although the M&E Consultants during their site visits, regularly interact with the FWO / NESPAK staff, and discuss issues pertaining to quality of material / workmanship and construction methodology of the ongoing works; however, very little compliance has been seen sub-contractors' works.</p> <p>As shown in Figure 01 & 02, the Culvert at KM: 6 + 501 is being constructed with undressed, irregular shaped stones at cores and backing without proper bedding and jointing of headers and stretchers. Also, the stones are neither cleaned nor thoroughly saturated with water before placing, and are being laid / packed dry without using cement sand mortar.</p>	<p>FWO / NESPAK must investigate the stated issue and ensure that best quality practice's adopted by subcontractors with the following general principles at minimum for stone masonry work.</p> <ul style="list-style-type: none"> • The largest stones should be used in the foundation to give the greatest strength and lessen the danger of unequal settlement. • A stone should be laid upon its broadest face, so that the spaces between the stones may be filled most easily. • For best appearance, the thickness of the courses should decrease gradually toward the top of the wall. • A stratified stone should be laid upon its natural bed. • Each stone must be completely dressed before being laid in the wall. • A stone in any course should break joints with or overlap the stone in the course below to bind the wall together lengthwise. • A large number of headers that extend from the front to the back / inside of a wall should be available to bind the wall together crosswise. • Hollow beds shall not be permitted.

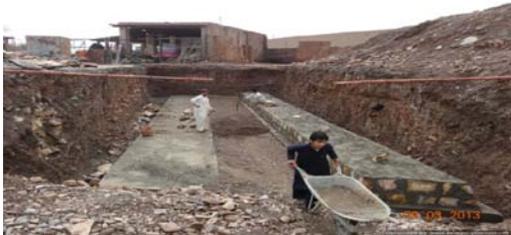
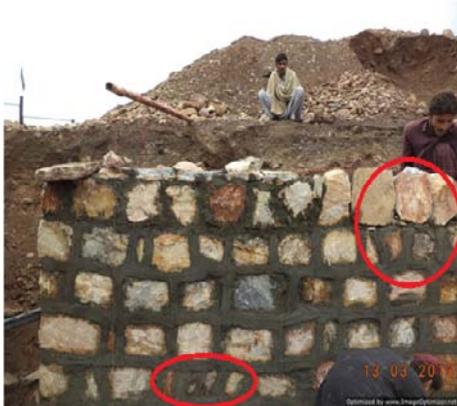
<p>Fig- 03 KM: 3 + 081 (Culvert bed backfilling)</p>

<p>Fig-04 KM 3+081 (undersize stones encircled)</p>	<p>It has been frequently observed that critical construction activities are executed in the absence of FWO / NESPAK personnel, thereby raising doubts about the legitimacy of the construction quality.</p> <p>The backfilling operation of culvert bed at KM: 3 + 081 is being handled by unskilled labor of subcontractor without any superintendence of prime contractor. The stone masonry mortar is still green and the backfill material is being deposited in layers exceeding the prescribed limits of 20cm loose thickness. NHA specification (107.3.3.h – Backfill) does not allow any backfilling against concrete or masonry structures before 14 days of placement. Further,</p> <p>Fig 04 highlights use of undersize stones in the Abutment wall No.2 of the culvert at KM: 3+081, which is again an example of poor quality control and non-compliance of the specifications.</p>	<ul style="list-style-type: none"> • The surface of porous stone should be moistened before the stone is bedded to prevent the stone from absorbing moisture from the mortar and thereby causing the mortar to shrink and become non-plastic. • A stone must not be dropped on the wall or slid along the wall during construction. If it is necessary to move a stone after it has been placed upon the mortar bed, it should be lifted clear, cleaned of mortar, and reset. • Stone should be clean when laid. All stones shall be well bedded in freshly made mortar and settled in place before the setting of the mortar • A vertical joint should not occur directly above or below a header. • Stones should never be bunched together. • Backfill should never be placed against stone masonry until the mortar has gained sufficient strength.

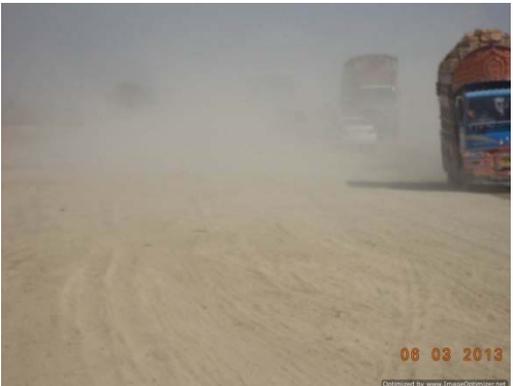
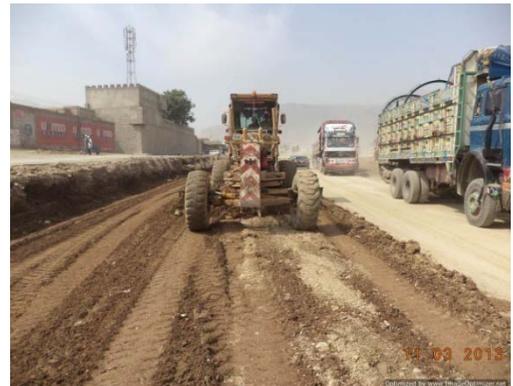
<p>Fig- 04 Detour b/w KM: 5 + 800 To 6 + 200</p>

<p>Fig- 05 Detour b/w KM: 7 +025 To 7 + 100 (Inadequate work zone safety)</p>	<p>2. TRAFFIC ACCOMODATION</p> <p>Road construction causes inconvenience & safety concern to the road users as well as to the local inhabitants. A well planned traffic accommodation strategy can alleviate many of these difficulties and hazards. FWO is responsible to formulate and implement a proper traffic diversion / detour that will efficiently and safely move traffic through the construction zone at all times. However, so far FWO has been unable to provide and maintain a proper detour, which is evident from the following observed facts:</p> <ul style="list-style-type: none"> • Fig 04: No dust control; thus compromising environment, visibility and safety of public. • Fig 05: No signage or hazard markers for driver's guidance / warning and no barriers to protect drivers as well as labor on work. 	<ul style="list-style-type: none"> • In order to devise a strategy that will efficiently and safely move the traffic through and around the construction zone, the Contractor (FWO) should evaluate: <ol style="list-style-type: none"> a. Whether or not traffic will be able to safely maneuver through all the proposed detours, keeping in view the traffic density, detour capacity and tribal background of the construction zone b. The location of adjacent traffic relative to worker and traffic safety, c. Whether or not there is sufficient room for equipment maneuverability, and d. Whether or not the construction phasing is appropriate. • Moreover the Contractor should develop a Traffic Control & Management Plan (TCMP), in compliance with the specification and standard engineering practices. • The TCMP should be compatible with the physical & environmental conditions of work zone, construction sequence and timeframe. • The Contractor should assign to the project an employee experienced in all aspects of traffic control that will serve as Traffic Manager (TM). • The TCMP once implemented, must assure the safety of motorists, pedestrians, and construction workers during the construction period.

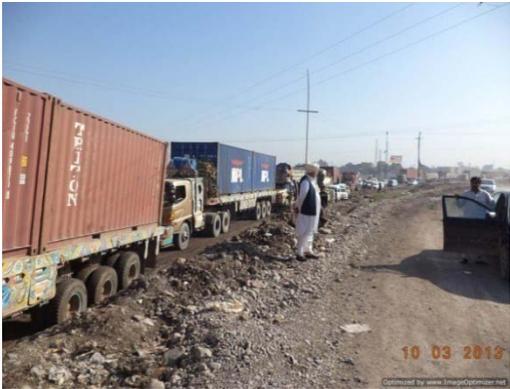
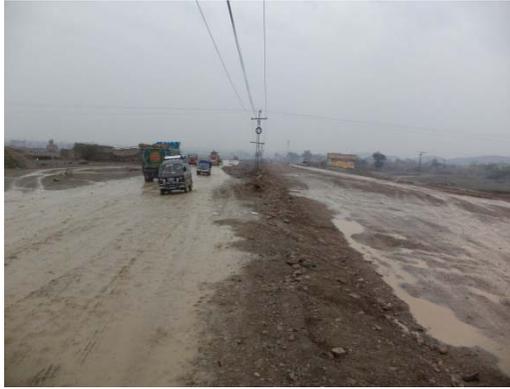
<p style="text-align: center;">Fig- 06 Detour b/w KM: 1 + 350 To 1+500</p>

<p style="text-align: center;">Fig- 07 Detour b/w KM: 7+600 To 8+100</p>	<ul style="list-style-type: none"> Fig 06 portrays another outcome of the poor traffic control practices, which is in the form of traffic jam observed all along the detours during the peak traffic hours. The detours are operating at an unacceptable level of service due to inadequate traffic capacity, substandard geometry and insufficient traffic controlling devices. Fig 07: Riding quality of the detour was further deteriorated after the rainfall. Poor surface condition and road geometry of the detour can jeopardize the safe maneuvering of traffic through the construction zone, especially during darkness. 	<ul style="list-style-type: none"> FWO on a regular basis should monitor the condition of the detour & route traveled through the work zone. This should be done not only during working hours but also at night time and holidays as well. The Traffic Control Plan should be regularly reviewed by the TM (FWO) with NESPAK & other project stakeholders. This review should be focused on the safety and efficiency of traffic movement through the construction zone, detours riding quality, geometric design elements, temporary cross drainage structures, dust suppression and whether traffic control conforms to the Traffic Control Plan. TM (FWO) to check that temporary structures and roadways (detours) are constructed & maintained in accordance with the requirements of the specifications. Traffic Control Devices must be reviewed continuously. The TM should make adjustments to the TCMP in the field as conditions warrant & put into practice immediately. Additional reviews to TCMP should be exercised following a change in the construction pattern or severe weather conditions. The M&E Consultants should regularly monitor and document the Contractor's surveillance and maintenance practices along the detour and the construction zone.

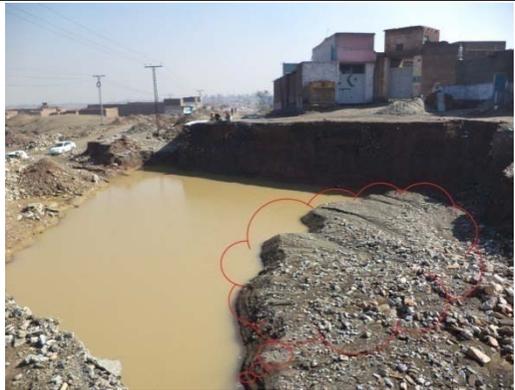
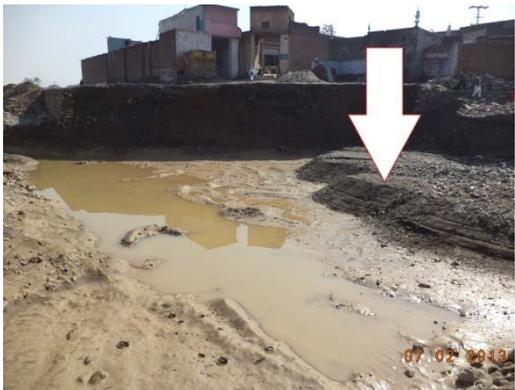
<p data-bbox="398 762 779 826">Fig- 08 Culvert at KM: 6 + 501 (View from U/S side)</p>

<p data-bbox="398 1311 779 1375">Fig- 09 Culvert at KM: 6 + 501 (View from Abutment # 02)</p>	<p data-bbox="913 395 1413 427">3. Design concern of Culvert at KM: 6+501</p> <p data-bbox="860 437 1467 756">During their routine site visits, the M&E Consultants Field Staff pays special attention to the construction of new cross drainage structures along the natural streams. There are total 16 culverts to be constructed along section – I; work on 12 is in progress. Figure 08 to 11 highlights different sides of the 05 cells culvert (3m x 1.5m each cell) at KM: 6 + 501, which is being installed with 3% bed slope on erodible materials.</p> <p data-bbox="860 868 1467 1267">The attached figures (08-11) demonstrate the distinctive channel characteristics including transportation & accumulation of sediment load, channel clogging & upstream deposition of debris at the construction site following periodic rainfall and peak runoff event b/w Feb 01 To Mar 31, 2013 time period. Sediment deposition within a culvert system may cause significant problems to the hydraulic performance of the system in the event of a large storm. In addition, the deposition also poses a maintenance problem in the long run.</p>	<ul data-bbox="1503 395 2047 1321" style="list-style-type: none"> • A critical factor in the assessment of channel crossing design and structural capacity is its allowance for handling or passing sediments / debris. Experience has shown that channel crossings have failed not because of inadequate design to handle unanticipated water flows, but because of inadequate allowances for sediments load / floatable debris which eventually blocked water passage through the culvert. Therefore, the contractor (FWO) should analyze each channel crossing for its sediments / debris handling capacity, by hiring the services of specialist, preferably a hydrologist who made a site-specific evaluation of channel stability factors. • Since a successful bottomless culvert design depends on a clear understanding of upstream and downstream hydraulic conditions, therefore the proposed channel assessment must encompass the influencing factors in the water-shed

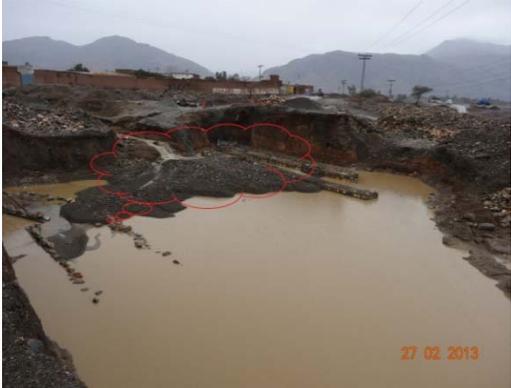
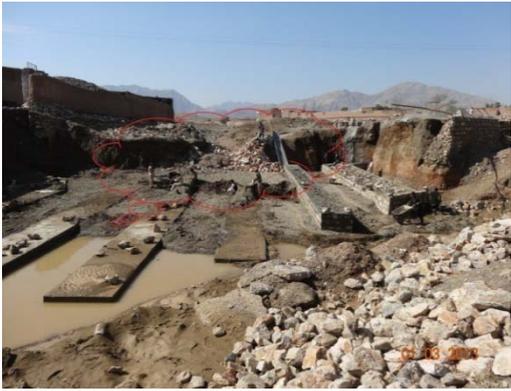
<p data-bbox="398 815 801 879">Fig- 10 Culvert at KM: 6 + 501 (View from D/S side)</p>

<p data-bbox="398 1358 801 1422">Fig- 11 Culvert at KM: 6 + 501 (View from D/S side)</p>	<p data-bbox="882 443 1469 639">Similarly provision of 3% slope for ensuring self cleaning velocity across the culvert will necessitate the outlets to be properly designed in order to withstand the high flow velocities and thus avoid excessive downstream scouring and possible road failure.</p> <p data-bbox="882 679 1469 876">The proposed downstream protection work at the stated culvert location, as obvious from the tender drawings are inadequate and warrants drastic modifications that must be compatible with site conditions and all flow regimes.</p>	<p data-bbox="1541 389 2056 501">that may change over time, resulting in differing sediment conditions at the culvert location.</p> <ul data-bbox="1496 528 2065 1161" style="list-style-type: none"> • The designer (FWO / NESPAK) needs to use engineering judgment to account for stated potential variances. • Scour calculations must be done carefully so that proper protective measures to resist undercutting and washout at the culvert outlet may be chosen. • The M&E Consultants will continuously monitor the design standards of cross drainage structures with regards to alignment with the channel, hydraulic capacity, sediments / debris control, energy dissipation and documents the protective measures that might be necessary to protect the culvert from scour.

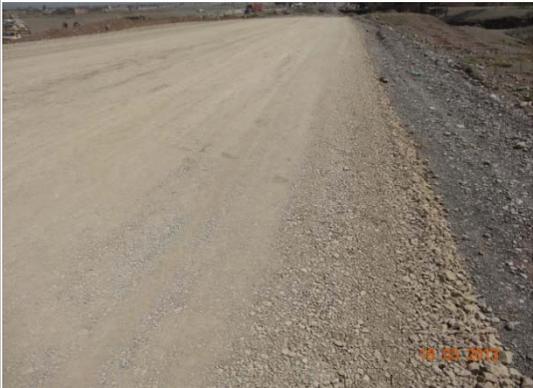
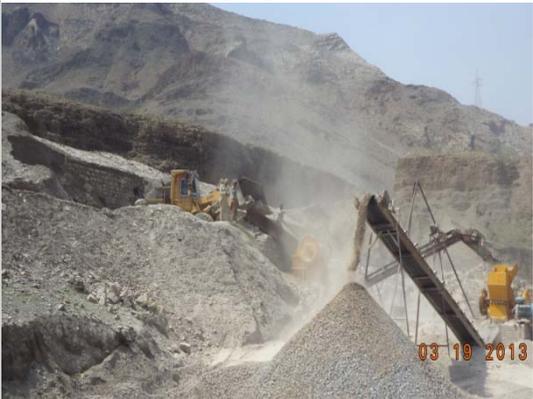
The contractor (FWO) prepared a Trial Section for Aggregate base course at KM: 7+425 to 7+500 in full width but the section was highly segregated due to poor workmanship of the contractor's personnel at site. The samples were collected from the subject section and tested in the AGES laboratory as well as in the contractor's laboratory. The analysis of the subject material meets the specifications; however, the workmanship needs improvement to avoid segregation. The contractor has been advised to hire technical and skilled staff to control such type of deficiencies at site. The NESPAK Material Engineer has already rejected the subject Trial section and promised that they will improve the methodology for Aggregate base course stock piling, laying and compaction.

<p>Fig-12 Compacted Aggregate Base Course layer with marked bands of segregation.</p>

<p>Fig- 13 Crush plant in action without screening operation following each successive stage of reduction.</p>	<p>4. AGGREGATE BASE COURSE</p> <p>During the site inspection of the ongoing construction activities of section – I, it was observed that the contractor has initiated work on laying & compaction of aggregate base course b/w KM: To, without conducting any trial section demonstration, as per specification requirements. Trial section demonstration is necessary in order to assess the methodology for deposition of material on finished roadbed, spreading to avoid segregation, the adequacy of the contractor's equipment, depth measurement of loose material to confirm achieving the specified compacted layer depths, the field moisture content, and the relationship between the number of compaction passes and the resulting density of the material.</p> <p>As shown in Fig 12, neglecting the specification requisites has resulted in compacted layers of base course with streak of coarse or fine materials concentration at different reaches. It was detected with concern that segregation and contamination of crushed material actually aggravated due to improper methods of crushing, handling and stockpiling at the crush plant at KM: 9 + 600 .The Jaw type crush plant consists of a primary and secondary crusher without any scalping/grizzly facilities. Similarly the blend sizes for meeting gradation requirements get destroyed due to absence of screen between the two successive crushers, thereby pushing the finished product towards the finer sizes.</p>	<ul style="list-style-type: none"> • Generally, the handling and stockpiling operations cause some segregation and breakage of coarse aggregate, but such difficulties can be minimized by separating the aggregate into a number of sizes by adoption of screens and by use of well designed and properly operated handling systems. • Aggregate should not be allowed to fall freely from the discharge end of a conveyor belt. • Stockpiles should not be built up in high cone shapes (conical pile) nor allowed to run down slopes, which will otherwise cause segregation. • Method of permitting hauling equipment to operate over the same level of stockpile repeatedly should be discouraged. • Pile built radially in horizontal layers by dozer / FEL working from materials as dropped from conveyor belt is permissible, but the progressive layers should not be stacked on slope falter than 1:3. • The end of the belt should be kept as low as possible and the aggregate should be discharged through a rock ladder containing baffles to prevent segregation. • In order to closely control the product size and limit the waste material, bottom of the swing jaw of the crusher should be adjusted according to the max aggregate size required. • It is a good crushing practice to install a scalper ahead of primary crusher and after each stage of reduction to remove the specification sizes. This separation direct certain selected material to receive additional or special processing, or certain material may be diverted to bypass unnecessary processing.

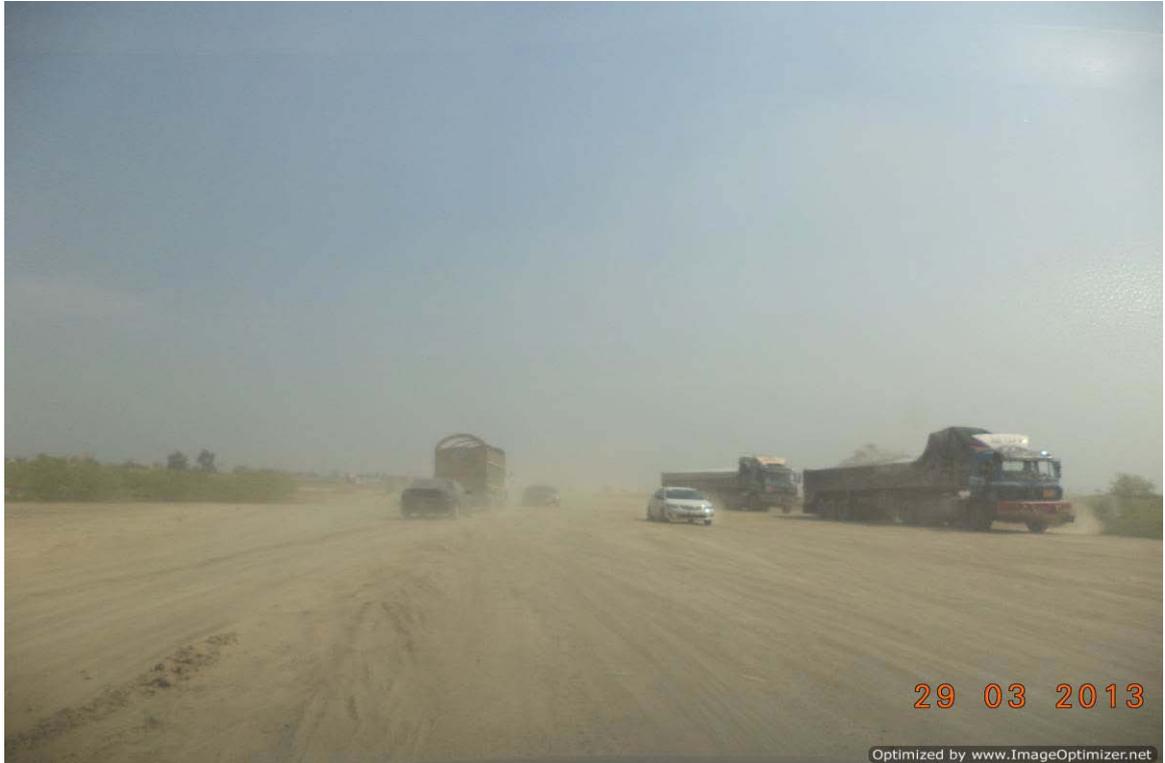
KM: 6 + 650 Detour dusty surface without traffic safety devices

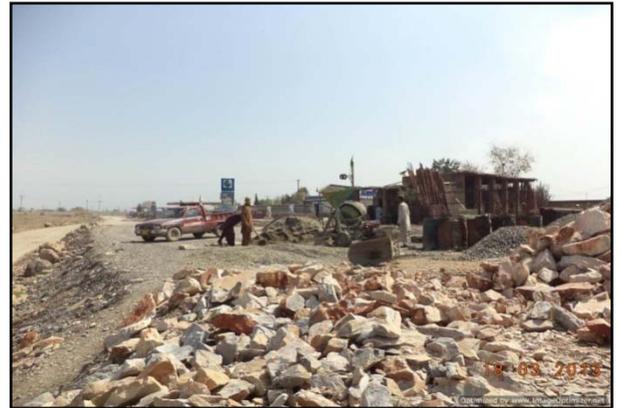
Photo # 1

Construction material haphazard dumping, drainage problem and other social issues due to culvert construction at KM: 3+375 (Photo # 1, 2)

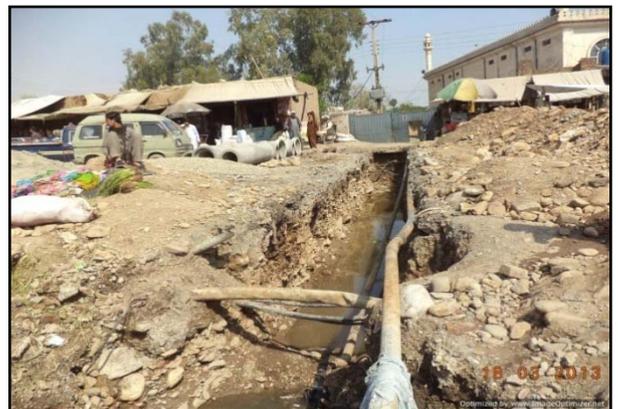
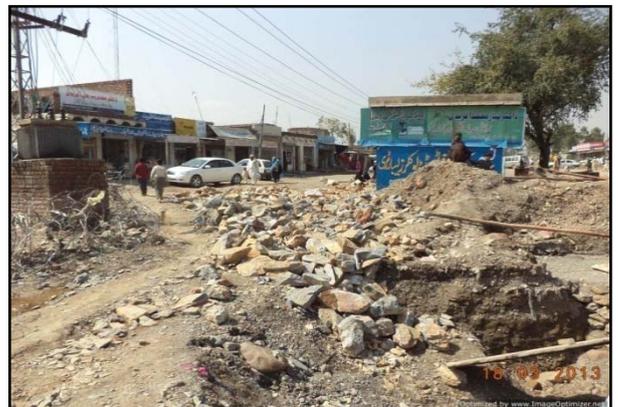
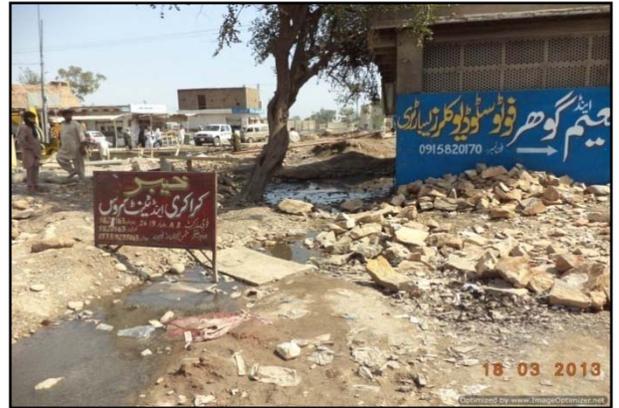
Stagnant sewerage water due to construction of culvert at start of Jamrud bazaar at KM: 4+600 (Photo # 3, 4, 5, 6, 7, 8)

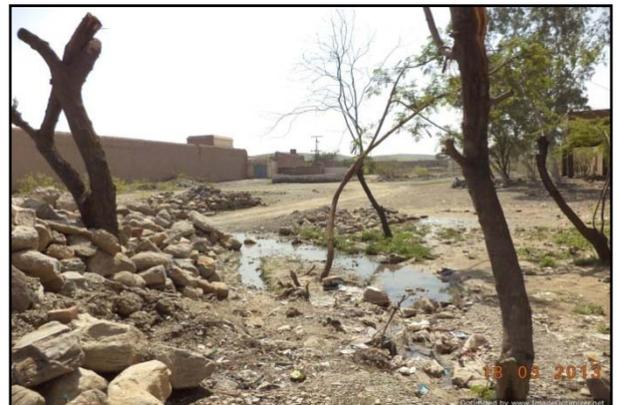
Photo # 11

Blockage of sewerage water and other social problems due to culvert construction at KM: 6+191 (Photo # 11, 12)

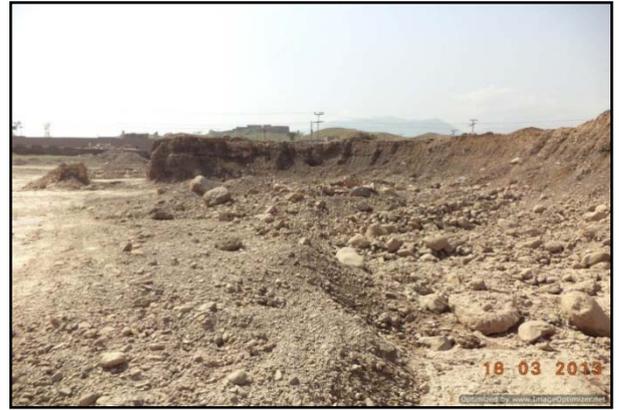
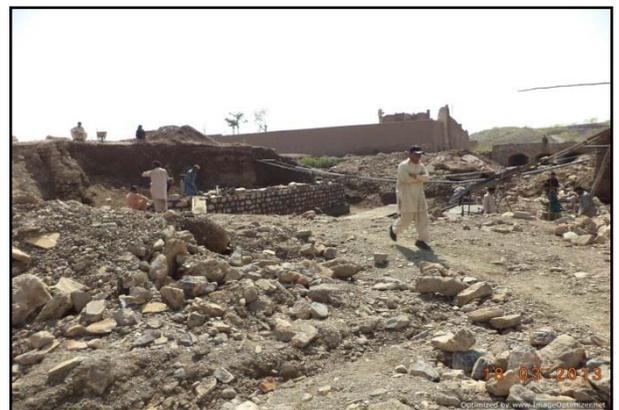
Stagnant water, land pits of quarry area require proper land leveling, proper drainage and reuse of land at KM: 6+50 (Photo # 13, 14, 15, 16)

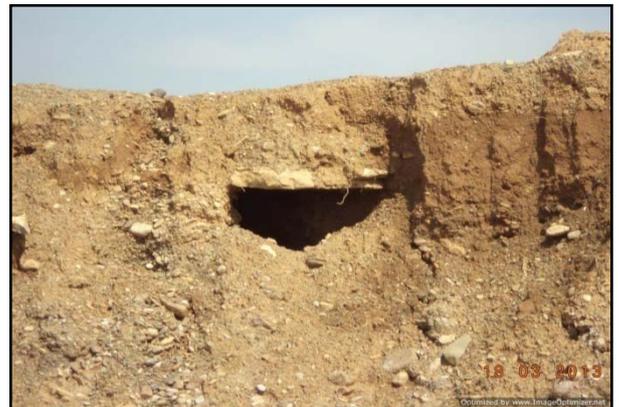
Photo # 17

During excavation process in the quarry area near KM: 6+50, some graves were exposed at site (near KM: 6+50) but the contractor did not repair the graves. The contractor should have stopped the work at site immediately and restore the damage graves with proper protective measures. Due to this negligence social problems may arise. At the time of incidence, Mr Hanif L Niak (FWO) was present at site. (Photo # 17, 18)

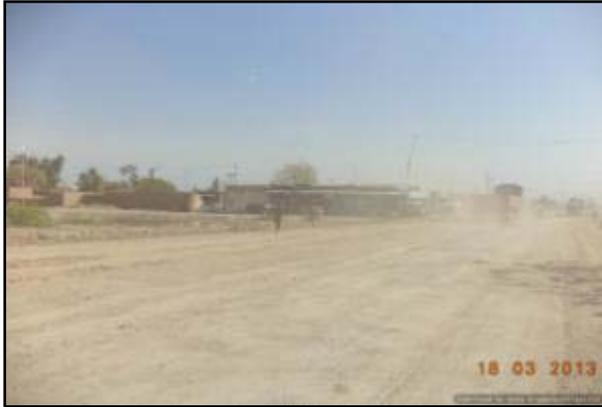
Dust Pollution at KM:1+000 (Photo # 19)

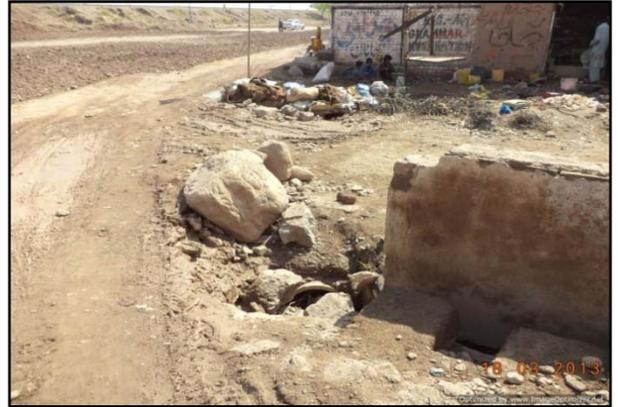
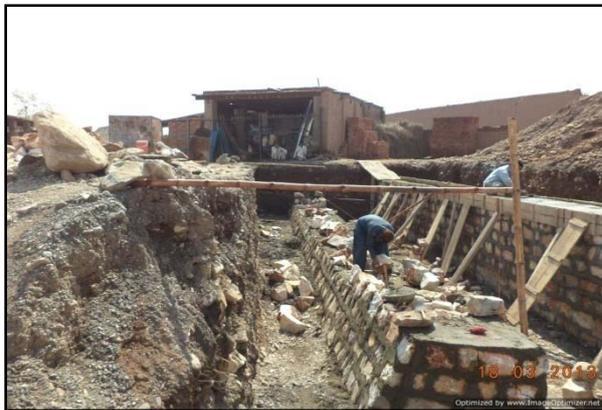
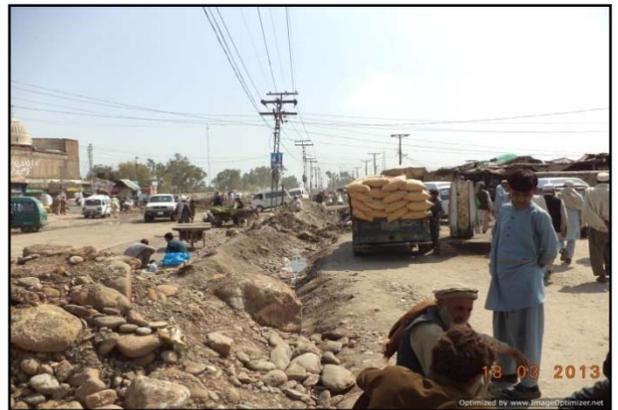
Main drain blockage due to construction activities at KM: 2+700 near Total Petrol Pump (Photo # 20, 21, 22)

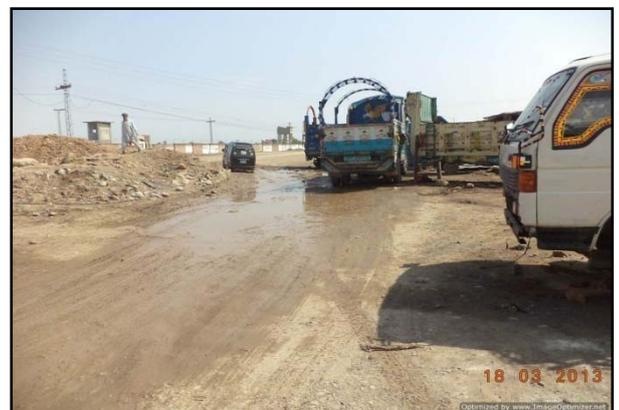
Stagnant water though no construction activities at KM: 4+850 (Photo # 23, 24)

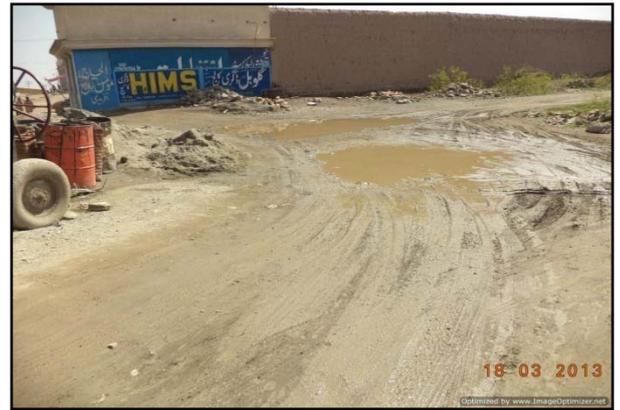
Photo # 25
Stagnant water near residential area at KM: 6+100 (Photo # 25, 26)

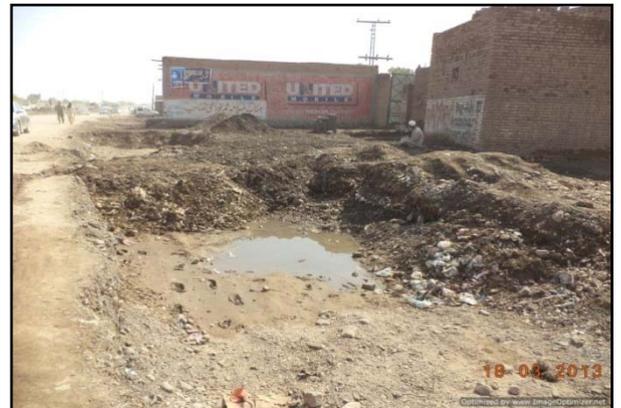
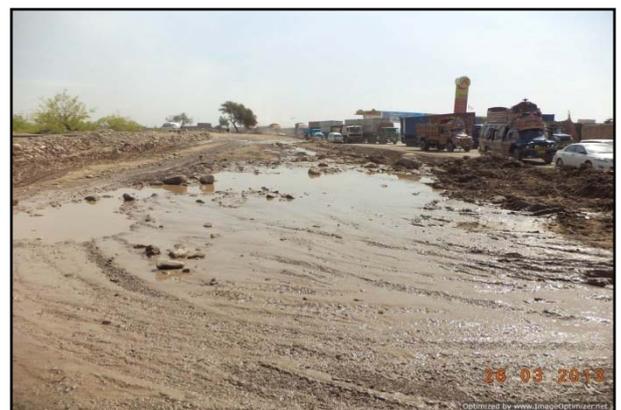
Solid waste dumping and stagnant water in front of houses along the road due to construction activities (KM: 1+600) (Photo # 28, 29)

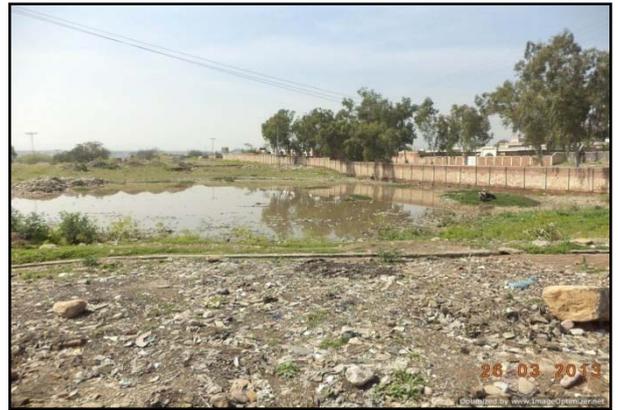
Dumped excavated and Solid Waste materials, and Stagnant water due to construction of road at KM: 3+550 (Photos-31, 32)

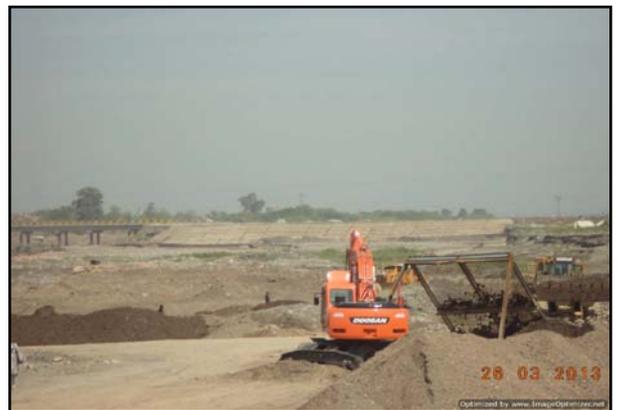
(Photo-35) View of Graves, open during excavation which is not properly cover at quarry area near KM: 6+050

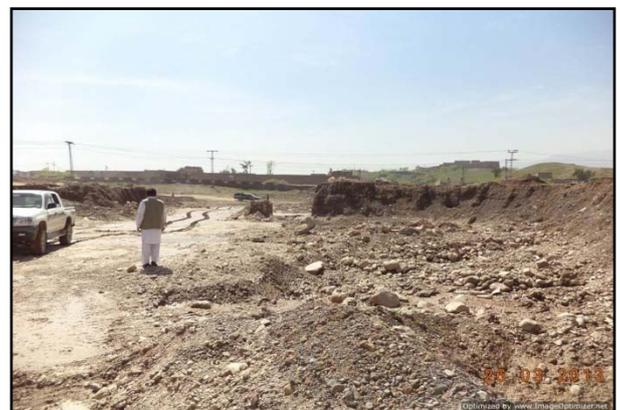
(Photo-36) land pits of previous quarry area require proper land leveling, proper drainage and reuse of land at KM: 6+050

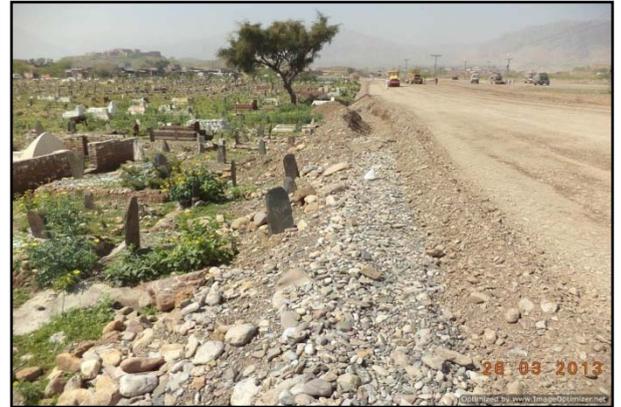
(Photos-37, 38) Dumped materials in graveyard due to construction of road near KM: 5+630

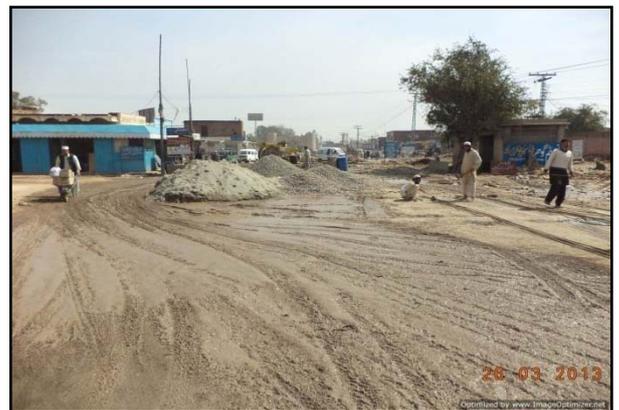
Haphazard placement of construction materials at Culvert's construction in middle of Jamrud Bazar KM: 4+600 (Photos-39, 40)

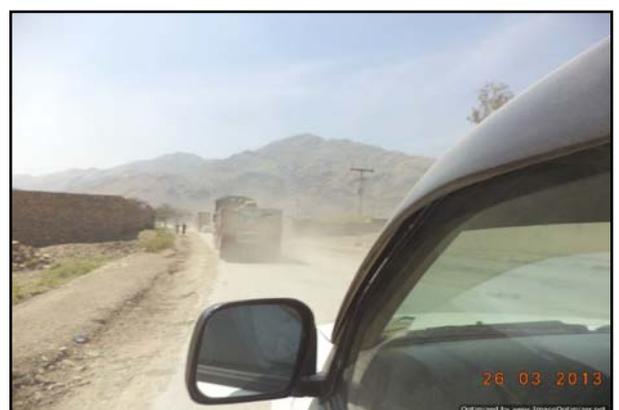
Dust due to no sprinkling water near KM: 3+00 and KM: 8+500 (Photos-41, 42)
