ENERGY POLICY PROGRAM VISIT REPORT SATPARA DAM PROJECT

JUNE 4, 2013

Satpara Dam Field Visit Report

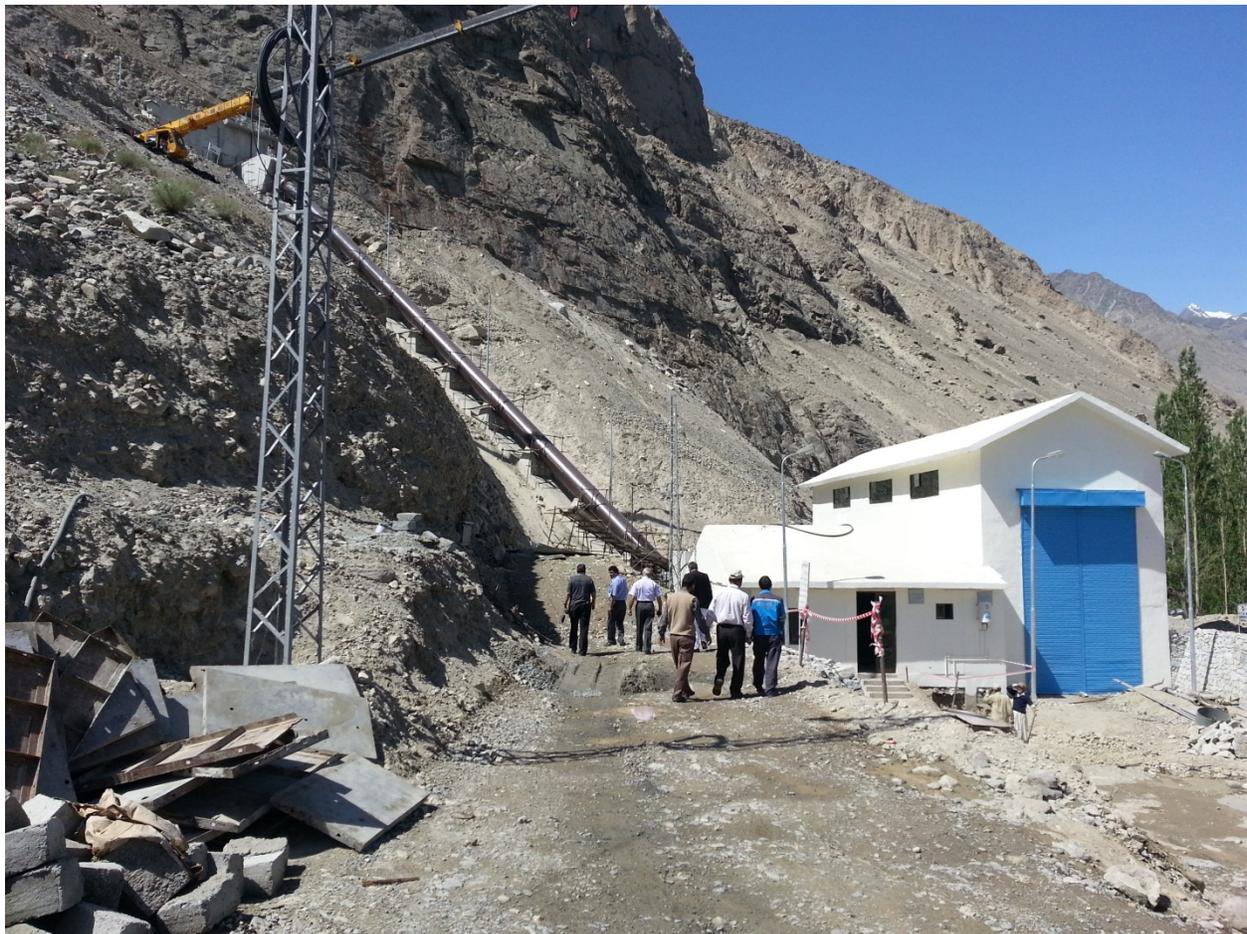
Figure 1: Power House 4

The overall completion status of Powerhouse Nos. 3 & 4 is 98 % as of May 25, 2013. The testing and commissioning of Power house 3 was witnessed during the visit and 2.4 MW was dispatched to Skardu Grid. The contractor has started the pre-commissioning tests on Powerhouse no. 4 and mechanical test was scheduled during our visit; however, heavy rains and landslides damaged the irrigation canals and further testing of Powerhouse # 4 is deferred.

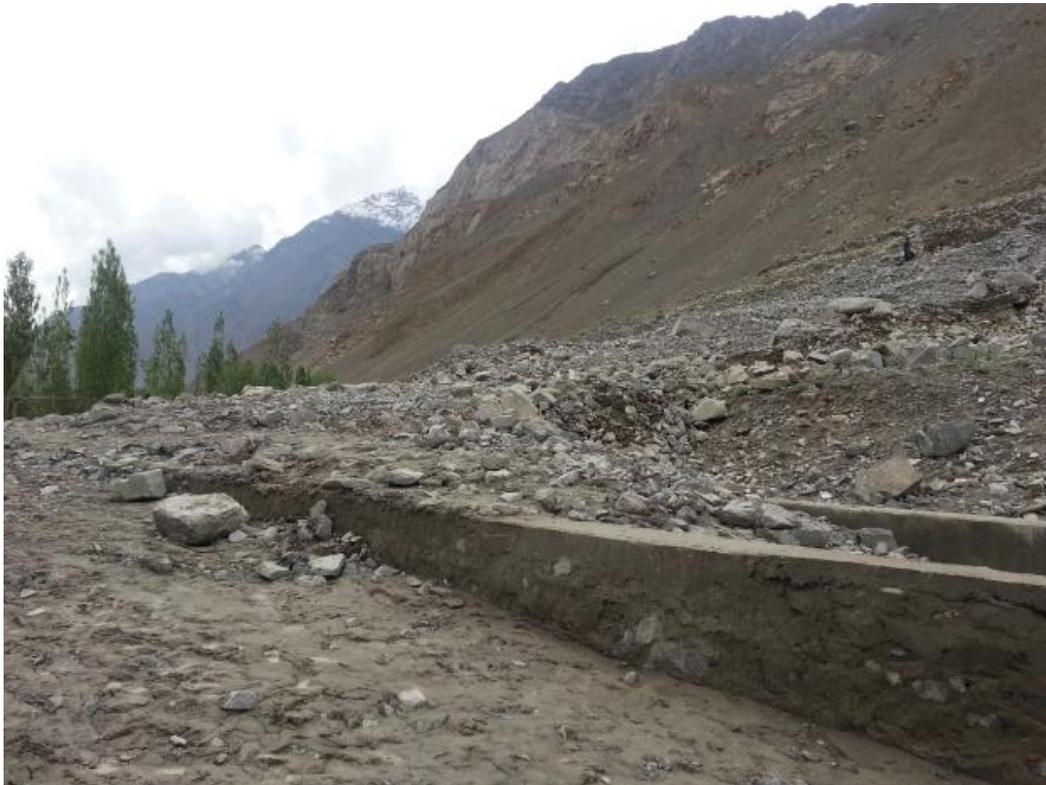
Due to heavy rains from May 25 to May 27 landslides occurred on various locations and damaged the irrigation canal on multiple locations. Main Dam and all the power houses are safe; however, the main damage is on the left and right bank canals. We visited the left bank canal on May 28 and took photographs of the damaged and buried areas of the canals. The testing and commissioning of powerhouse # 4 was deferred due to blockage in the powerhouse discharge. WAPDA was requested to submit a detailed report assessing the damages to the canal system and specify timeframe and cost estimate to restore the irrigation system to its original condition and commence the commissioning of powerhouse # 4.

Figure 3: Main damage on the left bank canal about 200-300 ft long

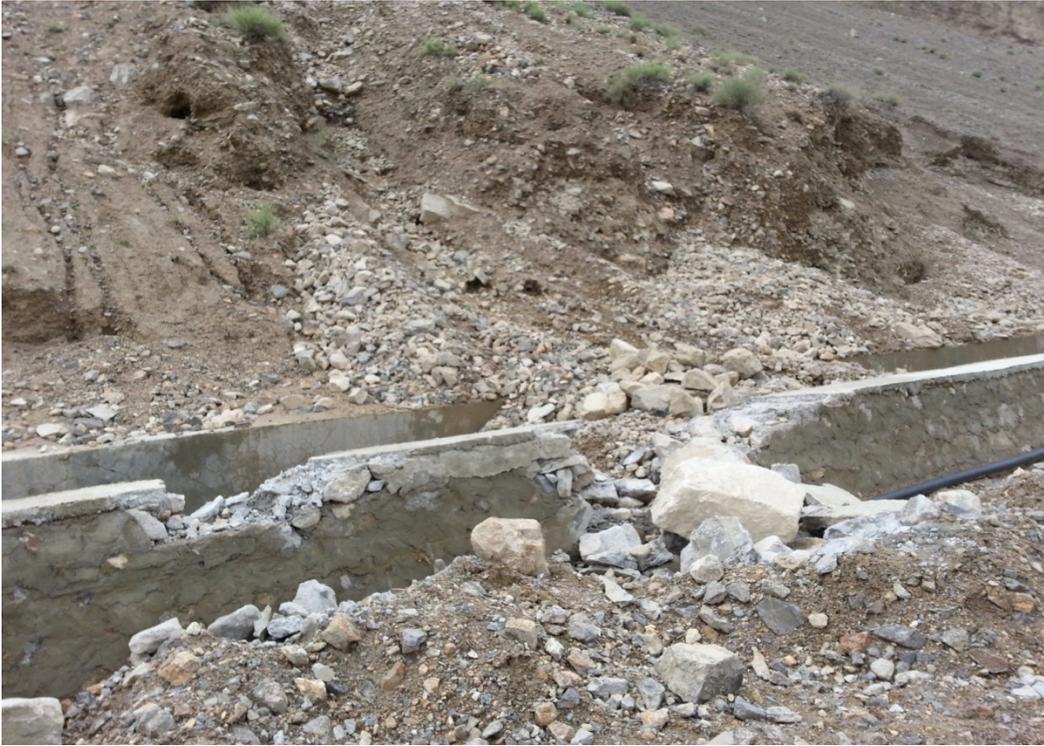
Figure 4: Irrigation Canal Damage due to Land Sliding

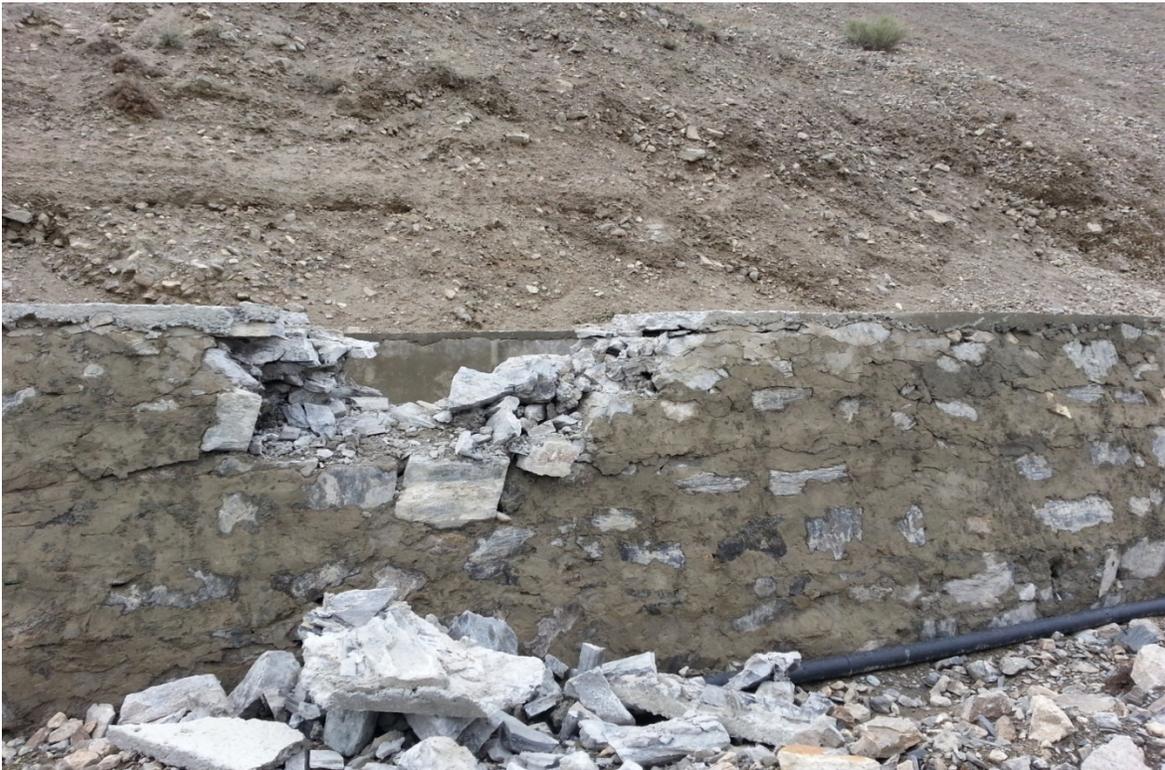
Figure 5: Left Bank Canal damage due to Land Sliding

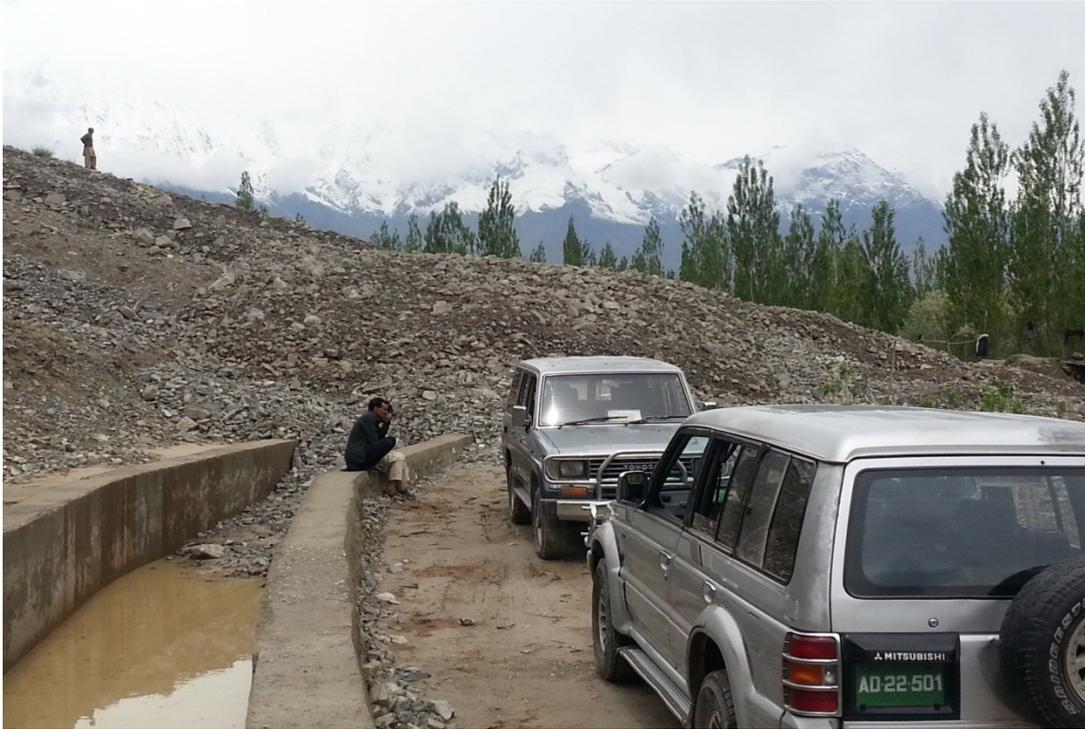
Figure 6: Blockage in Canal channel due to land sliding
