# USAID ENERGY POLICY PROGRAM

## SITE VISIT REPORT MUZAFFARGARH THERMAL POWER STATION

### MUZAFFARGARH THERMAL POWER STATION

## BRIEF REPORT ON THE VISIT TO TPS MUZAFFARGARH

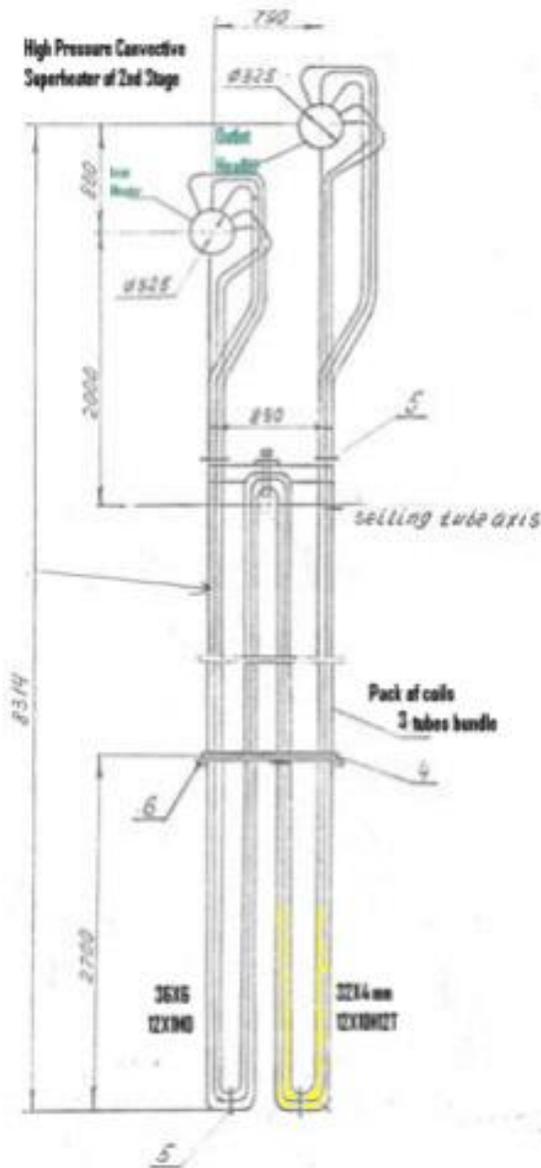
## Annexure 'B'

On these units (particularly 1&3), repeated leakages of final superheater occurred during the year 2008-09 and earlier as is evident from the Outage status of units attached as Annexure 'A'. Roughly 41% of total forced shutdown hours of unit no. 1 are due to super heater tube leakages. Due to this defect, drum pressure and consequently steam pressure ahead of steam turbine has been kept low as 110 Kg/cm<sup>2</sup> against the rated 130 Kg/cm<sup>2</sup> which has resulted into load reduction. One tube bend was seen which had a pinhole after thinning out the bend wall which was already 4mm against 6mm thickness of other heating surfaces.

The drawing of these tube beds along with material is given in Annexure-'B'

Partial replacement of superheater tube bends of 32X4mm tubing is recommended. The metal composition is as below:

C; 0.12, Si;0.80, Mo;2.0, P;0.035,  
S;0.02, Cr;17-19.0, N1;11-13

As a result of ICB, G.M. (Thermal) has issued a letter of intent (1510-13/GMT/P&S/MZG/T-1641) to place Purchase Order on 13.08.2009 to a Ukrainian Firm for Supply, Dismantling, Installation, Testing and Commissioning of 1340 numbers of Tube Bends/8M length (approximately) of 2nd loop for HP Convection superheaters of all three units at a total FOB cost of 3.09 million Euro. It is expected that due to stringent conditions of payment stipulated in LOI, the supplier will waste lot of time in correspondence and even may back out.
