Collapsed Towers Evaluation / Investigation Final Report

Project:
WO-A-0104 DABS 220 kV Transmission Line Tower Inspection

Date:
June 6, 2016

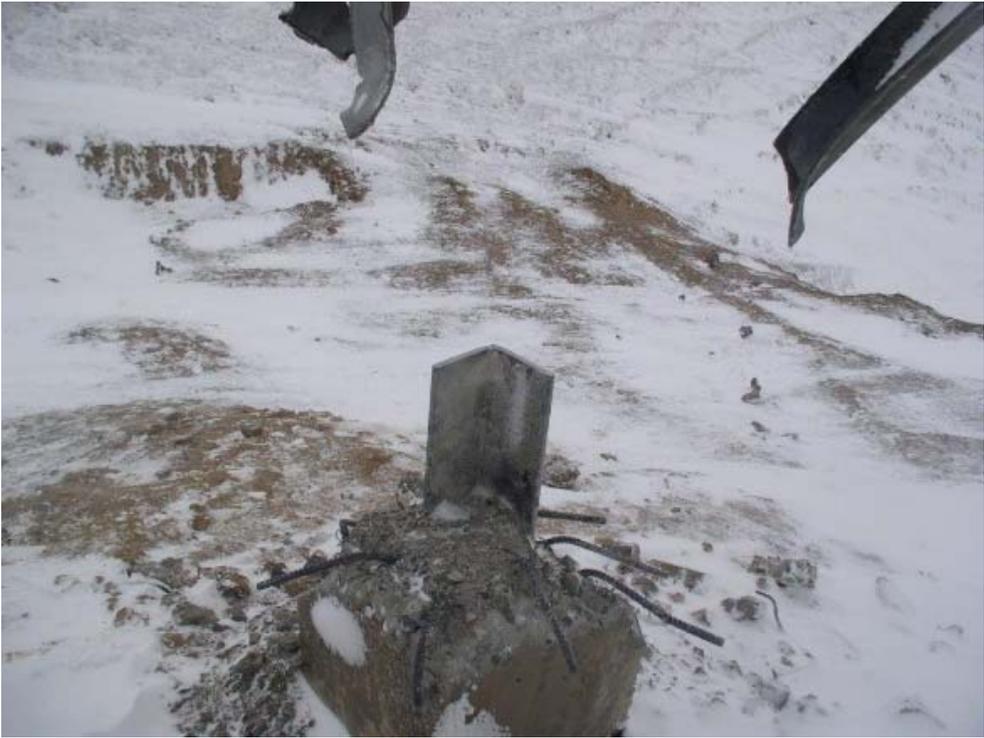
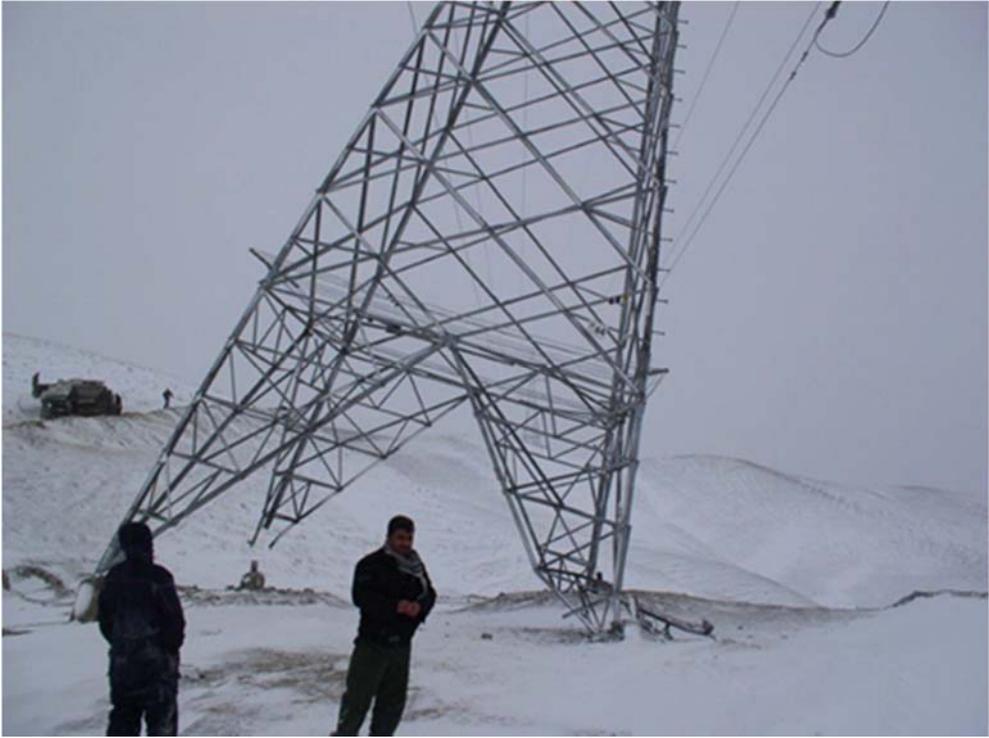
There is clear evidence from the photographs that tower legs were destroyed by an explosive charge. This explains the cause of the failure. Samples of tower steel were collected and tested for yield strength, ultimate strength, and elongation.

Photograph 1: Tower 544, Pul-e-Khumri to Kunduz

Photograph 2: Tower 544, Pul-e-Khumri to Kunduz

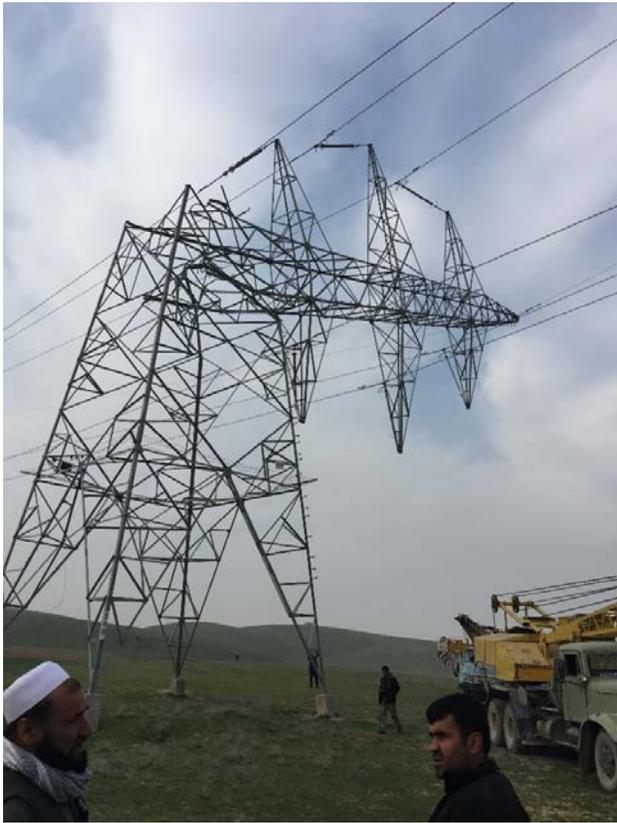
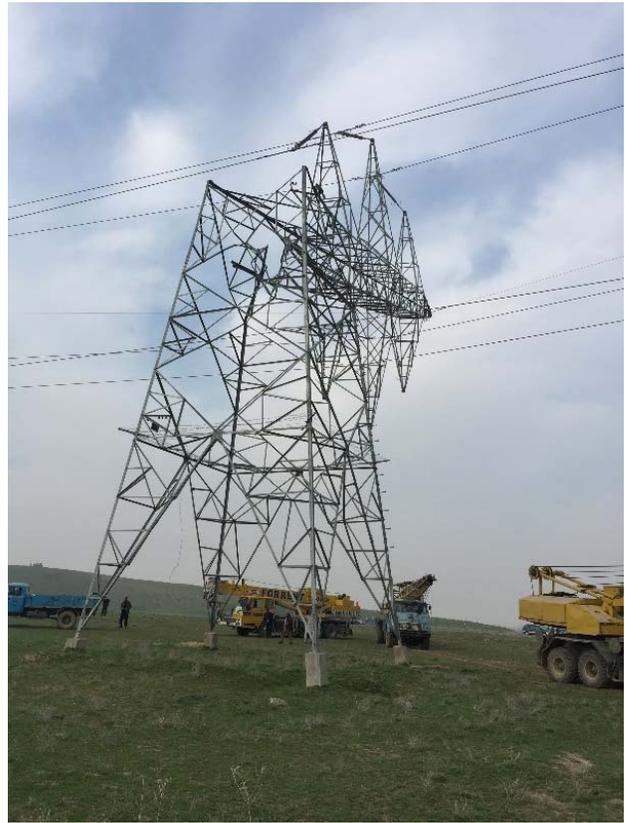
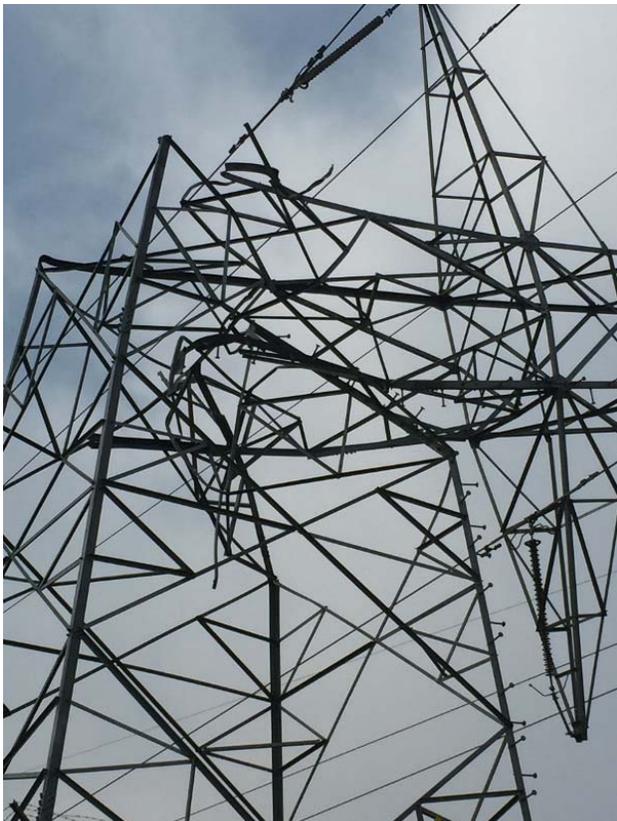
Photographs were provided which show the tower folded over with the conductors on top. Failure occurred at the fourth panel. Samples of tower steel were collected and tested for yield strength, ultimate strength, and elongation. There is no further information available on this failure.

Photograph 3: Tower 500, Pul-e-Khumri to Kunduz

Photograph 4: Tower 500, Pul-e-Khumri to Kunduz

Photograph 5: Tower 500, Pul-e-Khumri to Kunduz

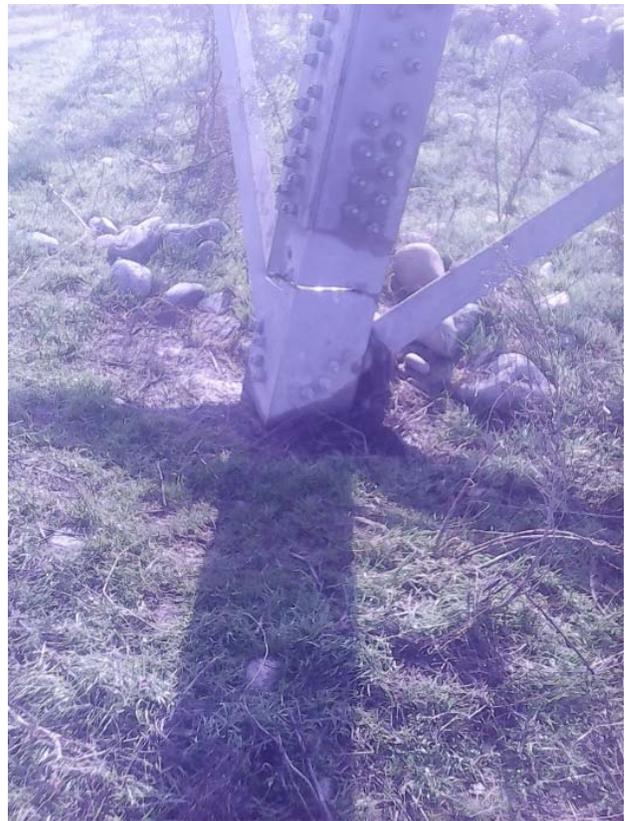
There were no photos of the entire tower provided. There is a photo of a tower leg showing a torch cut through the angle iron leg near the concrete foundation. This is obvious sabotage intended to cause tower failure. There are no other photos that might have shown the tower's ultimate failure mode.

Photograph 6: Tower 494, Pul-e-Khumri to Naibabad showing cut leg
