ENGINEERING SUPPORT PROGRAM

Tarakhil Thermal Power Plant Site and Power Block "B"
Control Assessment

Final Report

April 22, 2014

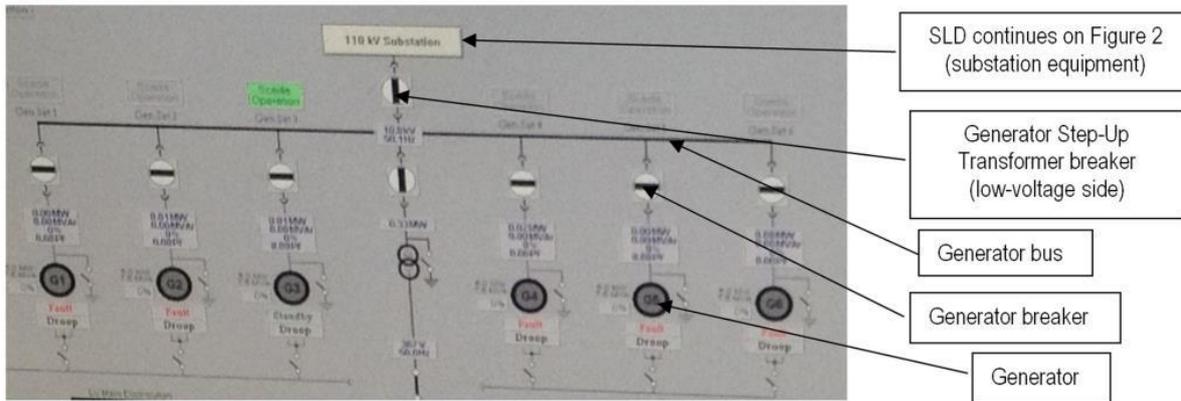
Figure 1: SLD of Generators and Generator Bus

Block B consists of 6 engines rated at 6 MW each, connected to a common bus by individual generator breakers (Figures 1, 2). The generator bus connected to a Generator Step-Up Transformer (GSUT) via a breaker.

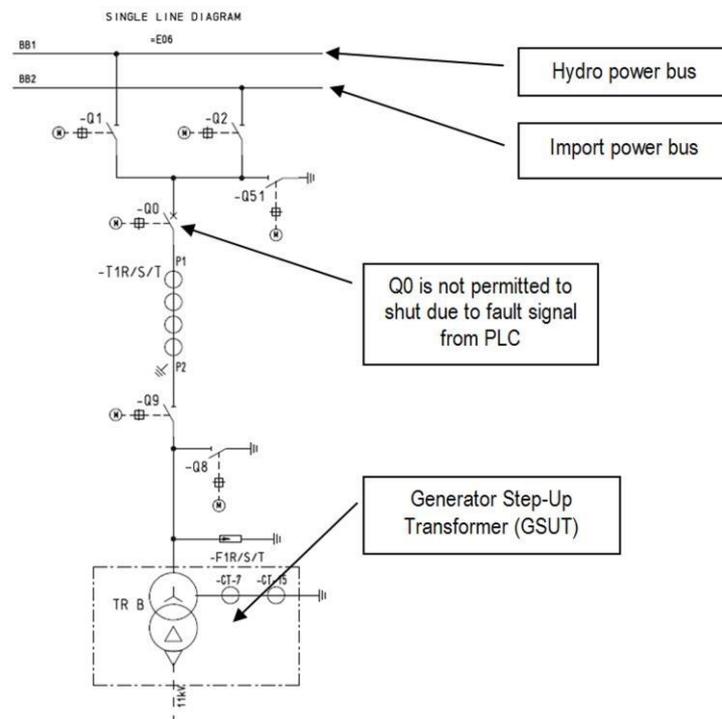
Figure 2: SLD of Switchyard Equipment

The Block B engines will not start (in normal mode, by design) unless the generator bus is powered. The generator bus cannot be powered because breaker Q0 will not shut.

Breaker Q0 is receiving a fault signal (“Transf external protection trip”) from the Block B PLC (Programmable Logic Controller). This output was confirmed to come from the GSUT protection panel relay K9. It was confirmed by removing relay K9 and observing the signal clear at the PLC. Of

After days of troubleshooting, the AESP team de-compiled PLC code and observed a software bug that prevented Q0 from being reset. The team patched the code, installed it on the PLC, and observed proper operation of Block B gensets, including powering the grid as designed.

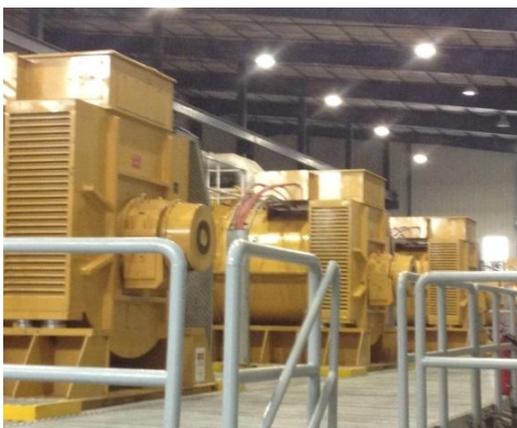
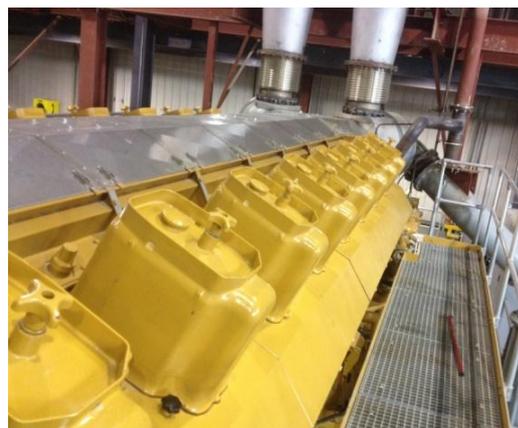
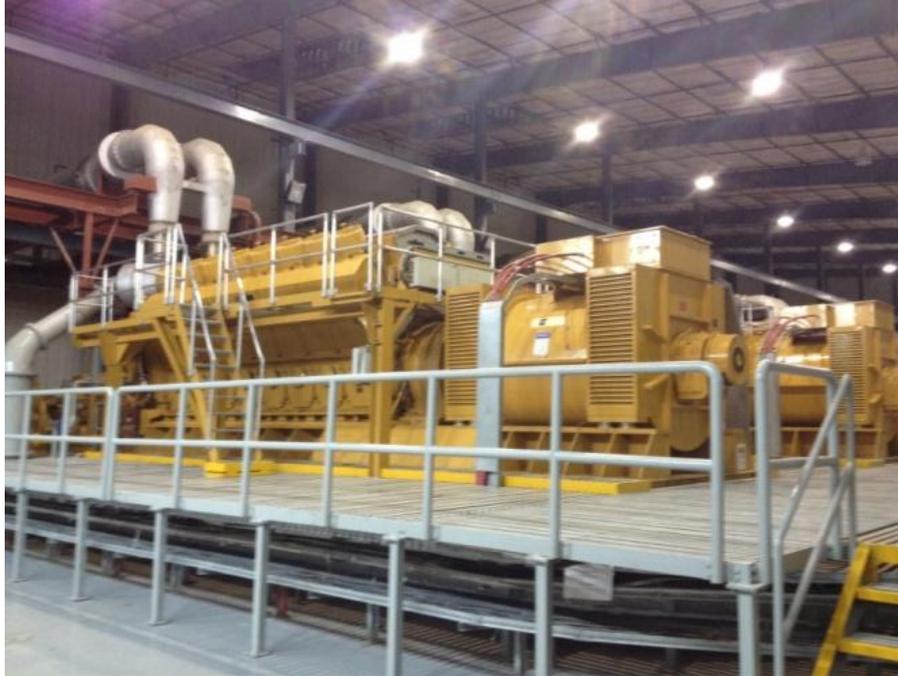
The team assessed the material condition of each power block gensets (Figures 3, 4, 5). The condition was generally good, with evidence of good housekeeping practices and periodic preventative maintenance. This was to be expected given the young age of the plant..

Figure 3 Block B Gensets

Figure 4: Block B Genset Head Covers

Figure 5: Genset B1

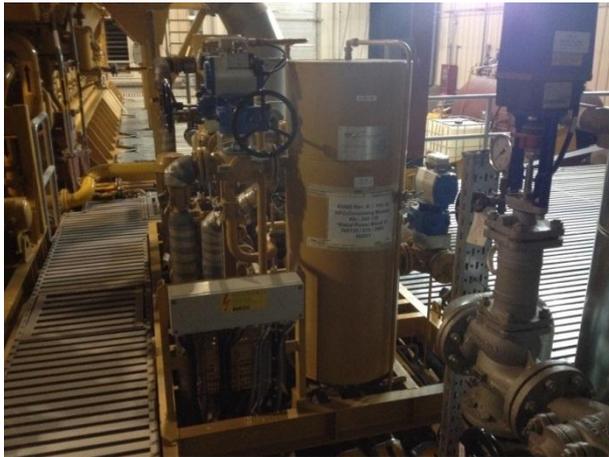
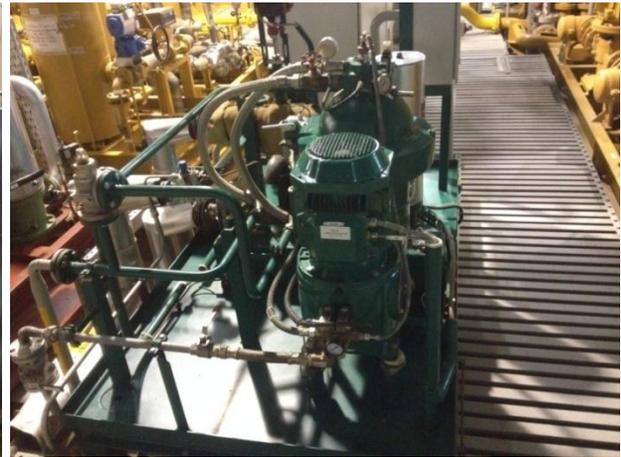
Balance-of-plant equipment (lube oil, air, fuel oil systems and the like) was also assessed in good condition, with evidence of good housekeeping practices and periodic preventative maintenance (Figures 6, 7). During Power Block B light-off, the team observed some equipment that failed to start or operate correctly. We believe this is due to the infrequent operation of the power block and plant. Specifically, on light-off of Power Block B on March 1, 2014, the team observed:

Figure 6: B1Fuel Oil Equipment Skid

Figure 7: Lube Oil Pump Skid
 (Note: Evidence of generally good Material Condition and Housekeeping)

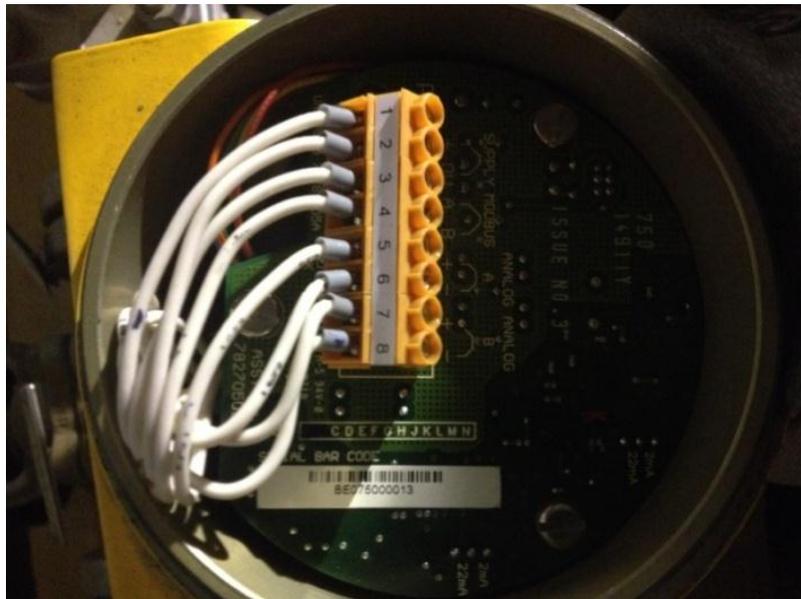
Figure 8: Faulty Viscosity Sensor on Genset

- Faulty viscosity sensor on Genset B1 (Figure 8); requires replacement.
- On Genset B3, several fuses blown in fuse block F5; still require replacement.
- Genset B2 HT cooling water pump #1 breaker failed; replaced from spare inventory.
- Various loose connections in several gensets; tightened.
- Genset B6, starting air shut off valve sensor inoperative; cleaned and reinstalled.
- Genset B3 and B5, main breaker for automatic voltage regulation showed open when actually shut; cleaned contacts.
- Dirty air distribution filters on Genset B3 and B6; cleaned.

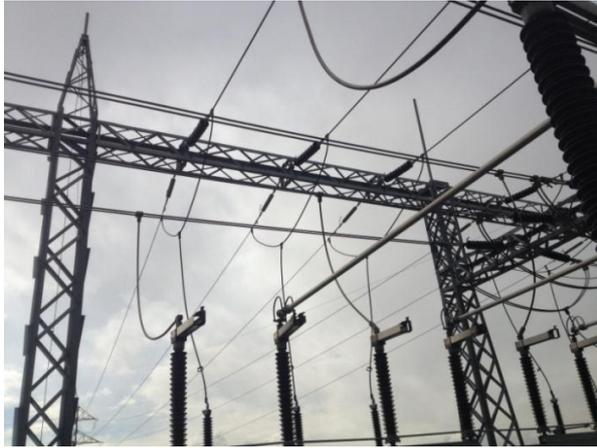
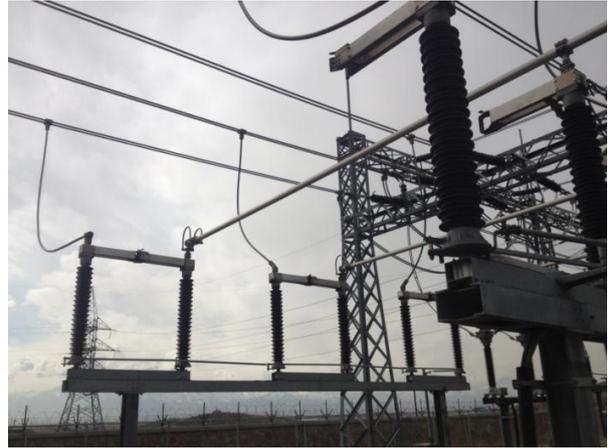
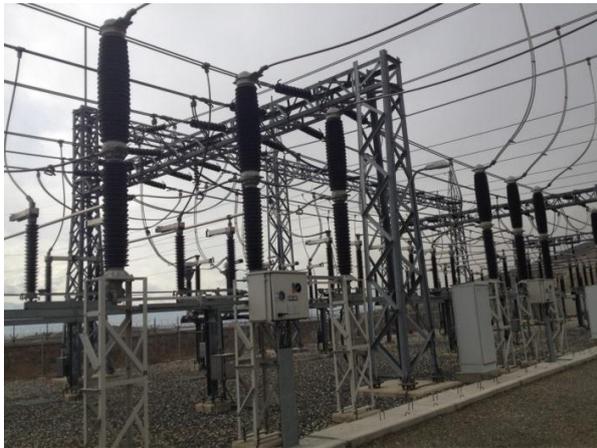
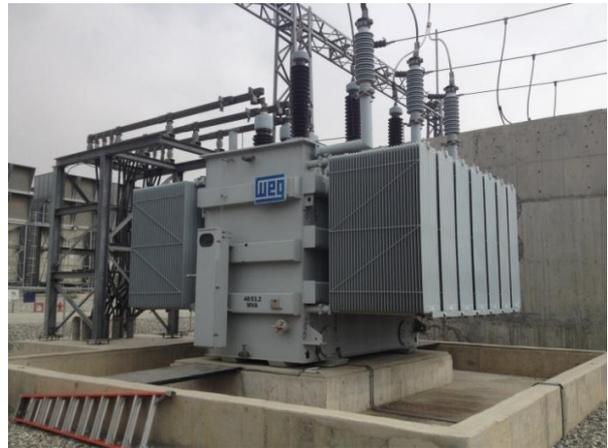
As with the engines and balance-of-plant, the team assessed the material condition of the electrical switchgear in the switchyard (Figures 9, 10, 11,12). The condition was also generally good, with evidence of good housekeeping practices and periodic preventative maintenance. The Plant Manager was also very focused on safety, and did an excellent job enforcing safety rules at the plant and in the switchyard.

The team observed breakers in the switchyard tripping several times due to grid instability. The frequent cycling of breakers and associated switchgear components will accelerate wear and reduce component lifespans.

Figure 9: Open Disconnects from Hydro Power Bus To Switchyard

Figure 10: Closed Disconnects from Import Power Bus to Switchyard

Figure 11: Breaker Q0 in Switchyard

Figure 12: Generator Step-Up Transformer in Switchyard.

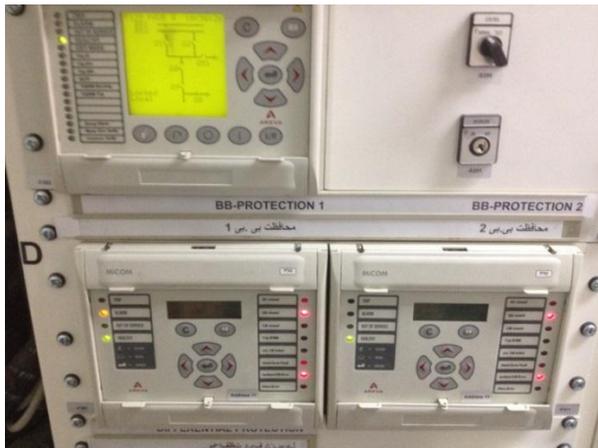
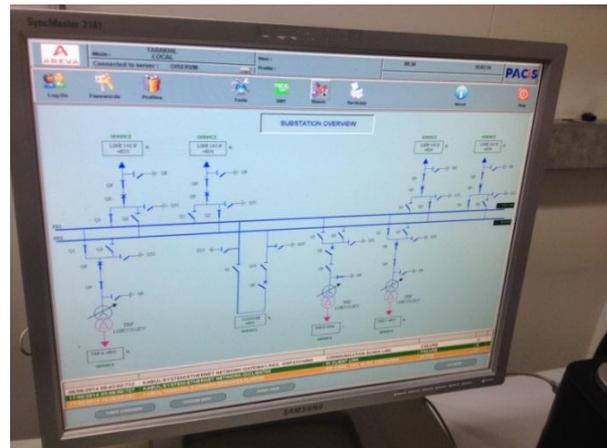
Components in the switchyard are controlled by an Areva control system, which allows operation of components from inside the switchyard (Figure 13) or from remote terminals (Figure 14) inside each power block.

The Areva system in the switchyard gives incorrect indications. Specifically, it shows some components closed when they are actually open. The team observed the following erroneous position indications:

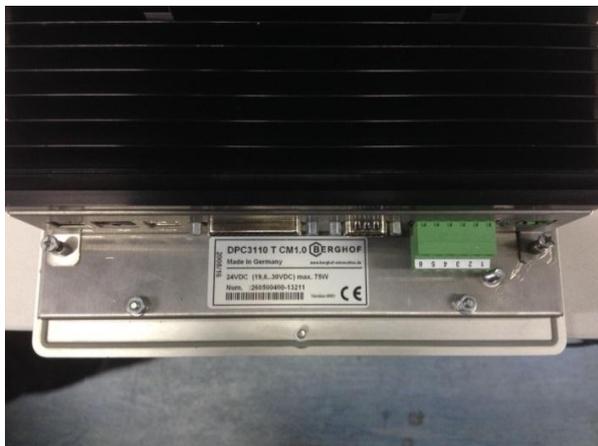
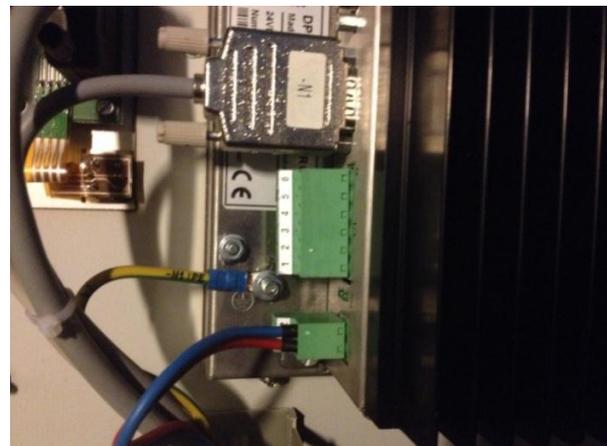
The generator control software runs on a small industrial computer (Figures 15, 16) in the generator control panel, inside the power house. This industrial computer can be controlled locally via a human-machine interface (HMI), or remotely, through network connections to the control room computers. The control software is run on Wonderware, running in Windows XP.

The industrial computers are hard-wired to their power supply, with no startup or shutdown protocol. Although they have a battery backup power supply (uninterruptible power supply, or UPS), the backup only lasts a matter of minutes. Because of grid instability, there are frequent outages that exceed the battery's capability, affecting the control computers. These outages cause a loss of power to the industrial computer without a proper shutdown of Windows. Over time, we believe the improper shutdowns caused file corruption and a failure of the Windows operating system in some of the computers. We believe it also caused a hardware failure in one of the genset HMI's.

believe it could lead to hardware damage in the future. According to the Plant Manager, the software becomes corrupt and requires re-imaging every 2-3 months.

The genset HMI’s are also at risk of failure due to power-cycling. Because the existing UPS does not last long enough to protect the system, and because the existing UPS does not properly shut down the software before powering down, we offer the following solution.

An off-the-shelf microcontroller-based device should be utilized, along with accompanying software, to act as a power controller. It would also manage the power supply to the HMI, monitor UPS battery health, and issue shutdown and startup commands when appropriate. A basic outline of the circuit is outlined in Figure 19.

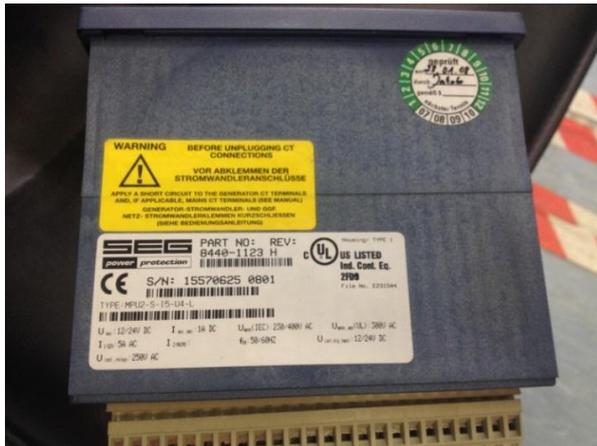
Figure 17: Faulty MPU-2S Multifunction Relay

In addition to the industrial computers, each genset control panel contains a programmable multifunction relay (part # MPU-2S)(Figure 17). Two of these relays are currently inoperative and prevent starting of their associated gensets (A5 and C1). When they are replaced with a relay from a different genset, the genset operates correctly, so it is reasonable to assume the problem is with the relay. These relays can be programmed by hand, entering values using a button; or with a computer, connecting to the relay with a special cable. The power plant does not have this cable, so the team programmed the relays by hand, but was unable to make them work. We believe that either the relays are faulty, and require replacement, or there are additional programming steps that require the use of the cable.

Some equipment requires replacement, and should be purchased as soon as feasible. Also, a programming cable should be purchased to more easily enable programming of multifunction relays. Specific equipment to be purchased includes:

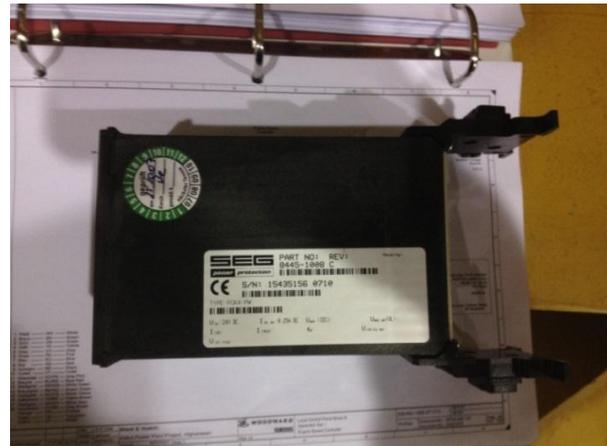
Figure 18: Faulty PCK-4 Gateway

Finally, each genset also contains a “gateway interface converter” (part # PCK-4) (Figure 18). This converts between communication protocols within the control system. One of these converters is currently inoperative and prevents starting of its associated genset (A6). It requires replacement

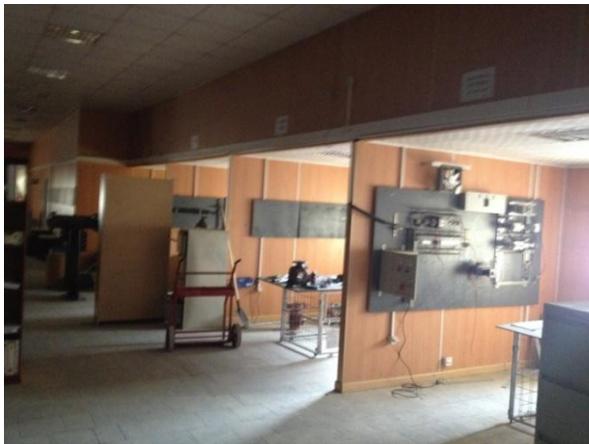
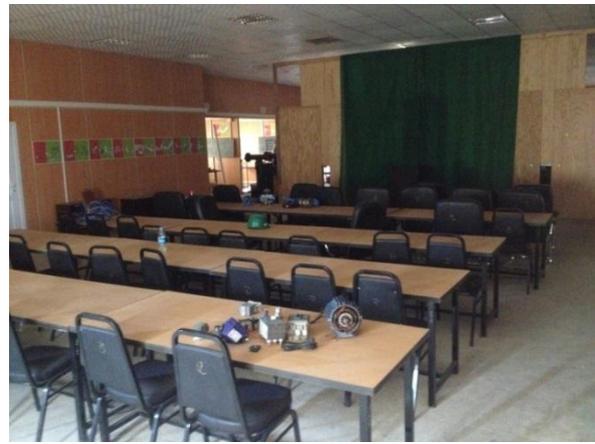
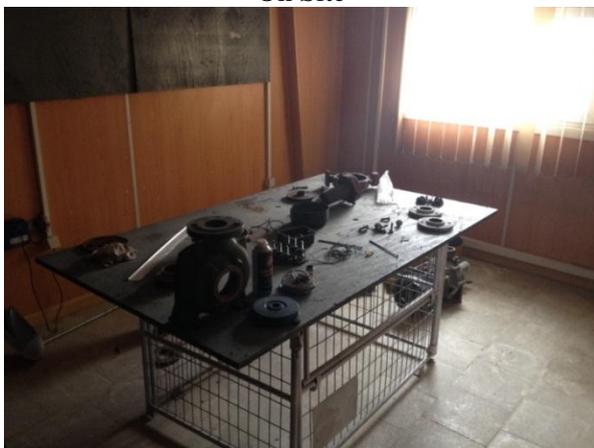
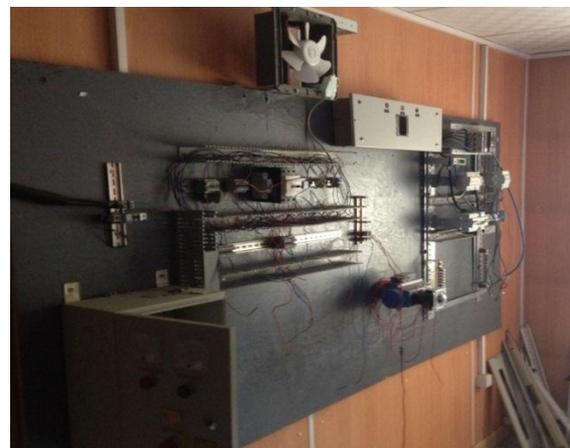
Of note, the training classroom (Figure 20, 21, 22, 23) built and used after the plant was first constructed remains in place, with most of the training equipment inside. This classroom and equipment would facilitate a local training program.

The site's technical library contains several training syllabuses, complete with lecture notes and teaching guides. These should be incorporated into a periodic training program for all shifts, conducted by shift leadership
