**AUDIT OF USAID/GUATEMALA'S
RURAL ACCESS ROADS
PROJECT NOS. 520-0274 AND 520-0332**

**Audit Report No. 1-520-91-009
June 28, 1991**

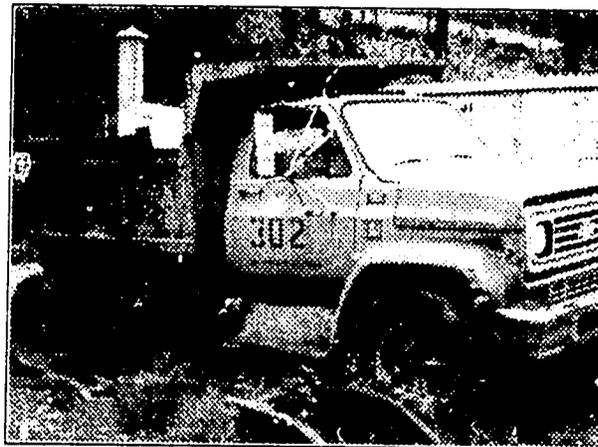
- During a tour of a regional facility, we observed the idle dump truck shown below which was purchased under a prior AID-funded roads project. Government of Guatemala officials stated that the vehicle had been idle for three or four years awaiting spare parts.

Recommendation No. 4: We recommend that USAID/Guatemala require the Government of Guatemala to resubmit a plan for a preventive maintenance program for project vehicles and equipment.

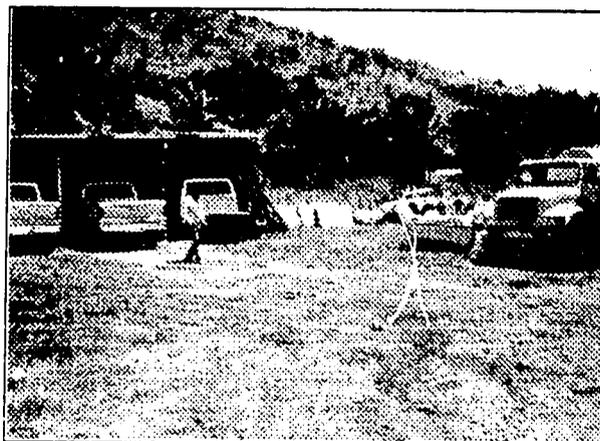
- During a tour of a second regional facility, we observed a water truck-- which appeared never to have been used--parked in an equipment storage area. Government of Guatemala officials stated that, although the water truck had been available for six months, it had not yet been used because wet weather conditions sufficiently moistened road materials. They anticipated that the water truck, (shown below - far right), could be used during the future dry weather season.

Recommendation No. 3: We recommend that USAID/Guatemala require the Government of Guatemala to submit a vehicle utilization plan for project vehicles and equipment including the provision for sufficient fuel and spare parts to regional facilities.
