**ROAD RESOURCES MANAGEMENT PROJECT**

**(KA-6)**

**EXPERIENCES AND LESSONS LEARNED**

**JUNE 1991**

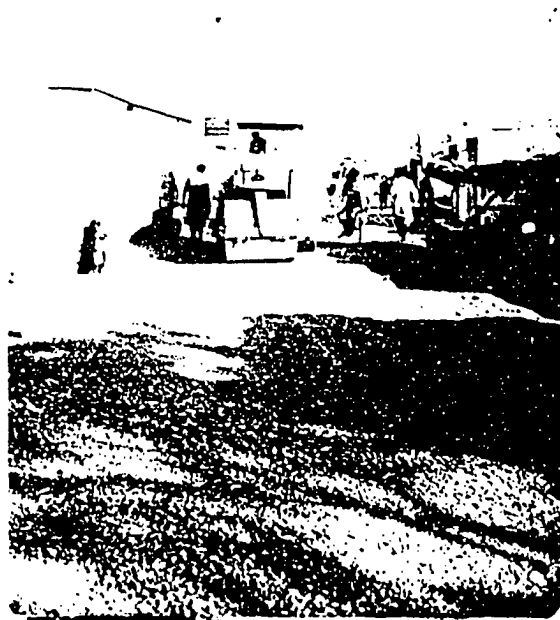
CONSTRUCTION PHOTOS INDICATE THAT COMPACTION PROCEEDED IN ACCORDANCE WITH SPECIFICATIONS. LABORATORY TESTS CONFIRMED THAT COMPACTION WAS ADEQUATE. THE SMOOTHNESS OF THE ROAD THREE MONTHS AFTER PROJECT COMPLETION IS TESTIMONY OF THE HIGH STANDARDS MET IN EXECUTING THE BASE PREPARATION AND COMPACTION.

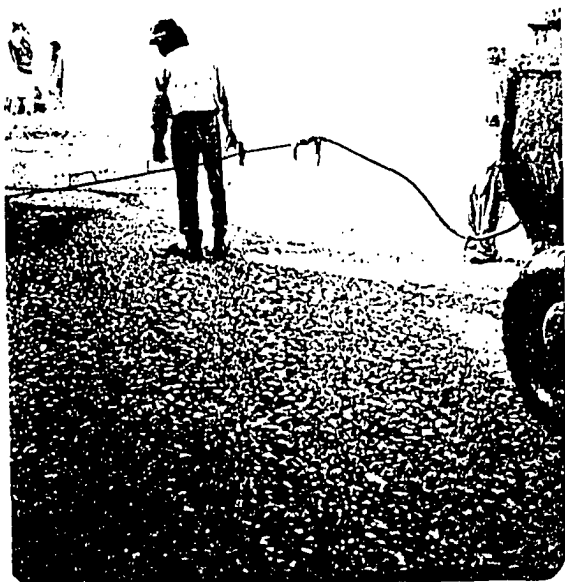
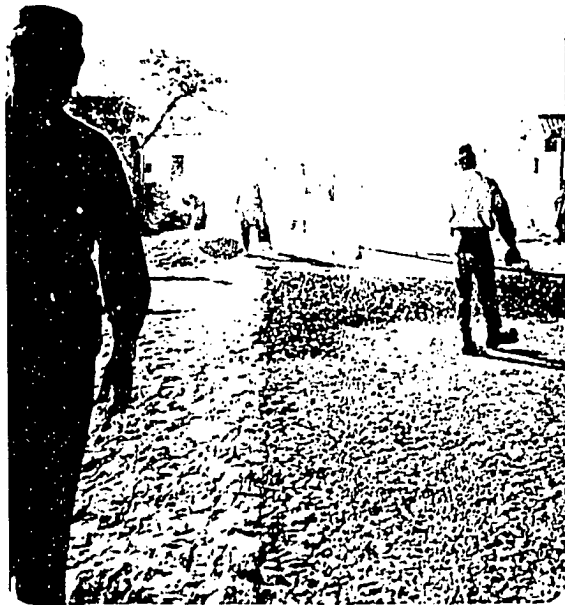
OCCASIONAL DIFFICULTIES IN CONTROLLING THE TEMPERATURE OF THE LIQUID ASPHALT AND THE FAILURE TO SCREEN THE AGGREGATE ARE EVIDENCED BY THIS PHOTO. AGAIN, THE RICHNESS OF THE MIX COMPENSATED FOR THIS DEFICIENCY AND THE STRUCTURAL VALUE OF THE PAVEMENT WAS NOT COMPROMISED.

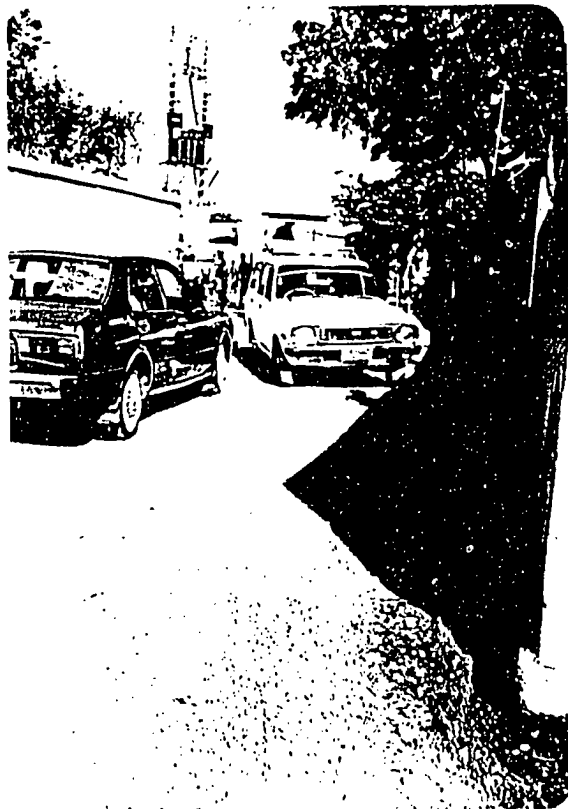
TRAFFIC WAS NOT CONTROLLABLE DURING BASE PREPARATION AND COMPACTION. DISTRICT ENGINEER FAILED TO PROVIDE ADEQUATE SUPPORT.

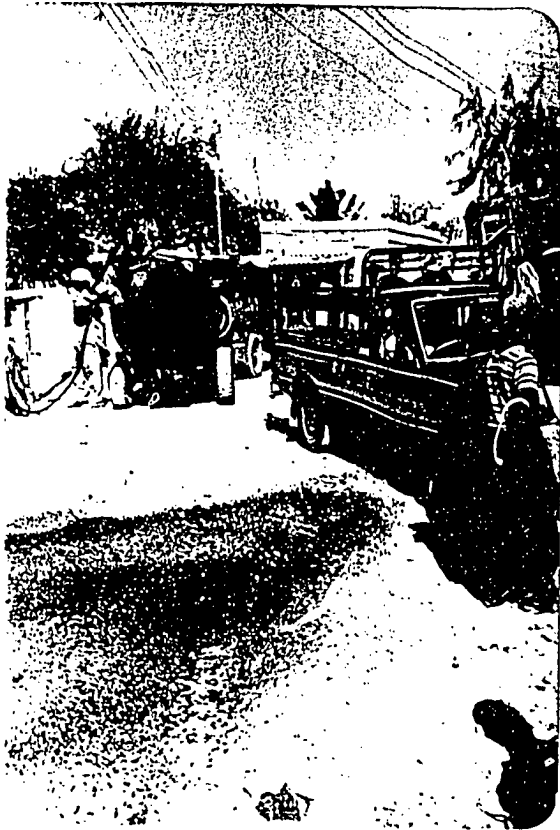
TRAFFIC WAS ALLOWED TO PASS OVER THE COMPACTED BASE PRIOR TO SURFACE DRESSING DUE TO THE HIGH COMPECTION STANDARDS THAT WERE MET, THE BASE MATERIAL WAS NOT DISTURBED.

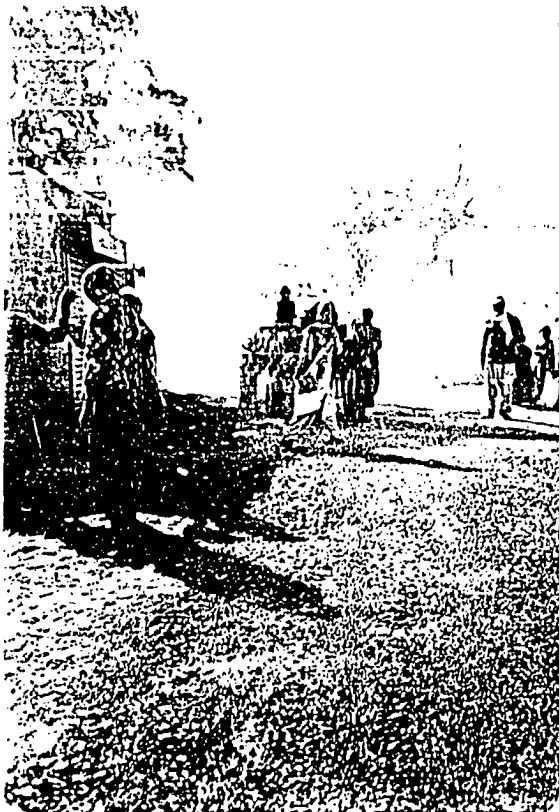
RESIDENTS INTERFERED WITH NORMAL PROGRESS OF THE CONSTRUCTION. NEVERTHELESS, THE INSPECTION TEAM AND THE CONTRACTOR WERE ABLE TO PROGRESS AT A SATISFACTORY RATE, AND WITH FEW EXCEPTIONS, THE QUALITY WAS MAINTAINED THROUGHOUT THE PROJECT. IMPORTANT LESSONS LEARNED BY THE DISTRICT INSPECTORS ARE BEING INCORPORATED IN CCSC TRAINING PROGRAMS TO STRESS THE NEED FOR THE DISTRICT ENGINEER TO IMPROVE TRAFFIC CONTROL AND INCREASE THE AWARENESS AND INVOLVEMENT OF RESIDENTS DURING CONSTRUCTION WORK. PERFORMANCE STANDARDS WILL BE MODIFIED TO SUGGEST USE OF STANDARDIZED WARNING DEVICES AND PERHAPS TRAFFIC POLICE IN CONGESTED AREAS.

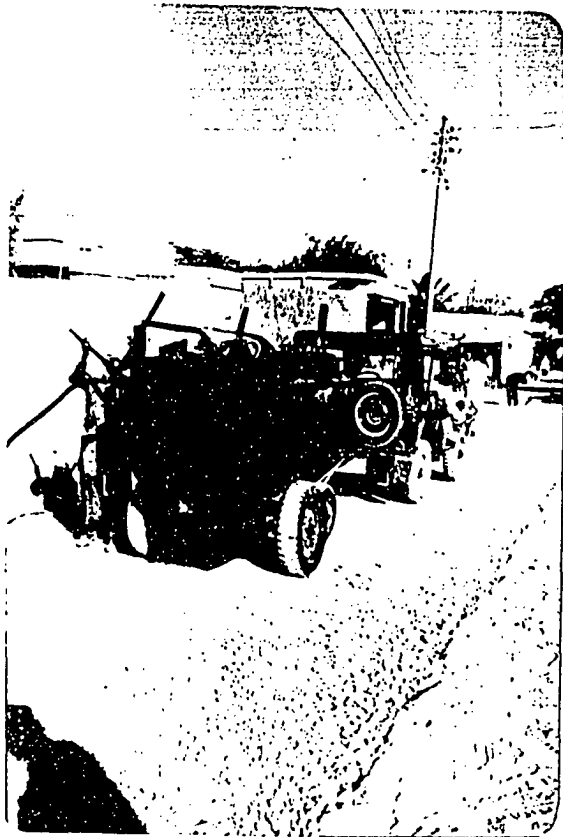
ASPHALT DISTRIBUTION  
EQUIPMENT IS SATISFACTORY  
AND PROVIDES FOR RELATIVELY  
UNIFORM DISTRIBUTION OF  
BITUMINOUS MATERIAL IN  
CONFORMANCE WITH  
SPECIFICATIONS.

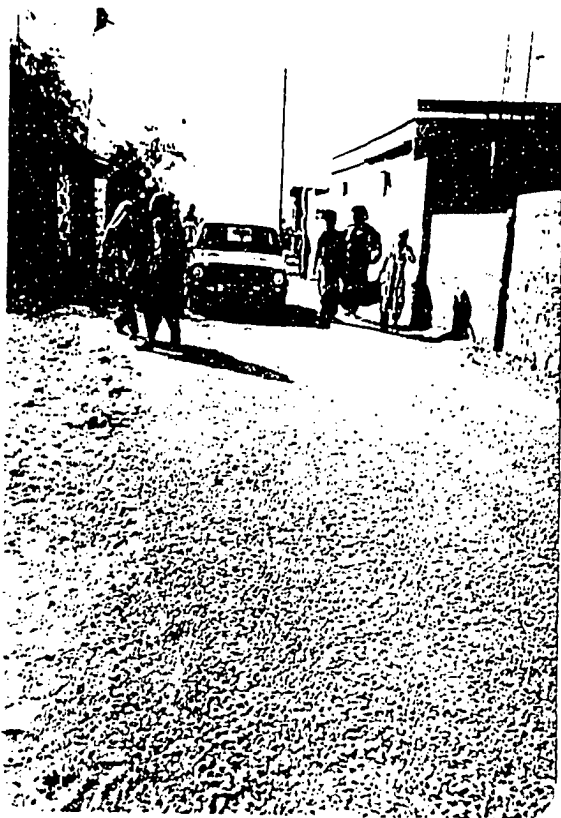
TRAFFIC INTERFERENCE DELAYED  
APPLICATION OF AGGREGATE  
AGAIN RESULTING IN DEFICIENT  
TEMPERATURE CONTROL.  
REMARKABLY, THE QUALITY OF  
THE SURFACE TREATMENT WAS  
NOT VISIBLY AFFECTED.

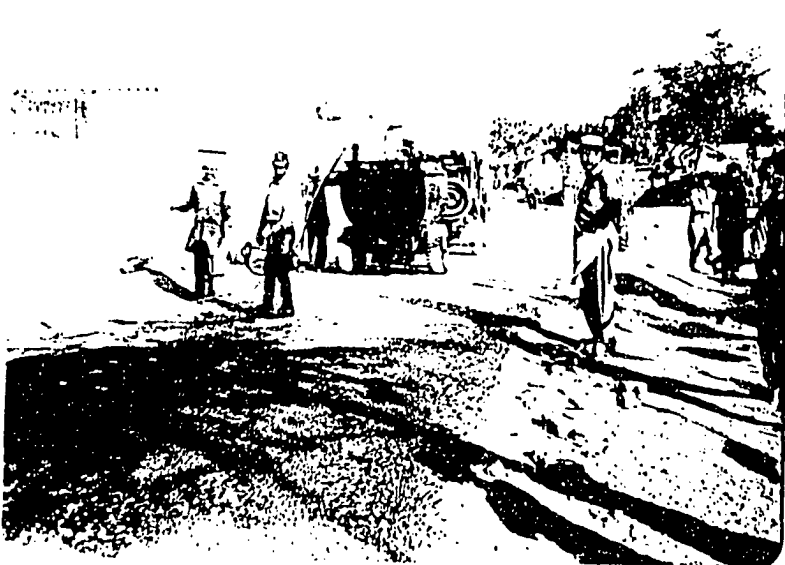
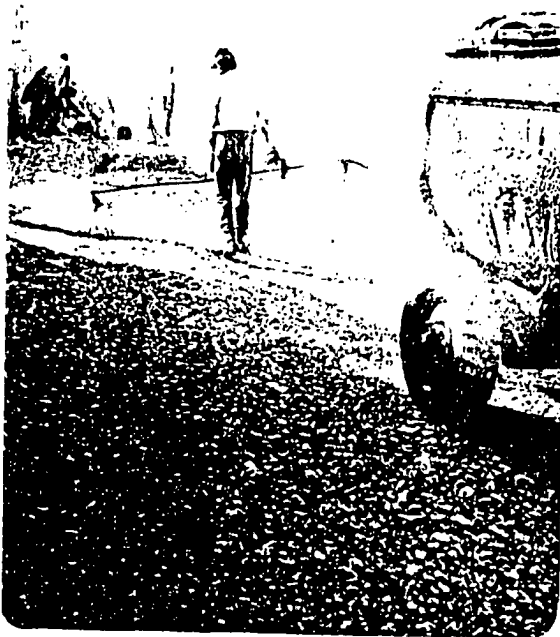
RATE OF DISTRIBUTION OF AS-  
PHALT WAS PROPERLY  
CONTROLLED THROUGHOUT THE  
PROJECT. PHOTOS OF CRITICAL  
ACTIVITIES THROUGHOUT THE  
MANY PROJECTS ARE BEING  
COMPILED FOR TRAINING  
PURPOSES.

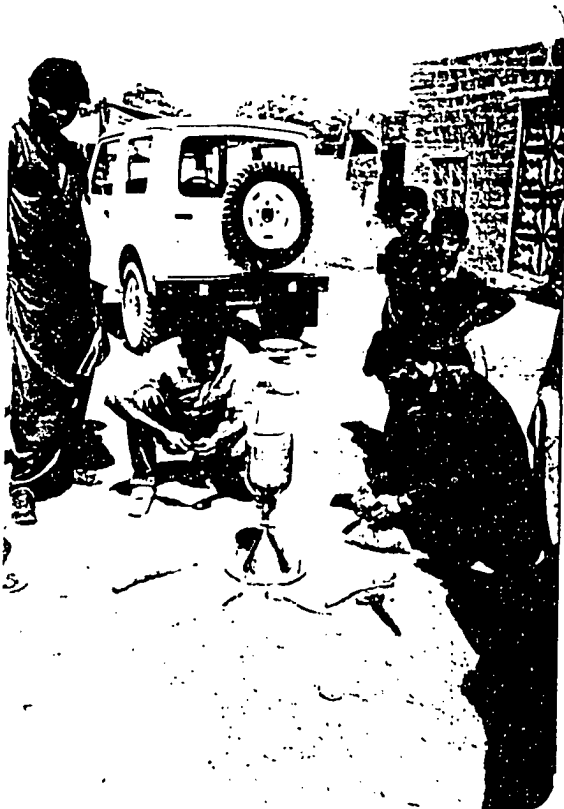
MATERIALS TESTING ON SITE  
AND IN THE LAB BY SOIL  
ENGINEER PROVIDED  
SATISFACTORY QUALITY CONTROL  
OF MATERIALS AND COMPACTION  
PROCEDURES. ON THE JOB  
TRAINING OPPORTUNITIES FOR  
DISTRICT INSPECTION STAFF  
WERE ALSO PROVIDED SO THAT  
FUTURE DISTRICT LEVEL  
PROJECT MANAGEMENT WILL BE  
IMPROVED.

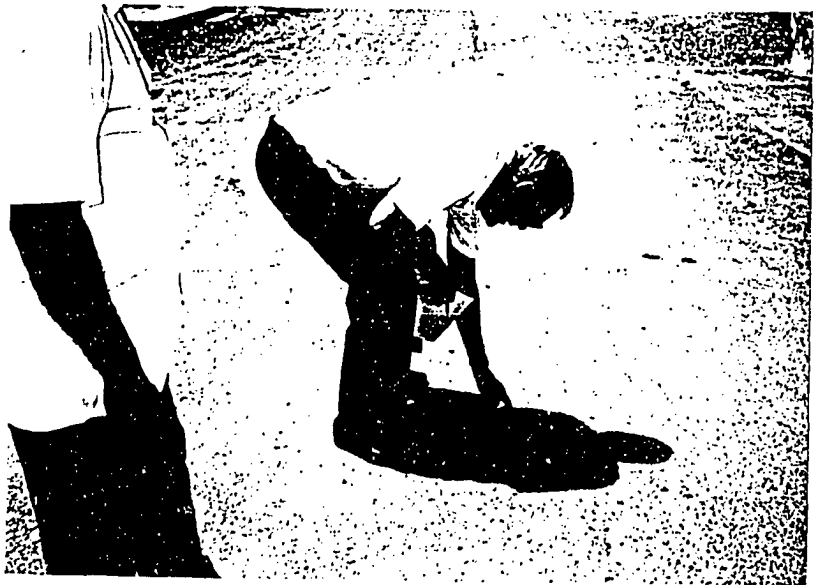
EXCESS BITUMEN ON THE SURFACE

- A) Areas having or displaying surplus bitumen should be burnt off with a propane torch and sand coated while still hot.
- B) All potholes should be patched immediately in accordance to the district engineer's instructions and specifications.
- C) Funds should be made available by the district council to correct the surface drainage of sewage water. It is advised that adequate under road drainage be utilized and completed prior to pothole patching, thus avoiding future traffic problems, improper repair of the existing road and shoulders.
- D) The entire length and width of the new road should be given the second bitumen treatment in accordance to the existing specifications, and extreme care be taken that the surface dressing aggregate is of proper size and designated coverage.

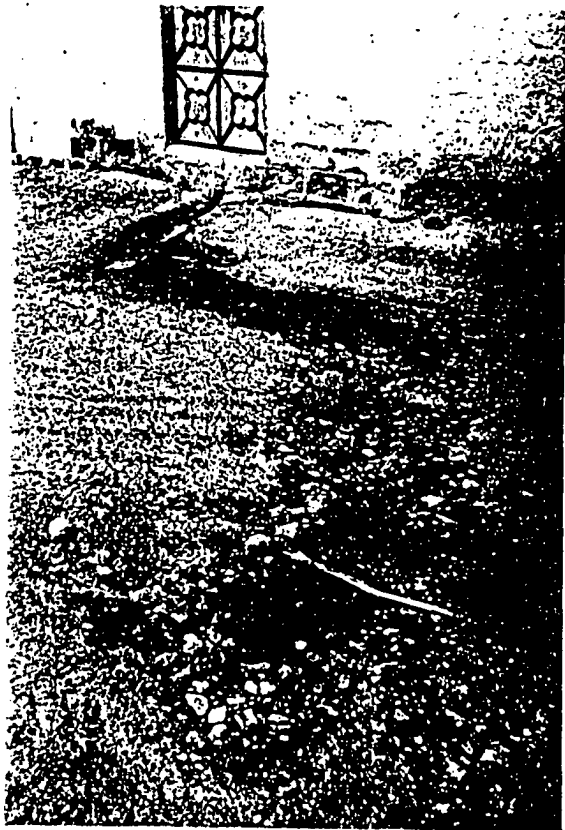
SEWERAGE WATER COMING ON SURFACE OF  
THE ROAD DUE TO NON-EXISTENCE OF DRAINAGE

To assure that the road provides satisfactory service throughout its design life, it is recommended that the District Council immediately undertake the construction of adequate underground drainage in the areas where drainage outlets are impinging on the road surface. The Consultant stands ready at any time to provide technical advice in this regard. Immediate attention to remedying these drainage deficiencies will safeguard this important infrastructure investment.

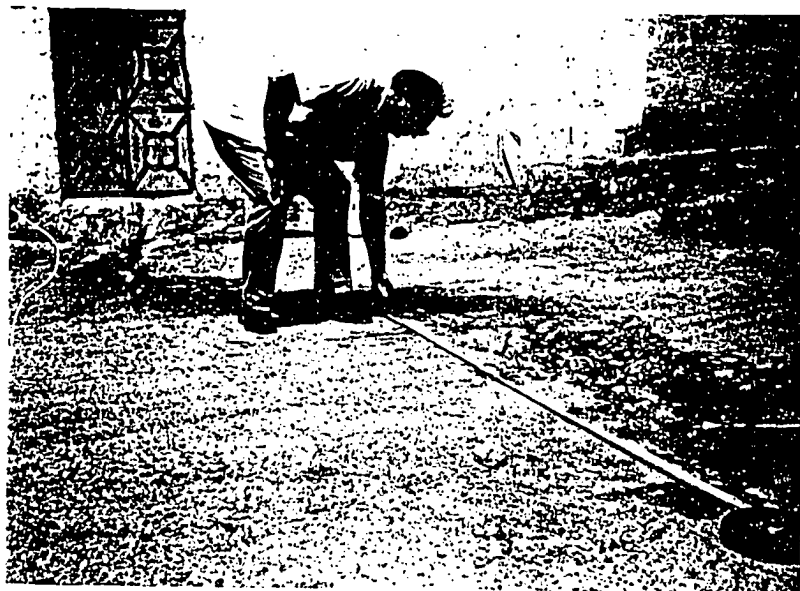
ROAD SURFACE DAMAGED DUE TO SEWERAGE WATER

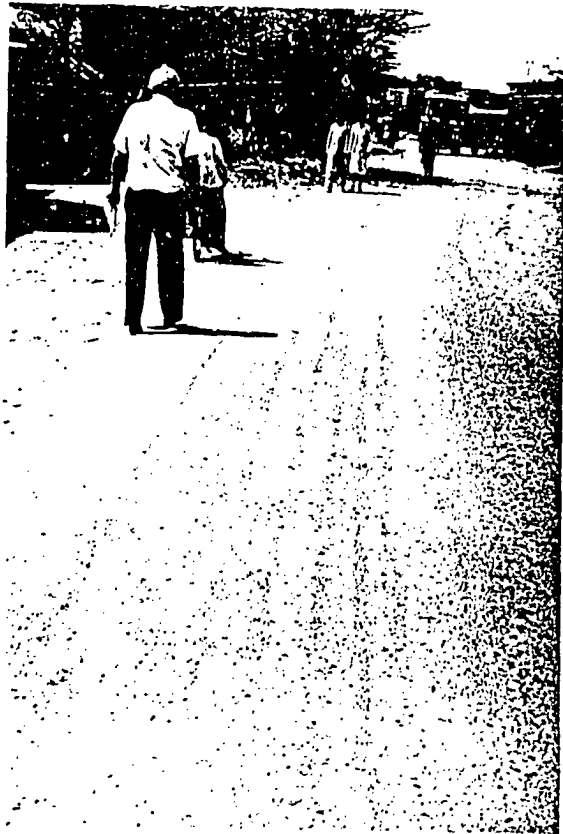
SURFACE OF ROAD IN GOOD CONDITION

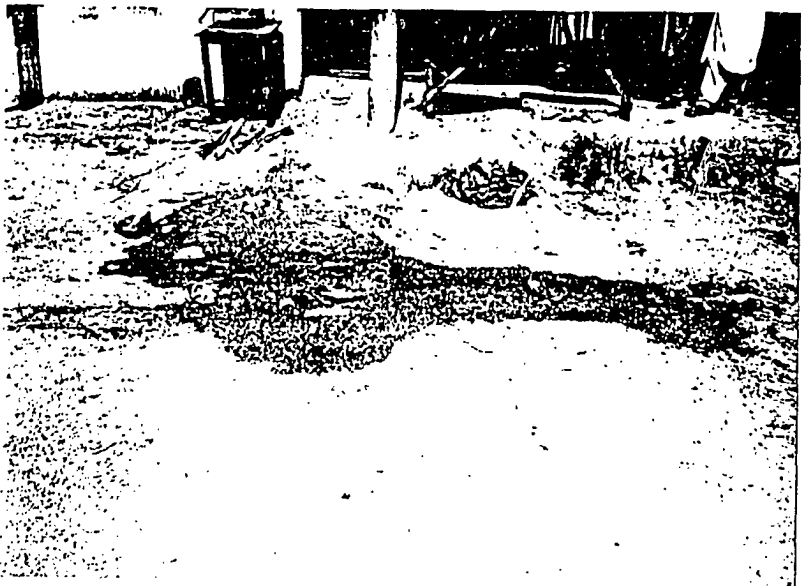
ROAD IS BEING DAMAGED DUE TO WASTE  
WATER COMING OUT OF HOTEL
