A REPORT OF A SURVEY OF HOSPITAL MAINTENANCE

HONDURAS HOSPITALS

From December 8-19, 1974

Hy A. Bershad, P. E.

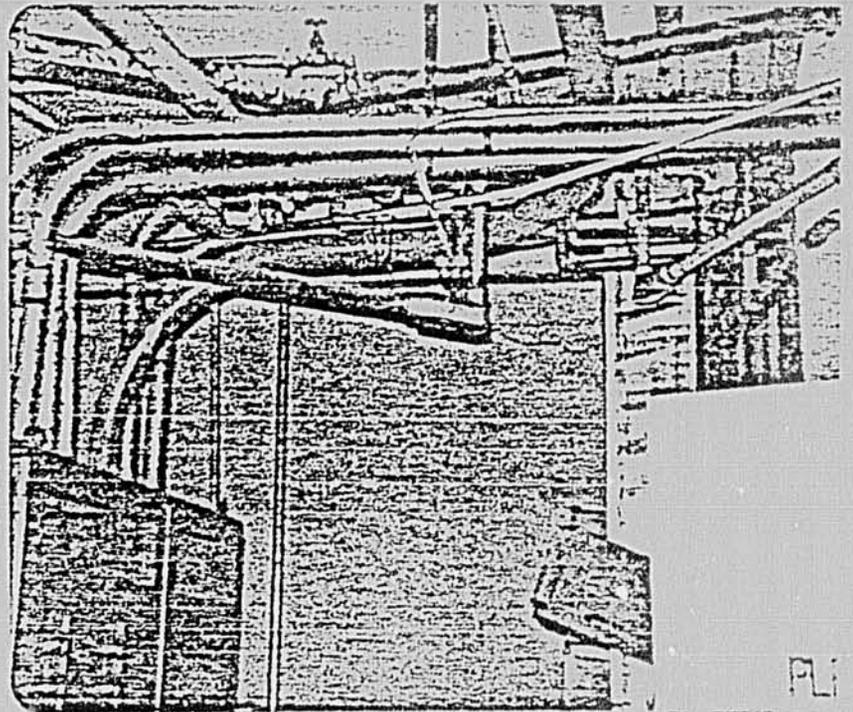
Photo No. 2 - Electrical Service  
Room (Hospital Materno Infantil)

3. We then walked to the electrical service room which is nearby and noticed that soiled and steam lines were routed over the main distribution panel. We suggested that some sort of drip pan protection be provided above the main distribution panel just in case any leaks should develop in the piping. We checked the transfer switch in the emergency generator. We were told that it is energized upon the utility company failure but that it does not automatically switch back to normal power when the utility company comes back on the line. Dr. Medina mentioned that it only takes about 17 seconds for emergency power to be provided when a power outage occurs. The switch directions are in English and on Friday the hospital electrician and I hope to check out the solenoid

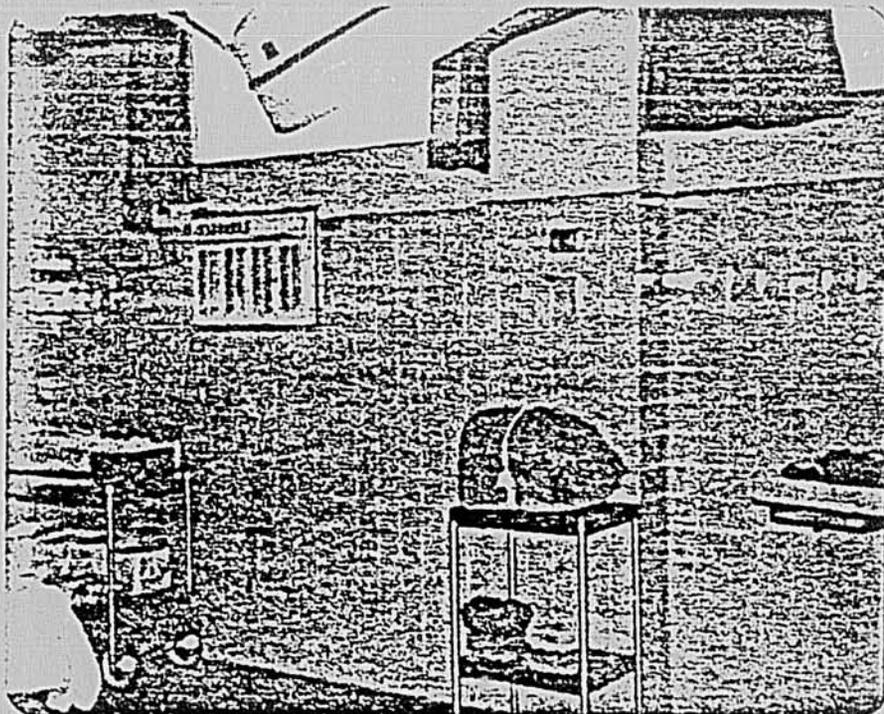
Photo No. 3 - Operating Room  
(Hospital Materno Infantil)

17. We visited the Operating Room which is the Delivery Suite and noted many potential problems. The nurses call system, an Executone Unit, was out of order. Doctors, Nurses, etc. use expensive conductive shoe covers but we did not see a Conductometer to check on whether or not personnel are correctly dressed before entering the Delivery Area. We were told that the floors in some of the Operating Rooms were of conductive material. It appeared to be a conductive linoleum or sheet material which was terribly worn in certain areas. Some of the rooms had in fact replaced the worn conductive material with a non-conductive floor tile. No tests are performed on conductivity of floors since there is no test meter available. In addition no one checks the casters or wheels of movable equipment to guarantee conductivity.

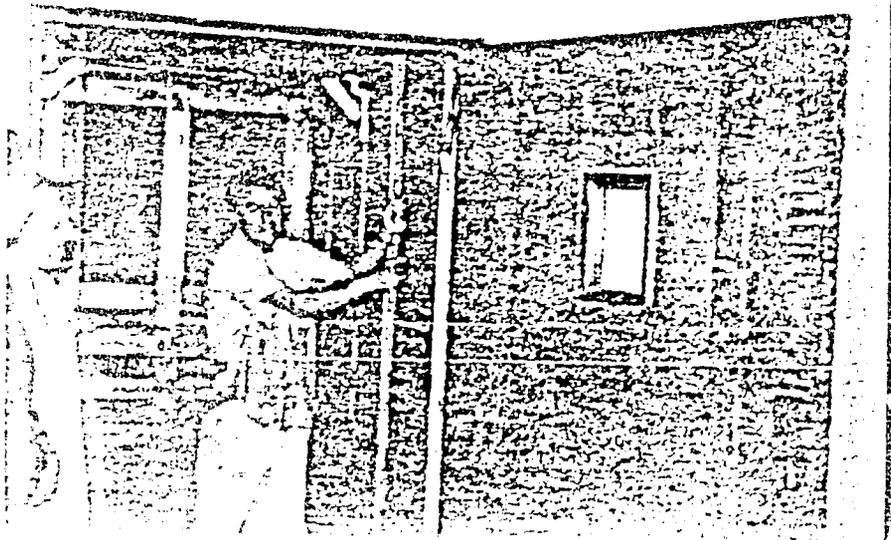
Photo No. 7 - Kitchen Area  
(Chest Hospital)

The Kitchen generally is a disaster area and appears to be ready for total replacement. Sinks are old, are corroded and are germ catchers as are all of the food preparation work tables which are made of wood. There is a juxtaposition of very old poor equipment and some few shiny new pieces. We can't begin to suggest palliative measures of preventive maintenance here when what is really needed in this area is radical surgery. Some of the things that are required include new flooring to replace the old chipped, cracked, eaten floor, new lights, new equipment, such as sinks and tables, etc.
