**TECHNICAL ASSISTANCE
IN THE MANUFACTURE AND
QUALITY CONTROL OF THE
AID/BATTELLE HANDPUMP IN THE
DOMINICAN REPUBLIC**

WASH FIELD REPORT NO. 20

JUNE 1981

**Prepared by:
Robert Knight
Consultant**

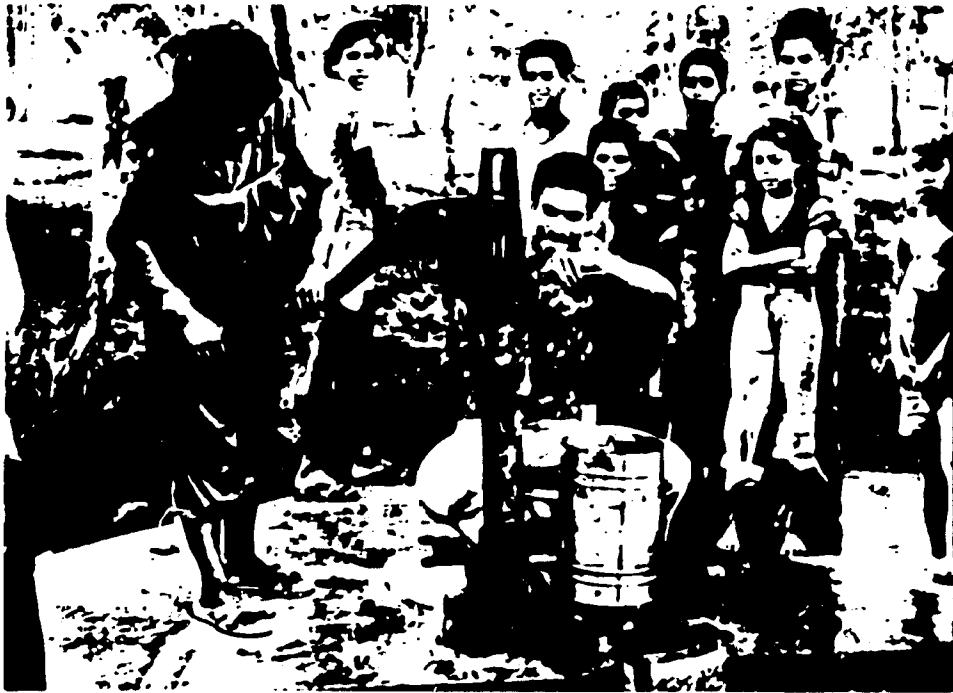
PLATE 6: The pump at Guaco after replacement parts had been installed.

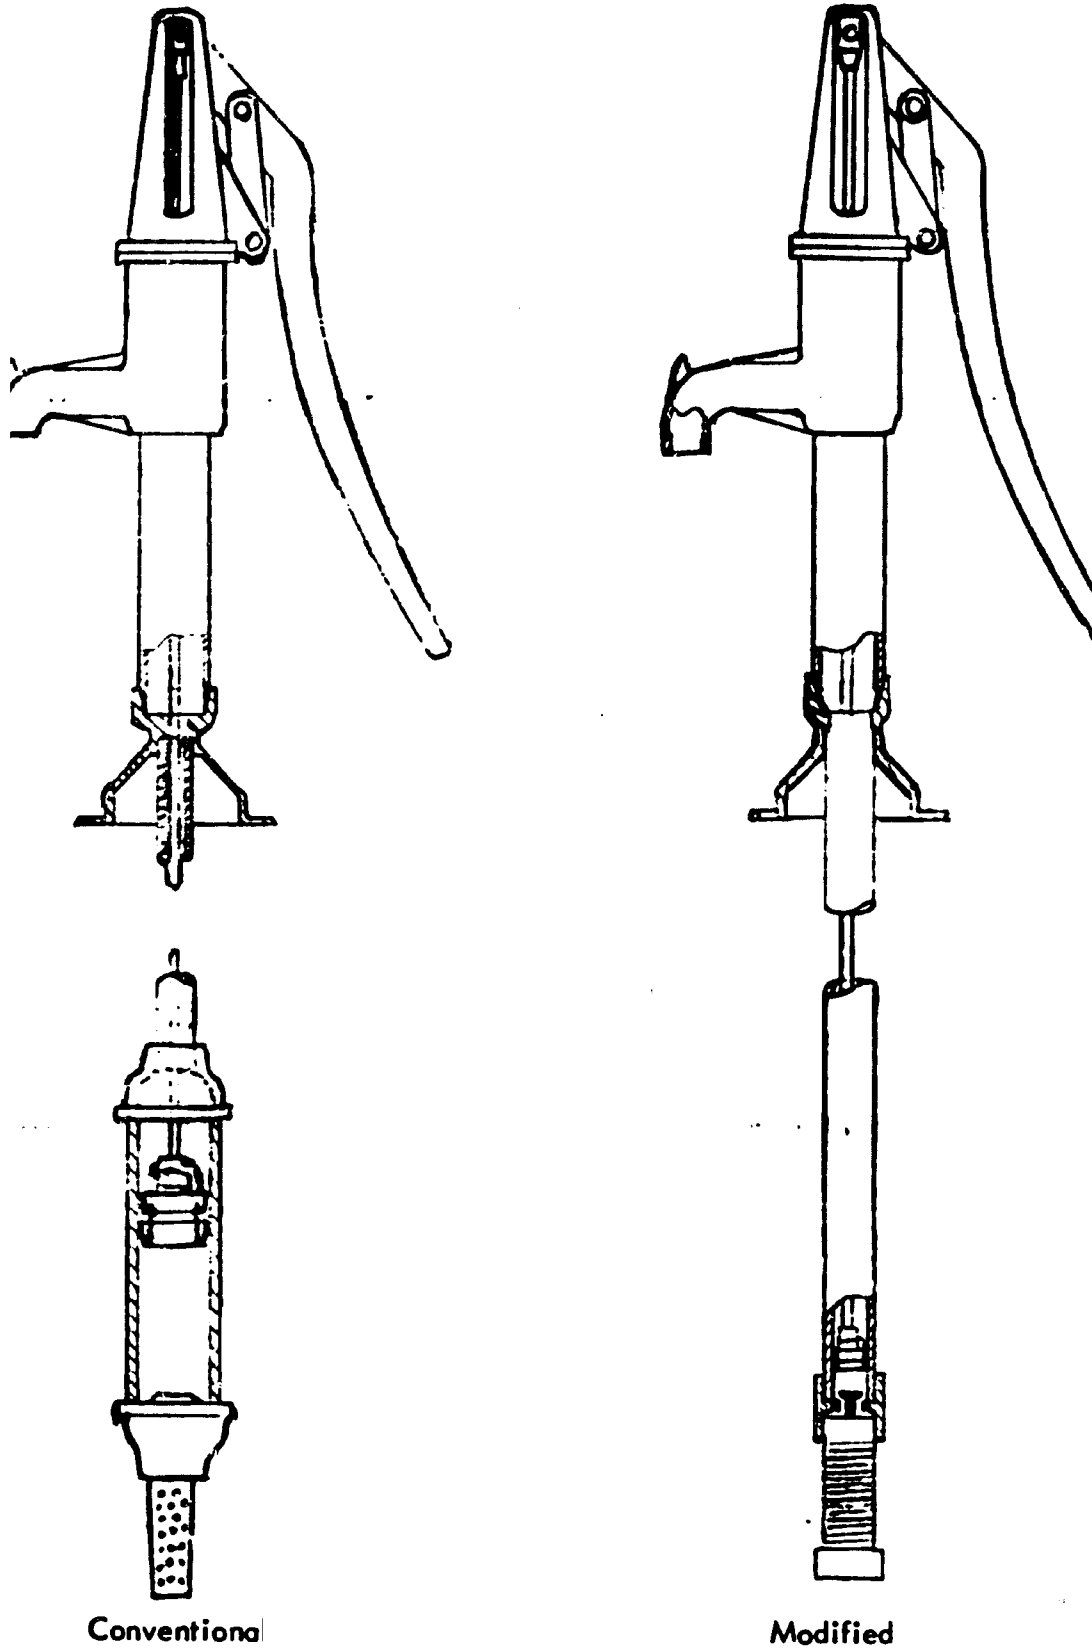
Some of the advantages of the proposed design changes will be found in the ease of installation and maintenance of the handpump. It will no longer be necessary to place the drop-pipe, cylinder, pump rod, and plunger as a complete assembly in the well before installing the pump body. The simple requirement will be to place a desired length of PVC drop-pipe, part of which will be the cylinder, into the well and then attach it to the pump base. The pump rod and plunger assembly can be installed by feeding it down through the pump body until the plunger is in the desired position below the water table. The normal pump rod cutting and threading and a pump cap assembly will then be required. (For clarification, refer to Figure 1.)

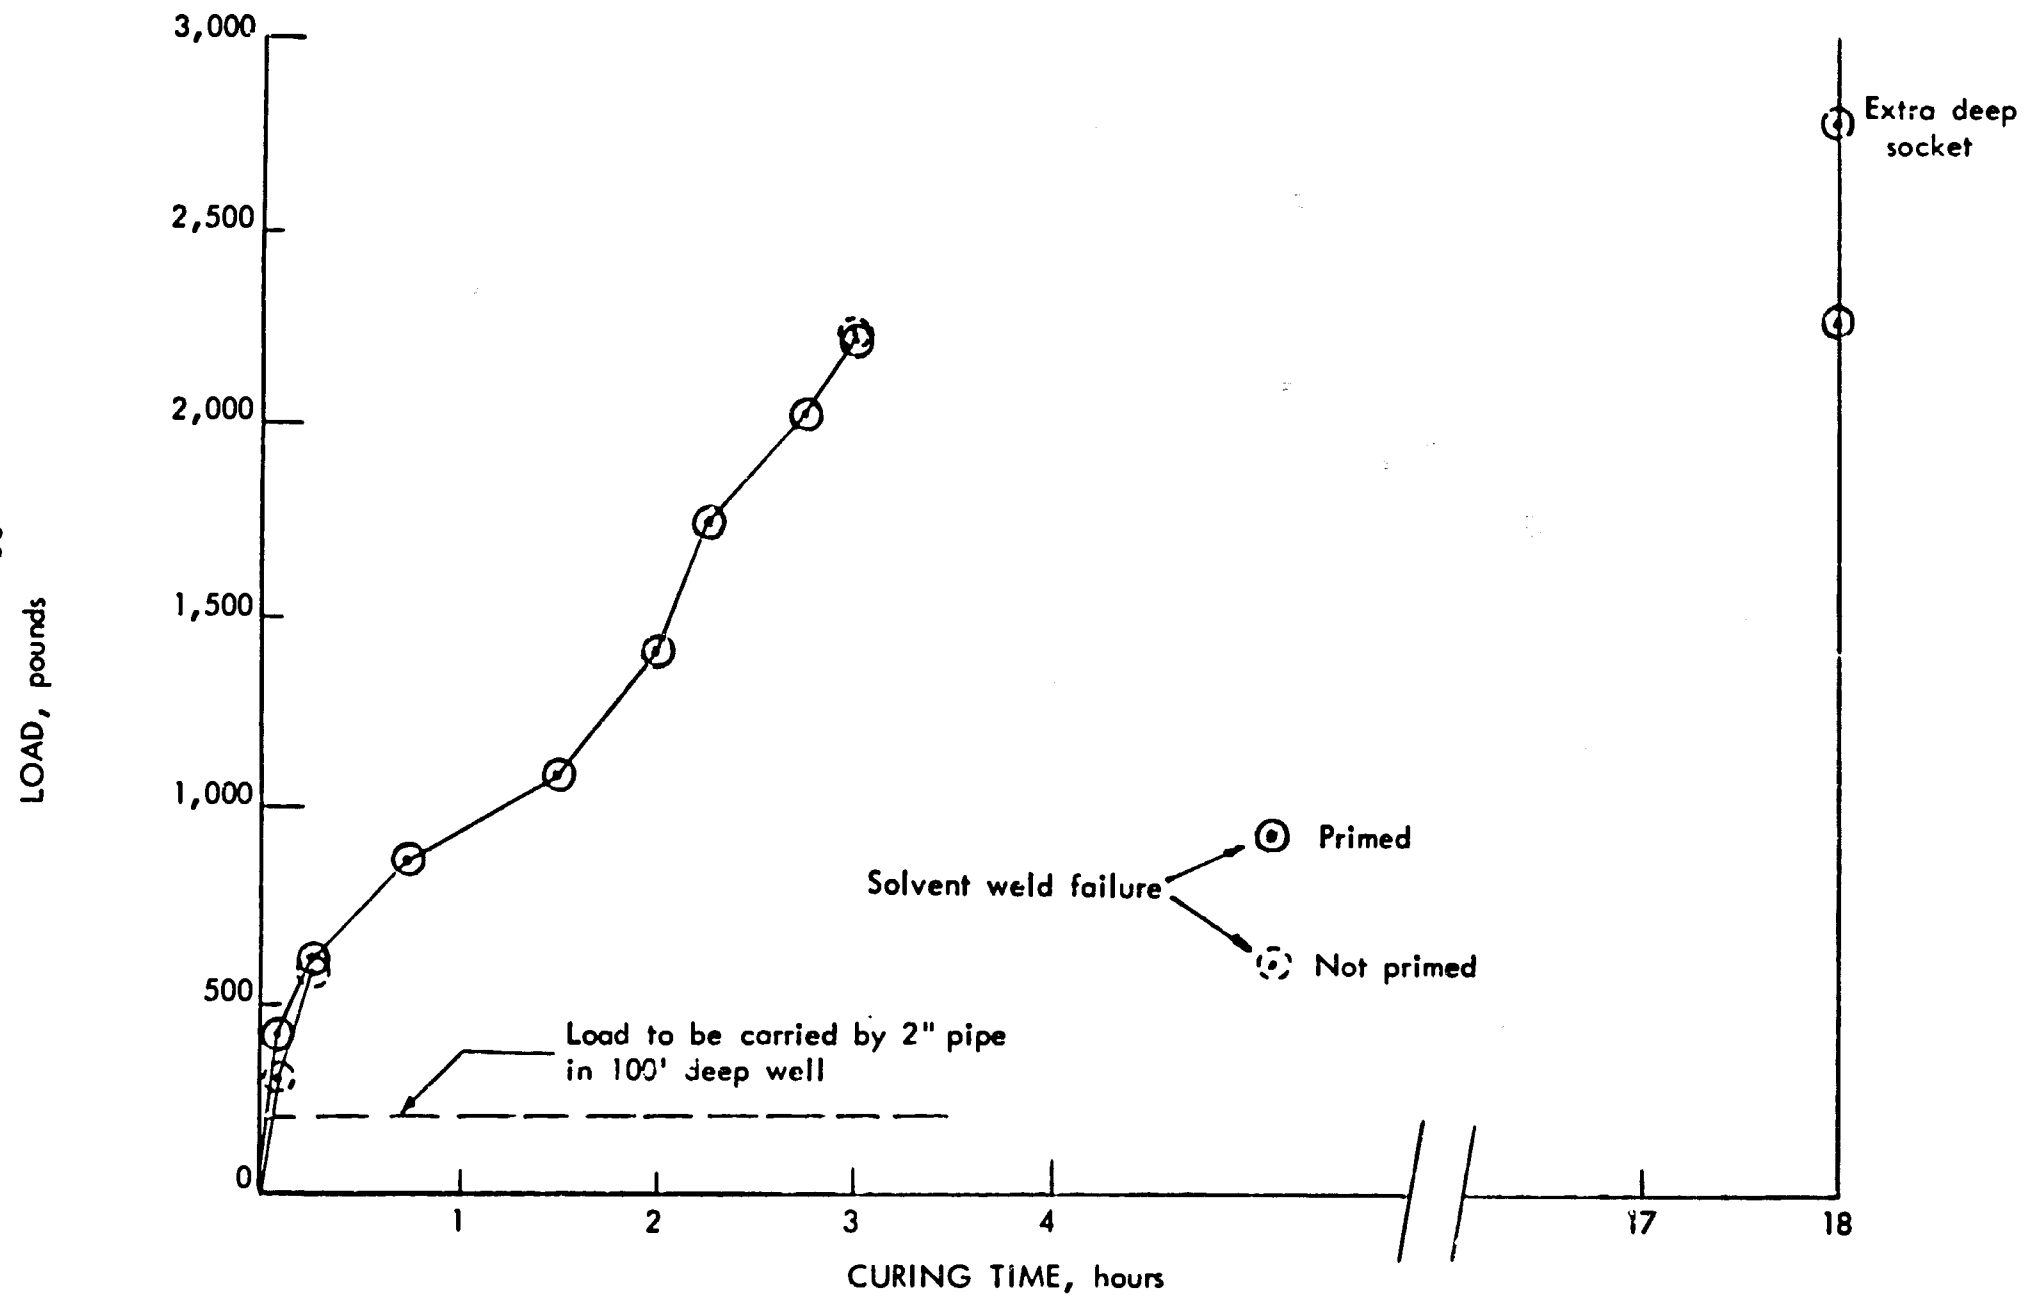
Figure 2
Load Tests on Solvent Welded PVC Pipes and Adaptors

The lack of information available on the tensile strength of solvent welded PVC pipe joints gave cause for concern as the plan was to use this easy method for the drop-pipe connections. To fasten the pipe to the pump base, a standard PVC adaptor is used. The male end is threaded into the cast iron base, then the pipe is solvent-welded into the socket end of the adaptor. This is a critical point of the assembly as it has to support the weight of the entire drop-pipe plus possibly a column of water. Therefore, it was considered prudent to conduct a number of tests. A variety of specimens were fabricated and tested. Some of the results can be seen in Figure 2. One and one-quarter inch pipe and fittings were used in this series of tests. The surfaces to be solvent-welded were not all prepared the same way.

Some were cleaned and primed before the cement was applied. Some were cemented without preparation. Referring to Figure 2, it appears that priming the joint surfaces is most critical during the first few minutes. At the three-hour mark, the points on the curve for the primed and the not-primed almost coincide. Only four unprimed specimens were tested for comparative results and two of them failed very quickly. It is intended that all joints be properly prepared during field installations.
