EROSION AT SANTO TOMAS RIVER DIVERSION DAMSITE

SEDIMENT PROBLEMS AT DIVERSION STRUCTURES

IN THE PHILIPPINES

Ernest L. Pemberton

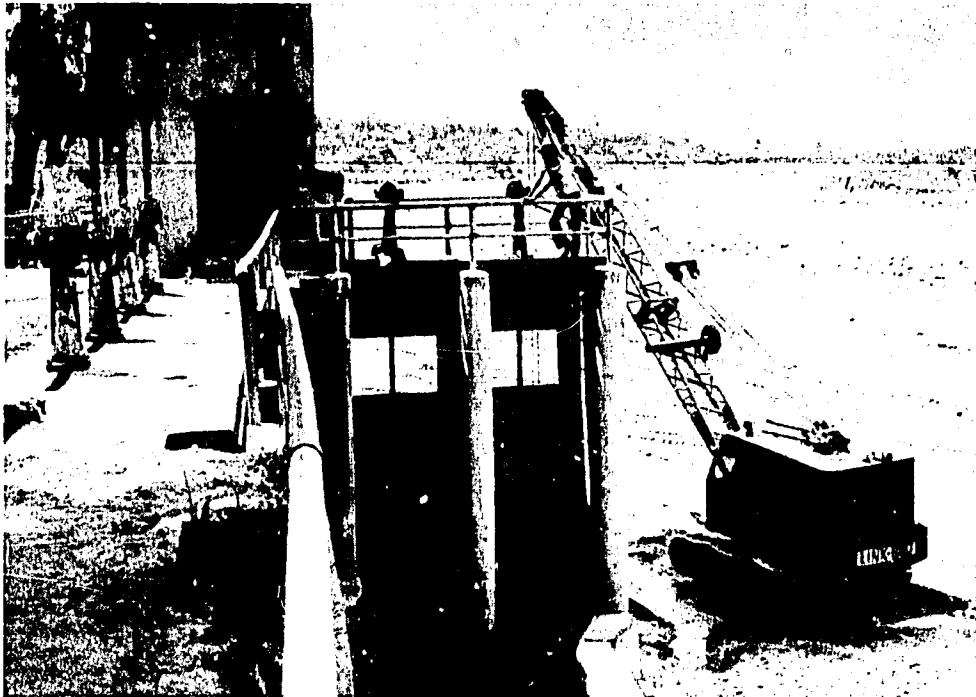
Photograph 5. - Headworks remaining at Santo Tomas River Diversion damsite.

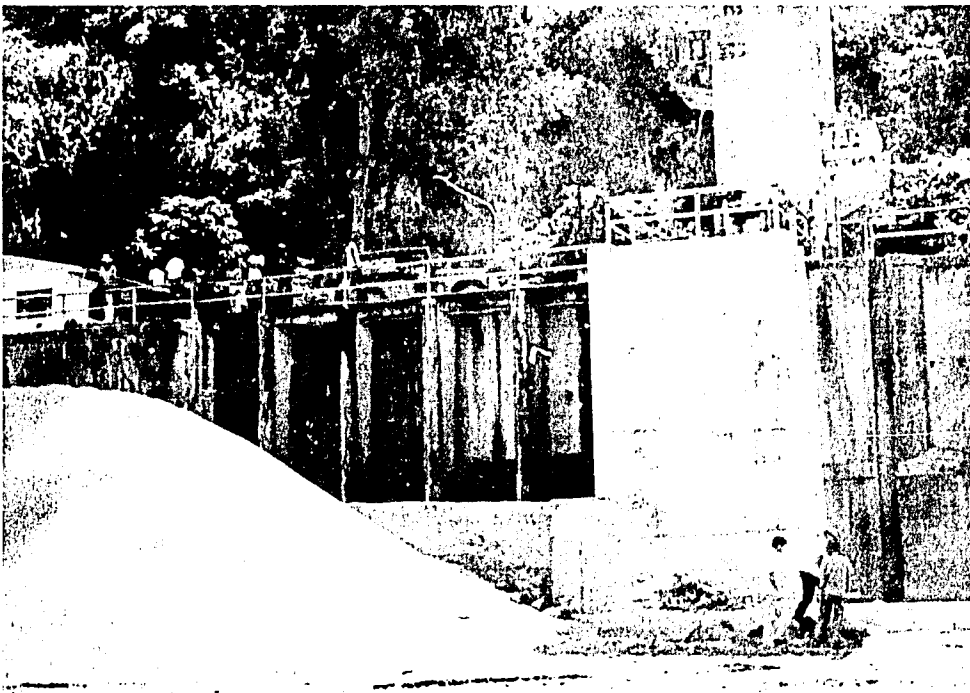
Photograph 6. - Headworks remaining at Santo Tomas River Diversion damsite.

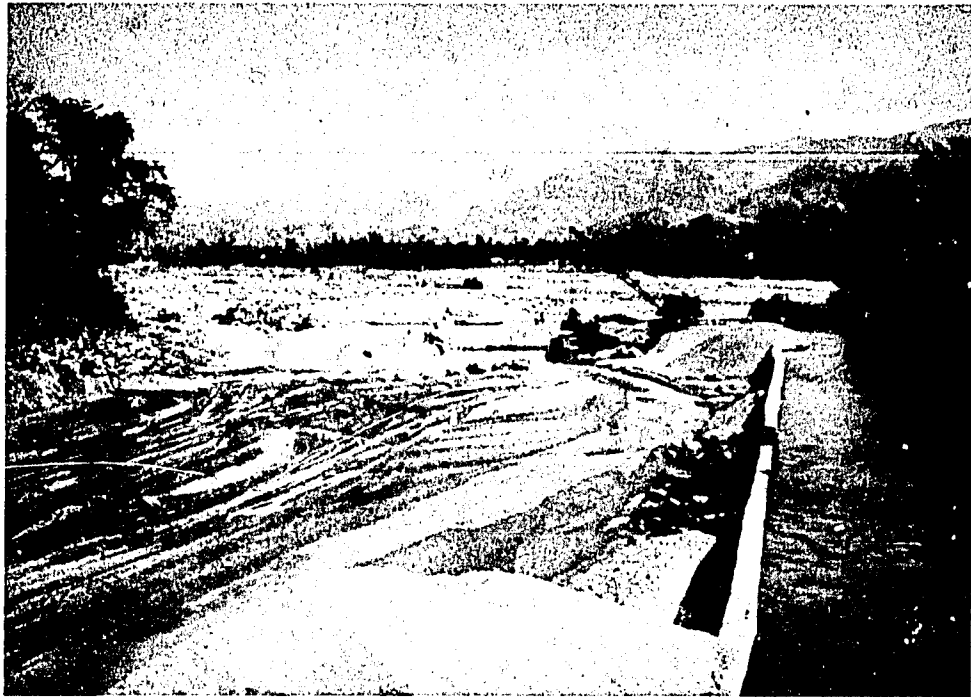
Photograph 7. - Upstream view from near headworks at Santo Tomas River Diversion damsite showing removal of sheet piling.

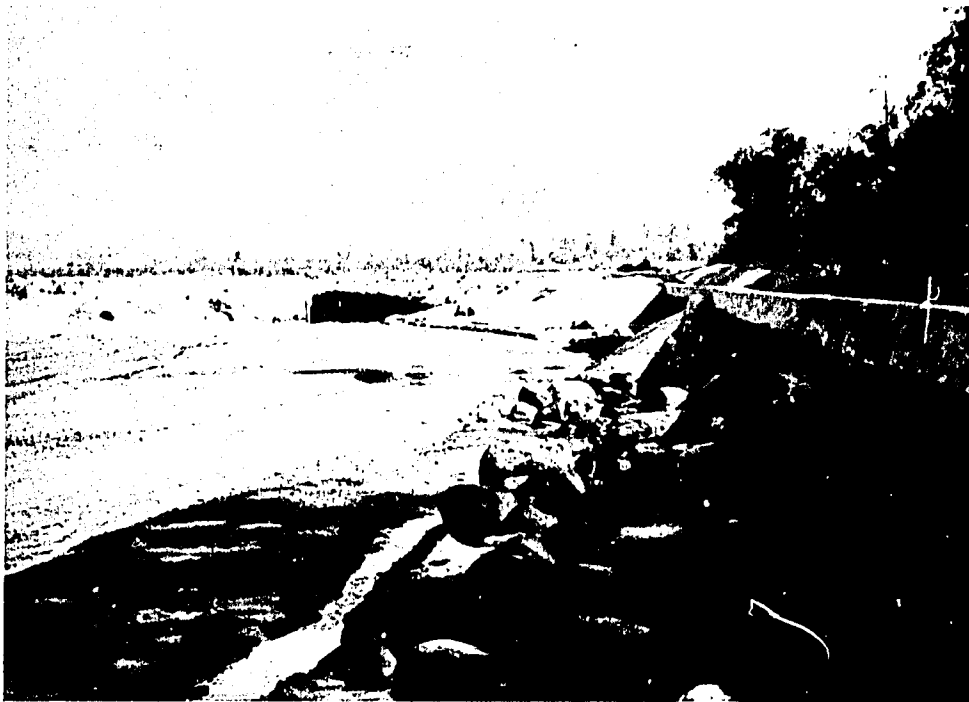
Photograph 8. - Upstream view from near headworks at Santo Tomas River Diversion damsite showing type of rock used for riprap along diversion wall.

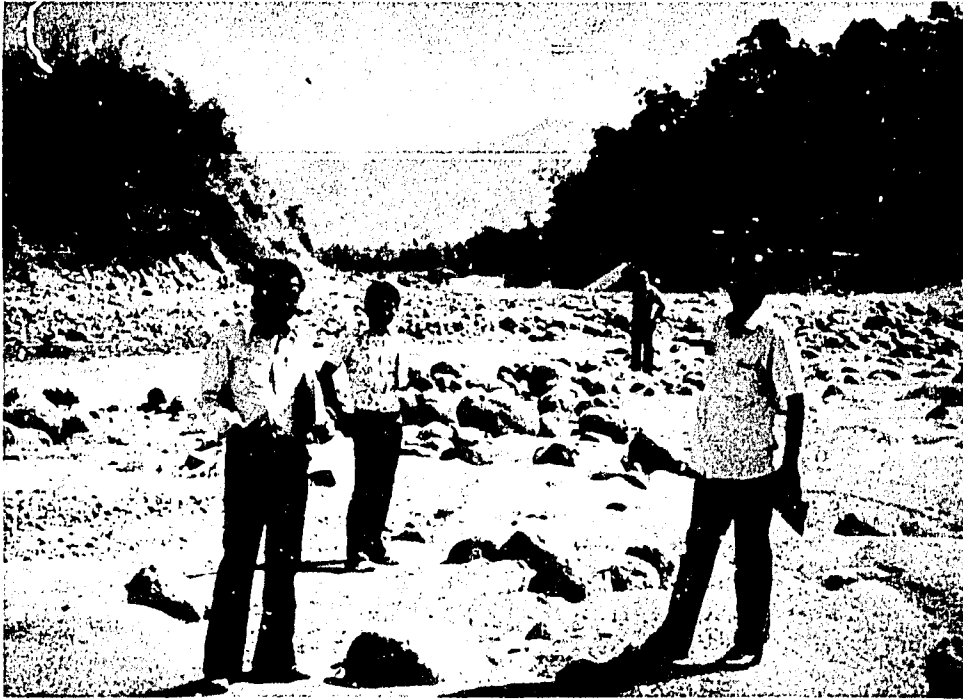
Photograph 11. - Looking upstream on Santo Tomas River showing rock in channel below old diversion damsite.

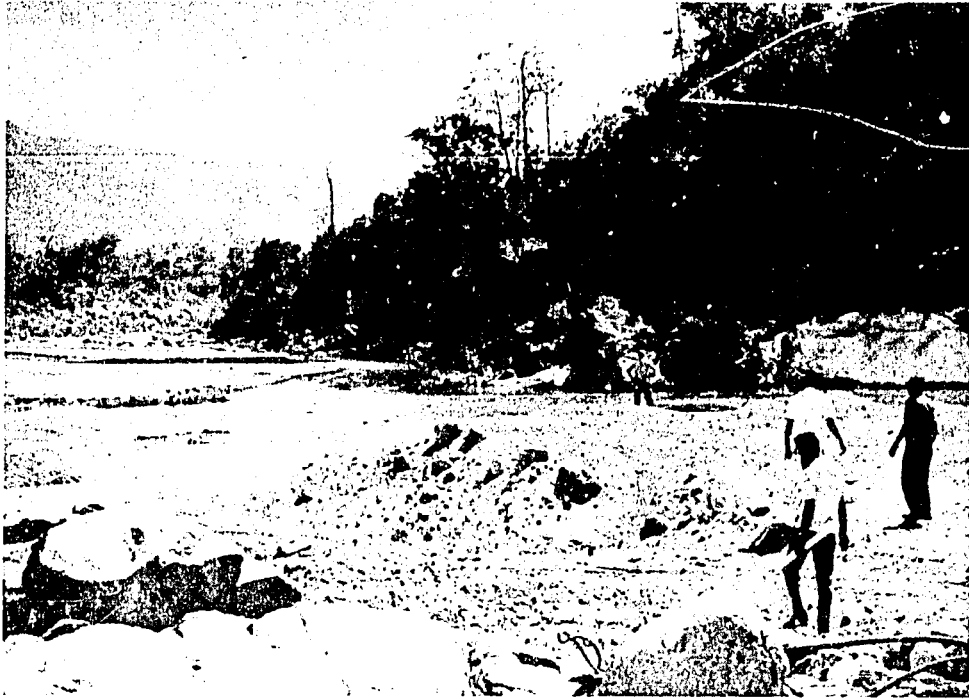
Photograph 15. - Looking across Santo Tomas River from right bank showing left bank abutment to a proposed diversion dam-site about 180 meters above the old diversion dam-site.

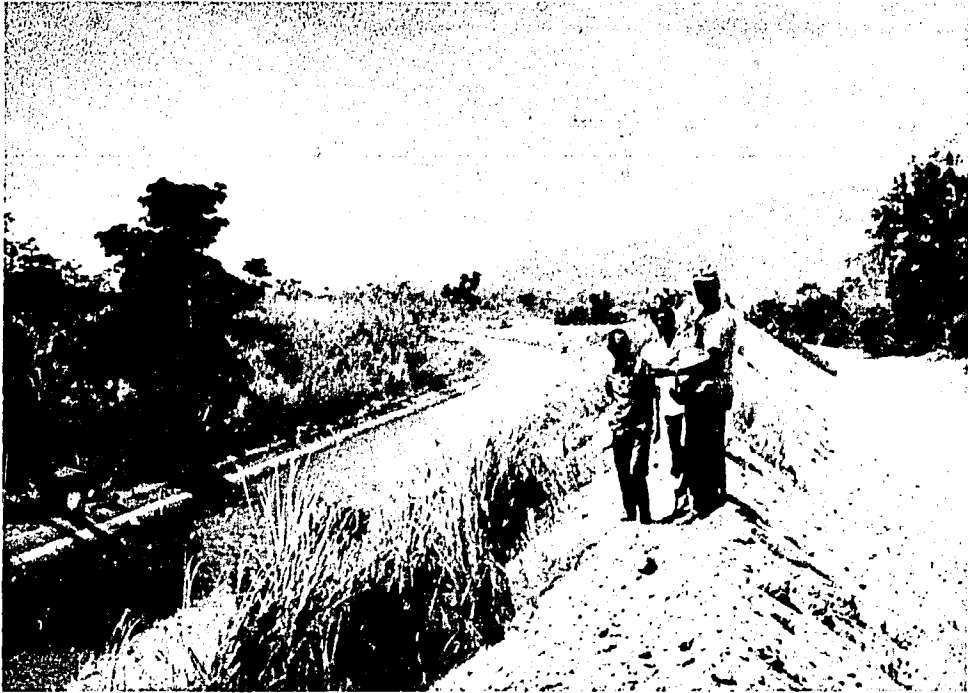
Photograph 17. - Canal below Santo Tomas River Diversion showing type of material cleaned from concrete-lined canal section.

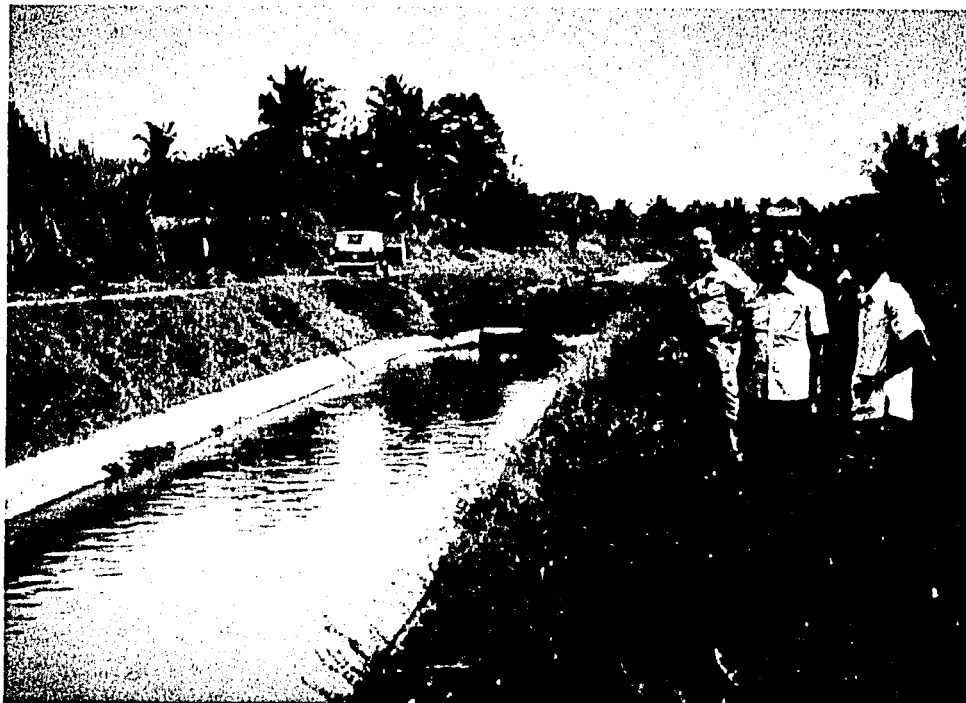
Photograph 23. - Looking down the canal below Marbel River Diversion Dam where bend in canal could be utilized to sluice bottom sediments back to the river.

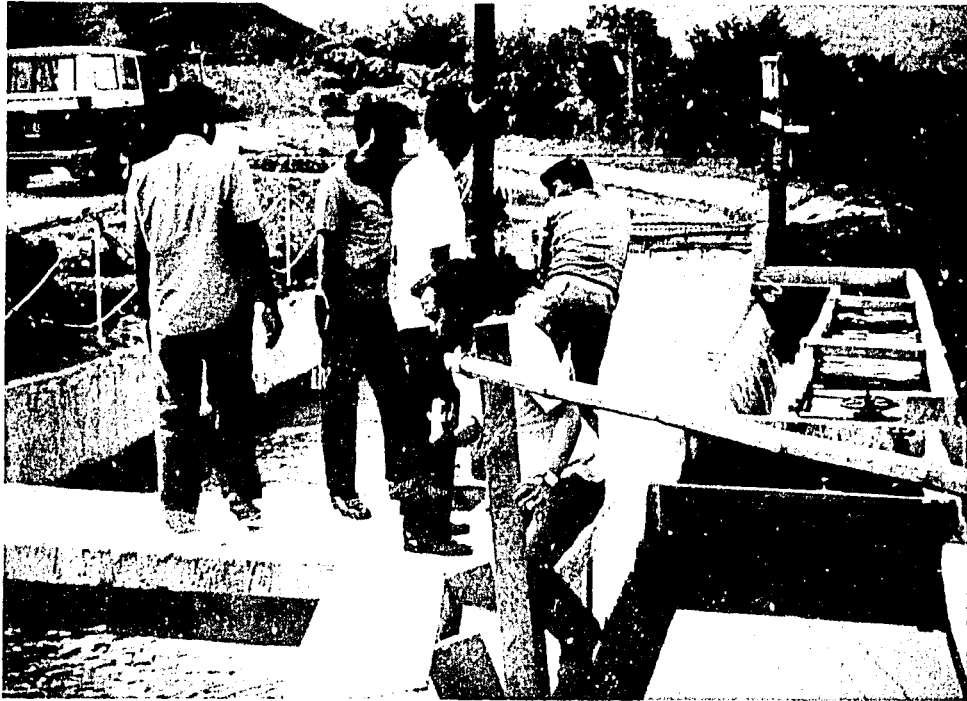
Photograph 24. - Looking up the canal several miles below Marbel River Diversion Dam at the powerplant intake structure showing the water being skimmed used for cooling

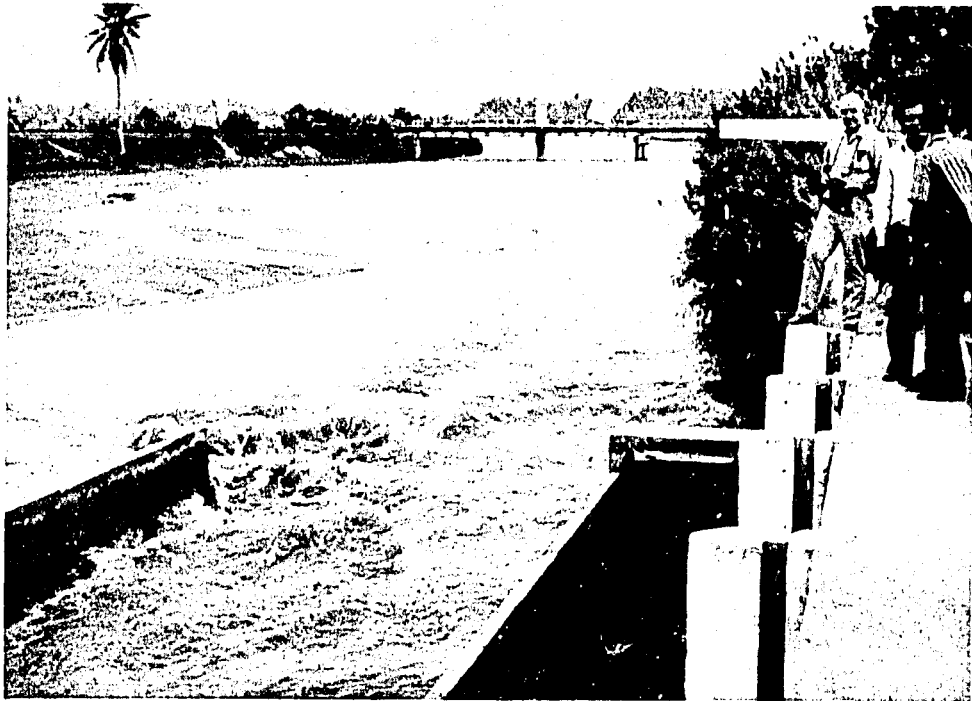
Banga River Diversion Dam. - The field inspection of the Banga River Diversion Dam was made on March 7, 1975 (photographs 26 through 31). This inspection was late in the day and we observed the sluicing operation. At this time of the year, the sediment is sluiced away from the headworks for 1 hour in the morning and 1 hour in the evening of every day. The present diversion dam is roughly shown on the attached sketch, figure 4. In this type of design, the intent is to skim the clear water into a boxed area in front of the canal headworks. The sediment is deposited in the river channel. The problem is that if the sediment accumulates too long it starts coming through slots near the top of the guidewalls. The slots provide most of the skimming action seen on photographs 26 and 27. This technique of skimming is adequate where the water can be ponded and sediments will drop out and the top water is diverted into a canal. When the river channel is filled with sediment upstream from the diversion dam, then the skimmers usually become ineffective because of the turbulence created at the skimmers. In this case, about all that can be done is to operate exactly as Banga River Diversion Dam with the periodic sluicing of the deposited sediments.

Photograph 29. - Upstream view during sluicing operations at the Banga River Diversion Dam.

One possible alleviation of the problem is shown on the sketch, figure 4. This technique has worked effectively in separating the water diverted into the canal from the water being sluiced. This is done by either one or a series of boxes or undersluices whereby the bottom water that carries the sediment load is sluiced down the

river. The top water is diverted into the canal. A temporary measure shown on figure 4 tries to duplicate this undersluice technique by placing some pipes parallel to the river along the front of the canal headworks. The slide gate at the upper end of this area would have to be removed. The downstream end of the pipes would have to be bulkheaded into the existing sluicing gate which is a slide gate. The bedload would be moved through the pipes on down the river. The amount of water lost by this action should be kept to the minimum required to move the bedload. The bulkhead at the lower end of the pipes would limit flows to the pipes and the slide gate would control the sluicing water. A problem with this type of structure would be the plugging of these pipes with trash and debris. Some kind of trashrack at the upstream end of the pipes may be required. The second phase for this temporary solution would be the addition of slots in the top of the pipes to capture the coarser suspended sediment. Another alternative would be to add another pipe to increase the capacity for bedload movement on down the river. This pipe would be shorter in length and placed beside the two shown in figure 4. The first step is to take out the stoplogs that are now in front of the headworks to the six slide gates. By removing these stoplogs the velocity of flow will be reduced thereby decreasing the transport and sediment inflow to the canal. The removal of stoplogs and installation of the two pipes should be tried before constructing any major modifications.

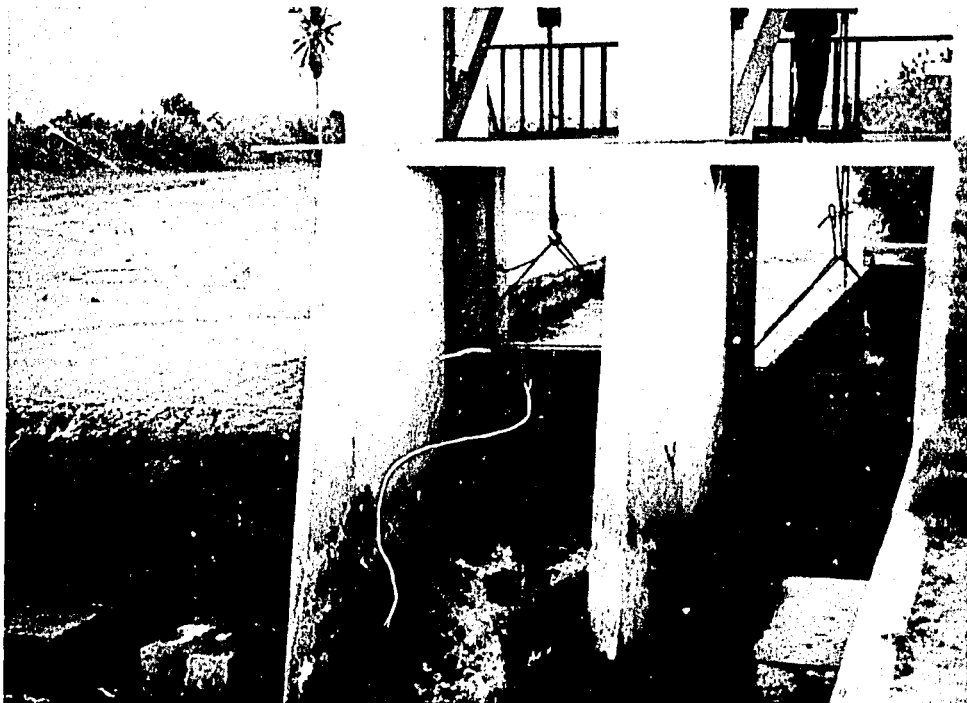
Photograph 30. - Looking upstream from below the sluice gates at Banga River Diversion Dam during a sluicing operation.

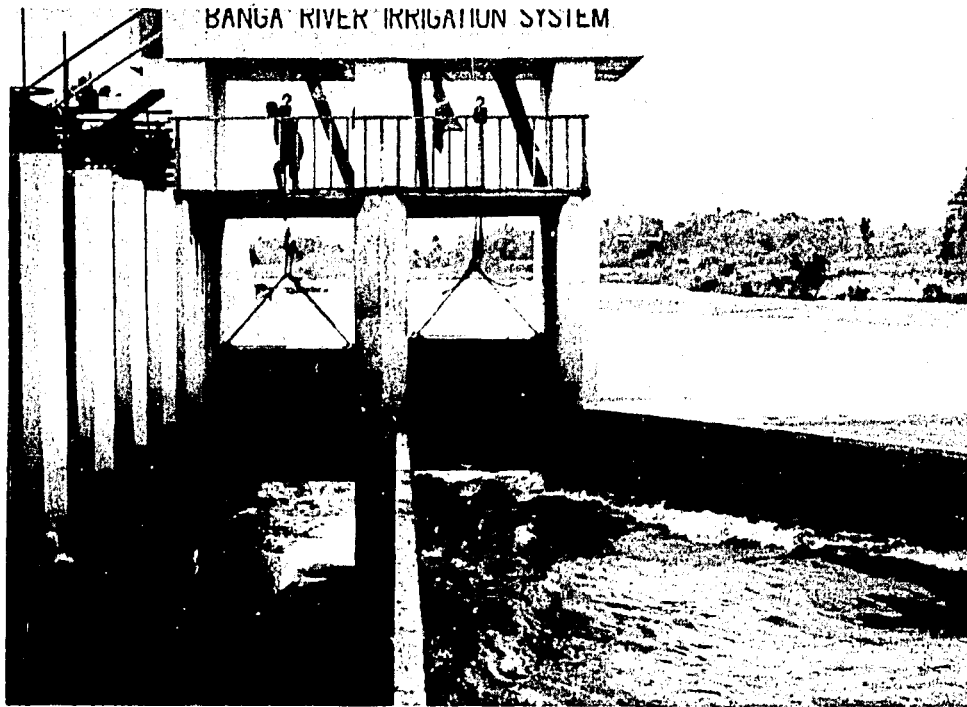
Photograph 31. - Downstream view of headworks and sluice gates at Banga River Diversion Dam during a sluicing operation.
