USAID HANDPUMP PROGRAM IN HAITI

WASH FIELD REPORT NO. 128

SEPTEMBER 1984

**Prepared for:
USAID Mission to the Republic of Haiti
Order of of Technical Direction No. 46**

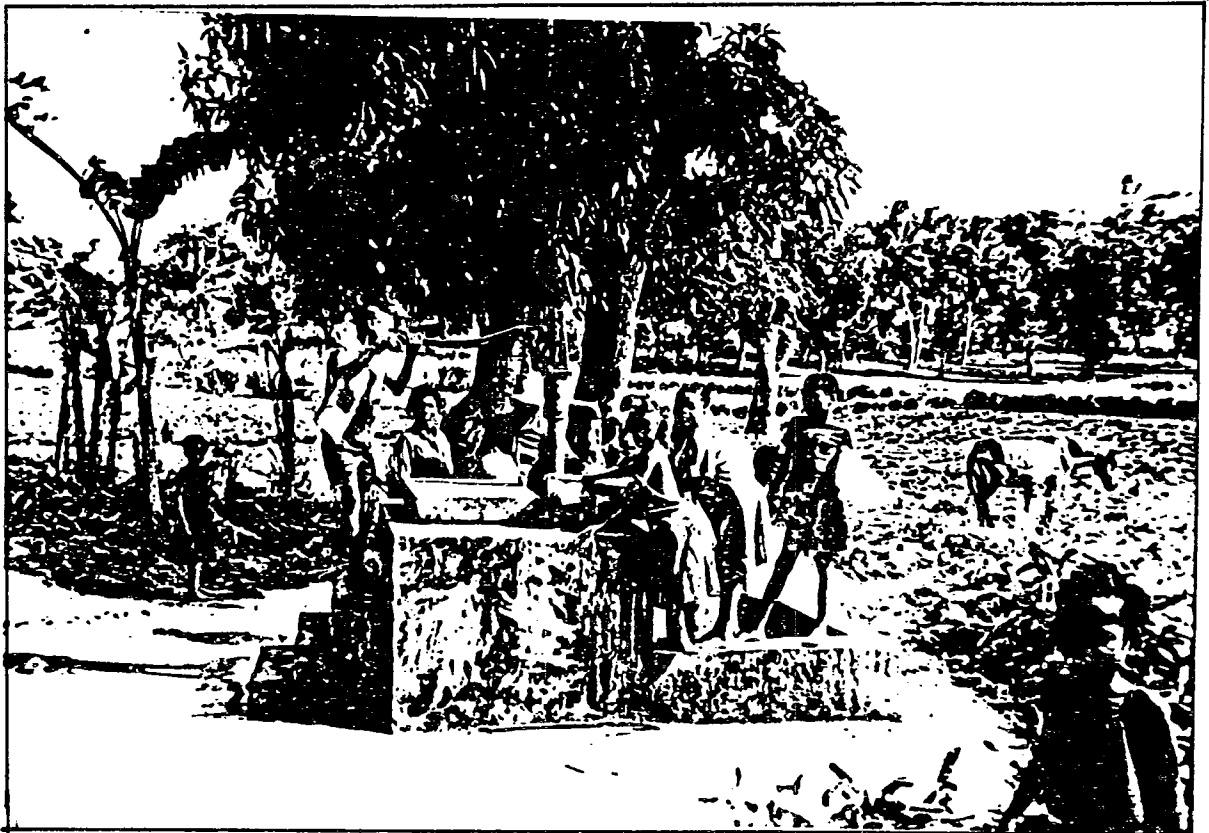
ILLUSTRATION 1

AID HANDPUMP INSTALLATION AT MADEQUE

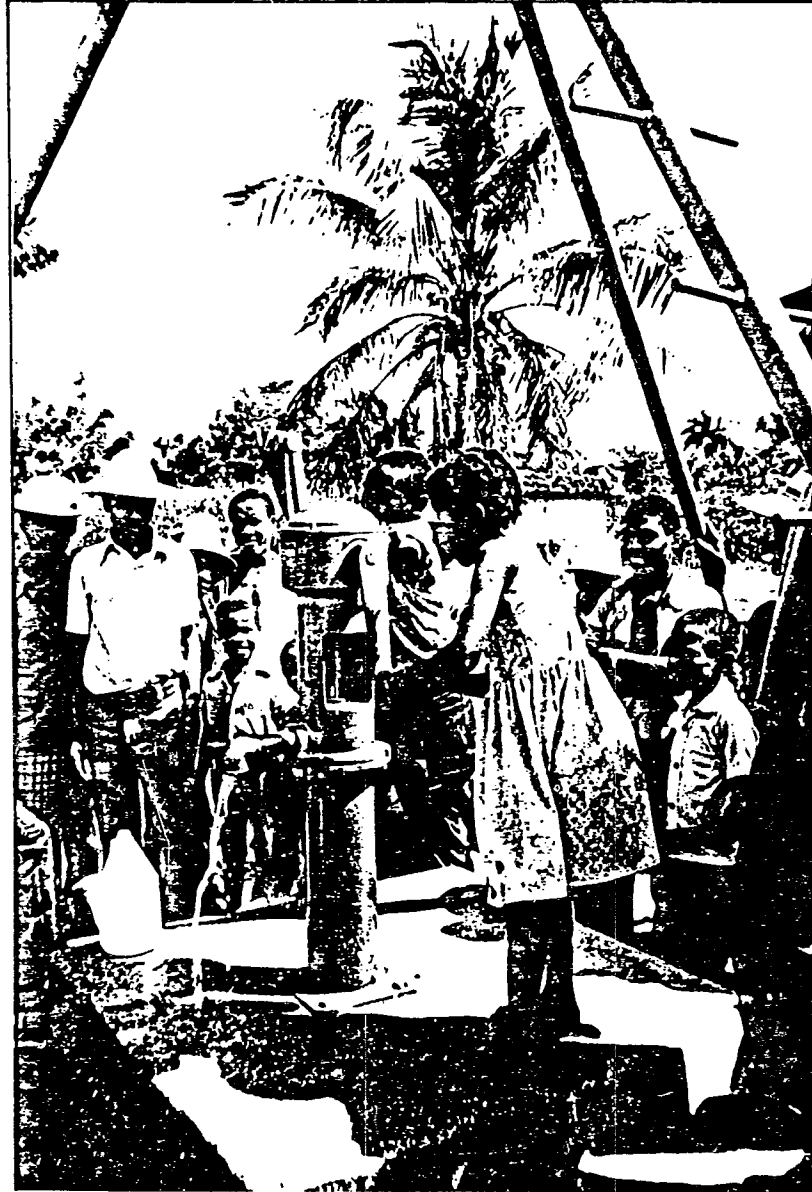
ILLUSTRATION 2

MONO HANDPUMP INSTALLATION AT MIZINE

Manufactured in England, the Mono handpump is a rotary progressive cavity-type pump driven by a hand-operated gearing mechanism. It was installed in December 1983 on a six-inch diameter tube well with a total depth of 71 feet and a static water level of 41 feet (see Illustration 2). After approximately two months of use, this pump failed (see Appendix H). It failed because moisture entered the gear box, and caused the shaft to rust and freeze inside the ring gear. This caused the ring gear to turn in reverse and thereby to unscrew the rotor rod joints connecting the gear box to the pump cylinder. This pump was repaired by removing all of the components in the gear box and refinishing the shaft in a lathe. After reassembly, grease was applied on the shaft to prevent further rusting. Four months after these repairs, the Mono handpump was still operating satisfactorily.

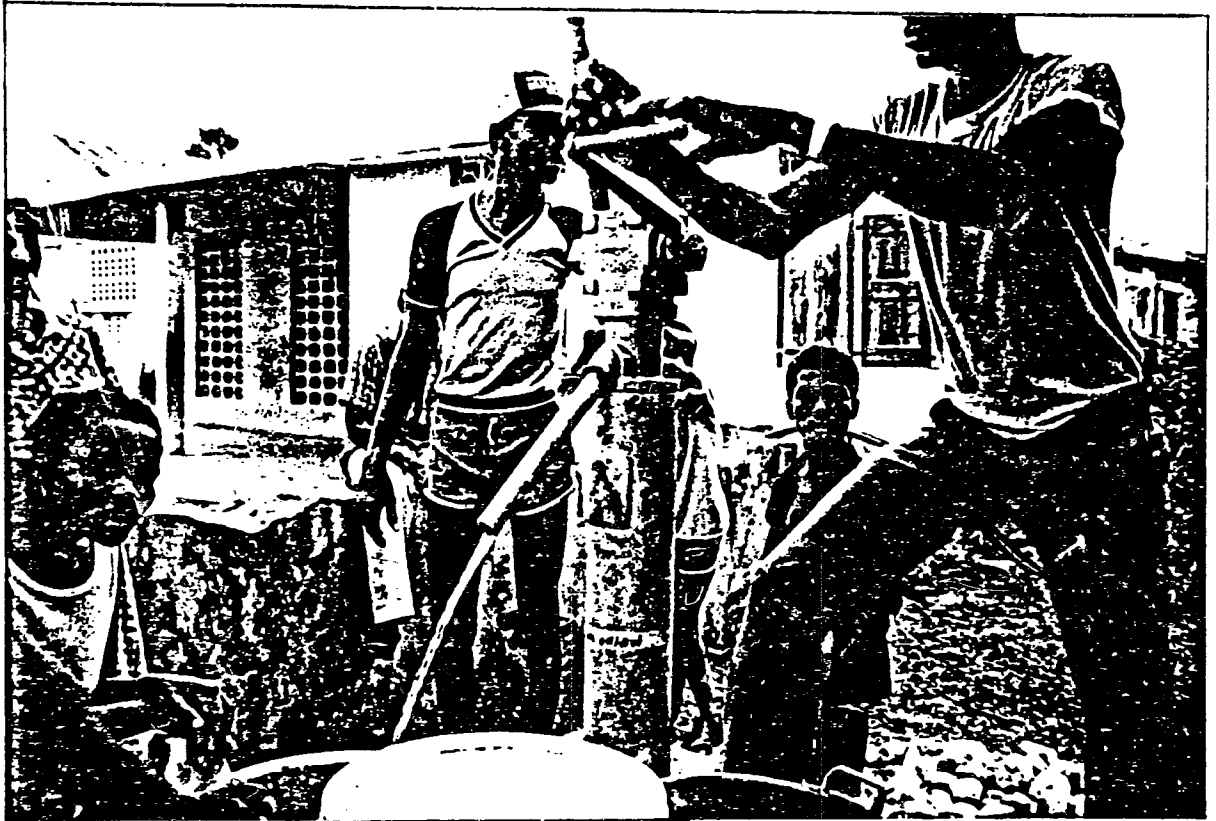
ILLUSTRATION 3

MOYNO HANDPUMP INSTALLATION AT KANS

progressive cavity-type pump driven by a hand-operated gearing mechanism. The Moyno handpump was installed in October 1983 on a six-inch diameter tube well with a total depth of 200 feet and a static water level of 121 feet (see Illustration 3). The pump operated for three hours and then failed. The rotor rod broke in the threaded section, that is screwed into the gear head.

The gear head was removed, the rotor rod rethreaded, and the gear head reinstalled. The pump operated for three days and failed again. The failure was again caused by rotor rod breakage at the same location. The entire handpump assembly (gear head, drop pipe, rotor rod, and rotor/stator assembly) was removed and all of the components inspected. The only anomaly found was that a standard "off-the-shelf" 2-inch to 1-1/4 inch bushing used to adapt 1-1/4 inch drop pipe to the 2-inch pipe threads in the gear head was faulty. The fault was that the central axis of the 1-1/4 inch threads instead of being coaxial with the 2-inch thread axis had an angular deviation of approximately five degrees. This faulty reducing bushing was replaced, the rotor rod rethreaded, and the handpump assembly reinstalled.

The handpump operated satisfactorily for three more days and failed again. This time the cause of failure was found to be rotor rod breakage in the threaded section that is screwed into the pump rotor. The rotor rod was removed, the gear head was reinstalled and the handpump was left inoperable until it was replaced in January 1984 with a Mono handpump.

After repeated failures, the Moyno handpump was removed and replaced with a Mono handpump. Because the replacement handpump had internal components identical to the first Mono handpump, which had been installed at another site and had failed, it was anticipated that this pump would also fail. An engineer associated with the Atelier Ecole was informed about the types of breakdown to expect and instructed in suitable repair techniques. The pump was installed without incident, operated for approximately two months, and failed in the mode predicted. The engineer from the Atelier Ecole was able to get the handpump repaired and back in service in a short time. The Mono company has subsequently furnished additional component parts with a modified design which have been sent to the AID Mission in Haiti.

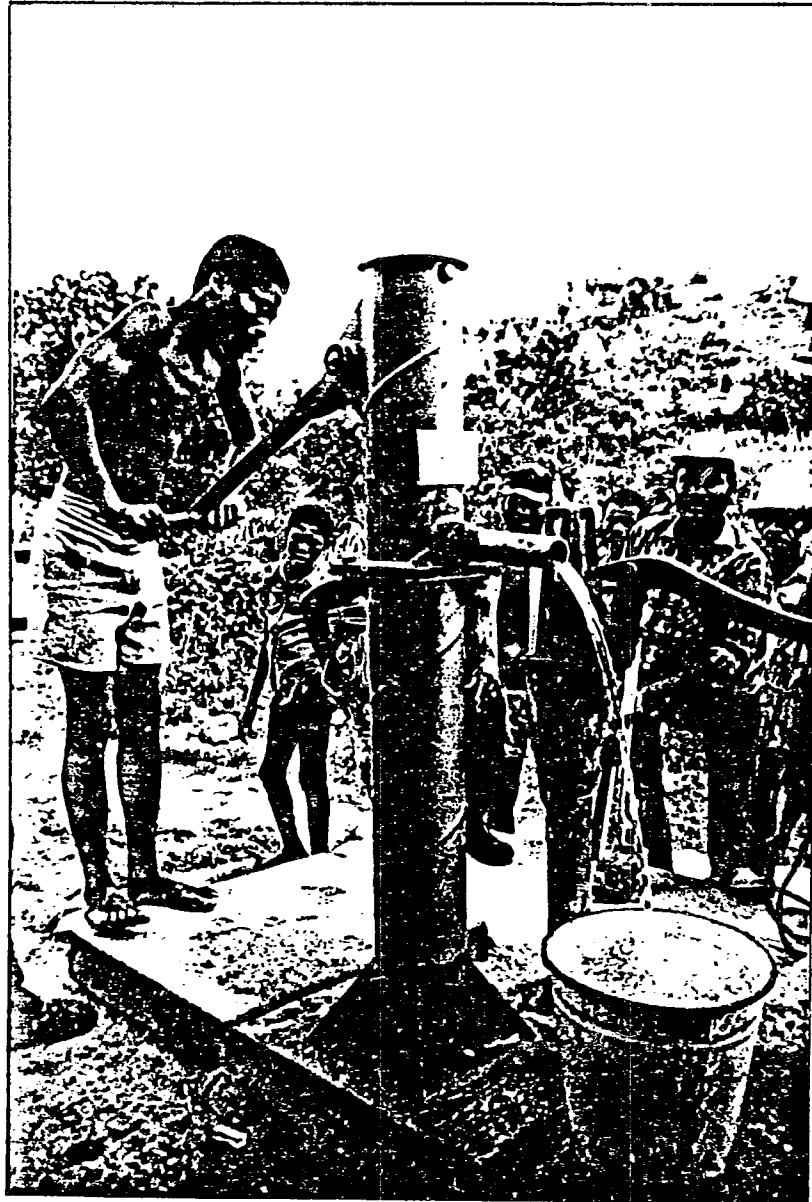
ILLUSTRATION 4

MALAWI HANDPUMP INSTALLATION AT TAIWAN

This handpump, manufactured in Africa, consisted of the above-ground structure only. This mechanism was designed without an articulated fulcrum. This causes the point of attachment to the drop rod to be translated laterally about two inches as it swings through its arc. The Malawi pump was installed in October 1983 on a dug well with a total depth of 55 feet and a static water level of 41 feet (see Illustration 4). The installation was made using a three-inch diameter AID-design pump cylinder assembly manufactured in the Dominican Republic. This handpump had three failures in five months of operation. All of the failures were caused by breakage in the topmost threaded section of the drop rod that is screwed into the handpump rod end.

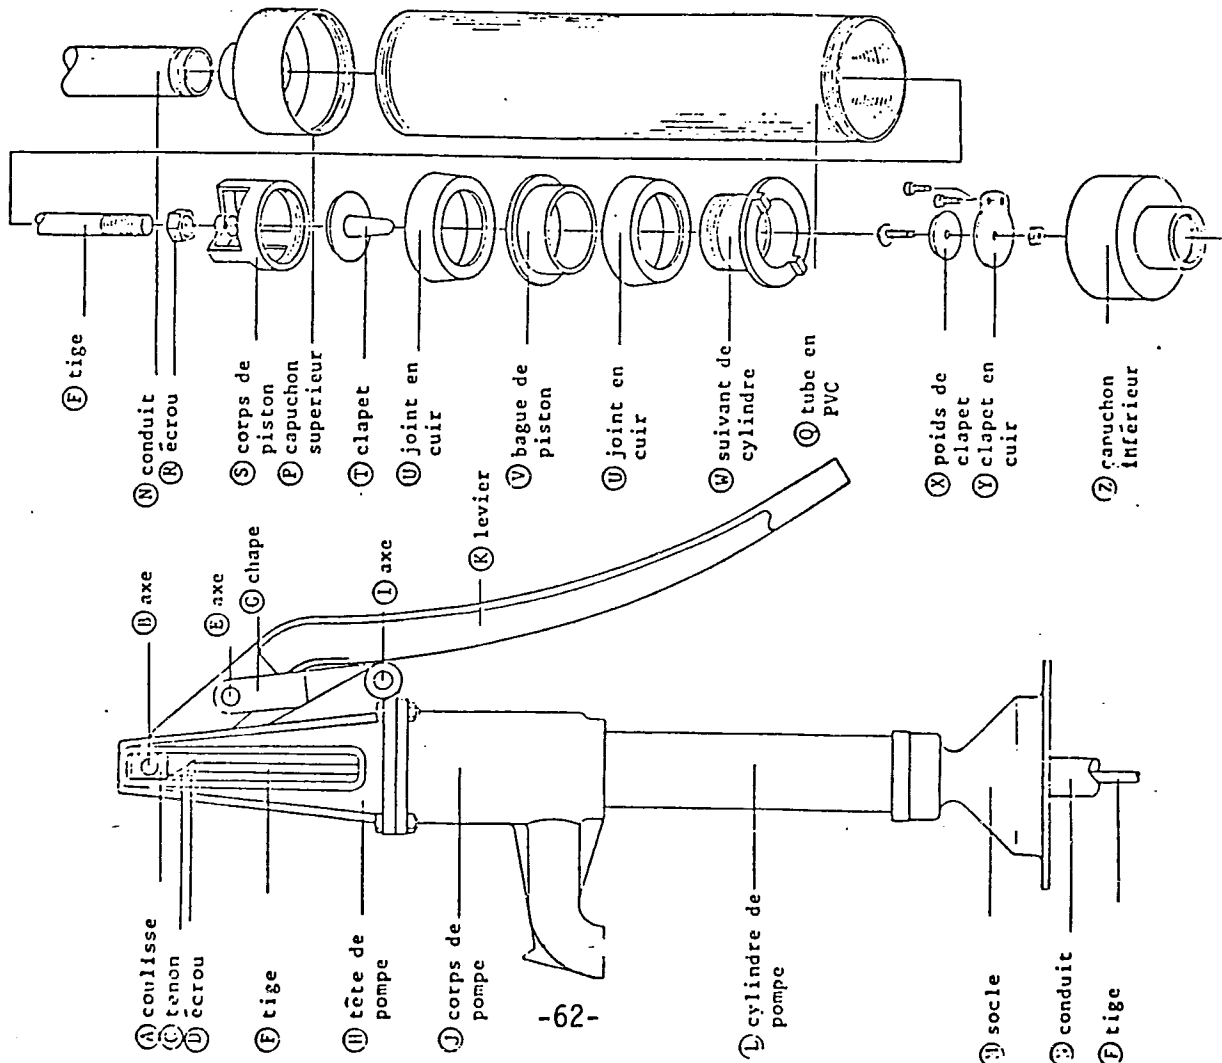
Contrôle d'Assemblage

date: 8/1/83
nom: NABAN DUJ
N° de pompe:

pièce	observations
A	OK
B	X
C	NO KEYS... PIV FLAILED ON ONE END
D	OK
E	OK
F	OK
G	OK
H	CLAVIS CRACKED LEFT SIDE
I	BUSHINGS LOOSE IN CAP
J	OK
K	OK
L	OK
M	OK
N	BASE LOOSE
P	
Q	
R	
S	
T	NOT CHECKED
U	
V	
W	
X	
Y	
Z
