STATUS OF THE AID TYPE HANDPUMP IN THE DOMINICAN REPUBLIC

WASH FIELD REPORT NO. 98

AUGUST 1983

Prepared for:
USAID Mission to the Dominican Republic
Order of Technical Direction No. 143

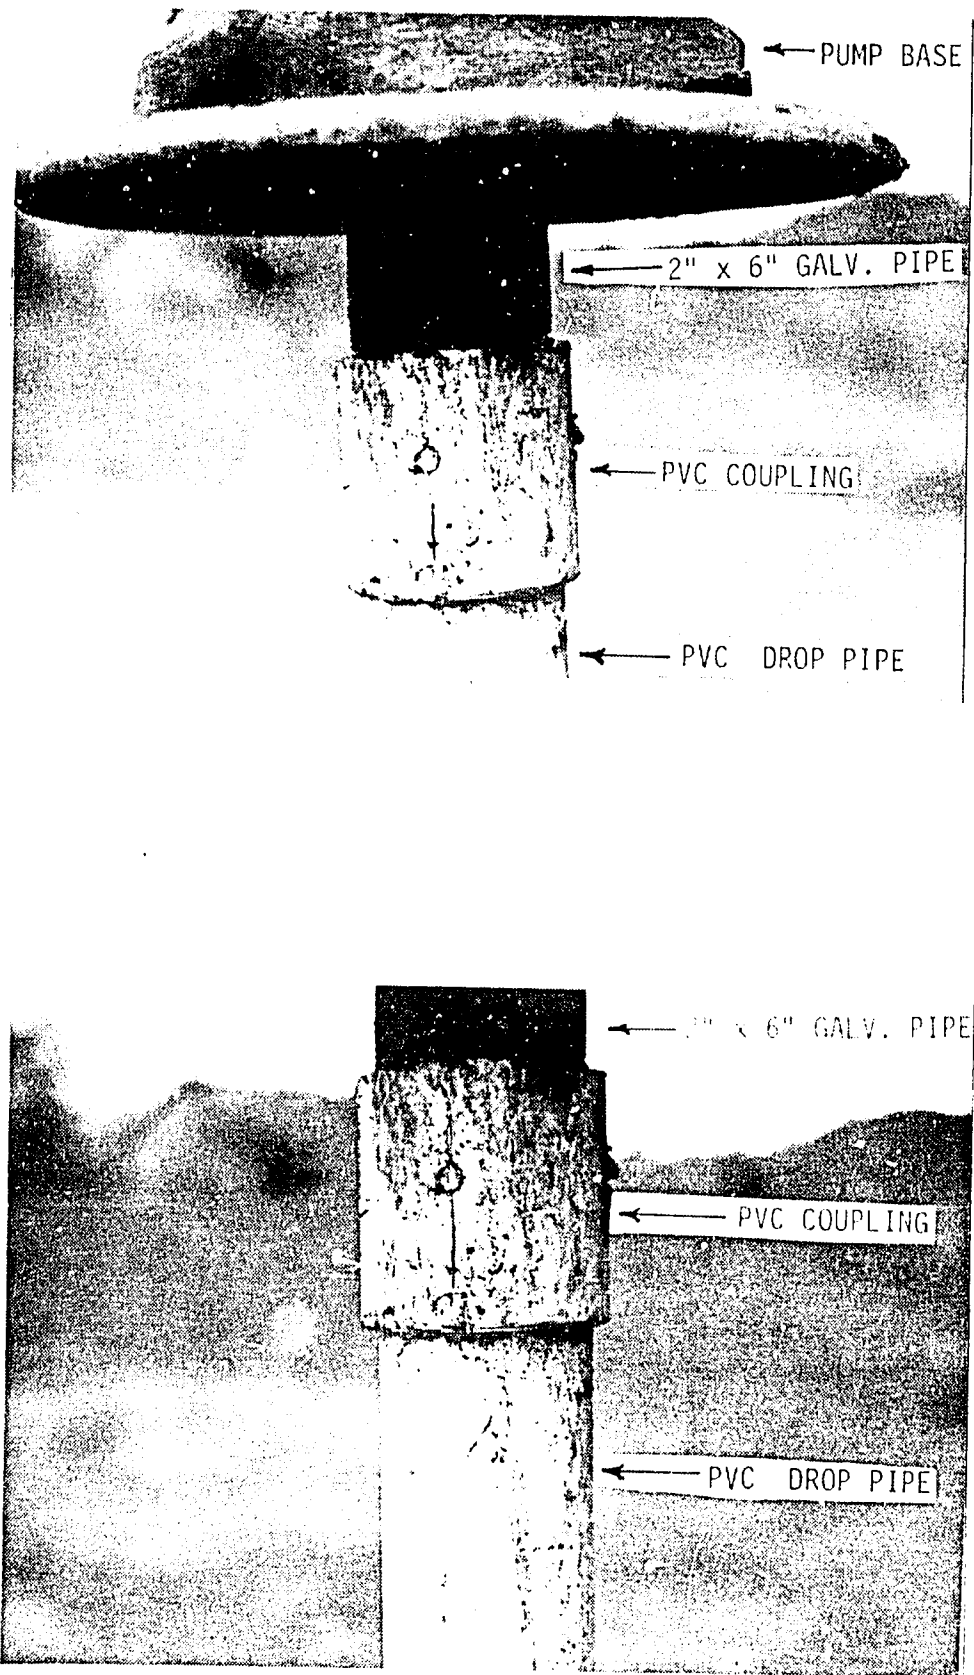
Figure 2

- o Problem Area 3 (15 percent) - Separation of the PVC occurred at the joint between the drop pipe and the PVC male-threaded adaptor in six cases. When inspected, little, if any, PVC solvent was found sticking to the internal surface of the PVC adaptor (Figure 2). In five cases the drop pipe had to be lifted out of the well by bonding another length of PVC pipe to it. The pipe ends became covered with new solvent in this process, so their surfaces could not be inspected. In one case it was possible to lift the PVC pipe out of the well with a rope. This allowed a better inspection since the pipe surface was not covered by new solvent.

HAND PUMP BASE AND DROP PIPE
CONNECTION ASSEMBLY

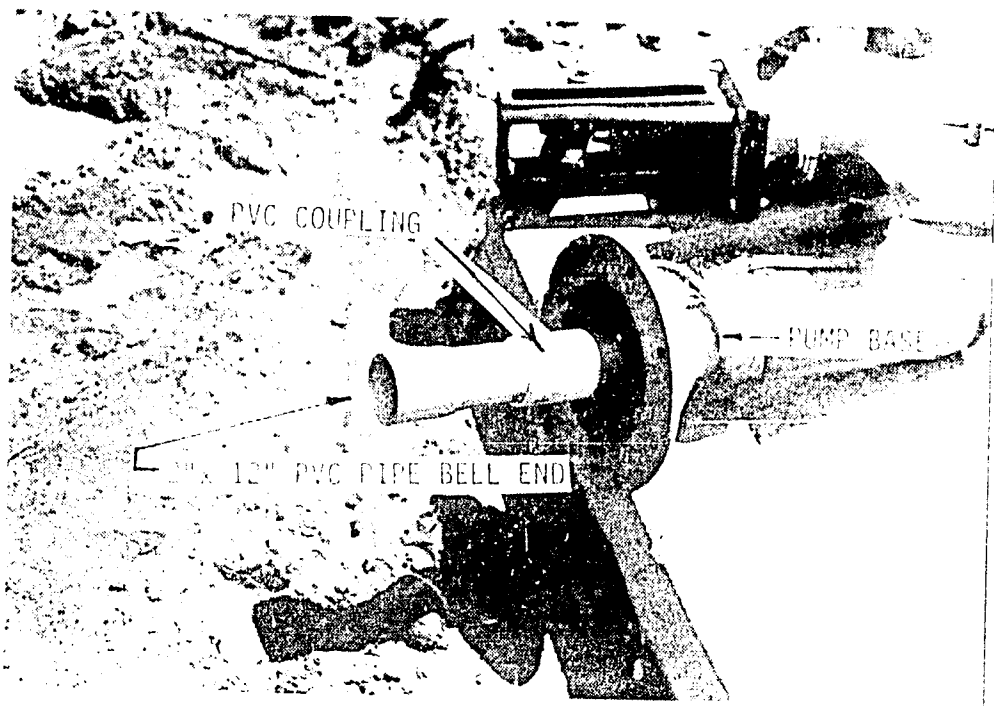
Figure 3

PVC DROP PIPE CONNECTION GLUED 24 HRS. PRIOR PUMP INSTALLATION
TO PREVENT PVC DROP PIPE SEPARATION

- o To prevent separation of the PVC pipe assembly at the handpump base, SESPAS could continue to use the 2-inch diameter by 12-inch long bell-ended PVC pipe section between the 2-inch PVC coupling and the PVC drop pipe assembly (Figure 3). This seemed to have reduced the frequency of pipe separation at this location. However, field data are not sufficient to guarantee the success of this approach, and it should not be expected to totally correct this problem (i.e. while it can be expected to reduce the number of early drop pipe failures it cannot be expected to eliminate them).

- o The remaining 640 handpumps yet to be manufactured could be of the modified AID design. However, the PVC foot valve should be replaced with a locally available 1.25-inch brass foot valve (a Clayton Mark or equal model which is available in Dominican Republic hardware stores for approximately \$8.00). Implementation of this change would require purchasing the brass foot valve and a 2 by 1.25-inch reducer.
- o To prevent separation of the PVC drop pipe assembly at the handpump base, the SESPAS installation and maintenance crews have used a 2-inch diameter by 12-inch long bell-ended section of PVC pipe between the 2-inch PVC adaptor and the PVC drop pipe assembly (Figure 3). The 2-inch PVC adaptor and the 12-inch section of PVC pipe are glued 24 hours prior to handpump

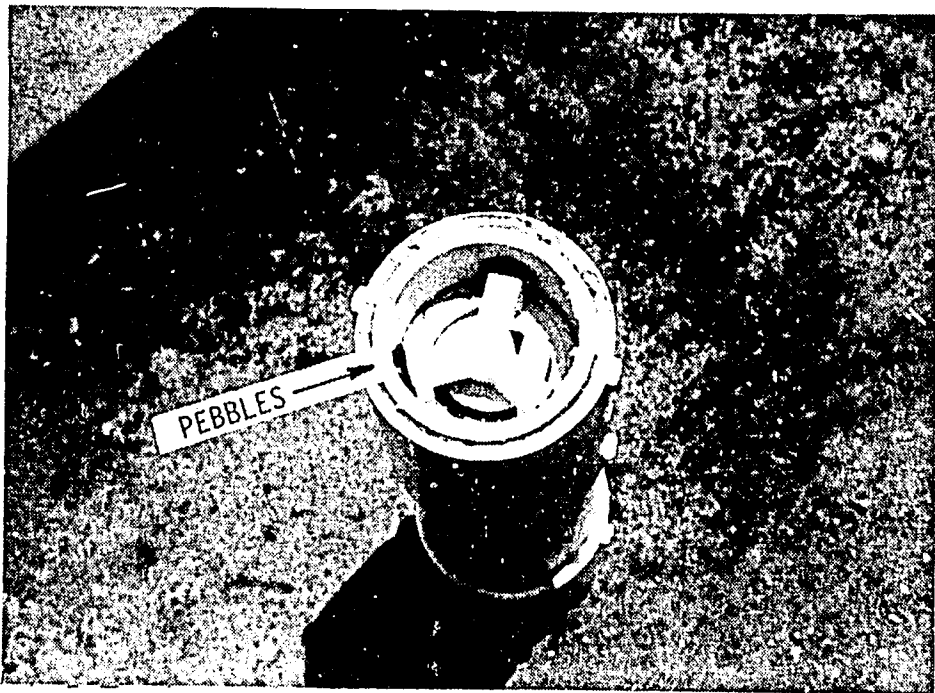
- o Problem Area 1 (42.5 percent) - Foreign materials such as pebbles, stones, sticks and even a "C" battery were found in the drop pipes as a result of an oversized drop rod opening on the pump head, improper installation techniques and/or deliberately inserting them through the spout (see Appendix G). The foreign matter became lodged between the plunger poppet valve or the foot valve poppet and seat, preventing the poppet from properly closing. Since no similar field investigation has been conducted on the "conventional" pumps that are currently in the field it cannot be said that this is a problem unique to the "modified" pump. However, the frequency of failures and short length of time between installation and failure are unusual deviations from other experiences with handpump installations in the Dominican Republic and elsewhere.

- FOREIGN MATTER -

Pebbles lodged between poppet valve and its seat causing leakage of the water column

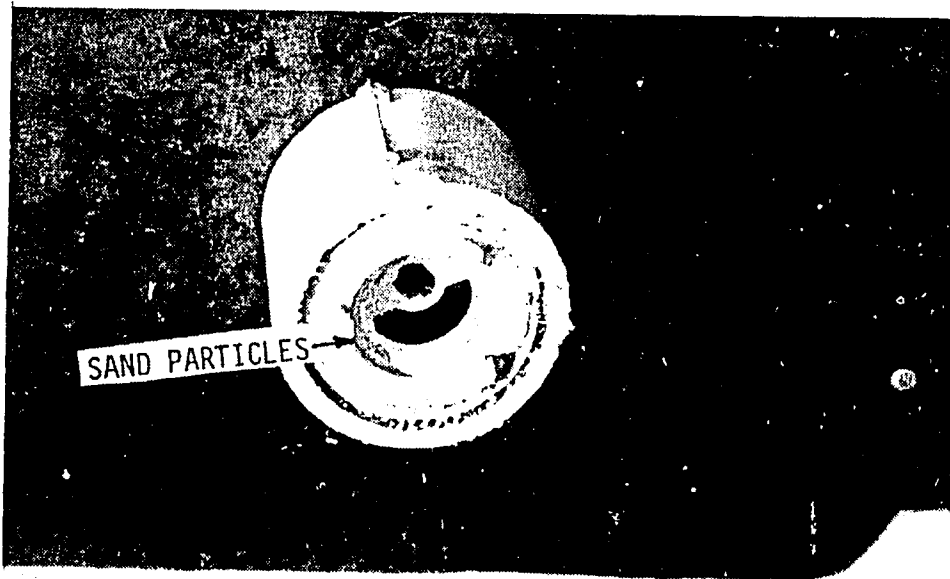
- FOREIGN MATTER -

Sand particles interfering with the proper operation of the PVC foot valve causing leakage of the water column

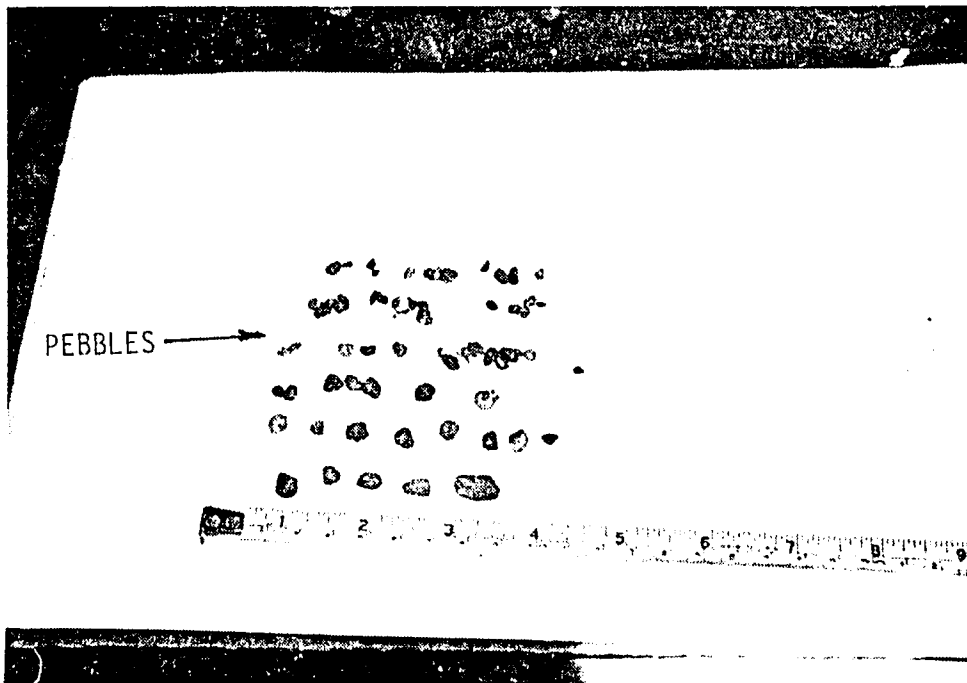
- FOREIGN MATTER -

Pebbles found in a PVC foot valve

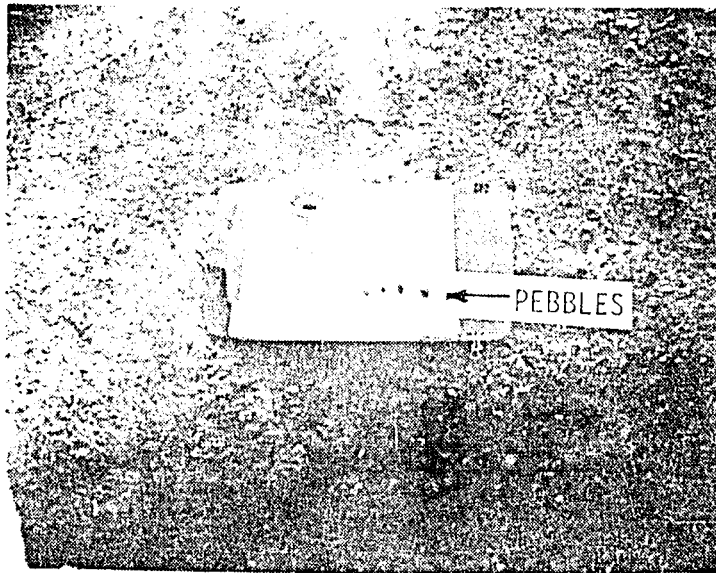
- FOREIGN MATTER -
Pebbles lodged between poppet valve and the seat of this PVC foot valve causing leakage of the water column

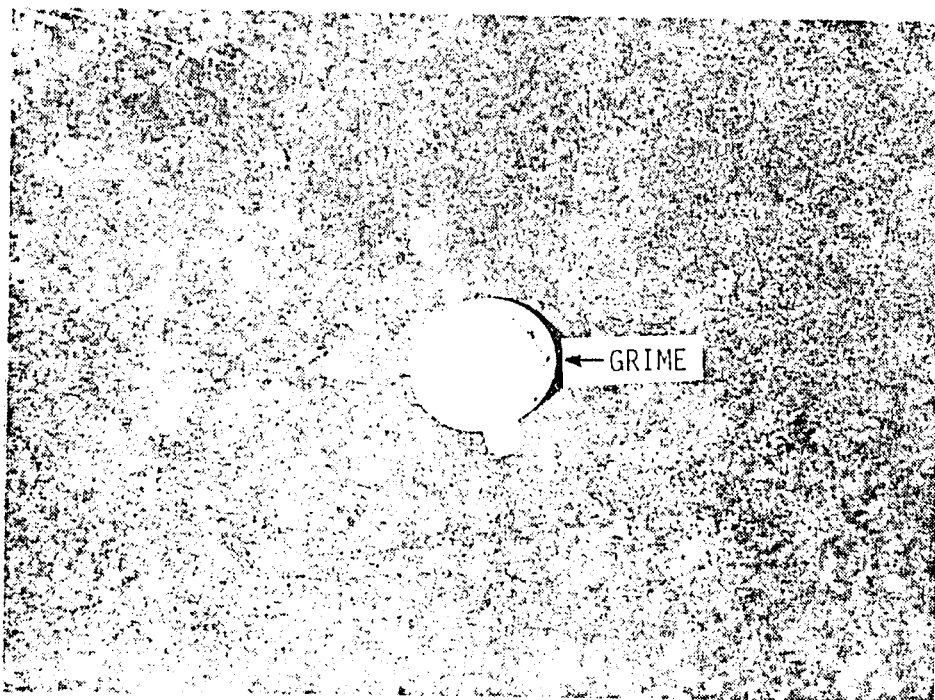
- FOREIGN MATTER -
Grime on the PVC poppet valve seal causing leakage of the column of water

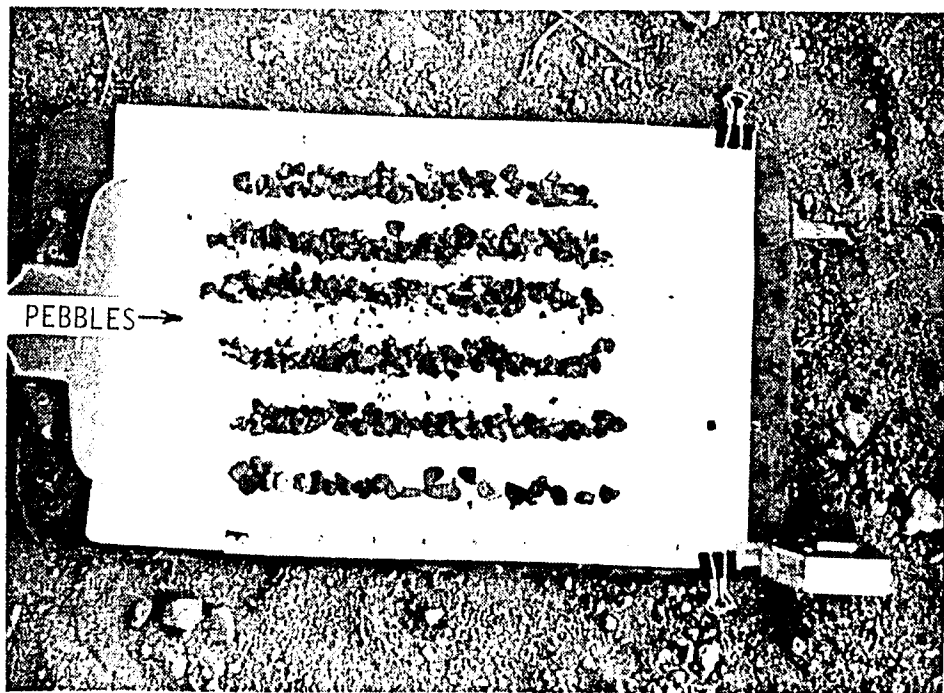
- FOREIGN MATTER -

Pebbles found in the above plunger

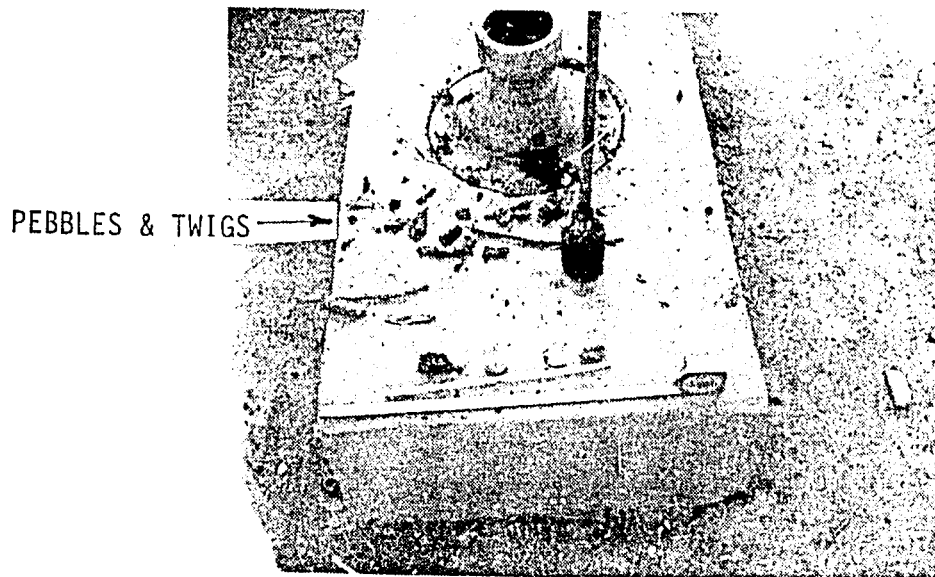
- FOREIGN MATTER -
Pebbles and twigs lodged between poppet valve
and its seat causing leakage of the water
column

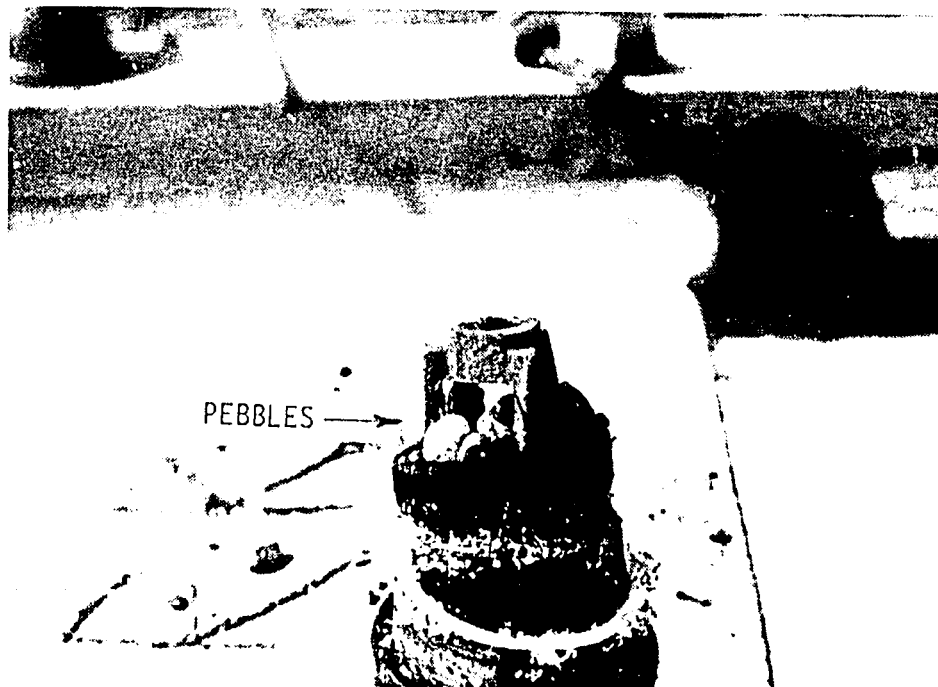
- FOREIGN MATTER -
Closer view of the above plunger

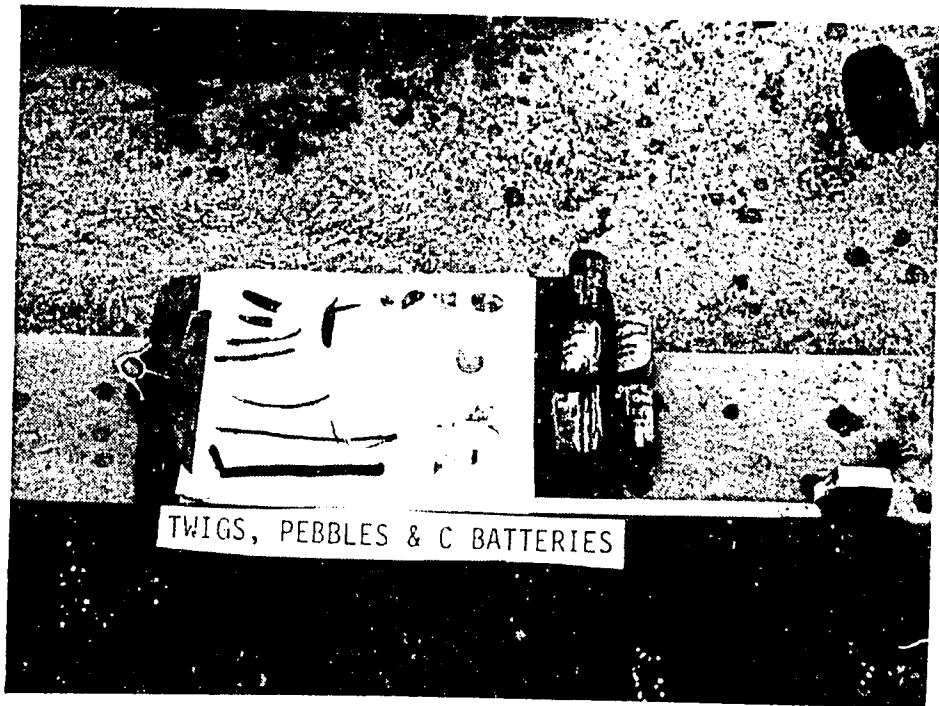
- FOREIGN MATTER -

The above items were found in the plunger,
"C" batteries were resting on the plunger

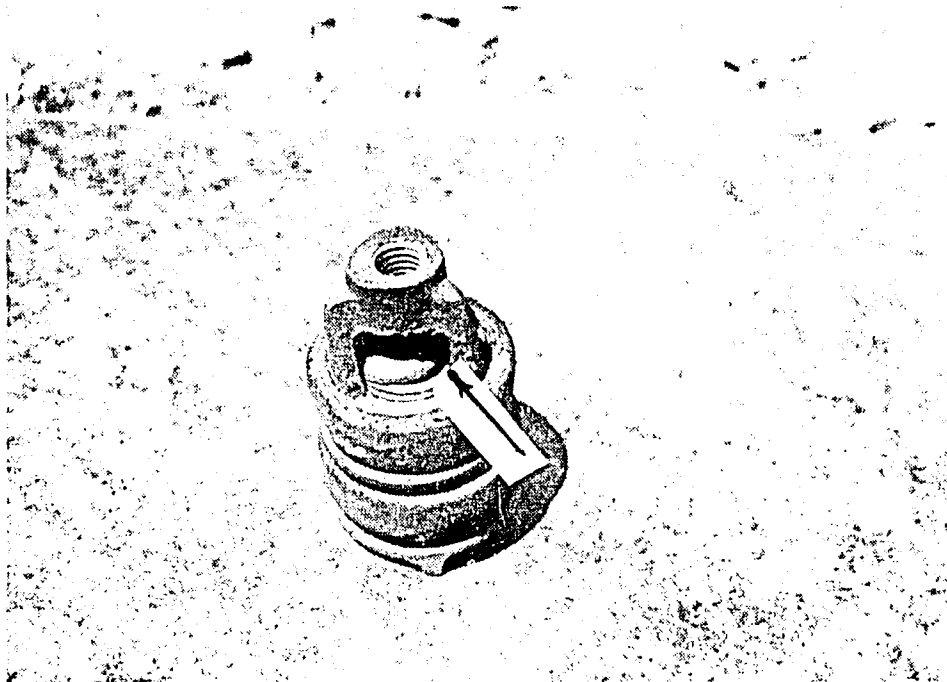
- o Problem Area 2 (15 percent) - Due to a defective plunger poppet valve, failures occurred when the valve got stuck between two legs of the cage or did not completely cover the valve seat. This is an apparent design problem.

- PLUNGER POPPET VALVE FAILURE -
Plunger poppet valve not covering the valve
seat thus causing loss of pumping efficiency

It is recommended that the plunger poppet valve failure be corrected by increasing the diameter of the top of the poppet as well as increasing the diameter and length of its shaft, to provide a better seal and to prevent it from getting stuck between two legs of the plunger cage. Additional poppet valves should be manufactured to replace those in the field.

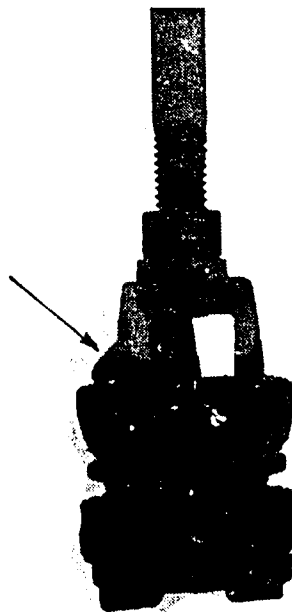
- PLUNGER POPPET VALVE FAILURE -
Plunger poppet got stuck between two cage
legs preventing lifting of the water column

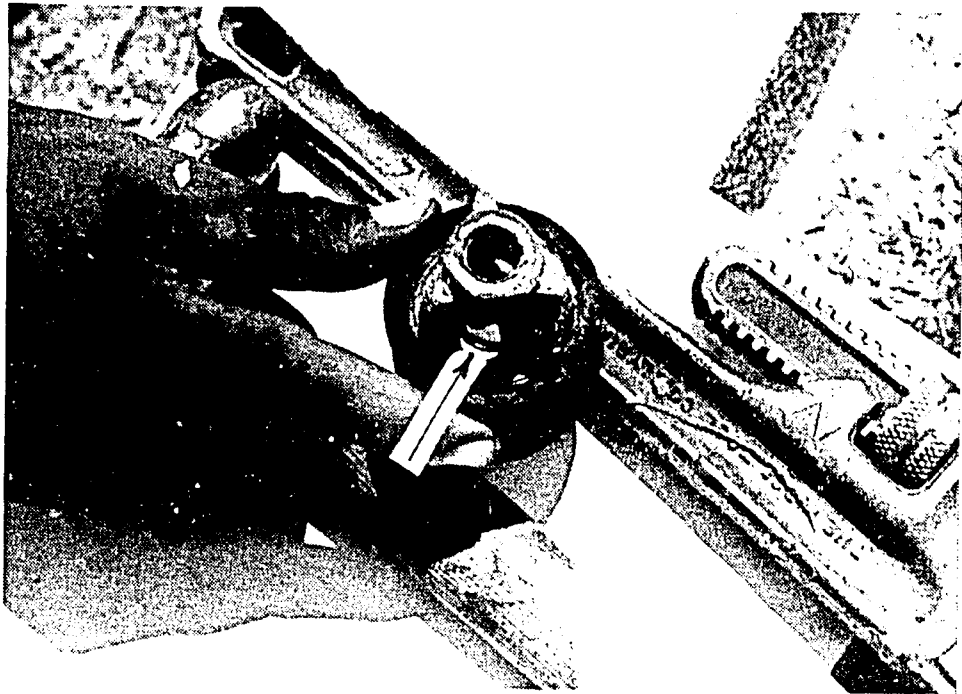
- PLUNGER POPPET VALVE FAILURE -
Plunger poppet valve not covering the valve
seat thus causing loss of efficiency

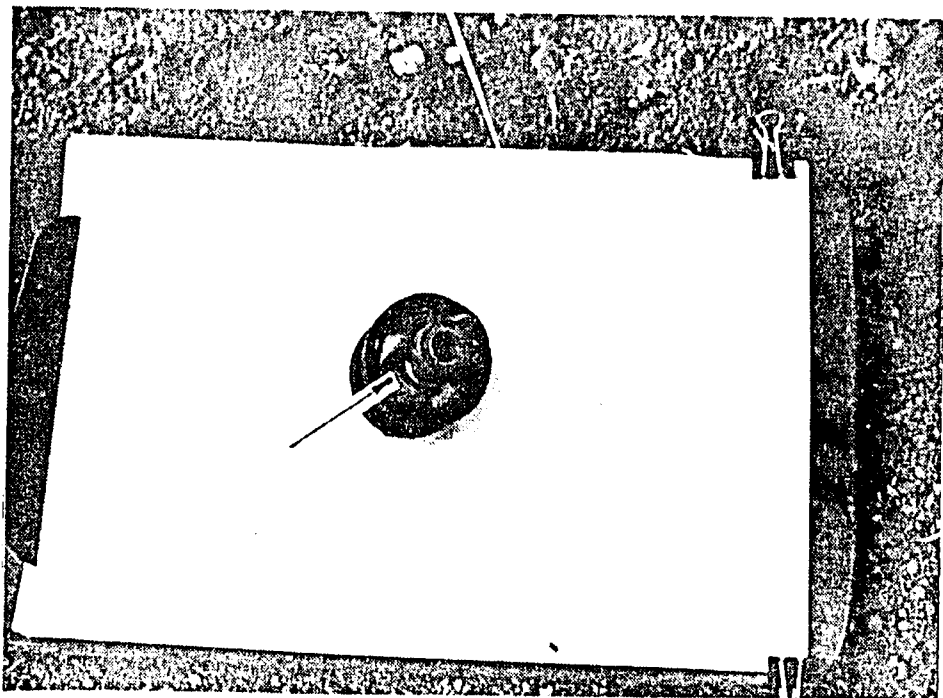
- PLUNGER POPPET VALVE FAILURE -
Another site with the above problem

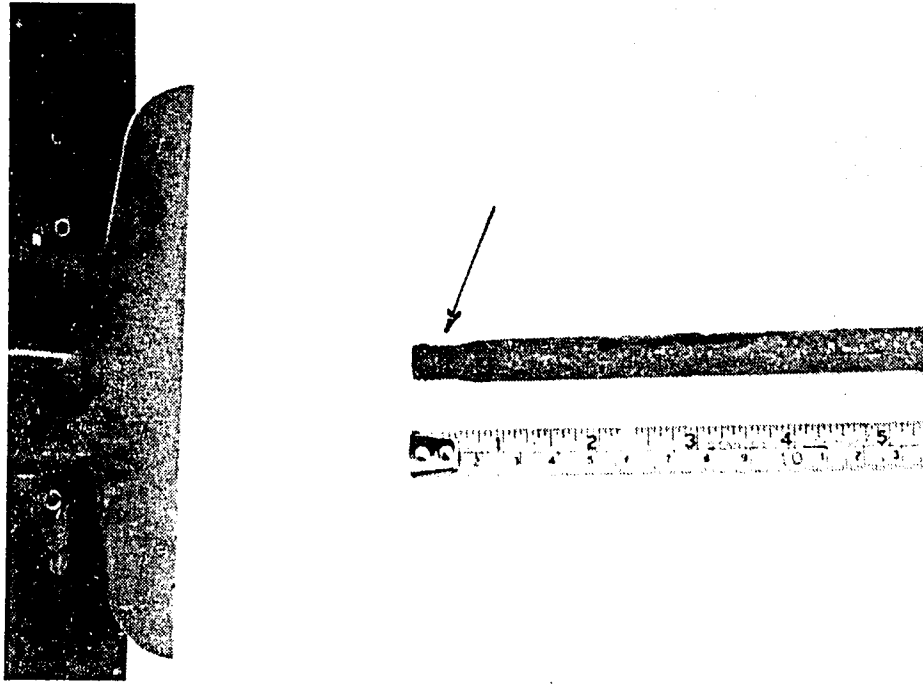
- o Problem Area 4 (15 percent) - Plunger rod separation was found in six cases. In two cases, the plunger rod had separated from the rod end. In three cases, the separation was at a coupling between rods. In one case, the separation was at the plunger assembly.

- SEPARATION OF DROP ROD FROM "T" COUPLING -
Defective drop rod section end threads caused
separation of plunger rod

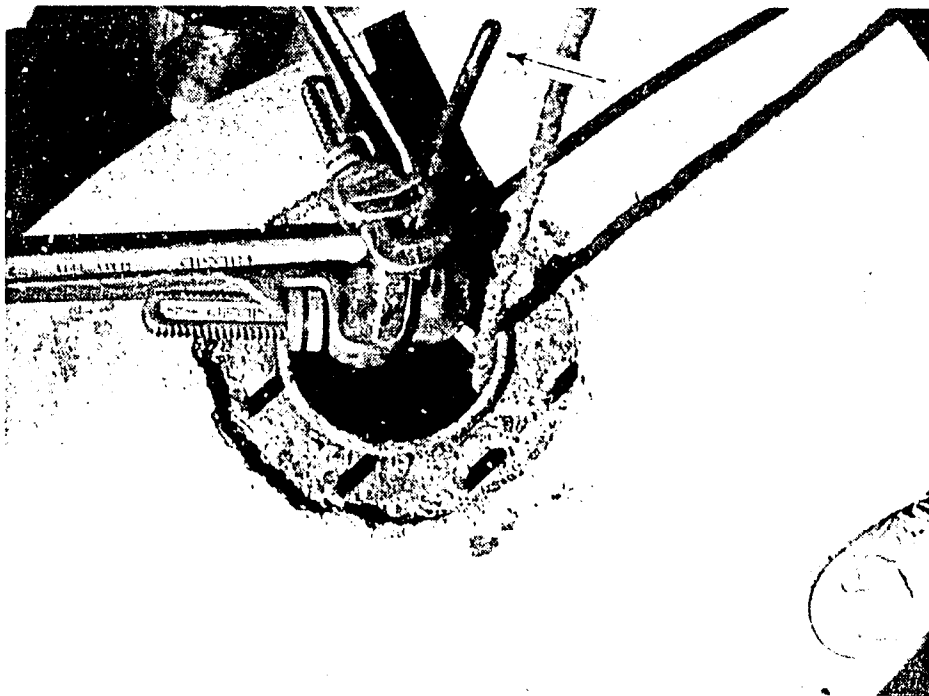
- SEPARATION OF DROP ROD FROM "T" COUPLING -
Another site where the above problem occurred

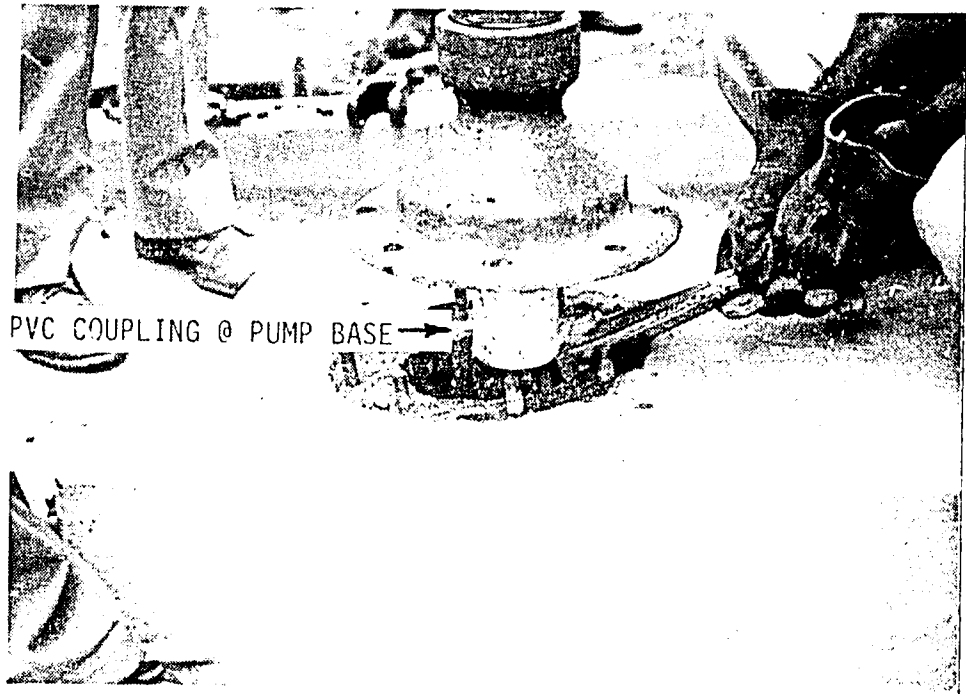
- PVC DROP PIPE SEPARATION -
PVC drop pipe separated from the PVC adapter

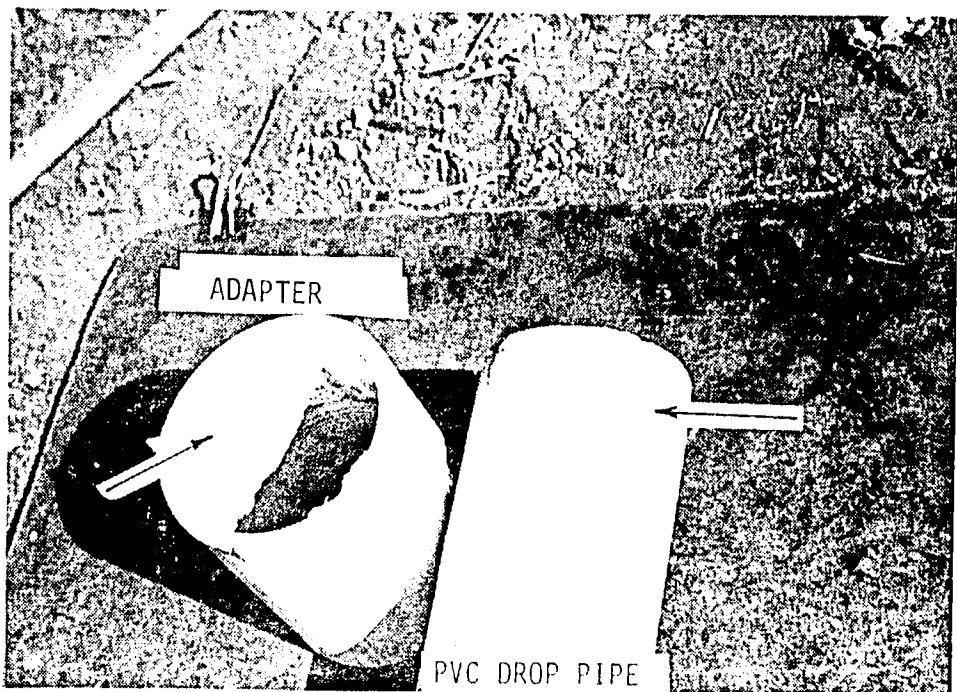
- PVC DROP PIPE SEPARATION -
These samples show little if any PVC solvent
action on the surfaces

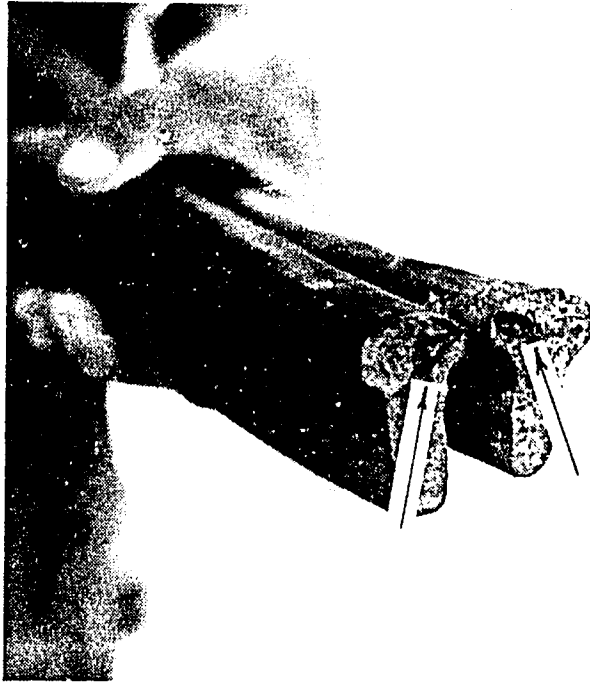
Hand pump handles have been breaking as a result of porosity as shown by arrows. These voids weaken the handle.

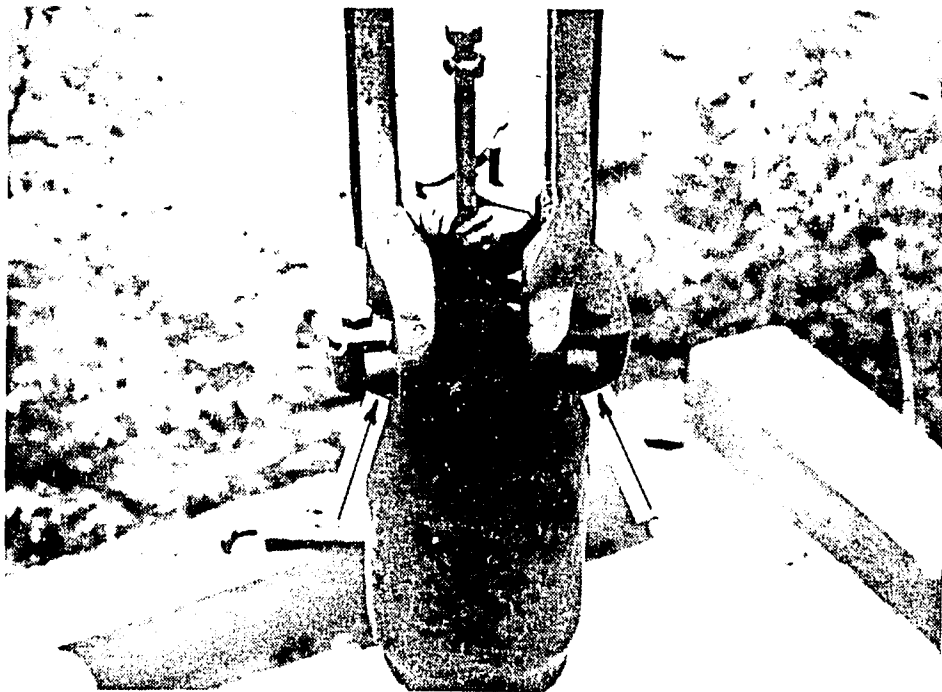
Arrows indicate the loose bushings. These should be press-fit and should not fall out as shown above

Additional cap assemblies should be manufactured to replace those in the field with loose bushings. The leather flapper foot valves should be replaced with metal popper/rubber seat foot valves in the AID handpumps of conventional design that were installed before the modified pump.

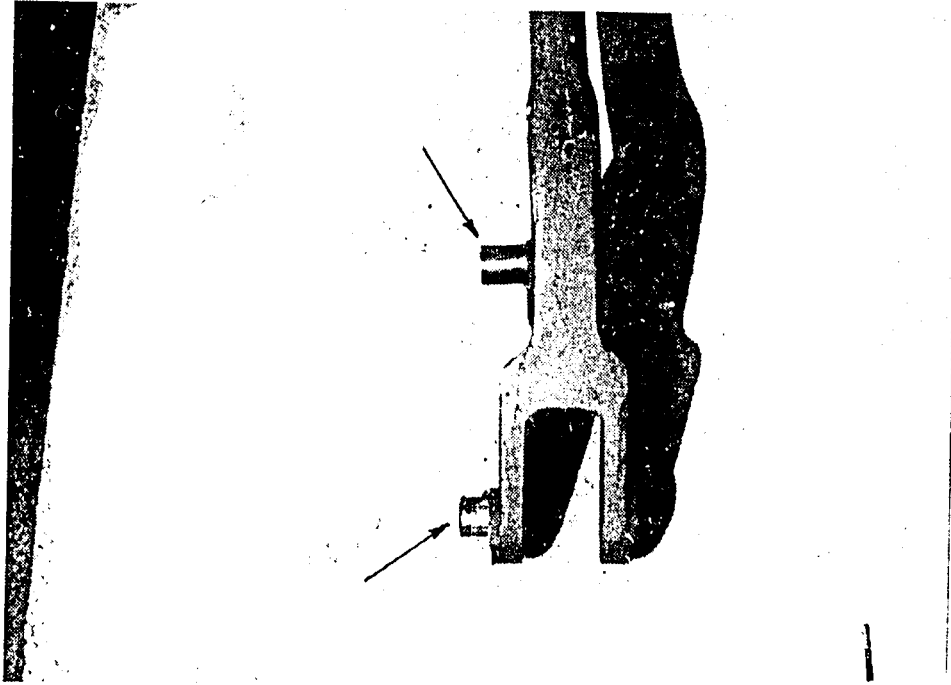
Arrows show loose bushings

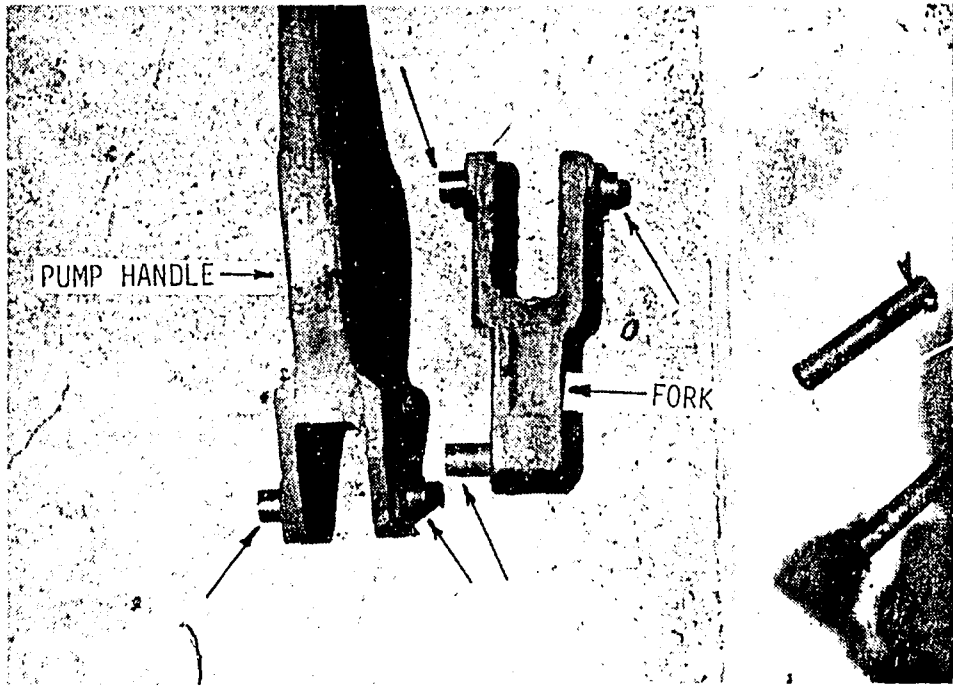
Loose bushings on handle and fork

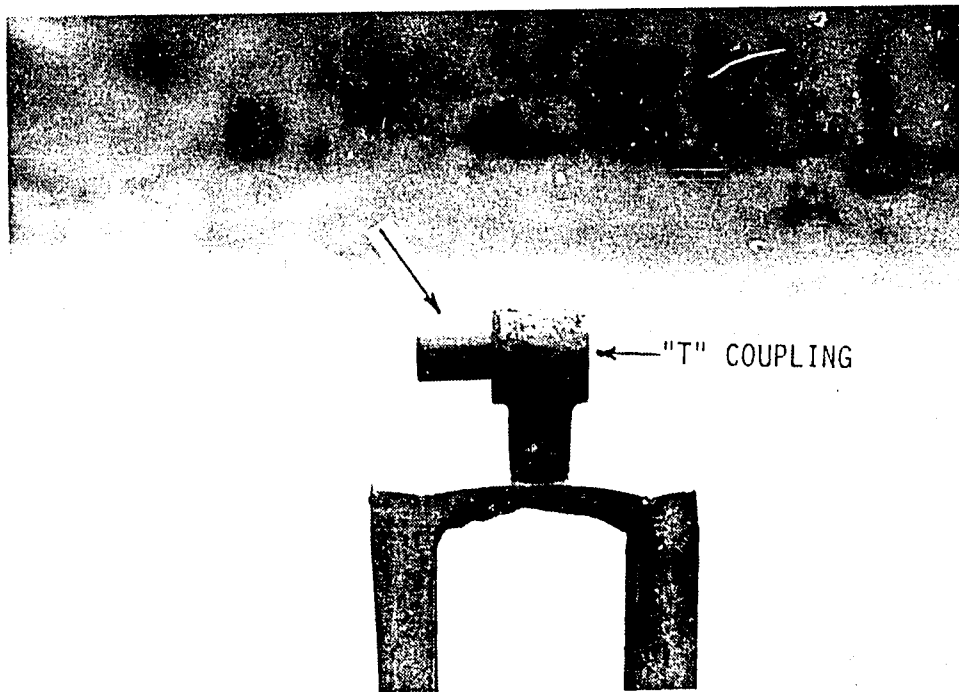
Loose bushing on "T" coupling

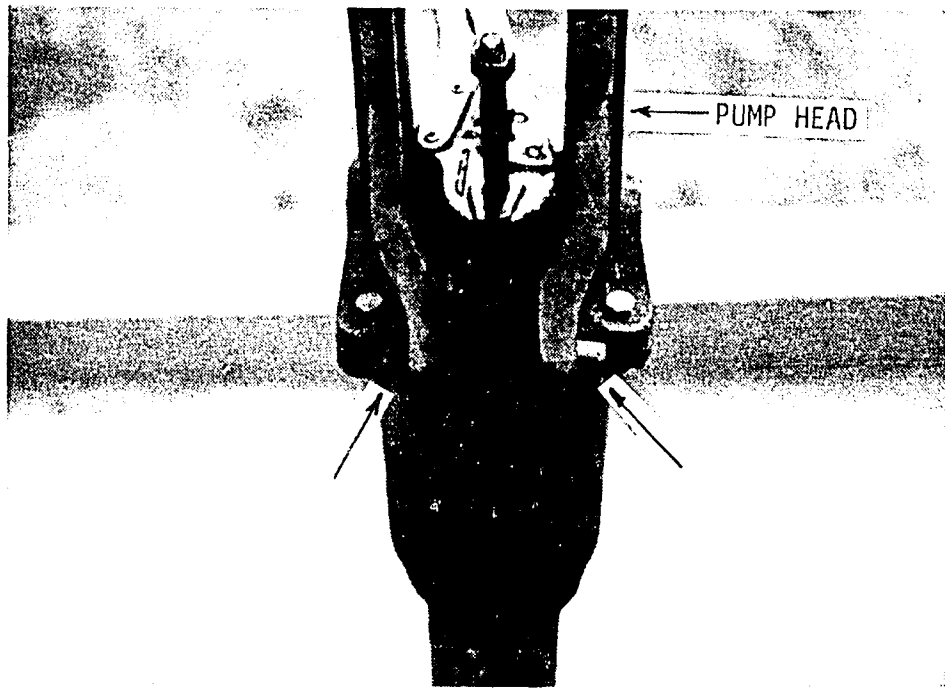
Another site with loose bushings on the pump head

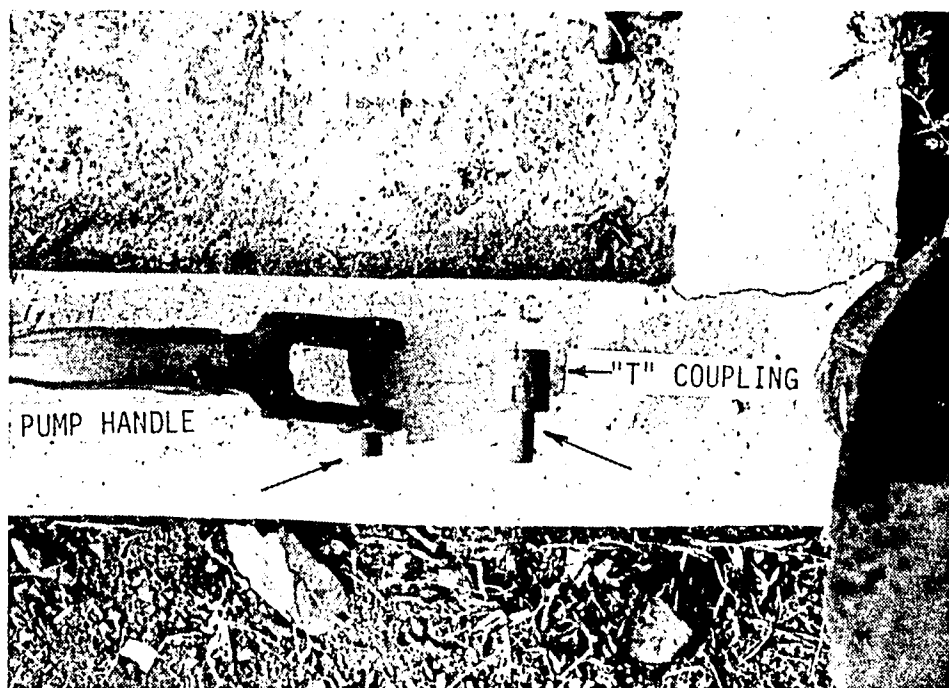
Another site with loose bushings on pump handle and "T" coupling

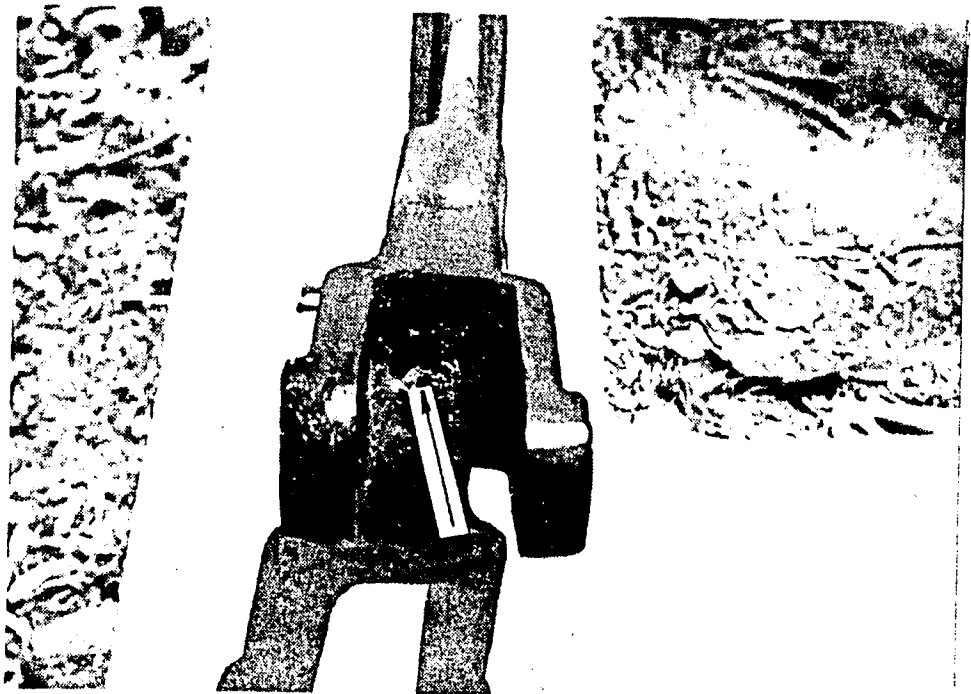
Arrow shows porosity

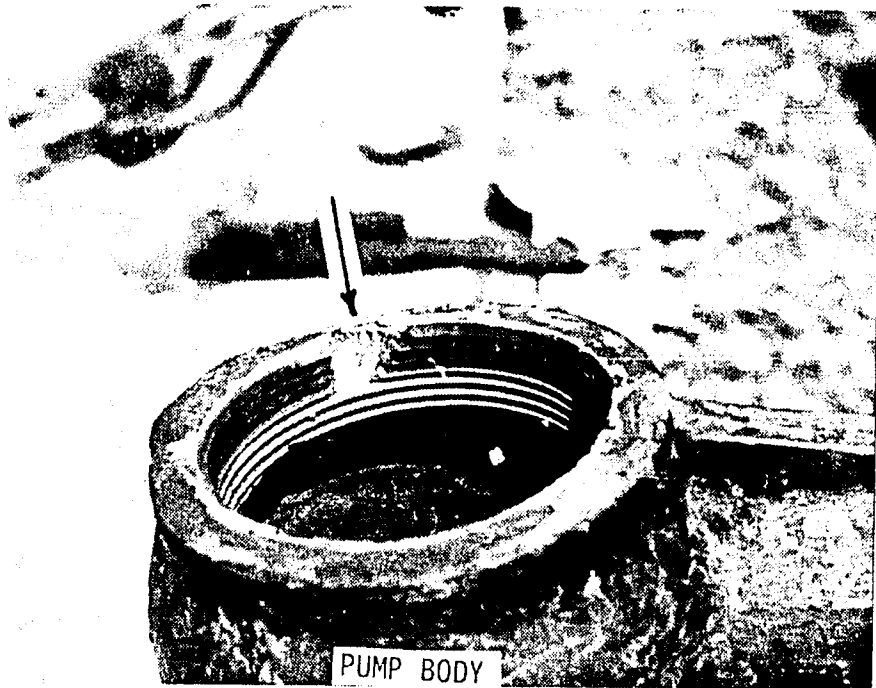
Defective threads on hand pump body causing water leakage

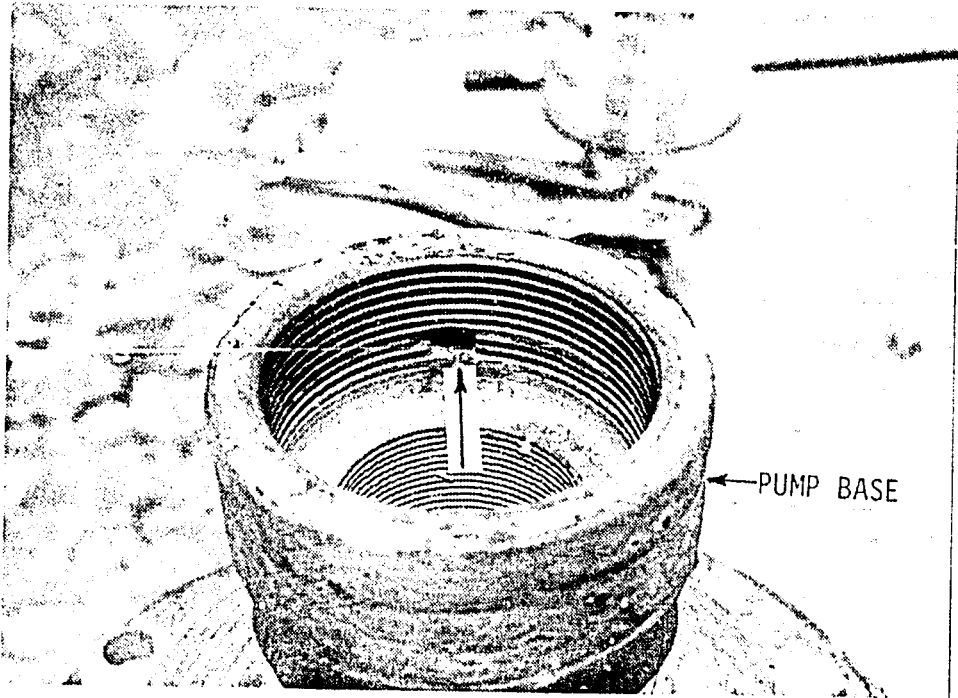
Porosity on interior pump base upper threads causing water leakage

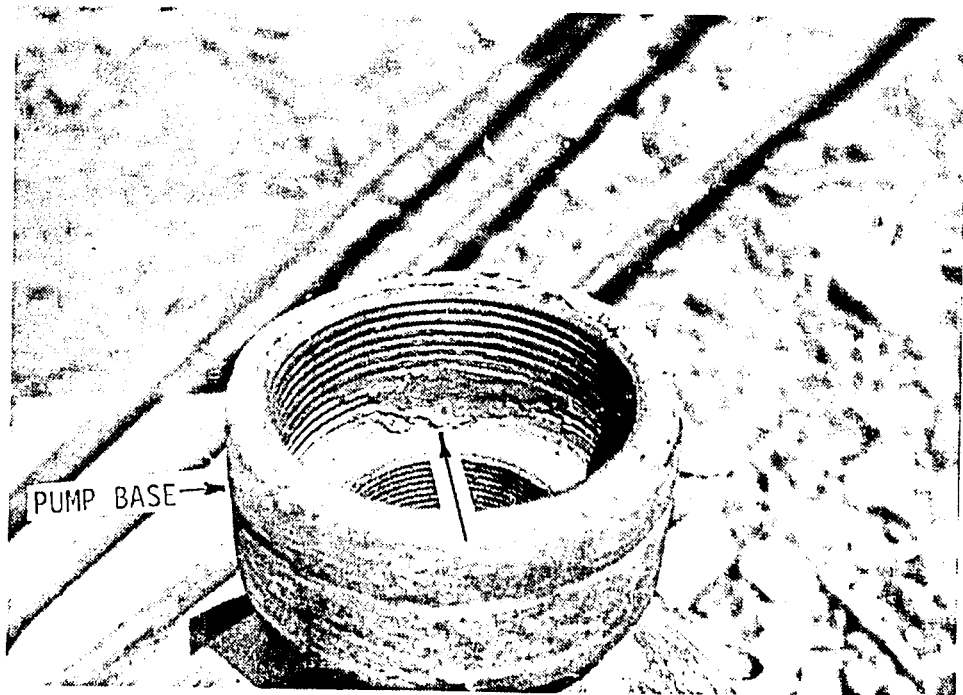
Arrow shows plaster placed by manufacturer to cover porosity. Pump was accepted and installed as shown.

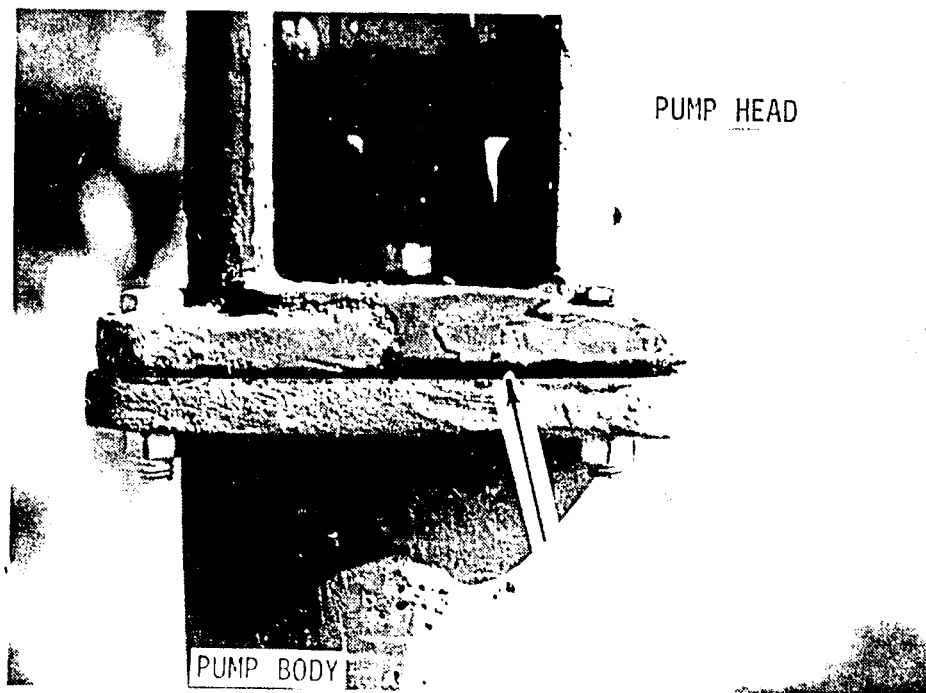
Plaster placed by manufacturer to cover severe porosity

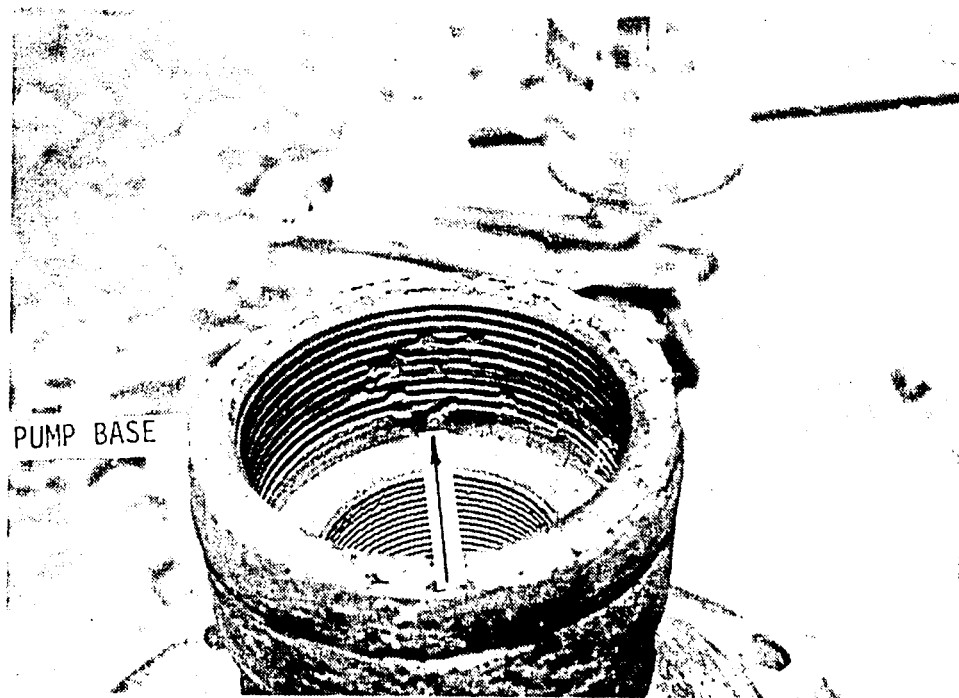
Another site with the porosity problem on the upper threads of the pump base. This causes excessive water leakage.
