TECHNICAL ASSISTANCE FOR HANDPUMP COMPONENT OF THE HEALTH SECTOR LOAN II PROJECT IN THE DOMINICAN REPUBLIC

WASH FIELD REPORT NO. 101

JANUARY 1984

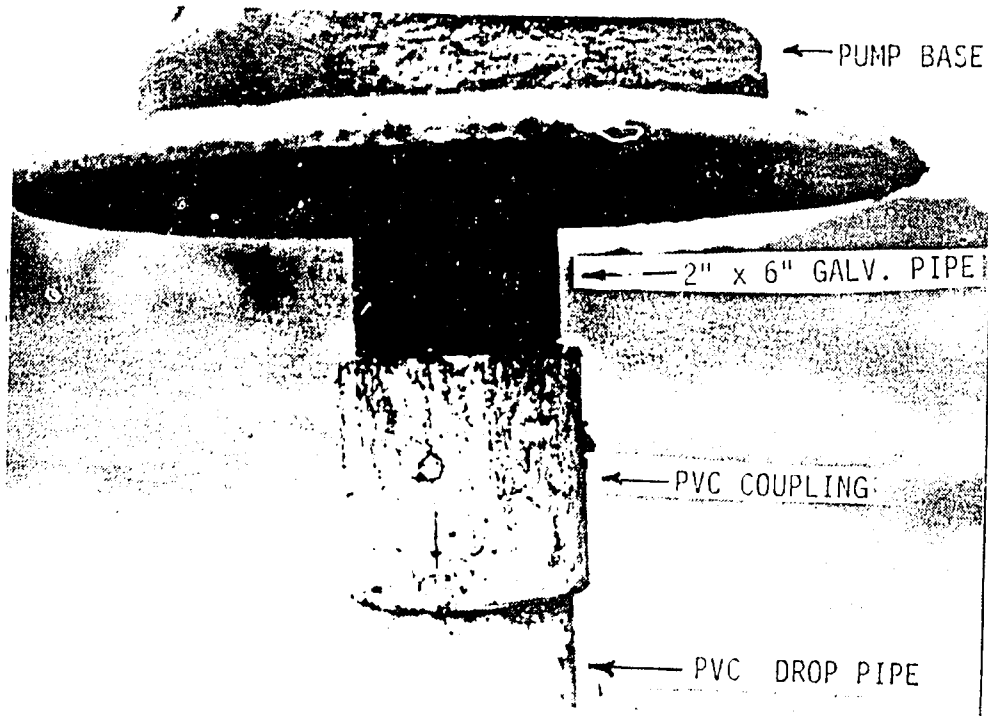
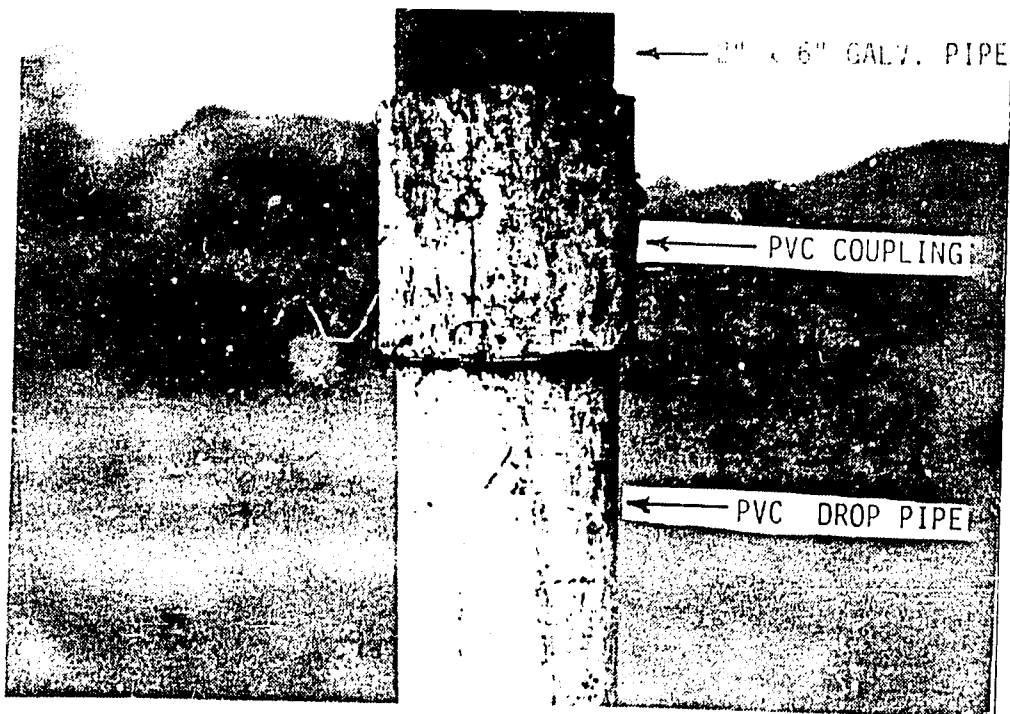
Figure 2

- o Problem Area 3 (15 percent) - Separation of the PVC occurred at the joint between the drop pipe and the PVC male-threaded adaptor in six cases. When inspected, little, if any, PVC solvent was found sticking to the internal surface of the PVC adaptor (Figure 2). In five cases the drop pipe had to be lifted out of the well by bonding another length of PVC pipe to it. The pipe ends became covered with new solvent in this process, so their surfaces could not be inspected. In one case it was possible to lift the PVC pipe out of the well with a rope. This allowed a better inspection since the pipe surface was not covered by new solvent.

HAND PUMP BASE AND DROP PIPE
CONNECTION ASSEMBLY
