FIELD INVESTIGATION OF CAUSES
OF FAILED WATER SUPPLY BOREHOLES
AND PUMPING SYSTEMS IN IMO
AND AKWA IBOM STATES, NIGERIA

WASH FIELD REPORT NO. 286

JANUARY 1990

Prepared for
USAID Nigeria and Africare
WASH Task No. 115

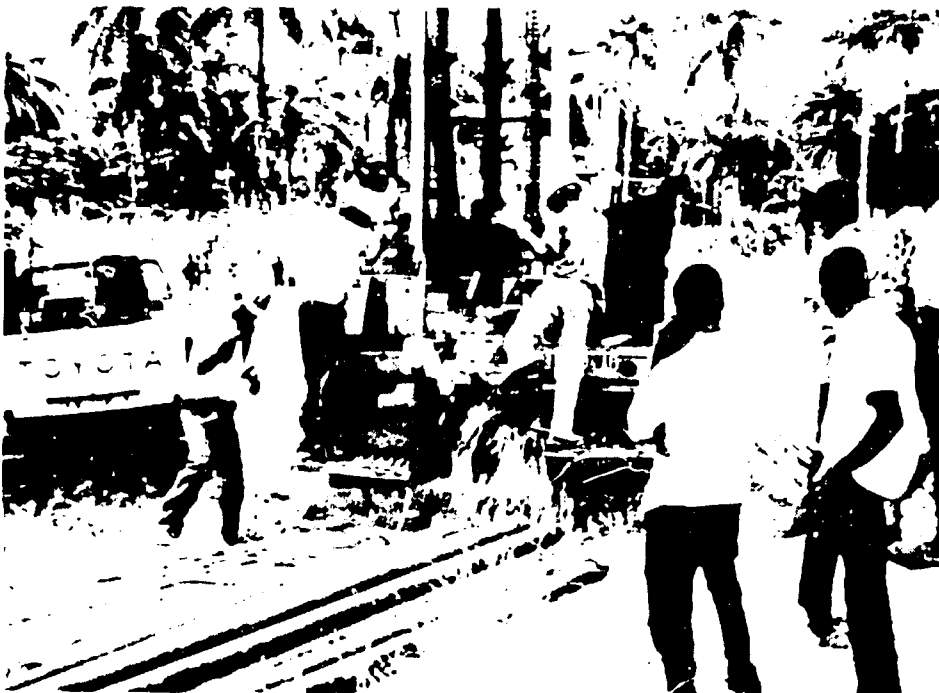
2. Removing the improperly sized 7.5 hp submersible pump at Umuelum

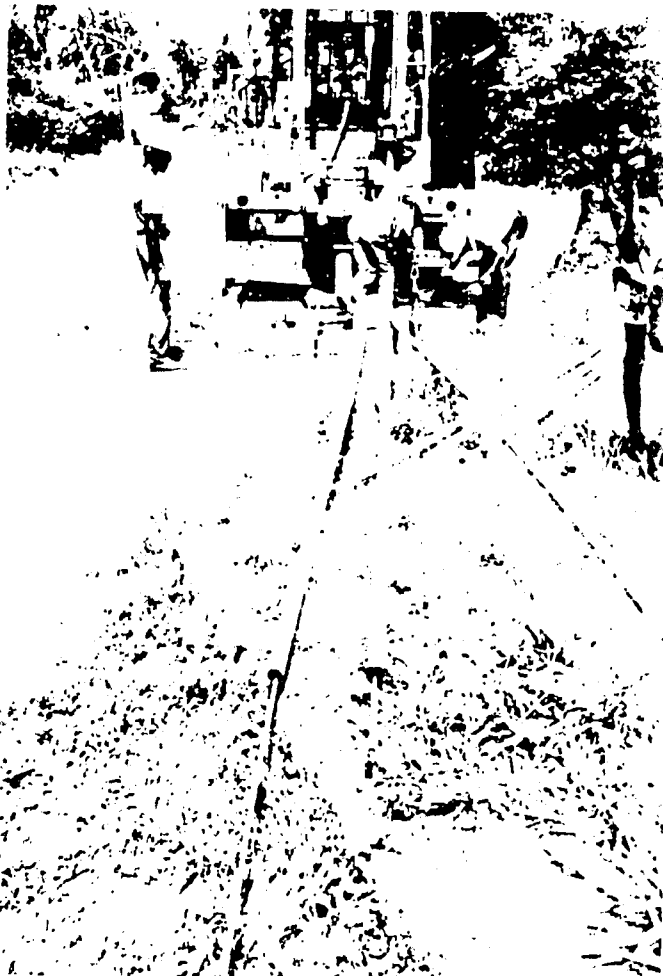
- **Remove and Inspect Pump.** Upon removal (from 70 feet) it was discovered that threads connecting the galvanized riser main to a coupler (at the second union, down 20 feet) were severely rusted through, causing water to leak from the riser main back into the borehole. The threads were stretched on one side, indicating that the riser main was pulled off center. When the pump cylinder was disassembled, the seals were completely worn--mostly on one side. The piston was severely worn and gouged, suggesting that a foreign object had fallen down the riser main and bound the piston movement. The lift rods were examined and found to be wearing on one side of the couplers (on each and every coupler). A visual inspection of the borehole (using a mirror) showed it out of plumb and

doglegged. The static water level was taken at 43 feet. Only half of the water could be seen from the surface, indicating degree of the dogleg. The entire pump and riser main were very discolored and thickly coated with rust. The villagers watching the inspection complained that the water was no good because of its color and taste; they also complained that the water would stain their clothes.

8. The removed India Mark II handpump at Ntit Oton. Note: Rusty-colored riser main, resulting from riser main failure at a connection, with water running down the outside of the main becoming rusty.

Fit the borehole according to the recommendations in the Executive Summary per Alternative Recommendation C-9. The pump should be a model NIGER Mark II equipped with open cylinder (also equipped with a body port for adding chemicals). One stabilizers is to be installed immediately above the pump barrel (just over the first lift rod connector), another immediately above the third lift rod connector above the pump (approximately 23 feet from pump barrel). The pump should be set at 50 feet and checked for suitable water yield. (If unsatisfactory, lower pump another 10 feet and recheck.) Chlorine should be added monthly into the borehole (standard-sized bottle of liquid washing bleach acceptable), and the pump then operated until the discharged water smells and tastes of bleach. The well then should be left idle overnight. The following morning, pump the well until the bleach is not noticeable and reopen the well for public use.

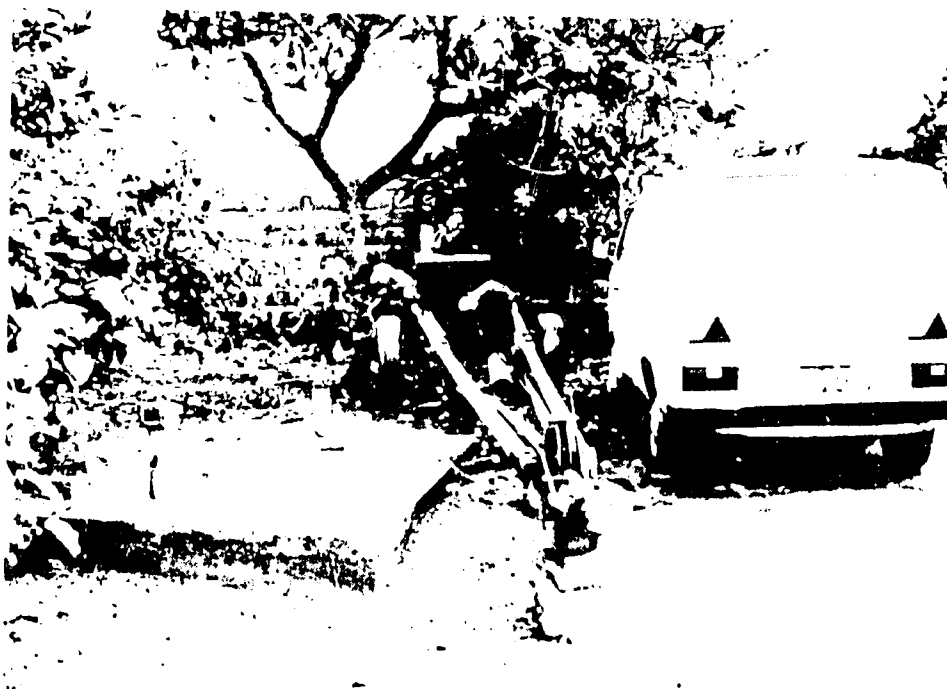
16. The very simple and inadequate cable tool percussion drill.
