**Overview Report on Making a Survey of the North Cairo Court  
Building Basement in its present condition  
Osama El Nahas  
Contract No 263-C-00-95-00134-00  
Administration of Justice Support Project  
AMIDEAST/ AOJS Cairo  
July 1998**

## On Making a Survey on The North Cairo Court Building Basement in its Present Condition

**A Report About the Status Quo and suggestions  
of the Basement of The Main Building  
of North Cairo Court (Archive),**

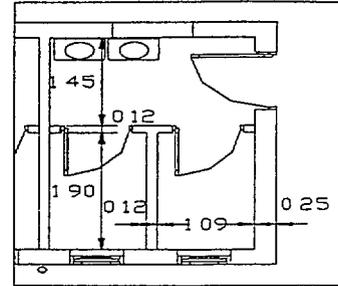
**Space No 1**

Walls Gypsum coating needs to be changes

Ceiling Gypsum coating needs to be changes

Flooring Mosaico 30x30cm tiles in medium state

Skirting White 15x15cm ceramic, 1.5m high

Its State 30% broken It is better to be changed

- \* One window opening with frame, without glass, 60cm wide, 50cm high
- \* One window with 60cm wide, 50cm high glass The window is one wooden leaf moving on a horizontal axis at the bottom of the window
- \* One window opening without glass, without frame, 90cm wide, 55cm high
- \* One door opening with only wooden door frame, 80cm wide, in bad state and needs to be changed

The sanitary works are in bad state and they need to be changed (the instruments and their connections)

- \* There is one water pipe + 2 showers + 2 Combinations, in bad state (not suitable for use)
- \* There are 2 basins 30x60cm without any connections + cock

All electrical works need to be reconstructed

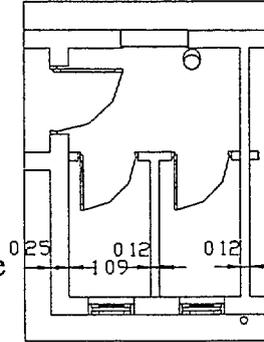
### Space No 2

Walls Gypsum coating needs to be changes

Ceiling Gypsum coating needs to be changes

Flooring Mosaico 30x30cm tiles in medium state

Skirting 17x28cm ceramic, 150cm high, acceptable state

Its State 30% broken It is better to be changed

- \* One window opening with frame only, without glass, 60cm wide, 50cm high
- \* One window with glass 60cm wide, 50cm high The window is one wooden leaf moving on a horizontal axis at the bottom of the window
- \* One window opening without glass, without frame, 90cm wide, 55cm high Contains wire net
- \* One door opening with wooden frame only, 80cm wide, in bad state and needs to be changed

The sanitary works are in bad state and need to be changed (the instruments and their connections)

- \* There is no 2 water pipe + one showers +, in bad state
- \* There are one urinal without any connections + cock

All electrical works need to be reconstructed

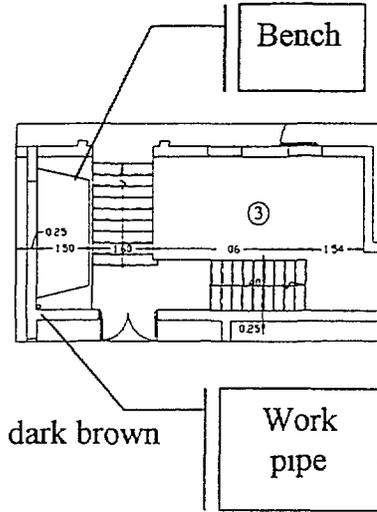
Space No 3

Walls Cement splash needs to be restored

Ceiling Gypsum coating needs to be changes

Flooring Mosaico 30x30cm tiles in medium state

Skirting Mosaico tiles, 12cm high, coated with dark brown  
paint, in medium state

- \* Two window openings without glass, with frame, 90cm wide, 55cm high with wire net
- \* One metal door, 1.5m wide, 2.2m high, in good case, without lock (entrance door) needs to be coated
- \* One door opening with wooden doorframe (of the space no 2)

All electrical works need to be reconstructed

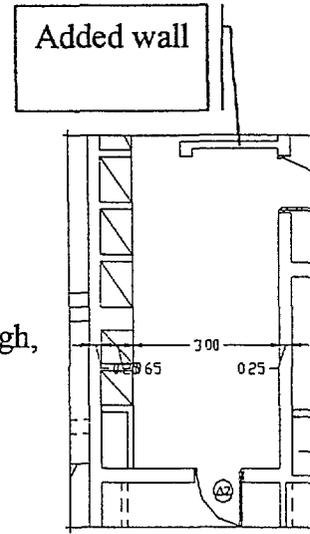
Space No 4-1

Walls Bad Oil coating

Ceiling Oil Pistachio coating, in acceptable state

Flooring Mosaico 20x20cm tiles in medium state

Skirting Mosaico tiles, dark blue coated, 12cm high,  
bad state

N B There are three places thought to be for telephone cabins (their walls are dark blue coated

All electrical works need to be reconstructed

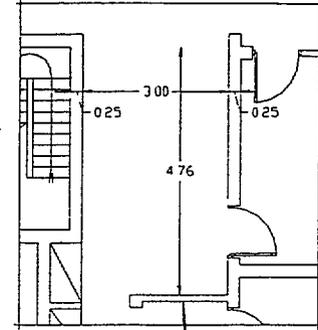
Space No. 4-2

Walls White gypsum coating + there are parts with sky  
blue coating in bad state There are protrusions  
and broken parts of the wall

Ceiling Oil Pistachio coating, in acceptable state

Flooring Mosaico 20x20cm tiles in medium state

Skirting Mosaico tiles, dark blue coated, 12cm high, in bad state

All electrical works need to be reconstructed

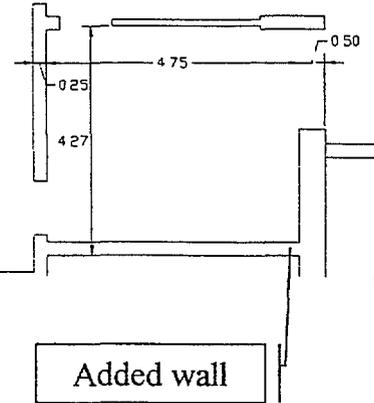
Space No 6

Walls Oil sky blue coating in bad state There  
is a part with pistachio coating

There is a part without skirting (Added wall)

There is an old damaged switch panel box

N B There are U-shaped kretal profiles fixed on walls

There is a steel bar fixed on walls by bolts All of them need to be  
removed

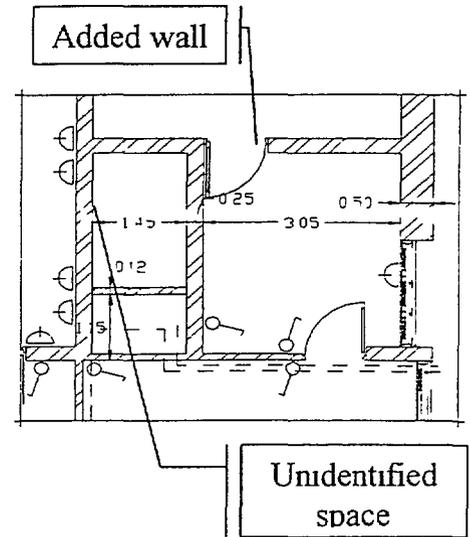
Space No 7

- \* 1 door opening, m wide, 2.2m high, with sky blue coated from,  
without architrave and in bad state There is 10cm high concrete sill
- \* 1 opening (the arch, previously mentioned in space no 6)
- \* 1 window (with external steel), 4 leaves, steel frame There is one  
leaf with blue coated glass on two sides + 1 broken leaf

NB There is steel bar fixed on walls by steel bolts It needs to be  
removed

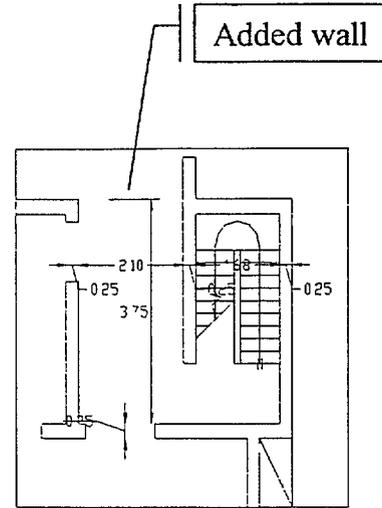
Space No 11

Walls Oil yellow coating with gypsum

Ceiling Damaged oil coating

state There is 25cm dia damaged part in flooring

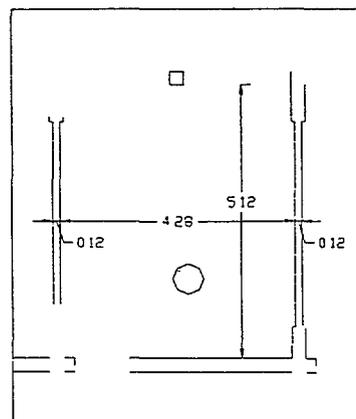
Space No 13

Skirting Mosaico tiles, 12cm high, brown coated

Flooring Moasaico 20x20cm tiles, in medium  
state There is 25cm dia damaged part in flooring

- \* 1 window opening, 3 leaves, with wooden frame without glass (There is granular wood instead of glass) The middle leaf is moving, while the two other leaves are fixed
- \* 1 window opening, 3 leaves, with wooden frame One leaf is with glass, the other two are with wood instead of glass The middle leave is moving the other two are fixed
- \* Steel door, 1m wide, 2 2m high in acceptable state, without lock

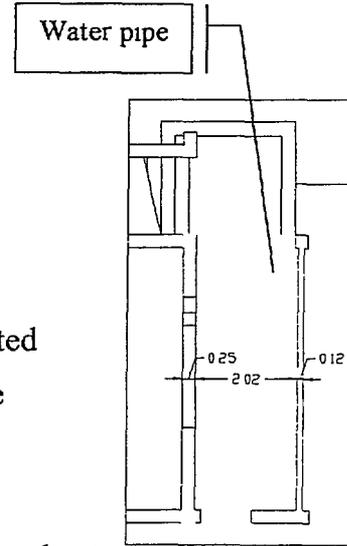
Space No 15

Walls Chemplico white coating in bad state

N B There are U-shaped kretal profiles fixed on wall

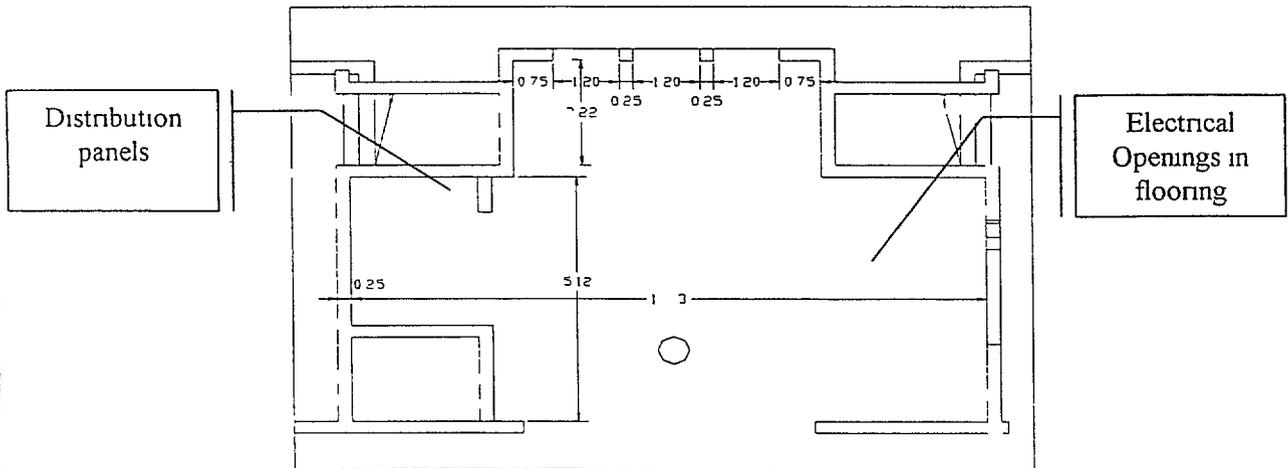
Space No 16

Walls Gypsum coating in bad state (The walls are in bad state as a result of passing electrical cables)

N B There is steel piece at the top of the opening of space no 15 fixed in  
wall and need to be removed

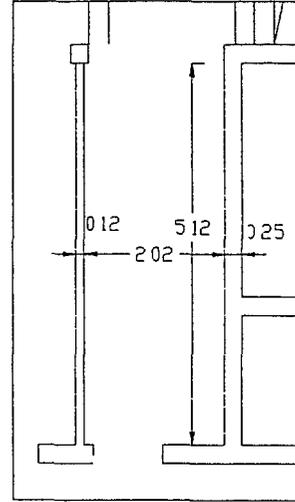
Space No 17

Walls Chemplico white coating in bad state

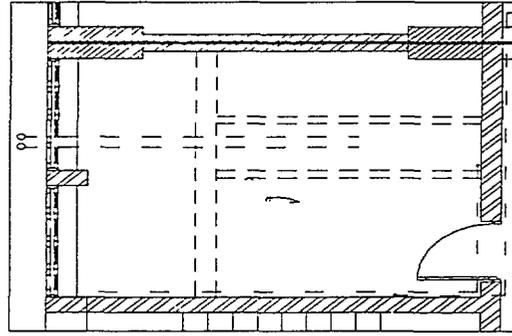
Space No 40

(The space was changed from W C to be a storehouse)

NB There are damaged parts in the external beam as well as ceiling  
(There are parts of apparent rusty reinforcing steel) They need to  
be restored
