Inspection of Vocational Education Centers Built Under BEST II

SEPTEMBER 2000

Contract No. 522-G-00-00-00243-00
USAID/Honduras

INSPECTION OF VOCATIONAL EDUCATION CENTERS BUILT UNDER BEST II

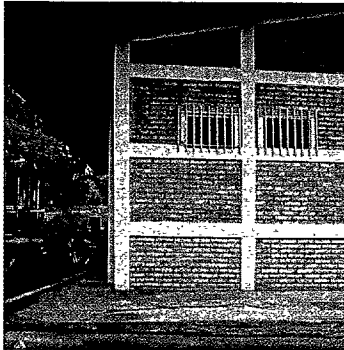
Except for cracks at the walkway, caused by poorly executed shallow control joints, and some *chipping away (spalling)* of plaster from the base of the NW corner column, the fairly new concrete frame and brick structure is in sound structural condition and needs no structural retrofitting.

Even the NE column that was erected out of plumb causes no serious structural concern being tied by the three ring beams placed all around the building.

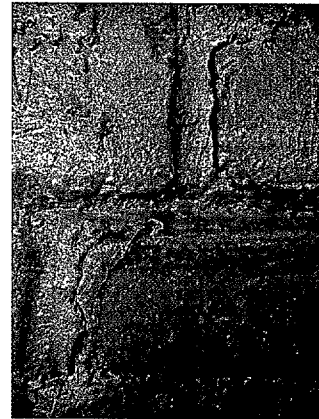
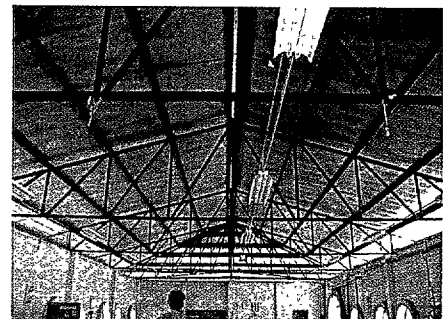
We also observe several shrinkage cracks at floors for insufficient control or construction joints, badly executed bearing connections of trusses to top of columns, lack of continuity of an undersized bond beam (missing on some walls), and shrinkage cracks so severe that daylight is visible through some of them as they continue to grow...

The director informs that he observed adobe walls being erected rapidly as blocks were produced, indicating that the contractor used non-cured adobe to build walls that exhibited severe early shrinkage. This

explains the randomly widespread cracks and the working loose of some vault units...

Despite the numerous more-or-less severe cracks, these non-bearing adobe walls would be safe only as long as no dynamic loads, such as those caused during an earthquake and/or hurricane winds, are excluded. They would certainly crumble, however, should any such calamity ever strike!

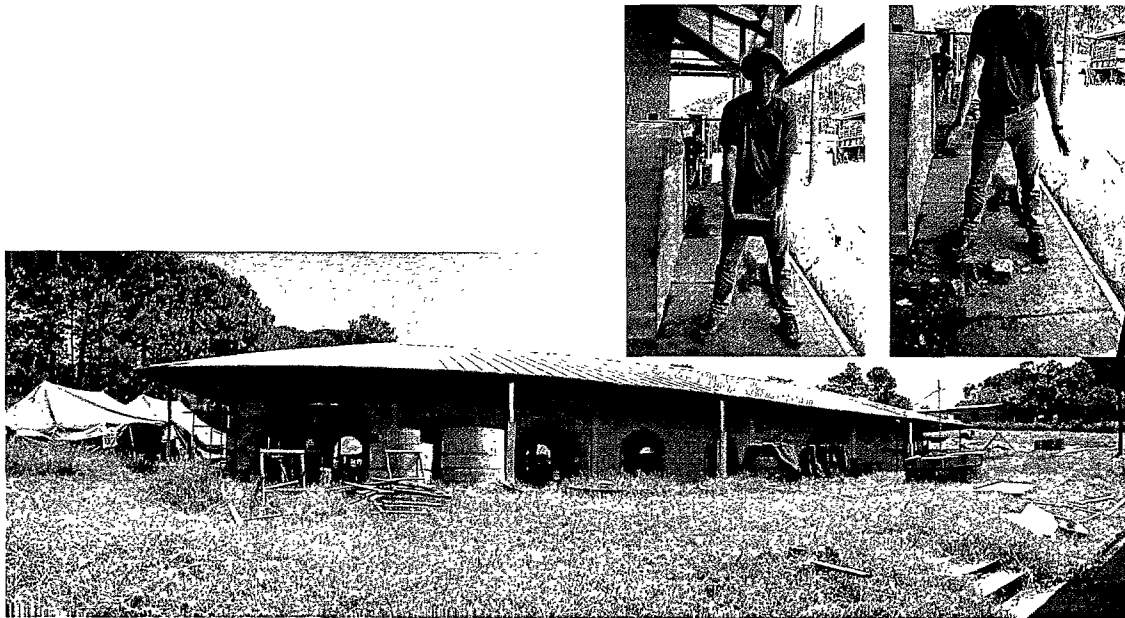
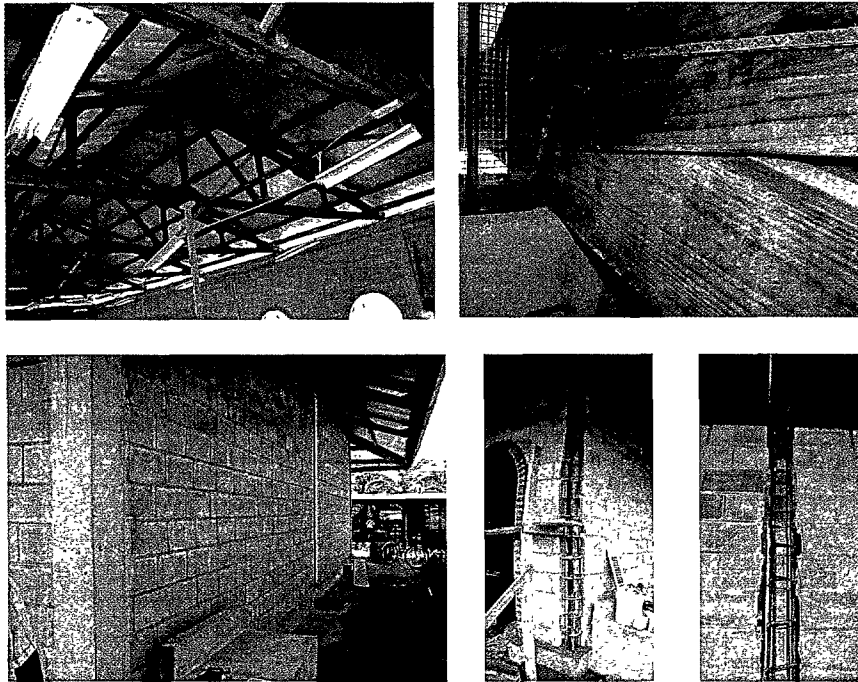
The reconstruction is not well conceived, however. The structural system of pouring columns after erecting the wall on either side, despite being widespread in developing countries because it saves formwork, has no known tested behavior whose resistance to vertical and overturning loads could be properly designed and analyzed for safety. Practical experience in building construction leads to believe that the 6" thick bearing walls and columns combination, standing about 12', is unsafe. The *Uniform Building Code (UBC)* recommends minimum thickness of a hollow concrete-block bearing wall, in low seismic zones (0 - 1), to be 1/18 its height (but no less than 8") and 1/20 for a non-bearing wall.

The VTC roof structure in Peña Blanca, made out of timber obtained from the U. S. Department of Defense surplus, is not properly connected to the walls below.

Although giving the appearance of being larger, the effective size of concrete columns poured after the walls are erected are only 6"x6". Columns expected to sustain both vertical loads, transmitted by the roof, and horizontal loads, conveyed by high wind and/or earthquake, need to resist relatively high stresses... In the case of the VTC in Peña Blanca, hardly any reinforcement (only one 3/8"Ø rebar) is used to transmit column loads to the walls that could otherwise help in absorbing some of the forces acting upon the building.

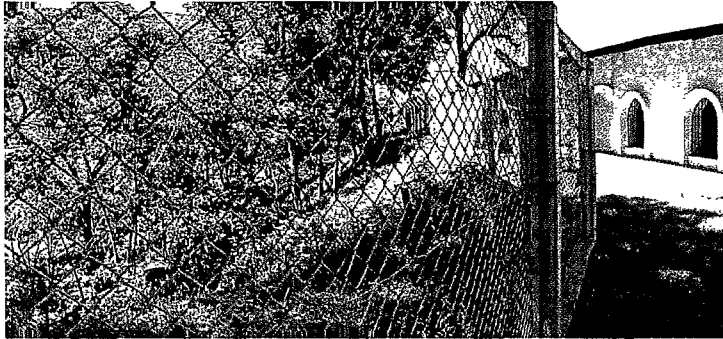
Except for major cracks and impending structural failure due to settlement of filled earth material at the western end of the site, the absence of severe shrinkage cracks in the other two buildings proves

that it is best to use the adobe as it should be: a gravity-bearing wall. However, the 12" thickness is substandard.

With regards to the western building, it is best to remove the portion that is in danger of being absorbed by the some 40' deep ravine a very short distance away.

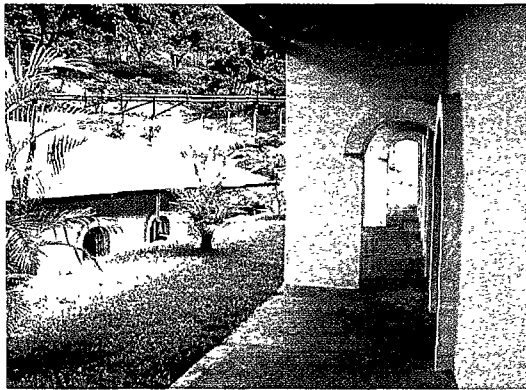
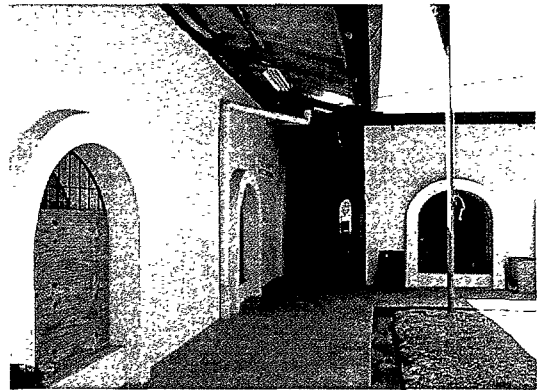
As in San Marco de Colón, the roof trusses in El Mochito, made out of timber obtained from the U. S. Department of Defense surplus, rest on adobe walls but are not anchored to them, as they should be. Both VTCs exhibit weakly designed and built roof decks that will offer negligible resistance to overturning should high winds and/or earthquake ever strike. The only advantage of timber trusses is their greater weight, compared to steel trusses, that helps a little in stabilizing the supporting walls against tipping over.

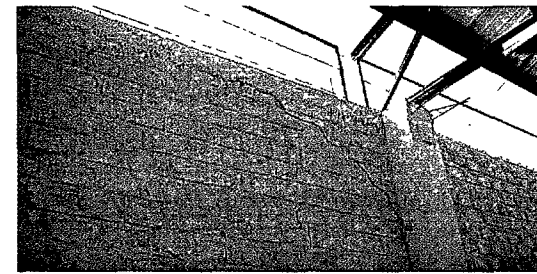
The Ernesto Ponce VTC in **Guaymas**, completed in December 1999 and which, in addition to a 550s.f toilet facility and two auto service ramps, consists of three 12' high concrete-frame and adobe with steel-hip-roof buildings, two of which measure 4,275s.f for the auto- and industrial-mechanics respectively, and one 4,700s.f for the industrial cut and sewing training. Severe cracks at walls, a bond beam that is more rigid than

those previously observed in other sites but causing additional horizontal cracks, *poorly-poured unbound aggregate-exposed concrete (honey-combing)*, less than desirable down-spout design,

contributing to weakening and potentially flooding the interior of the adobe walls, characterize this center.

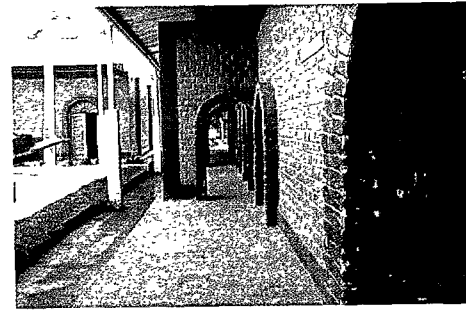
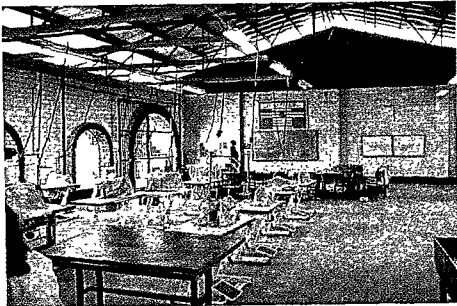
A 450s.f toilet facility abuts the west end of the welding training building, where some foundation settlement has occurred creating minor cracks at the walls. Although the material used for the adobe is less than optimal, we are informed that the blocks used in this center were cured before construction began. Lack of severe cracks,

a stiff bond beam at the top of longitudinal walls supporting the non-connected trusses characterizes this center erected on flat land.

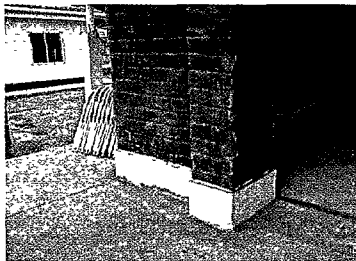
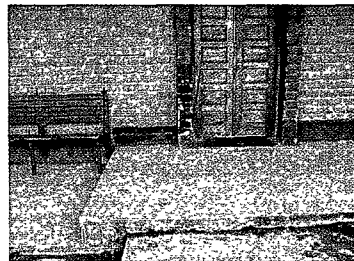
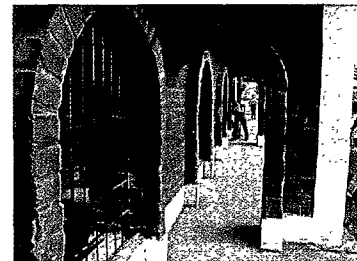
chanics, has a hip roof and measures 4,275s.f Poor workmanship, less than optimal material used for adobe (causing the walls to crumble easily), moderate cracking of the walls and vaults, small 8" x 8" pilasters at the end walls, roof trusses tied at their seats against wind uplift with field-bent rebar (the only site observed with tied down wood trusses) characterize this center.

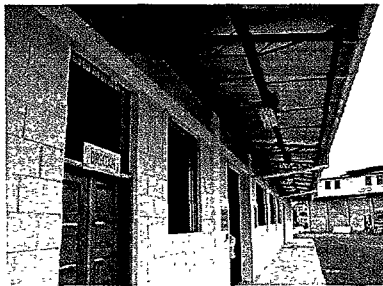
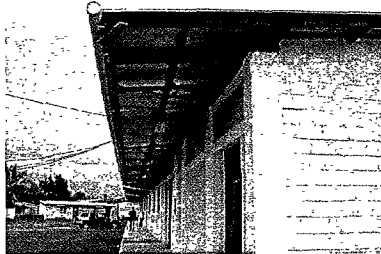
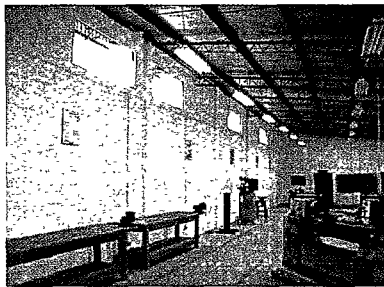
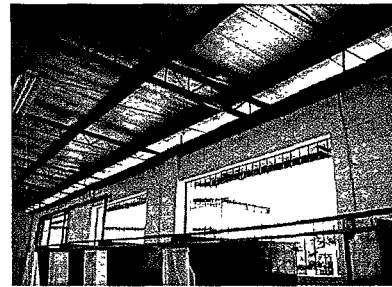
demolished by the contractor who left standing, next to a road, only one 8" thick and 15'-7" high concrete block wall, portions of the top few courses of which were re-

moved to allow for air circulation and daylight. The floor slab and the foundations belong to the old structure, but the contractor added the lower 8" and 11'-4" high

hollow concrete block wall along the western front elevation. He also utilized the old roof joists that sagged excessively, and added an equal number

of new deeper joists—minus one, that had to be cut at the supports to allow for erection. The roof is precariously unsafe as are the walls that lack dependable columns/pilasters or a bond beam that could assist in lateral stability.

With the exception of the multi-purpose brick building in Tegucigalpa, all roof decks, columns, and walls are weak and slender, but the ones in San Pedro Sula are excessively under-designed...

- The center in San Pedro Sula, the roof structure of which needs to be dismantled, the top two courses of concrete block walls removed, a continuous bond beam poured, and a new roof deck erected.

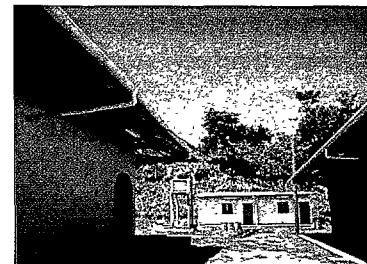
tor Assencio informs us that the walls were erected using fresh adobe as the extensive severe cracks in these six-month-old buildings witness!

Despite being the only center where the contractor braced vertically and longitudinally the middle of all trusses, these buildings show the poorest workmanship in adobe construction responsible for some of the worse cracks we observed during this assignment. Moreover, the electrical distribution system, with wires lying directly on the ground from one building to the next, is utterly unacceptable.
