**ENVIRONMENTAL ASSESSMENT OF
VOROTAN CASCADE REHABILITATION PROJECT**

ARMENIA

October 1999

Prepared by: Burns and Roe Enterprises, Inc.

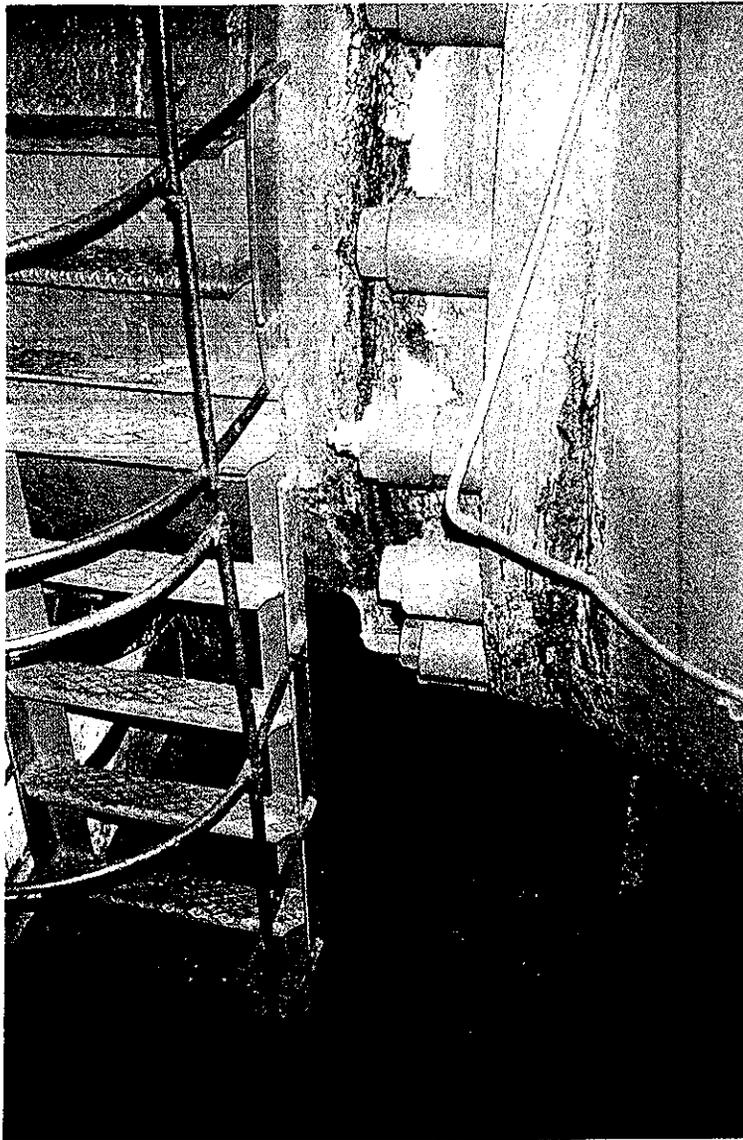
Photo # 1
Spandarian Inlet Valve and Interior
Penstock Wall

There was a substantial amount of water evident on the floor below the primary inlet valve (see Photo #1). The interior wall of the penstock had visible moisture damage. According to HPP personnel, all leaks and washdown water are directed to a drainage chamber and is then pumped to the Vorotan River. No oil/water separator is present within the drainage chamber nor anywhere else in the facility. Total flow to the drainage chamber was estimated by plant personnel to be 2 liters/sec. The 200mm drainage chamber discharge pipe is shown in Photo #2. There was 38 MW of electricity being produced at the time of the visit.

- Spherical inlet valves – The proposed replacement of these valves will reduce current loading to the drainage chamber and would reduce the amount of entrained oil and sediment currently being discharged to the River.
