INSPECTION OF MECHANICAL FEATURES

**Helmand Valley
Development Project**

AFGHANISTAN

May 1964

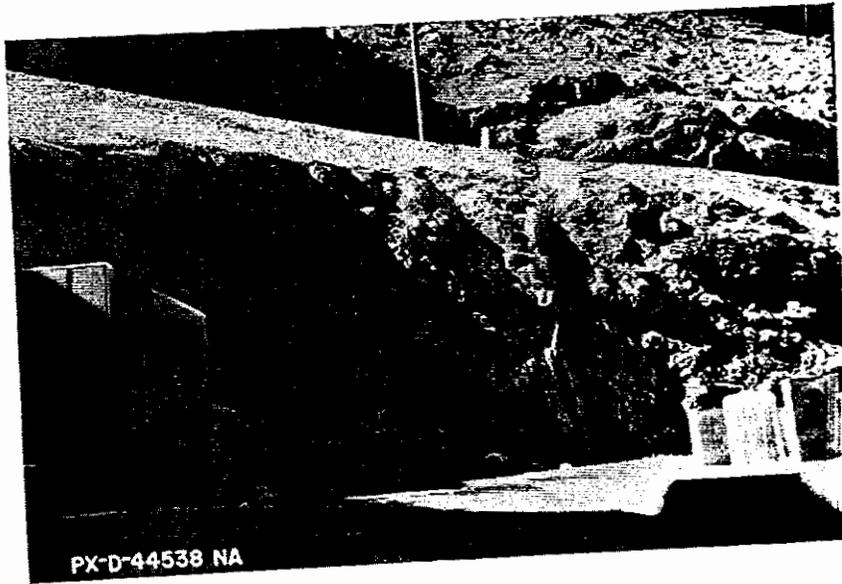
Figure 3.--Kajakai Dam. Hollow-jet valve control house and the gear unit control stands covered with ice from spray from the hollow-jet valves. January 28.

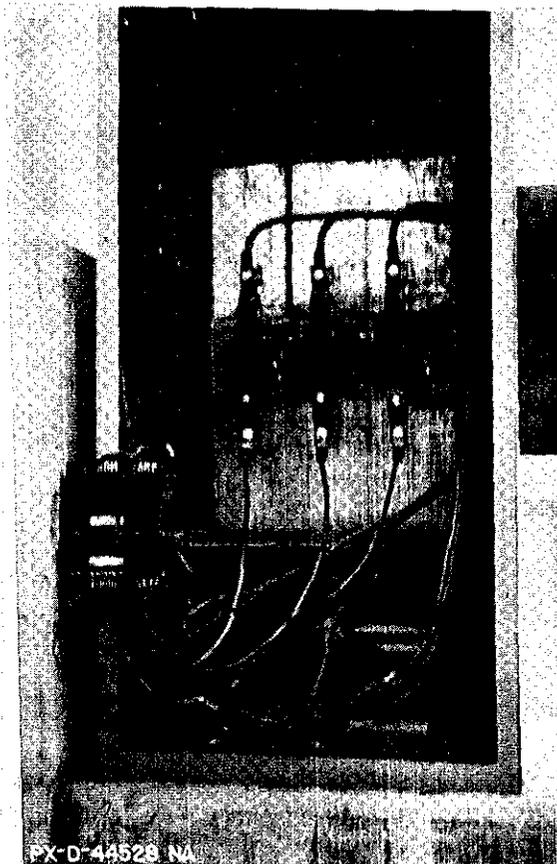
Figure 13. --Arghandab Dam. The back cover of the turbine generator unit control cabinet has been removed for convenience of additional wiring.

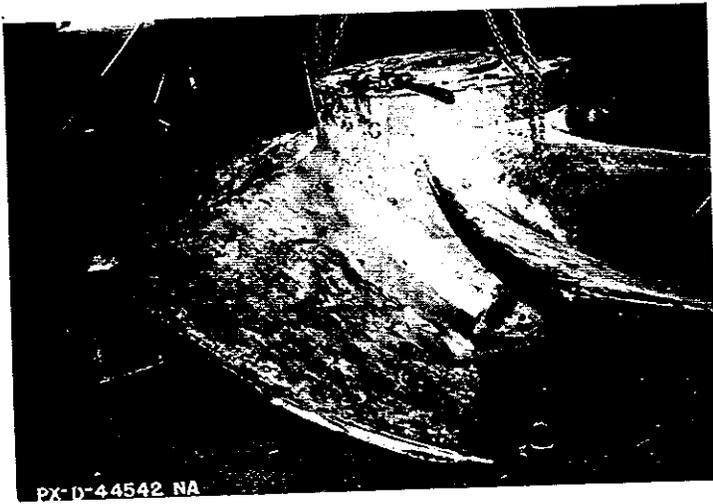
Figure 18. --Girishk Powerplant Unit 2
turbine runner. Edges of blades show
wear from dragging on the lower
crown ring.

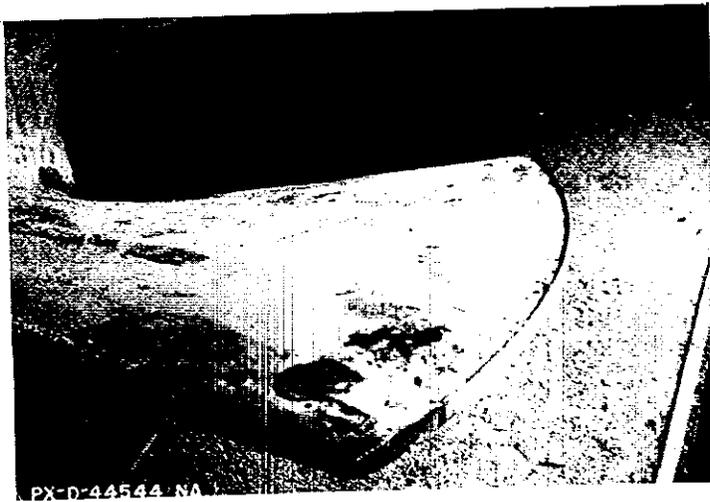
Figure 19. --Girishk Powerplant Unit 2.
Turbine runner blade shows evidence
of severe dragging between the edge
of the blade and lower crown ring.

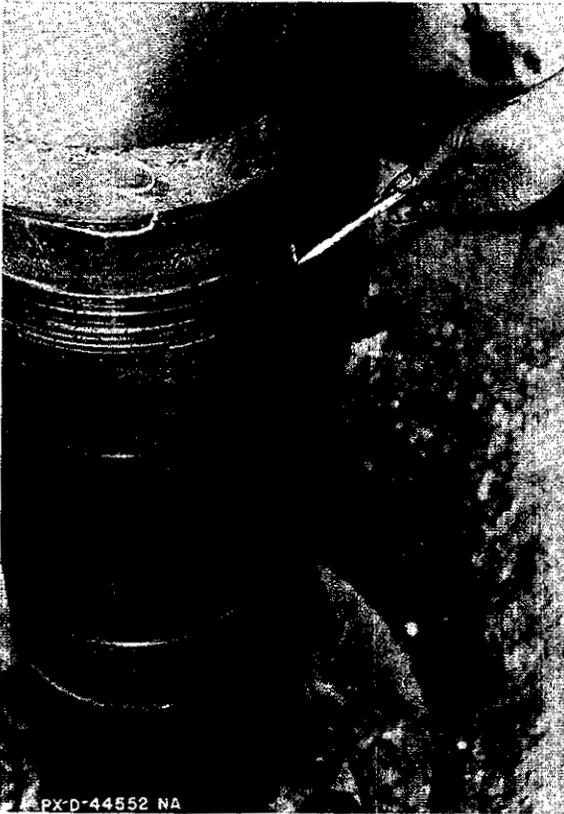
Figure 20.--Girishk Powerplant Unit 2. An enlarged view of the turbine shaft showing the bearing surface bodily grooved and worn. Pencil points to area that was in contact with oil packing. Lower oil packing wore similar grooves.

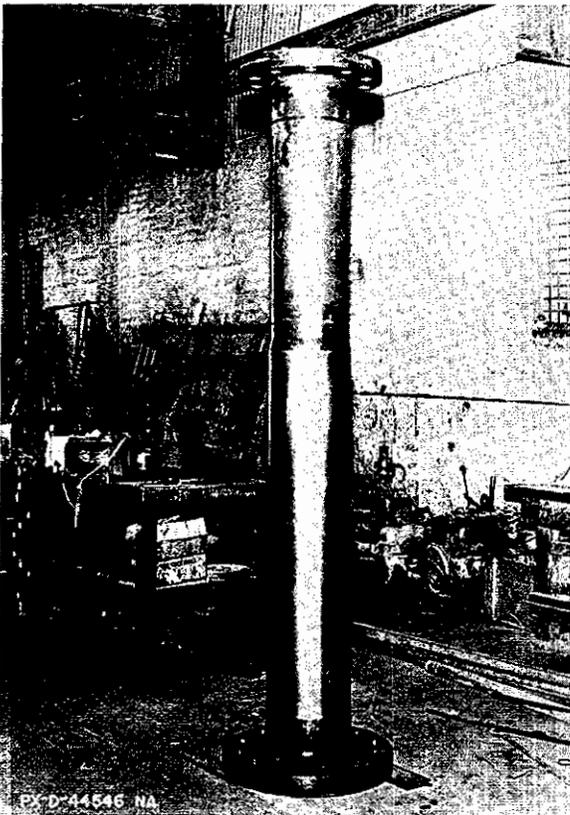
Figure 21.--Girishk Powerplant Unit 2. Turbine shaft after machining undersize to eliminate grooving. Shaft will be used temporarily while Unit 1 is shut down for examination.

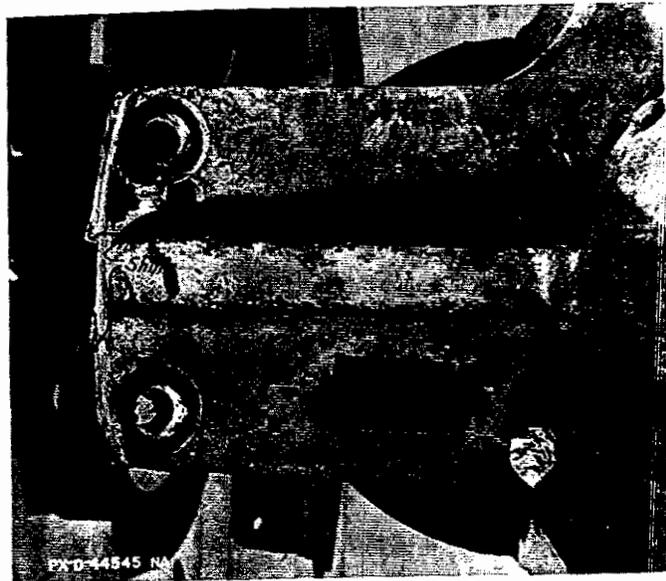
Figure 23. --Girishk Powerplant Unit 1. One leg of bearing bracket showing boltholes drilled oversize and filled with lead, and shimming to compensate for turbine misalignment.

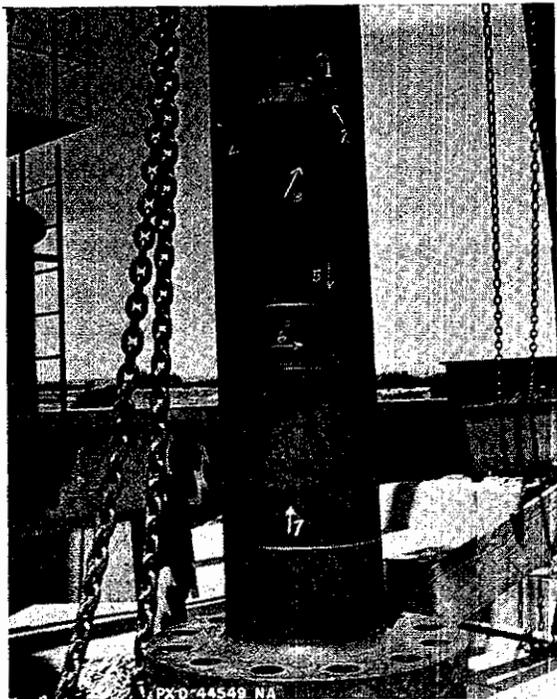
5. A visual inspection of the shaft showed severe wear over the entire bearing area. Apparently, most of the wearing had been done before the present bearing was installed as the bearing showed little wear. The turbine shaft measured 0.120 inch flat at Point A - (Drawing No. 6). From Point A, the shaft tapers at an angle to the centerline 0.124 inch to Point B. This makes the shaft a total of 0.244 inch undersize at Point B.

Figure 25.--Girishk Powerplant Unit 1. Turbine shaft bearing area showing severe worn surfaces. Area between 2 and 5 is the main bearing area.

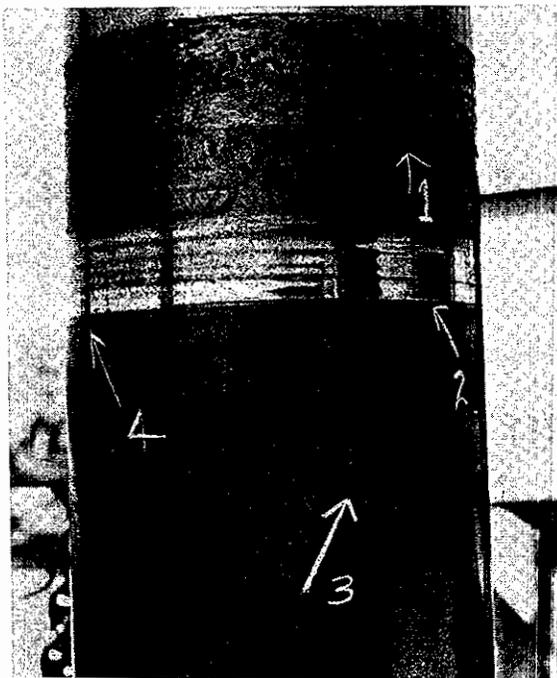
Figure 26.--Girishk Powerplant Unit 1. Turbine shaft--Area 1 is upper packing gland surface. Area between 1 and 2 is upper packing surface. Note pitting in bearing Area 3. Note eccentric wearing at points 2 and 4. This is likely caused by shifting of the shaft center as wear occurs on the shaft and bearing.

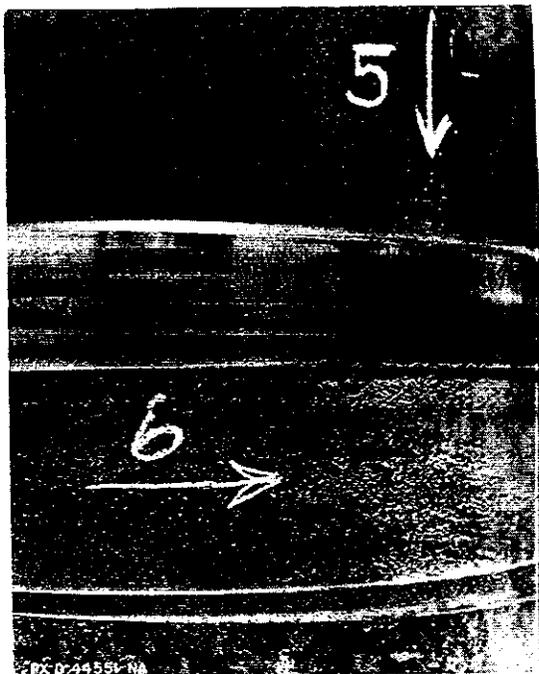
Figure 27. --Girishk Powerplant Unit 1. Turbine shaft showing severe wear. Groove between 5 and 6 was caused by the lower packing which was missing completely at time of disassembly. Area 6 shows galling under the packing gland.

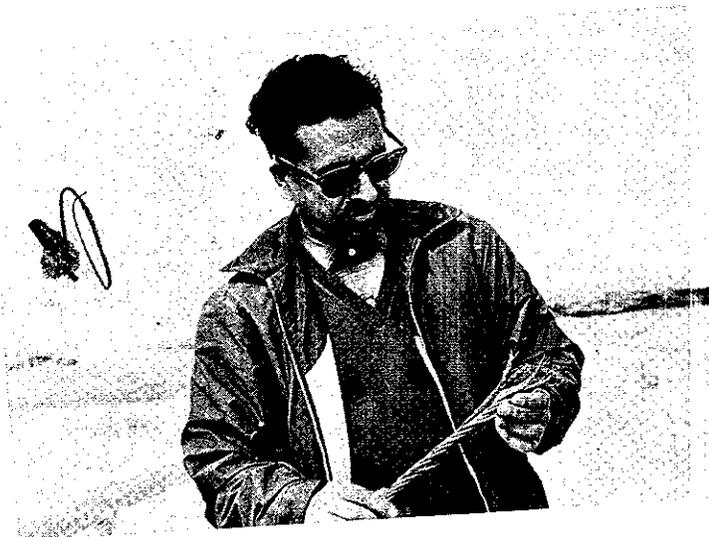
Figure 32. --Boghra Canal Checkgate. Wire rope on one checkgate was rusted through.

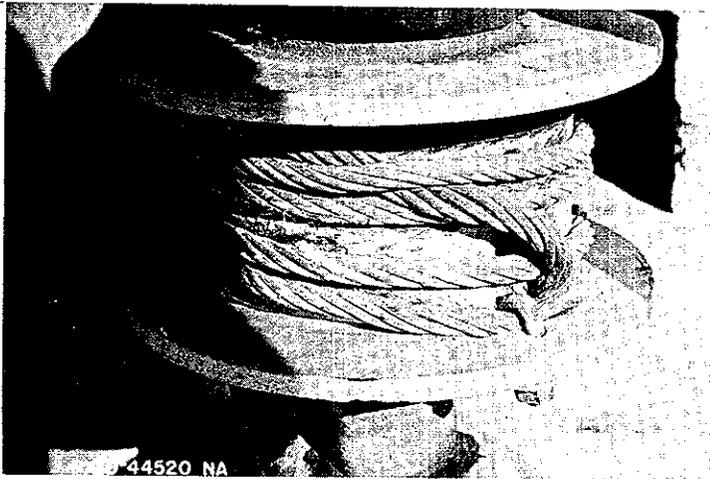
Figure 33.--Boghra Canal Waste-way. Wire rope drum shows type of anchorage and rope winding over loose end.

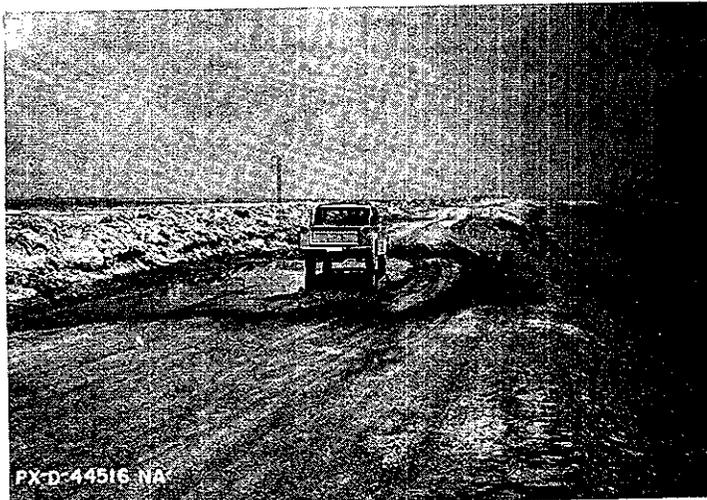
Figure 37. --Canal bank. Mudhole formed on canal roadway by blocking drainage with material removed from canal when cleaning.
