Structural Vulnerability Assessment for St. Kitts and Nevis

Post-Georges Disaster Mitigation Project in Antigua & Barbuda and St. Kitts & Nevis

July 2001

This report was prepared under contract with the OAS by Elmes and Associates, Engineers, Surveyors, Architects. Basseterre, St. Kitts

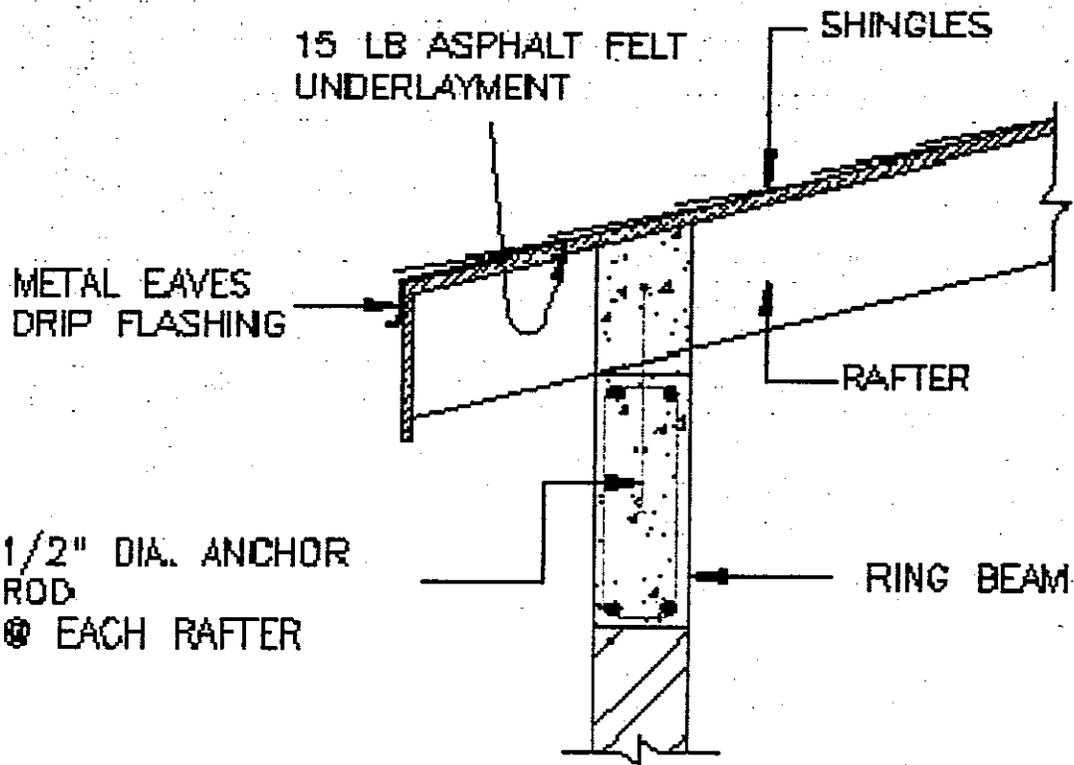
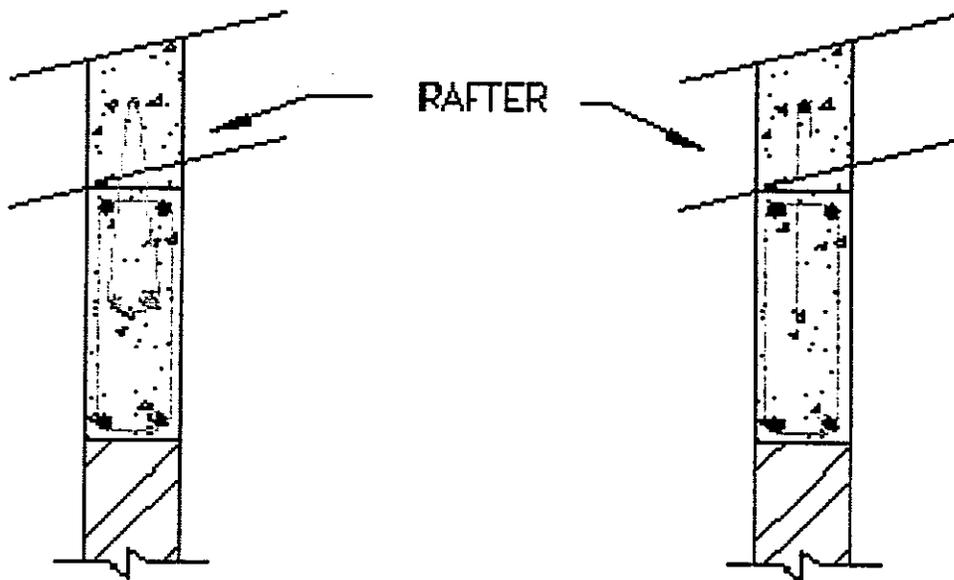
APPENDIX 1

WOOD RAFTER ANCHORING PRACTICE
NO LONGER RECOMMENDED DUE TO BAD EXPERIENCE
(WITH RAFTER SPLITTING UNDER HURRICANE WINDS)
