**Structural Vulnerability Assessment of Selected  
Government Facilities:  
Antigua and Barbuda**

**Post-Georges Disaster Mitigation Project  
in Antigua & Barbuda and St. Kitts & Nevis**

**July 2001**

This report was prepared under contract with the OAS by Everton Cornelius of VEC Consulting, with review assistance by the Antigua/Barbuda National Office of Disaster Services and Public Works Department.

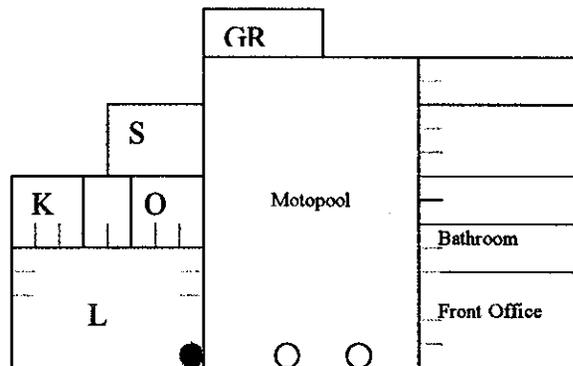
## St. Johns Fire Station

1. Built in 1956
1. The Total Square Footage of This Facility is 5,685.
2. The yellow area represents two-story block. The top Floor is sleeping quarters.
3. The additions to this Facility Was added at different Intervolves over time.
4. The area is well drained and Don't have a history of Flooding.
6. The Building has no Shutters
7. Geographical Location GR240931

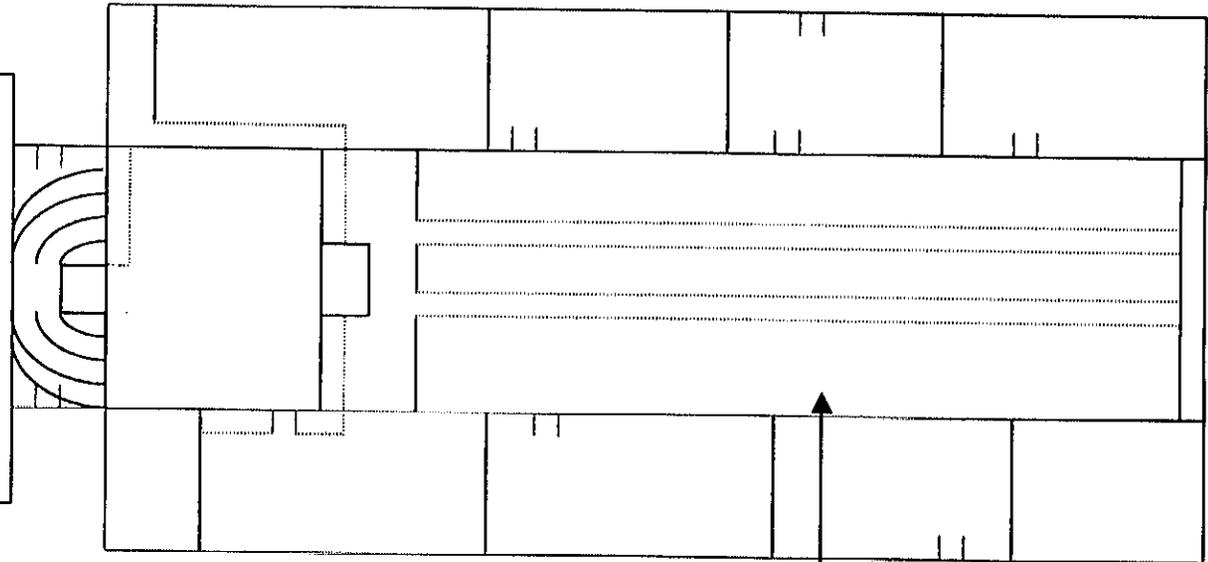
# General Post Office

1. Built in 1967
2. One Building Facility
3. Total square Footage = 17,600
4. Flat shed roof
5. This is a two story Building
6. Geographical Location GR222938
7. Yellow represents two story
8. This building has no shutters

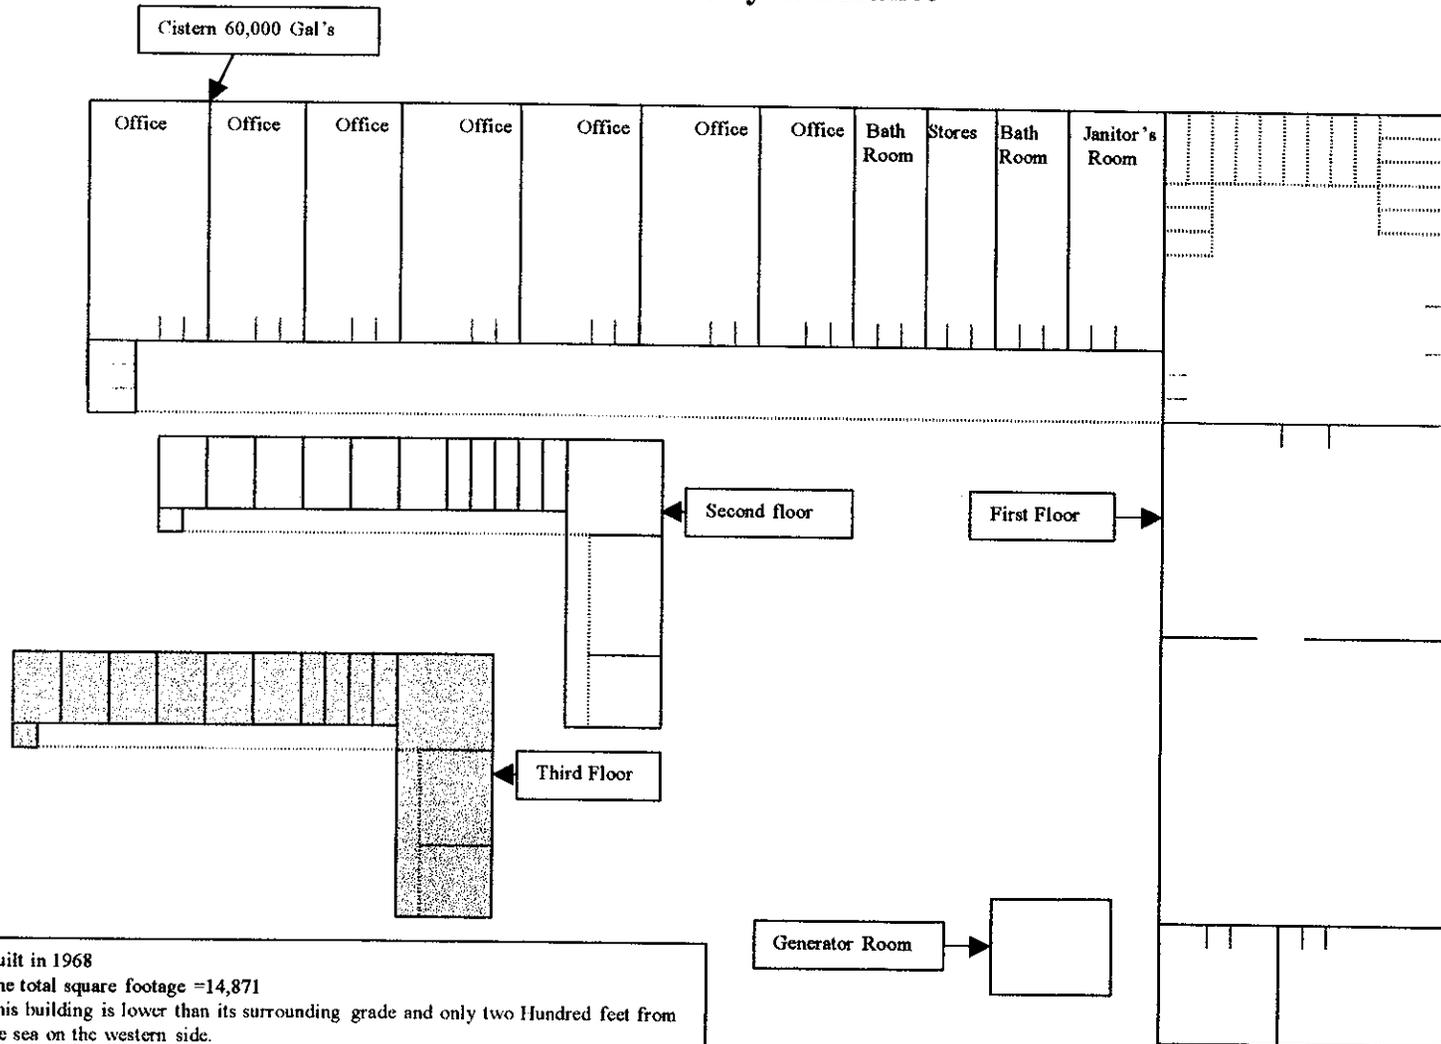
# Ministry of Finance

1. Built in 1968
2. The total square footage =14,871
3. This building is lower than its surrounding grade and only two Hundred feet from the sea on the western side.
4. Wooden Doors, Building has no shutters
5. Single Building Facility, three story
6. Geographical Location GR 222938
7. The yellow represents the two story area
8. Pink area represents the three story area

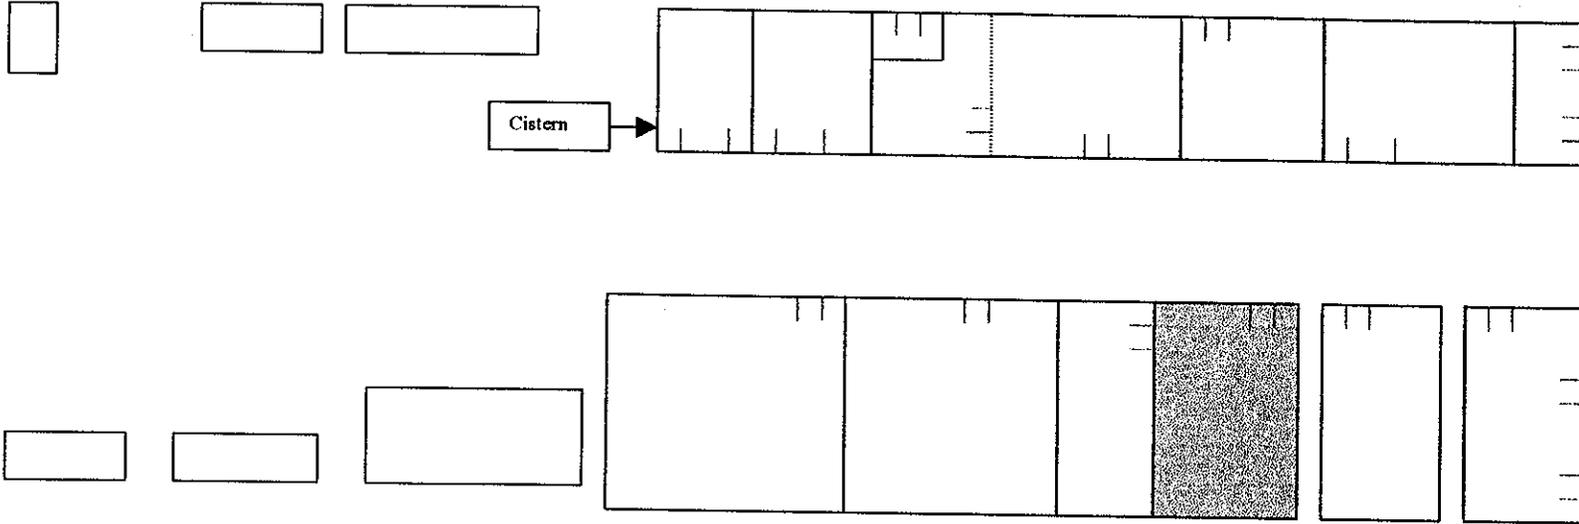
# Ministry of Public Works

- 1. Total square footage = 13,800
- 2. Built in 1965
- 3. Location GR 229937

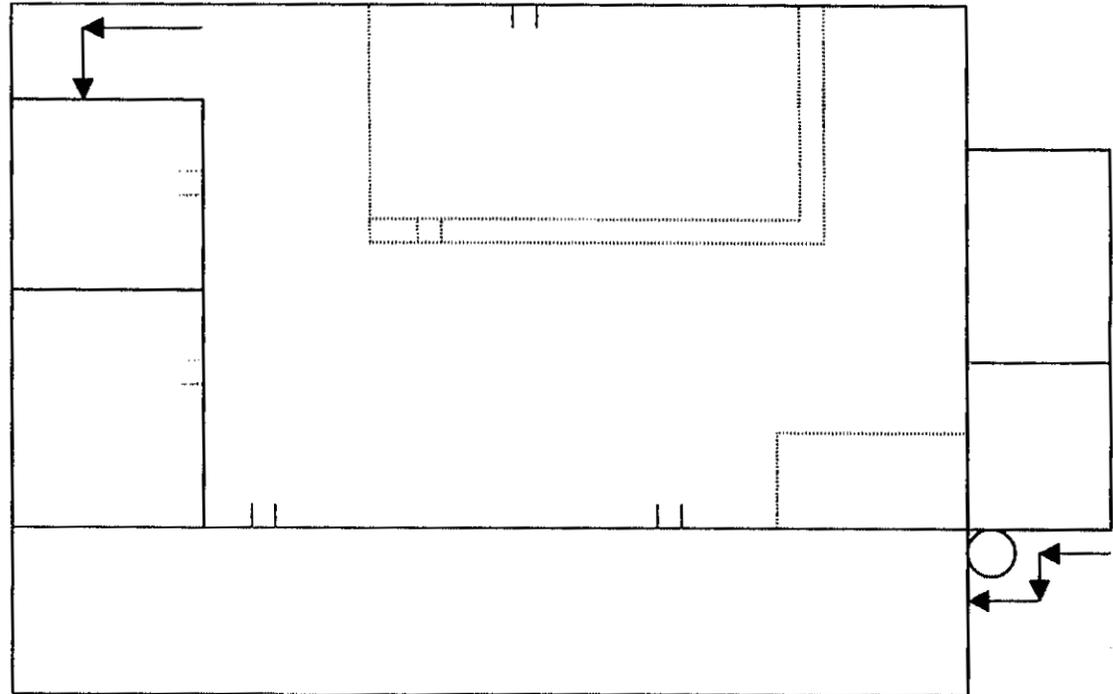
# Treasury

1. Total square footage 7,392
2. The Building has no shutters
3. Major repairs were carried out in 1991.
4. The building is Vulnerable to debris from its old parking garage
5. Single building facility
6. Geographical location GR233932
7. Built in 1837
