UNITED STATES AGENCY FOR INTERNATIONAL DEVELOPMENT

Moldova Weatherization Program

FINAL REPORT

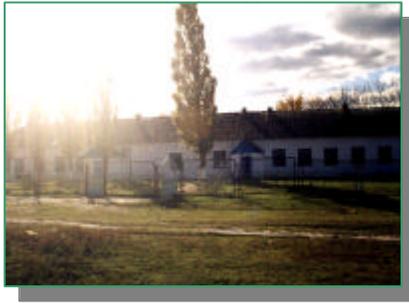
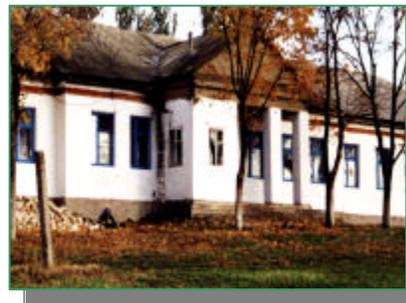
Socii Noi Auxiliary Boarding School

The technical condition of campus is poor. Severe roof leakage and moisture problems were mentioned in many places. According to the director, the campus was not repaired for many years due to lack of financing. There are approximately 39 windows and 8 entrance doors in the school buildings, with the total surface of 98.63 sq.m. Most of windows are double-paned with two panes operating separately. The condition of windows and doors was estimated as poor. The entrance doors need to be replaced, as they deteriorated over the years. All the windows face poor fitting, miss hardware and do not close tightly. The sash frames on most of windows deteriorated and need to be replaced due to putrefaction. Glass is missing on one or two panes on many windows. There are windows on the campus, which do not operate at all and can not be repaired or restored. No insulation materials were observed on any windows or doors.

Conclusions: The school was recommended by Ministry of Education as priority site for weatherization program. The windows are in very poor condition and heat losses occurs through gaps between window sashes and frames. Extensive repair work will be required prior to installation of

weatherization materials. The site is reasonable for the weatherization project due to high occupancy, number of students and the specific nature of school occupants. The piping system needs rehabilitation work, as the pipes are frequently leaking in winter.

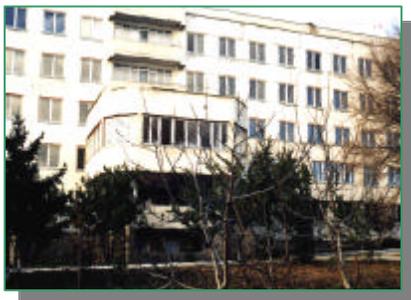
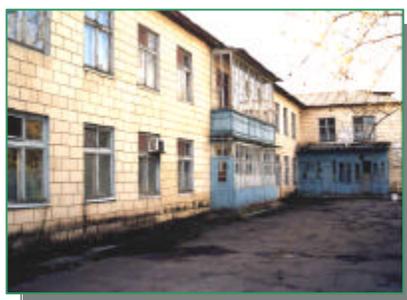
Falesti Central Hospital

The general condition of the buildings is fair. Minor roof leakage problems were noticed in the central hospital building, as well as signs of humidity on the basement. Roof repair works were performed last year. The second floor of maternity building is in the process of reconstructing now, the space will be used for children with infantile cerebral paralysis. No general structure problems were mentioned in any of the campus buildings. There are 513 windows in all of hospital buildings together, including 66 items in the maternity building. There are old type aluminum windows in the main hospital building, which deteriorated over the years. Many of wood windows in the remaining buildings do not close tightly due to poor fitting. Also, the hospital faces huge problems with cracked and missed glass on windows.

Conclusions: The site is a good candidate for weatherization from technical point of view, although there are some concerns with roof leakage problems. The windows are in satisfactory shape and can be restored with regularly repair work. The other reasons for site selection are the high occupancy rate, the number of beds and the number of population it's serving. The maternity building was selected for energy efficiency improvements, which will make the weatherization transparent, as it's the only heated building in the campus. Weatherization will increase the building's energy efficiency and improve living conditions of hospital population since the level of heating provided is very poor.

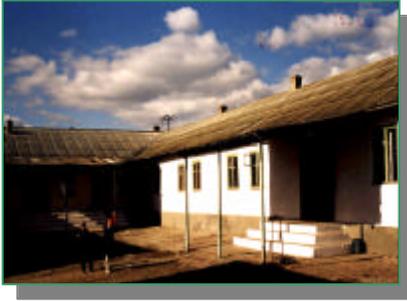
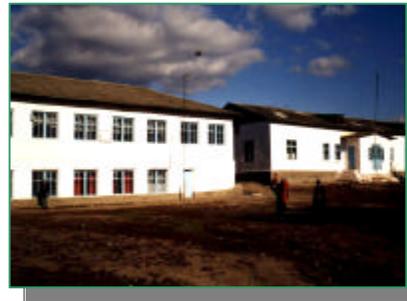
Albinetel Vechi Auxiliary Boarding School

The boarding school has been operating since 1971. Since 1950, when the classroom building was constructed, it housed primary school students. The dormitories were added in 1990. The total volume of buildings is 8739 m³. The buildings are in reasonable good shape, partially due to frequently sponsorships, which come from various Christian organizations. During the summer of 2000 general repair works were performed of all the buildings. No general structure or moisture problems were mentioned. There are 89 double-paned windows and 10 entrance doors in all of the campus buildings. Minor signs of deterioration or deformation of windows were noticed. Many windows miss glass on one pane, the window hardware does not operate properly. The director estimated an amount of 280 sq.m. of glass to replace the cracked/missing glass.

The school has its own coal-fired boiler, operating with 2 boilers installed in 1986. The average consumption of coal is 11 tones per month, which meets the campus heating needs. The temperature in the boarding school during the heating season of 2000-2001 was about 14 °C and reported as improper, compared to previous heating seasons. Partially this is due to cold air infiltration and shortages in electricity supply during the winter.

Conclusions: The site is a good candidate for weatherization program from technical point of view. The school buildings meet technical criteria for energy efficiency works, including the absence of signs of humidity, reasonable shape of windows and overall satisfactory technical conditions of school buildings. Weatherization and glazing will make the buildings more energy efficient and will significantly reduce the heat losses. The boarding school was recommended by Ministry of Education for weatherization project.

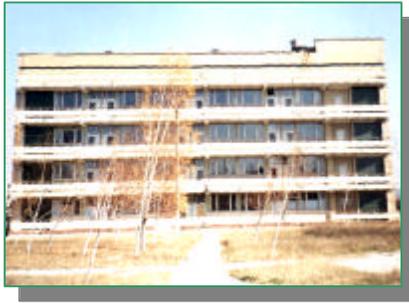
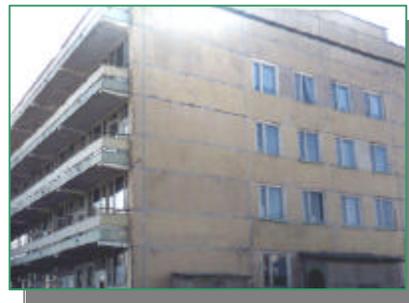
Comrat District Hospital

The general condition of buildings is reasonable fair. Minor roof leakage problems were noticed in all the buildings in the campus, as well as of signs of humidity. There did appear to be general structure problems in any buildings. There are 175 double-paned windows and a total of 69 balcony doors in the main hospital building with the total surface of 580.45 sq.m. The windows are in poor shape. Many windows do not close tightly due to poor fitting. Hardware is missing on all the windows. Also, the hospital faced problems with cracked and missed glass on windows. A need for 180 sq.m. of glass was reported by chief-doctor to replace the broken/missing glass. There are rotten sash frames on many windows, which do not operate due to putrefaction. No insulation materials were observed on any of windows or doors.

Conclusions: Although this site is a good candidate for weatherization due to high occupancy rate, number of population served and the location in one of poorest parts of Moldova, there are some concerns from technical point of view, including unsatisfactory shape of windows. The site can be a reasonable candidate for weatherization program if extensive repair work will be required prior to application of weatherization materials. Glass replacement can significantly reduce energy losses.

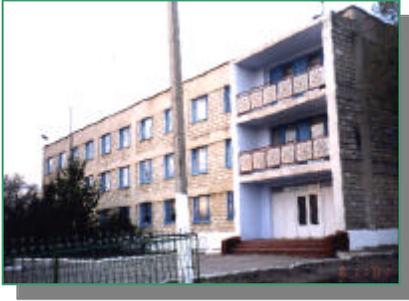
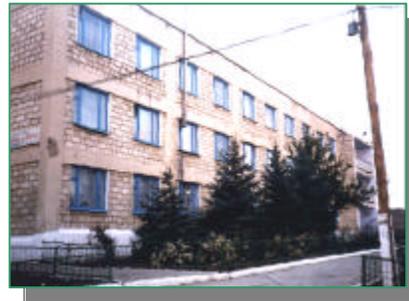
Cupcui Orphanage

The general condition of buildings is poor. The campus was not repaired for many years due to lack of financing. The roof is leaking in some places, minor signs of humidity were noticed, especially on the upper floors due to leaking roofs. There are 73 windows in the orphanage main building, with a total surface of 183.7 sq.m. The windows are double-paned with two panes operating separately. The condition of windows ranges from fair to poor. Most of the windows missed hardware and glass and do not operate properly due to deterioration of sash frames and many coats of paint applied to sash frames. The director estimated that about 150 sq.m. of glass is needed to replaced the broken/missing glass. There are some windows considered out of order.

Conclusions: The site is a good candidate due to specific nature of school population and its location, although there are concerns with poor condition of windows and doors and roof leakage problems. Extensive repair works on windows will be required prior to application of weatherization materials. The Ministry of Education recommended the orphanage for weatherization program, stating that the school is one of the poorest assisted institutions. The location of site was also taken into account while recommending it for weatherization project.

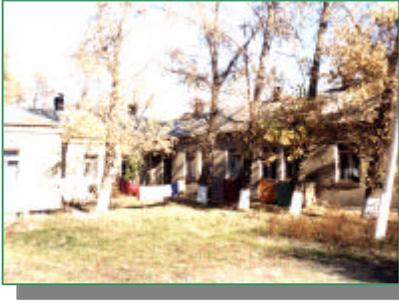
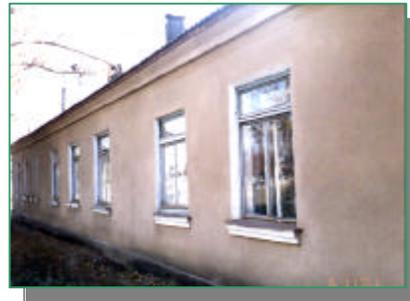
Comrat Boarding House for Elderly

The general condition of building is fair. The roof is leaking, although it was partially repaired last year and caused moisture problems. The hospital buildings date from 1960, but no general repair works were performed over the years. The windows are in poor shape. The sash frames deteriorated on many windows. The other problems mentioned included broken/missing or cracked glass on one pane. The director reported a need for 50 sq.m. of glass. The windows miss hardware and do not close tightly, partially due to many coats of paint applied to sash frames.

The building is connected to district heating network owned by Comrat municipality. According to the director, heating provided is reasonable good, but due to poor condition of windows and heat losses through windows and doors, the inside temperature during the last years was about 15-17 °C.

Conclusions: Gaguzia Departemnt of Labor and Social Protection recommended the boarding house for weatherization program. The site is a reasonable good candidate, although there are some concerns from technical point of view, including roof leakage problems. The windows are poor, but with extensive repair work they can be repaired and restored. Over the last decade, the boarding houses for elderly were reduced in size or closed all over Moldova due to lack of financing. In such a way there are only 3 regional boarding houses, which are not in danger of closure and stay open. The boarding house is appropriate for site selection, given the number of population it's serving, the location and high occupancy rate.

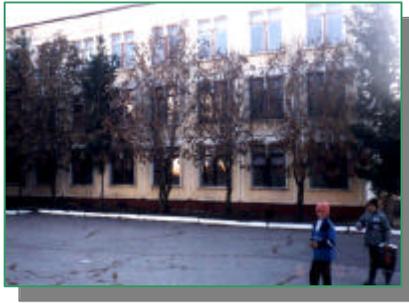
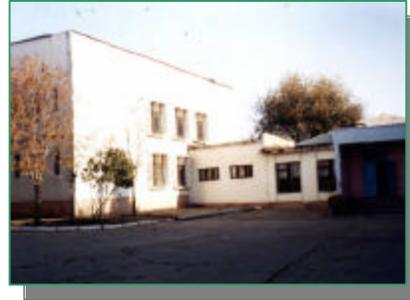
Baurci-Moldoveni Secondary School

The classroom building is in reasonable good structure shape. No roof leakage or moisture problems were reported. In 1999 the roof was repaired and partially replaced. There are approximately 175 windows and 11 entrance doors in the building, with the total surface of 557 sq.m. The windows are double-paned with the two panes operating separately. Every year attempts are made to keep the windows in proper condition, although the windows and doors face huge problems and their condition was estimated as poor. 20% of windows had cracked glass on one pane. The other problems mentioned included rotten sash frames on many windows and deteriorated windows.

Since 1938 the school was heated from the coal-fired boiler house located in the neighborhood, which provided heating to other public buildings in the village. Three years ago the school was disconnected from heating and coal-fired stoves were built in the school building. The average consumption of coal is 6 tones per heating season, which is unsatisfactory. According to the school director, the inside temperature during the winter is about 15° C due to inadequate heat supply and cold air infiltration.

Conclusion: Cahul Department of Education recommended the school for weatherization program. The site is a good candidate due to high occupancy rate, the number of students it's serving and the location. Also, the classroom building meets technical criteria for energy efficiency works, including proper condition of roof, absence of signs of humidity and the overall satisfactory shape of school building. As the quality of inside room temperature is poor, insulation works on windows and doors will

result in better working and living environment and improve the building's energy efficiency. Also, glass replacement will significantly reduce the energy losses.

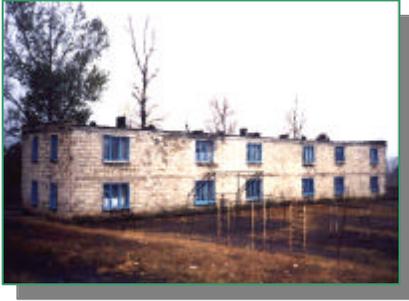
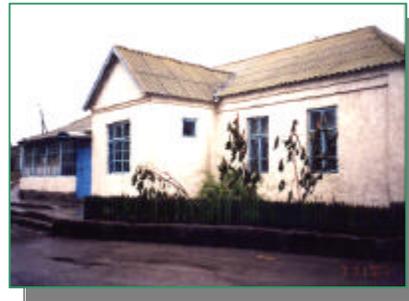
Popeasca Auxiliary Boarding School

The general condition of buildings is very poor. The roof is leaking in the dormitory building. There appeared to be problems of general structure, the envelope of the buildings deteriorated, as no general repair work were performed in any of the school buildings for many years. There are some problems with increased moisture level. The windows are in very bad shape. The problems noticed include missing or cracked glass on 80% of windows, improper fitting of all windows due putrefaction of sash frames and lack of maintenance over the years. There will be a need to replace the sash frames on 60% of windows. Most windows do not operate at all. No insulation materials were observed on any of windows or doors.

Conclusions: This site is questionable for the weatherization project for several reasons. The windows are very poor and it was estimated that the cost for repair of the window frames could be comparable with the cost of window replacement. No separate building in the campus meets the technical criteria for energy efficiency works on windows and doors, including roof leakage and moisture problems. The windows and doors deteriorated over the years and can not be repaired or restored. The site can be a

candidate for the project, if adequate budget is available for window replacement or extensive repair work. The school is one of most needy boarding schools in Moldova. It was recommended by Ministry of Education.

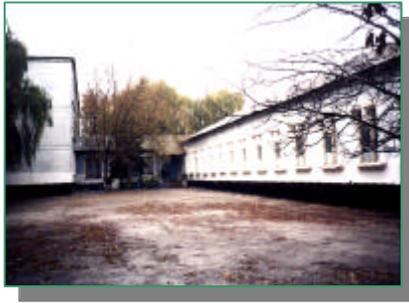
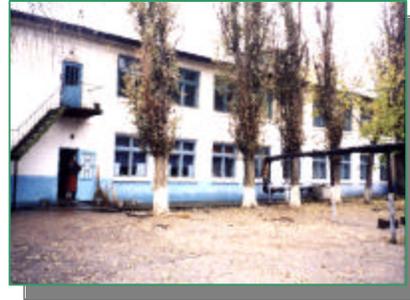
Ialoveni Lyceum

Conclusions: The site is reasonable good for weatherization project due to high occupancy rate and the large number of students served. Moreover, as the school switched to gas heating, which is more energy efficient and transparent, weatherization works and glazing will significantly reduce the energy losses. Although, there are some concerns from technical point of view, including poor condition of windows and doors. An extensive repair work to the window frames will be required prior to application of weatherization materials. Sash frames on most of windows need to be replaced.

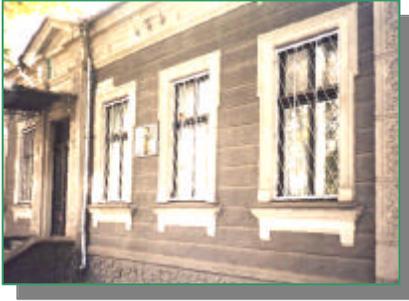
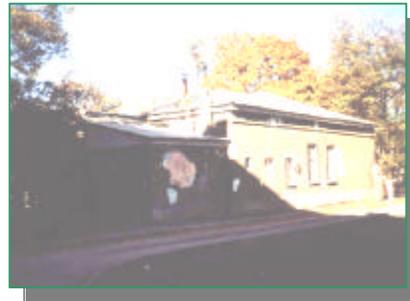
Chisinau Technical School for Blind Children

The school has been operating since 1975, although the building was constructed in 1920. The campus consists of one building, which houses the classrooms and workshops. The total volume of building is 2100 m³. Before 1975 the campus housed kindergarten children. There are 20 windows and 1 entrance door in the building. All the windows are double-paned with the two panes operating simultaneously. The general condition of building is fair. Although the building dates from 1920, no general structure problems were noted. The roof is not leaking and minor signs of humidity were mentioned in some places. The windows are very poor, they deteriorated over the years and face very poor fitting: the sash frames rotted, hardware is out of functioning and many coats of paint are applied to sash frames. There are 6 windows, which do not operate at all and need to be replaced. A few windows miss glass on one pane. The director reported a need for 20 sq.m. of glass to replace the broken/missing glass. The school is heated badly, the heat is provided from the gas-fired boiler located inside the building. The average consumption of gas during the winter is of about 2656 cub.m. per month, which is improper to the school needs, according to the school director. The inside temperature was reported as unsatisfactory, about 12-13 °C during the winter.

Conclusions: The representatives from Ministry of Education recommended the technical boarding school for weatherization program, as one of most needy institutions. The site is a reasonable candidate due to high occupancy rate, specific nature of school occupants and its uniqueness. Although, the school building is a questionable candidate for weatherization, given the very poor condition of windows. Extensive repair work will be required prior to application of weatherization materials. Six of windows need to be replaced.

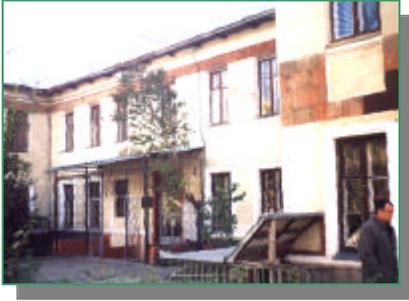
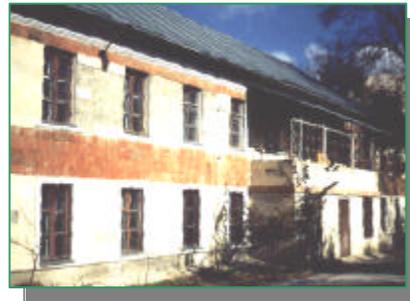
Chisinau Technical School for Deafen Children

The general condition of building is fair. The school faces some general structure problems, during rainy weather the water is leaking in the basement area, causing increased moisture problems. The other problems noticed include leaking roof in some places and deteriorated building envelope, which are in need for repair. The windows are very poor, they deteriorated over the years and face very poor fitting: the sash frames rotted, hardware is out of functioning and many coats of paint are applied to sash frames. There are windows that miss glass on one pane. The director reported a need for 50 sq.m. of glass to replace the broken/missing glass. No insulation materials were observed on any windows or doors.

Conclusions: The representatives from Ministry of Education recommended the technical boarding school for weatherization program, as one of most needy institutions. The site is a reasonable candidate for weatherization program due to high occupancy rate, specific nature of school occupants and its uniqueness. Although, the school building is a questionable candidate from technical point of view, given the poor condition of windows, leaking roofs and increased moisture level. Extensive repair work will be required prior to application of weatherization materials. After weatherization of windows and doors the building may become more energy efficient, since the heating system was recently rehabilitated.

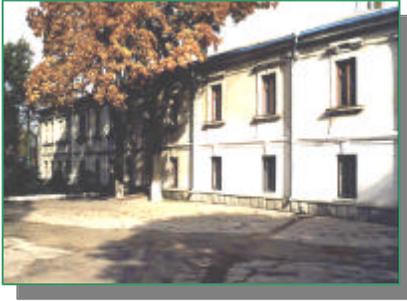
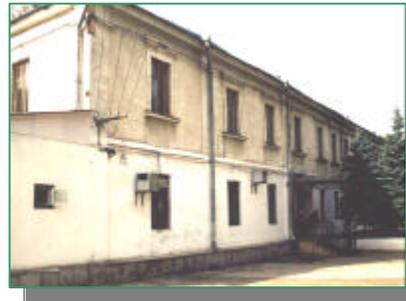
Chisinau Auxiliary Boarding School #7

Conclusions: This site is a good candidate for the weatherization project due to high occupancy rate, the number of population it's serving and specific nature of school population. Although, there are some concerns from technical point of view: the windows are poor and extensive repair work to sash frames will be required prior to application of weatherization materials. The classroom building was selected for weatherization. The site was recommended by Ministry of Education as priority institution, given the experimental curriculum the school occupants started to follow last year. Weatherization may significantly reduce the noise and dust levels and lead to better living and working conditions of school population.

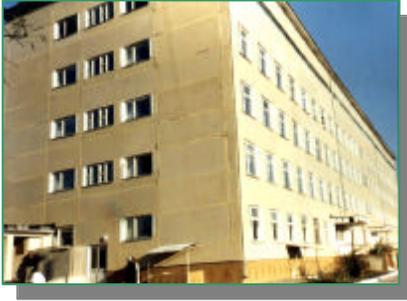
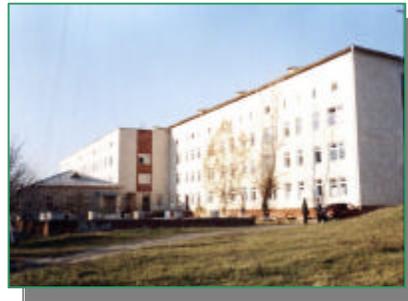
Hincesti District Hospital

Conclusions: The site is a good candidate for weatherization program, the reasons for selection are the high occupancy rate, the number of beds, number of population it's serving and recommendations from Ministries. Not all the buildings meet technical criteria for energy efficiency works. There are some concerns with roof leakage problems and signs of humidity. The windows are in poor condition, but can be restored with extensive repair work. The windows are of special design, with two panes operating separately, but not bolt-jointed. Also, meticulous procedure will be required to fix the windows in their initial position due to their partial deterioration. Two buildings, which are in appropriate shape for energy efficiency works, were selected for weatherization.

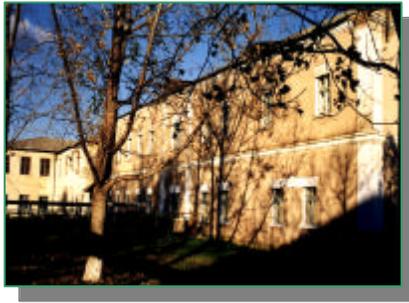
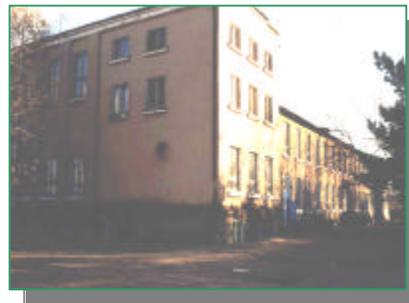
Cazanesti Orphanage

The general condition of buildings is very poor. The roof is leaking in all the buildings. According to the director no roof repair works were performed for more than 30 years. There appeared to be problems of general structure in the older buildings, the envelope of the buildings is deteriorated. Also, increased moisture level was noticed in many places. The windows are in very bad shape. The problems include missing or cracked glass on 65% of windows, improper fitting of all windows due to putrefaction of sash frames and lack of maintenance over the years. All the window hardware needs to be replaced. There will be a need to replace the sash frames on 30% of windows. Most windows do not operate at all. No insulation materials were observed on any of windows or doors.

The school is heated from the boiler house located on the property of the school. It operates on coal. The boilers were replaced in 1999. The level of heating was reported as normal. The inside temperature during the winter is about 18 °C.

Conclusions: This site is a reasonable candidate for weatherization project due number of students served, specific nature of school residents and location. Although, there are some concerns as the windows are very poor and extensive repair work to sash frames will be required prior to application of weatherization materials. The site can be a candidate for the project, if adequate budget is available for extensive repair work and partial replacement of sash frames. The orphanage was recommended by Ministry of Education as priority site.
