## **Caribbean Disaster Mitigation Project**

**Caribbean Electric Utility Services Corporation**

# **Case Study of the Effects of Hurricane Luis on the Buildings and other Structures of the Electricity Section of the Antigua Public Utilities Authority**

1996-02-23

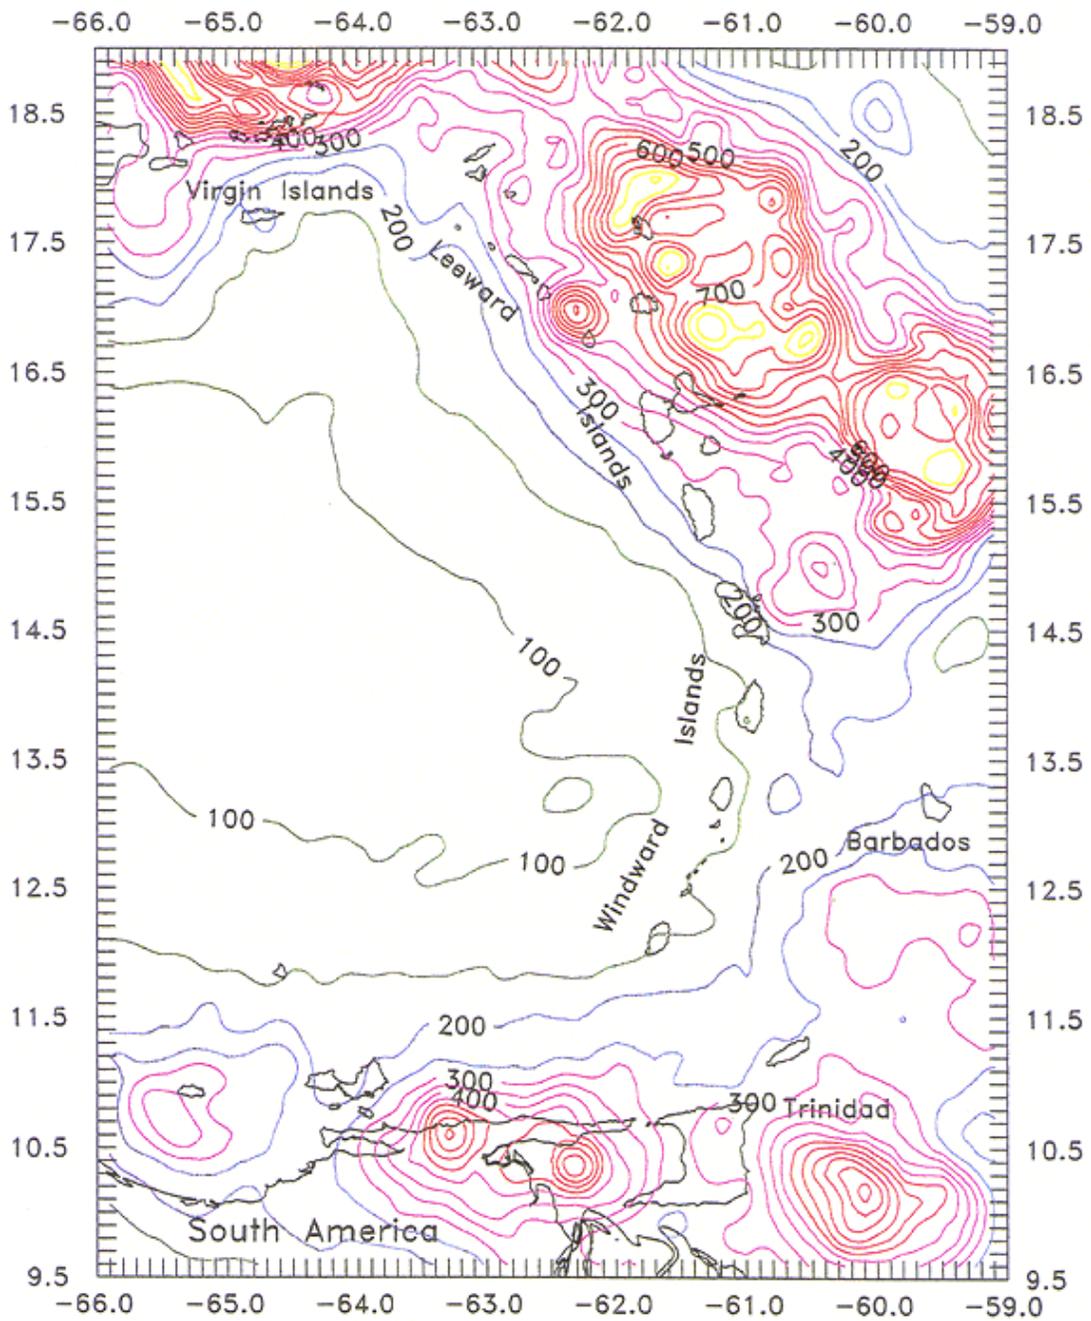
**Figure 2: Regional isoacceleration map**

Source PAIGH: contour interval 50 gals
