# Umm Qasr Port Assessment

USAID TRN-03-009

## Draft Report

April 2003

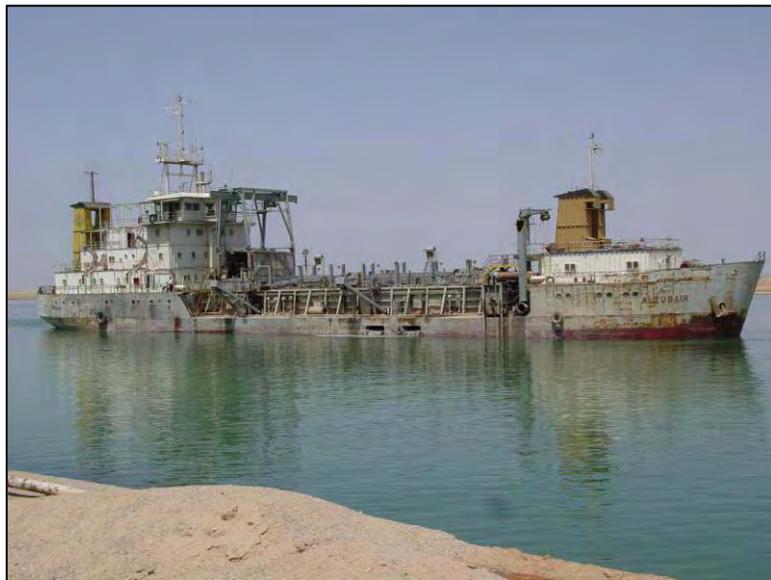
There appears to be only one or two old hopper dredges reasonably available for reactivation for use in the Port and approach channel area, see Photo 3.2.11-1. The British Military are attempting to repair and restart the dredges and man them with local workers supervised at least temporarily by the British Military. If the dredges have been unused for some time and were poorly maintained, as is apparent, reactivation on a reliable basis may be impractical without major overhaul. Retraining a local crew, especially replacing the officers, will take considerable time.

*Photo 3.2.11-1 The Hopper Dredge Alzubair Dredging at the Grain Terminal.*

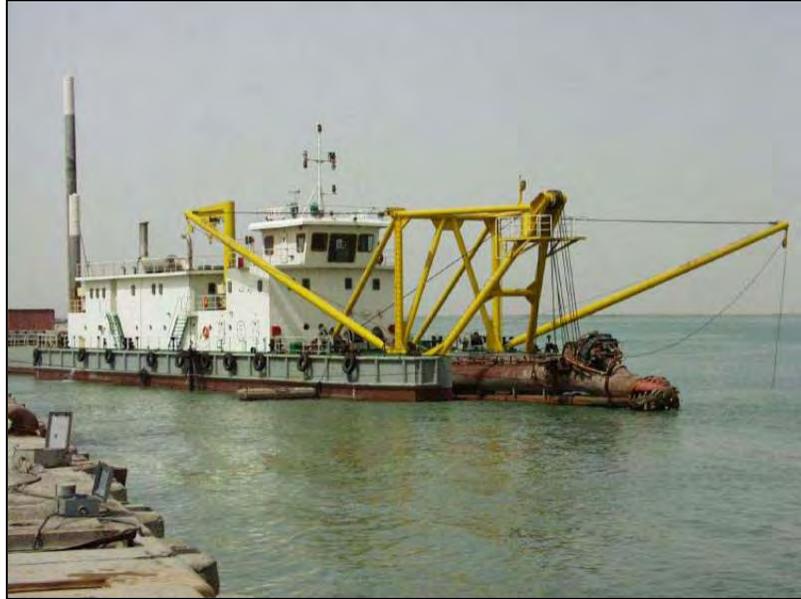
One medium cutter-suction dredge of about 500 mm discharge line, see Photo 3.2.12-1, is in reasonable condition for reactivation. This dredge currently has a very short discharge pipeline with a nozzle welded on to provide the minimum required centrifugal pump back pressure and to spread the dredged materials as far as possible without longer lines available. Another smaller cutter-suction is on site, but has not been evaluated fully at this time. The locals have indicated it was scheduled to be placed in the on-site dry dock for needed repairs. The unavailability of

*Photo 3.2.12-1 Cutter Suction Dredge.*

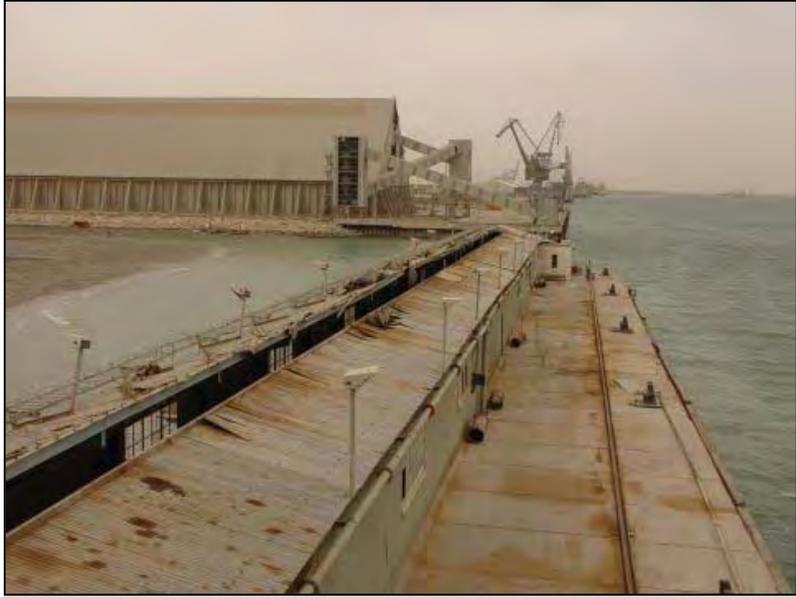
**Photo 4.1.1.1-4 Wharf Conveyor has No Capping Seal between Roof Sections**

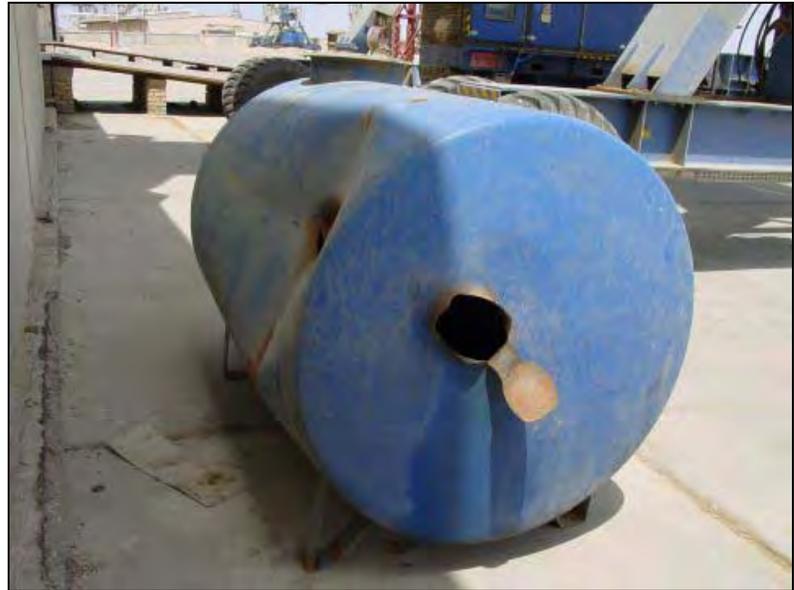
**Photo 4.1.1.1.2-2 Fuel Tank on One Vacuator Sustained Damage.**

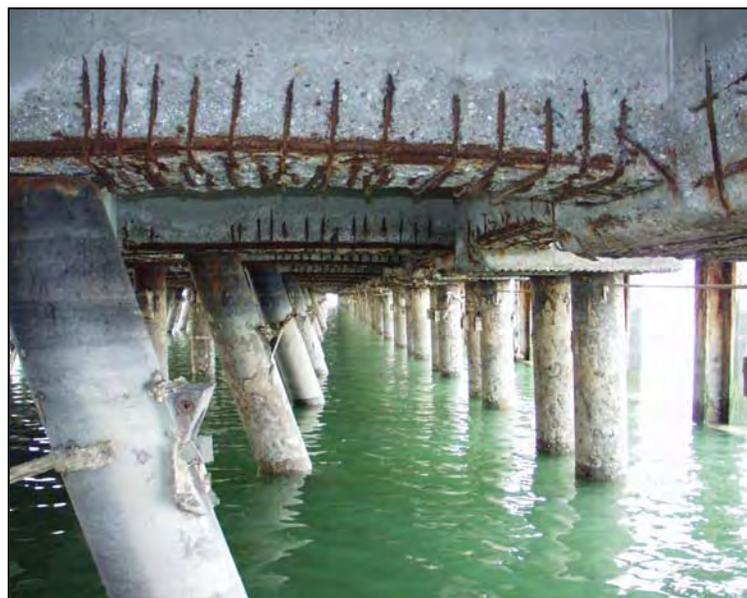
***Photo 4.1.2.1.4-4 Exposed or Missing Rebar on All Concrete Caps, Appears to Have Had Some Prep Work for Repair.***

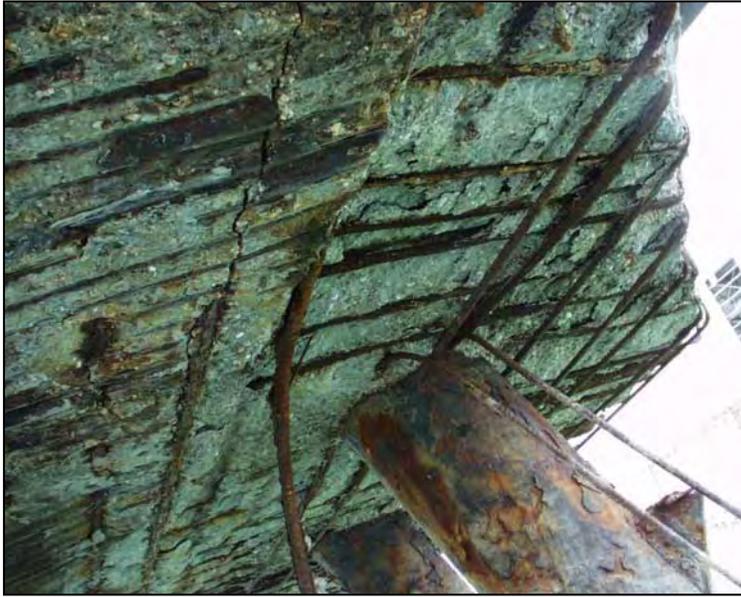
***Photo 4.1.2.1.4-7 Bottom of West Dolphin Appears to Have Had Some Prep Work for Repair.***

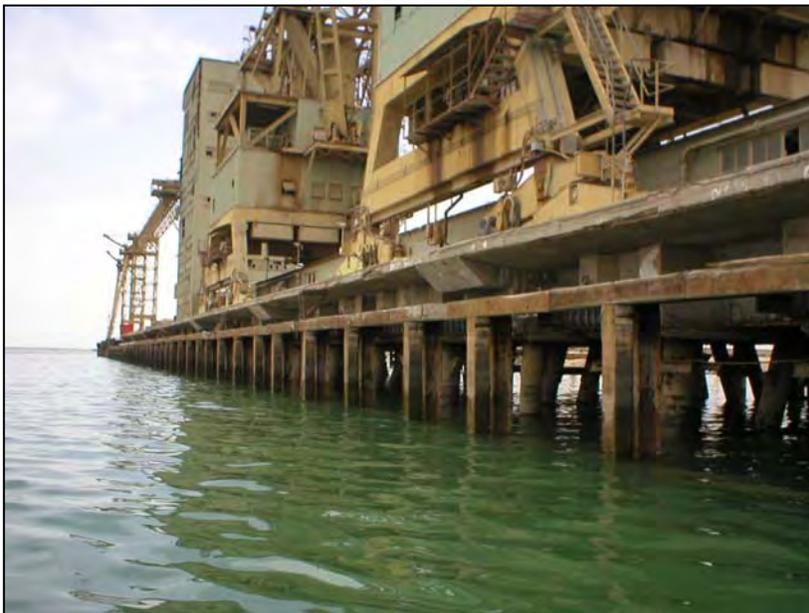
The fendering system at the main wharf is in poor condition. See Photos 4.1.2.1.4-8 and 4.1.2.1.4-9. At the main wharf section, it consists of steel H piles at 3.5 meters on center with two horizontal steel wales. See Photo 4.1.2.1.4-10. The wearing face of the fender system is timber. The fendering system is attached back to the wharf by rubber buckling fenders. The H piles have fairly thick flanges and appear to have little section loss.

***Photo 4.1.2.1.4-8 Fendering at Main Wharf.***

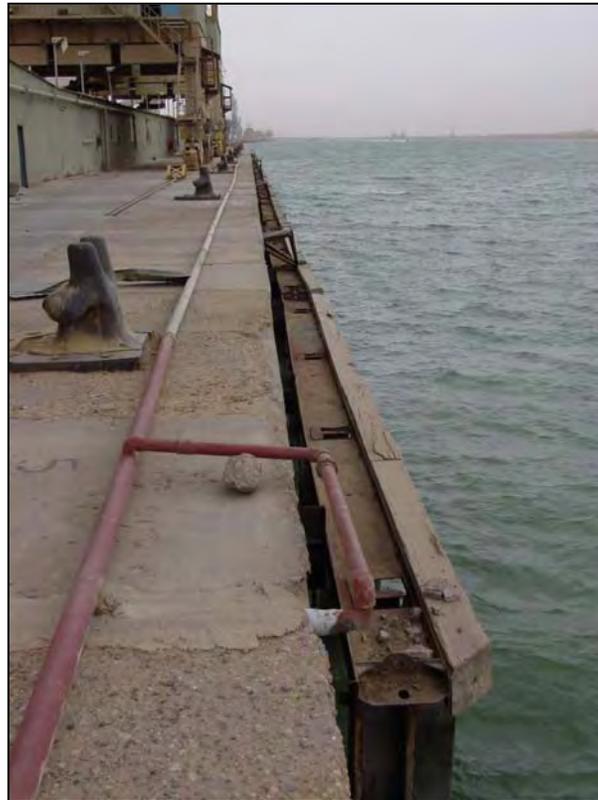
*Photo 4.1.2.1.4-9 Bollards and Fendering at Main Wharf.*

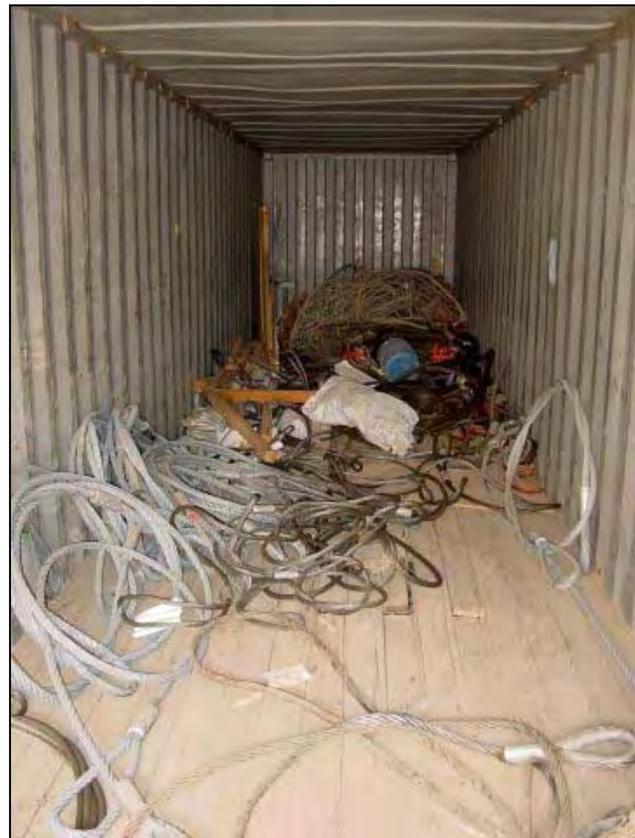
A search of the Port revealed only a minimum amount of soft gear, i.e., wire rope, slings, nets, shackles, lifting bars, etc. Additional soft gear will be required for vessel operations. Lifting gear of this type should be marked and proof load tested to comply with international regulations affecting safety. The components inspected did not display any form of safe load marking or identification that could be traceable to testing certificates. Nevertheless, most of the gear appeared to be in good condition and could possibly be used in a de-rated application. There is also a requirement for lifting platforms of various types and sizes and a need for large number of cargo boards (pallets) (500 to 1,000 estimated).

**Photo 4.2.1.1-7 Freight Container Holding an Assortment of Used and Uncertificated Slings, Shackles, and Cargo Hooks.**

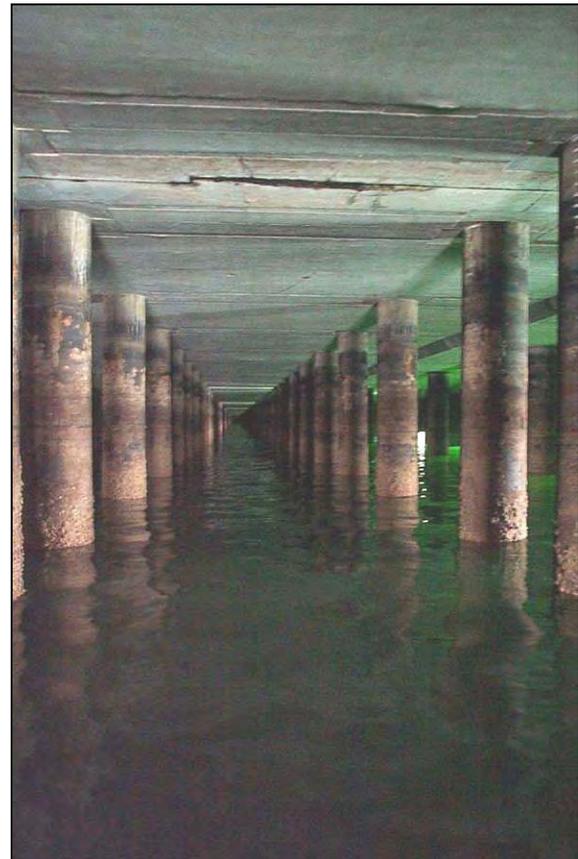
**Photo 4.2.2.1.3-4 Typical Pile Condition at "New" Port.**

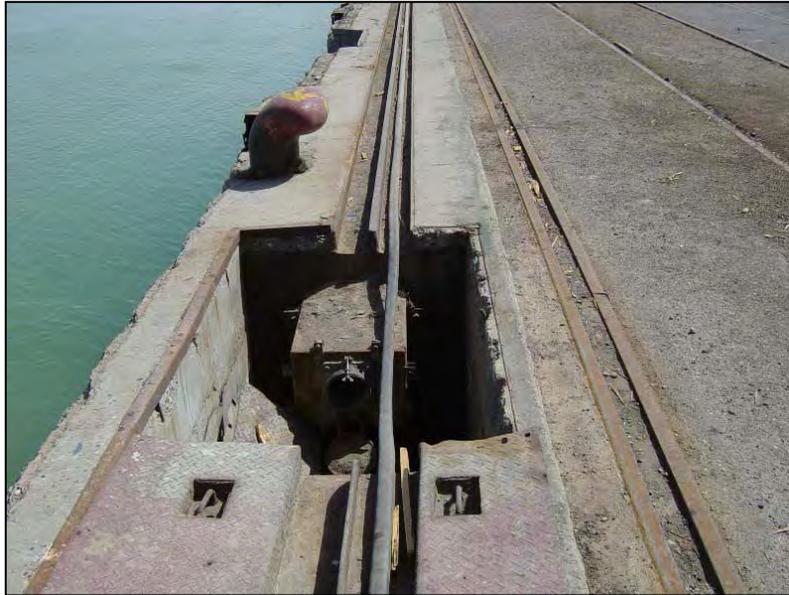
***Photo 4.2.2.1.3-5 Typical Condition of Power Connections at the Wharf Face.***

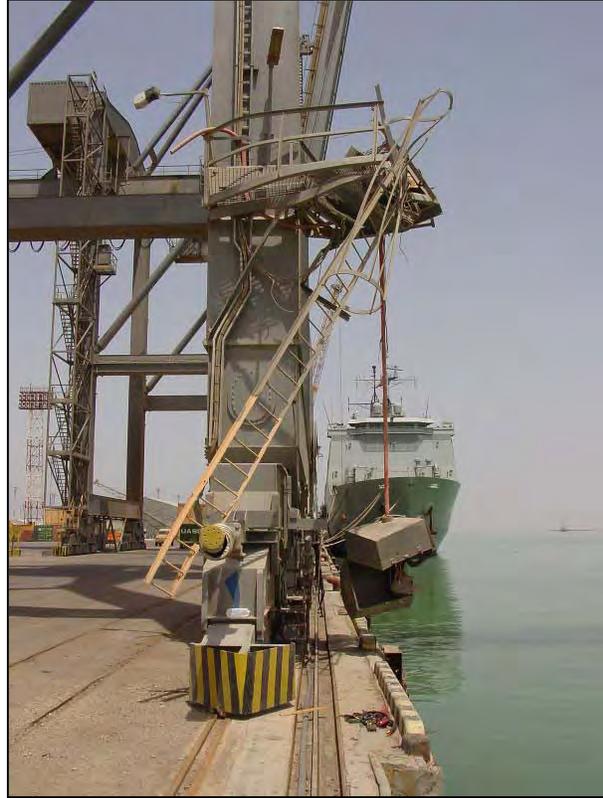
Two Nelcon quay cranes are installed in the “old” port serving Berth 5, see Photo 4.3.1.1-1. These Nelcon cranes are very old and the condition is unknown. One crane suffered damage to its cable reel assembly as the conflict started and it has been stuck in a boomed down position. See Photo 4.3.1.1-2.

**Photo 4.3.1.1-2 Damage to One of the Nelcon Cranes.**

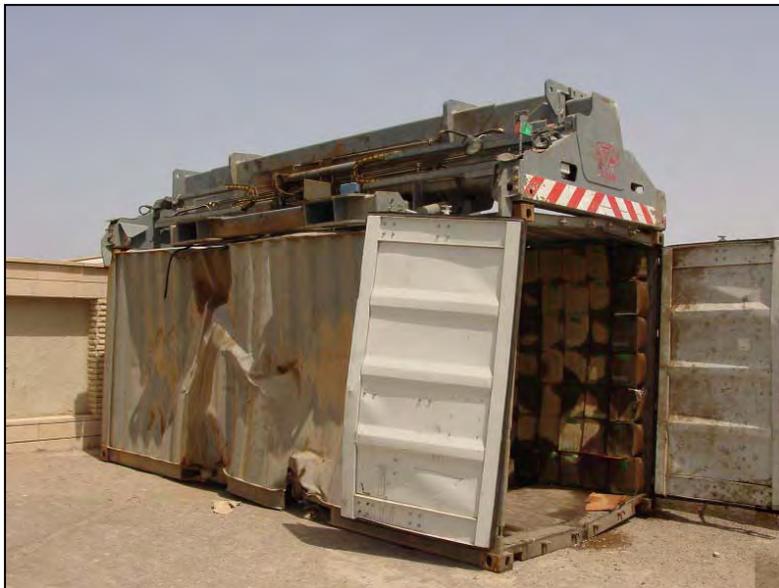
**Photo 4.3.1.1-6 One Spreader of a CVS Ferrari Top Pick Remains Locked onto a Damaged 20-Foot ISO Container.**

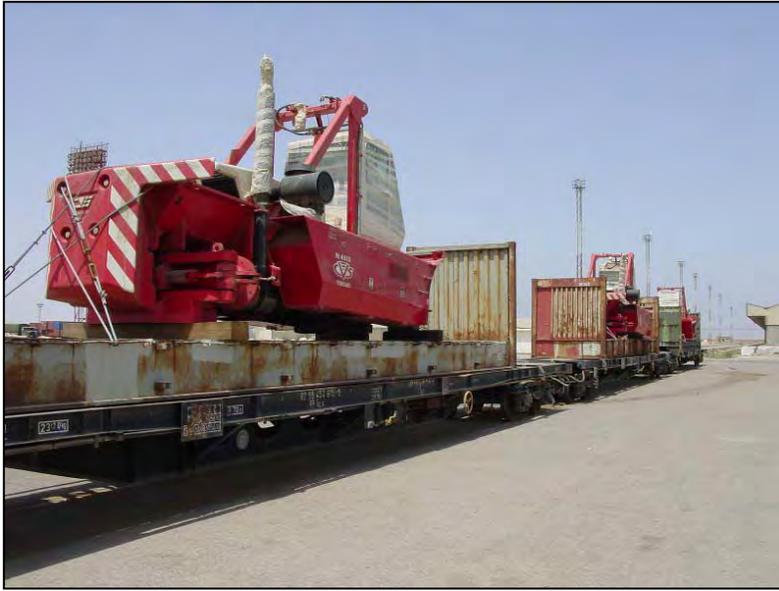
In addition, it was noted that the chassis of three new CVS Ferrari top pick chassis were still loaded onto rail cars within the “old” port (see Photo 4.3.1.1-7). They are missing key components such as mast, axles, and spreaders. The missing components could be containerized elsewhere in the port. The supplier has been contacted and we await his input to determine if and when this equipment could be considered for future operation in Umm Qasr.

**Photo 4.3.1.1-7 Three New CVS Ferrari Top Pick Chassis, Note Missing Components.**

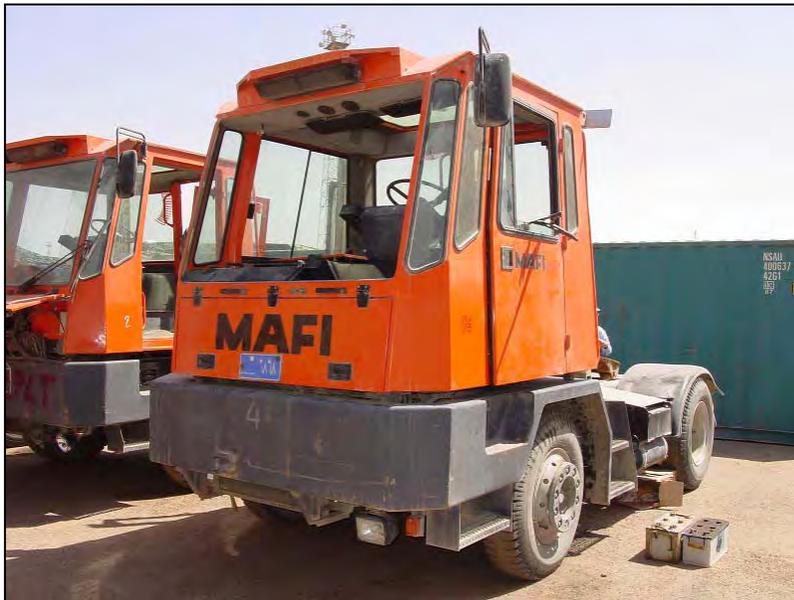
**Photo 4.3.1.1-8 Mafi Tractor Needing Repair. Note Missing Window and Batteries on the Ground.**

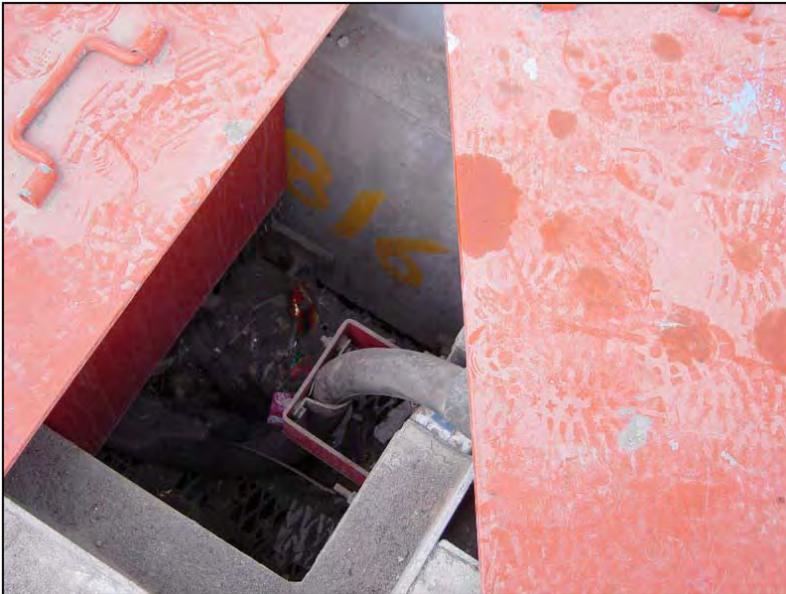
No disconnects were found for the 40-ton ZPMC container cranes. The connection appears to have been accomplished with a straight splice into the 11KV ring system at the wharf utilidor. See Photo 4.3.2.1.2-2.

**Photo 4.3.2.1.2-2 Typical Straight Splice into 11kV System at Wharf Face.**

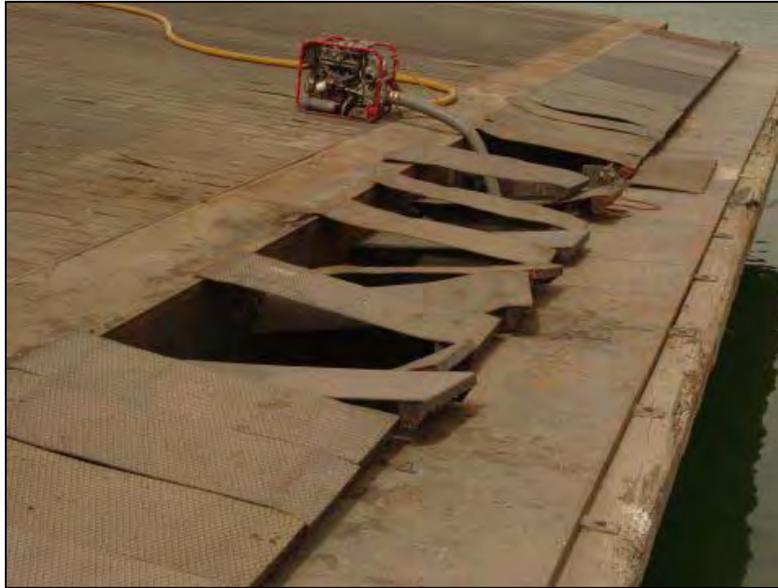
This ramp is well designed and able to support traffic moving to and from a RO/RO vessel. It is 40 meters long and 18 meters wide on the land side end. Minimal repairs will be required to the steel deck plating closest to the water edge of the ramp.

**Photo 4.4.1.1-2 Damage to Steel Deck Plate.**

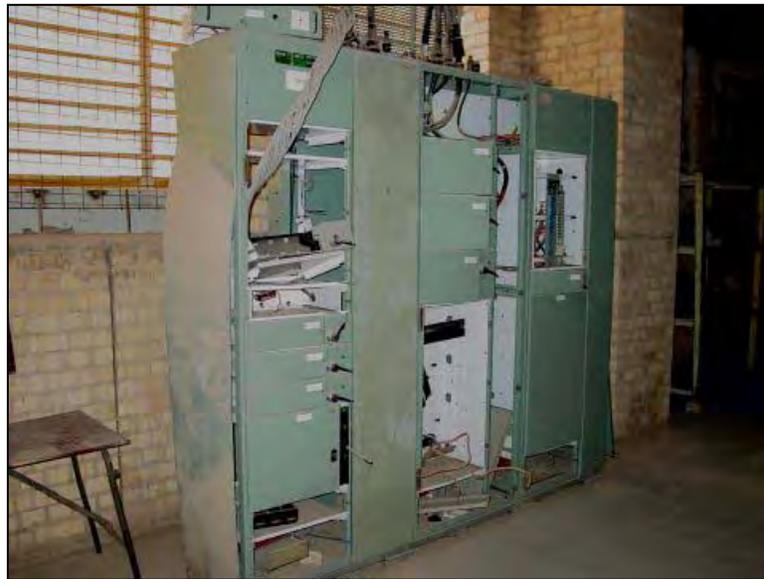
**Photo 6.1.1-4 Power Supplies have been Damaged.**

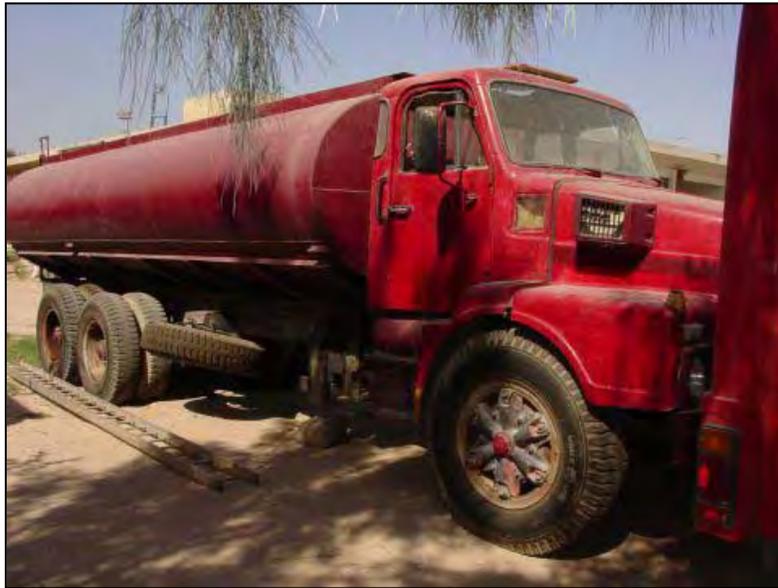
*Photo 6.5.2-2 Mobile Fuel Truck, Condition Unknown, not Yet Assessed.*
