The Philippine Environmental Governance 2 Project

Assessment of Disposal Sites of EcoGov-Assisted LGUs

*Determining ways to ensure
compliance with RA 9003*

September 2005

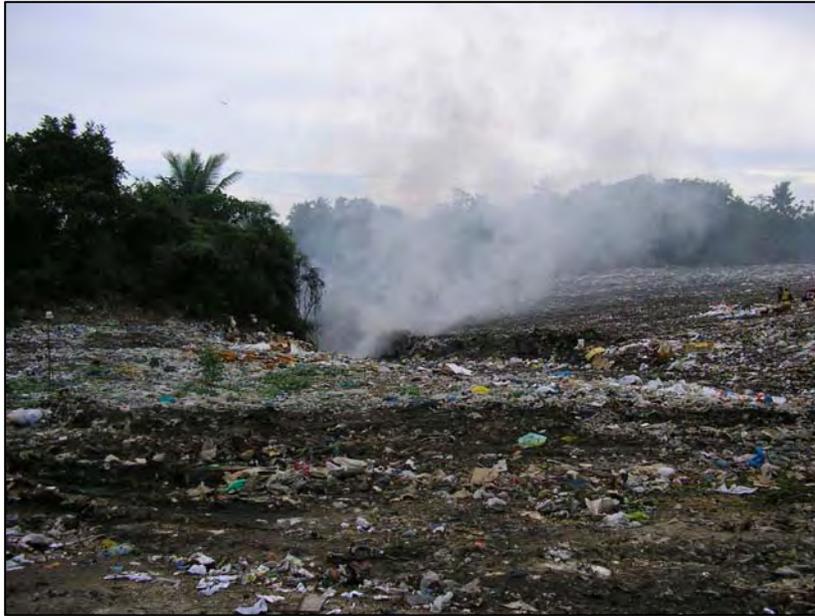
Exposed waste and open burning at the Dampas Open Dump ran

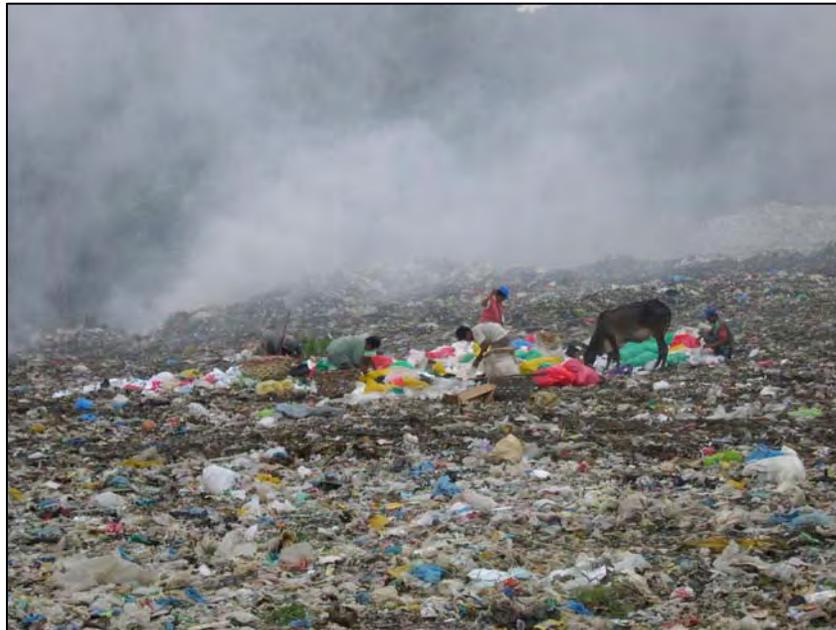
Waste pickers at exposed waste pile in Dampas Open Dump

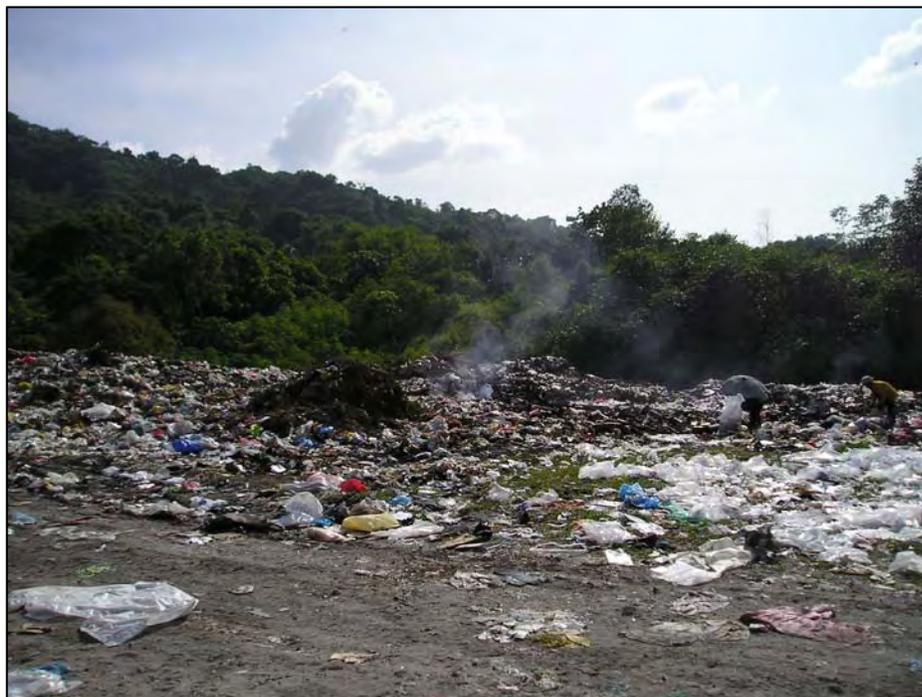
Open burning of exposed waste at Koronadal Open Dump

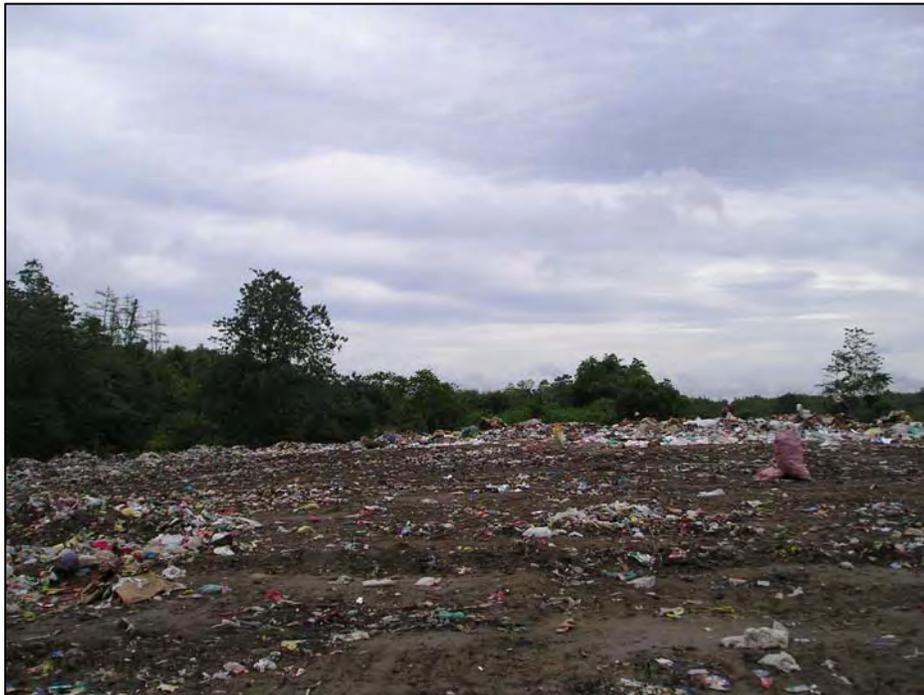
Exposed waste and litter atop the Kidapawan open dump

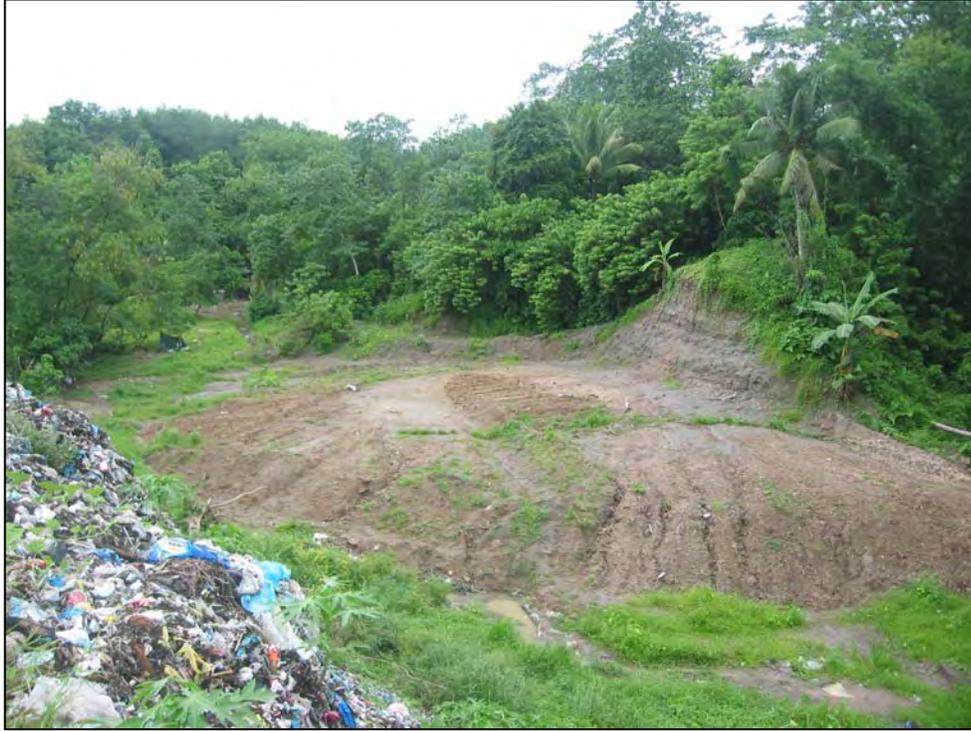
Small valley adjacent to open dump which will be utilized as controlled dump

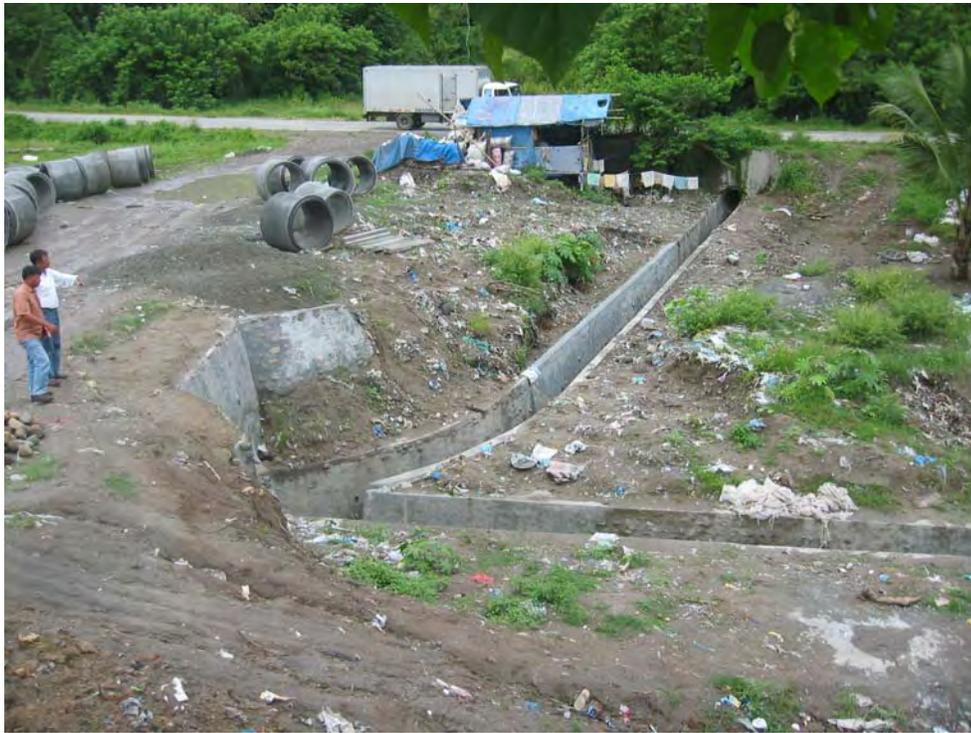
Drainage canal built to divert flow of intermittent creek away from the proposed controlled dump
