**Assessment Of Flooding And  
Bank Erosion At Berridale,  
Rio Grande, Portland, Jamaica**

# Ridge to Reef Watershed Project

February 7, 2005

David J. Miller and Ryan Ramsook  
for  
The Marine Geology Unit  
Department of Geography and Geology  
University of the West Indies  
Mona Campus  
Kingston 7, Jamaica

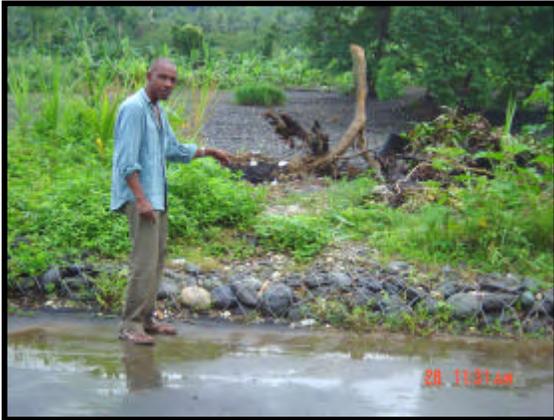
The main flood prone area in Berridale occurs immediately downstream of a pronounced meander bend of the river (Figure 1a), where the outer concave bank has been protected by gabion baskets. During high river discharges, the Rio Grande bursts its banks at this point to engulf the gabions and flood the road behind them. Figure 1b shows a local resident indicating where the gabion baskets were breached during the Hurricane Ivan flooding, while in figure 2 he estimates the height of the floodwaters which inundated the road. At this locality, the road level is at least 4.0-4.5m above normal river stage.

Figure 1b. Berridale resident, Mr. Miller, indicates where the gabion baskets were breached during the Hurricane Ivan flooding.

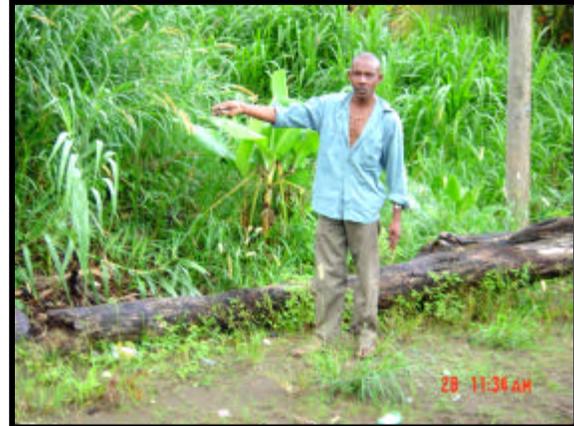
Figure 2. Mr. Miller estimates the height of floodwaters which inundated the Berridale main road.

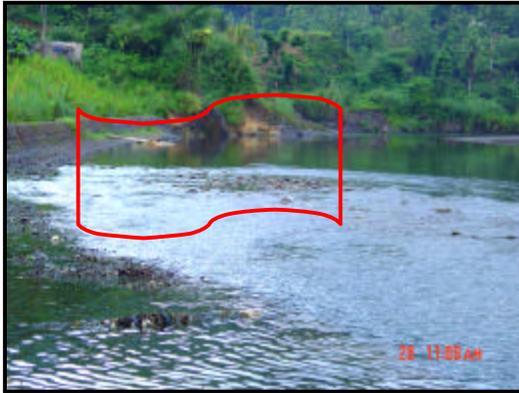
Bank erosion is commonplace along the entire river reach in the Berridale area. It is prevalent at meander bends, particularly on the outer concave bank of the river; though it is not confined to bends (Figure 3), but also occurs on relatively straight reaches on both the left and right banks of the river, especially where the channel contains medial braid bars (Figure 4).

Figure 3. Extensive bank erosion (bank collapse) on cultivated terraces of the Rio Grande River at Berridale.

It is recommended that the damaged gabions on the right bank of the river be replaced, while areas of bank erosion on the left bank could be stabilized by planting riparian vegetation.

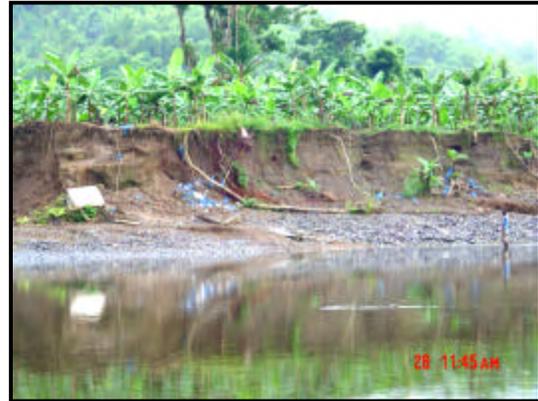
Figure 4. Extensive bank erosion on relatively straight reaches of the Rio Grande River at Berridale.

Bank erosion on the straight reaches of the river around Berridale is associated with flood events, where the channel is at bankfull- discharge or where floodplain inundation occurs at stages higher than bankfull. The banks are easily erodible as they consist of non-cohesive sediments, which are not particularly well-protected by riparian vegetation. Some straight reaches are also associated with medial- and braid-bars, dividing the channel in two threads and diverting them towards the channel banks. This leads to a concentration of flow towards the banks, leading to undermining and collapse, especially at high flow.

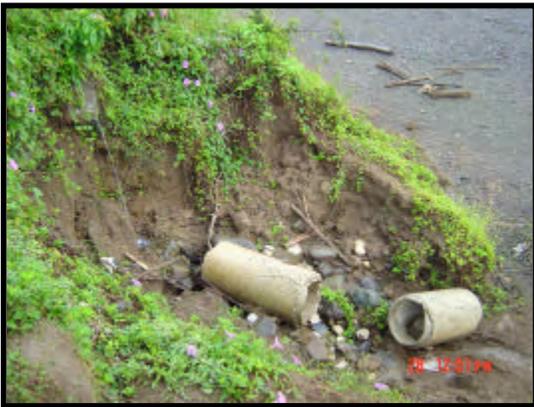
Bank erosion and undermining has also led to the destruction of physical infrastructure marginal to the river, such as drains and sewer lines (Figures 5 and 6).

Figure 5. Destruction of physical infrastructure induced by bank erosion at the Berridale Rafters Rest.

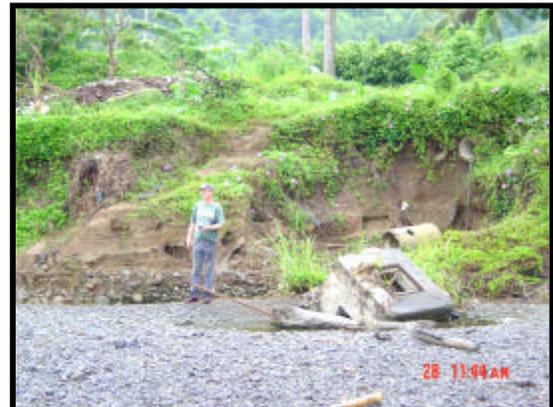
Figure 6. Destruction of physical infrastructure induced by bank erosion at the Berridale Rafters Rest.

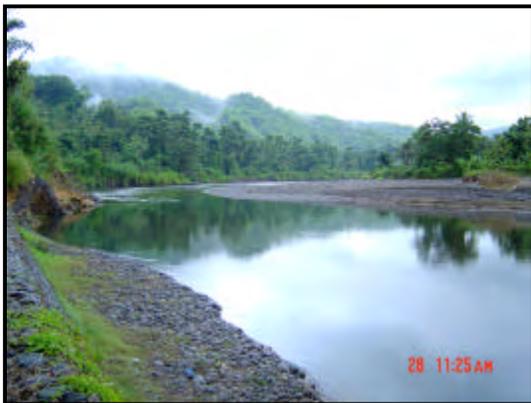
Meandering rivers and meander-braid transition channels have the ability to migrate across their floodplains as a result of selective bank erosion on the outer bend and deposition on the inner bend as point-bars. The channel cross-section at a meander bend is normally asymmetrical, where the stream is deeper on the outer concave bank. The line of maximum stream velocity and depth, or thalweg, becomes concentrated on the outer bank, such that the greatest stream velocities, stream power and water pressure are experienced at the concave bank. In addition to the thalweg being concentrated on the outer bank, intense secondary circulation cells in the form of helical flow also develop at meander bends, leading to an excess of water pressure on the outer bank and a deficit on the inner bank. A zone of flow separation also occurs immediately downstream of the axis of the meander, on the inner convex bends, leading to the development of a shear layer, with spiral vortices, reducing the effective width of the main current and concentrating water flow towards the outer concave bank. The net effect of the concentration of water on the outer bank is erosion, while point-bar deposits are laid down on the corresponding inner bend, where lower velocities, stream power and water pressures are experienced (Figures 7 and 8).

Figure 7. Meander bend erosion on the right bank of the Rio Grande River, 150m north of Rafters Rest, Berridale.

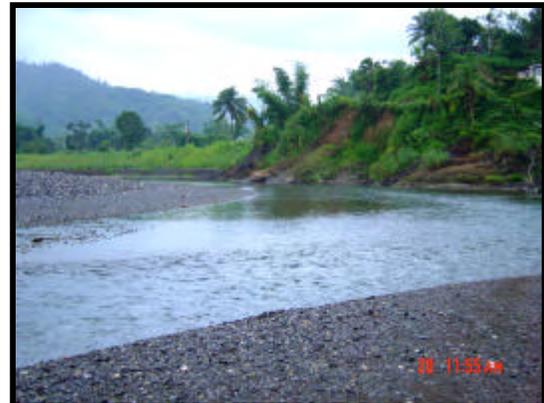
Figure 8. Meander bend erosion on the right bank of the Rio Grande River, 240m north of Rafters Rest, Berridale.

Within the area most prone to flooding, downstream of the main meander bend, gabion baskets have been recently constructed to extend from the level of the road to the bed of the channel (Figures 8 and 9). The baskets protrude into the channel itself by some 5-6m, presumably to act as a buffer to flow and to reduce the asymmetry of the channel. Vegetation has also been planted in conjunction with the gabion baskets (Figure 8).

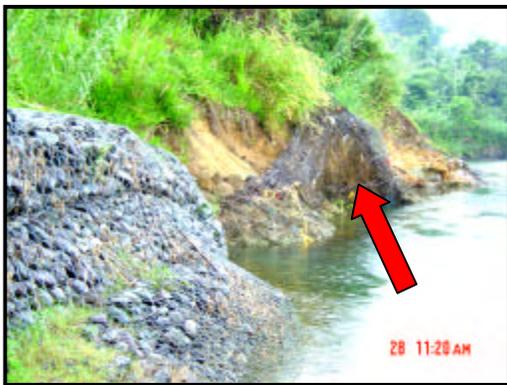
Figure 9. Gabion baskets recently constructed, along the right bank of the Rio Grande River. To the immediate right, ruptured gabions are exposed by an erosion scar.

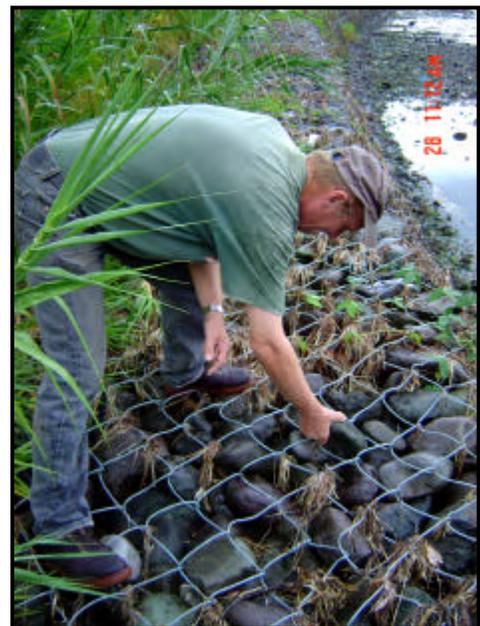
Figure 10. Dr. David Miller demonstrates the poorly constructed nature of gabion baskets at Berridale. Here, mesh size > cobble and boulder material

These gabion baskets are well-located as they afford some protection to the outer meander bend. However, they are poorly constructed, as the cobble and boulder material used to fill the baskets is commonly finer than the mesh of the holding basket (Figure 10). Gabion baskets are generally filled with materials from the local area to reduce haulage costs, in this case rounded river cobbles and boulders. It is best to use rounded materials when infilling gabion baskets to minimize damage to the steel mesh, however a finer mesh should have been used in this instance to conform to the grain size of the material locally available. Some of the gabions are already useless and undermined because they have totally (Figure 11), or at least partially, lost their infill. Many of the older gabions upstream of the main meander bend have also been ruptured by natural processes, such as bed load bombardment during flood events. Some gabions around the sand mining operation at Berridale may have been damaged by mining

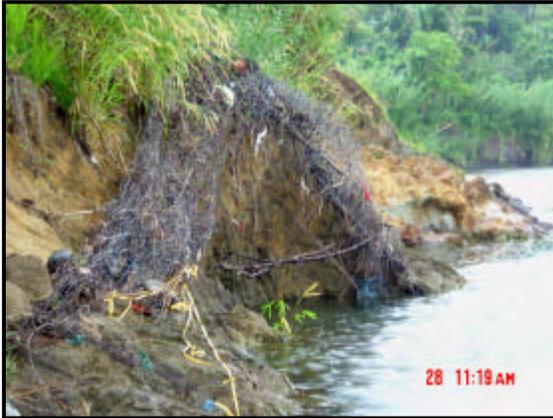
Figure 11. Ruptured gabions induced by massive bank collapse on the right bank of the Rio Grande River at Berridale.

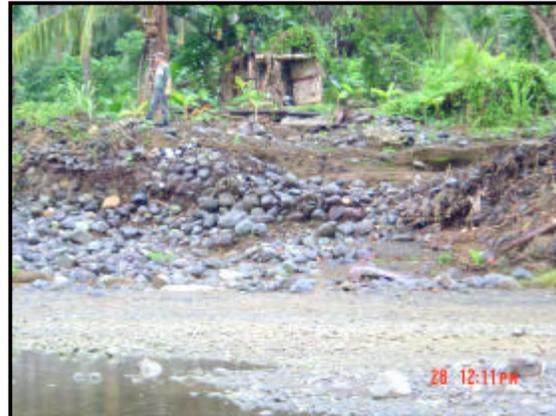
machinery during the stockpiling and loading of sand and gravel, leaving a substantial area of the right bank vulnerable to meander-style bank erosion (Figure 12) .

Figure 12. Damaged gabions around the sand mining operation at Berridale induced by stockpiling and loading of sand and gravel.

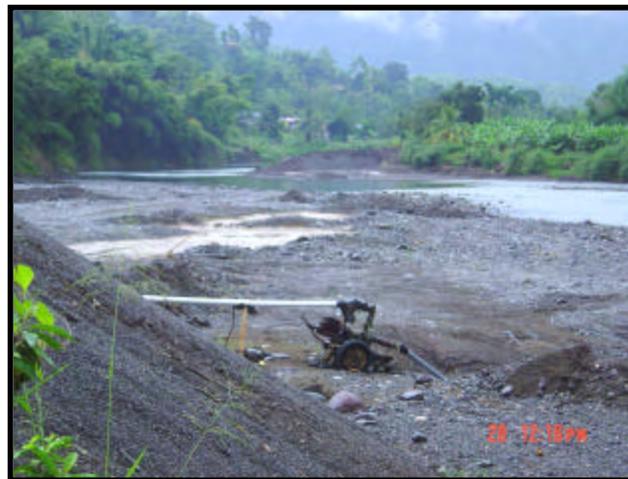
Figure 13. Mining operation at Berridale. To the immediate left, deliberate diversion of the river course to facilitate mining activities is evident.

The mining activity on the right bank of the Rio Grande River at Berridale may create a net shift in erosion concentration on the right bank meanders, thus proliferating bank undercutting, though bank erosion was no more prevalent at or downstream of the mining operation compared to upstream. Erosion of the left bank opposite the mining operation is evident and the may be related to a deliberate diversion of the river course to facilitate the mining of a large lateral bar (Figure13).
