ANNUAL REPORT

“Conservation of the Mosque of Aslam al-Silahdar in Darb al Ahmar, Cairo”

Aga Khan Cultural Services
(Christophe Boleau)

**QUARTERLY PROGRESS REPORT
DECEMBER 2006-FEBRUARY 2007**

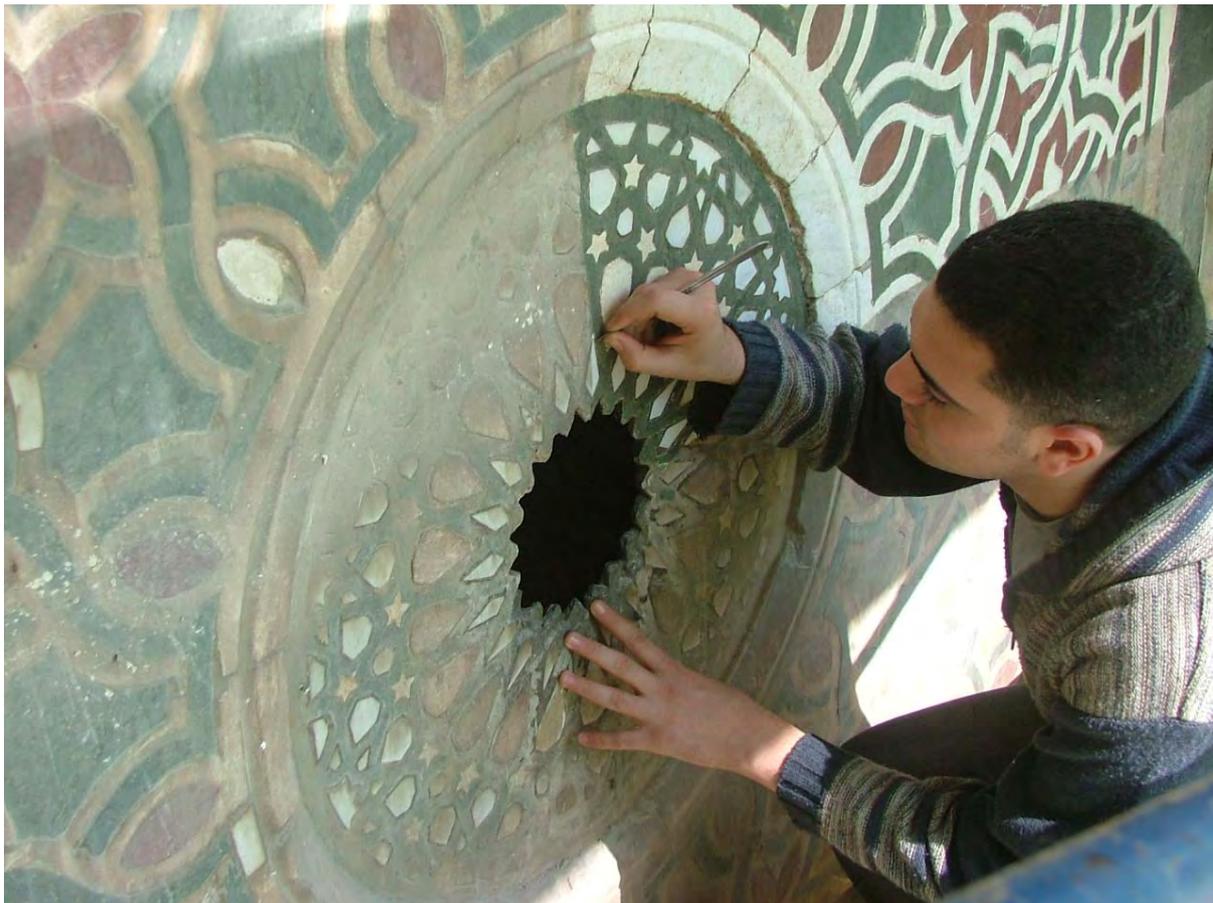
View of the marble panel on the main façade during cleaning

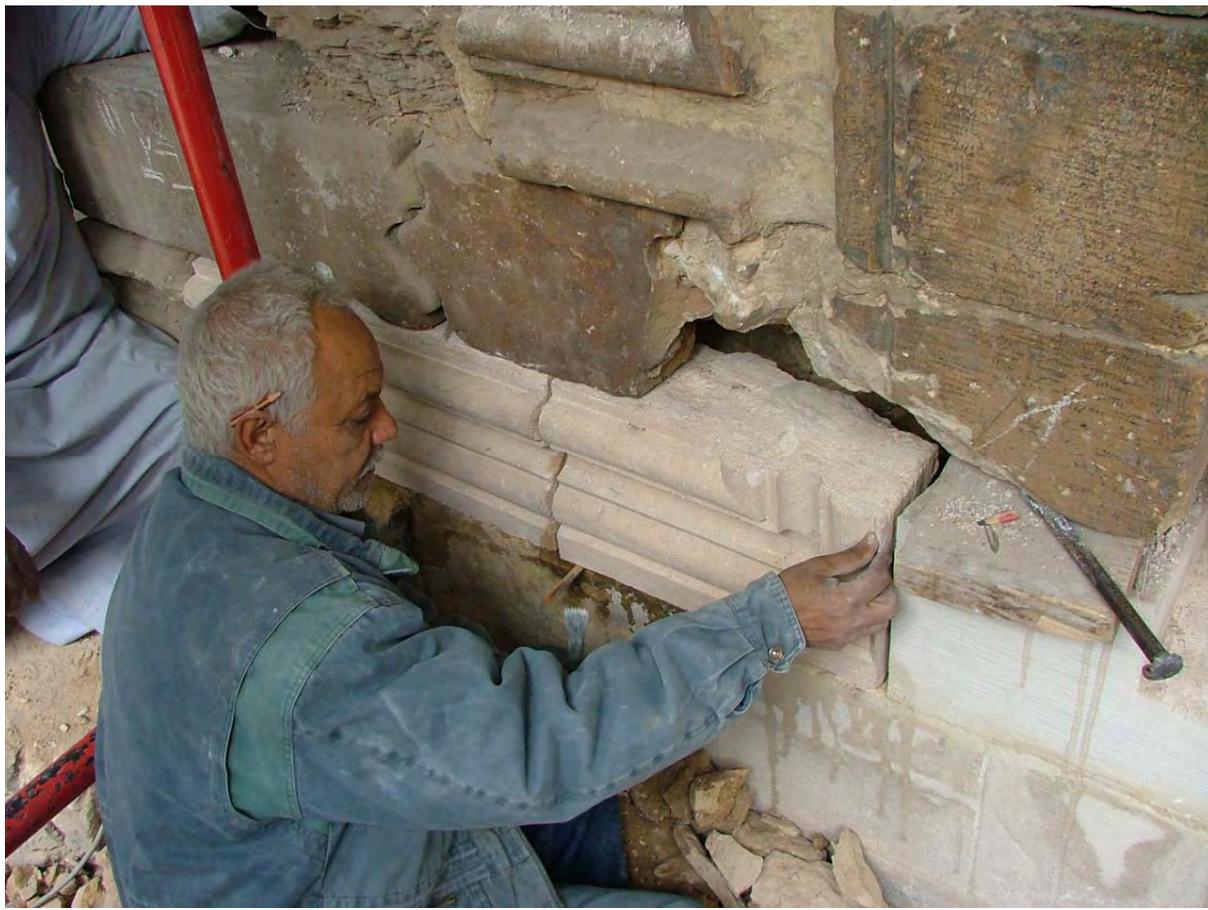
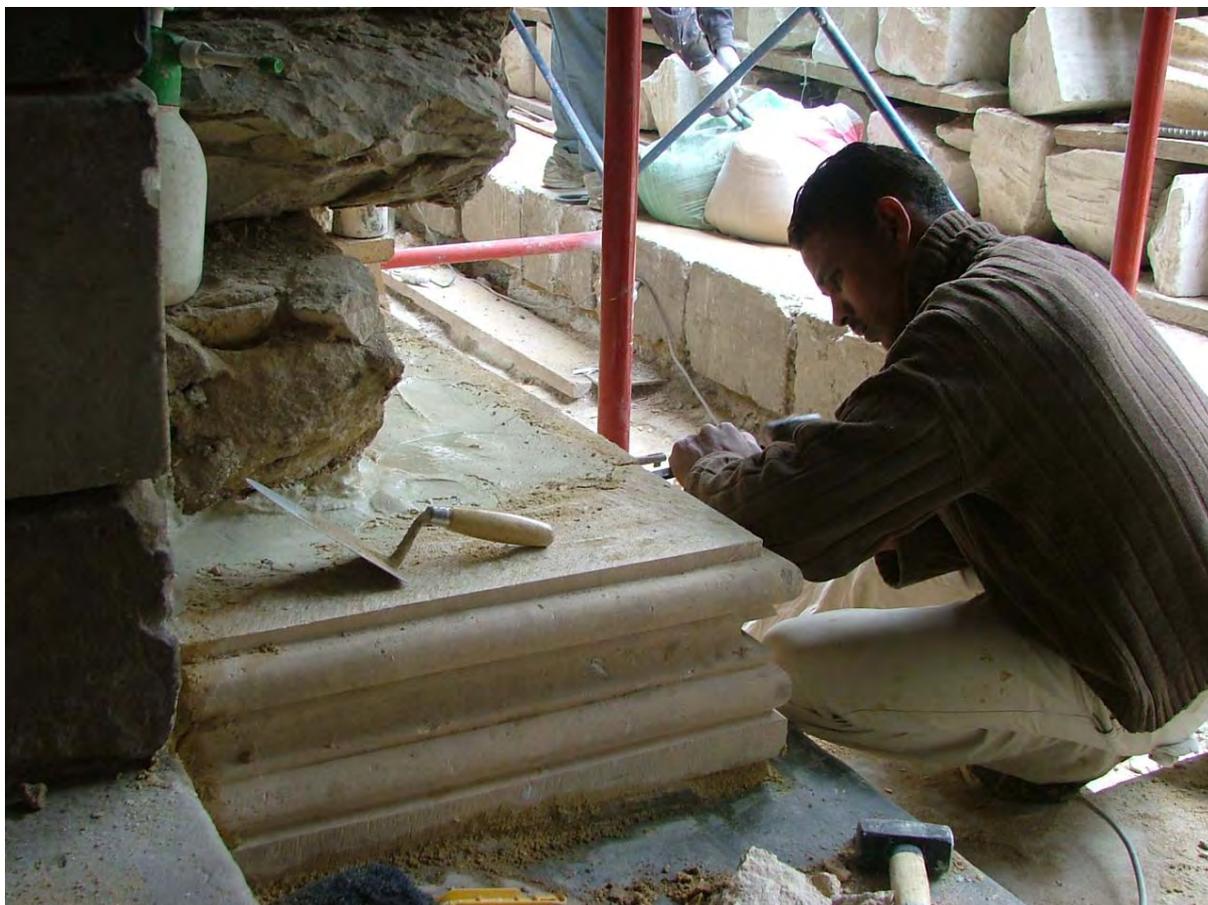
Stone replacement activities taking place on the Southern façade of the mosque

A campaign of selective stone replacement was completed at the southern and eastern facades: damaged plain facing and decorated lime stones were carefully replaced by new stones of a similar nature.

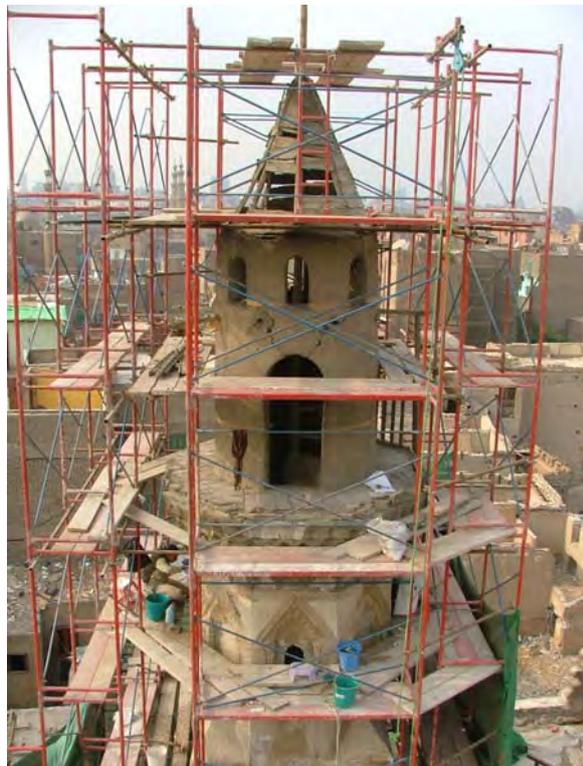
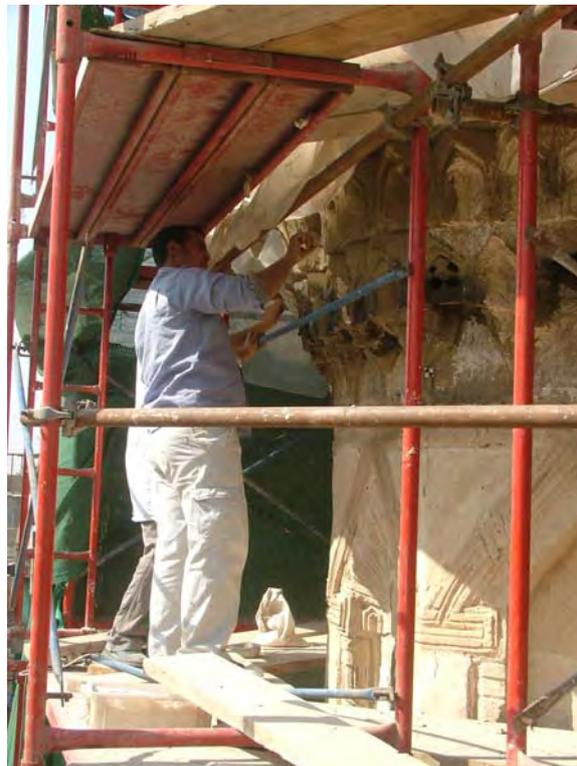
Cleaning activities on the minaret by poulticing

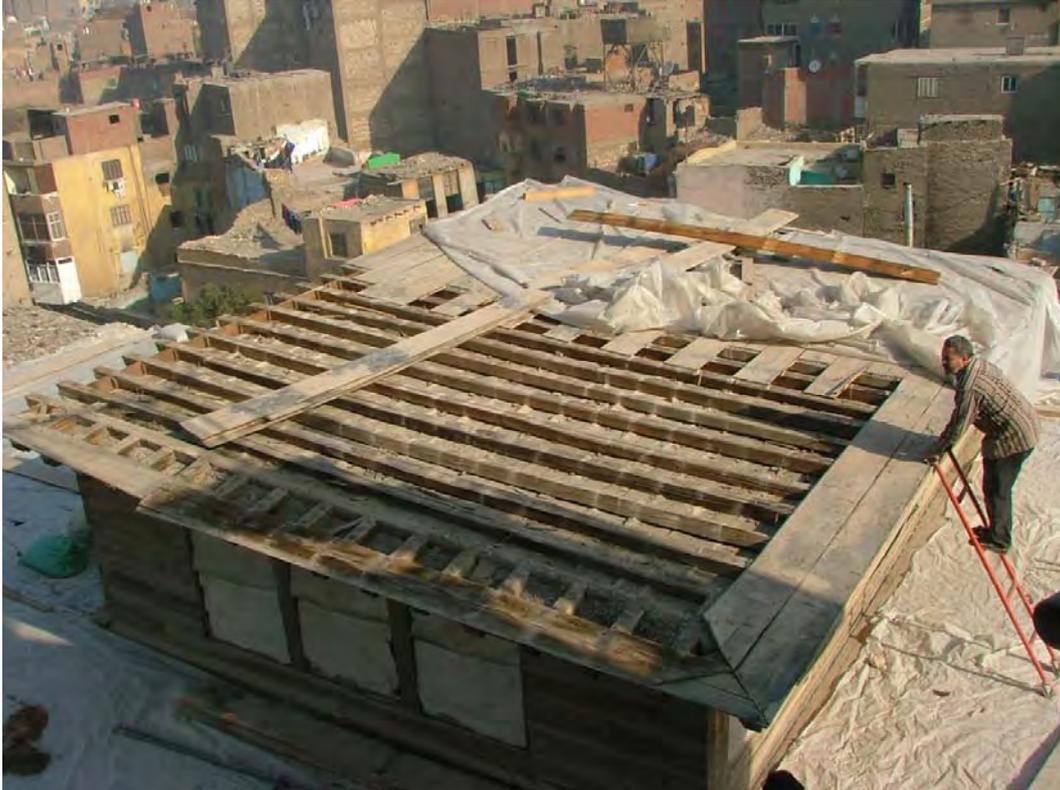
Assessment of wooden shingles and beams of the central shokhsheikha

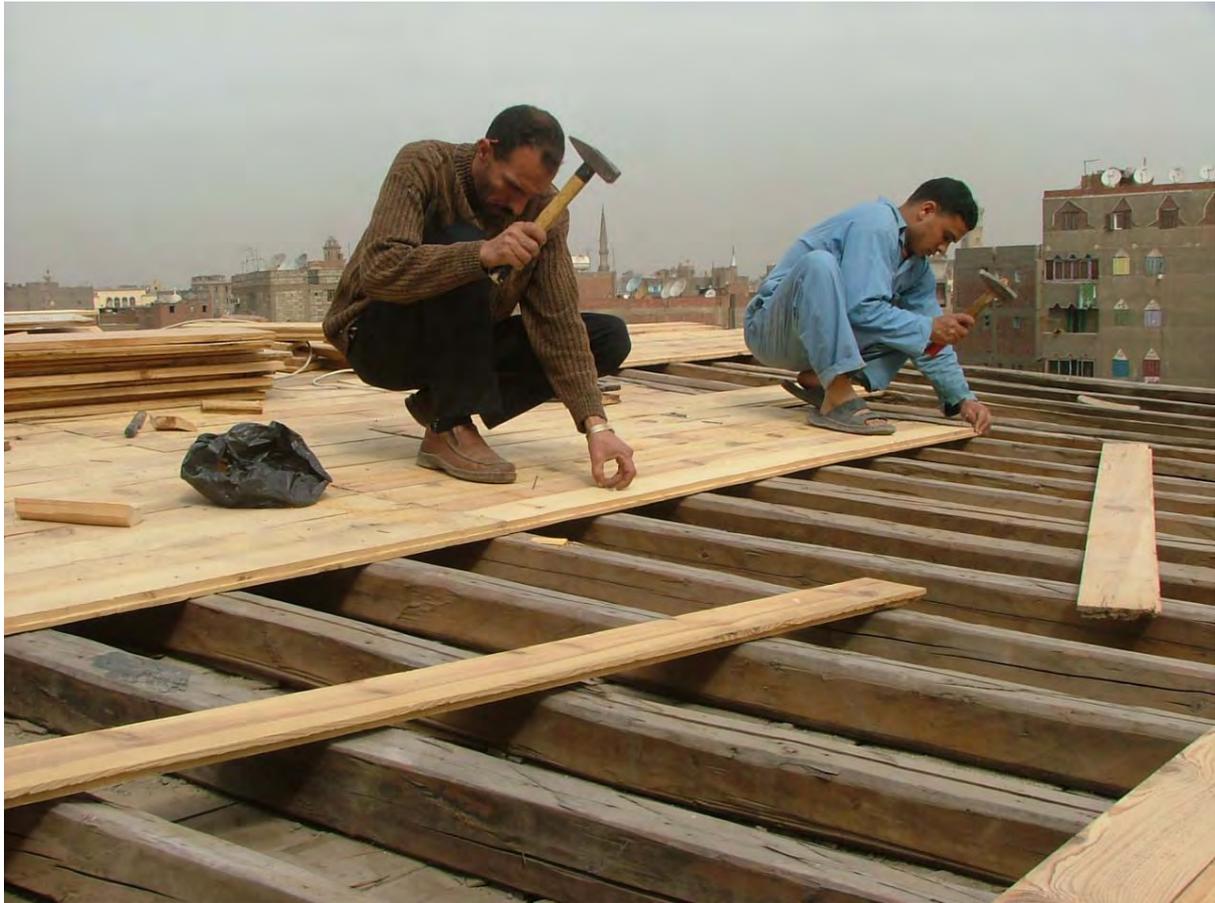
Carpenters replacing damaged wooden shingles

The replacement of broken and damaged beams was done and more than half the surface of the entire roof was already insulated using a bitumen sheet covered with mortar screed. The carpentry of the central shokhsheikha was restored and the construction made by the Comité in 1908 was maintained. It is planned to be covered with lead sheets in order to minimize the dead load.

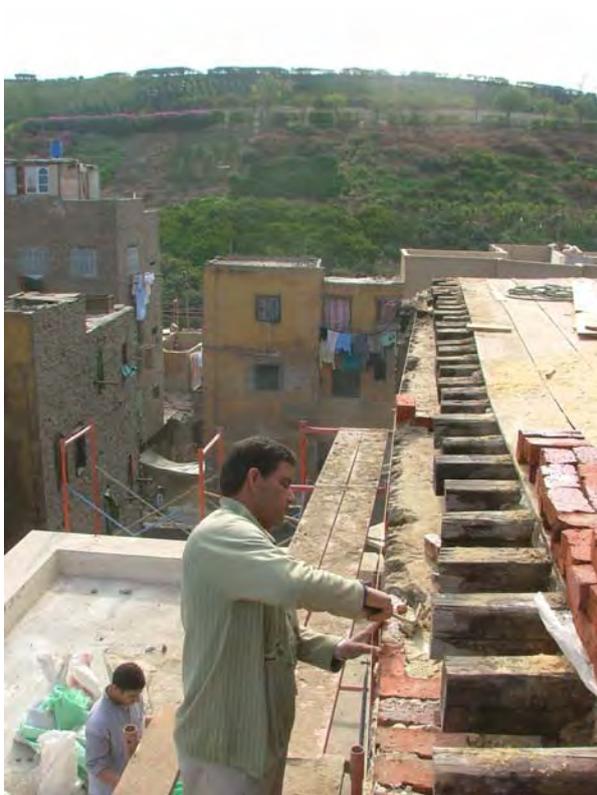
Brick construction of damaged roof parapets

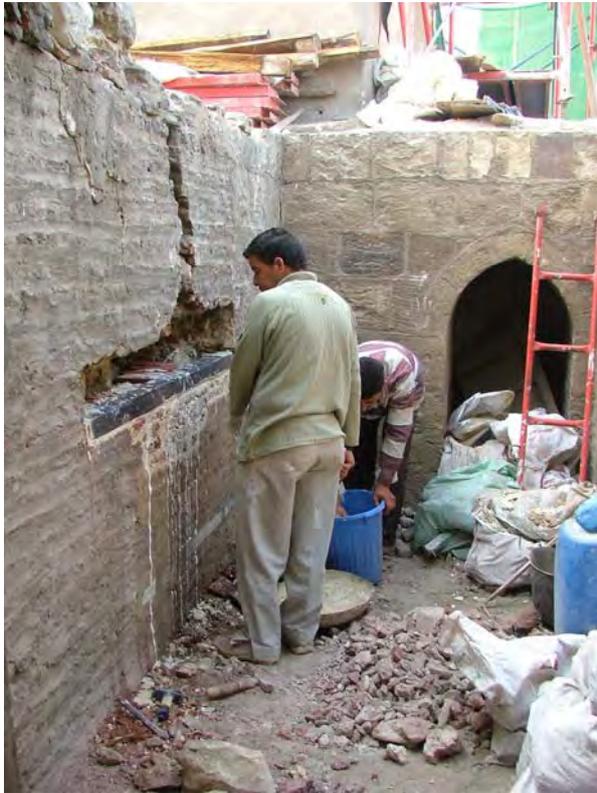
The brick masonry of the first floor rooms was affected locally by vertical cracking caused by earthquake loads. In the areas concerned with this damage pattern, the masonry was repaired by brick stitching. This concerns both southern and northern large rooms and the small qa'a along the western elevation.

Brick repair of cracks in upper level rooms

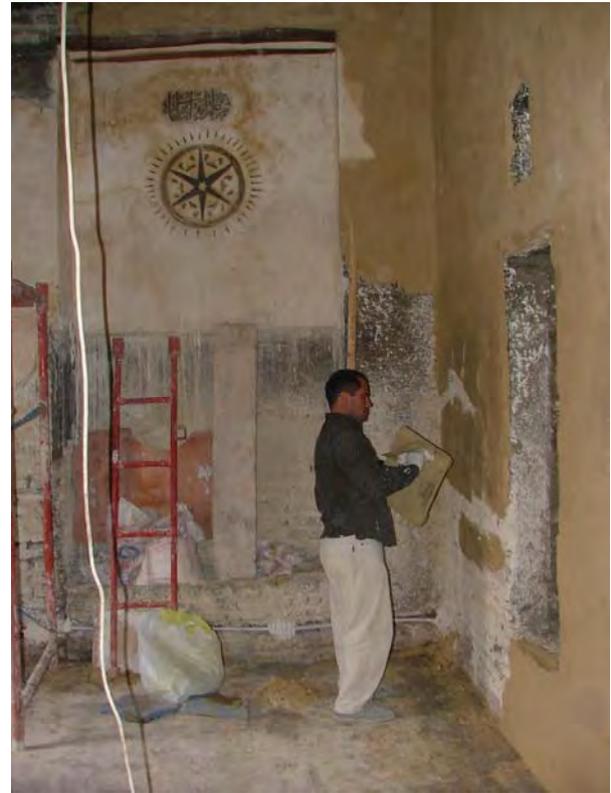
Plastering of rooms on first floor

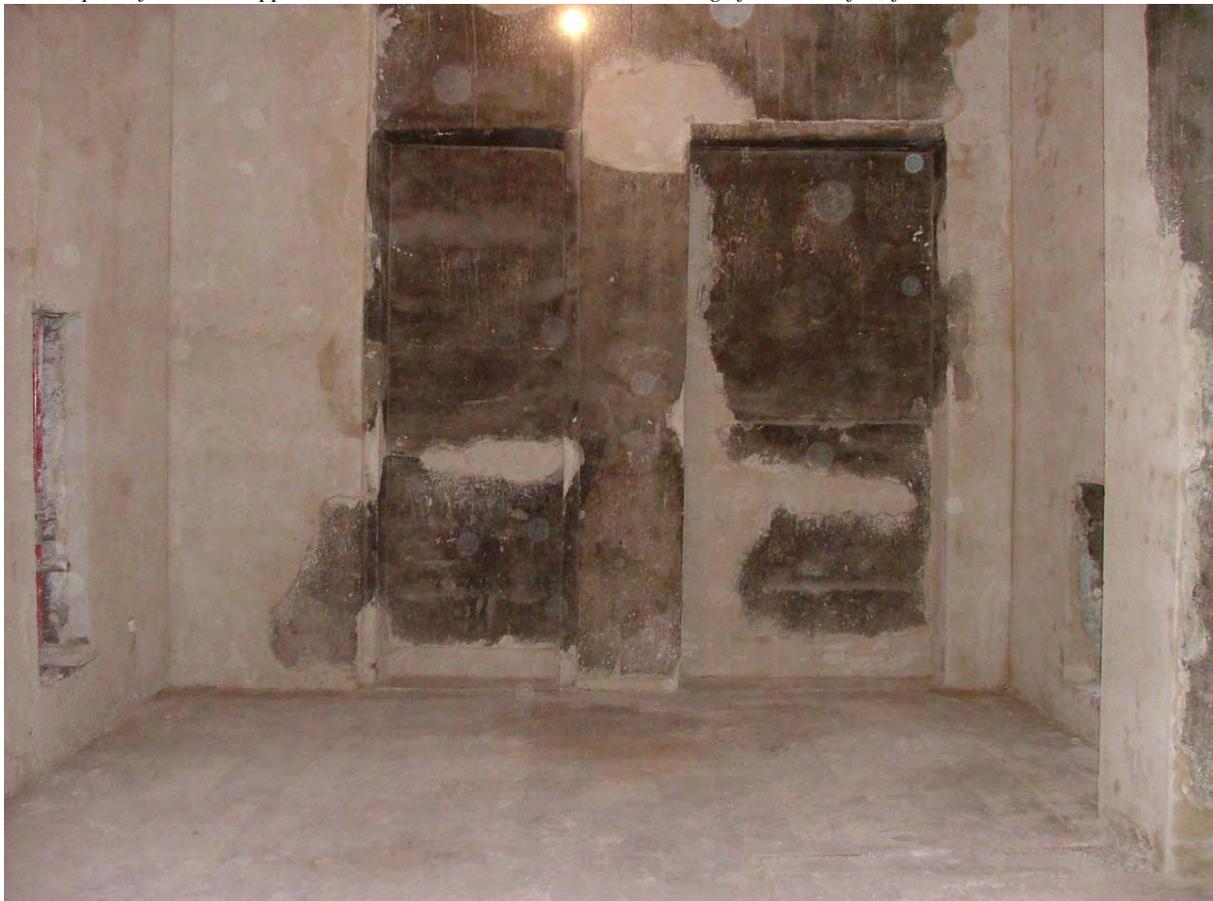
View of room on first floor after brick repair and plastering

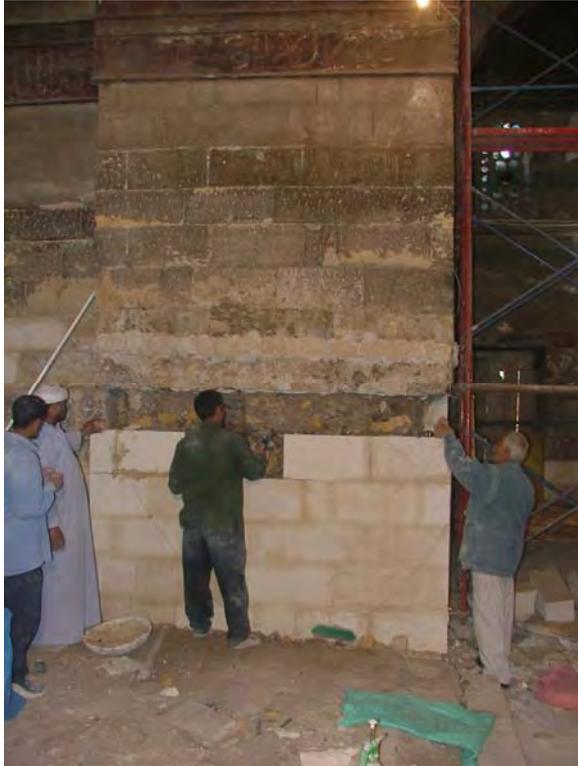
Stone replacement activities in the qibla iwan

Stone replacement of the damaged lower parts of the walls was performed and is still in progress. No conservation intervention of the surfaces of walls and ceilings will take place before September 2007.

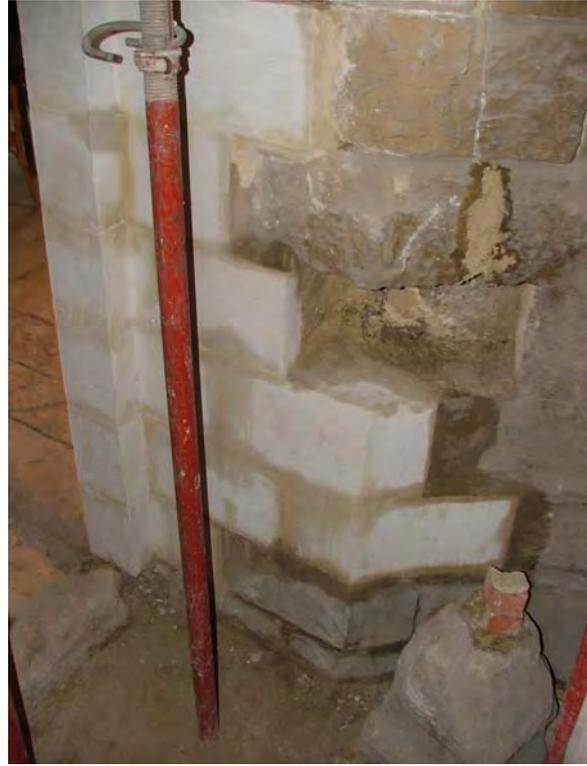
Stone replacement in main staircase

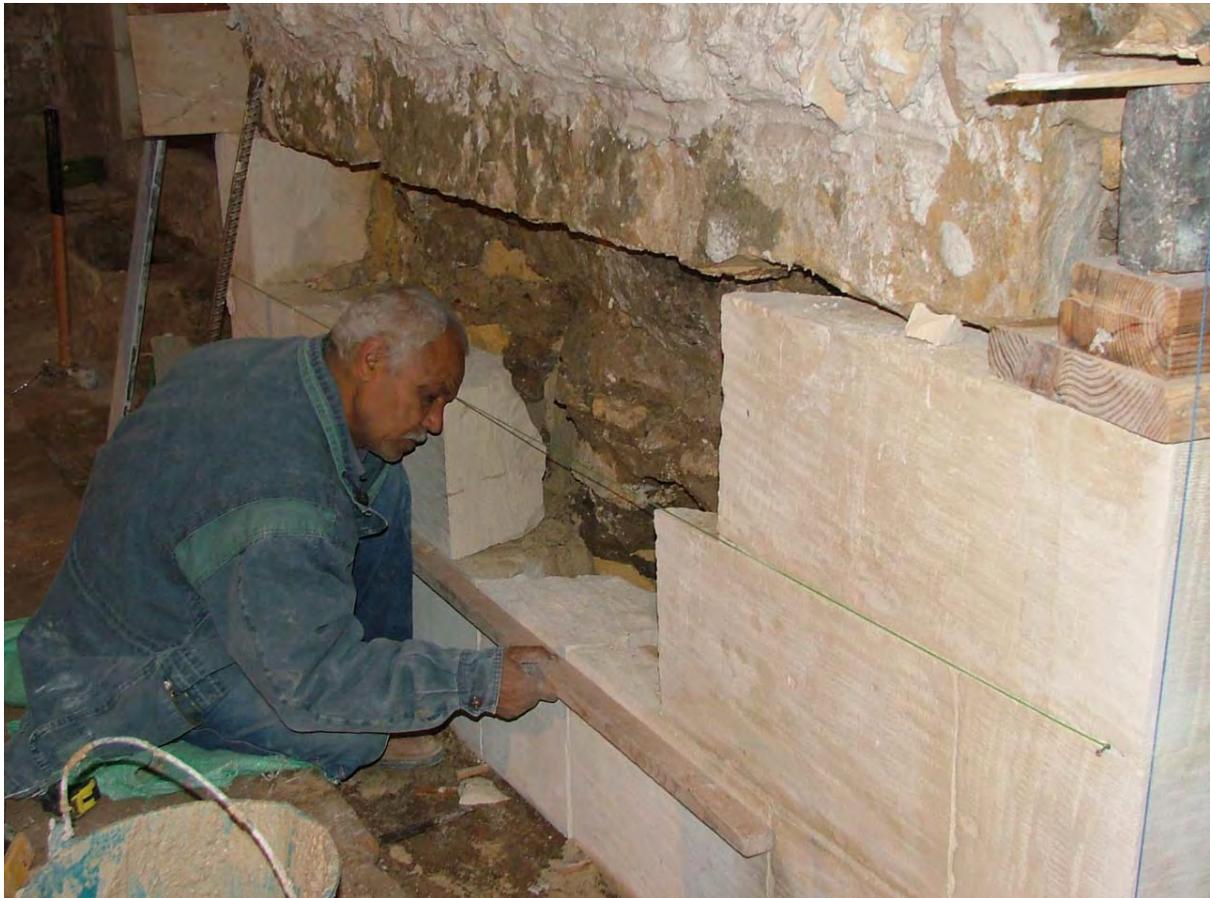
Stone replacement activities in the qibla iwan

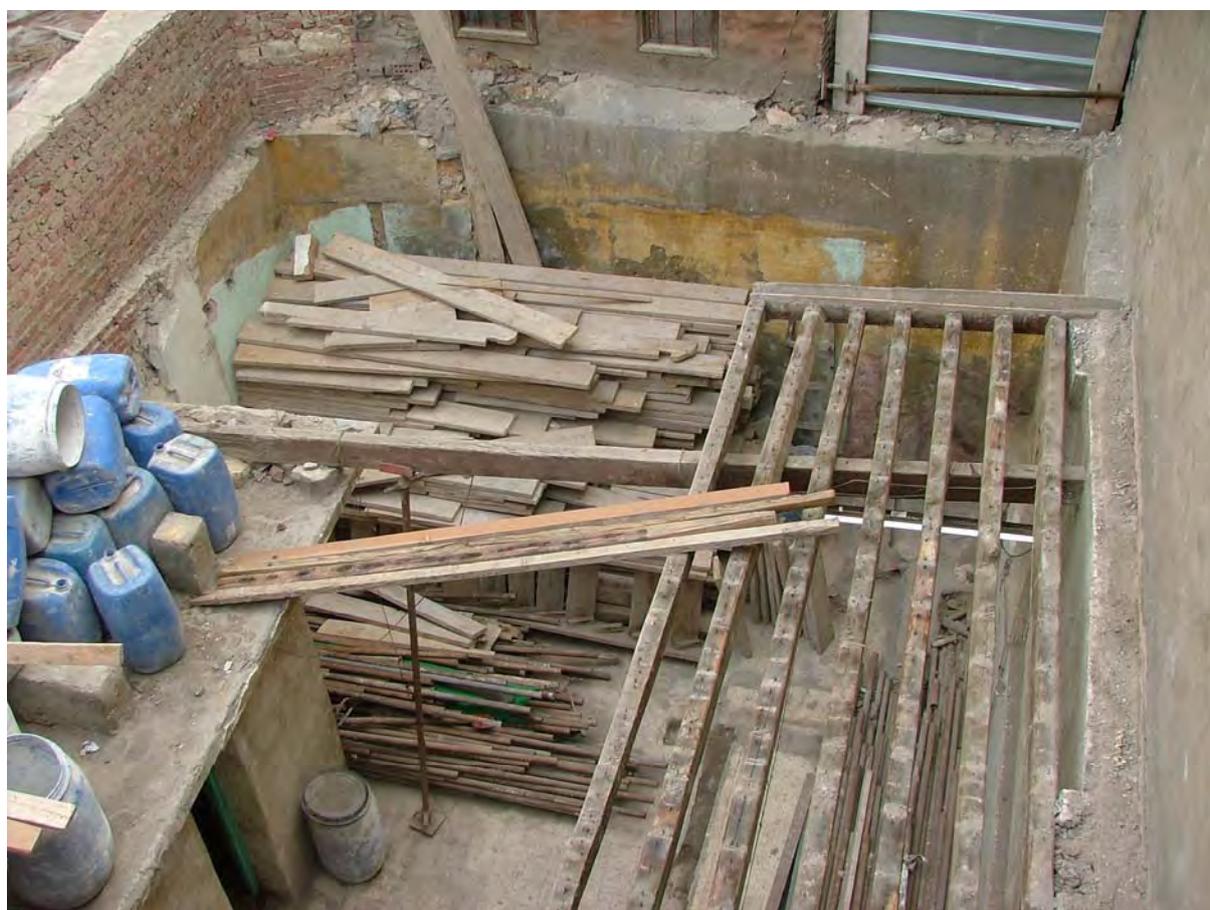
The existing structures of the ablution area were found in an advanced state of deterioration and were dismantled after survey. The location may be used as storage till the second quarter of 2007.

View of ablution area used as storage area

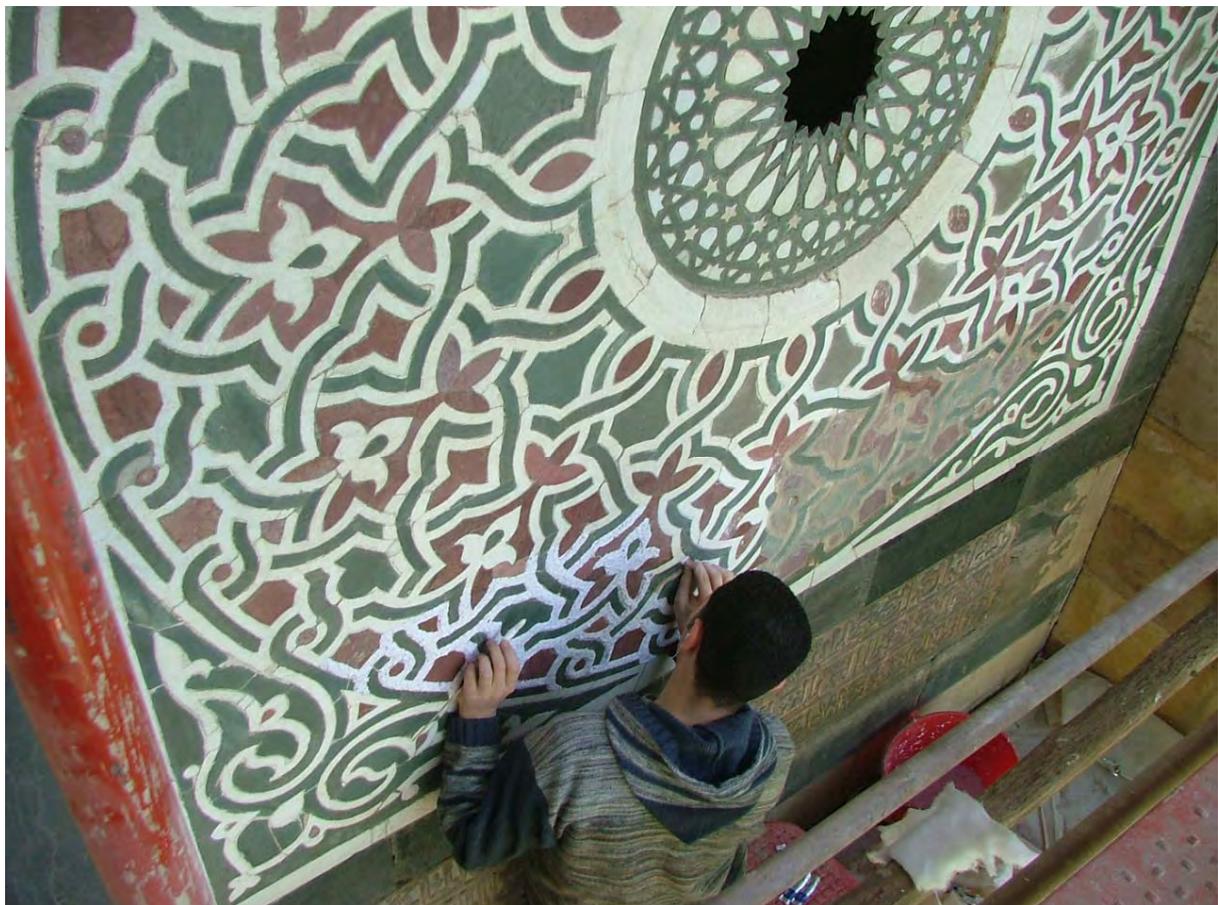
Cleaning of the marble panel on the southern facade

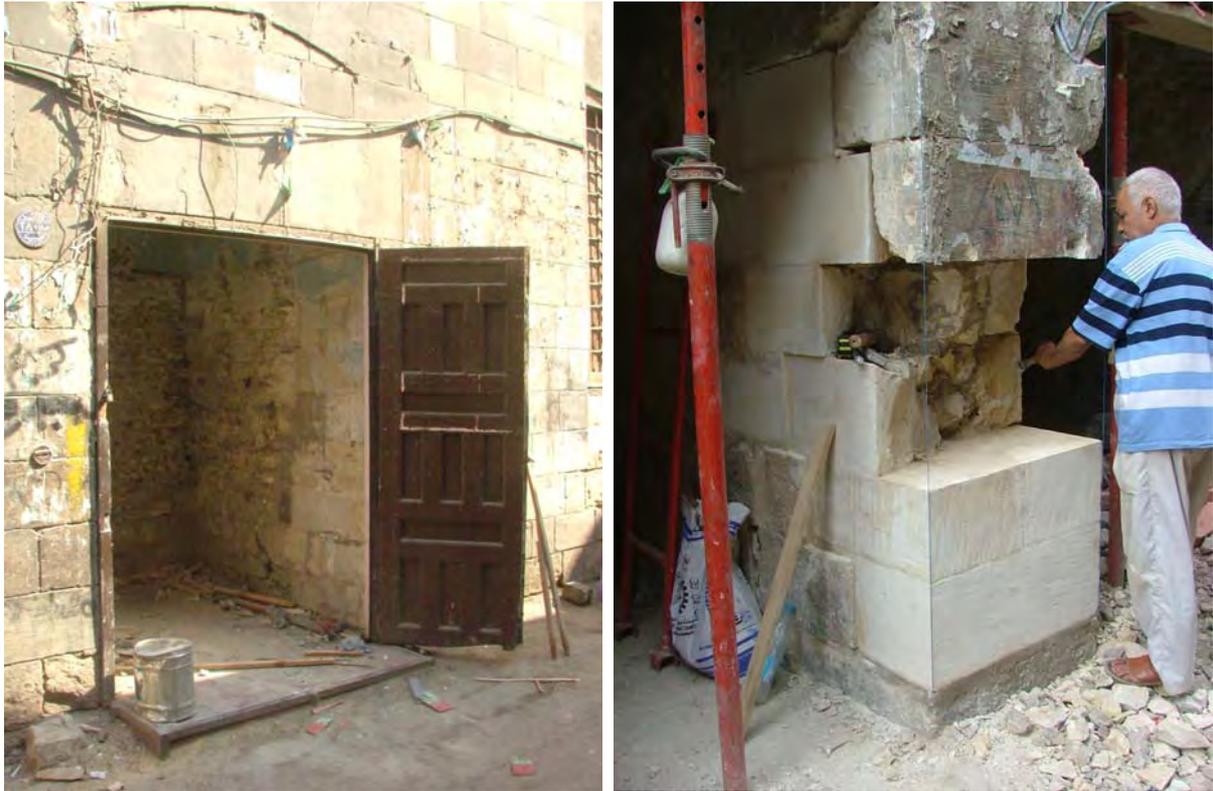
Clearing of shops on the western façade and selective replacement of damaged stones

The ground floor private shops on the western façade were cleared temporarily by the tenants and brick repair works started. Upon restoration, shops will be handed back to the tenants.

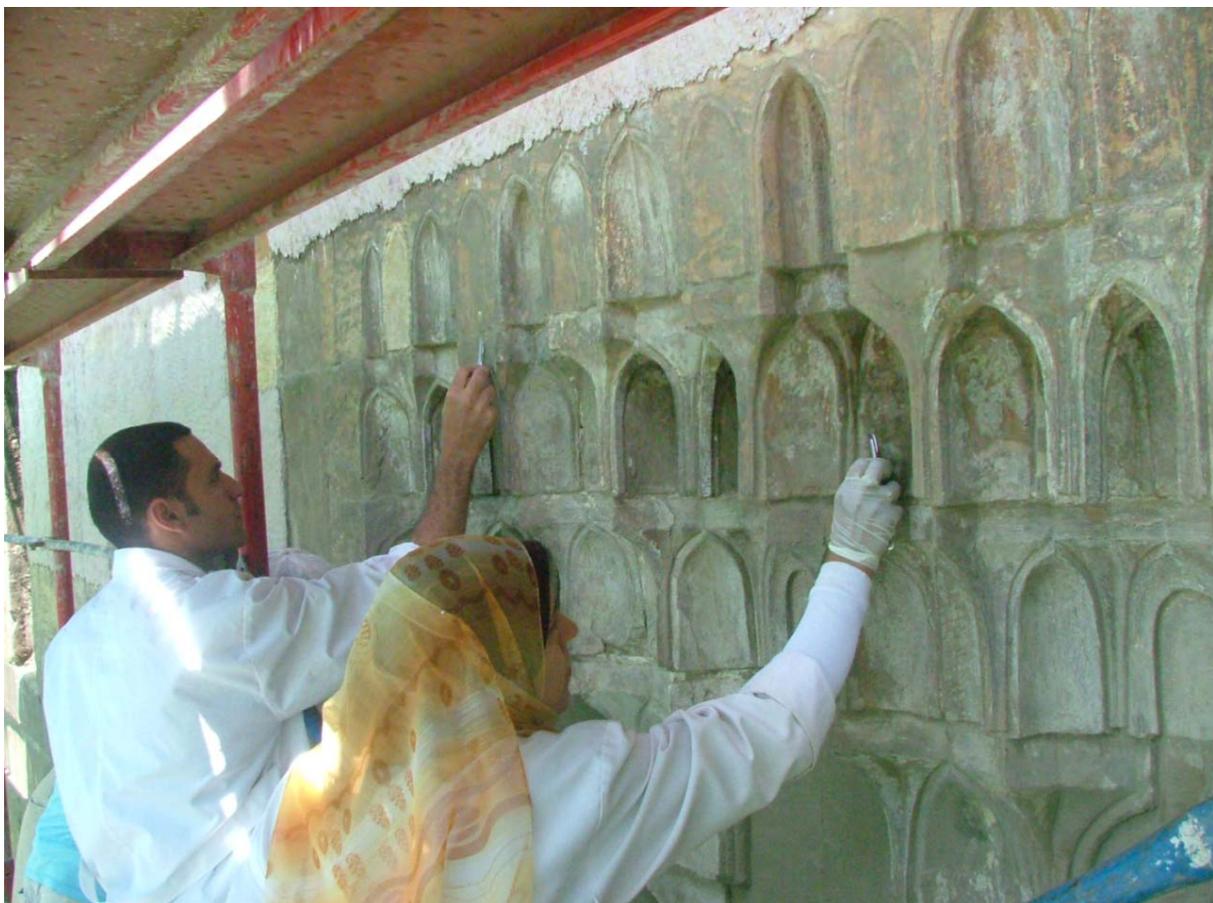
Mechanical cleaning of the western façade stalactites

Mechanical cleaning test were started on the western façade in order to determine the state of the lime stones. Following, the fine restoration activities were initiated using poultice made of bentonite and paper pulp with a low concentration (3-5%) of Ammonium Bicarbonate. The same polychromy pattern of the lime stone found on both the southern and eastern façade was revealed.

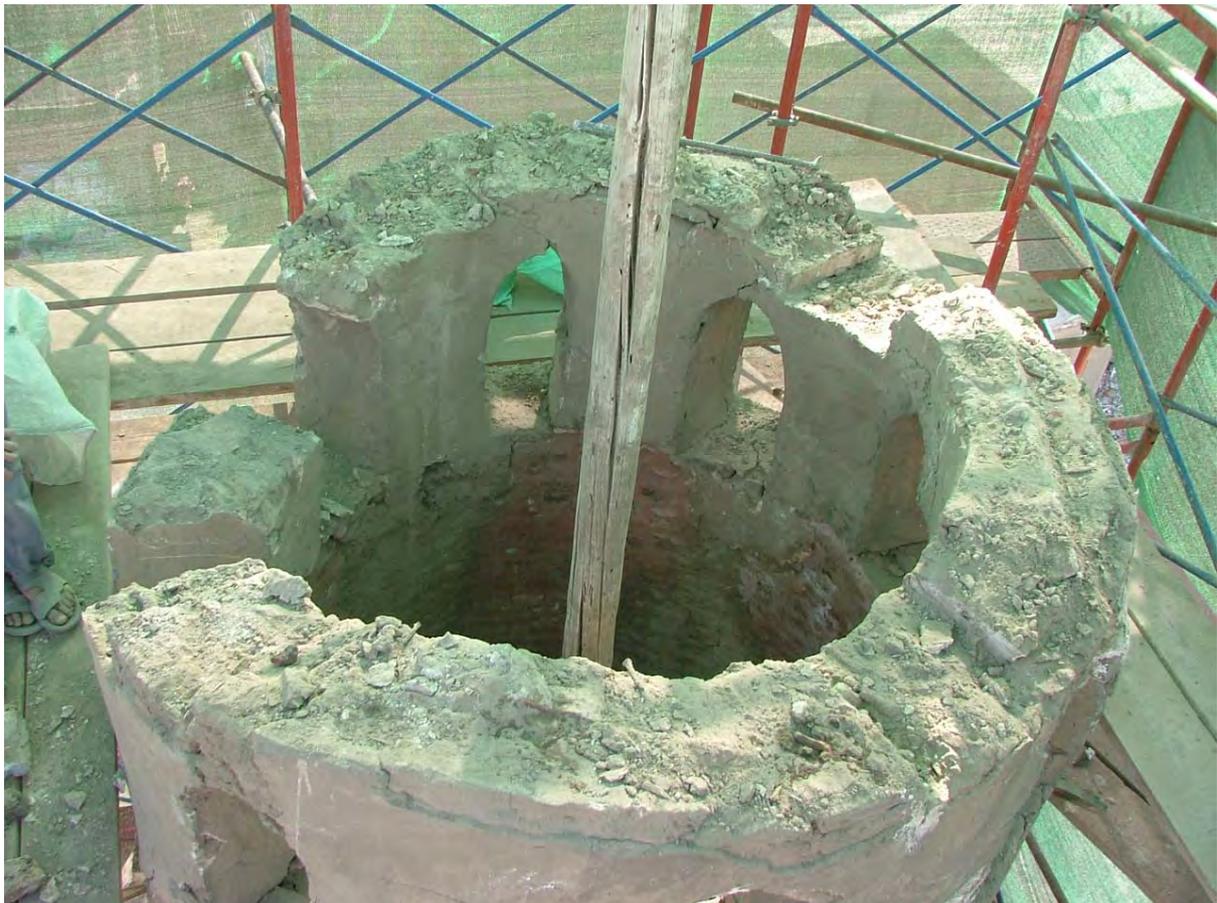
View of the minaret upper part after the removal of damaged beams.

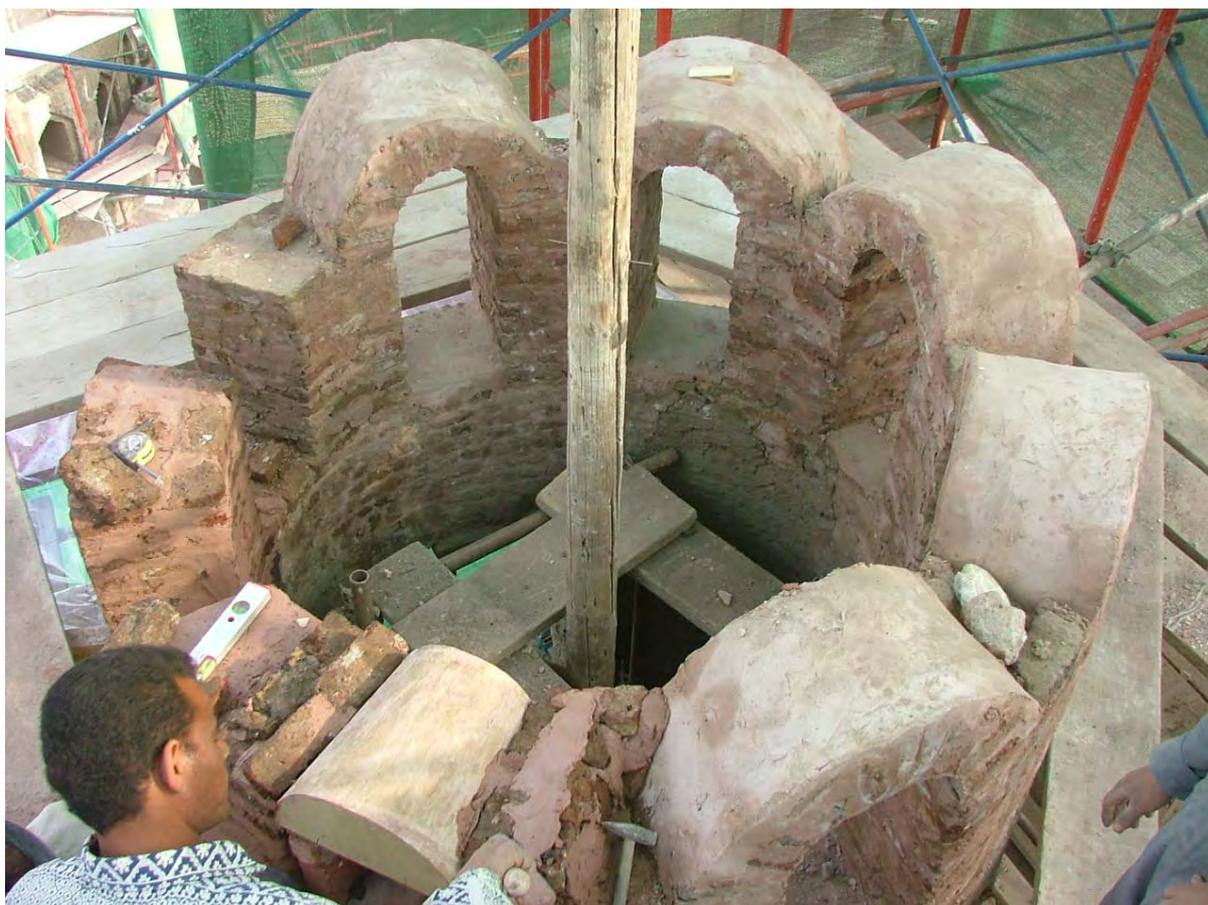
Brick repair activities on the minaret

The conservation work included brick repairs on the upper part, the construction of a pencil shaped carpentry top and the cleaning of the interior walls and steps using the sand blasting technique.

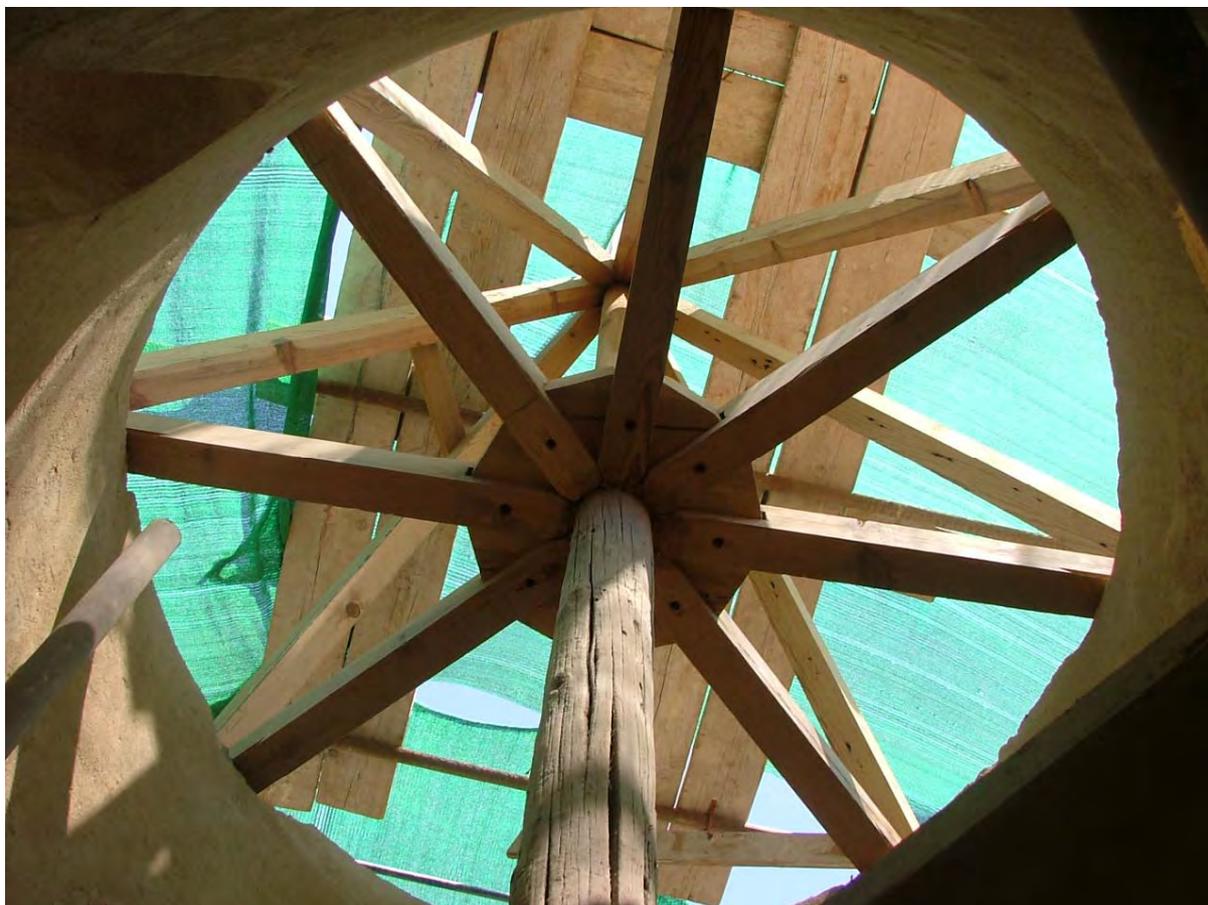
Inner view of the minaret after the installation of the main supporting beams of the upper part.

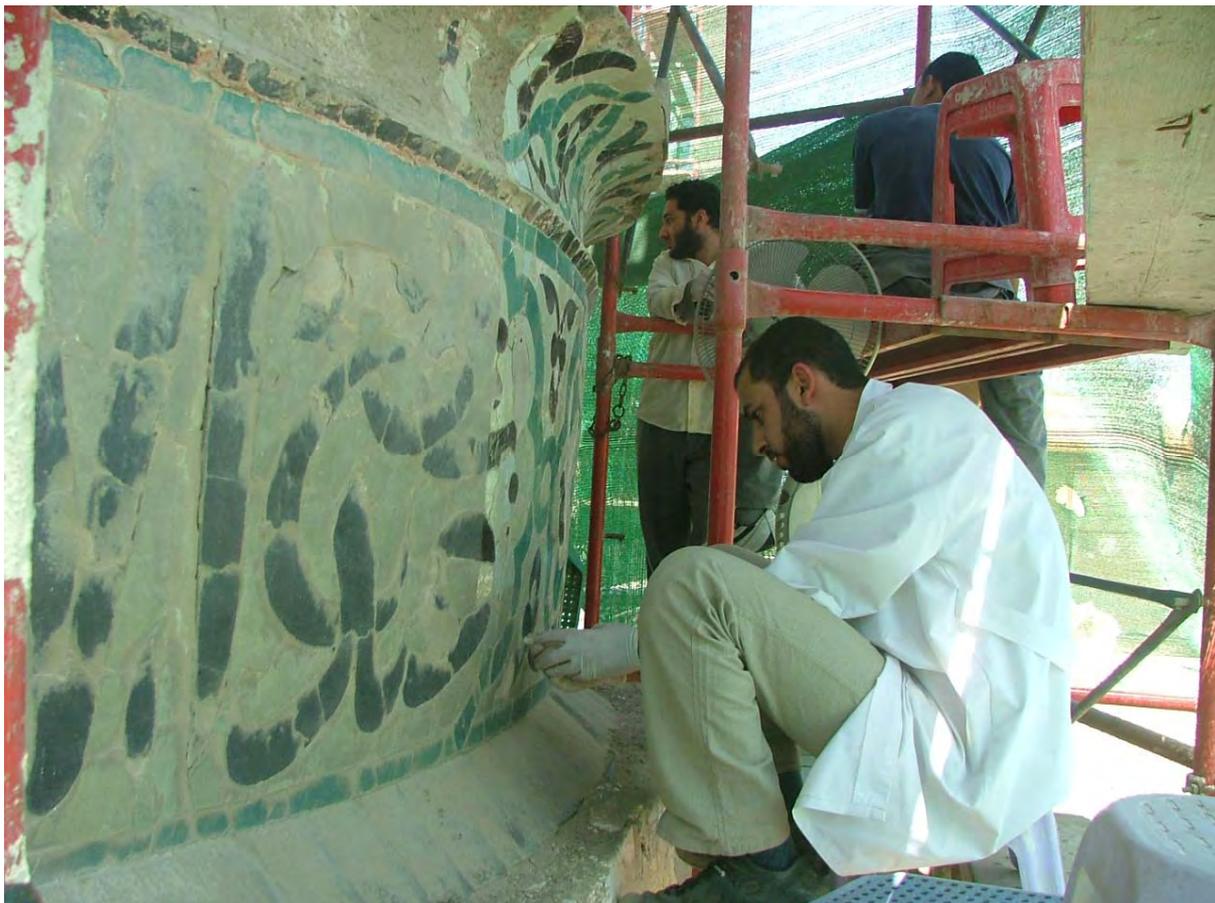
View of the ceramic inscription band on the dome during cleaning and consolidation of the ceramics

A detailed architectural drawing of the ceramic inscription band of the dome was completed. Cleaning and stabilization of the polychrome tiling decoration was finalised. Retouching of the missing ceramic glazed parts is currently proceeding while mortar samples of the missing upper crenellation are been prepared in order to study the feasibility of replacing all missing ceramic crenellations.

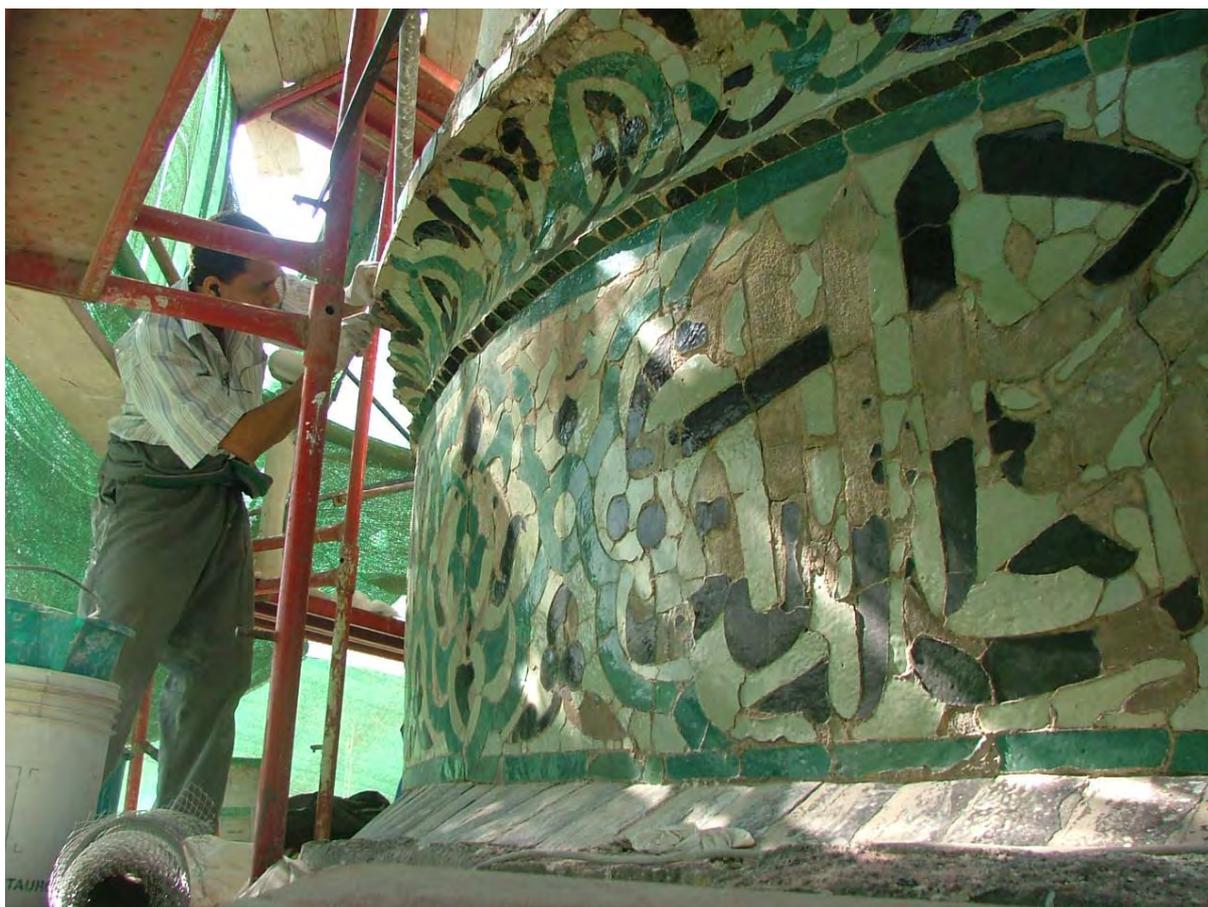
Mortar completion of the upper missing parts of the Dome Corniche

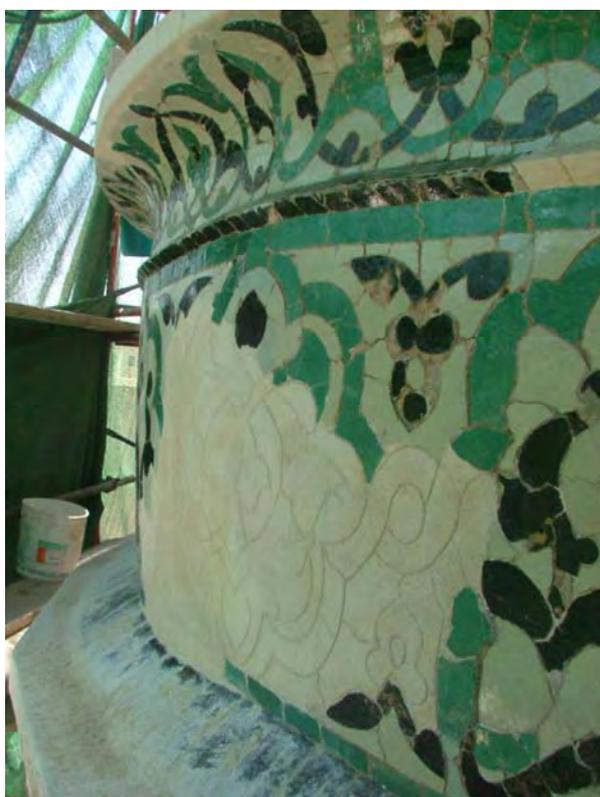
Mortar and drawing completion of missing parts

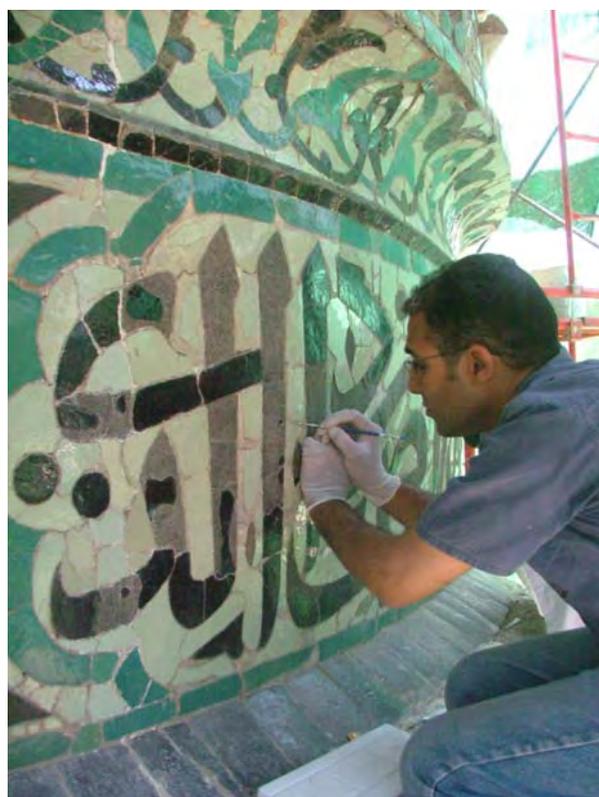
Retouching of the missing glaze of the inscription

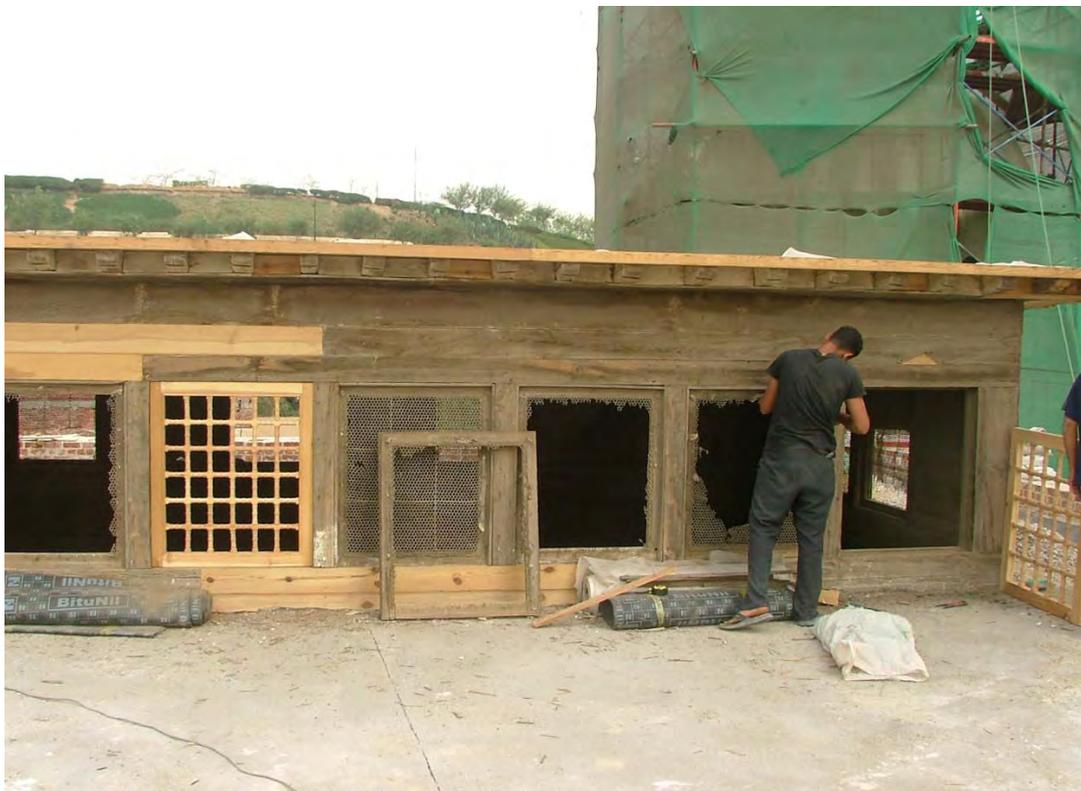
Central shokhsheikha during restoration and view of the new proposed wooden window
