ANNUAL REPORT

“Conservation of the Mosque of Aslam al-Silahdar in Darb al Ahmar, Cairo”

Aga Khan Cultural Services
(Christophe Boleau)

**QUARTERLY PROGRESS REPORT
DECEMBER 2006-FEBRUARY 2007**

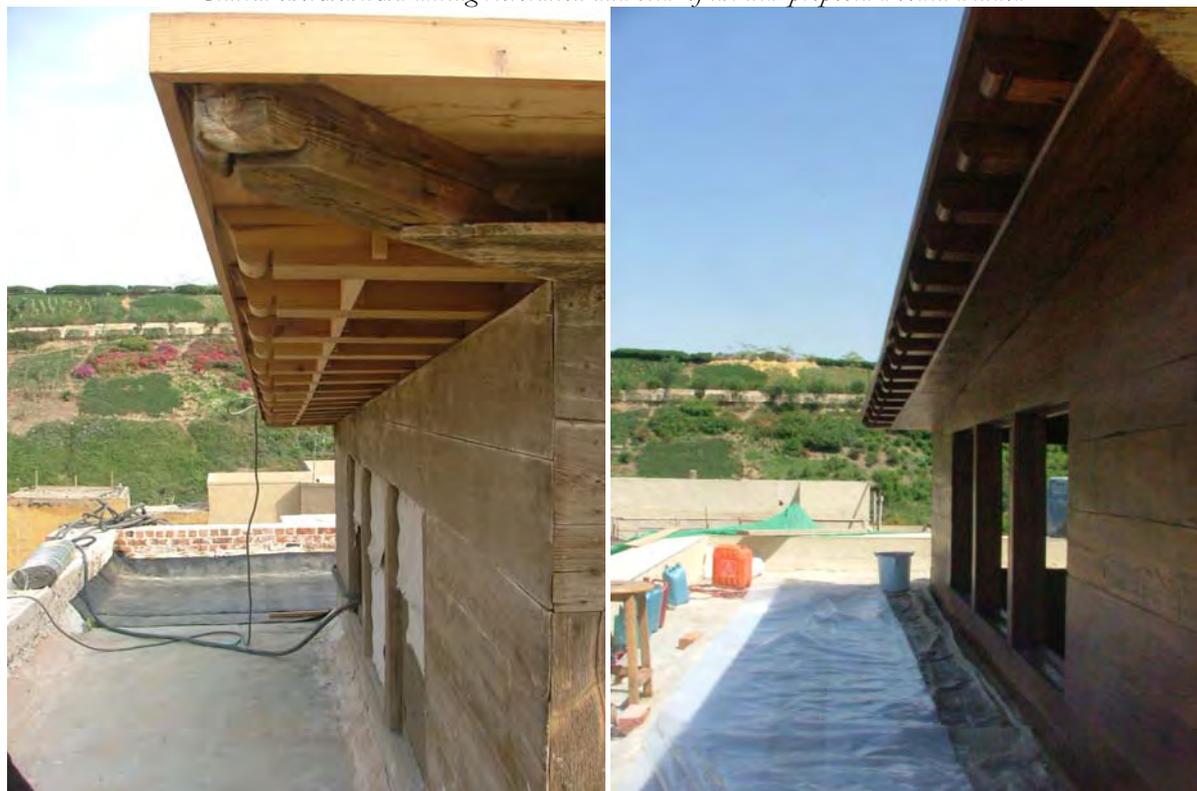
View of the central shokhsheikha after the replacement of damaged beams and shingles and after painting

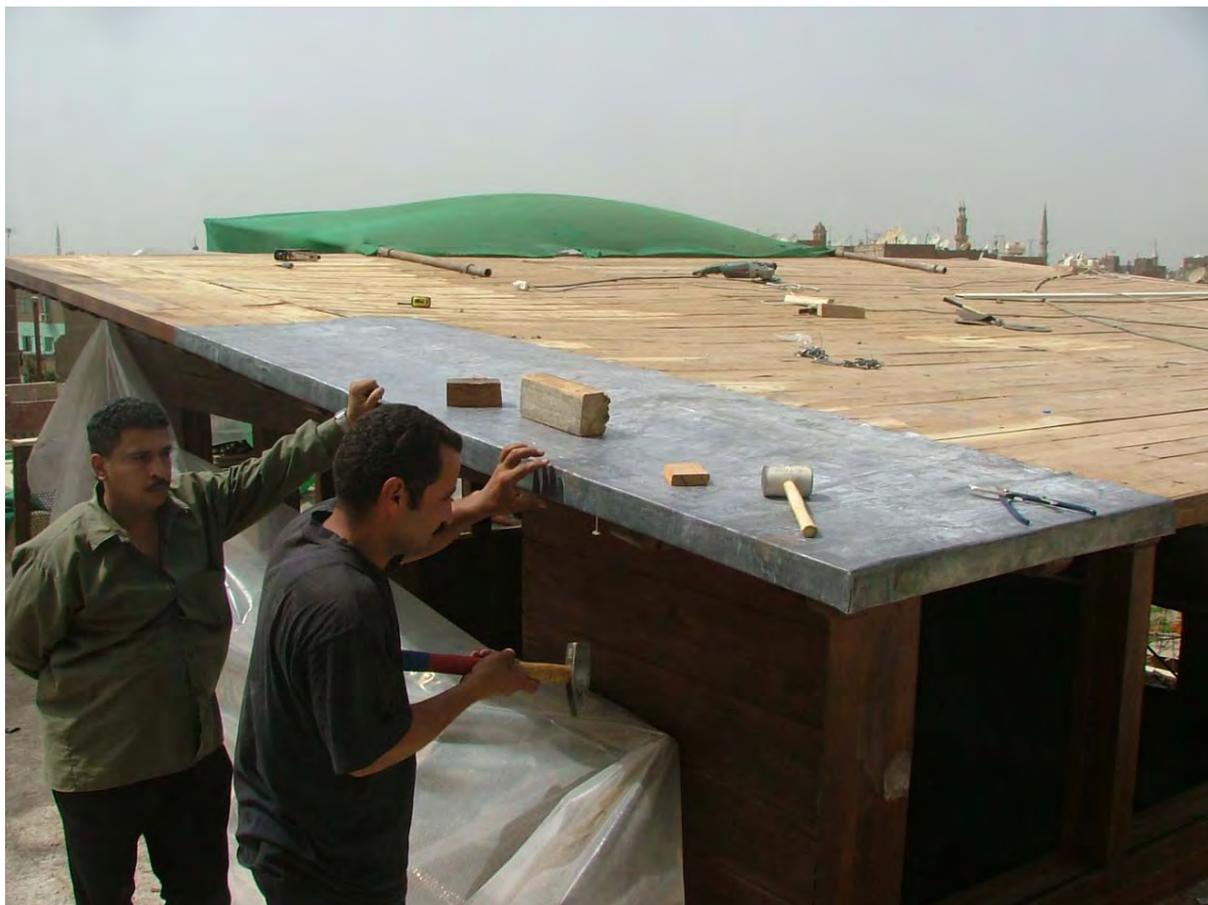
Central sbokhsbekba during the insulation using lead sheets

The carpentry of the central shokhsheikha was restored and insulated by lead sheets in order to minimize the dead load.

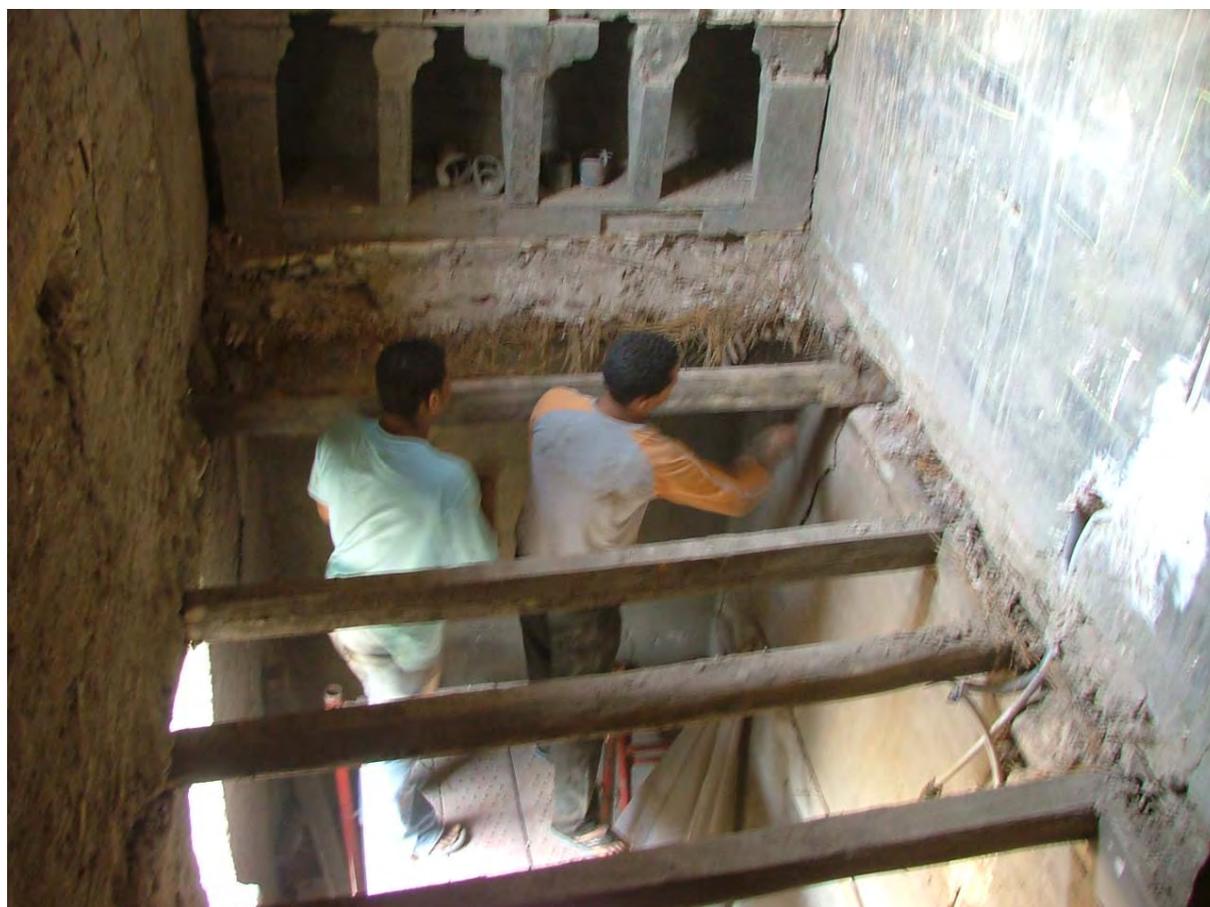
Room 1.2 during the replacement of the damaged beams

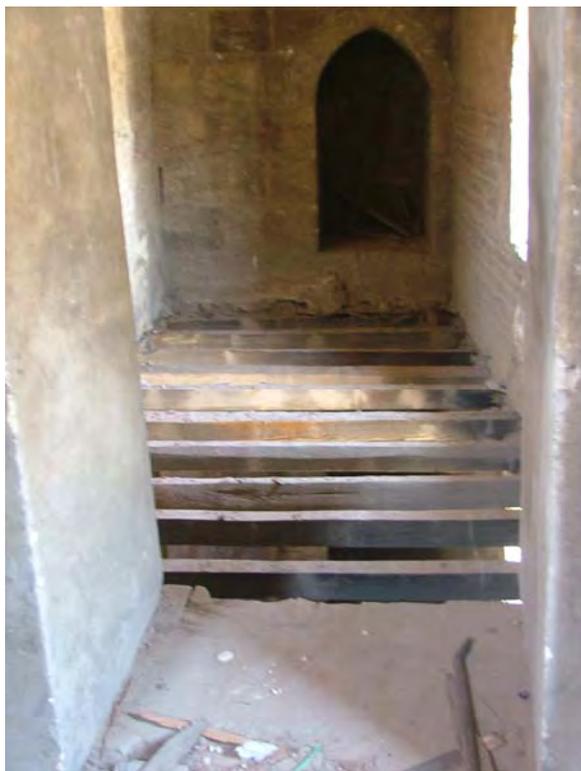
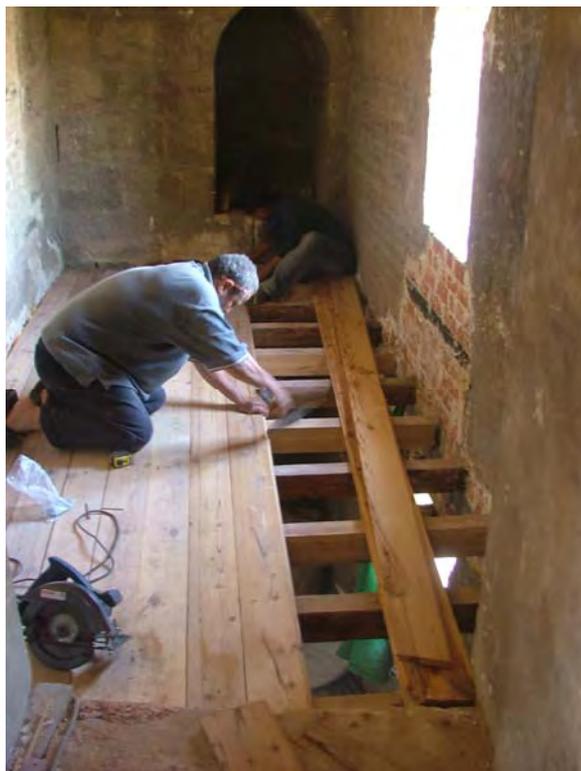
View of room 2.3 during the replacement of damaged beams and shingles.

Brick stitching in room 2.3 was completed and plastering and conservation of the remaining stone facing and plaster is on going. Electrical network has been embedded into the brick masonry.

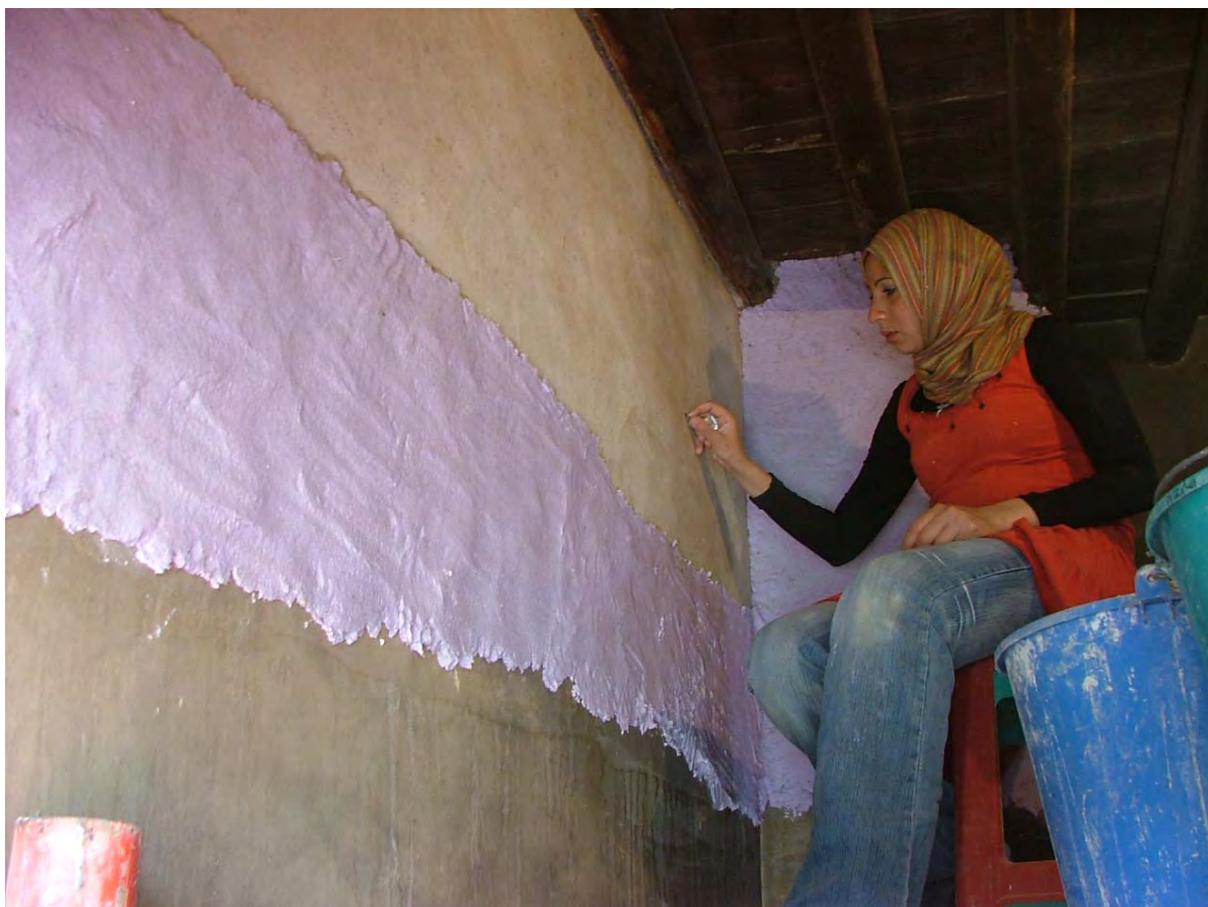
Cleaning of lime based plaster in room 2.2 using poultices after the injection of detached parts.

Room 2.1 on the second floor was found in a good condition. Fine restoration and cleaning activities were finalised. Currently conservation of room 2.2 is taking place. Cleaning and conservation techniques include grouting behind detached plaster layers and consolidation of the lime based plasters using poulticing.

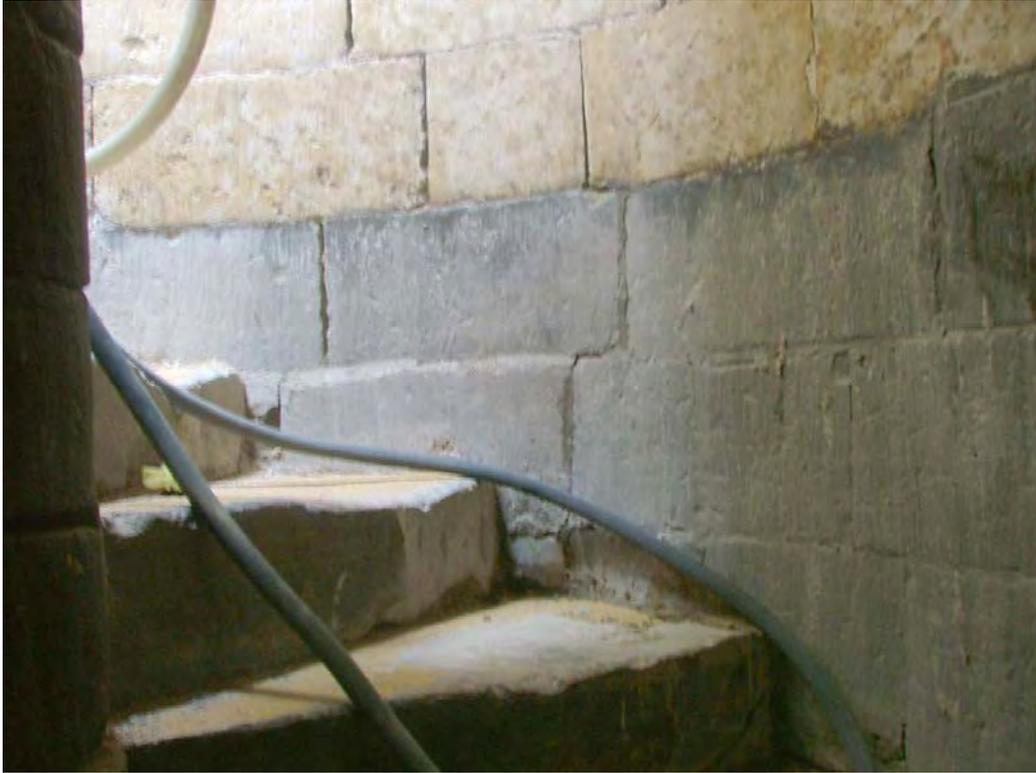
Interior of the main staircase during cleaning by sand blasting

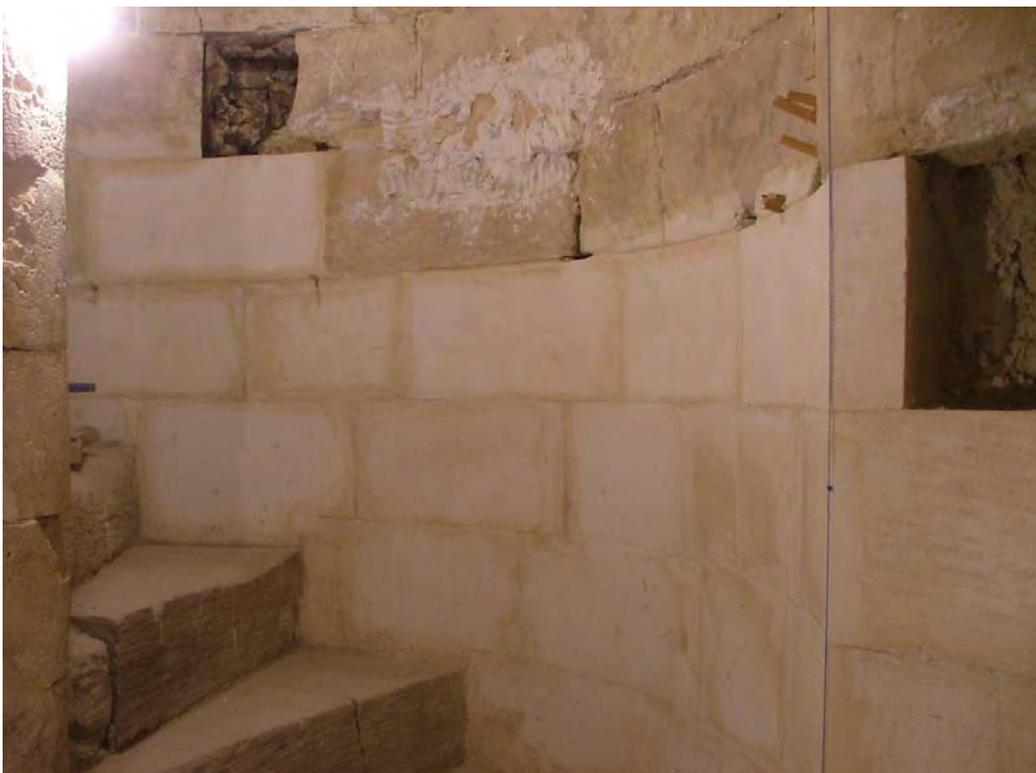
Stone replacement activities in the staircase

The mosque's main staircase showed many damaged stones which were replaced by new stones of similar nature. The electrical network was also embedded in the stone masonry during the restoration. The walls and steps of the staircase were cleaned by the sand blasting. Repointing of the wall masonry joints was finalised afterwards.

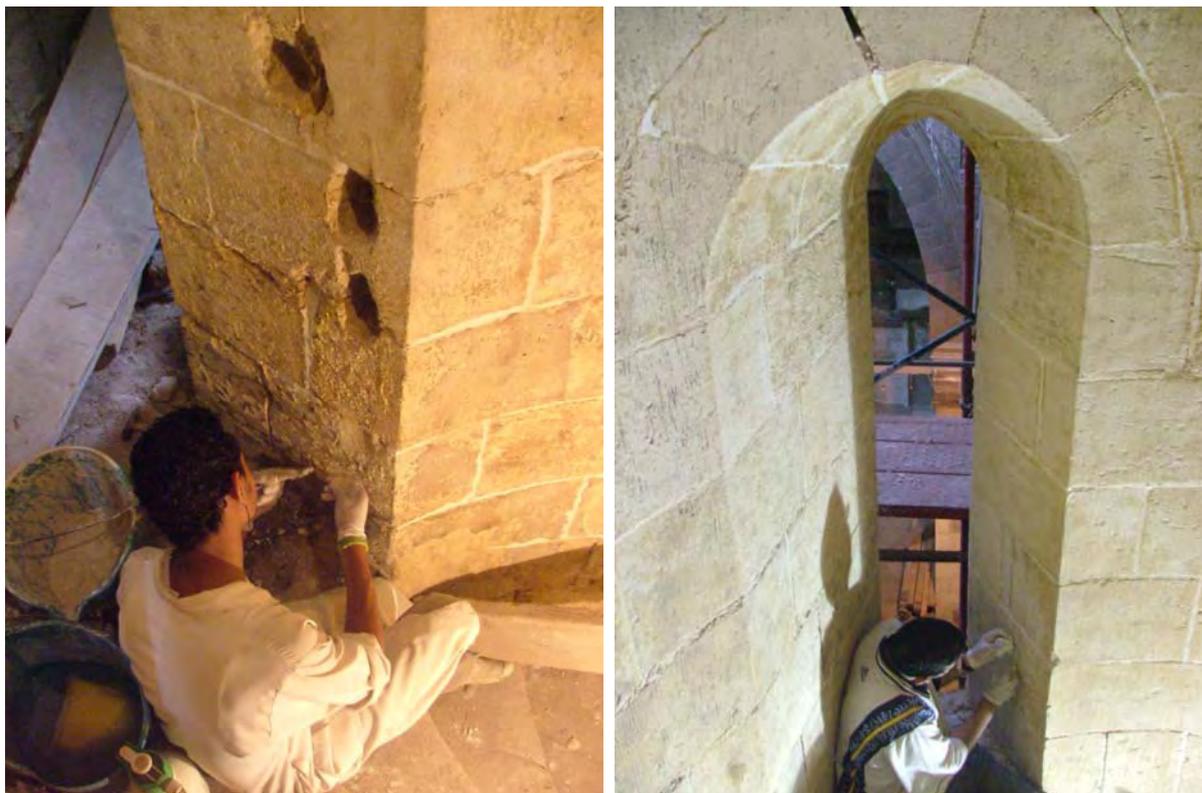
Repointing of the stone masonry after cleaning

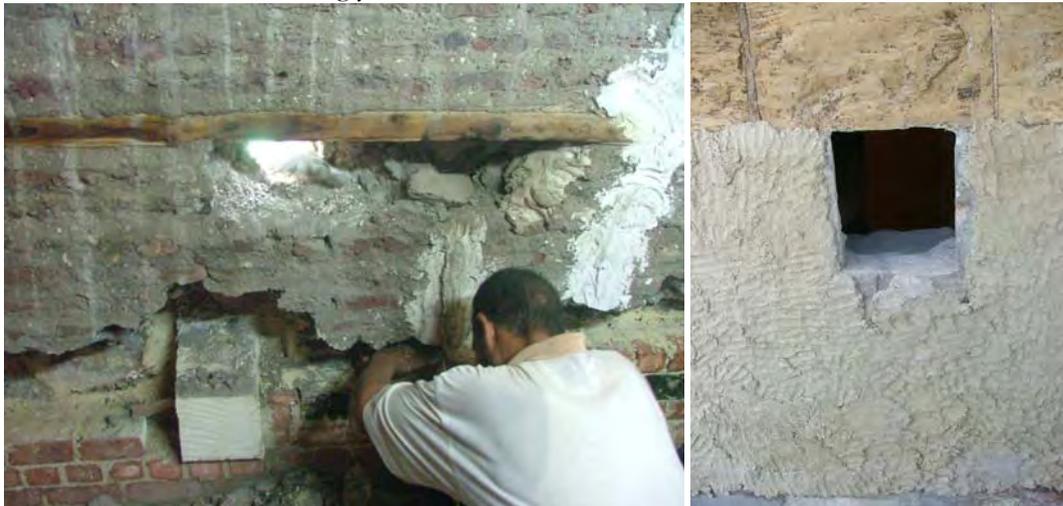
The western façade shows bulging in more than one area as well as cracks that appear from the interior of the rooms behind the façade. After investigation it was clear that the bulging and the cracks are due to the type of construction of this façade. The thickness of the wall is in some areas less than 45 cm and is composed of a stone wall on the exterior and a thin brick wall in the interior; these two are not connected and tend therefore to detach. Therefore it was decided to reconnect the two elements of the wall by removing some stones and prolonging them into the brick wall; in some areas stainless steel bars were also inserted into the stones also protruding up to the brick wall; in few areas the thickness of the brick part of the wall had to be slightly enlarged.

View of the interior of the room (1.2) on the western façade during brick repair activities and extending the stones into the brick wall (left photo shows the opening for the stone before placing it into the wall showing the thin thickness of the wall).

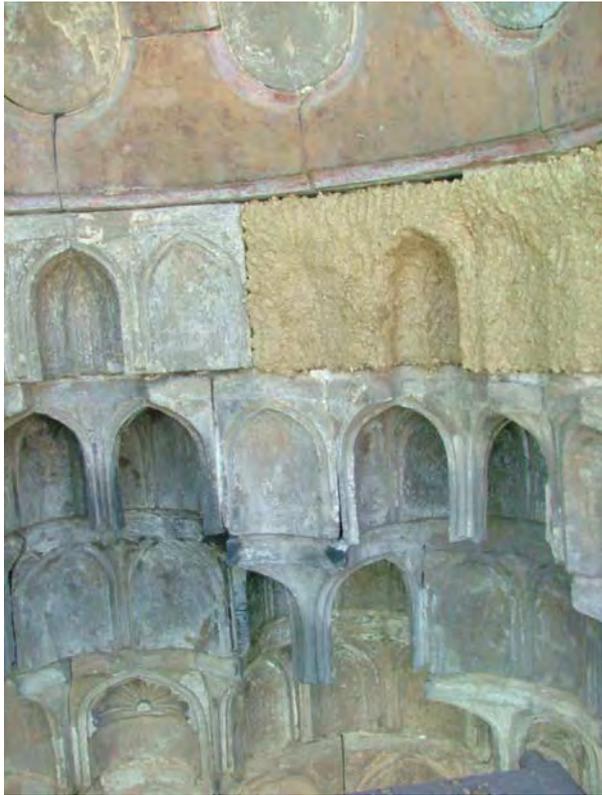
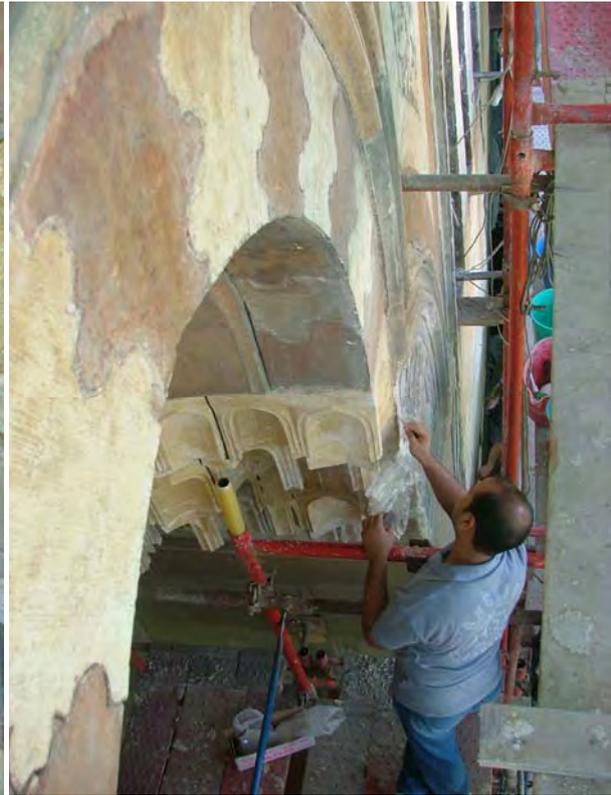
Poulticing and cleaning of the muqarnas entrance porch and its results

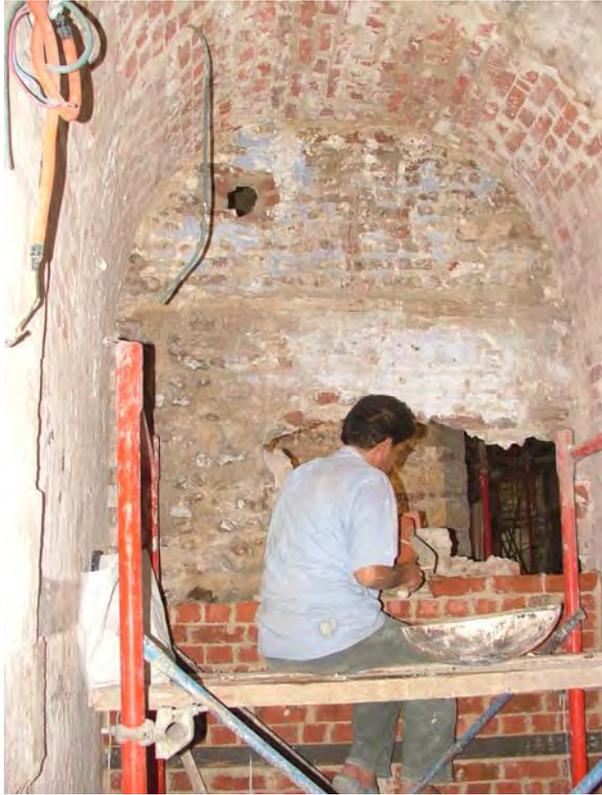
Some of the shops were in a bad structural condition and required a lot of brick repair of their vaults and walls; during this activity, electrical wires were also installed to fit the use requirements of the shop owners. The shops were then plastered. The shops with stone vaults are currently being cleaned.

Brick repair and reconstruction activities of damaged and crumbling brick walls in the shops on the western façade

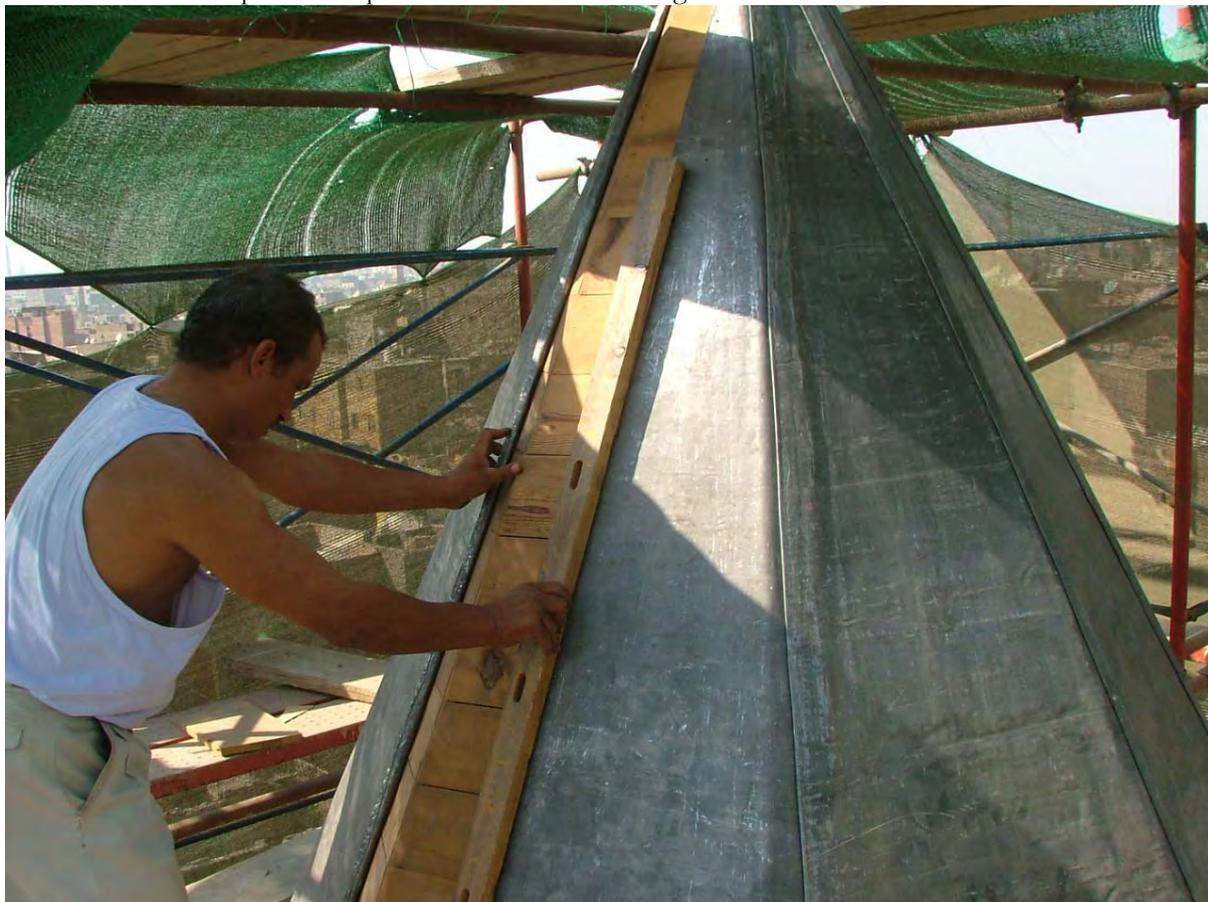
Placing the lead sheet of the insulation of the minaret

All remaining activities on the minaret were finalized: the balcony was tiled, the insulation of the upper wooden part was insulated in lead and the missing part of the crescent was manufactured and put in place. The outer and inner parts were plastered and the interior lights were installed.

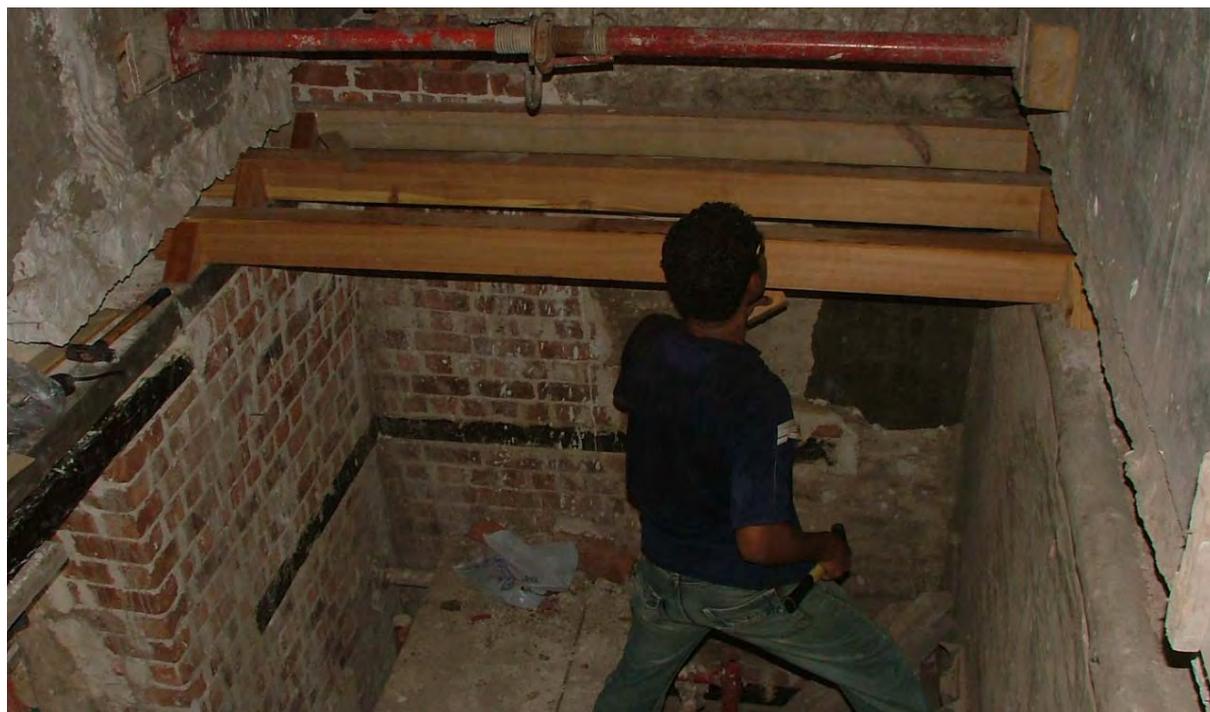
Erecting the wooden ceiling of room M1

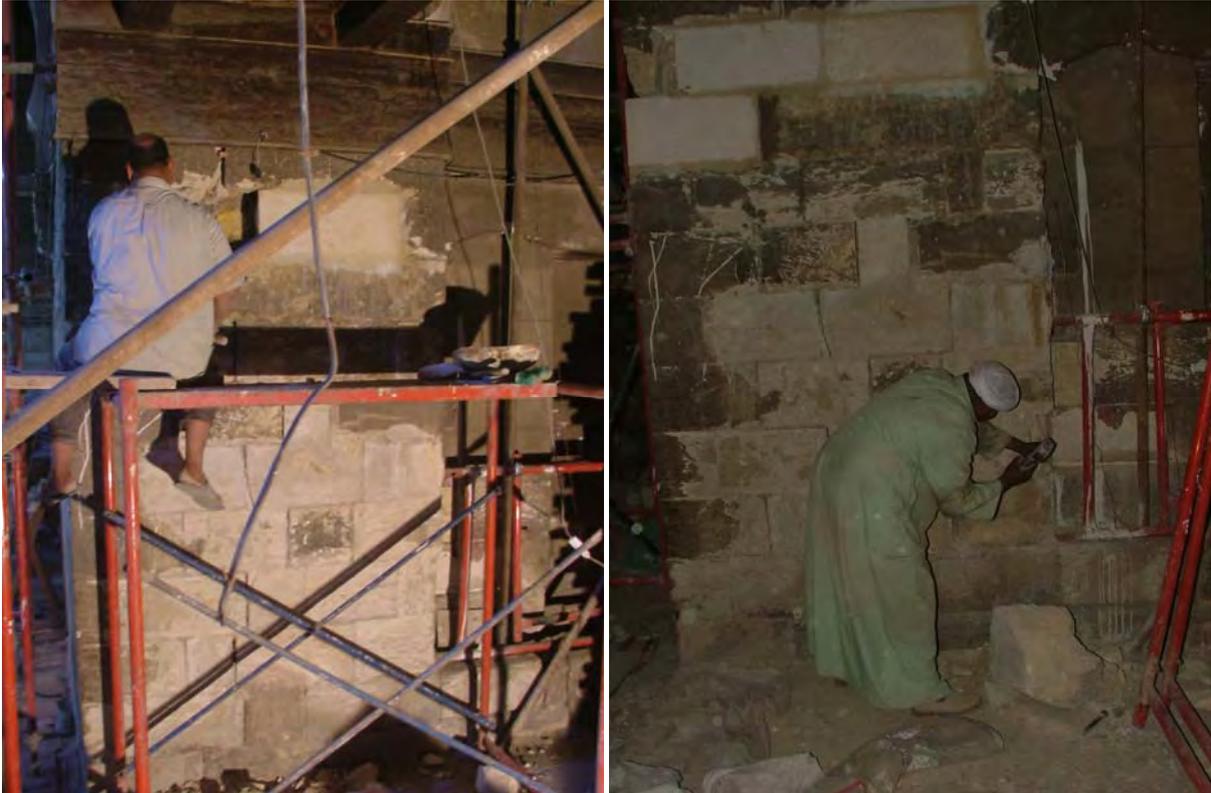
Stone replacement activities in the west iwan

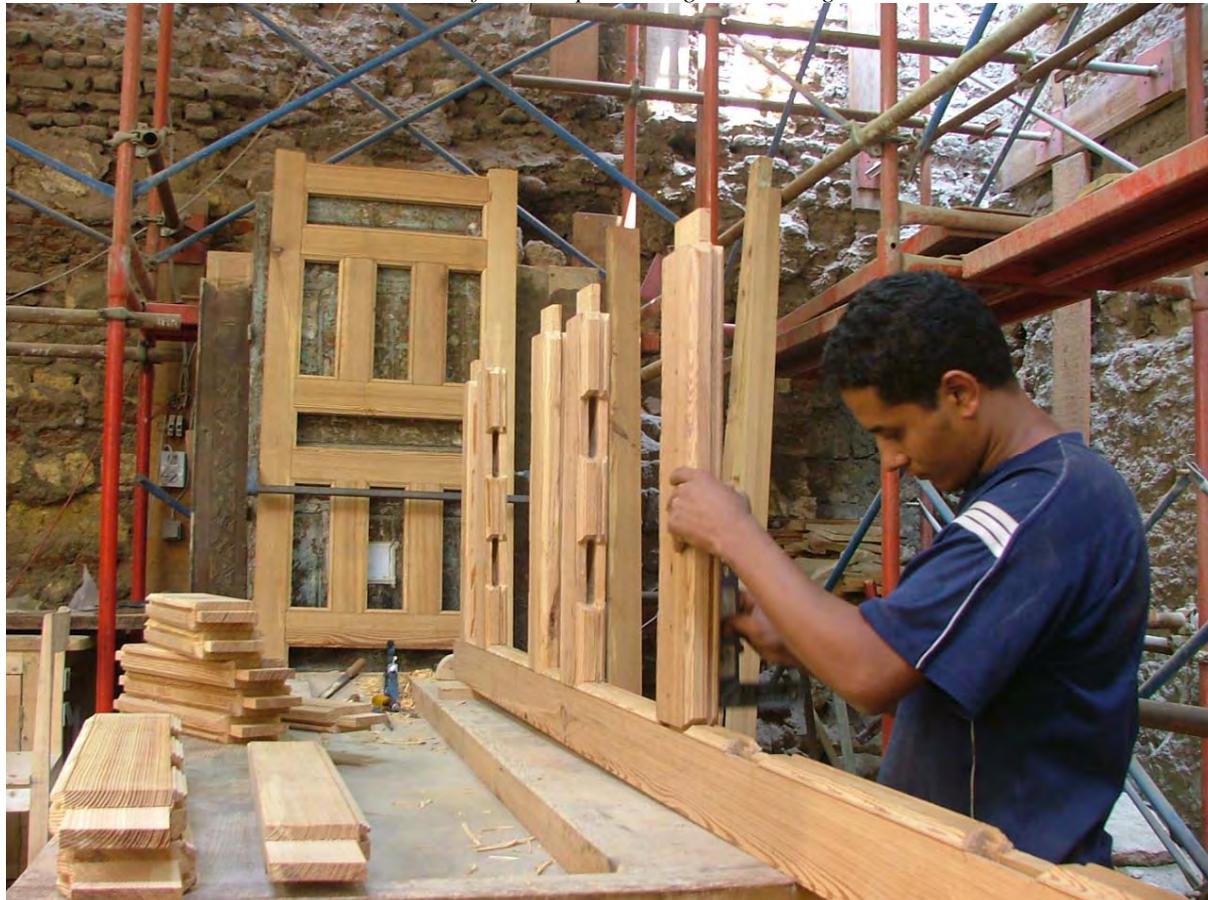
The wooden doors of the shops were repaired; their modern paint layer was cleaned using the paint remover and in other cases the hot air gun. The wood of the last shop's door was in a very bad condition and a new door was accordingly manufactured.

Manufacturing a new wooden door replacing the damaged one of shop 5

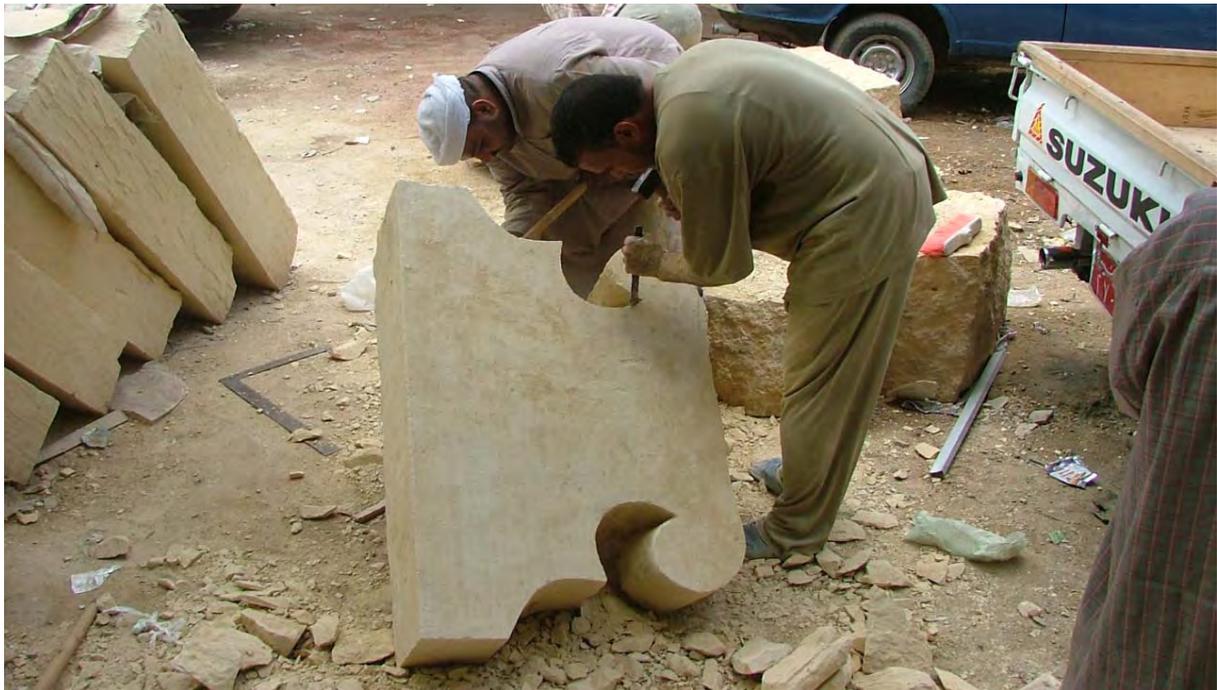
Carving the missing crenellation of the south (main) façade

The missing crenellations on the south (main) façade were carved, brought up to the roof and installed in place. The missing crenellations on the right side of the west façade were also carved and erected.

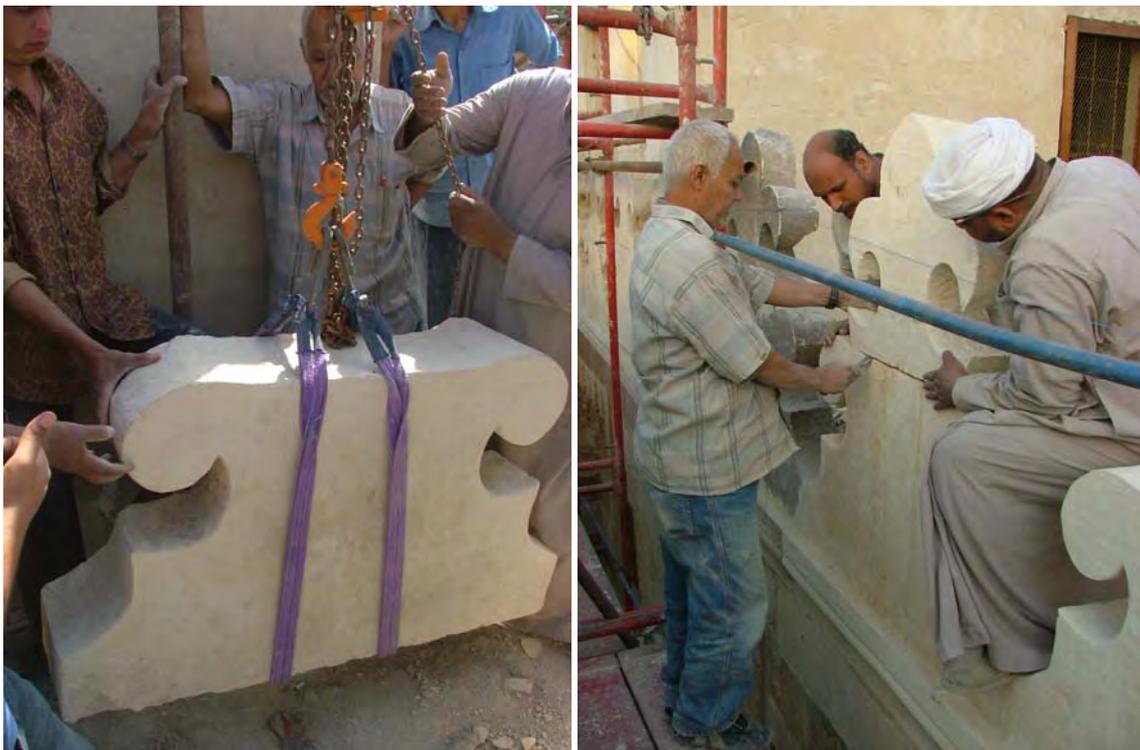
Activities of placing the missing crenellations

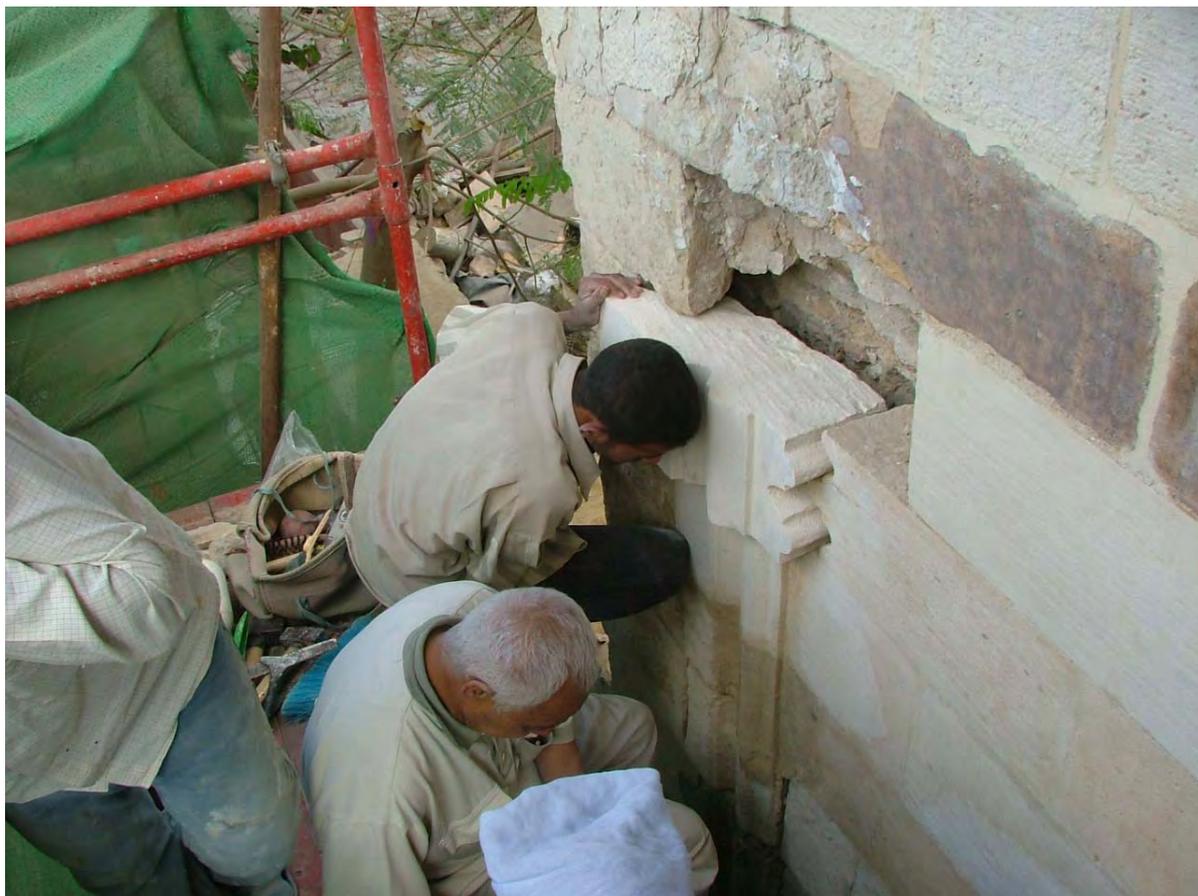
Stone replacement activities on the lower part of the west façade

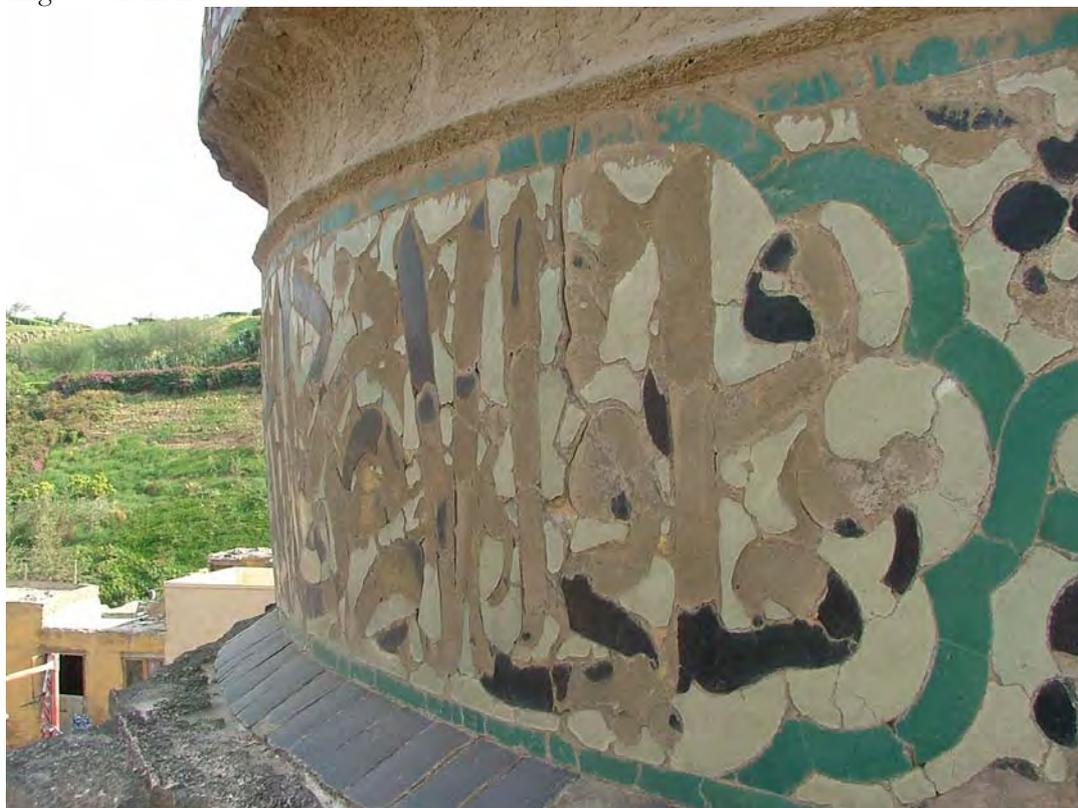
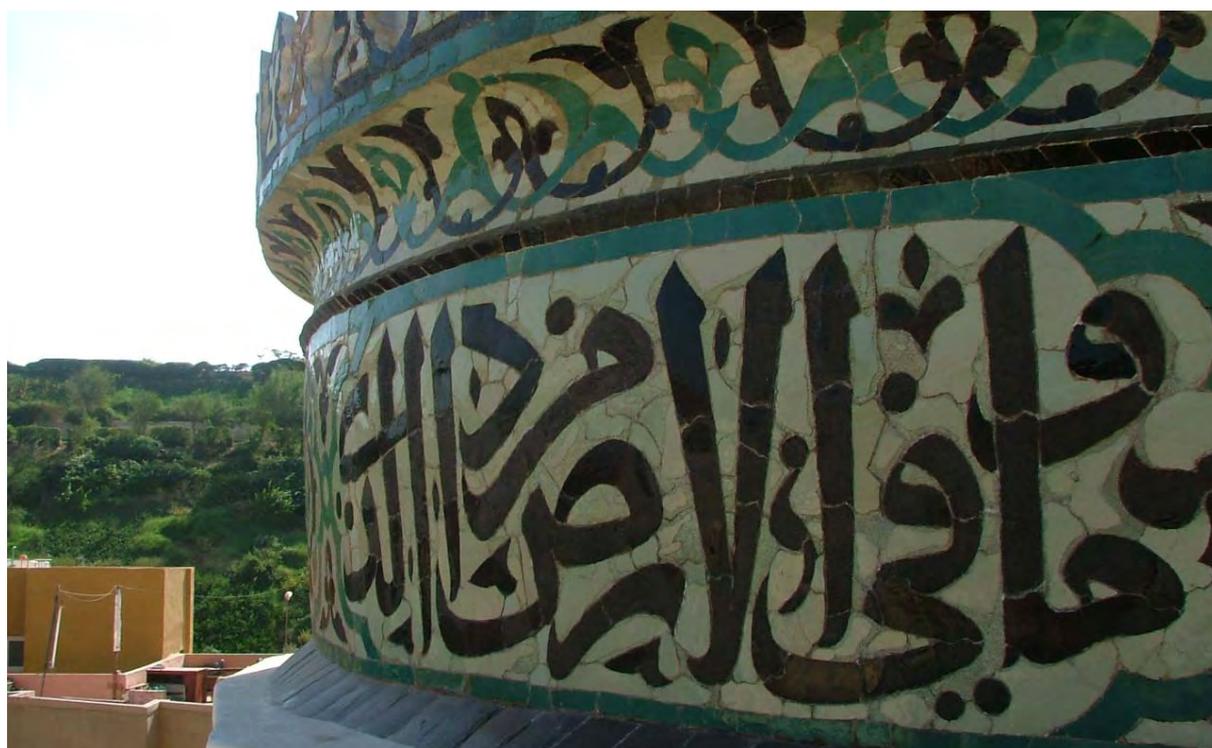
Details of the inscription band on the exterior of the dome before and after intervention

The retouching of the crenellations (made in plaster), the inscription band and its floral decoration was completed. A decision is being studied concerning the completion of the inscription band in the areas where no ceramic tiles are found. The existing gypsum grills with glass on the interior of the mausoleum were cleaned from the outside. As for the exterior gypsum windows (which are missing) designs were proposed to the SCA and discussions are taking place concerning the matter. The scaffolding was dismantled.

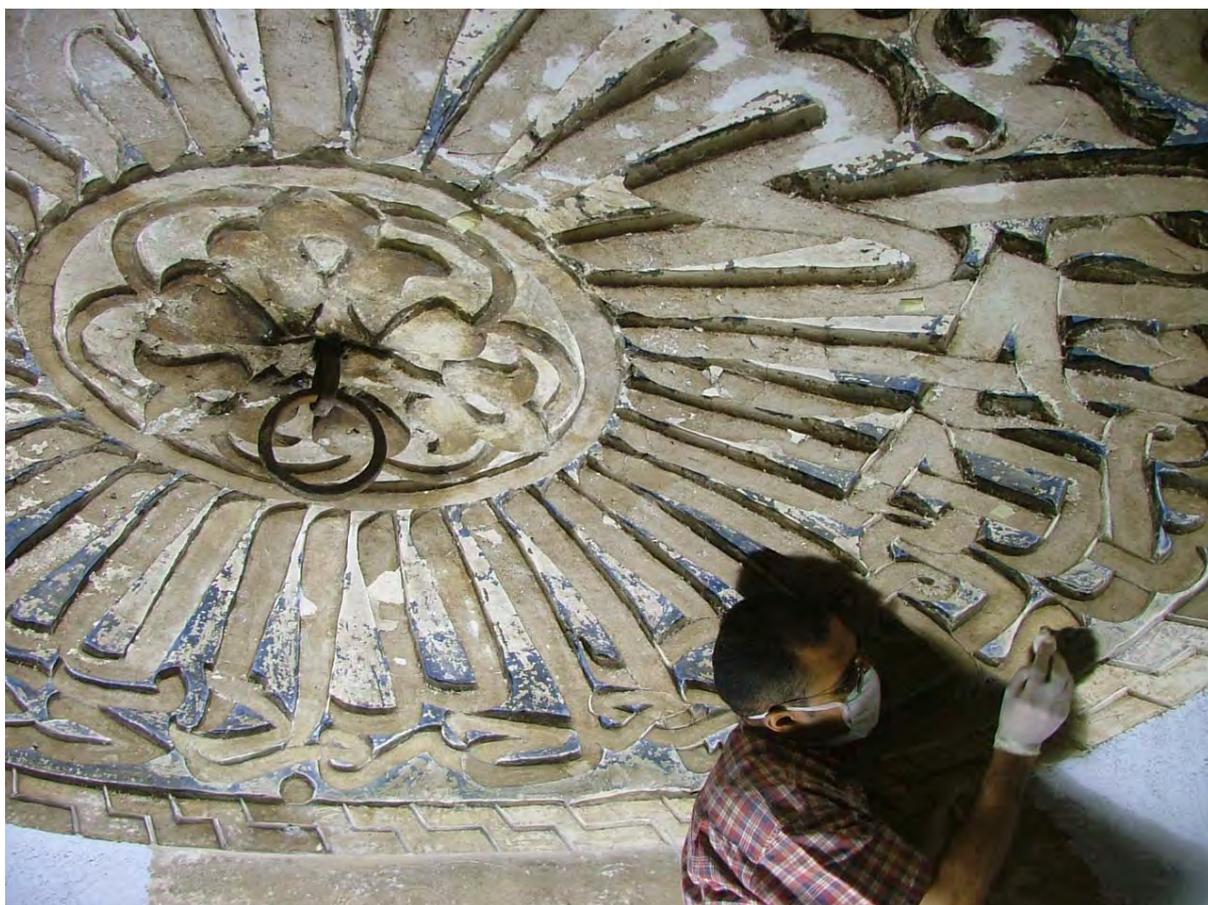
View of the roundel during cleaning

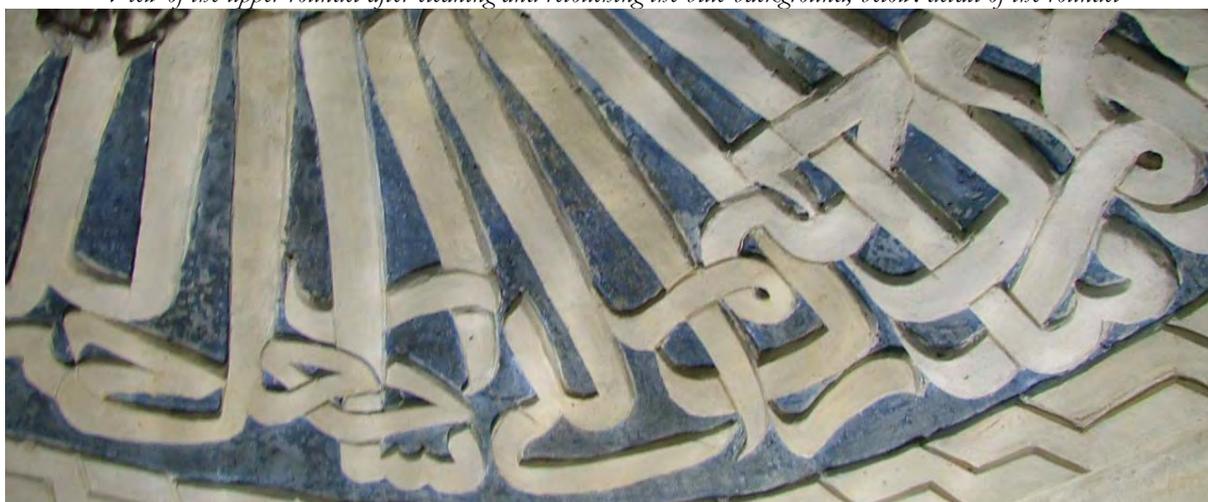
Views of repairing and protecting the gypsum decoration in-situ

On the lower levels of the mausoleum some gypsum grills and windows were in a very bad condition with numerous missing parts. These are being repaired in-situ. One grill was in a quite bad condition and was dismantled, repaired, cleaned and completed.

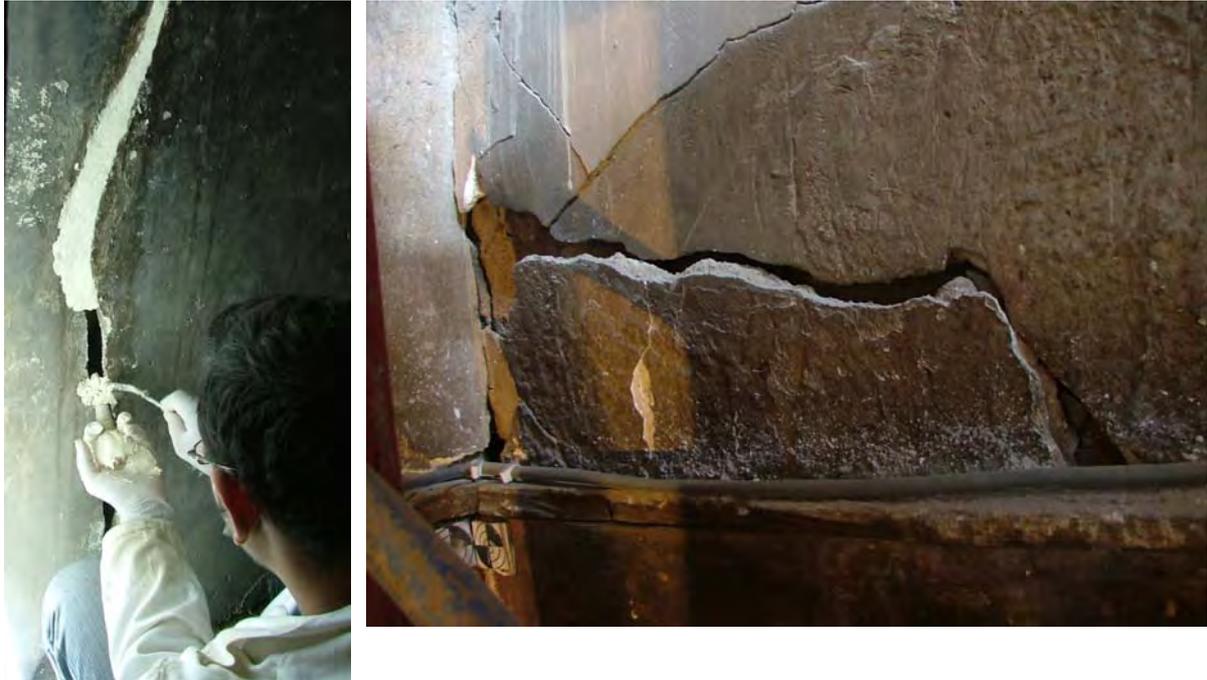
Example of the condition of the gypsum plaster in the courtyard showing serious cracks and detachment
