ANNUAL REPORT

“Conservation of the Mosque of Aslam al-Silahdar in Darb al Ahmar, Cairo”

Aga Khan Cultural Services
(Christophe Boleau)

**QUARTERLY PROGRESS REPORT
DECEMBER 2006-FEBRUARY 2007**

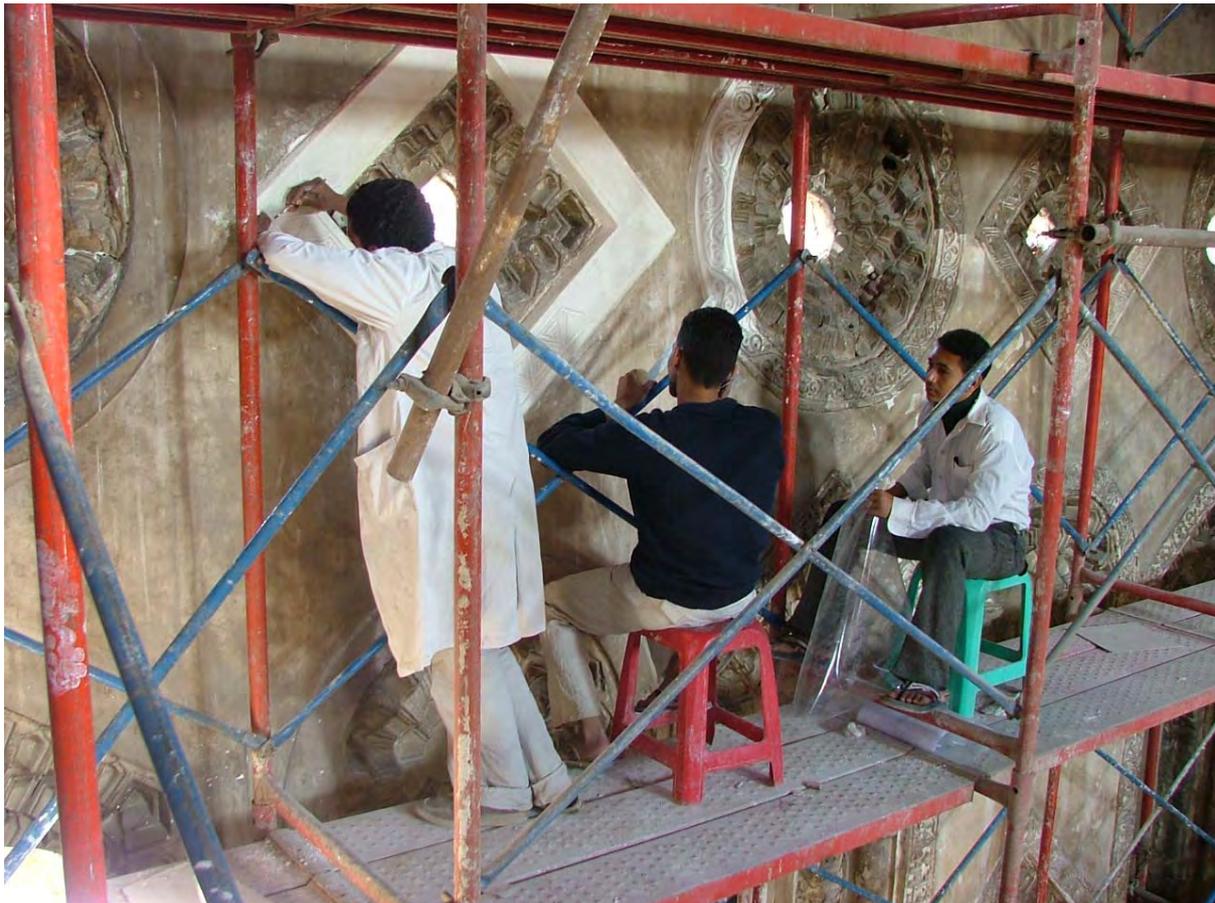
Activities of completing the gypsum decoration of the roundels and lozenges in the courtyard

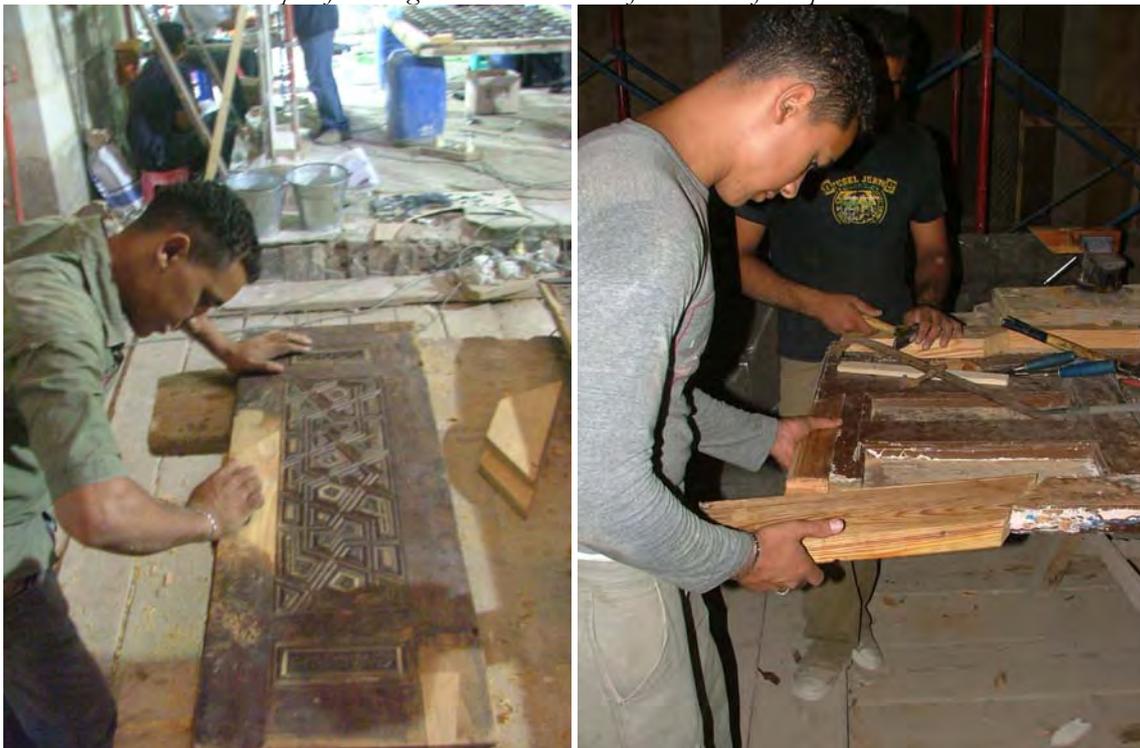
Architectural repair of damaged parts in the wooden shutters
