**DEPARTMENT OF THE INTERIOR
U.S. GEOLOGICAL SURVEY**

**Preliminary Report of Investigations
of the Central Chile Earthquake
of March 3, 1985**

Open-File Report 85-542

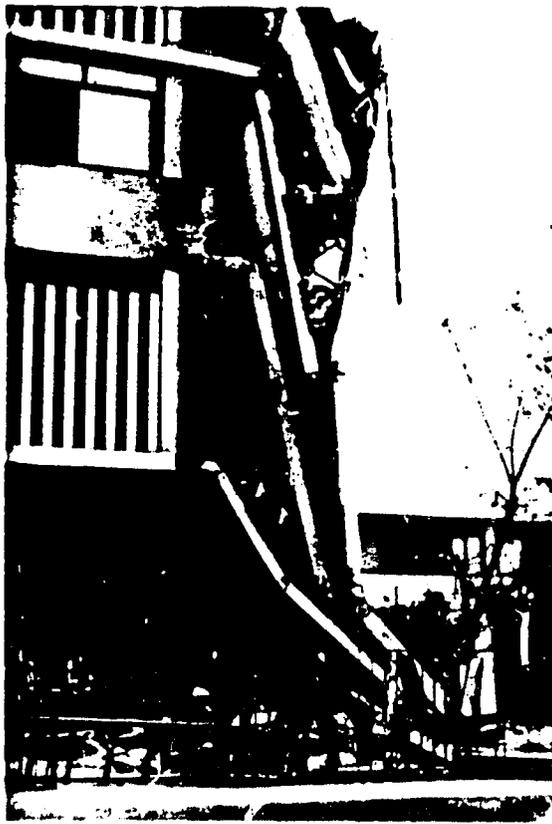
Figure 1.--Part of this building in Santiago collapsed. The building had soft first story. This building, one of several typical buildings in the same area, is the only one that did not perform well.

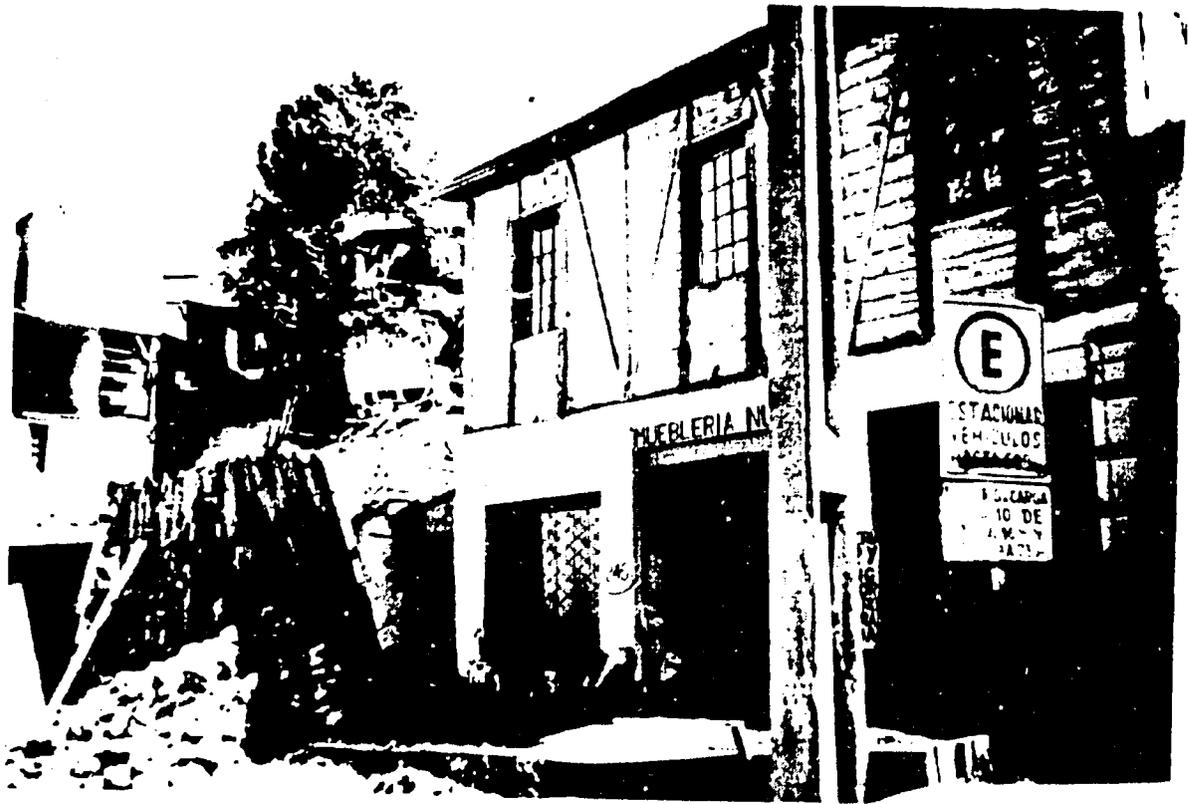
Figure 4.--A unique structure in downtown San Antonio. The first floor is reinforced concrete frame. The added on second floor is masonry reinforced with well braced timber. The building did not suffer any damage. Older adobe buildings adjacent to this building or behind it had completely collapsed.

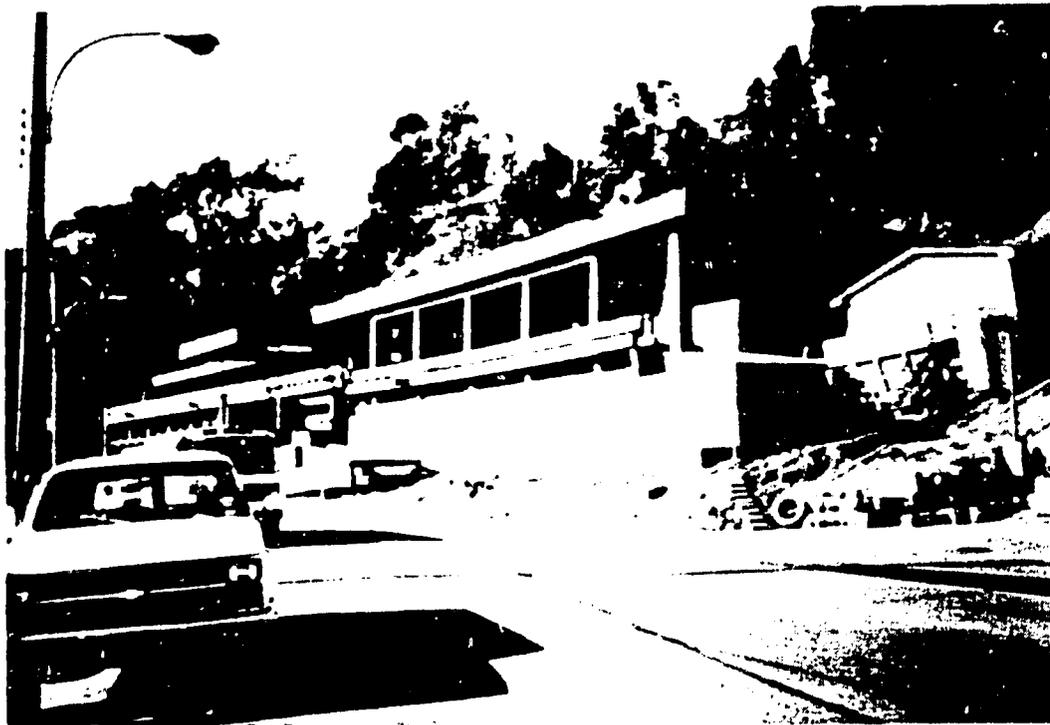
Figure 6.--A new reinforced concrete framed structure across from the San Antonio Harbor. Note the short columns between the tie beam (in the first floor) and the beam in the second story floor. These short columns were all damaged.

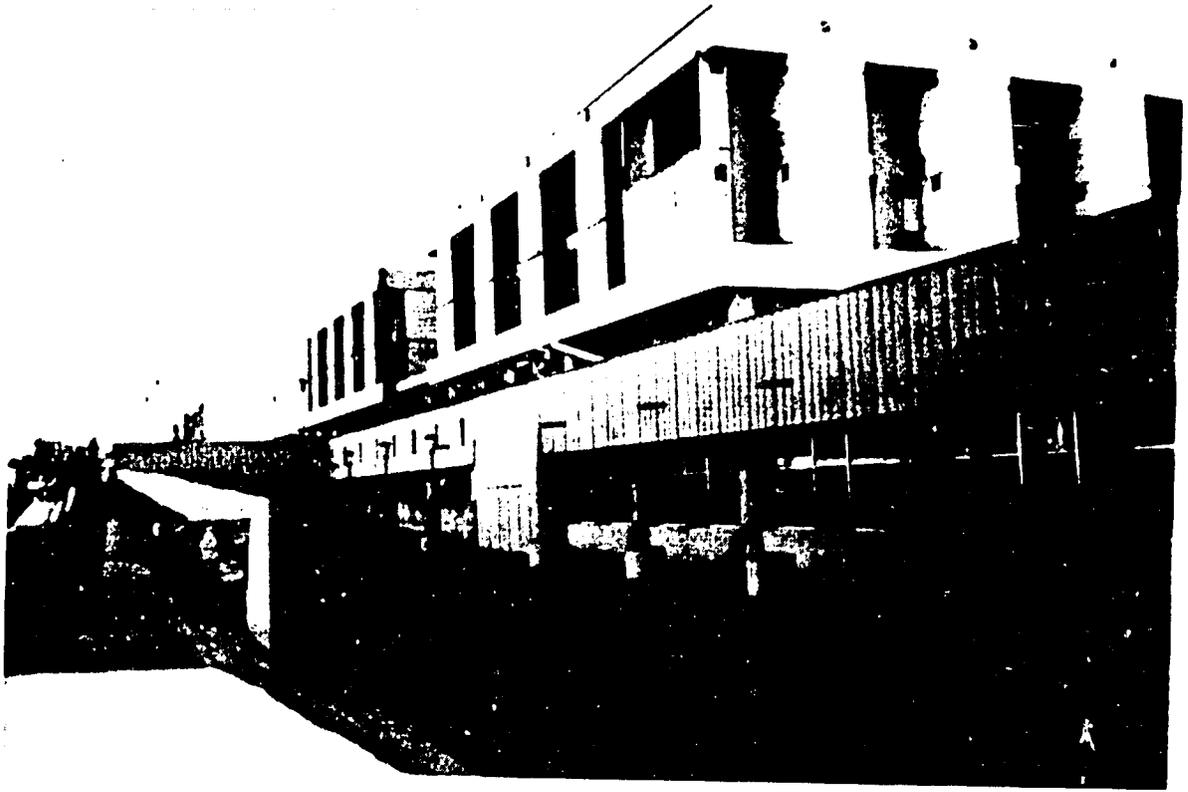
Figure 9.--Claudio Vicuña Hospital in San Antonio. The second story is the "soft story". The columns, particularly in one of the two blocks were damaged.

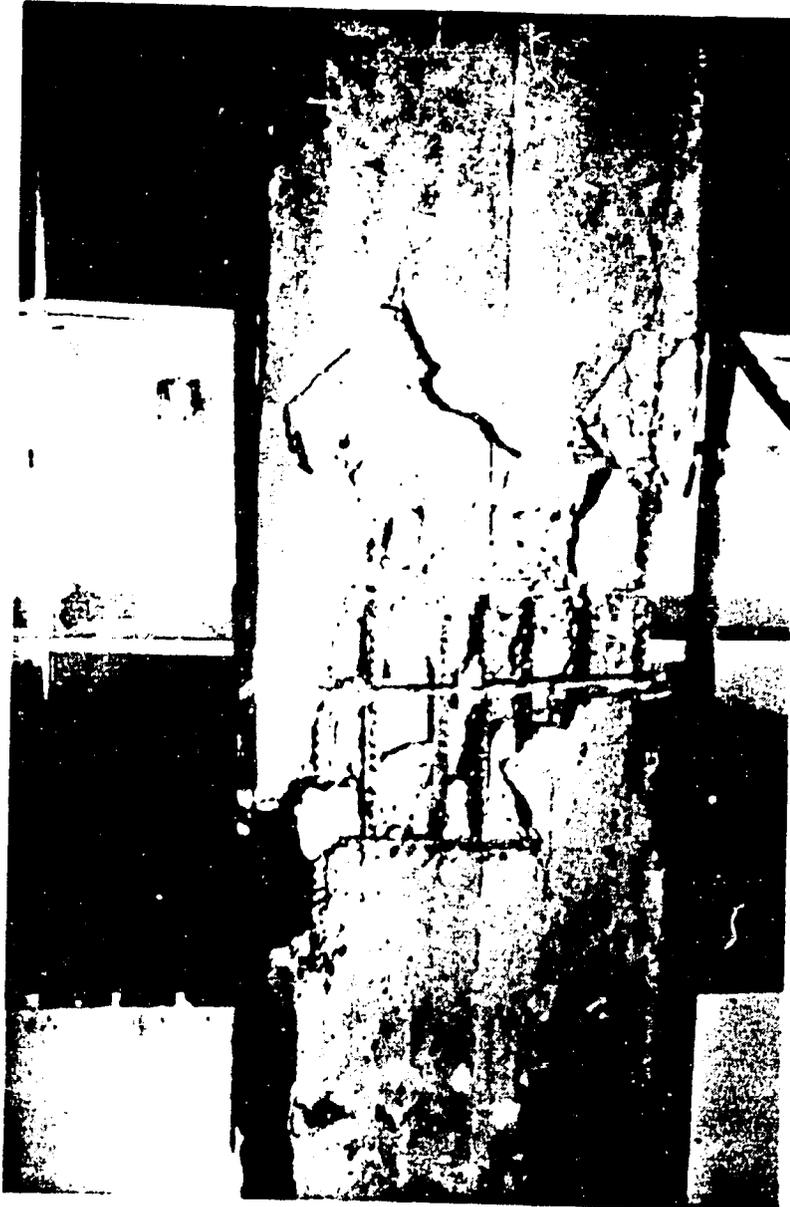
Figure 10.--Extensive spalling at the exterior and cracking in the confined concrete core of the column. The concrete quality appeared poor.

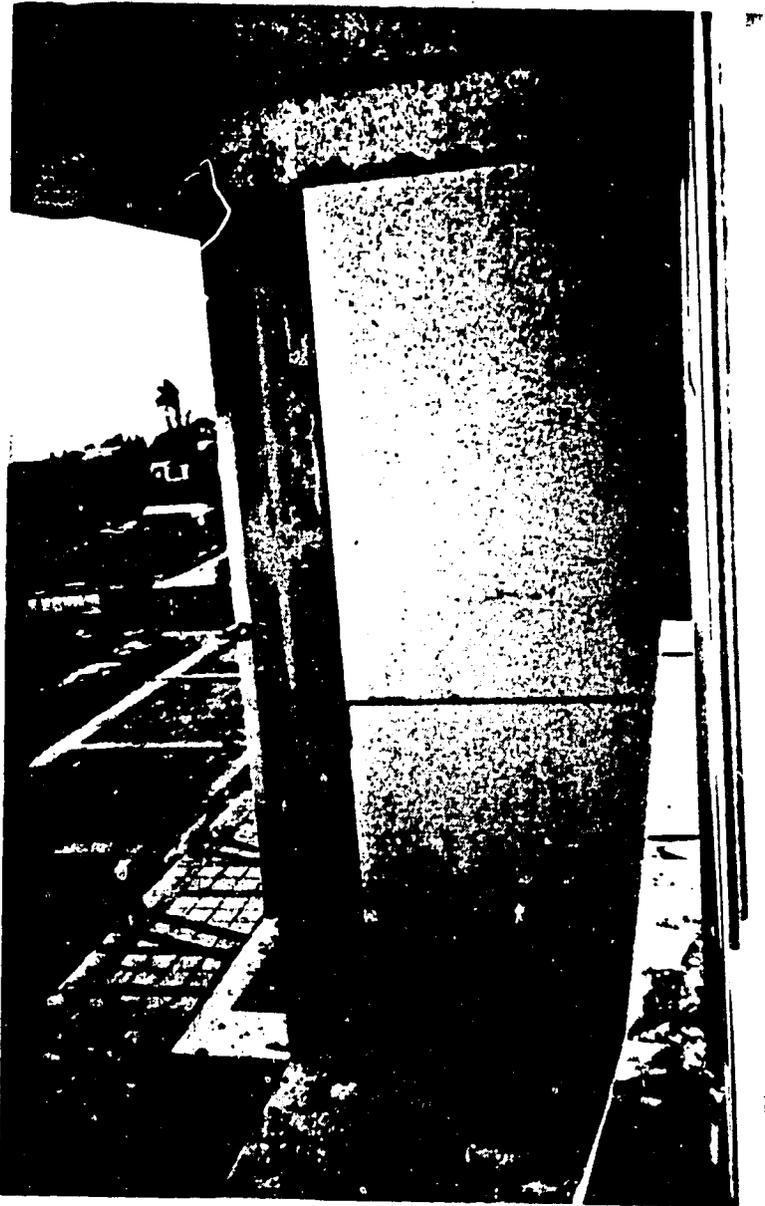
Figure 11.--Two story long column at the west end of the hospital severely cracked in the middle.

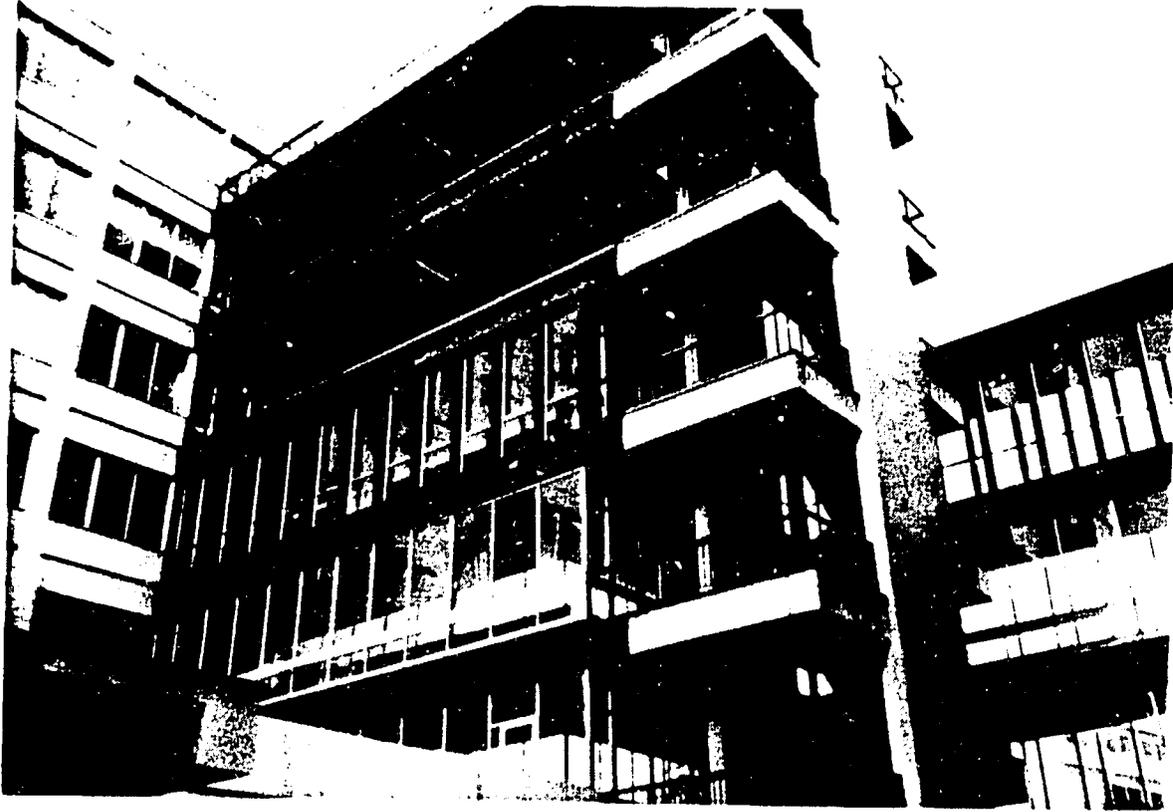
Figure 17a.--C. Van Buren Hospital in Valparaiso. There was no structural damage. However, the prefabricated infill panels separated from the frame elements in several locations. The operating room was damaged. The two blocks of this hospital is connected by a steel framed glass corridor.

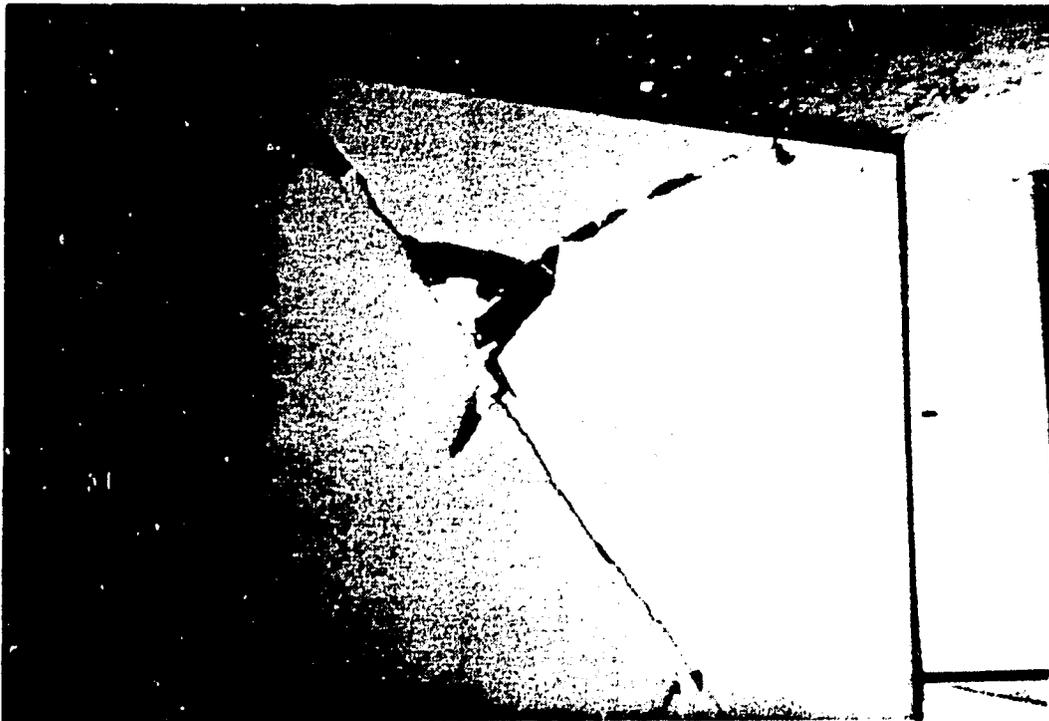
Figure 29.--Prefabricated brick panels of Edificio Del Mar cracked extensively,
particularly in the top floors.

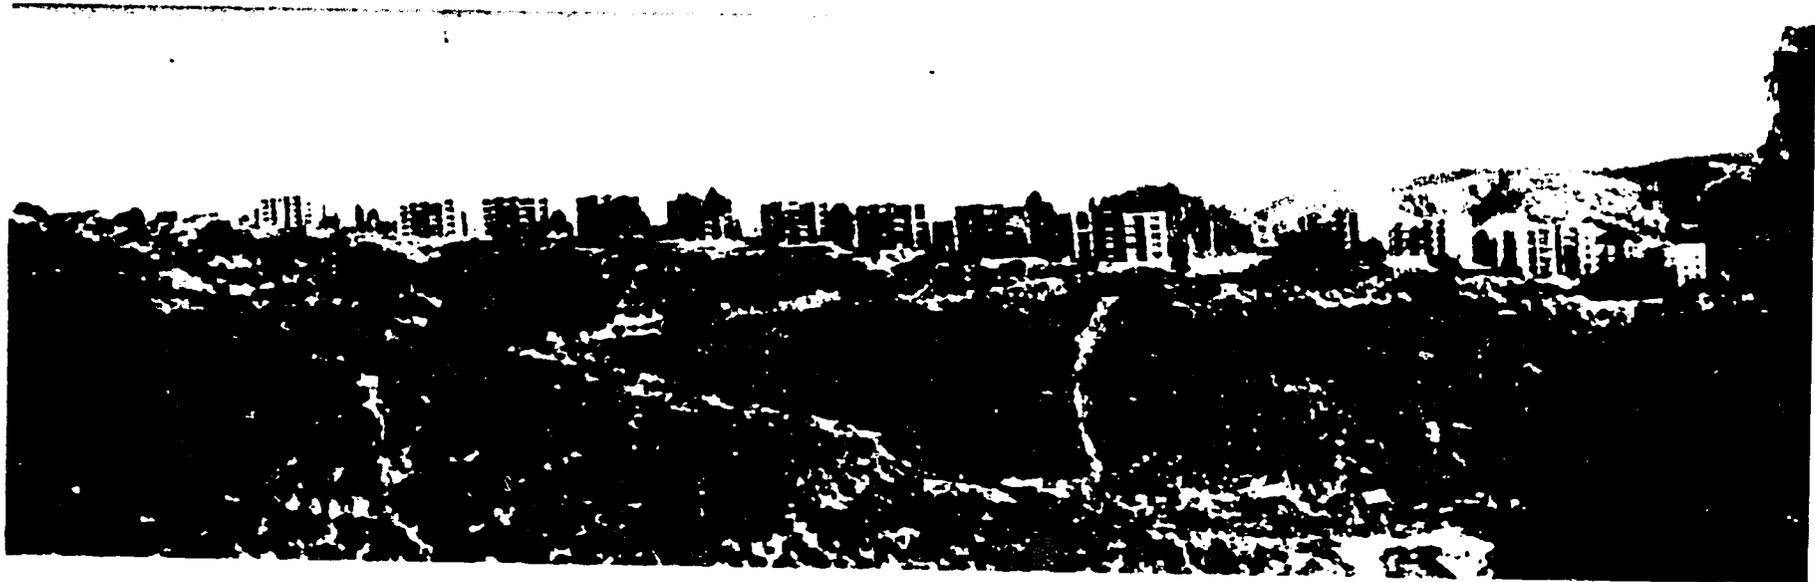
Figure 36.--Panoramic view of Type C structures on another ridge of Canal Beagle Subdivision. All of the type C structures were severely damaged.

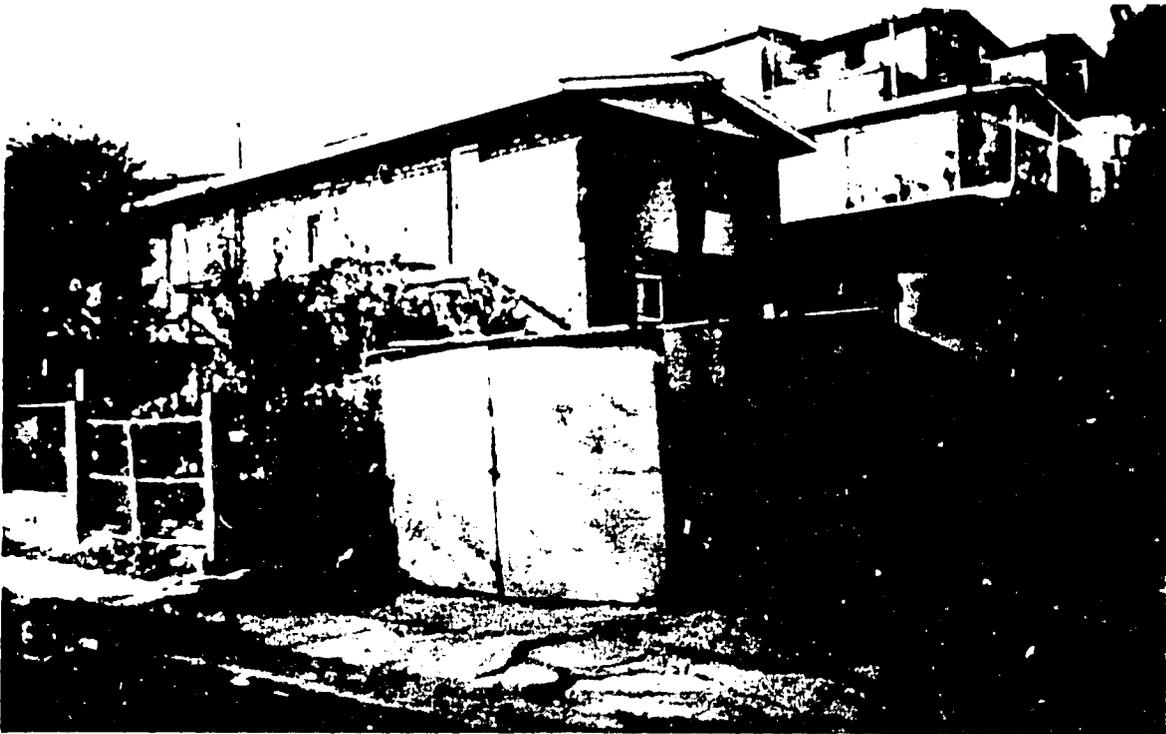
Figure 37.—One of the two Type A structures damaged. These structures are on a street next to a steep canyon.

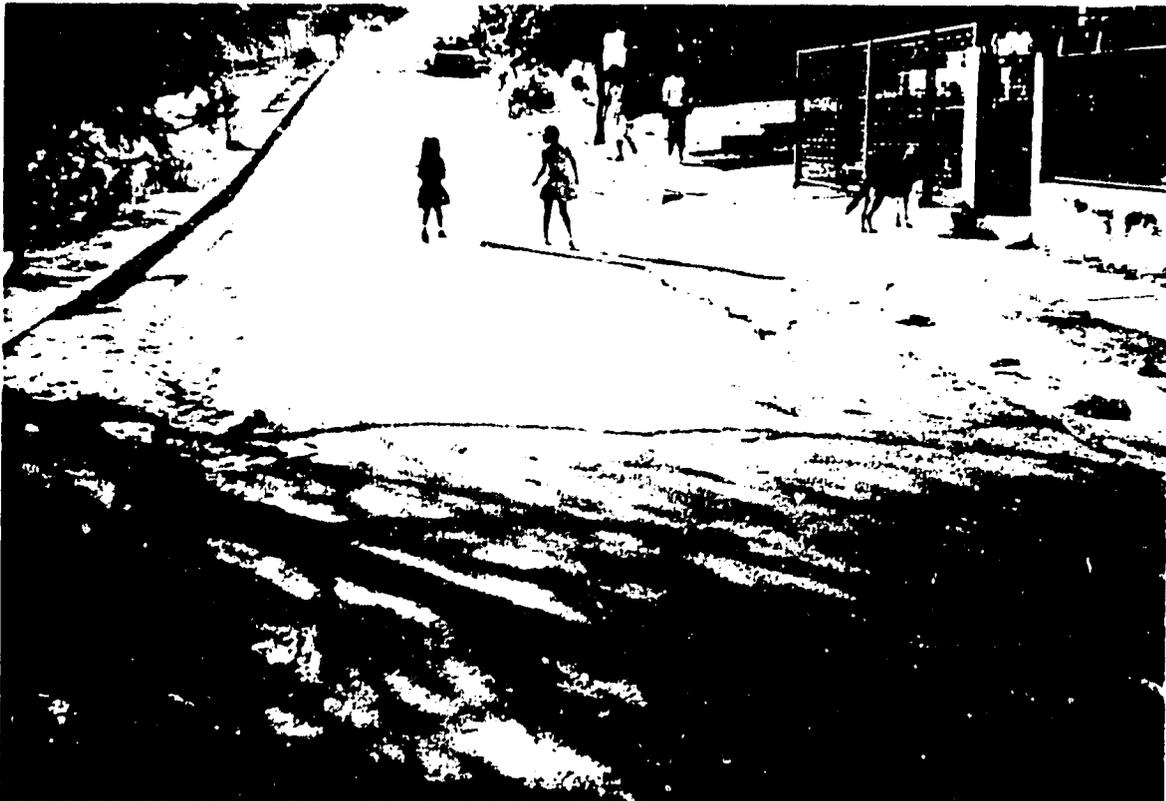
Figure 38.—The two damaged Type A structures are on this street which cracked extensively.

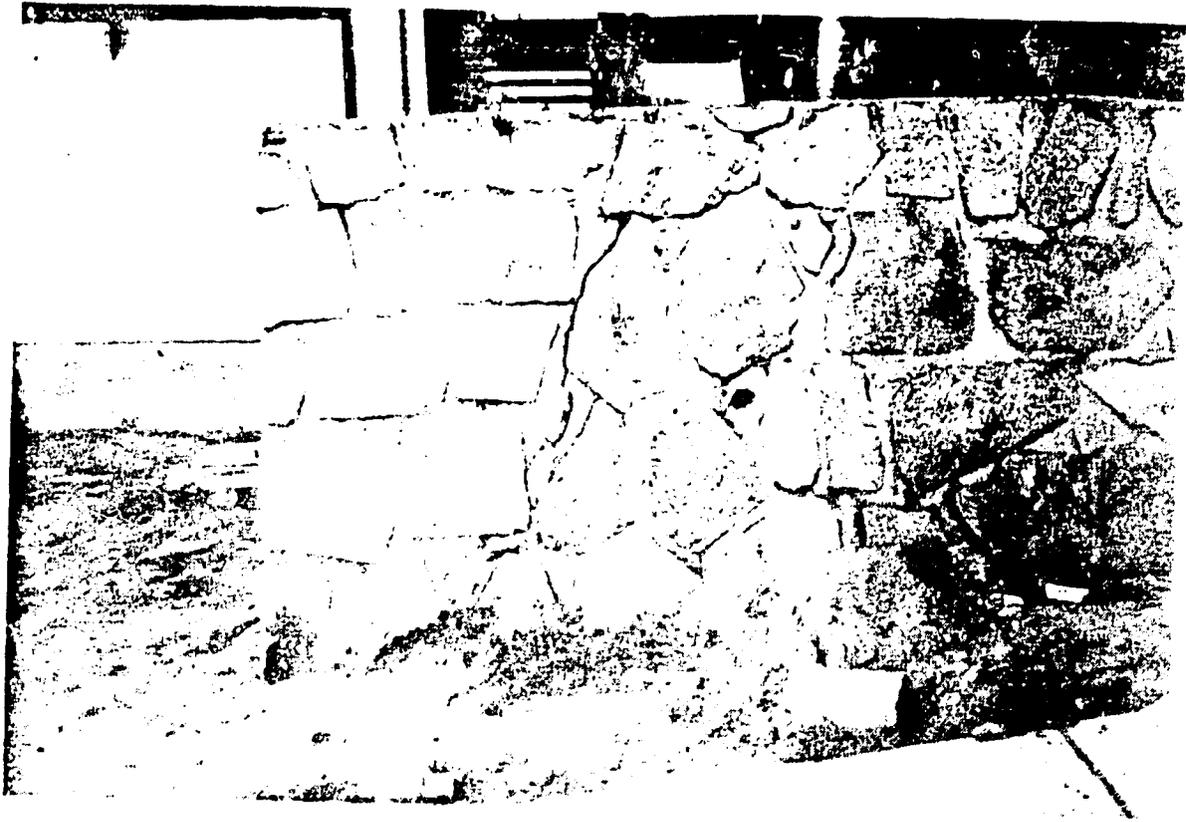
Figure 43.--A short retaining wall (cracked) in the vicinity of a Type B building (Isle Picton).

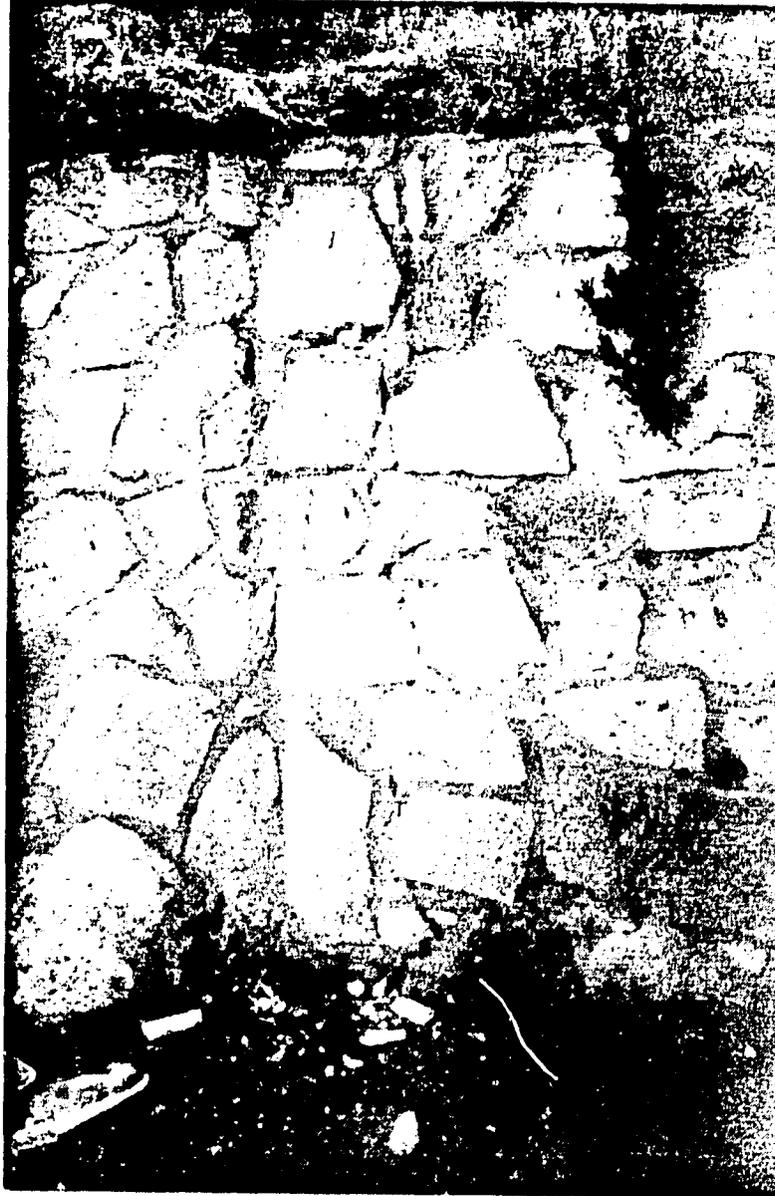
Figure 44.--A taller retaining wall cracked in the vicinity of two Type C buildings. These cracks extend from underneath the building above the retaining wall and follow down to the surrounding of the building below the retaining wall.

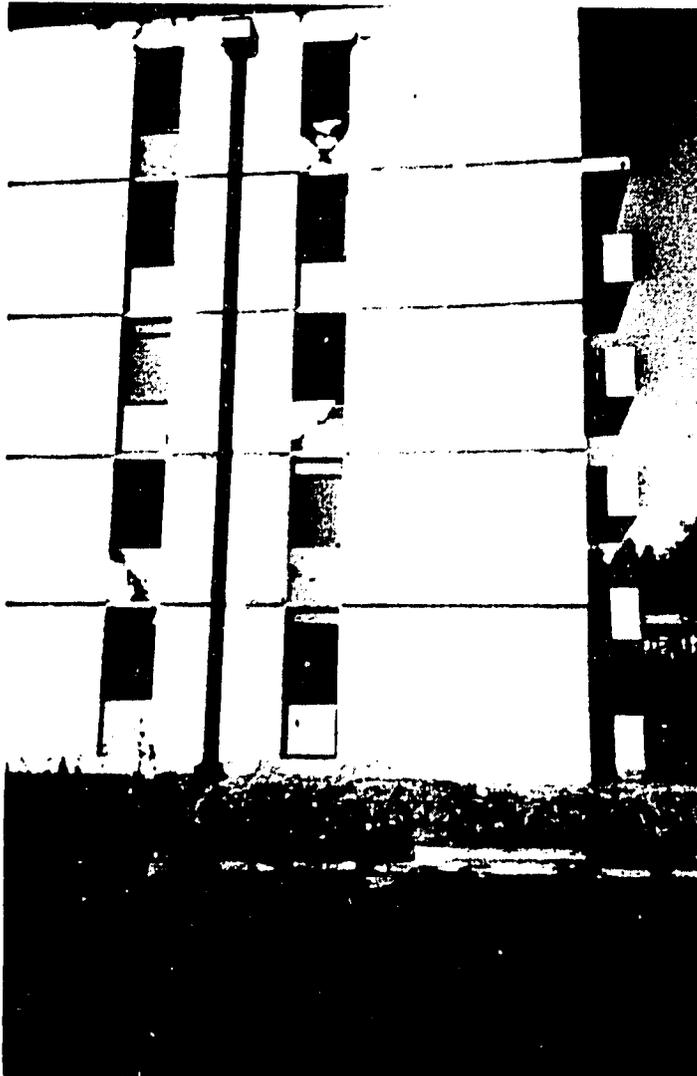
Figure 49.--Typical diagonal shear cracks in the infill walls that behaved as coupling beams (Type C buildings) These infill walls in window openings are not by design, but were installed by the owners of the apartment units.

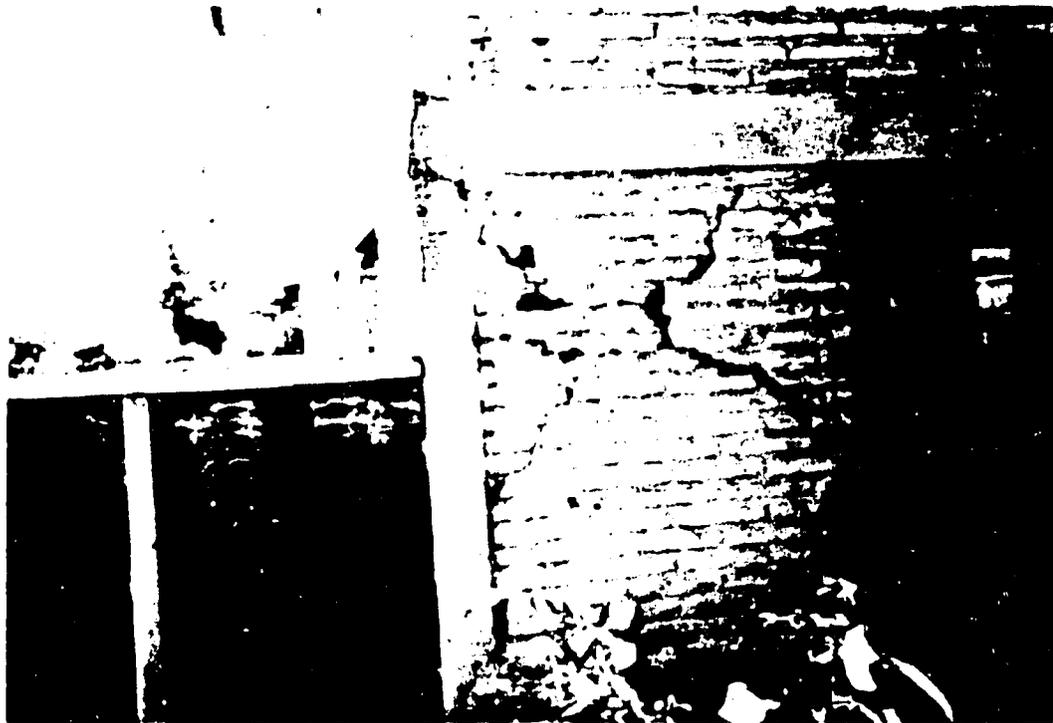
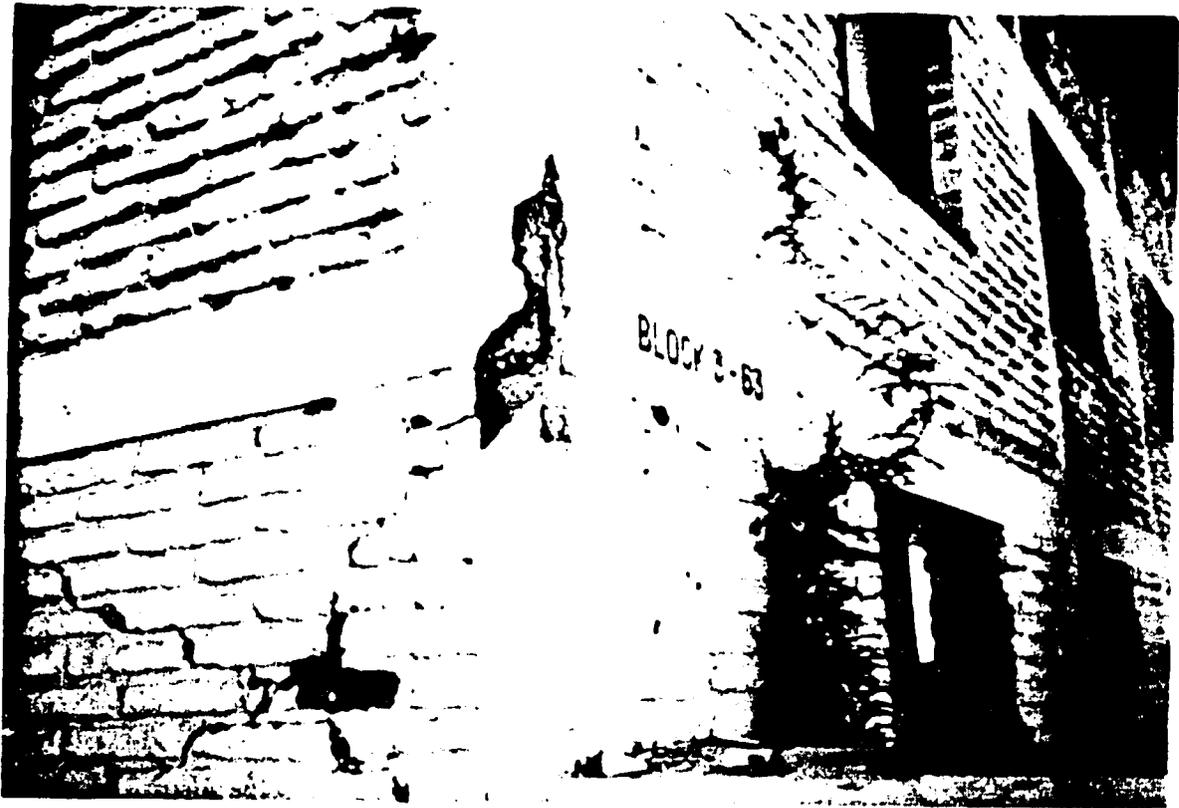
Figure 51.--Typical damages sustained by the infill walls and concrete frame elements as well as corner beam to column connections (a,b,c,d).
