**REHABILITATION OF ECONOMIC FACILITIES AND SERVICES
(REFS)**

**SARDEH IRRIGATION SYSTEM/
DAM CONDITION ASSESSMENT
REPORT**

Location: Andar District Ghazni Province

Date of assessment: May 05-06, 2003

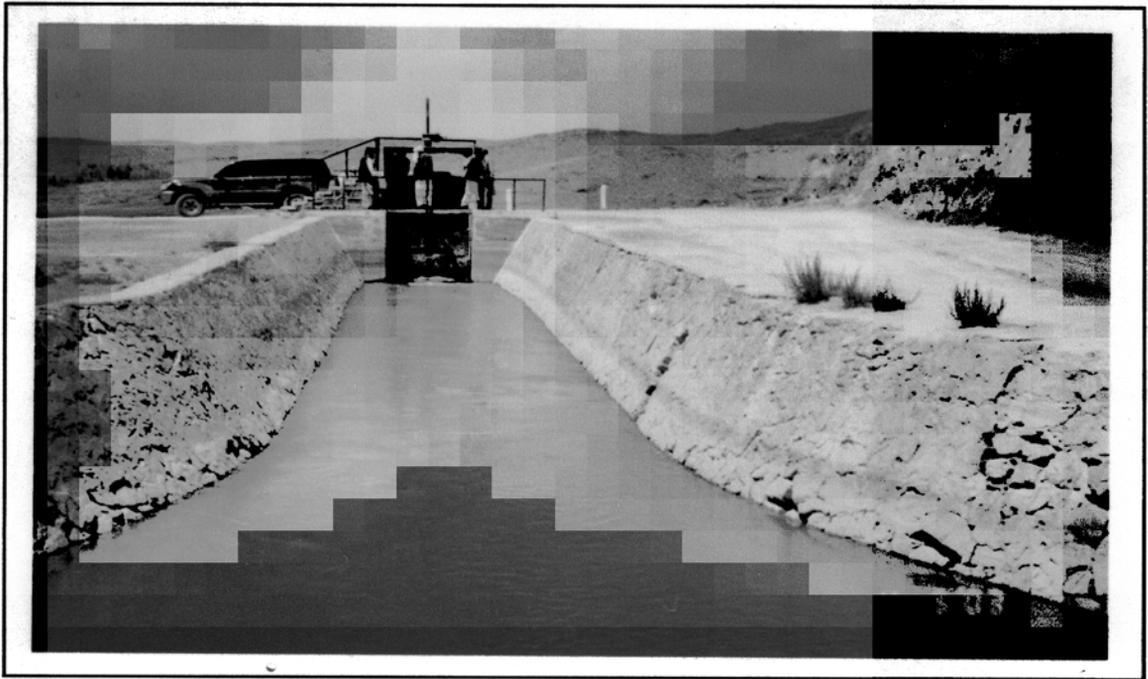
The right branch of main canal needs pointing and stone masonry.

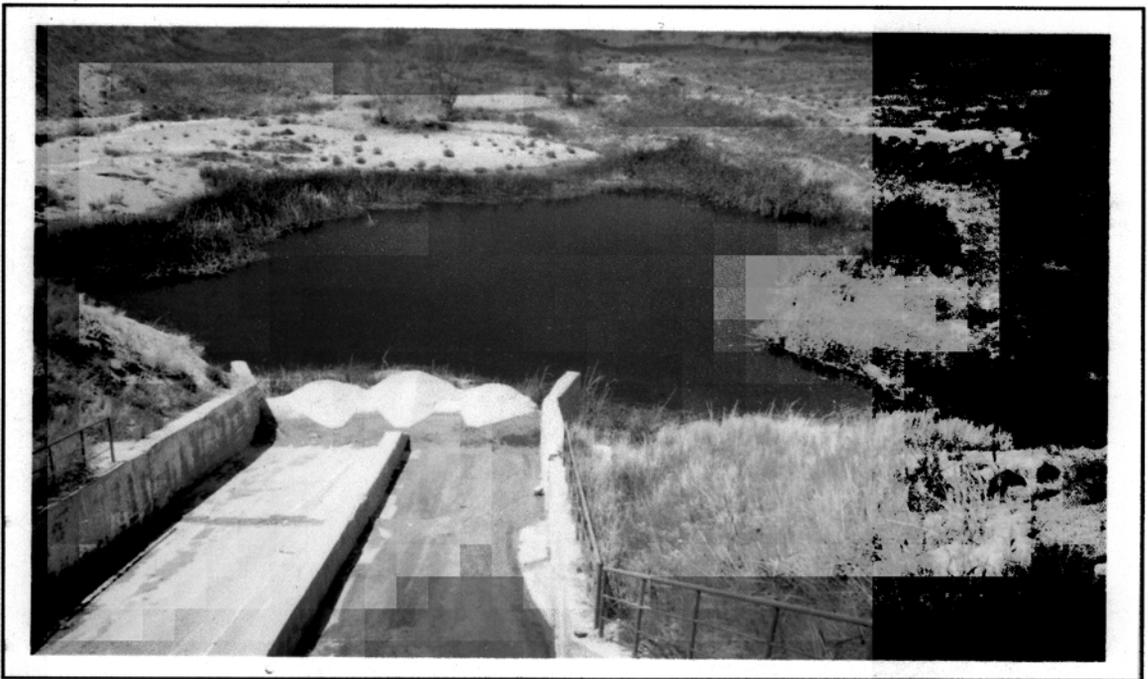
The main canal spillway.

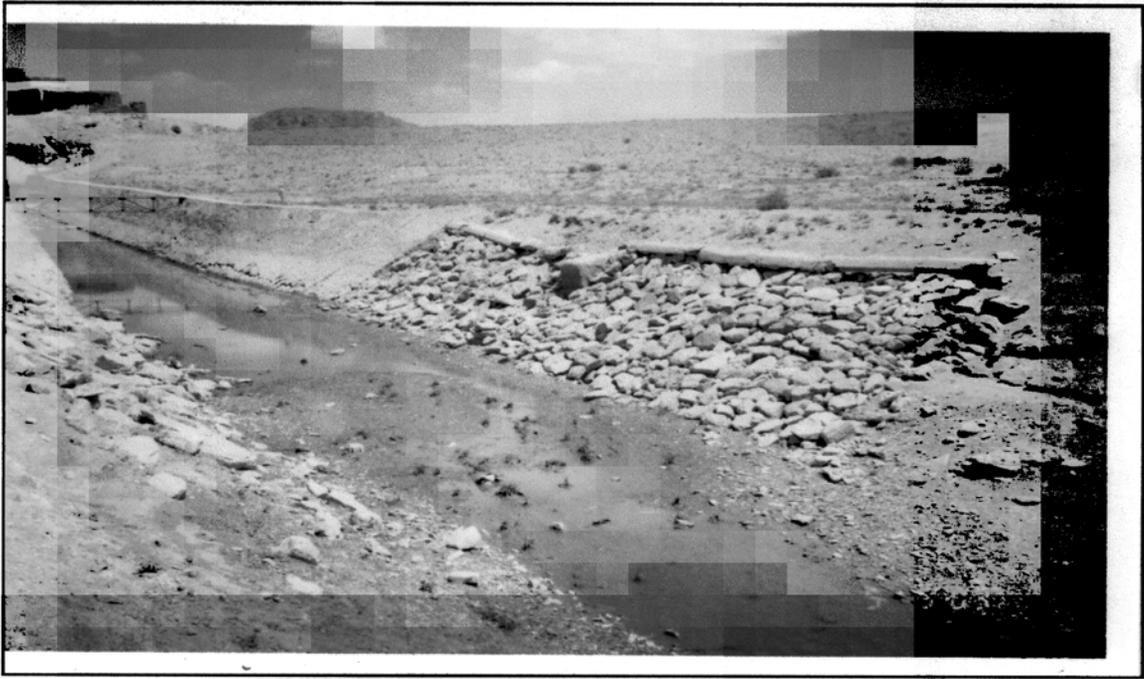
Left canal needs repairs.

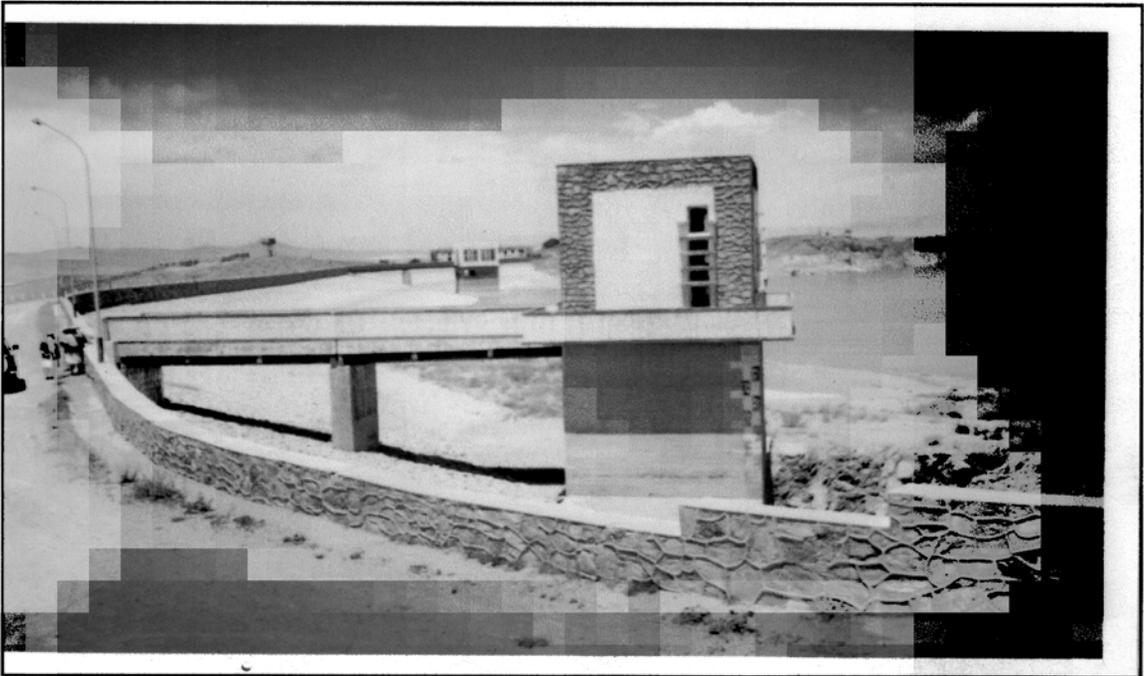
There are four installed intake valves with a total 15.2 cubic meter discharge capacity (two of them are reserve valves). The valves are functioning but need repair as do the intake tower and its bridge.

Sardeh Earth Dam intake tower

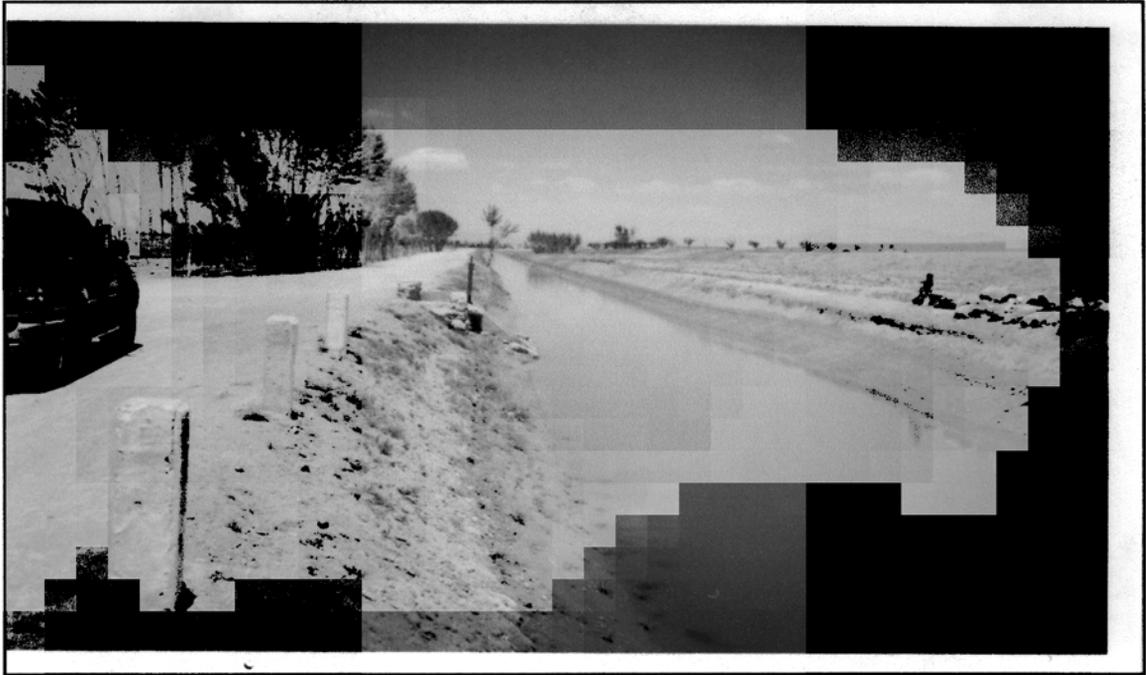
Right branch of main canal needs repair and cleaning.

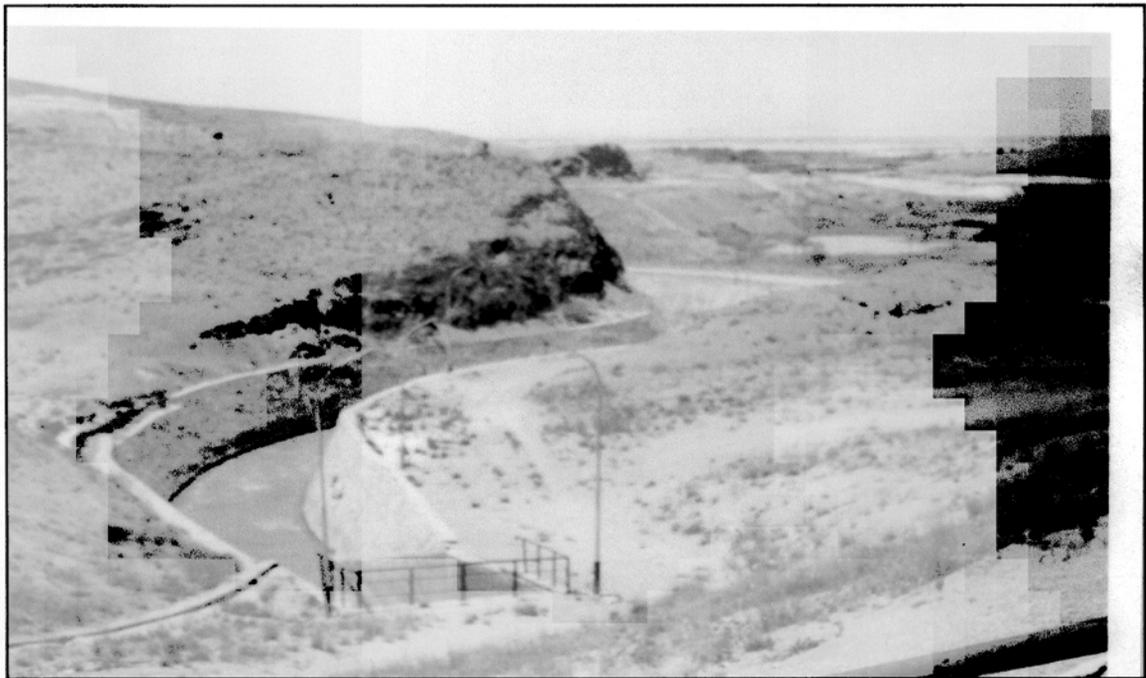
The main canal is 900 meters long has a trapezoidal cross section and is lined with stone masonry. The discharge capacity of the canal is 15.2 cubic meters per second. The main canal is located on the left bank. After 900 meters, it divides into two other main canals to the right and left. The canal's stone masonry lining is partially damaged and needs to be repaired. The left bank needs to be extended in height in order to prevent loose materials from falling in to the canal.

Main canal needs repair and additional stone masonry.

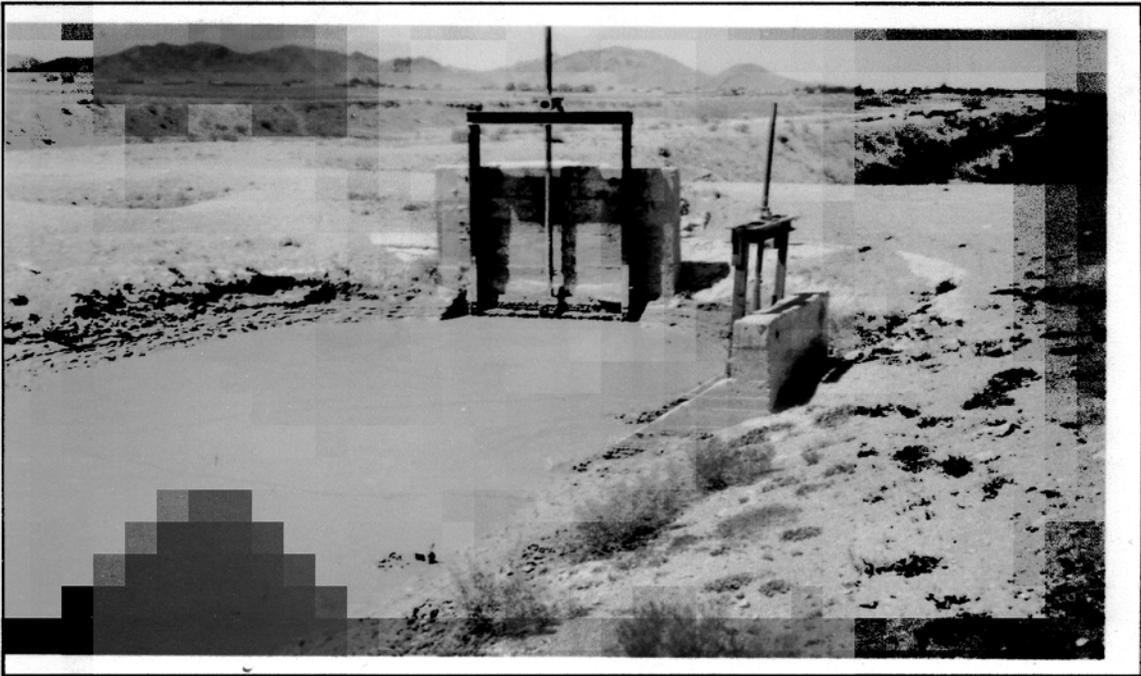
The gates on the left branch of the main canal need repair and cleaning.

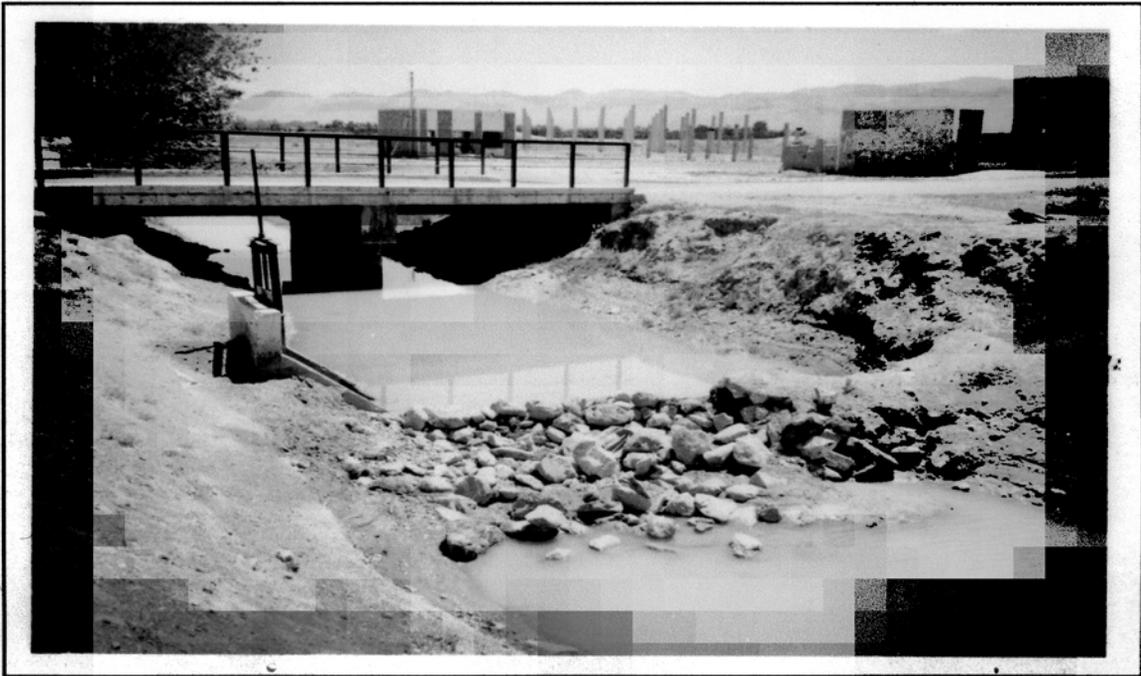
Before there was a gate. Now people use stone as a diversion dam.

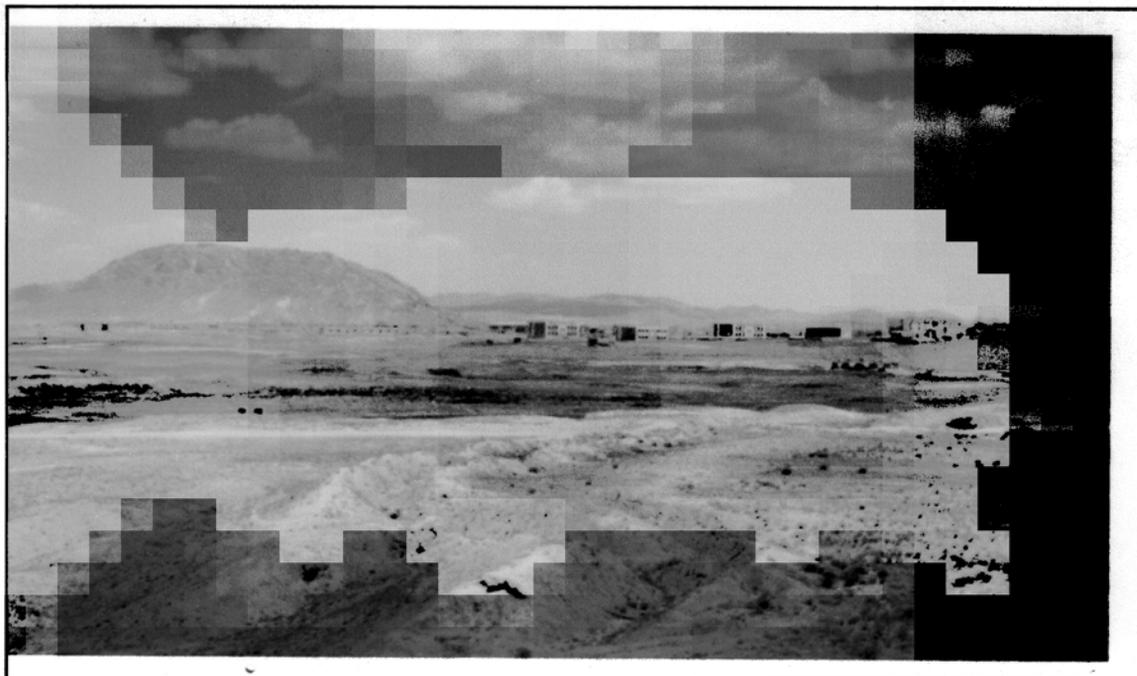
Dam related buildings.

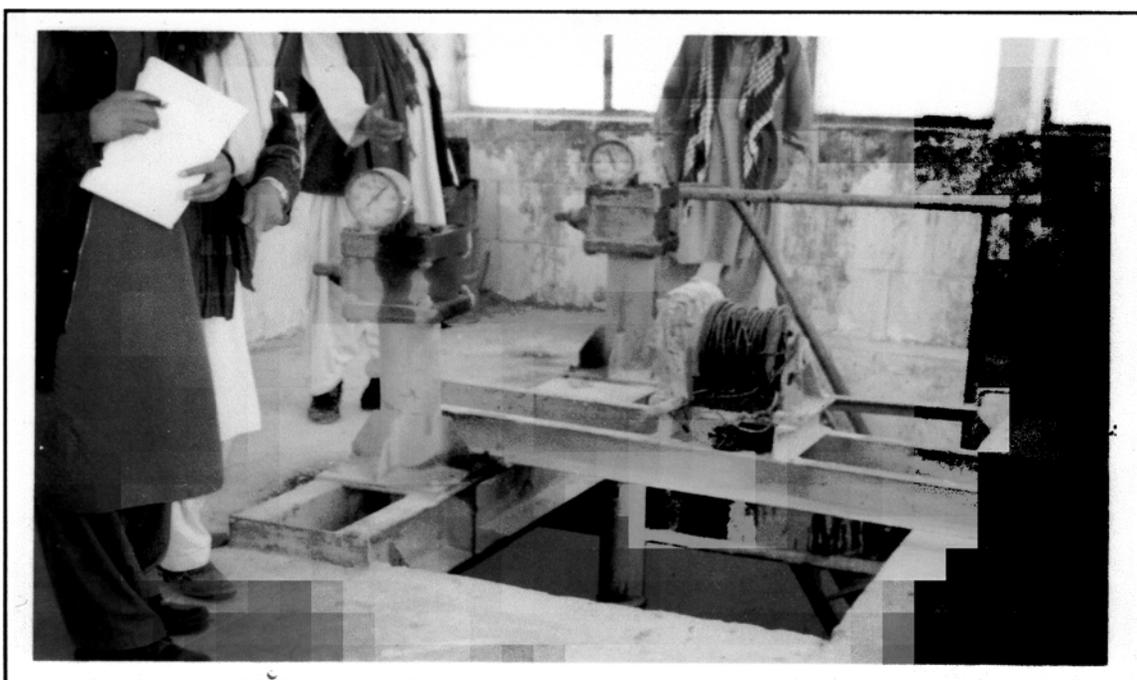
Spillway gate valves

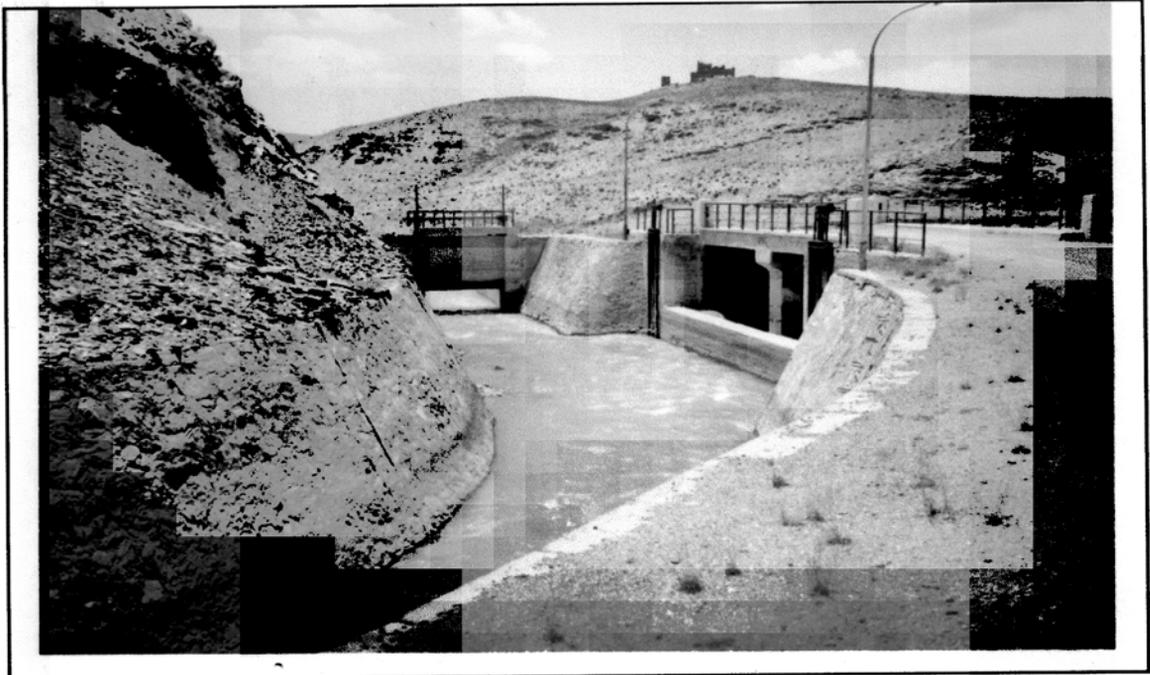
Main canal spillway and its gate

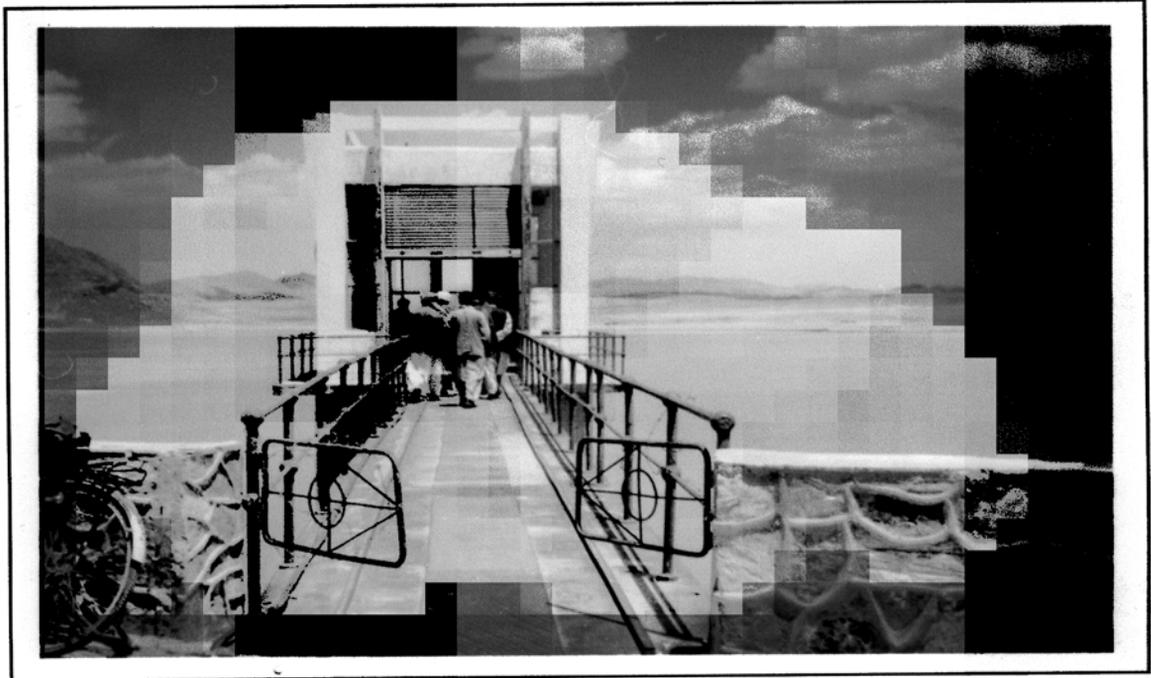
They manage flood water by two types of spillways controls: a trough gate well and an uncontrolled emergency trough spillway crest. They are functioning. The discharge capacity of the spillway is 50 cubic meters per second. The spillway tower has an access bridge. The spillway tower and its bridge need repairing.

Spillway's access bridge and tower

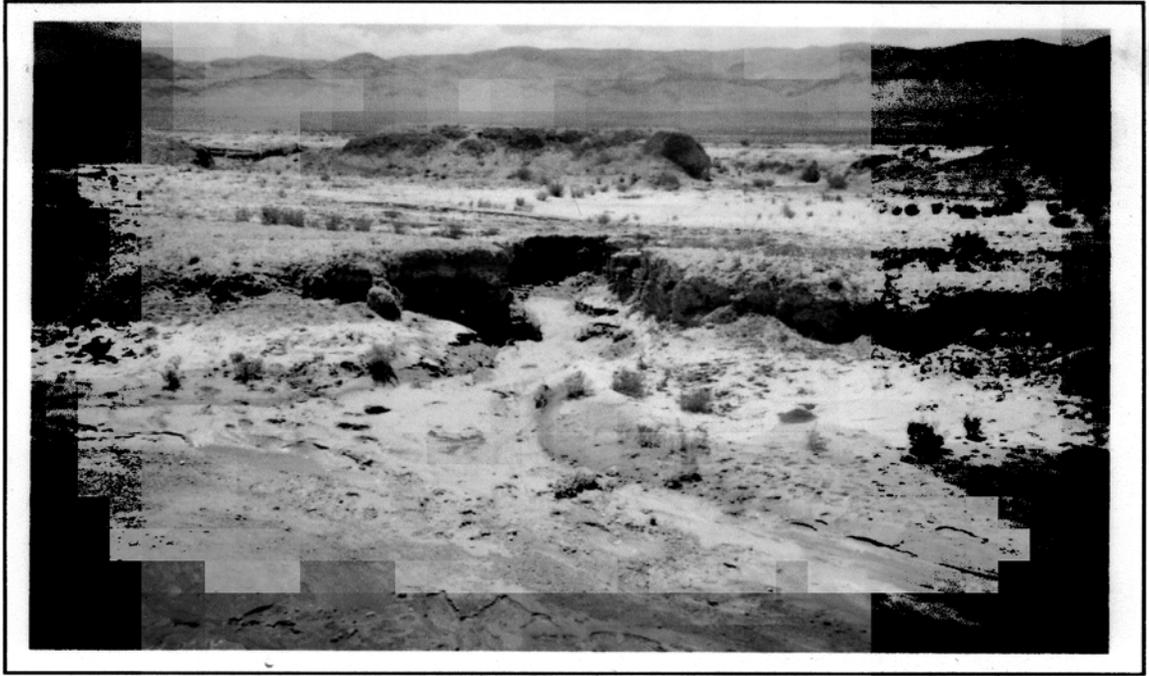
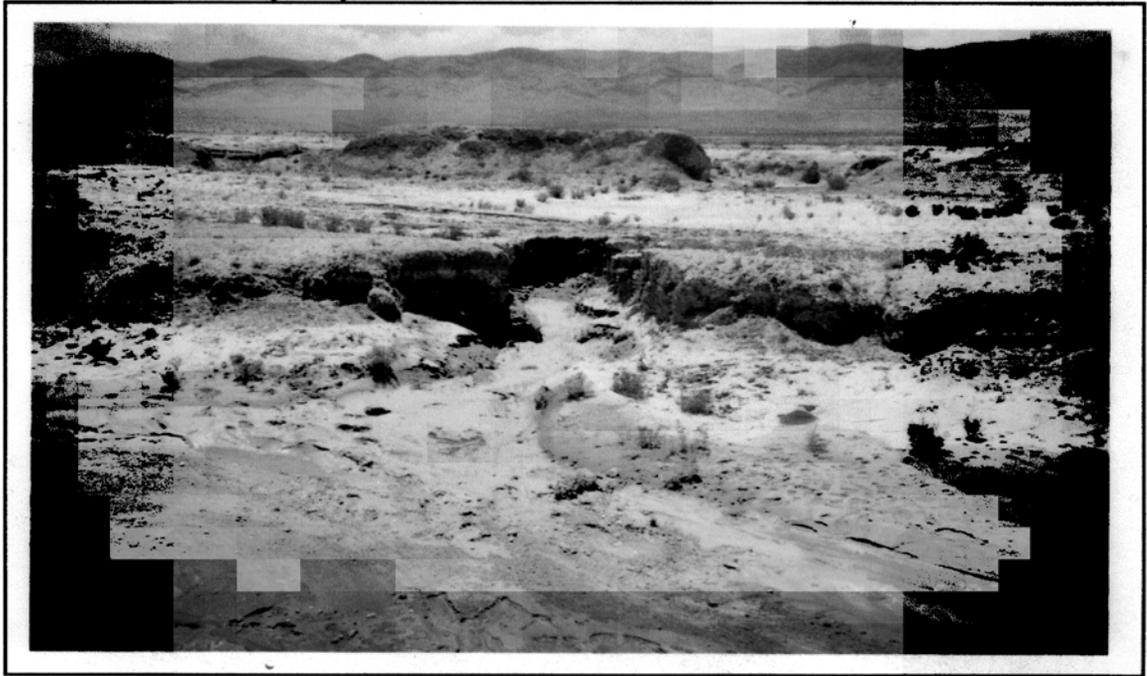
Canals bank destroyed by flood.

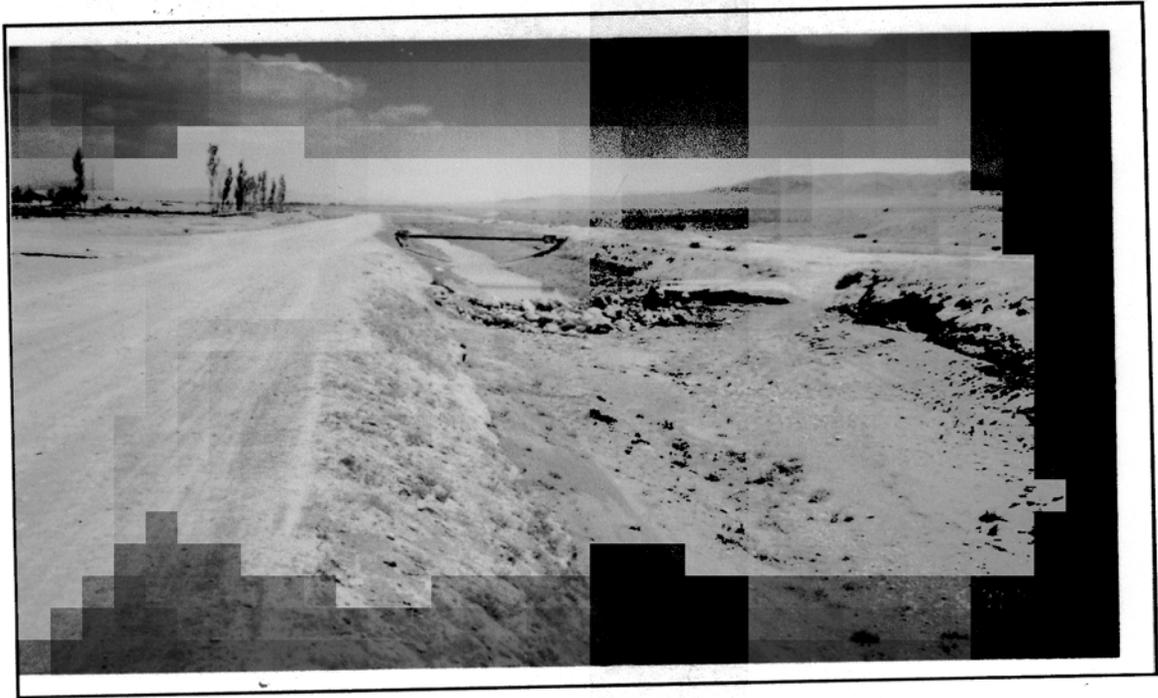
The farmers placed stone in place of the destroyed gate

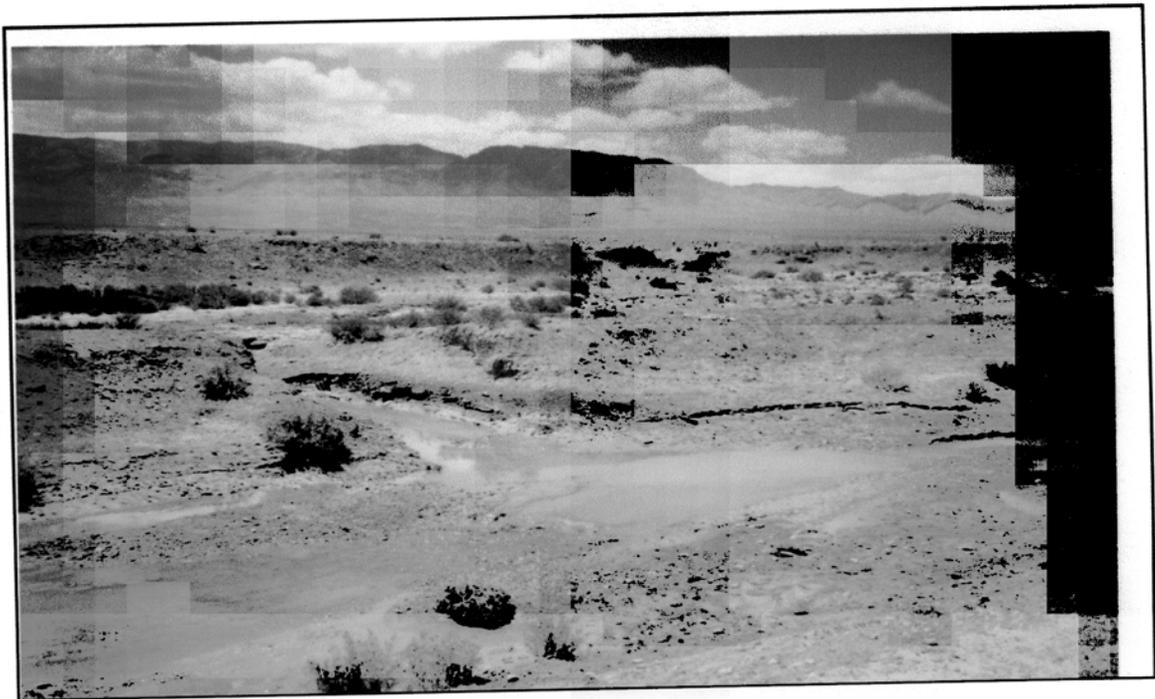
The left bank of the canal destroyed by flood.

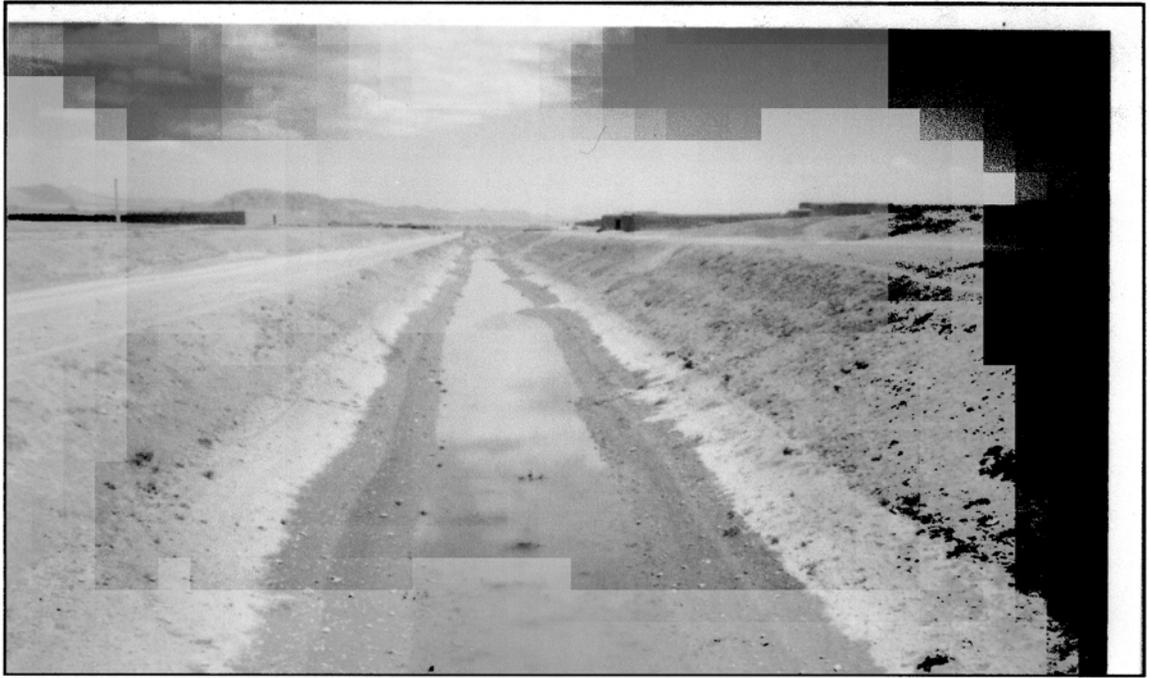
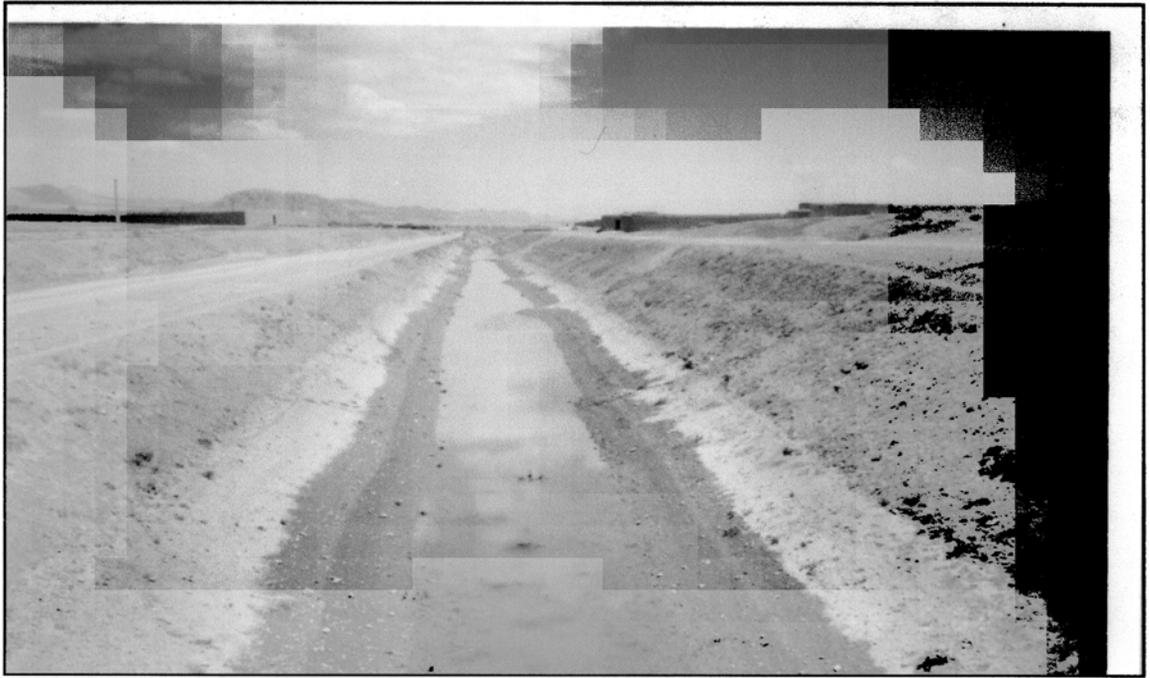
Left main canal needs cleaning and repair.

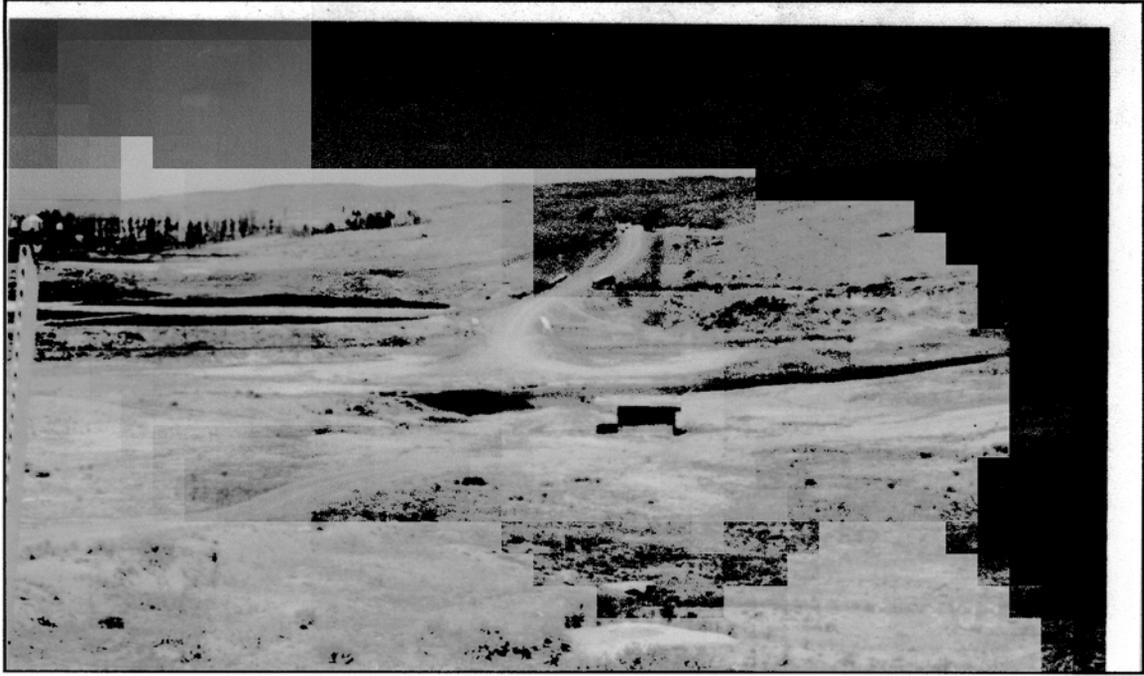
Left canal siphon.
