**AERODROME ASSESSMENT  
REPORT**

**BAGHDAD INTERNATIONAL  
AIRPORT**

VERSION: Aerodrome Assessment - Final Report  
27-May-03

Prepared by SkyLink Team 2

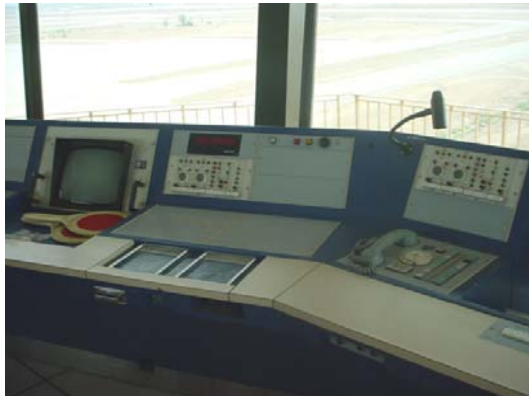
42. **Assessment.** All consoles and associated equipment are unserviceable. The assessment team was unable to determine the reason for the unserviceability and the likelihood of short term repair. The Iraqi maintainers advised that no spares were available and that appropriate spares would be difficult to procure. The assessment team supports this position. Off-field landline communications is unserviceable because the lines were channelled through the destroyed central communications centre in Baghdad.

ATC Consoles – Phone System

- a. ATC 6 - Assess the feasibility of the short-term repair of equipment.
- b. ATC 7 - Replace consoles and associated inter-face equipment as required in the short term.
- c. ATC 8 - Re-establish landline communications in the short term.

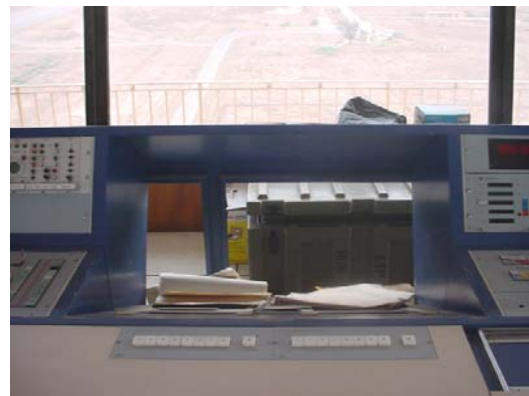
ATC Consoles – Missing Radar Display

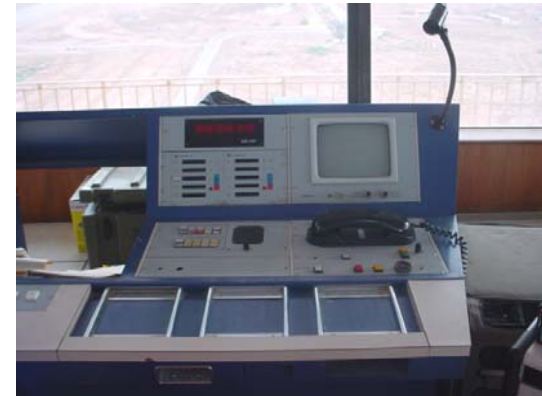
ATC Consoles – Communications

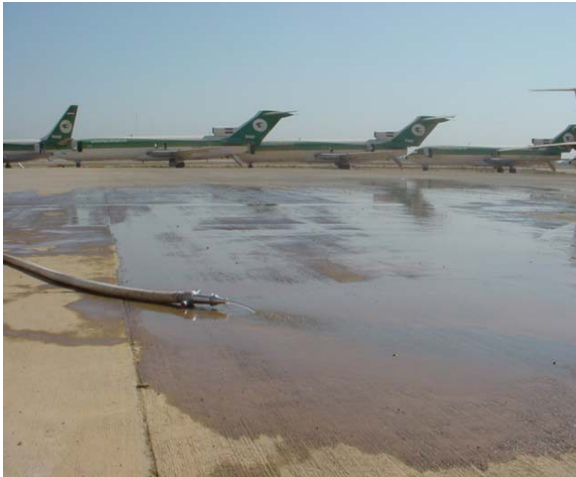
79. The firemain is not sufficiently pressurized to fight aircraft fires.
80. **Recommendations:**
- a. RFF 1 - Establish a civil fire fighting and rescue capability (to Cat 9) in the medium term.

Firemain Pressure – Max of 5m Stream

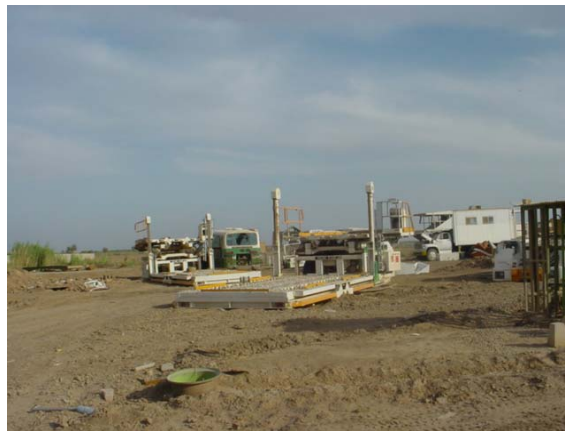
Wrecked GSE – Adjacent GSE Workshop

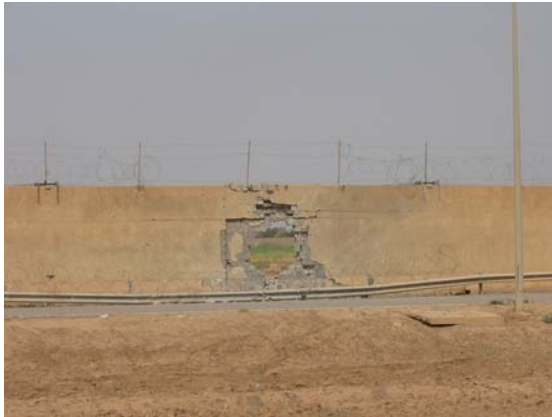
95. Access to the perimeter fence was severely restricted by the ongoing military operations. The assessment team examined several large sections of the fence and noted many large breaches. The fence is constructed with different materials along its length ranging from four metre brick, topped with barbed wire to chain wire. Within the confines of the perimeter fence is a network of wildlife control fences. These fences are ineffective as several goats and dogs were observed running freely across the tarmac throughout the assessment period.

Perimeter Fence – Breach

- a. PF 1 - Repair all wildlife control fences in the short term.
- b. PF 2 - Repair perimeter fences in the long term.
- c. PF 3 - Repair perimeter road in the long term.

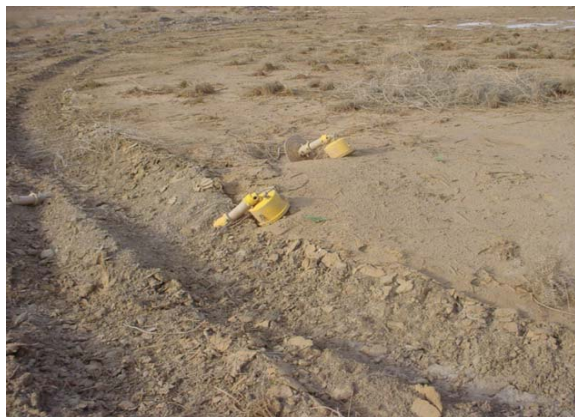
Damaged Approach Lights RWY 33R

- a. CA 1- Repaint civil runways, taxiways and apron markings in accordance with ICAO Doc 9157 – Aerodrome Design Manual in the medium term.
- b. CA 2 -Repair civil runway, taxiway and apron lighting in accordance with ICAO Doc 9157 – Aerodrome Design Manual in the medium term.

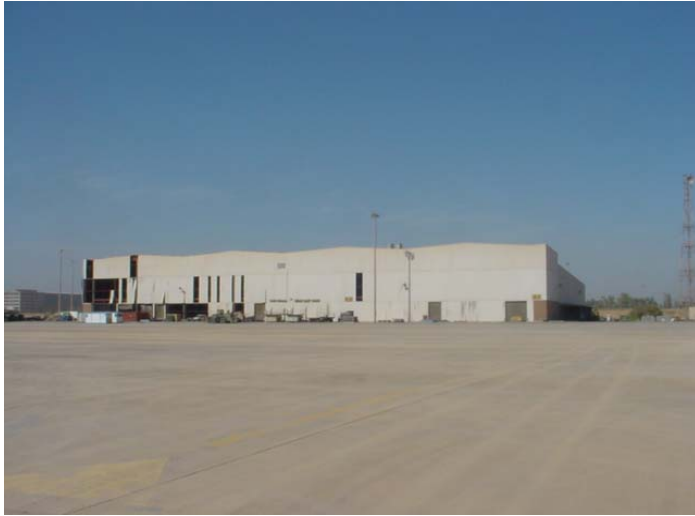
99. **Assessment.** The terminal building is structurally sound but has extensive battle damage to the exterior cladding. There was limited power and no water and sewerage supply to the building. The cold storage areas were not tested but should be functional after servicing. Only one of the many security cameras is serviceable. The fixed fire fighting system requires a complete overhaul. Fire fighting stations were denuded of equipment. The five-tonne scales were not tested, nor have they been calibrated. Although the air conditioning was reported to be working, there were several large leaks in the system. There is no security screening equipment. Although there are no defined Dangerous Goods (DG) and Hazardous Material (HAZMAT) storage areas, there is sufficient space to cater for this requirement. Furthermore there are no

Cargo Terminal

- a. CTML 1 - Install security screening equipment to comply with ICAO Annex 17 – Security in the medium term.
- b. CTML 2 - Establish DG and HAZMAT storage areas and develop handling procedures in accordance with both IATA DG Regulations in the medium term.
- c. CTML 3 - Service and overhaul the following in the short to medium term:
  - i. Power, water and sewerage.
  - ii. Cold storage areas.
  - iii. ETV system.
  - iv. Close circuit security camera system.
  - v. Five tonne scales.
  - vi. Air conditioning.
  - vii. Fixed fire fighting system.

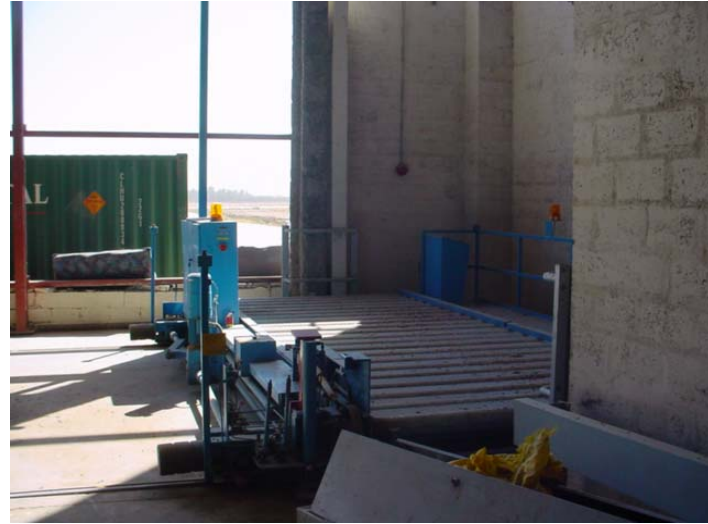
DG and HAZMAT procedures in place. The ETV is unserviceable but the assessment team concludes that it is recoverable after overhaul and maintenance. The storage racks and cages are in good condition.

ETV

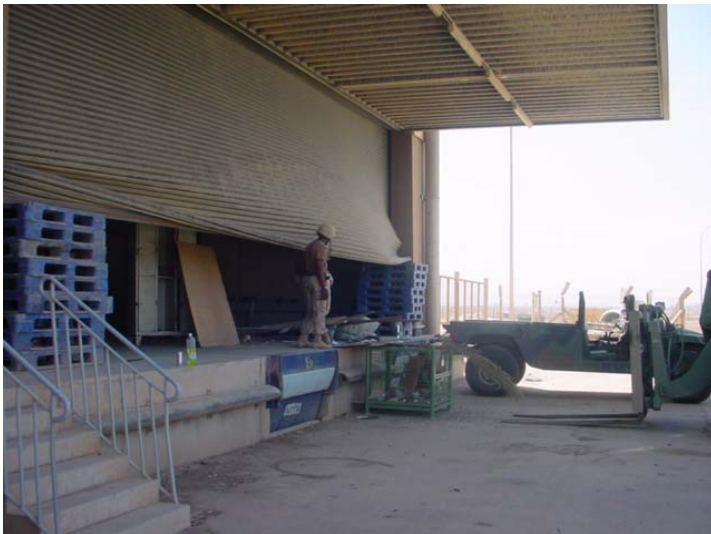
Damaged Roller Doors – Truck Docking Station

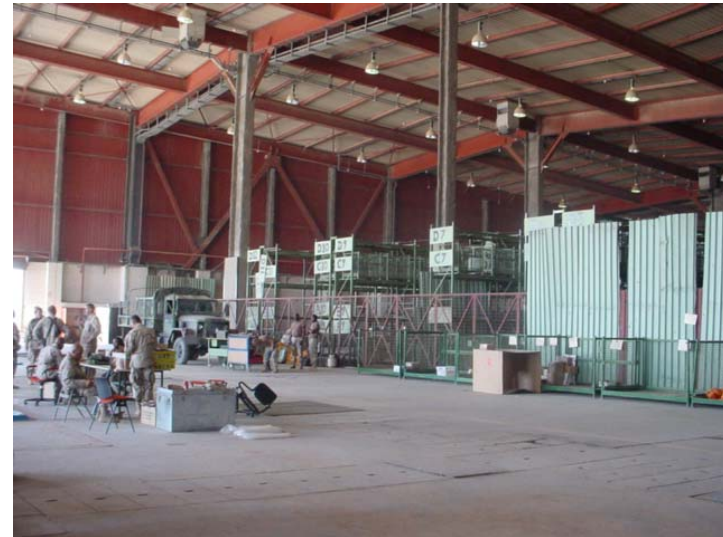
Storage Racks

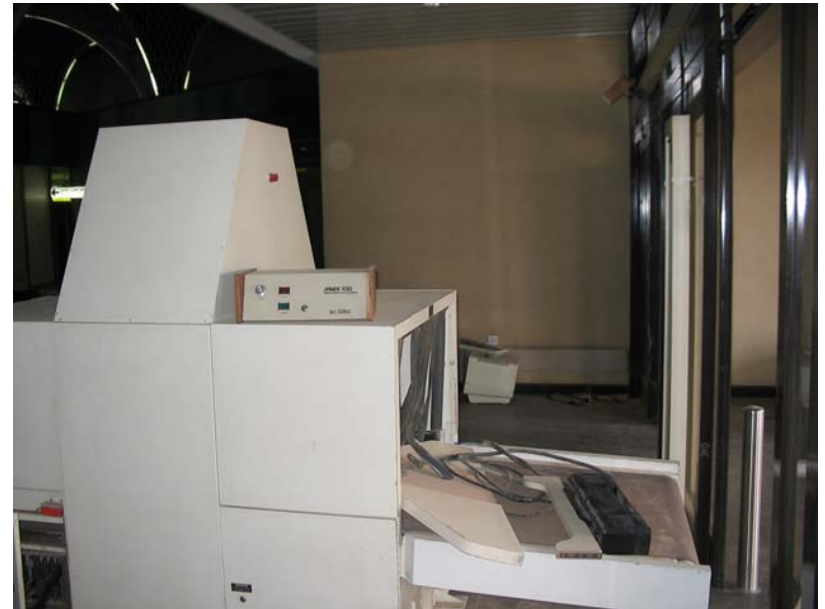
131. **Security Screening Machines.** The Scanray Xray screening equipment fitted throughout the terminals are reportedly unserviceable. They could not be tested because of an unreliable power supply. The metal detecting equipment is damaged beyond repair. Unserviceable screening equipment represents a security problem.

X-Ray Machine

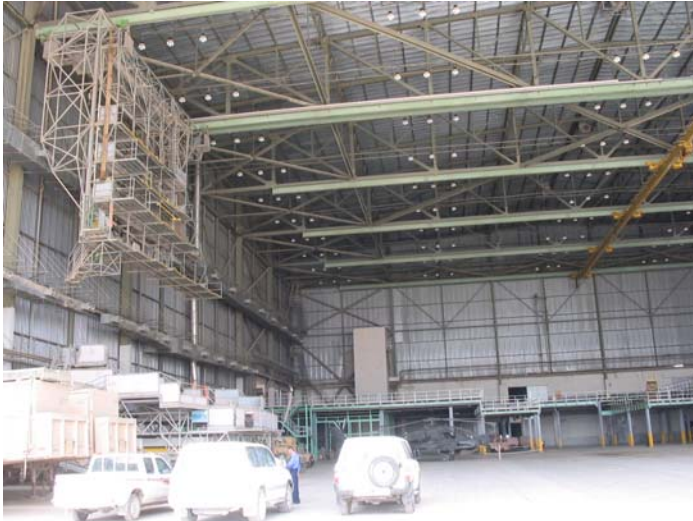
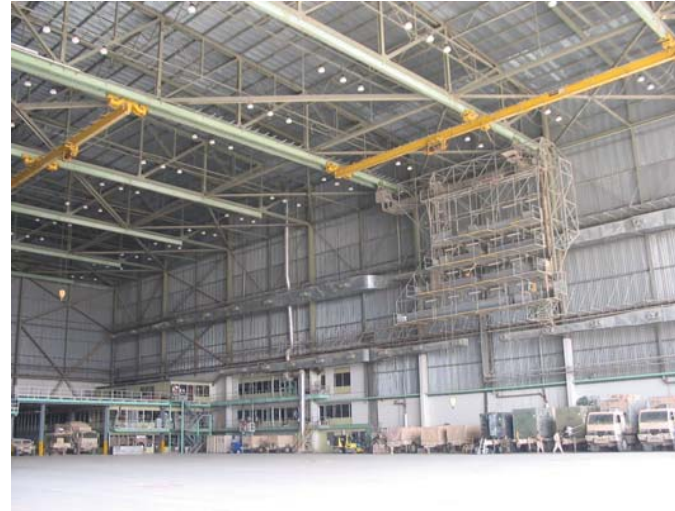
138. **Assessment - Hangar “new no. 1”.** The new no.1 hangar was completed in 1982 and had its cladding replaced in 1994 after being damaged during the 1991 war. It is capable of D-level servicing for B727 and B737 and C-level servicing for B747. The automatic hangar doors can be closed. Nose docks are fitted and serviceable; side and tail docks are installed but unserviceable. Two 10 tonne overhead gantries are unreliable. The hangar is fed by an underground 400Hz power supply for aircraft maintenance; the system is unserviceable and a mobile 400Hz supply is used in lieu. The Iraqi Airways SME advised that a MOU has been signed for the supply of five mobile 400Hz carts but the assessment team could not verify the status of this agreement. The air-conditioning system for aircraft in the hangar is unserviceable. Fitted fire fighting equipment includes six water cannons connected to the fire main, and one portable dry chemical trolley. The water cannons could not be tested because of a lack of pressure in the fire main. The dry chemical system was in poor condition.

Inside New No 1 Hangar

- a. HNGR 1 - Erect appropriate safety signs, install appropriate first aid equipment, deluge showers and eyewashes in the short term.
- b. HNGR 2 - Service gantries and elevators in the medium term.
- c. HNGR 3 - Verify status of the MOU for the supply of mobile 400Hz power supplies in the medium term.
- d. HNGR 4 - Service all utilities including fire fighting and air washers in the medium term.
- e. HNGR 5 - Service the aircraft air conditioning system in the long term.
- f. HNGR 6 - Service the side and tail docks in the long term.
- g. HNGR 7 - Inventory spare parts in the long term.
- h. HNGR 8 - Refurbish and render safe the paint shop in the long term.
