Landslides Triggered By Hurricane Mitch In Tegucigalpa, Honduras

By Edwin L. Harp, Mario Castañeda, and Matthew D. Held

Open-File Report 02-33

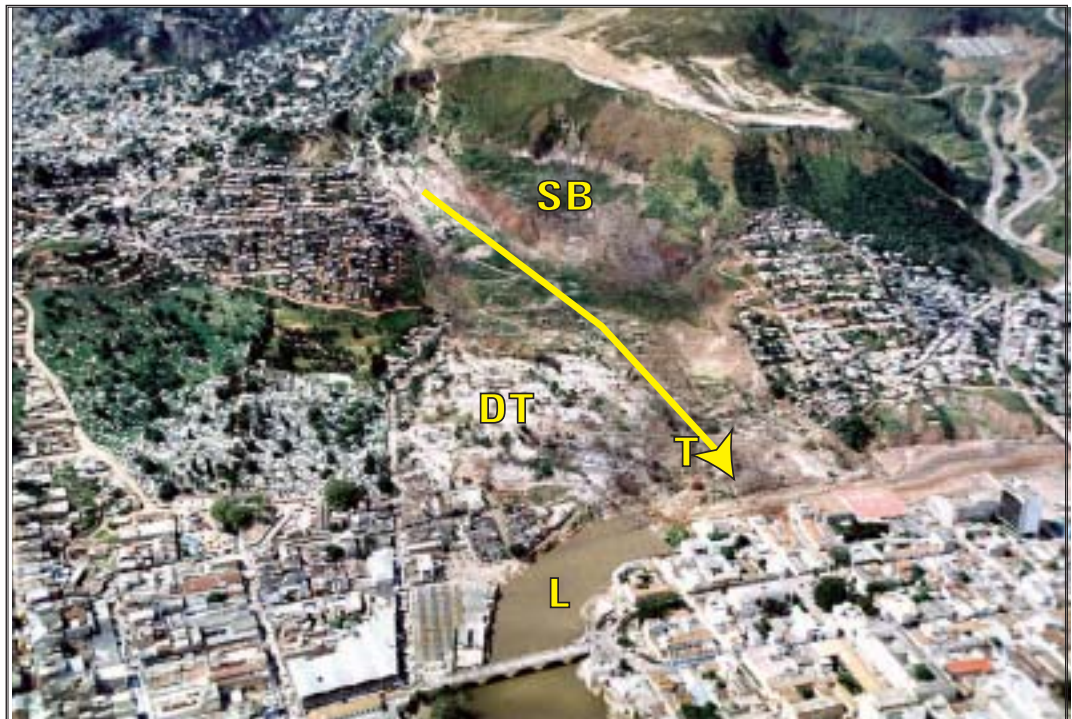
The El Berrinche landslide in Tegucigalpa was the largest single landslide (#1, Plate 1) triggered by Hurricane Mitch in Honduras. It destroyed a portion of the central part of the city known as Colonia Soto and dammed the Río Choluteca, creating a sewage-filled lagoon upstream from the landslide dam (figure 2). This complex slump/earth flow had a volume of approximately 6 million cubic meters. Because of initial slow movement of the landslide during the hurricane-associated rainfall, city residents living on the landslide mass were evacuated prior to its rapid movement that culminated in the damming of the river. The river was dammed at approximately 12:30 a. m. on October 31, about one hour after the peak flood flow of the Río Choluteca.

The El Berrinche landslide consists of three basic parts. With reference to figure 2, the part of the landslide marked "DT" is a highly deformed toe that buckled and folded extensively but did not travel across the Río Choluteca. A view of this area soon after the landslide occurred is shown in figure 3.

Just upslope from the deformed toe is an earth-flow tongue that extends the entire length of the landslide from upper left to lower right. This earth-flow tongue is that part of the slide mass that actually flowed across and dammed the Río Choluteca creating the lagoon. A downslope view of this part of the landslide mass is shown in figure 4.

Figure 2. Aerial view of the El Berrinche landslide, a complex slump/earth flow that dammed the Río Choluteca in Tegucigalpa. The arrow indicates the direction of movement of the earth-flow tongue. "T" denotes the toe of the landslide that dammed the river, and "L" indicates the lagoon dammed by the toe of the landslide. "DT" indicates the highly deformed toe of the landslide where the center of Colonia Soto was, and "SB" denotes the upper slump block.

Just to the left and upslope from the earth flow in figure 4 (denoted by a vertical arrow) is the third main portion of the landslide, a slump block shown as "SB" in figure 2. This slump block has a scarp approximately 30 m high at its upslope margin. This scarp appears to be a contact between deeply weathered deposits of clay and silt derived from rhyolitic volcanics that contain interspersed conglomerate and hard, competent, rhyolitic ignimbrite exposed above the scarp.

The damming of the Río Choluteca by the landslide and the creation of the lagoon upstream from the landslide dam also created a significant health hazard to the people who lived in the downtown area near the river. In early December 1998, dredging by construction crews from Mexico proved to be insufficient to cut a deep enough channel to drain the lagoon. With the drainage of the lagoon a high priority of the city of Tegucigalpa and the government of Honduras, the U.S. Army Corps of Engineers and the U.S. Geological Survey were asked, on an emergency basis and with no time to complete a systematic study, to evaluate the stability of the landslide mass near the toe should a deeper channel be excavated through the landslide dam. With the proposed channel design from local engineers, geologists from the U.S. Army

Corps of Engineers and the U.S. Geological Survey considered the proposed shape and dimensions of the landslide toe once the channel had been excavated and concluded that the toe would be stable except for small localized slumping of the toe as the river eroded material from the toe during the drainage of the lagoon. This decision, based mainly on experience and judgement and without the aid of borings, samples, or any preliminary stability analysis, proved to be correct, and the landslide toe has remained relatively stable since the lagoon was drained.

Since the initial draining of the lagoon, a slope stability analysis has been performed by the U.S. Army Corps of Engineers, and most of the landslide mass has been regraded and contoured to enhance the stability and drainage of the slide mass. Both rainy seasons since Hurricane Mitch have produced lower than normal cumulative rainfall, and the El Berrinche landslide has remained stable except for localized slumping within the lowest part of the landslide toe where steeper slopes have been produced by channel excavation. A more rigorous test of the landslide's stability will occur when a future rainfall season exceeds normal rainfall totals.

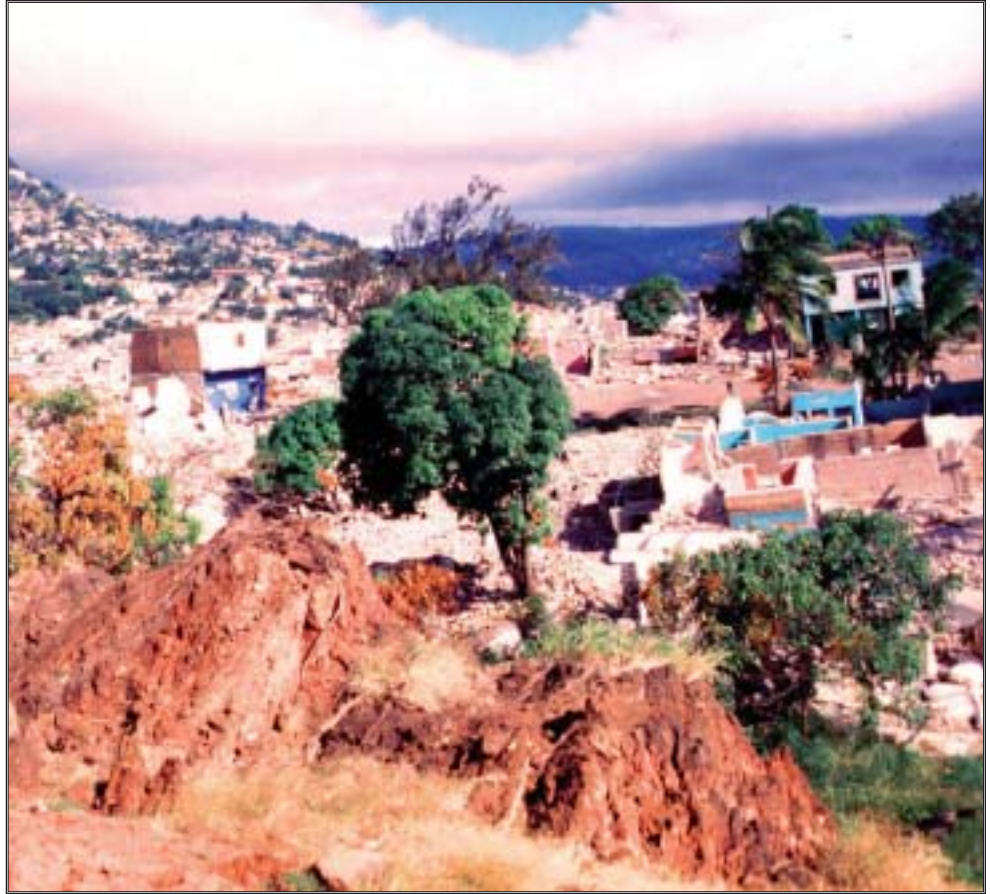
Figure 3. View of the highly deformed toe area of the El Berrinche landslide that destroyed Colonia Soto. The view here is of the remains of Colonia Soto as seen in December 1998. The remains of houses and streets can be seen rotated at high angles from horizontal.

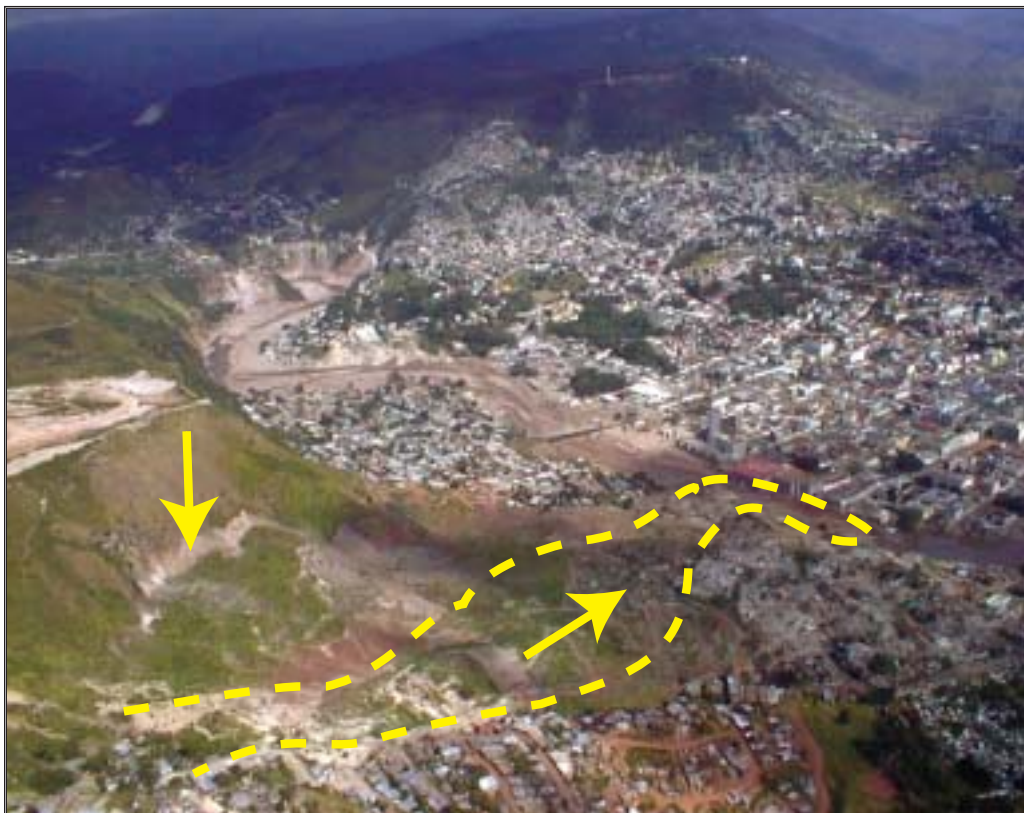
Figure 4. View of the El Berrinche landslide looking obliquely downslope. The earth flow that dammed the Río Choluteca is outlined by the yellow dashed line, and the direction of flow denoted by the yellow arrow. Vertical yellow arrow points to scarp of large slump block at head of landslide.

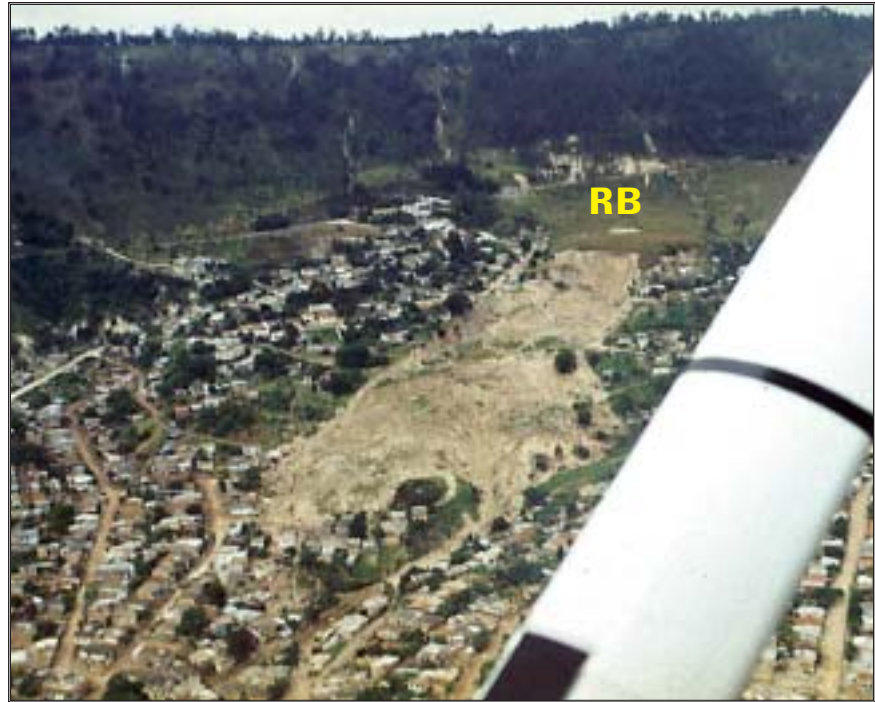
Another deep-seated landslide, a slump/debris flow having a volume of 400,000 m³, destroyed numerous houses in the Colonia El Reparto section of Tegucigalpa (#2, Plate 1; figure 5). This landslide occurred during the mid-morning of October 31 over a time span of several hours. The final movement of the slump resulted in the formation of a debris flow, which mobilized from the oversteepened toe of the landslide and demolished the houses. Because of the

The El Reparto landslide is a reactivated portion of a larger landslide complex. Its headscarp is at the margin of a large downward-rotated block (shown as "RB" in figure 5) of an older landslide complex whose headscarp is the surrounding steep slope forming the skyline in figure 5.

Figure 5. Aerial view of the El Reparto slump/debris flow. "RB" denotes a rotational block of an older landslide complex whose headscarp is the steep slope forming the skyline.

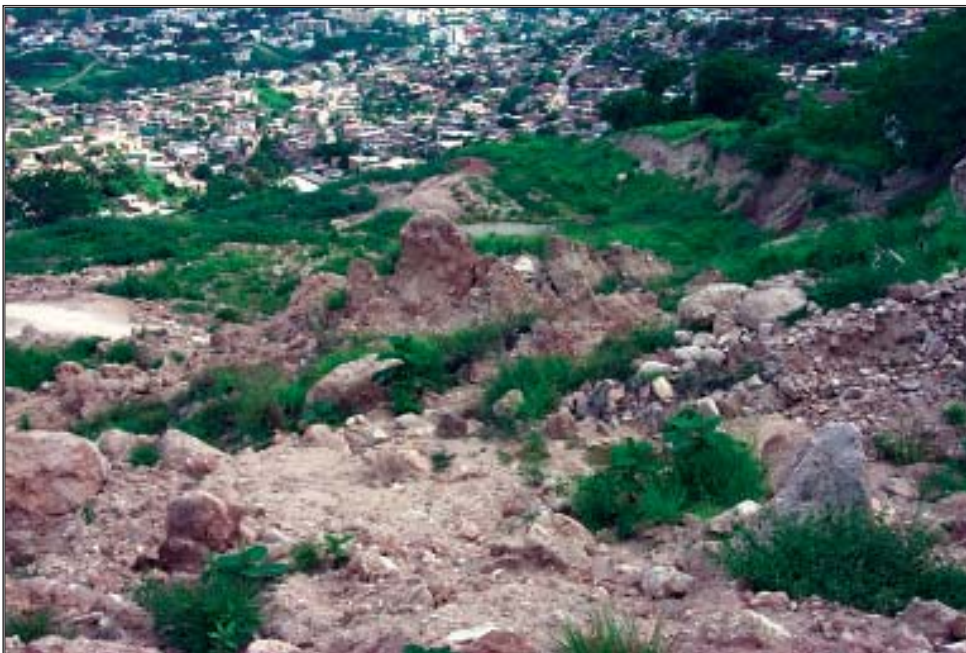
As shown in figure 6, the area below the headscarp of the landslide has a small pond fed by water and sewage lines that were severed by the landslide movement. Recommendations were made to the city to divert flow from these water sources to decrease the water level within the slide mass. These recommendations were subsequently undertaken in November 2000.

Figure 6. Headscarp area of El Reparto landslide showing small pond in right center of photo.

A series of survey points were established on the landslide mass in July 2000; These survey points were resurveyed periodically so that any renewed movement could be detected. This monitoring was undertaken because of all the residences that are still occupied adjacent to and downslope of the landslide.

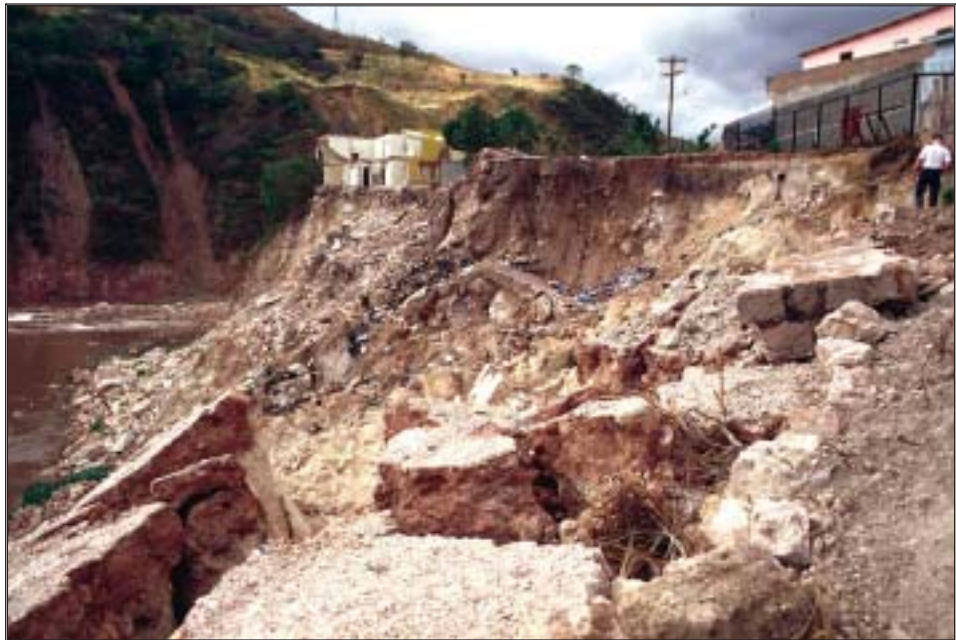
Several other deep-seated landslides caused damage to people and property in the city of Tegucigalpa. Two debris slides triggered by the undercutting of river banks destroyed houses at Barrio Mira Mesi adjacent to the Río Choluteca and at Nueva Esperanza adjacent to the Río Guacerique. The slide at Barrio Mira Mesi (#3, Plate 1) began as a relatively small debris slide of about 5,000

m³ in older terrace deposits adjacent to the Río Choluteca (figure 7). Several houses were destroyed or damaged by the sliding and subsidence caused by the erosive undercutting of the terrace by the river. The headscarp of this landslide continued to be unstable even during dry seasons of 1999 and 2000 and continued to retrogress upslope and involve additional houses (figure 8).

Figure 7. Debris slide at Barrio Mira Mesi adjacent to the Río Choluteca.

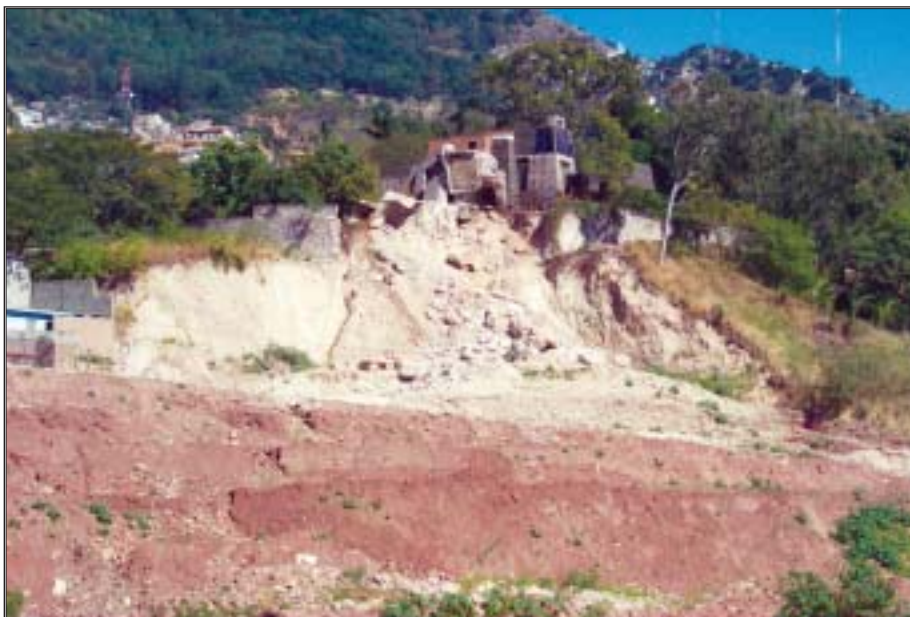
Figure 8. Debris slide at Barrio Mira Mesi that has progressed headward even during dry seasons following Hurricane Mitch despite the placement of a soil berm (shown in the foreground) to protect the slope.

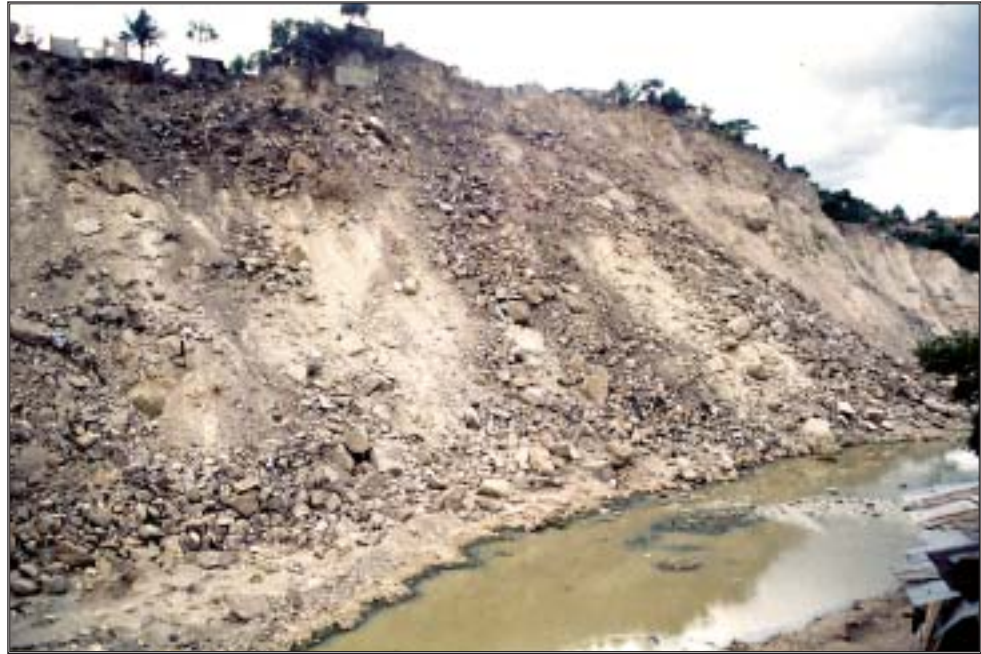
The debris slide at Nueva Esperanza (#4, Plate 1; figure 9), triggered by the erosive undercutting of the slope by the Río Guacerique during its peak flow during Hurricane Mitch, destroyed more than 20 homes perched on the steep

slopes above the river. As at Mira Mesi, the loose alluvial deposits continued to slide, especially during the rainy seasons following the hurricane; the ongoing sliding destroyed several additional homes.

Figure 9. Debris slide along the Río Guacerique.

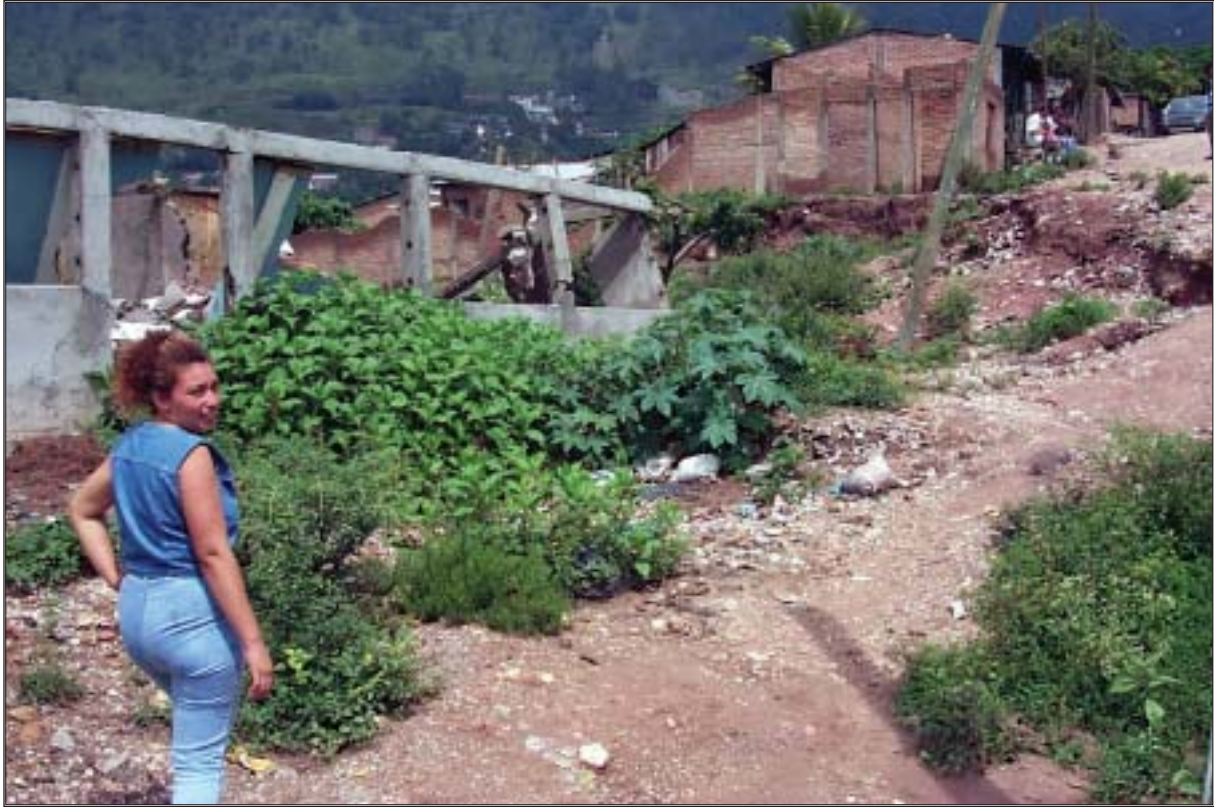
In Barrio Santa Rosa, 0.5 km southeast of the El Reparto landslide, a slow-moving slump was reactivated in September 1999. An incipient slump that had begun to form during Hurricane Mitch, with about 80 cm of displacement along a partially formed headscarp underwent renewed movement during a period of intense afternoon rainfall. The

reactivated slump involved a volume of about 1,800 m³ and affected 37 homes. This occurred at a time when we were doing field work in Honduras, so we responded to a request from the city to advise them on how many people should be evacuated from the area. The reactivated movement on the headscarp of the slump began on the afternoon of September 23 and totaled about 80 cm that evening, with another 30 cm of displacement occurring by the next morning (figure 10). We assessed the situation on the afternoon of the 23rd and recommended evacuation for those homes that were within the limits of the slump. After the end of the intense period of rainfall that afternoon and night, the movement of the slump also terminated. Little, if any, renewed movement has occurred since this episode.

Figure 10. Reactivated slump in Barrio Santa Rosa triggered by intense rainfall in September 1999.

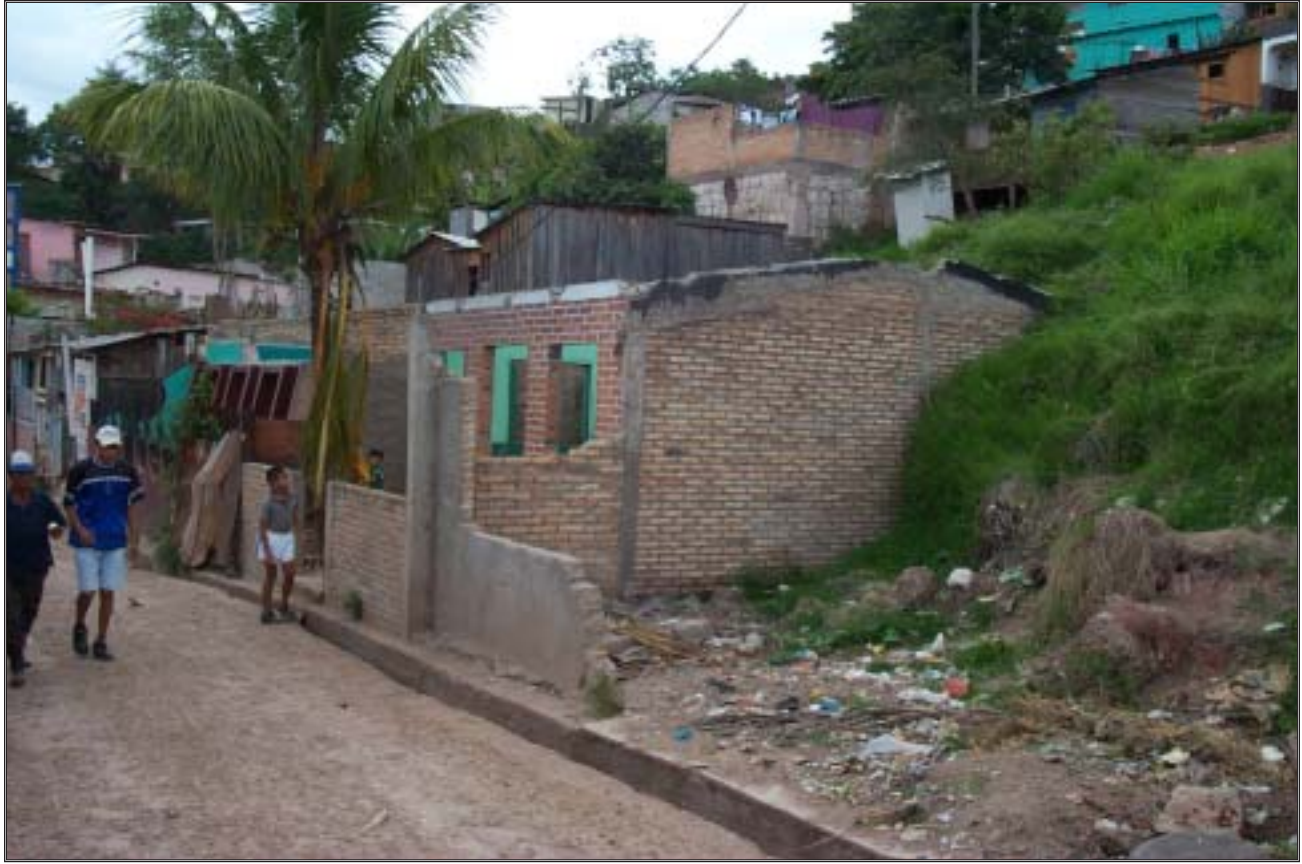
Another moderate-sized slump of about 2,500 m³ occurred about 200 m south of the El Berrinche landslide in a small neighborhood called Campo Cielo. This landslide began its movement on or about September 23, 1999, on the southeast-facing nose of the ridge just south of the El Berrinche landslide. The initial movement occurred as a scarp about 15 m long having about 20 cm of displacement. Once this scarp had formed, little additional displacement occurred at this site, and subsequent slope movement shifted downslope as another headscarp area formed with multiple cracks from which water percolated. The slope below this was saturated to the surface, making foot travel across the landslide almost impossible without sinking into the saturated soil. The toe of this slump was situated behind a row of houses next to a street in the neighborhood. As the slump continued to move at a rate of several centimeters per day over a period of

several weeks at the end of the rainy season, the toe grew and eventually made contact with the back walls of the row of houses fronting the street (figure 11). As movement continued, the toe of the slump began squeezing between these houses and breaking through the back walls of the houses. Residents of the houses evacuated the dwellings just prior to the toe of the slump reaching the rear walls.

Figure 11. Toe of slump in neighborhood of Campo Cielo in Tegucigalpa. At the right of the photo, the toe of the slide mass is seen impinging against the row of houses.

This area had been the site of recurring spring activity in the rainy seasons of most years. Prior landslide movement of this hillside occurred during Hurricane Gilbert in 1986, when four houses were destroyed and during Hurricane Mitch, when 17 houses were destroyed. During the dry season of 2000, the city dug trenches through the landslide that are greater than the depth of the slide surface, which is 2-3 m deep. These trenches have succeeded in draining the slide mass and halting movement of the slope.
