USAID/El Salvador Tropical Storm Ida Reconstruction Project

Programmatic Environmental Mitigation Plan for Schools

February 2013

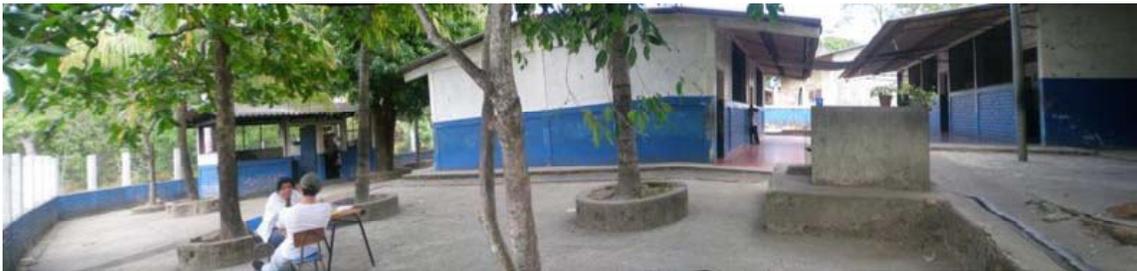
In general, all roofing are badly damaged, the floors are in fair condition, with worn areas and with the final step damaged, paint shows certain deterioration and fading, roof structure has anticorrosive paint and roof leaks are generating rust in the metal structure, the electrical system is in a fair state.

Image 10: Internal view of facilities, CE Cantón San Sebastián Abajo.

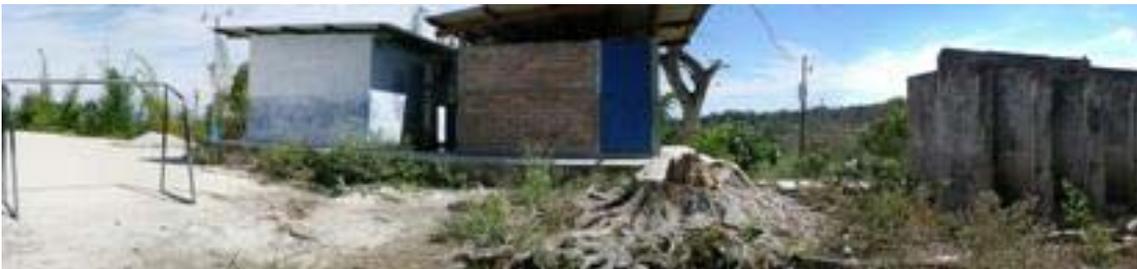
In general, all roofing is badly damaged, the floors are in fair condition, with worn areas and with the final step damaged, paint shows certain deterioration and fading, roof structure has anticorrosive paint and roof leaks are generating rust in the metal structure, the electrical system is in fair condition.

Image 14: Panorama of infrastructure conditions, CE Felipe Soto.

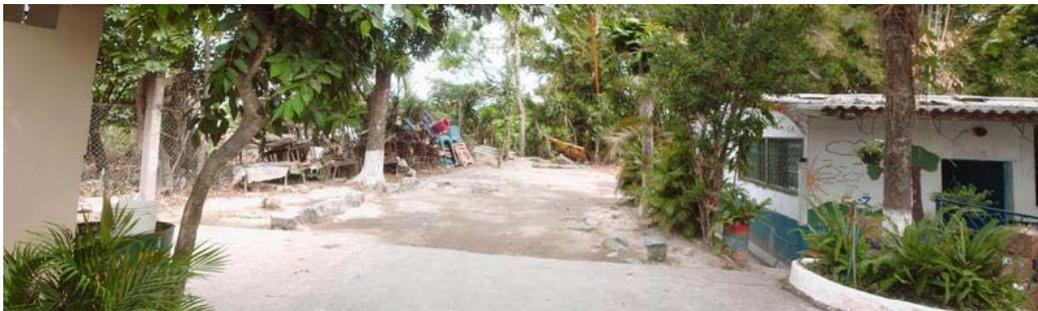
In general, all roofing is badly damaged, the floors are in fair condition, with worn areas and with the final step damaged, paint shows certain deterioration and fading, roof structure has anticorrosive paint and roof leaks are generating rust in the metal structure, the electrical system is in fair condition.

Image 16: View of facilities, CE Escuela Parvularia Reynaldo Galindo Pohl.

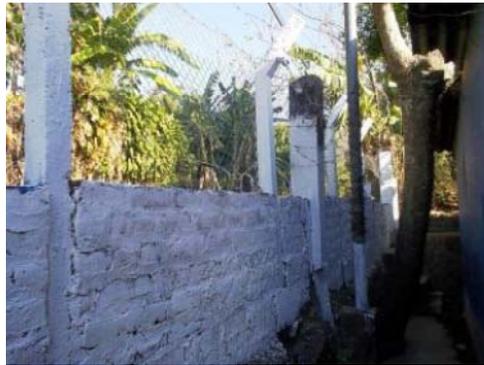
In general, the electrical and hydraulic facilities are collapsed, lack of access ramp in all buildings and in the school's main access. Rainwater downspouts are deteriorated.

Image 18: View of existing infrastructure, CE Cantón Puertas del Golpe.

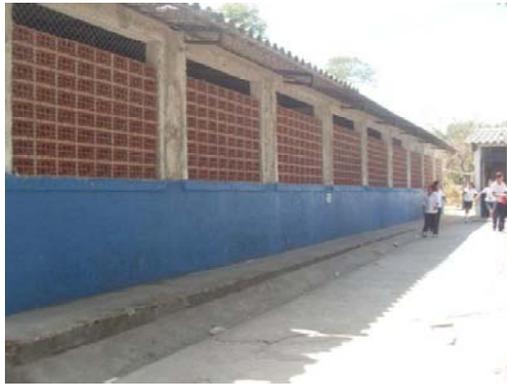
In general, the electrical and hydraulic facilities have failed, lack of access ramps in all buildings and in the school's main point of entry. Rainwater downspouts are deteriorated.

Image 20: View of existing facilities, CE Cantón Ojos de Agua.

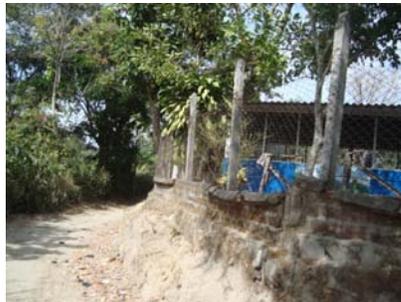
In general, the floors of the classrooms, multi-use hall and kitchen/warehouse are in fair condition, there is deterioration and fading of wall paint, roofing is deteriorated, thus generating leaks, the roof structure is missing paint and rusty, the lack of windows in the building allows rainwater to enter, there are no wall clamps, electrical system is deficient, the kitchen does not have a chimney, thus generating smoke contamination, door locks are not working.

Image 22: Existing conditions, CE Cantón El Copinol.

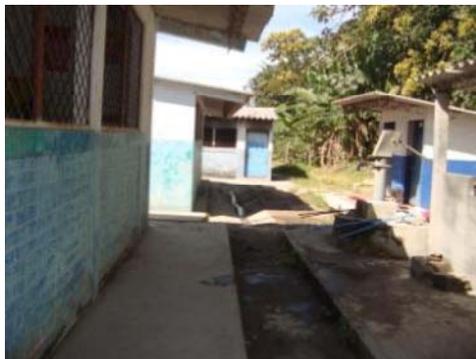
In general, classroom floors are in fair condition, windows are damaged, window guards are rusted, roofing is deteriorated, generating leaks, roof structure is unpainted and rusty, doors are unpainted and wall paint is faded.

Image 24: Status of Facilities, CE Cantón Veracruz.

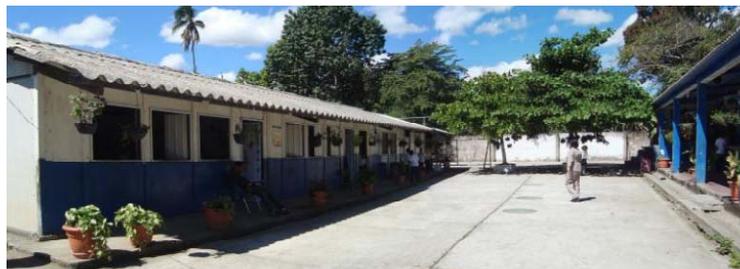
In general, classroom floors are deteriorated and raised, the building does not have windows on its southern side, only a fence with metal supports located where the windows should be; in the northern side, the windows are aluminum and glass, but deteriorated, and window guards are rusty, doors are unpainted and there is deterioration and fading of wall and column paint. The classrooms have wood and plywood divisions in poor condition.

Image 26: View of existing facilities, CE Cantón El Paraíso.

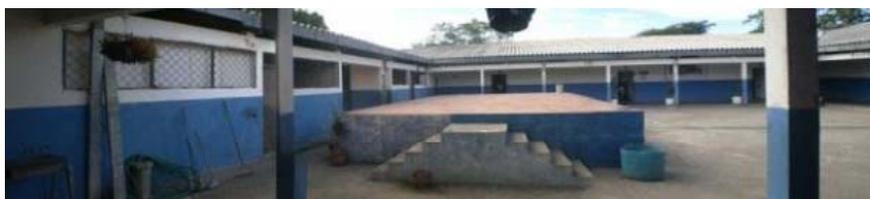
In general, classroom floors are in fair conditions, with significant damage in the final step of the floor, the ceilings are very stained and damaged by roof leaks, roofing is very deteriorated, generating leaks, there is paint deterioration and fading of the walls, wooden windows are significantly damaged or missing in certain areas, plaster is deteriorated, rainwater downspouts have failed, there are no wall clamps and pests live within the ceiling, electrical system is deficient, the rainwater exit allows for stagnation of rainwater, etc.

Image 28: View of existing facilities, CE Dr. Adrián García.

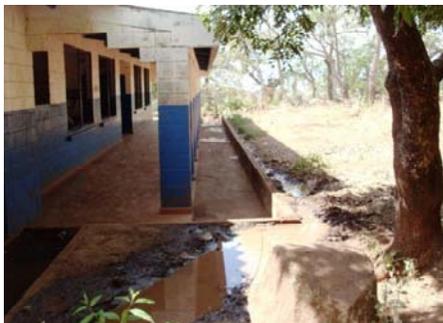
In general, the floors at the principal's office are in fair condition, ceilings are pretty stained and damaged by roof leaks, roofing is very deteriorated, generating leaks, there is paint deterioration and fading in walls, and the warehouse-kitchen has completely stained walls, windows need cleaning and some glass replacement, electrical system is deficient, the basin in the warehouse-kitchen does not have a water supply, etc.

Image 31: View of internal facilities, CE San Francisco de la Cruz

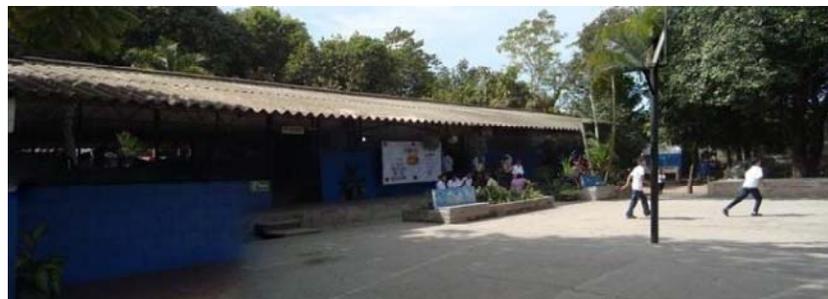
In general, the concrete floors of the classrooms are in poor condition, with significant damage in the final step of the floor and the wear of time, the ceilings are stained and damaged by roof leaks, the column frames and metal beams are unpainted and rusted, the plywood divisions are deteriorated, roofing is very deteriorated provoking leaks, there is wall paint deterioration; there are no windows, therefore, during the rainy season, water splashes into the classrooms and alleys. The electrical system is deficient.

Image 33: Internal facilities, CE Cantón La Primavera.

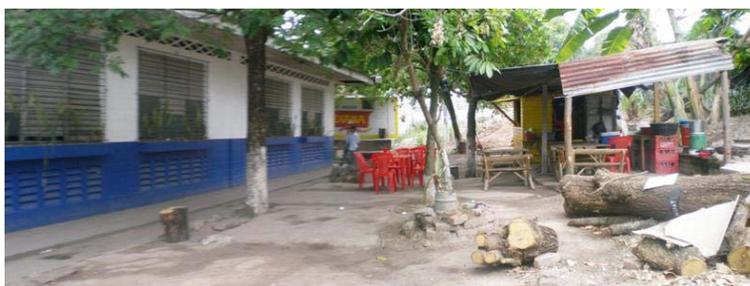
In general, all roofing is severely damaged, floors are in fair condition with worn areas and with the final step damaged, paint shows certain deterioration, fading, roof structure has anticorrosive paint and roof leaks are generating rust in the metal structure, the electrical system is in fair condition but operating.

Image 35: Infrastructure conditions, CE Instituto José María Peralta Lagos.

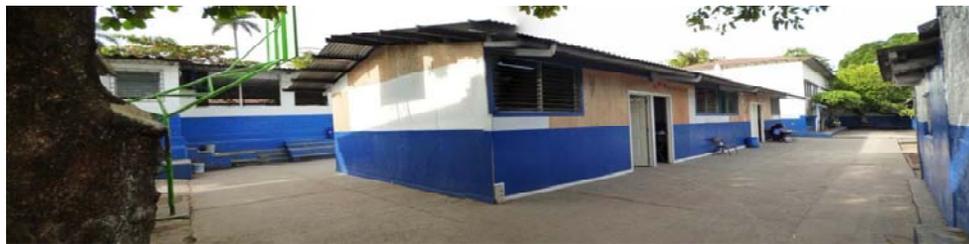
In general, classroom floors are deteriorated.

Image 37: View of facilities, CE José Dolores Larreynaga.

14	CE José Dolores Larreynaga, Quezaltepeque, La Libertad.	<ul style="list-style-type: none"> • AT THE LOCATION <p>The waste water produced by the cafeteria of the school is discharged towards the street, generating bad odors.</p> <p>Current inadequate use of railway facilities (used by the poor).</p> <p>Temporary classrooms over the area of the BKB court.</p> <ul style="list-style-type: none"> • DURING CONSTRUCTION <p><u>Demolitions:</u> there will be no significant demolition with the exception of the intervention in certain components of the buildings that will remain for their adaptation.</p> <p>Tree cutting: there is no tree cutting foreseen.</p> <p><u>Subsoil perforations:</u> in the prior stage and in the design and construction phase, ground perforations will be made, producing noise.</p> <p><u>Landscaping:</u> minor excavation work will be carried out, which does not generate significant impacts.</p> <p><u>Preparation of the components of the building:</u> Produces noise, suspended particles (dust, paint, fumes); construction waste etc., water and energy demand.</p> <p><u>Risks for the school community</u></p> <p>Construction work could represent risks for the school community; the school does not have sufficient space for ongoing school functions during construction.</p> <ul style="list-style-type: none"> • DURING OPERATION <p>Demand of utilities: (water, energy, fuel.) Reduction of water and</p>	1

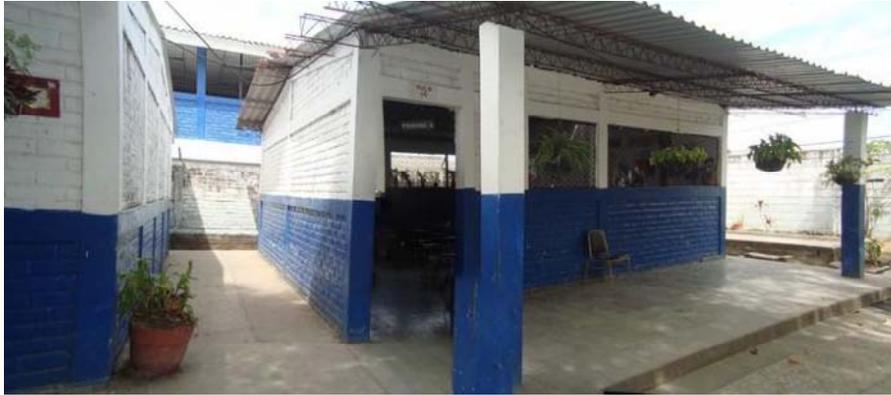
In general, classroom floors are deteriorated.

Image 39: Detail of facilities, CE Miguel Ángel García.

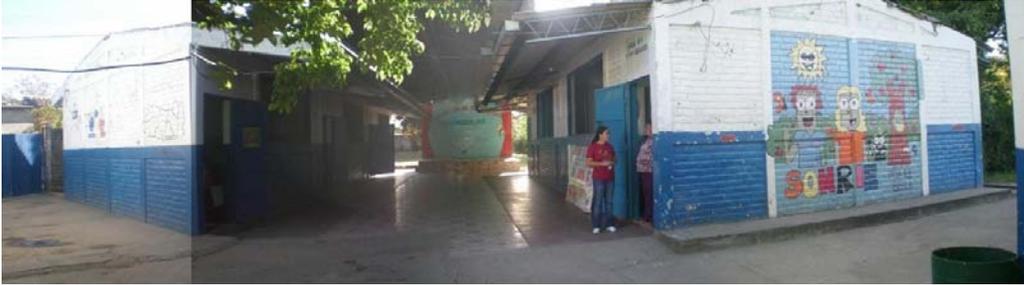
In general, all roofing is badly damaged, floors are in fair condition with worn areas and with the final step damaged, paint shows certain deterioration, fading, roof structure has anticorrosive paint and roof leaks are generating rust in the metal structure, the electrical system is in poor condition.

Image 40: Panorama of internal facilities, CE Juana Galán de Quintanilla

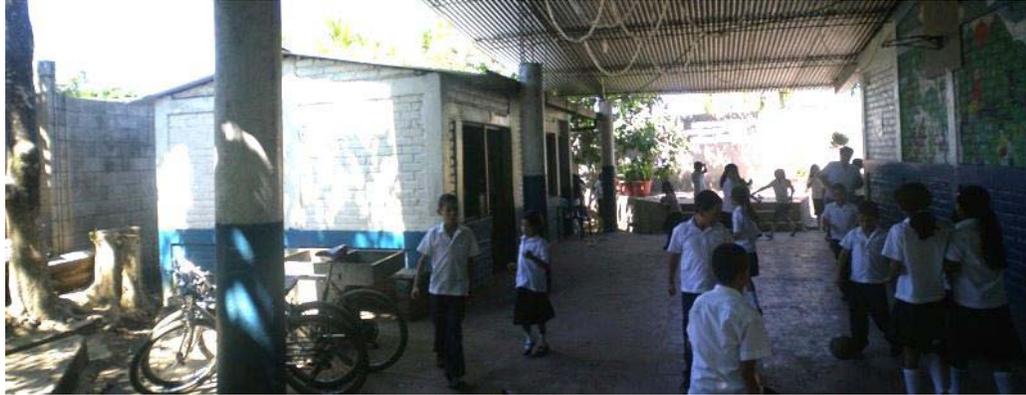
In general, all roofing is badly damaged, floors are in fair condition with worn areas and with the final step damaged, paint shows certain deterioration, fading, roof structure has anticorrosive paint and roof leaks are generating rust in the metal structure, the electrical system is in fair condition.

Image 42: View of the facilities, CE Colonia Las Margaritas 1 y 2.

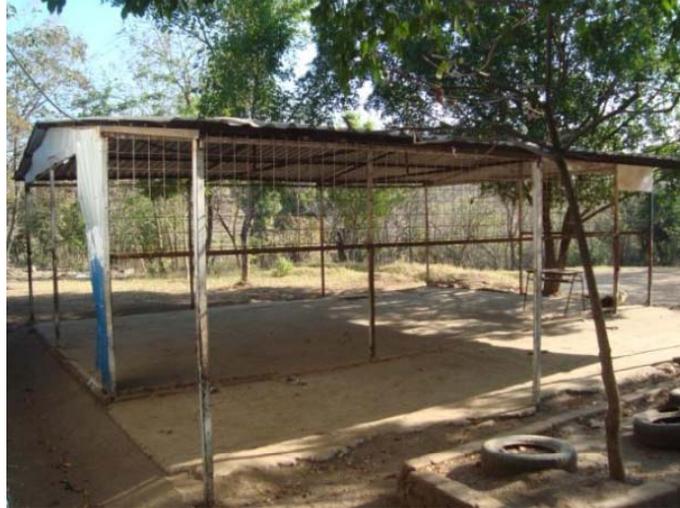
In general, classroom floors are deteriorated.

Image 44: View of infrastructure conditions, CE Cantón Chantusnene.

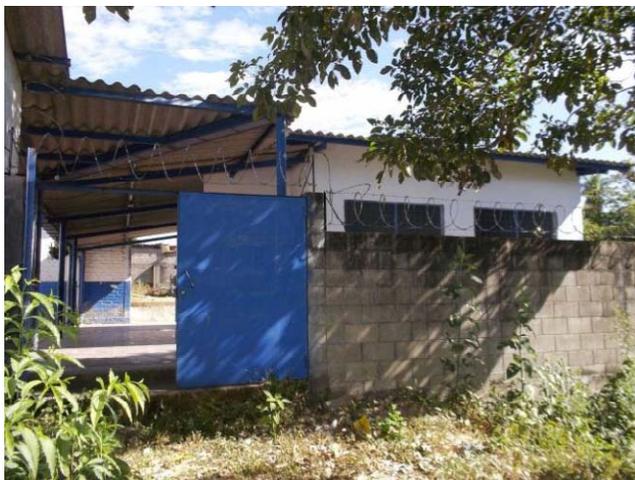
In general, the electrical system is deteriorated. Likewise all gutters and rainwater downspouts are deteriorated and rusty.

Image 46: View of infrastructure conditions, CE Dr. Francisco Antonio Lima.

7	<p>CE Dr. Francisco Antonio Lima, Jayaque, La Libertad.</p>	<ul style="list-style-type: none"> • AT THE LOCATION The town's rainwater drainage is discharged into a creek in the southern side of the school. • Existence of temporary classrooms in the recreation area <p>DURING CONSTRUCTION</p> <p><u>Demolitions:</u> there will be no significant demolition with the exception of the intervention in certain components of the buildings that will remain for their adaptation. Demolition of ramps and damaged parts of sidewalks.</p> <p><u>Tree cutting:</u> there is cutting of trees of diameters or heights foreseen which could imply a risk.</p> <p><u>Subsoil perforations:</u> in the prior stage and in the design and construction phase, ground perforations will be made, producing noise.</p> <p><u>Landscaping:</u> There will be filling, slopes and wall construction that</p>	2

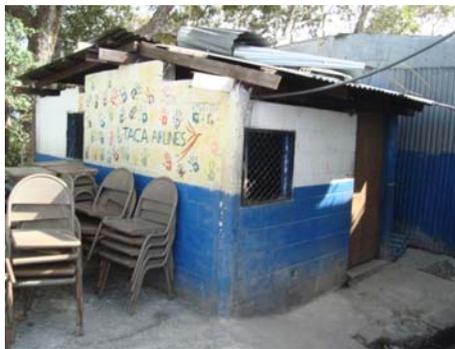
In general, classroom floors are damaged in certain areas, there is no ceiling, a rainwater gutter located where the building joins the added pre-school classroom is in very poor condition and needs replacement. The roof structure must be cleaned and painted, roofing is badly deteriorated, wall paint is deteriorated and faded, the lack of windows allows rainwater to splash, and windows have a metal frame and a rebar grid which needs maintenance. All walls that have been added to the building should be demolished or in any case, reinforced, as they appear to have been constructed with little quality control.

Image 48: Condition of facilities, CE Cantón Ojo de Agua.

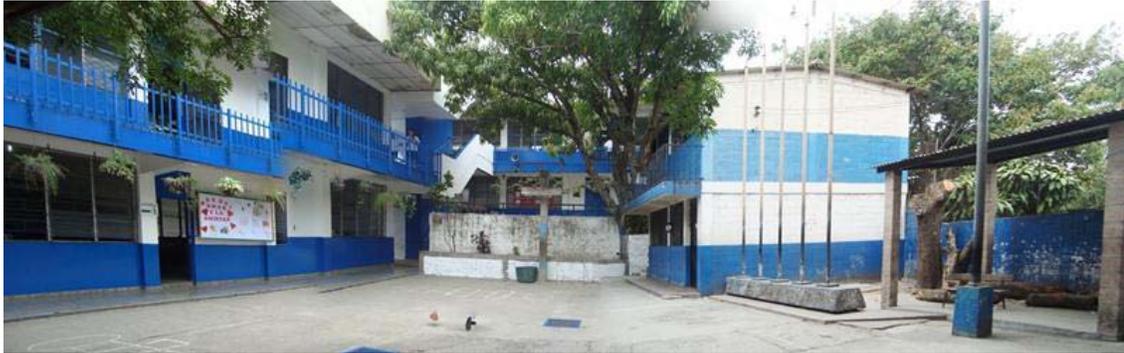
In general, classroom floors are deteriorated.

Image 51: Internal view of facilities, CE José María Cáceres.

16	CE José María Cáceres, Zaragoza, La Libertad.	<ul style="list-style-type: none"> • AT THE LOCATION Water ponding generates the environment for vector growth. Generation of bad odors and environment for vector growth. Hazards for the persons entering the classrooms, since they can provoke a fall. • DURING CONSTRUCTION <u>Demolitions</u>: there will be significant demolitions. <u>Tree cutting</u>: The palm trees within the area of intervention will be felled. <u>Subsoil perforations</u>: in the prior stage and in the design and construction phase, ground perforations will be made, producing noise. <u>Landscaping</u>: the level of the school will be raised 1.00mt.; this will generate significant impacts due to the movements of removal 	2

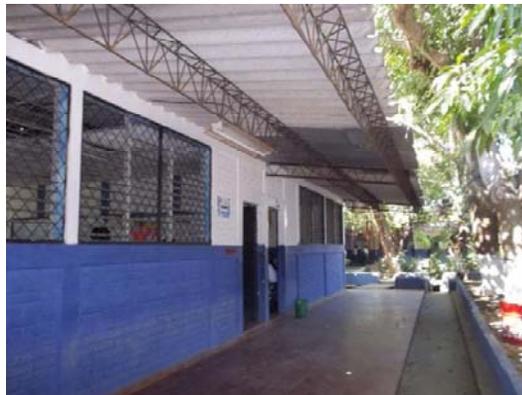
In general, the floors of the principal's office are in good shape, the ceilings are badly stained by the leaks in all roofs; the roof cover is quite deteriorated, showing leaks. The metal structure supporting the roof is rusty due to being in the coastal zone. There is paint deterioration and fading of the walls. Glass and aluminum windows are damaged, and glass is missing in parts. The electrical system is deteriorated, the free falling rainwater allows for water stagnation, the toilets are dirty and have water leaks; this maintains the floors with permanent humidity, etc.

Image 54: Detail of existing facilities, Instituto Nacional Puerto de La Libertad

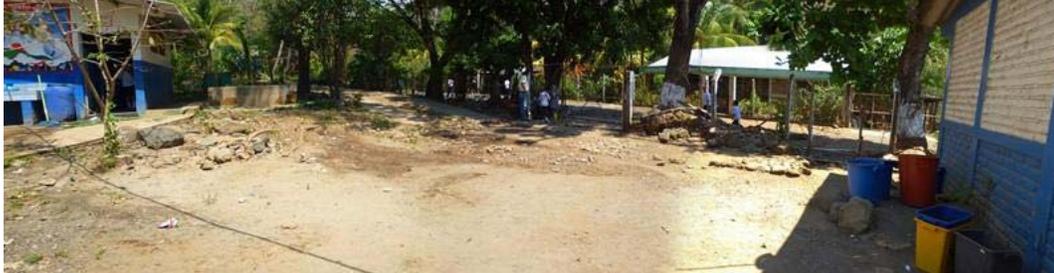
In general, the floors and roofing of the classrooms are deteriorated.

Image 56: Detail of status of the facilities
