TECHNICAL ANALYSIS REPORT

Investigation of the phases of construction of the church. Laboratory analyses of samples taken from the facade, prothesis and north corridor.

Conservation and Documentation of the Wall Paintings at the Red Monastery, Sohag.

Re. Investigation of the phases of construction of the church. Laboratory analyses of samples taken from the façade, *prothesis* and north corridor.

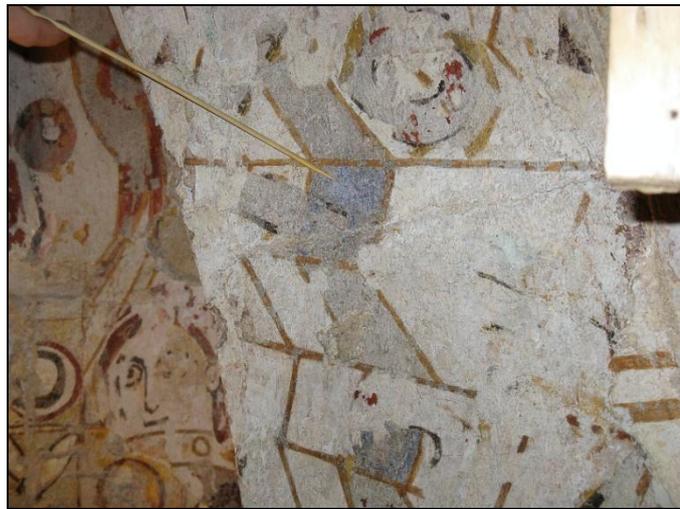
Facade, north side, second tier, arch, right side, beside impost painted with geometric motifs. The sample was taken from a blue background.

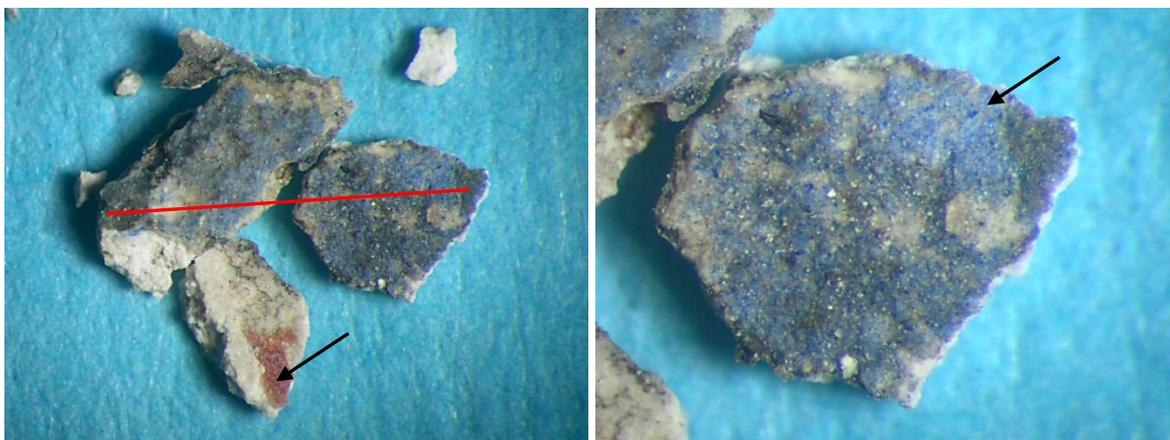
Stereo-microscope reflected light, enlargement approximately 18 (a sx) and 40 X respectively.

The image on the left shows all the tiny fragments comprising the sample. The fragment at the bottom, taken from the inside ‘face’ shows how beneath the whitish preparation over which the blue paint layer was applied, there is another pale red paint layer (see arrow). The picture on the right, greatly enlarged, shows the surface of one of the fragments, revealing the structure of the blue paint layer. Within it, minute angular blue particles (see arrow) can be made out; these are granules of lapis lazuli. On the upper part there are traces of particulate matter possibly mixed with the residue of an organic protective agent (P) [*sic*]. The red line indicates roughly the line along which the thin section was cut for the micro-stratigraphic analysis described in the following pages.

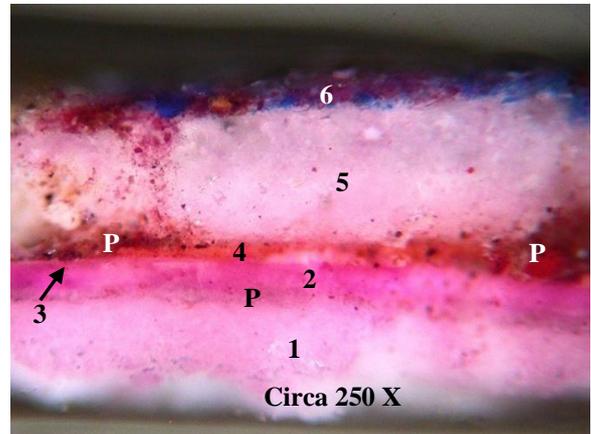
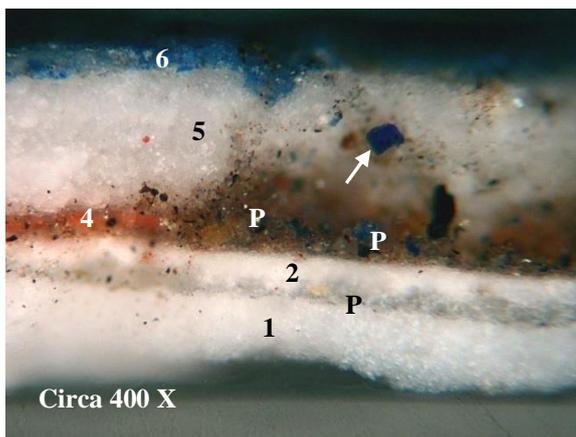
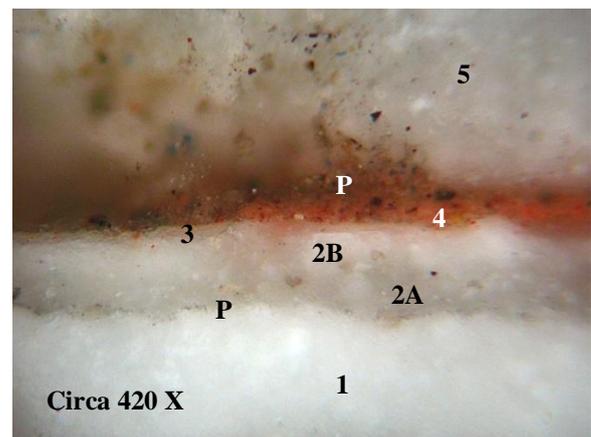
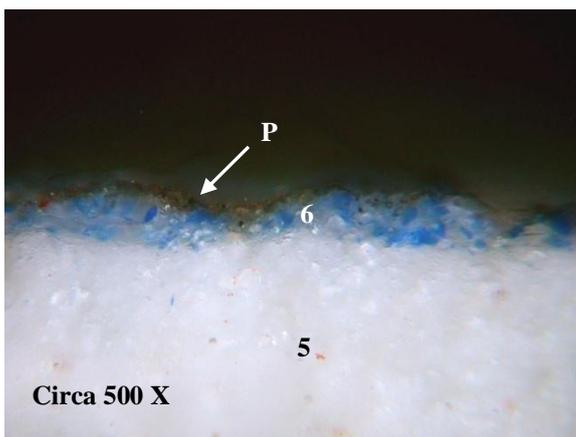
Thin section, reflected light.

The two images above show virtually the entire surface of the section. The image on the right was taken after the histo-chemical test with fuchsin was carried out in order to identify and locate protein compounds (particularly animal glue and gelatine) within the stratigraphy. The other images, which are greatly enlarged, each illustrate a detail of the stratigraphic sequence by showing the features of the various layers. The innermost layer (no. 1) comprises the plaster layer. On its surface, which is slightly uneven, there is a thin layer of particulate matter (P) made up of very fine micrometrical granules of lamp

black. The presence of this layer indicates that a certain period of time elapsed before the application of the next layer (no. 2). This was applied in two coats (2A and 2B) that are made up of hemidrate gypsum (or anhydrite) and animal glue or gelatine.

The sequence continues with a thin, intermittent, translucent layer of a whitish color (no. 3) that is a protein-based primer applied to the underlying preparation while it was still wet, and a thin and patchy orange-red paint layer (no. 4) produced by dispersing red ochre (hematite) in a protein binder. At the edges of the orange-red paint layer there are pockets of particulate matter (P) which have been deposited in the gaps between the layers.

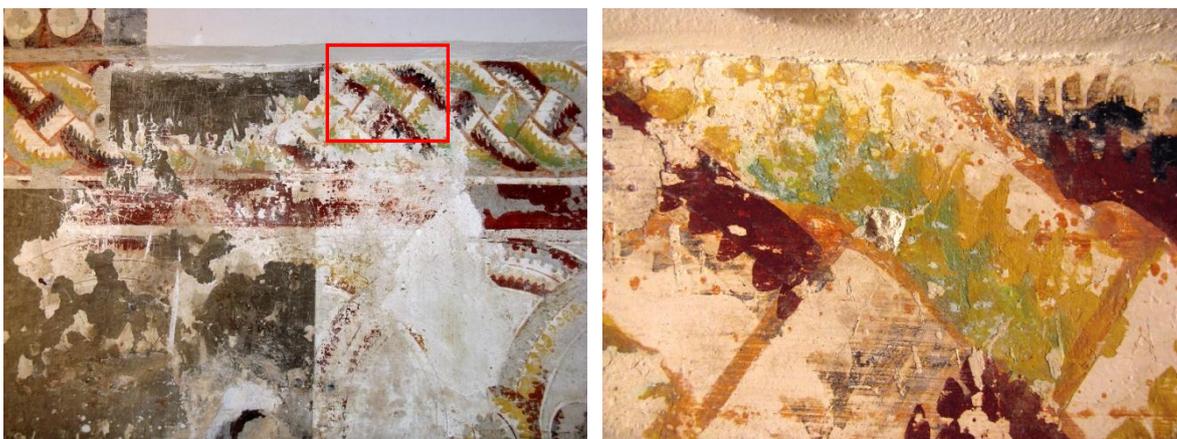
North Corridor, wall decorated with concentric circles, left side, from the band painted with a multicolored braid. Sample taken from a portion with a green coat applied over a yellow one.

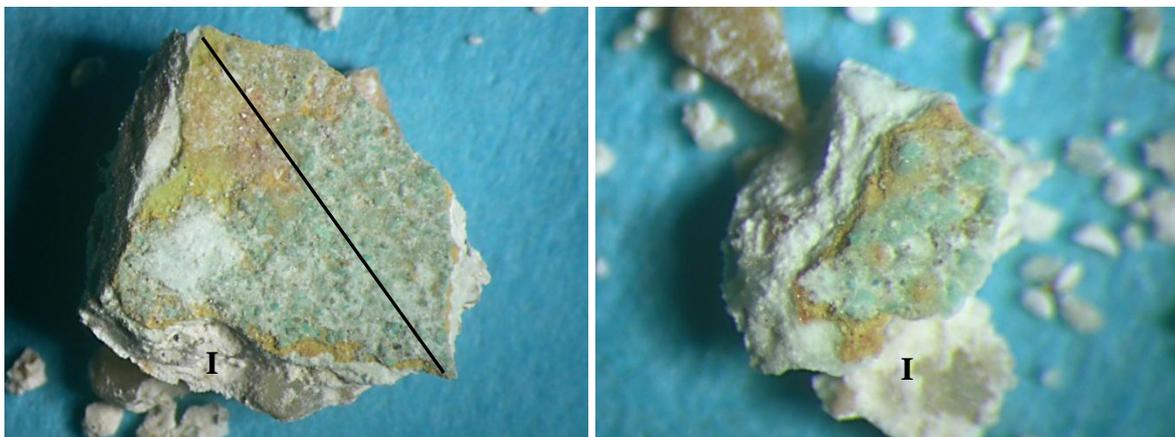
Stereo-microscope, reflected light, enlargement approximately 10 (a sx) and 40 X respectively

The image on the left shows the upper part of the fragment used to provide the thin section used in the micro-stratigraphic study (see the images shown on the following pages⁴). The paint layer, comprising two coats of greenish yellow and green paint was applied over a light-colored lime and sand plaster (I).

The image on the right, greatly enlarged, shows the surface of another of the flakes of plaster included in the sample. The granular structure of the green paint layer is clearly visible in the photograph. The small green masses visible in the image were found to be composed of two pigments mixed together, one white and one green (see the results of the microscopic and FT-IR analyses set out on the following pages).

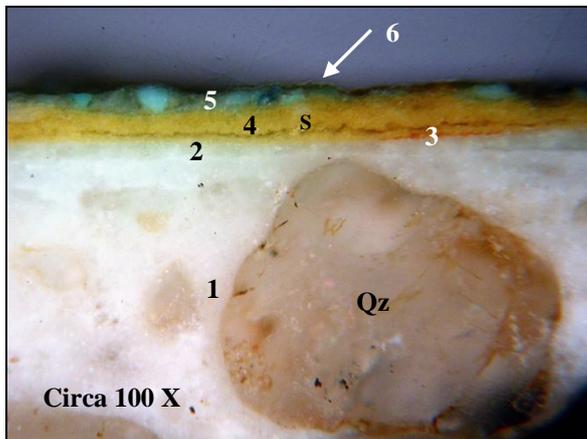
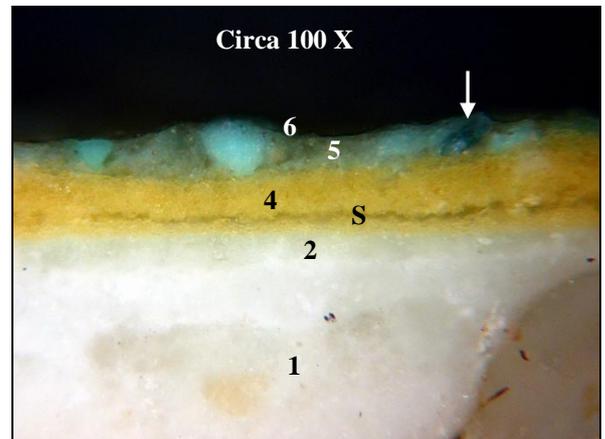
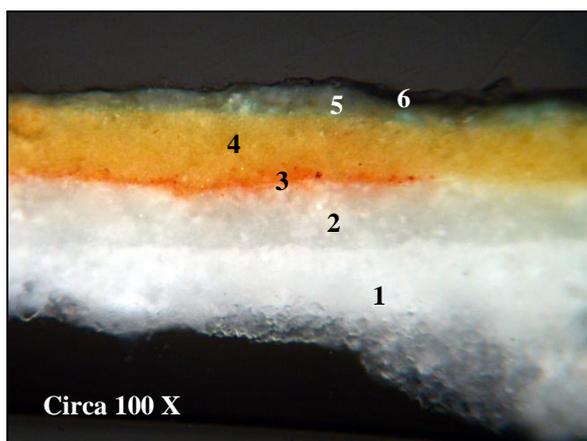
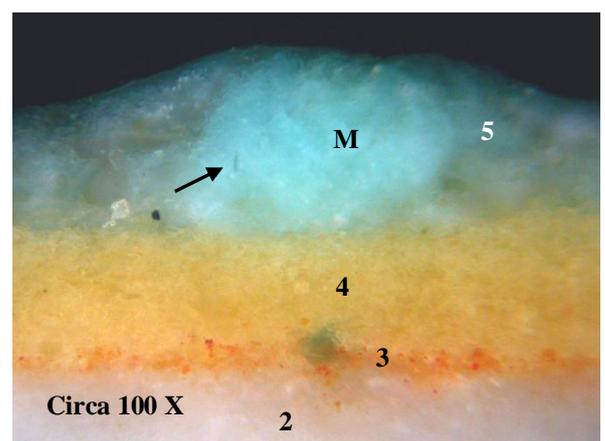
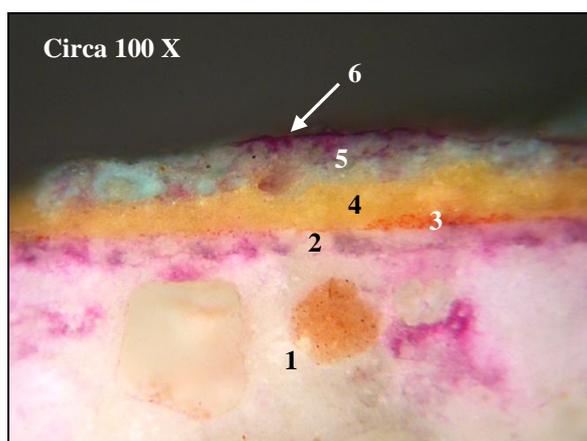
Thin section, reflected light.

The top left-hand image, at a relatively low magnification, shows a good part of the section and the entire stratigraphic sequence. The other, more highly magnified images show other details of the layers contained in the sample. In particular, the bottom left-hand image was taken after the histo-chemical test with fuchsine aimed at identifying and locating protein compounds within the stratigraphy (especially animal glue or gelatine).

The porosity of the mix is average (estimated to be in the region of 30-35%), determined by the presence of cracks, mostly caused by the desiccation of the lime. Cracks produced by physico-mechanical stress can be seen towards the surface of the layer, possibly caused when the sample was taken.

In some areas of the paint layer there are long longitudinal cracks that tend to separate the layer into two parts.

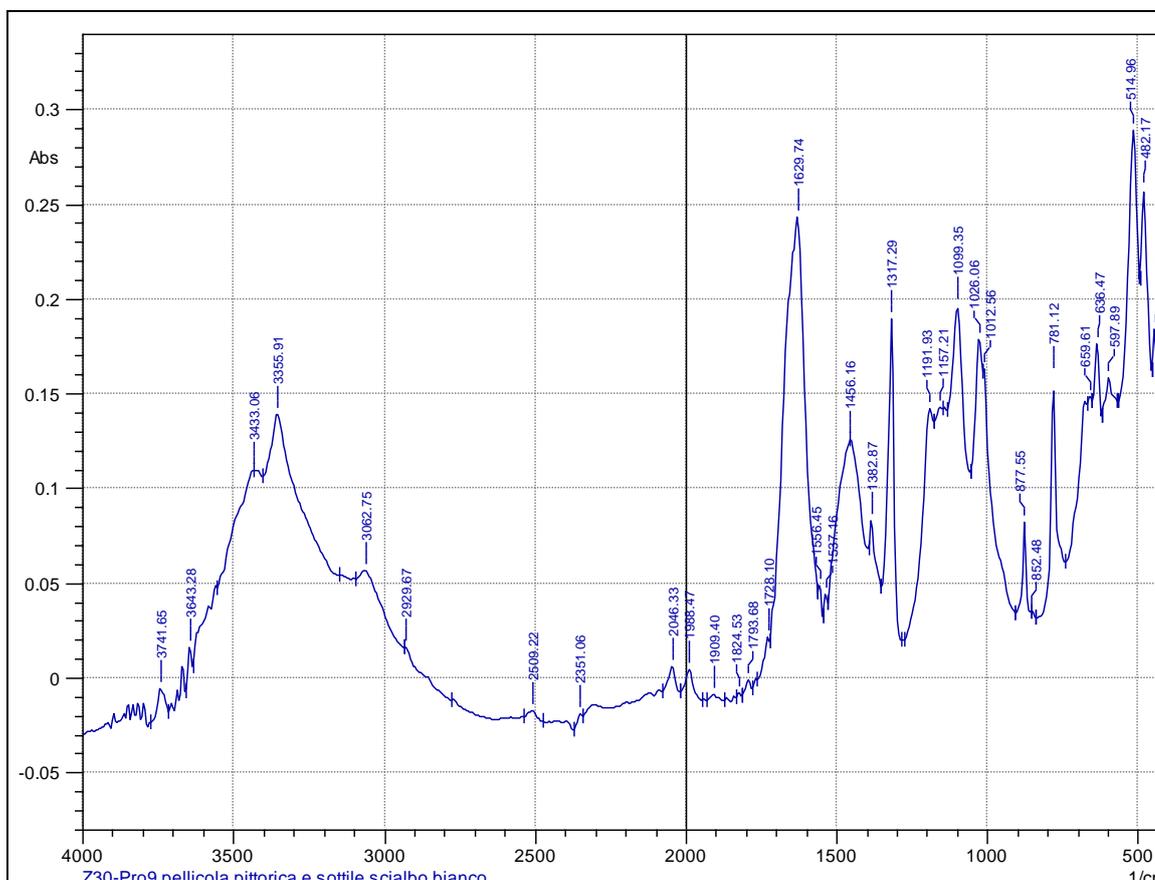
FT-IR Spectrum.

The FT-IR spectrum obtained from the analysis was interpreted by comparing it with the laboratory data base and others published in various scientific journals⁵. In particular, the assignments were made on the basis of the vibrational frequencies of pure or mixed reference standards at particular matrices (calcite, gypsum, animal glue, etc.) recorded under the same experimental conditions.

Certain absorption bands corresponding to peaks in the IR spectrum could be partially caused by the presence of *atacamite* [Cu₂(OH)₃Cl]. These bands are found in areas of the spectrum in which the effects of absorption produced by *natrojarosite* (514, 482 cm⁻¹) and *calcium sulphate* (3433, 597 cm⁻¹) are also found. Therefore, owing to the interference caused by both *natrojarosite* and *calcium sulphate*, on the basis of the data acquired from the spectrum study, we cannot be certain that *atacamite* is present.

During the course of the IR spectrum study, particular attention was paid to the presence of other copper pigments used in Egypt such as *malachite* and *chrysocolla*. However, no absorption band that could be attributed to either one of these two pigments was found.

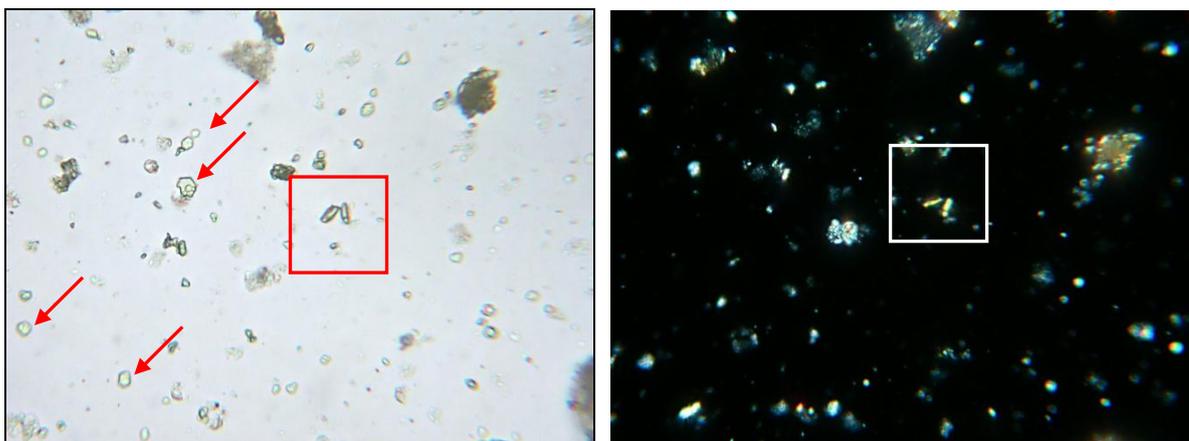
Slide, transmitted light, enlarged circa 500 X (both images). Right-hand photo, polarizer only; sx photo, crossed Nicol.

The two images represent the same frame taken under different optical conditions. The left-hand image shows several jarosite crystals, distinguished by a polyhedral habit and very pale greenish yellow color. Inside the red box there are two prismatic crystals whose optical characteristics enable us to identify them as atacamite. In the image on the right the high birefringence of the two crystals (white box) can clearly be seen by comparison with the very weak birefringence of the jarosite (the jarosite crystals are hardly visible under these optical conditions).

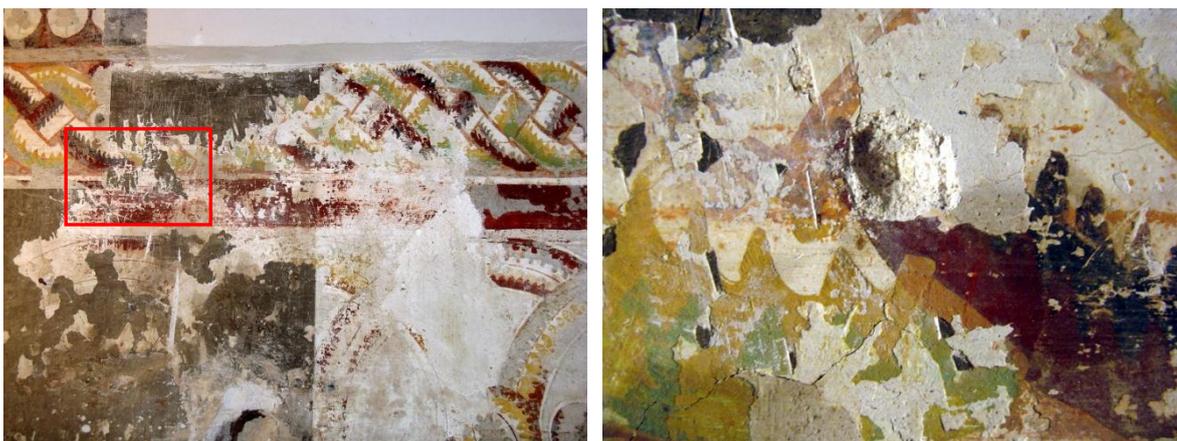
North corridor, wall decorated with concentric circles, left side, from a dark red background within the band decorated with a multicolored braid.

The sample included the paint layer, a white preparatory layer and traces of the underlying base plaster. Owing to the poor adhesion between the finishing plaster and the overlying preparation, it was not possible to include in the sample a fragment of plaster large enough to allow any meaningful definition. Therefore we had to take another two samples (11B and 11C) from the finishing plaster underlying the preparatory and paint layers and the base plaster adhering to the masonry respectively. The results of the analyses of these two samples are provided in two separate analysis sheets.

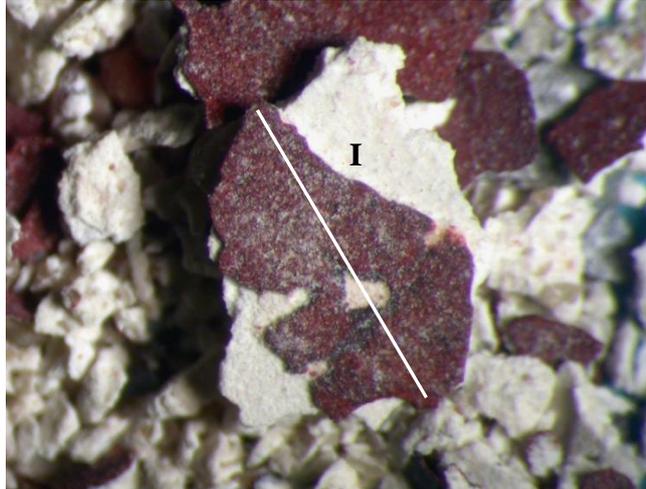
Stereo-microscope, reflected light, enlarged circa 16 X.

The image shows one of the small flakes included in the sample. The purplish red paint layer can be seen on top of the plaster (I), which is very well smoothed and compacted. Below the purplish red level there is also a thin blackish layer which can be identified, on the basis of the data acquired from the micro-stratigraphic analysis (see below), as an altered lead pigment.

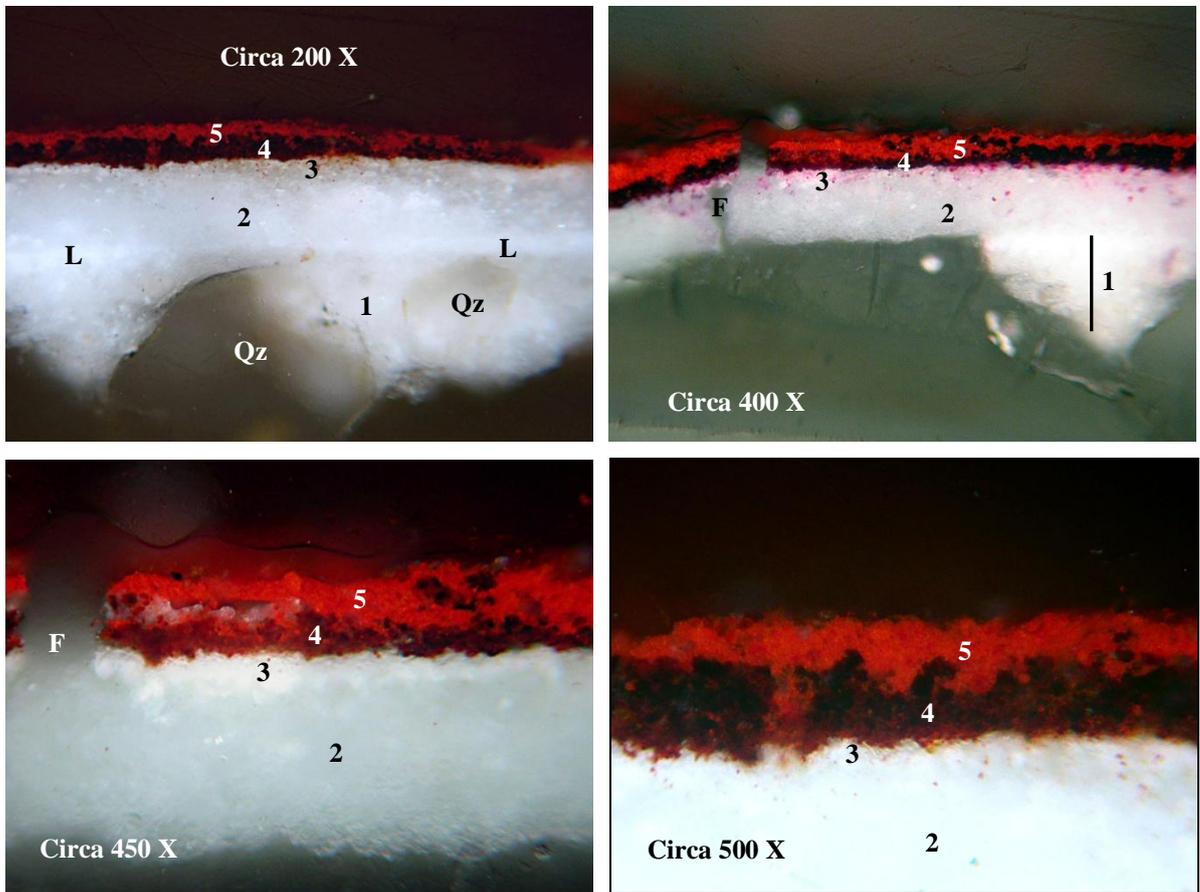
Thin section, reflected light.

The four images, representing different enlargements, show a good part of the section and enable us to describe the entire stratigraphic sequence.

The diminutive size of the fragments of plaster taken in the sample do not permit a definition with a minimum statistical value as set out in UNI-Normal 12-83 documentation. We can only state that the surface of the plaster is very regular and has been carefully compacted and smoothed with a float or trowel. This action has probably caused the lime in the binder to effloresce on the surface, forming a thin, more compact layer (approximately 0.02 mm thick) that can be seen clearly on top of the plaster (see the images on the previous page).

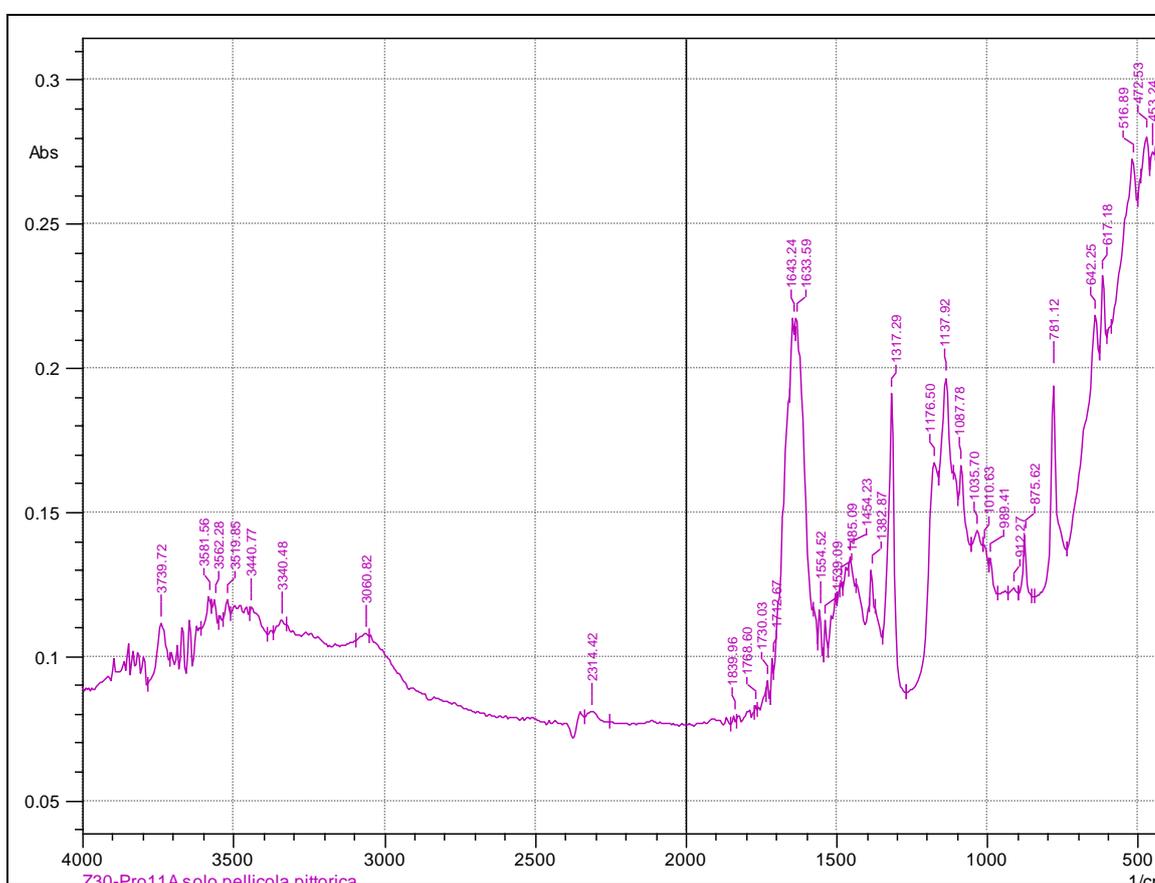
FT-IR Spectrum.

The FT-IR spectrum obtained from the analysis was interpreted by comparing it with the laboratory data base and others published in various scientific journals⁽⁹⁾. In particular, the assignments were made on the basis of the vibrational frequencies of pure or mixed reference standards at particular matrices (calcite, gypsum, animal glue, etc.) recorded under the same experimental conditions.

A single absorption band at 453 cm⁻¹ can be linked with the presence of *minium* (Pb₃O₄). Of those bands visible in the analytical interval (4000 – 400 cm⁻¹) possible when using the standard instrument, the only one missing is that at 527 cm⁻¹ which may have been covered in any case by the effect at 516 cm⁻¹ caused by the bihydrate calcium oxalate.

The *phyllosilicates* can be associated with hematite which derives from the refining, and often the calcination, of earth pigments, a raw material normally distinguished by the presence of argillaceous and micaceous minerals.

In the spectrum no absorption bands for hematite were observed owing to the strong interference of the other substances. The main peak for hematite at approximately 600 cm⁻¹ was interfered with by that of barium sulphate.

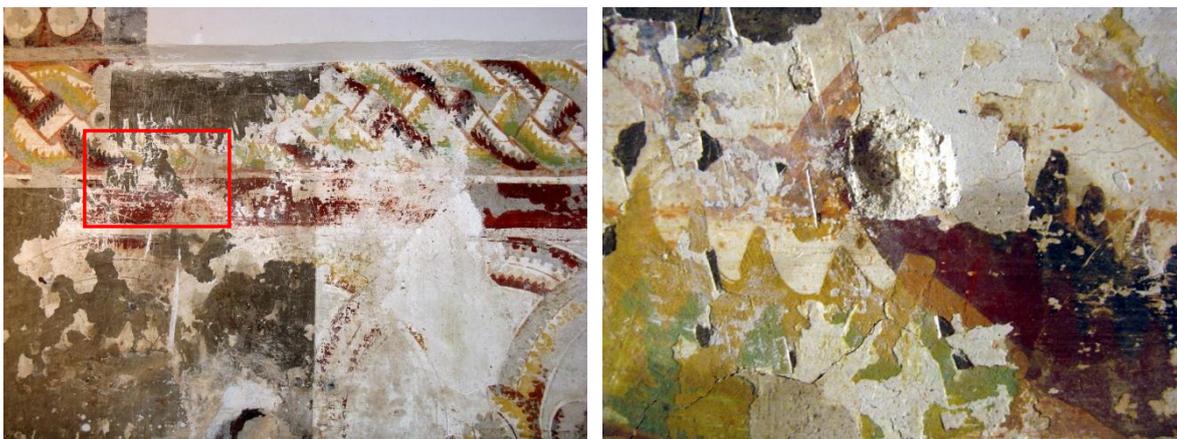
North corridor, wall decorated with concentric circles, left side, from a dark red background (area stratigraphically beneath sample 11A) within the band decorated with a multicolored braid.

The sample included several fragments of finishing plaster underlying the preparatory and paint layers (compare with sample 11A).

The top left-hand image shows a good part of the surface of the transverse section of one of the two fragments used for the microscopic study. The image shows the structure of the finishing plaster which is a mortar of slaked lime and well-graded sand composed mainly of silicates (mostly quartz: Qz) and, to a lesser extent, fragments of alabastrine limestone. A longitudinal crack (F), located approximately 0.25 mm below the surface of the plaster tends to separate it into two portions: 1A and 1B.

The crack, caused by small physical and mechanical stresses, may have been encouraged by a pre-existing latent break where one layer overlaid the other. The plaster may in fact have been applied in two coats at one time.

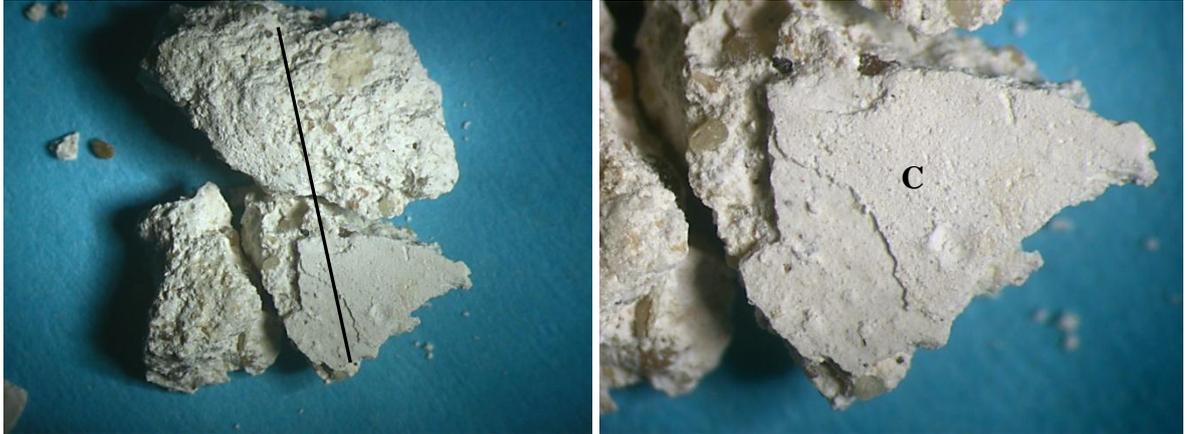
Stereo-microscope, reflected light, enlargements approximately 10 (sx) and 16 X.

The image on the left shows the flakes of finishing plaster included in the sample. The lower flake shows the surface of the plaster. However, this is more clearly shown in the enlarged image on the right.

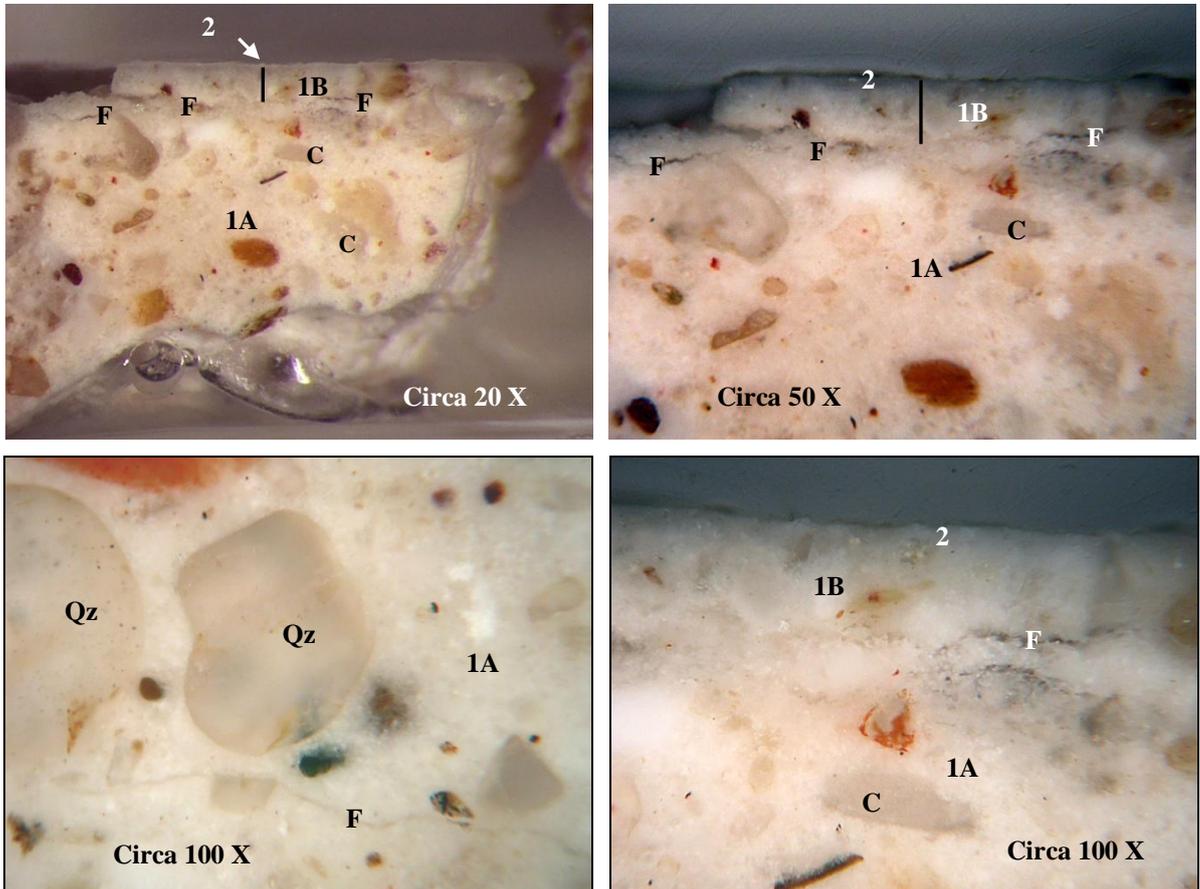
Thin section, reflected light

The porosity of the mix is average (estimated to be around 30%), owing to the presence of cracks produced as the lime dried out and bubbles resulting from the fact that the mortar was not mixed to a perfect consistency.

Approximately 0.25mm below the surface of the plaster a long crack displays a tendency to isolate a fragment parallel to the surface. The crack, caused by small physical and mechanical stresses, may have been encouraged by a pre-existing latent break where one layer overlaid the other. The plaster may in fact have been applied in two coats at one time (1A and 1B).

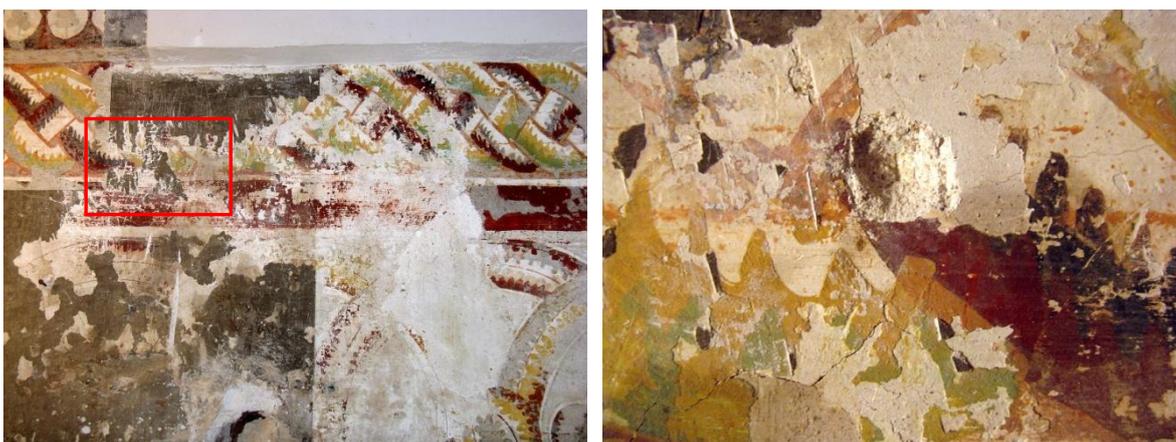
North corridor, wall decorated with concentric circles, left side, from a dark red background (area stratigraphically beneath samples 11A and 11B) within the band decorated with the multicolored braid.

The sample included several fragments of the base plaster, underlying both the finishing plaster and the preparatory and paint layers.

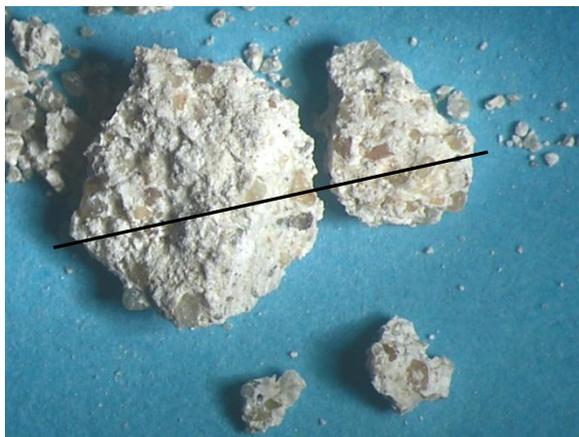
Stereo-microscope, reflected light, enlargement approximately 8 X.

The image shows the two fragments of plaster from which the thin section was taken for the micro-stratigraphic analysis. The black line indicates roughly the line along which the thin section was cut.

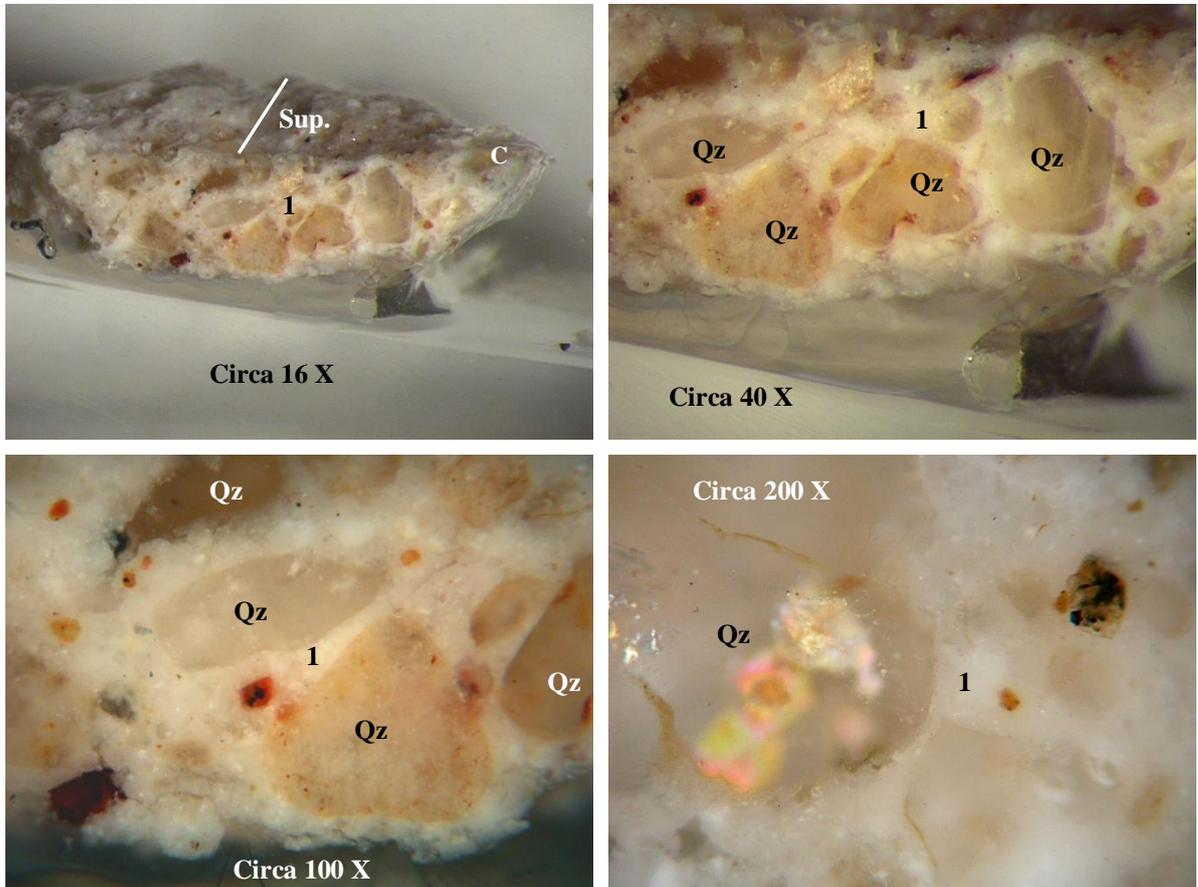
Thin section, reflected light.

The top left-hand image is a relatively low enlargement and shows a good part of the surface of the transverse section of one of the two fragments used to prepare the thin section for the microscopic study. The image shows the structure of the finishing plaster (no. 1) which comprises a lime mortar (slaked lime) and well-graded sand, principally made up of silicates (especially quartz) and to a lesser extent, fragments of alabastrine limestone (C).

The porosity of the mix is average (estimated to be in the region of 30%), determined essentially by the presence of cracks produced as the lime dried out.

The sandy aggregate used to make the mortar in the sample under examination is further distinguished by its darker color (a reddish tinge) caused by the presence of iron oxides (and possibly manganese too) within or on the edges of the grains of quartz.

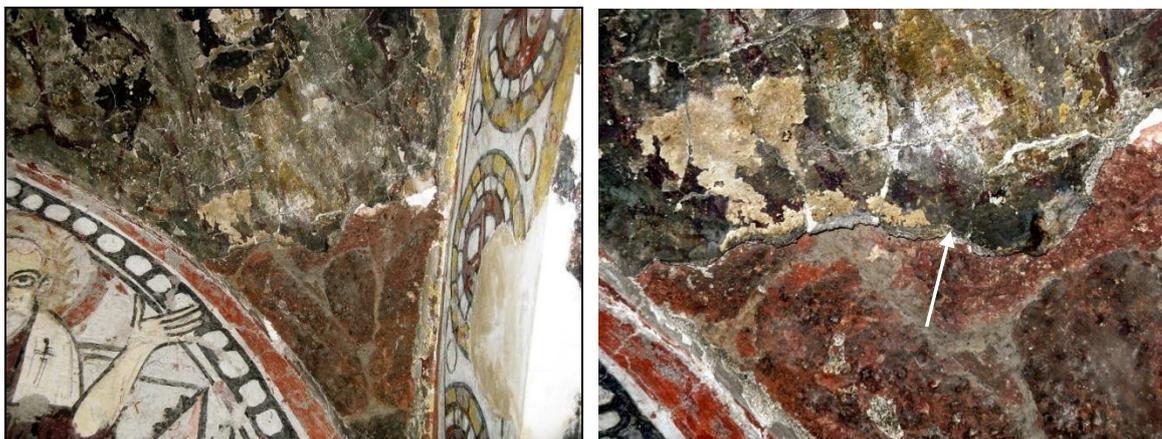
Prothesis, vault, wall with Madonna and Saint, from the area above the point of the cross, from the edge of the large gap in the plaster layers.

The sample included the entire thickness of the base plaster and all the layers overlying it.

A whitish, lime-based preparation (no. 2) affected by typical drying cracks (arrow), and a thick blue paint layer (no. 3) based on Egyptian Blue, probably dissolved in a protein-based binder, have been applied over the plaster. The paint layer, now very patchy and broken up, does not display within it the drying cracks encountered in the underlying preparation.

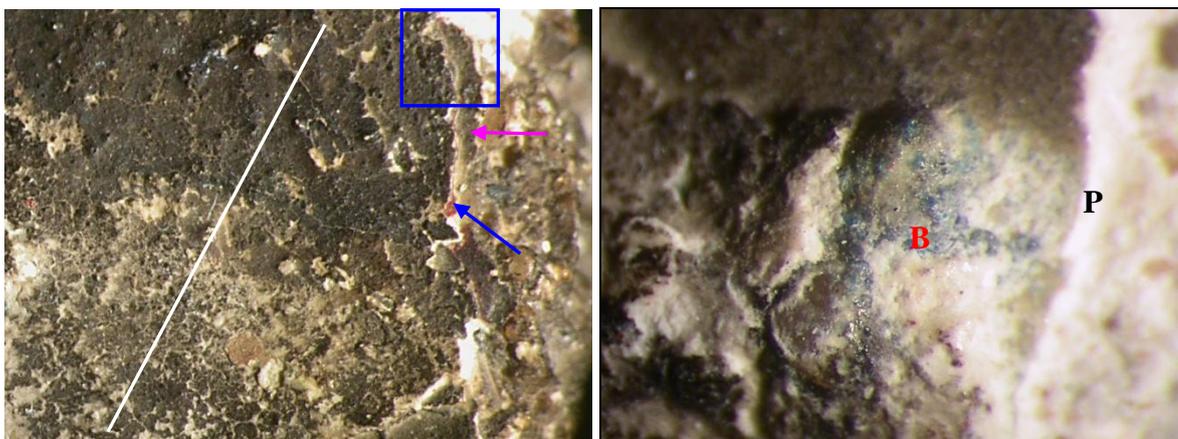
Stereo-microscope, reflected light, enlargement approximately 12 (sx) and 35 X respectively.

The left-hand image shows a portion of the surface of the sample fragment. Along the edge of the fragment there are traces of a red layer (blue arrow) that is in turn overlying a well-smoothed surface covered with blackish particulate matter (pink arrow). The right-hand

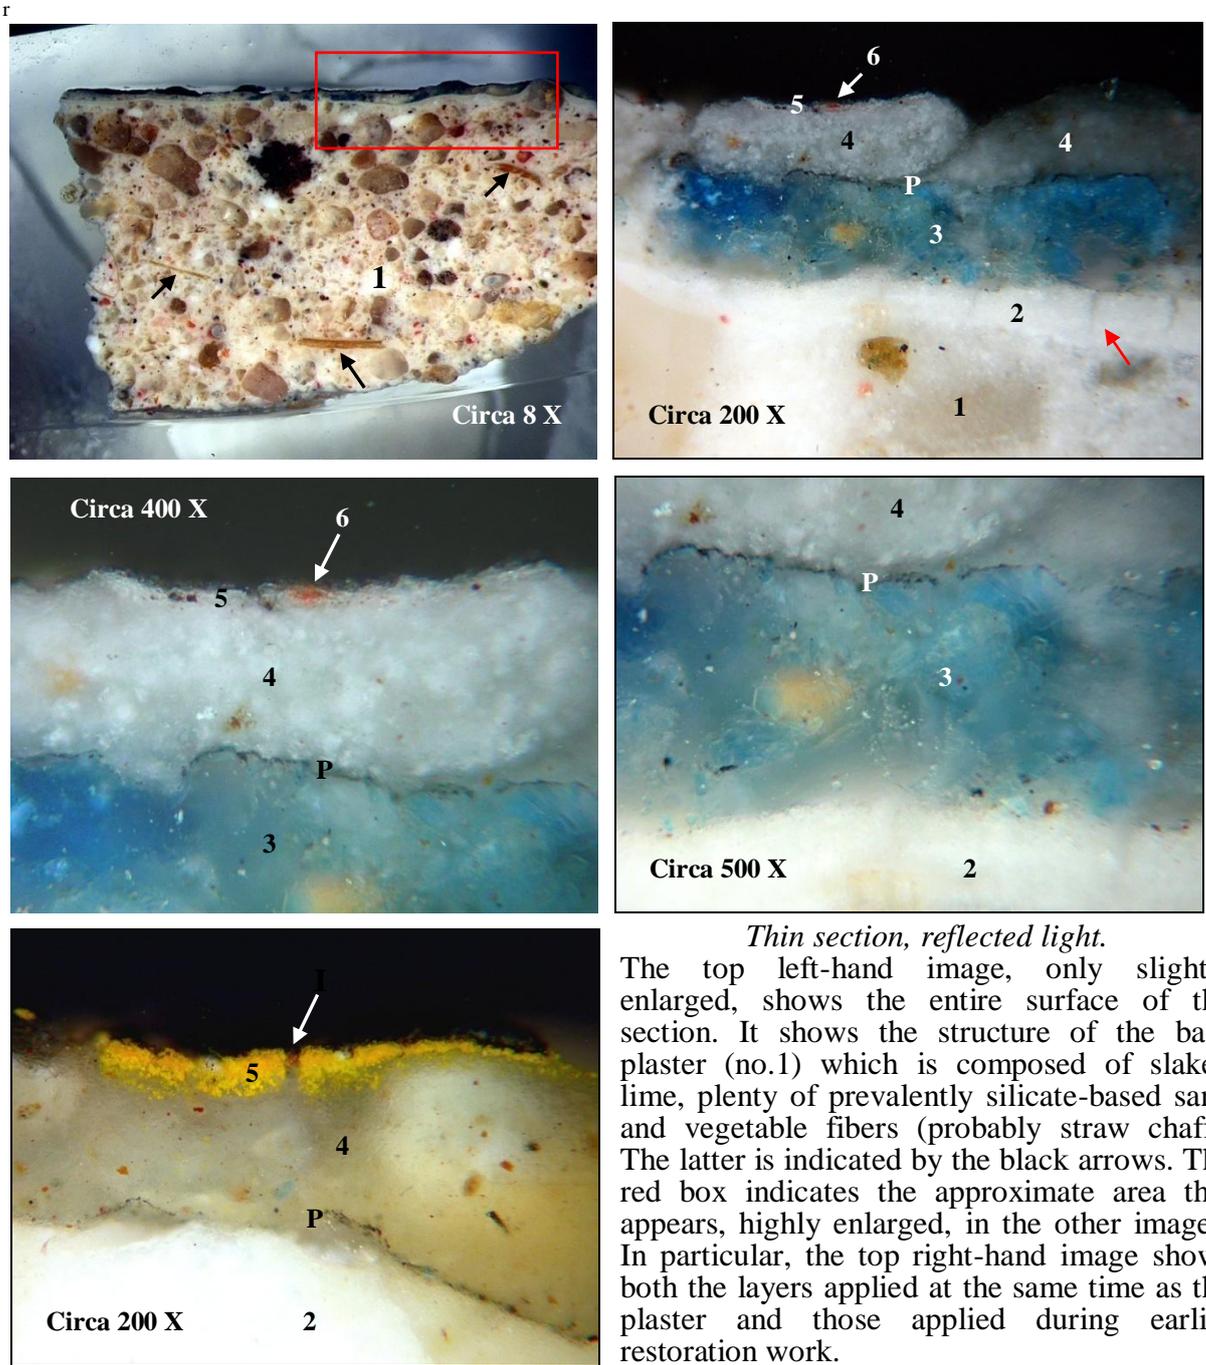
Thin section, reflected light.

The top left-hand image, only slightly enlarged, shows the entire surface of the section. It shows the structure of the base plaster (no.1) which is composed of slaked lime, plenty of prevalently silicate-based sand and vegetable fibers (probably straw chaff). The latter is indicated by the black arrows. The red box indicates the approximate area that appears, highly enlarged, in the other images. In particular, the top right-hand image shows both the layers applied at the same time as the plaster and those applied during earlier restoration work.

The layer is affected by several transverse cracks caused by the drying out of the lime (drying cracks). These cracks do not penetrate the overlying paint layer. This shows that the blue paint layer was applied after the hardening of the lime-based preparation.
