# FINAL REPORT

“Conservation and Documentation of the Wall Paintings at the Red Monastery, Sohag”

Dr. Elizabeth Bolman

**CONSERVATION AND PUBLICATION OF THE  
LATE ANTIQUE AND MEDIEVAL WALL PAINTINGS AND SCULPTURE IN THE  
RED MONASTERY (DAYR ANBA BISHAY), SOHAG**

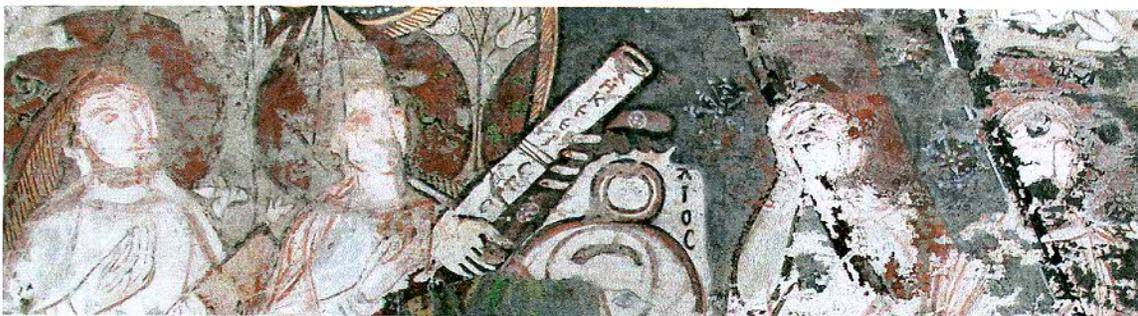
*Apostles, First Phase of Painting, Underpainting (Sinopia), with remnants of fourth-phase painting. East apse. Photograph: E. Bolman.*

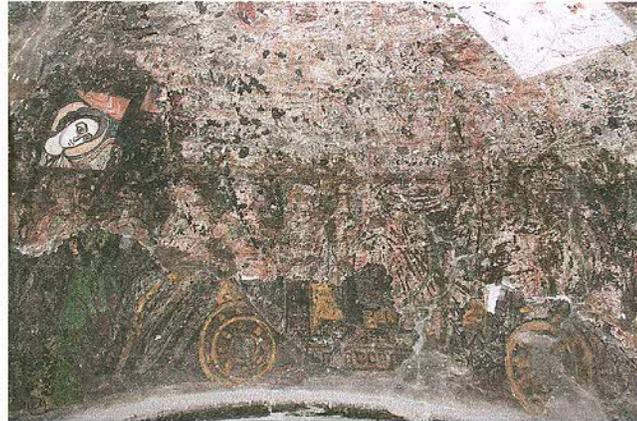
*East semidome with two test cleanings, showing the second and fourth phases of painting.  
Photo: E. Bolman, May 2010.*

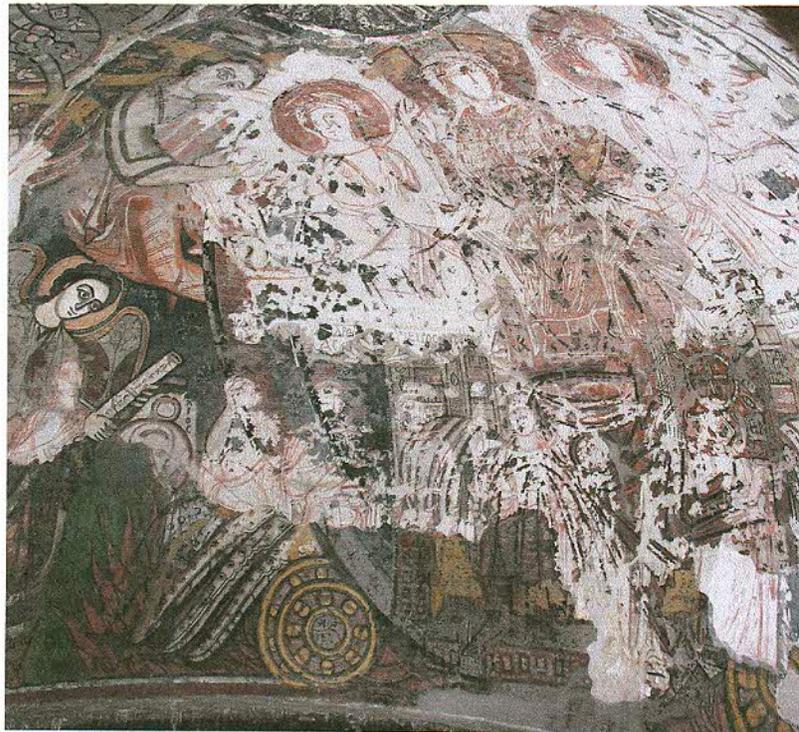
*East semidome conserved, showing the second and fourth phases of painting.  
Photo: E. Bolman, December 2010.*

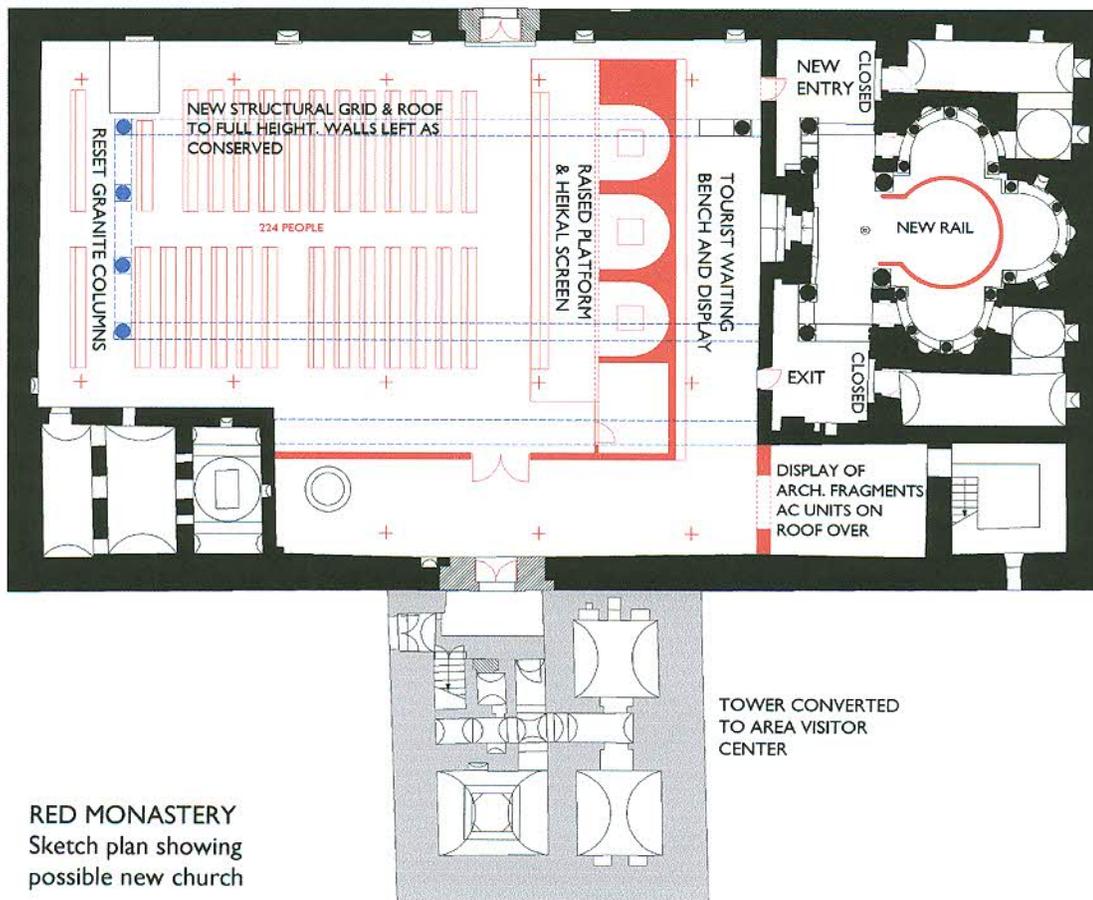
*Site Management Plan, Nicholas Warner, May 2011.*

The pressures to reuse the triconch as a church will continue well beyond our tenure at the site, and as a result of the political sensitivity of the situation, it is impossible to expect the Antiquities staff to protect it. After long deliberation, the solution that seems most workable for the long run is to build a new church within the now open-air nave, in front of the triconch sanctuary and its exterior façade wall. This would give Father Antonius a church

in close proximity with, but not attached to, the triconch. This historical area could be prepared for visitation, along with the qasr (to be used as a visitor's center with a raised viewing platform at the top). This plan would have the benefit of creating a roof to protect the medieval paintings now exposed on the inner western face of the nave wall. A mono-directional visitation plan could be implemented, beginning at the south nave door, and going into and out of the triconch at opposite ends. Warner has prepared a preliminary drawing visualizing this plan, and is working on a detailed Site Management Report, which he will deliver in June.

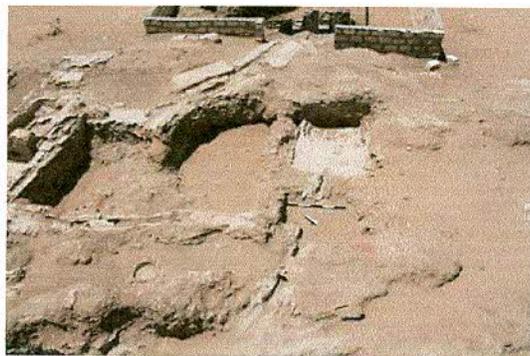
*Overview of area immediately east of the well.  
Notice robbed out tanks and pipes. Direction SW.*

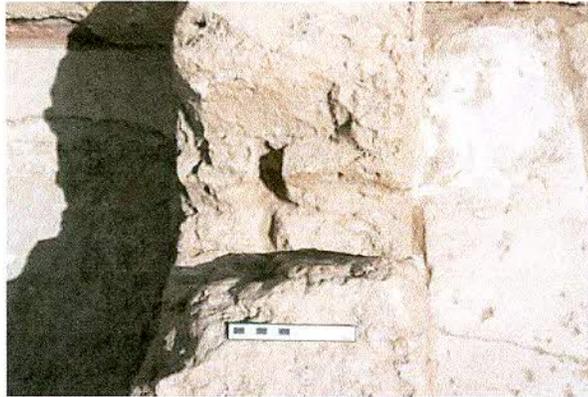
*Limestone block separating eastern and western part of large southern tank. Notice slot for closing off water flow. Direction N.*

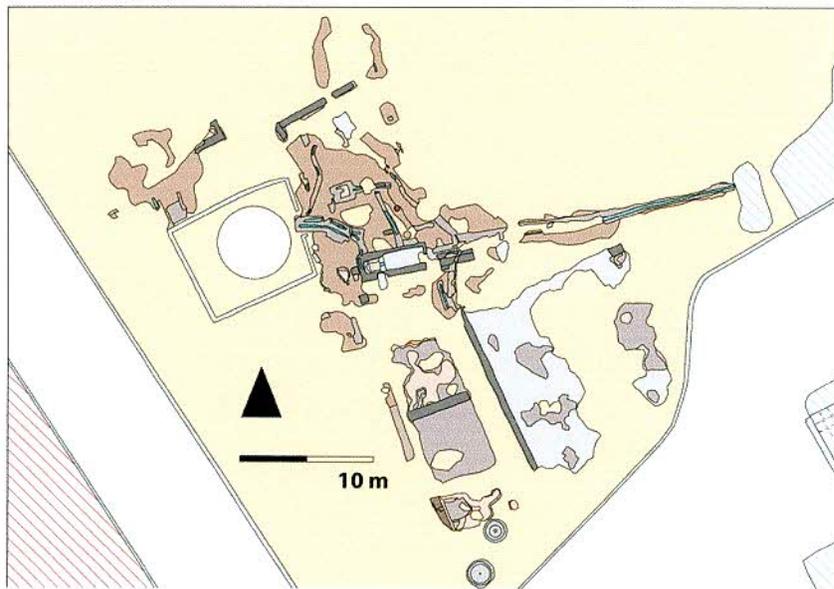
*Survey Map of area immediately adjacent to and south of the well.*

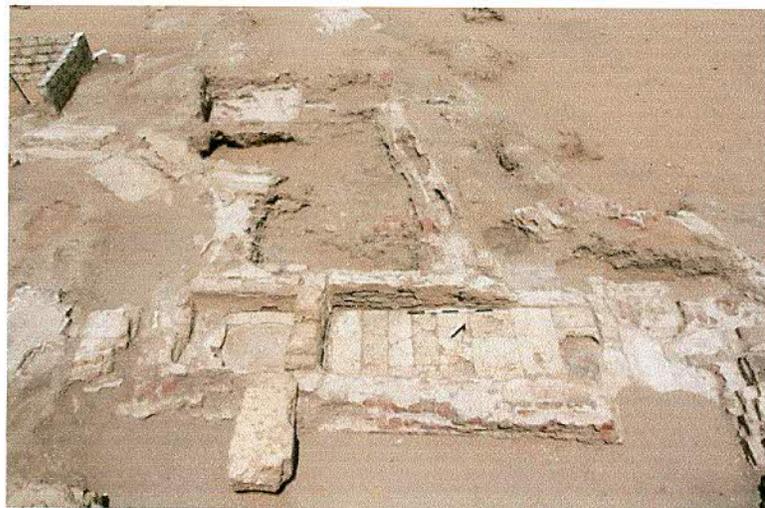
*South tank in area immediately east of the well. Direction NW.*

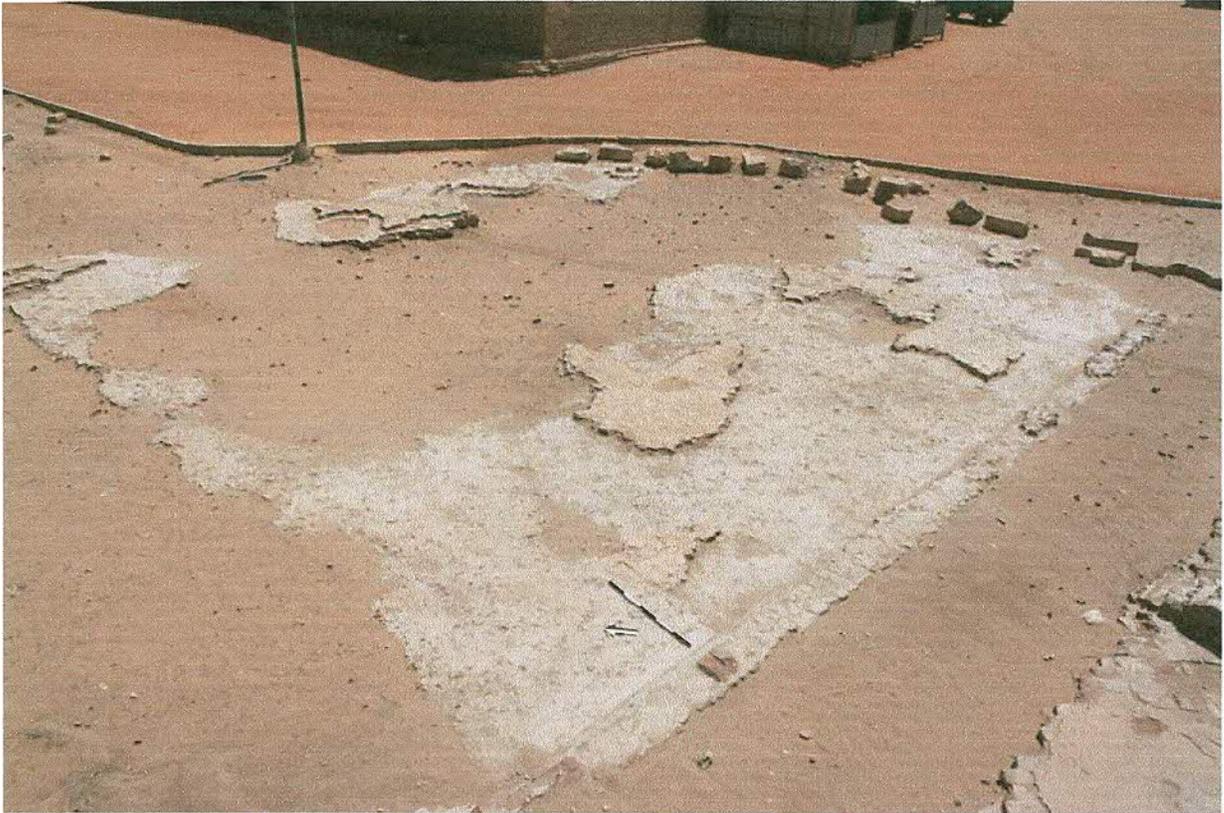
*Remains of subfloor in the south west corner of the archaeological site. Direction SE.*

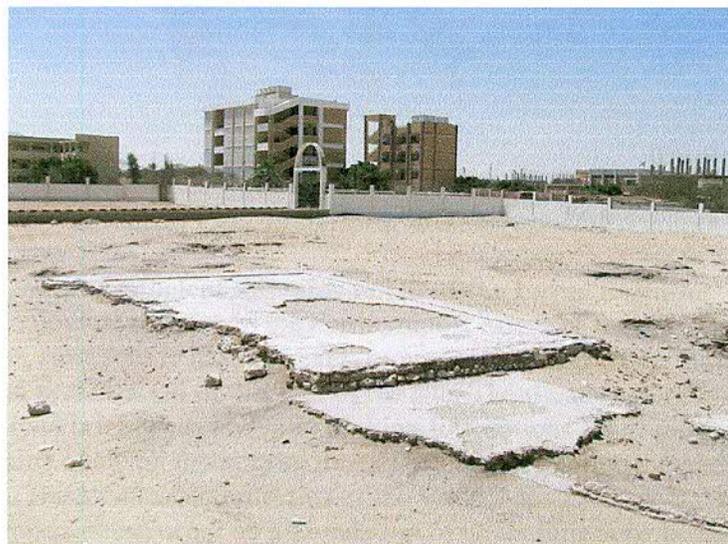
Among the site's main architectural features is a large building located in the centre of the archaeological area. The walls of the building are constructed from fired bricks and are preserved on the north, east and west side. On the south side, a large part of the wall is now lost revealing a section of the building's foundation. Remains of a plaster floor cover the majority of the building's interior space. Regularly spaced square impressions and remaining fired brick and pink plaster-mortar traces show that the floor-space was by no means empty, but it is not clear to what architectural element these impressions belong. They appear too abundant, small and closely-spaced to be piers, and their organisation is not consistent with, for example tables, benches or other furniture. The western exterior of the building is flanked by an architectural element with rounded projecting terminals.

*Overview of central building. Direction NW.*

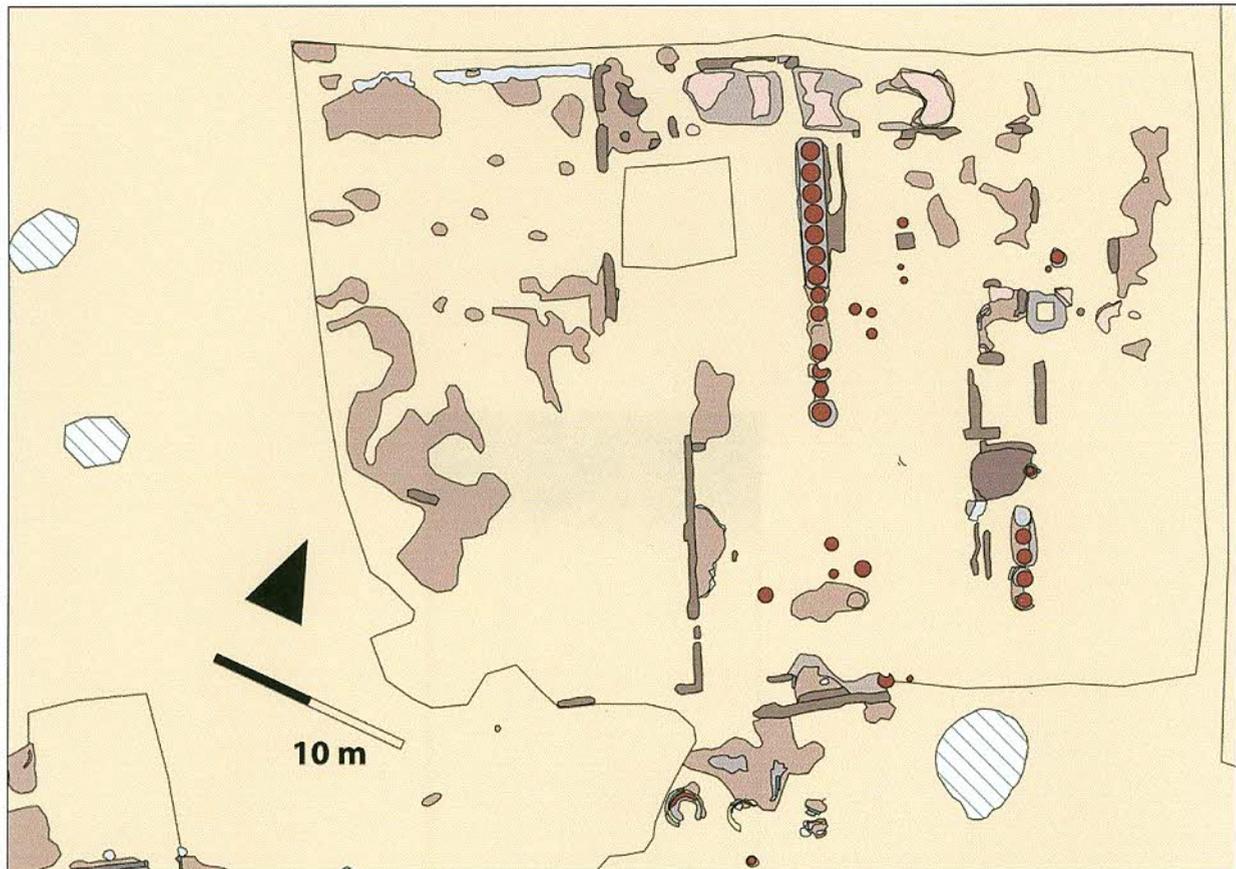
The western half of the northern area contains several important architectural features. Two *tabuns* were identified in the southern end, possibly suggesting that at least a section of the area was dedicated to food production. A large number of storage vessels separate this area in function from its western counterpart. These are set into walls as well as emplaced into the sand. A total of 33 pot emplacements have been identified in this area. The orientation of a series of fragmented mud brick walls along the eastern and northern edge of this excavation area might suggest a spatial organization of a series of rooms organized around an open space. This is particularly evident by a tank made from fired bricks and the southern lying room, where the mud bricks clearly take up the space of two square rooms.

*Survey map of northernmost area. Notice large number of ceramic emplacements and remains of two circular tabuns in the south central end.*

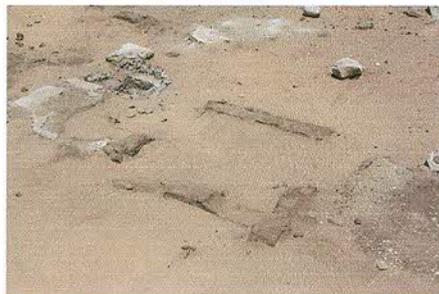
*Room divisions in the east end of the northern excavation area.*

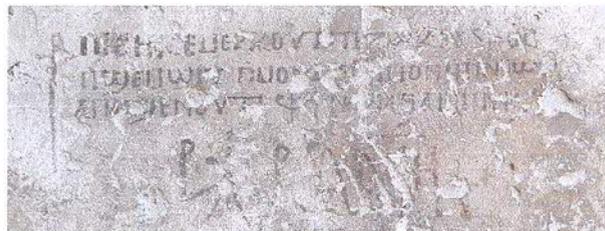
*"The poor Mercurius, painter. The (servant of?) the monastery of our father Apa Shenoute. God have mercy on him. Amen (and Amen). Era of the martyrs 1038." (=1322 CE)*

The painter Mercurius now appears in five Red Monastery inscriptions and one White Monastery inscription, of which this one has the latest date. He may have been responsible for the last phase of painting.

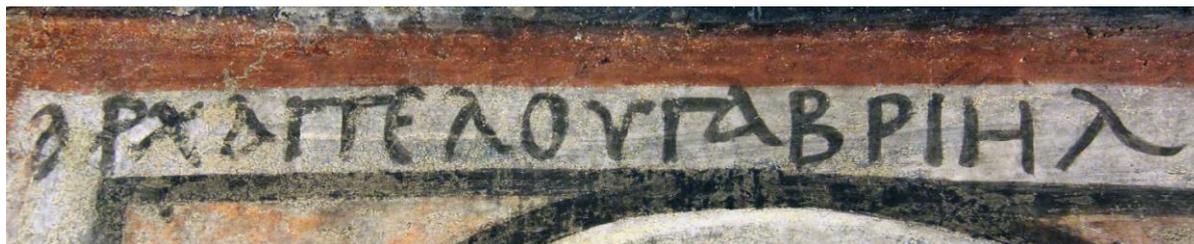
*Coptic inscription reading: The Archangel Gabriel, eastern lobe, south niche.  
Photograph: E. Bolman, December 2011.*

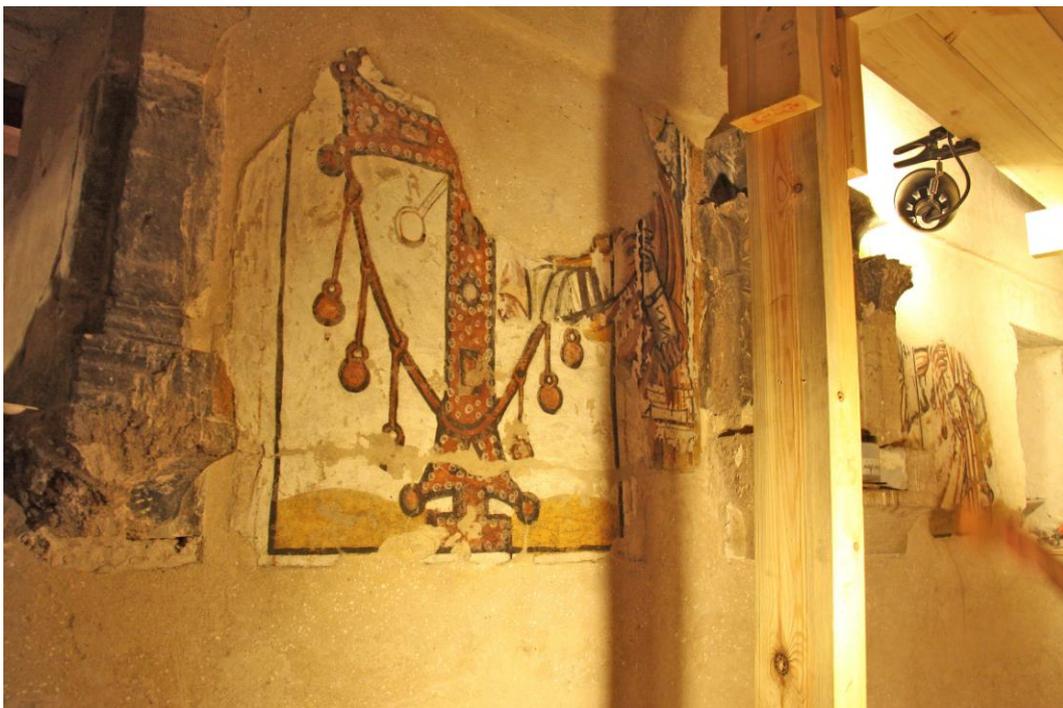
*Cross (fourth phase) and remains of Prophets (third phase), western clerestory.  
Photograph: E. Bolman, December 2011.*

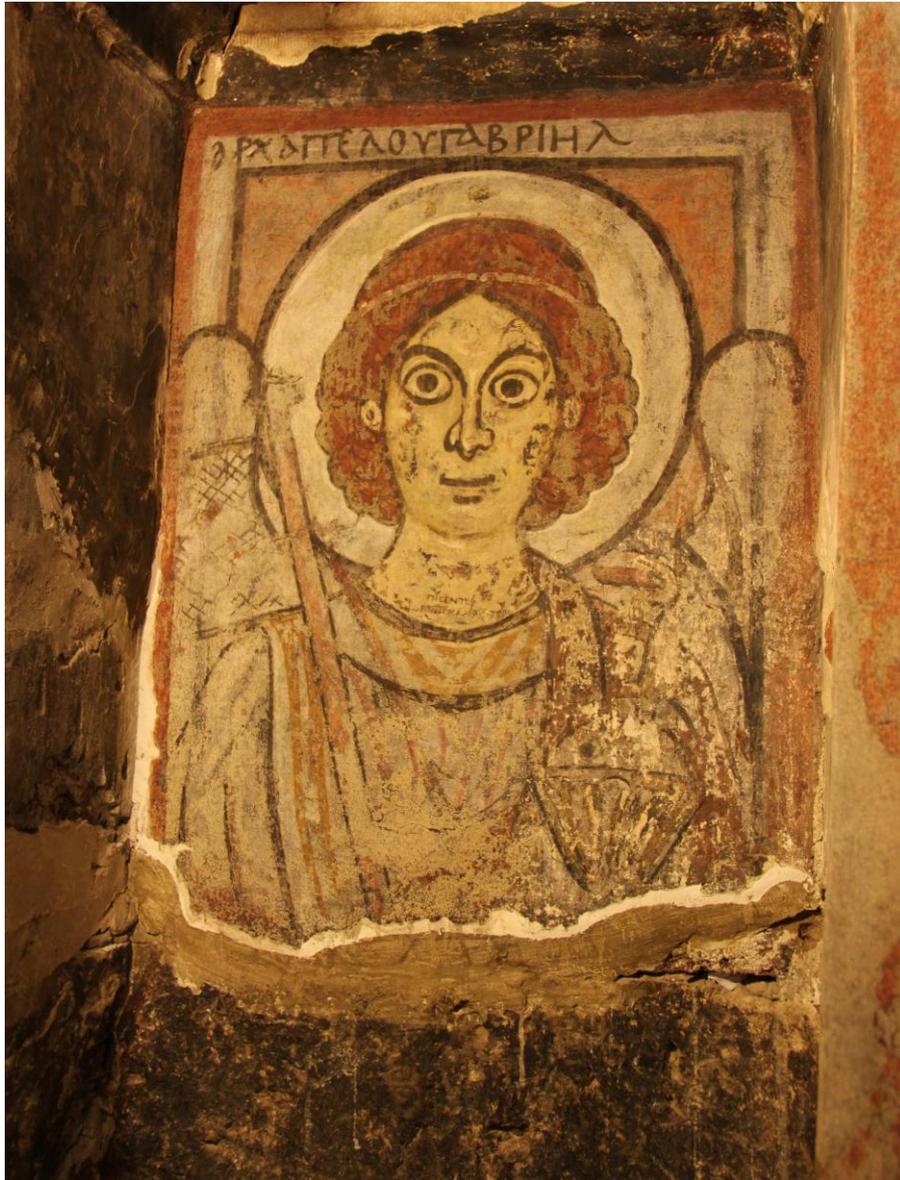
The subjects at the backs of the niches at the left (north) and right (south) were completely cleaned and conserved during this campaign. They revealed impressive bust-length paintings of the Archangels Michael and Gabriel. Due to stylistic parallels, particularly with the Virgin Mary *Galaktotrophousa* in the north semidome, it is clear that they belong to the fourth and final late antique phase of work in the sanctuary.

*Archangel Gabriel, south niche, ground floor level, east lobe. Fourth phase of painting.  
Photograph: E. Bolman, December 2011*

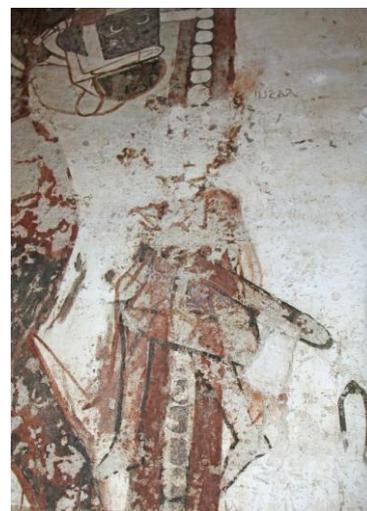
Work continued on the equestrian saint and surrounding inscriptions and graffiti. A small figure in profile, not very well preserved but clearly holding a sword, became visible after conservation. He was painted over the border, and faces the horse. Especially interesting is the overlap of the border of the equestrian painting on top of the adjacent painting of the cross (to the west). This demonstrates that the equestrian painting was added after the cross, and by implication, after most of the (as yet unconserved) paintings in the nave.

*Small figure facing horse, North wall, west of the façade wall. Photograph: E. Bolman.*

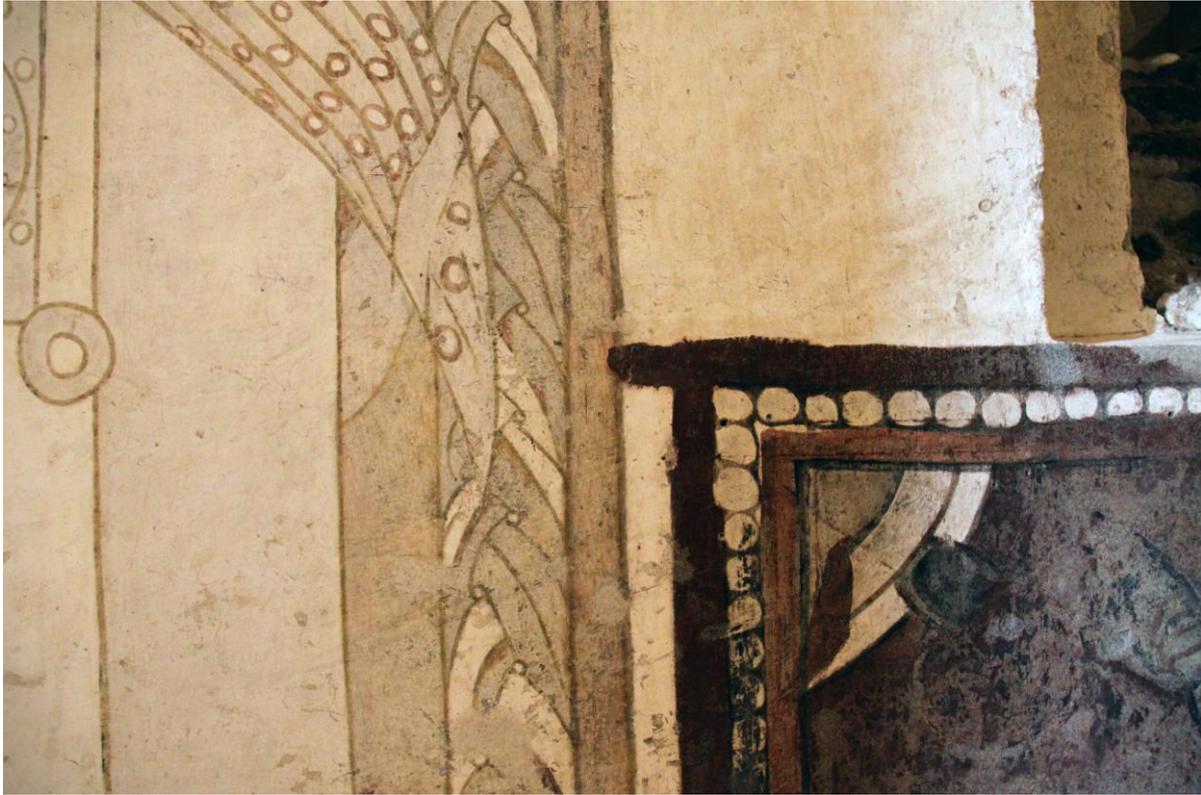
*Northern nave wall, within the Comité façade wall, showing the overlap of the border of the Equestrian Saint's painting on the painting of a Cross in an aedicule. Photograph: E. Bolman, December 2011.*

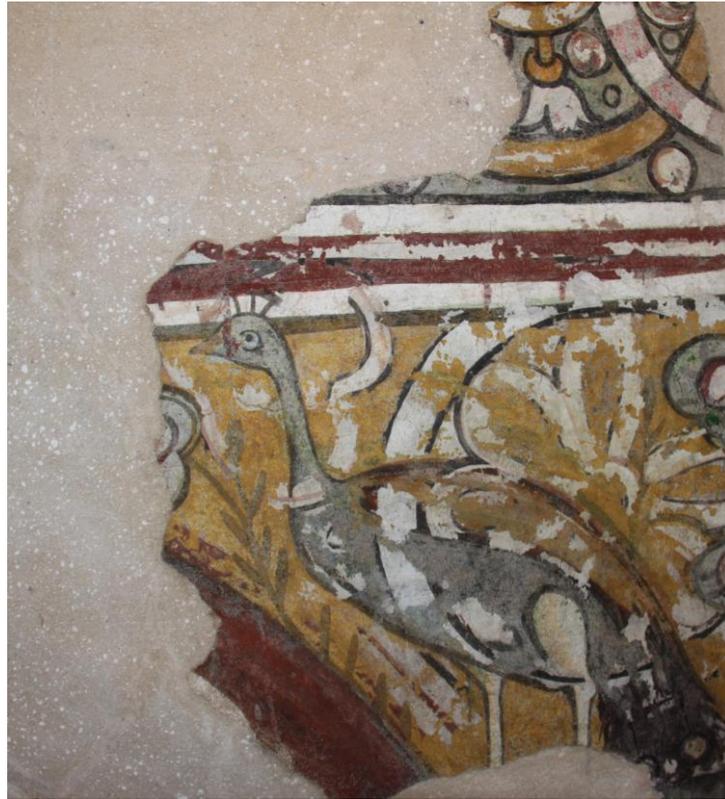
*Peacock (third phase), partially covered by fourth-phase decorative motifs.  
Photograph: E. Bolman, December 2011.*
