FINAL REPORT

Fall Mission: November 22, 2011 – December 21, 2011

Emiliano Ricchi & Alberto Sucato, Restorers

“Conservation and Documentation of the Wall Paintings at the Red Monastery, Sohag”

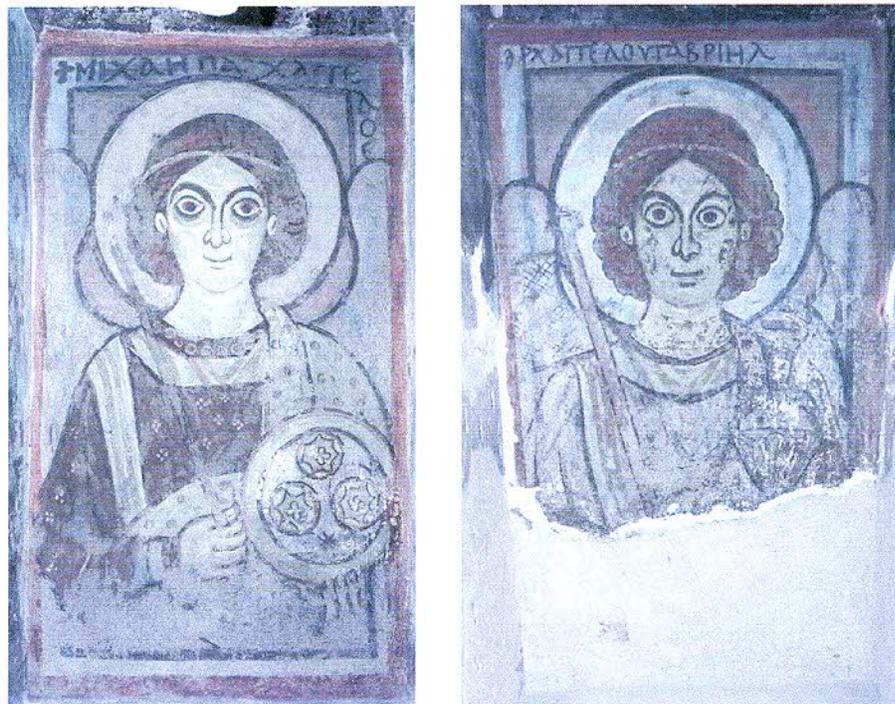
(Figures 1 and 2)

In the east lobe, work was carried out on the lowest tier inside the two lateral niches (north and south) [Figures 1 and 2] and restoration of the small apse within the central niche was started.

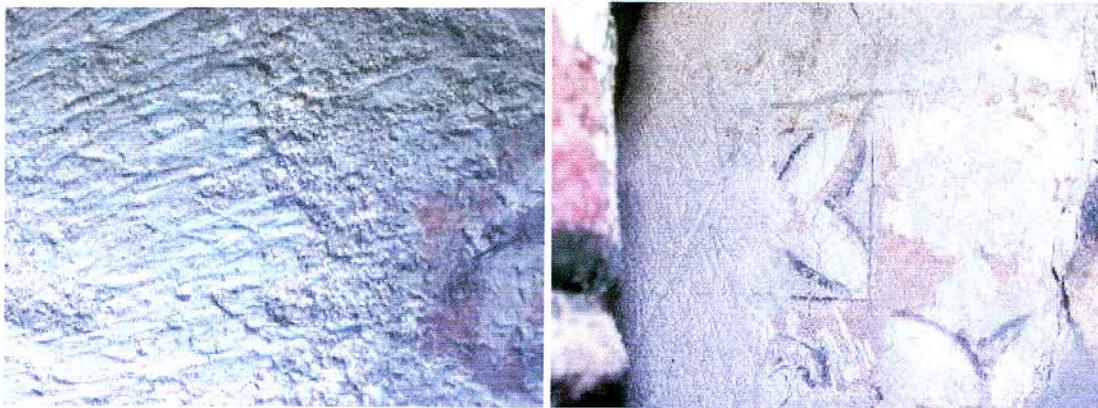
(Figures 4 and 5)

In the niches of the lowest tier of the east lobe the palimpsest comprises three levels: the oldest, that has proved impossible to examine in the areas restored during the campaign, has been identified as the first decorative phase in the triconch. It is uniform with a fine white wash [*covering*] the surface of the stone and the masonry (Figures 4 and 5).

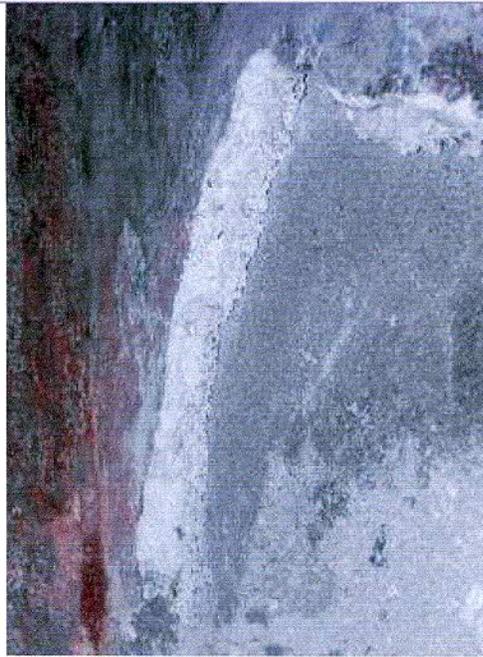
(Figure 6)

This first thin layer is covered by the third-phase plaster. This was applied in a layer approximately $\frac{1}{2}$ to 1 cm thick (it is thinner on the moldings and column shafts). It is lime-based with inclusions in the form of smooth round² grains of sand and has a white surface finish (Figure 6). Here the third-phase plaster here has a much smoother surface than it does in the upper tiers. This plaster is covered by the fourth and final late-antique phase with its trademark white wash.

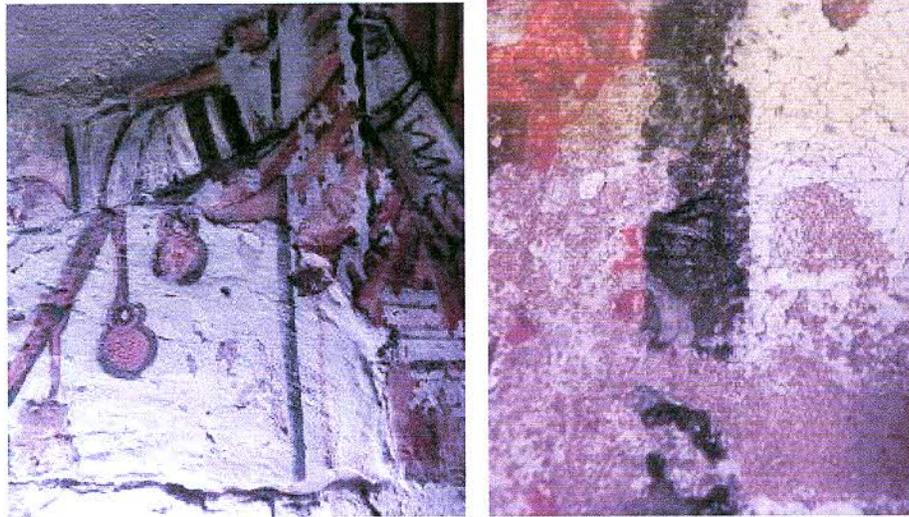
(Figures 7 and 8)

Here, as in the east apse, there are extensive areas where the presence of old gaps in the plaster enables us to ascribe a rough date sometime between the third and fourth phases of

painting to the major structural disturbance suffered by the building probably as a result of subsidence of the structure and/or a seismic event to (Figures 7 and 8).

This enables us to identify the major (although perhaps not the first) structural disturbance affecting the church as having taken place in the short period of time between the execution of the third and fourth phases of painting (see Figures 7 and 8).

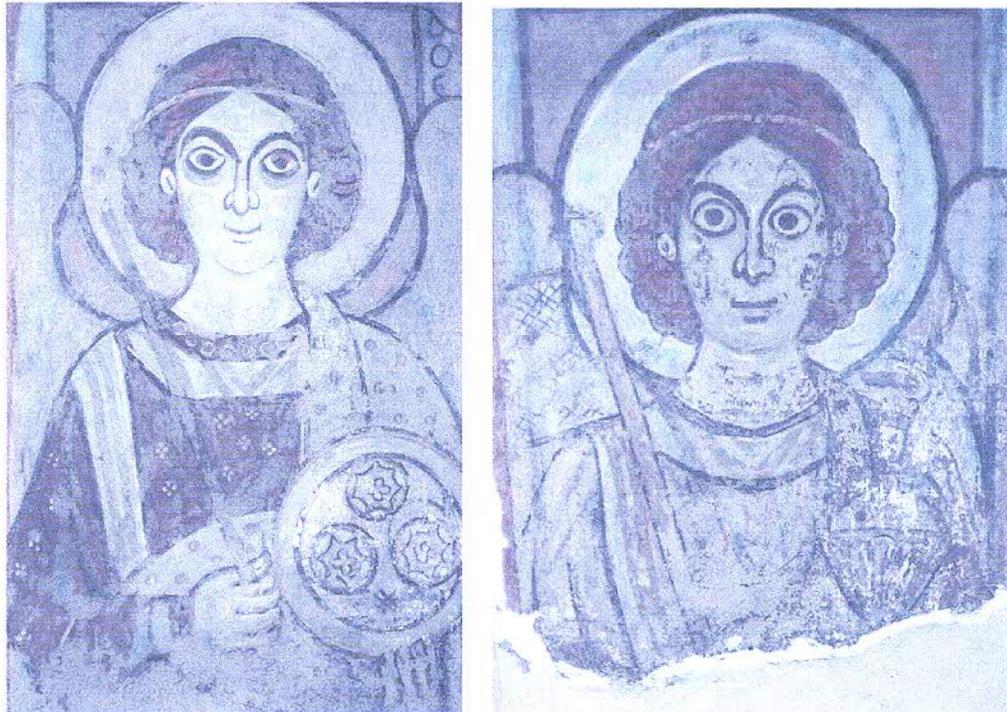
(Figures 11 and 12)

The opportunity of working in the lateral niches in the lowest tier of the central lobe has allowed us to confirm data relating to the working techniques and the painted palimpsest of the niches with the icons. In both niches the fourth-phase white wash is well preserved and decorated with half-length representations of the archangels Michael (north) and Gabriel (south) respectively. The discovery of the archangels' names written in Coptic on the upper borders of the paintings (Figures 9 and 10) made it possible to identify the figures. Michael is depicted holding a stick with a cross in his right hand and the blessed bread (or rather, a plate bearing three pieces of bread) in his left. Similarly, Gabriel is holding a stick in his left hand and a chalice in his right (Figures 11 and 12).

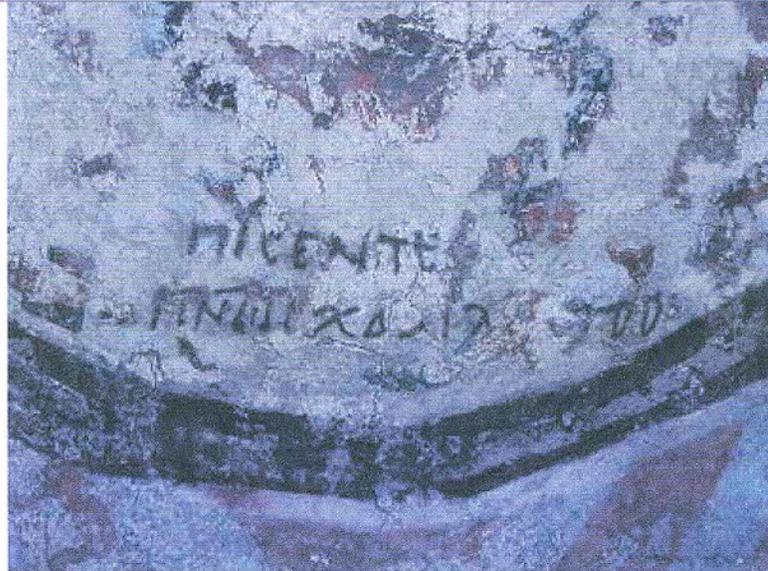
(Figure 13)

Owing to the presence of some particularly patchy areas, we have been able to confirm the presence beneath the white wash of the palimpsest showing the same subject painted during the third phase. In particular, in the center of the icon of the Archangel Gabriel where the fourth-phase white wash is especially thin, some colored fragments of the face beneath are clearly visible. Cleaning of the same icon revealed a well-preserved Coptic inscription on the figure's neck. A preliminary interpretation supplied by Dr Bentley Layton suggests that the inscription bears the name of two artists (Figure 13).

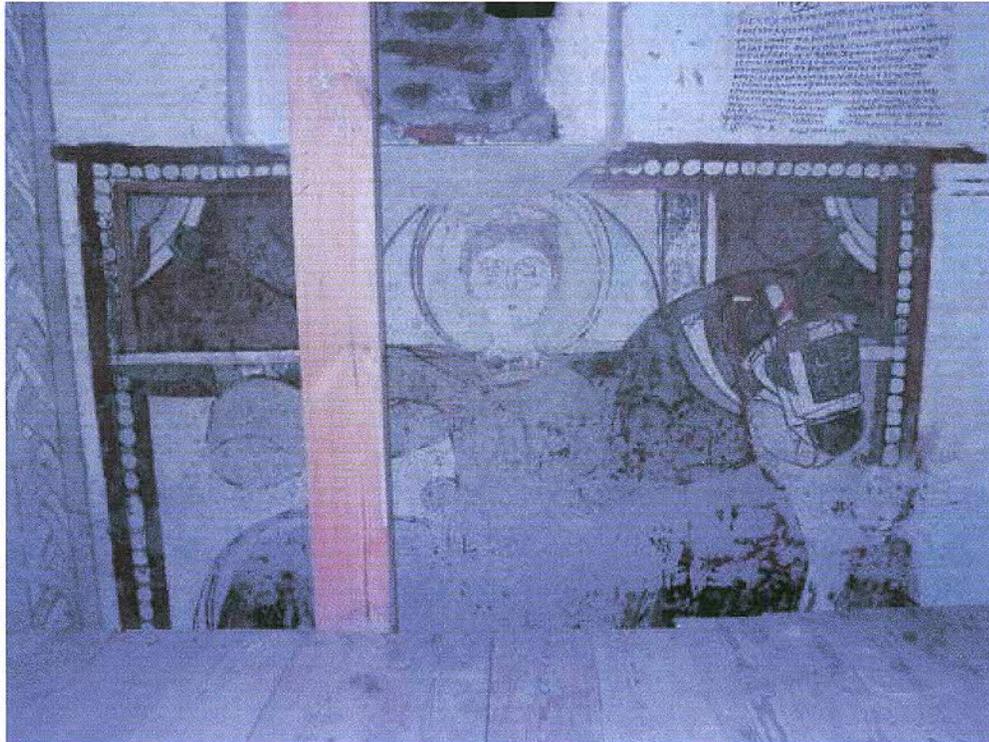
(Figure 23)

Ongoing work on the icon of the Saint on Horseback has recovered the delicately painted trappings of the horse, a small subdued-looking soldier on the right-hand border and a Coptic inscription on the opposite side between the horse's rear hooves. We have also been able to confirm that white lead, which has now turned purple in many places, was the white pigment used to highlight certain details. Usually the painter left areas of the background plaster unpainted in order to obtain white. In spite of the very patchy nature of the painting, it has striking technical and compositional similarities to the cycle of saints on horseback at the Monastery of St Antony on the Red Sea (Figure 23).

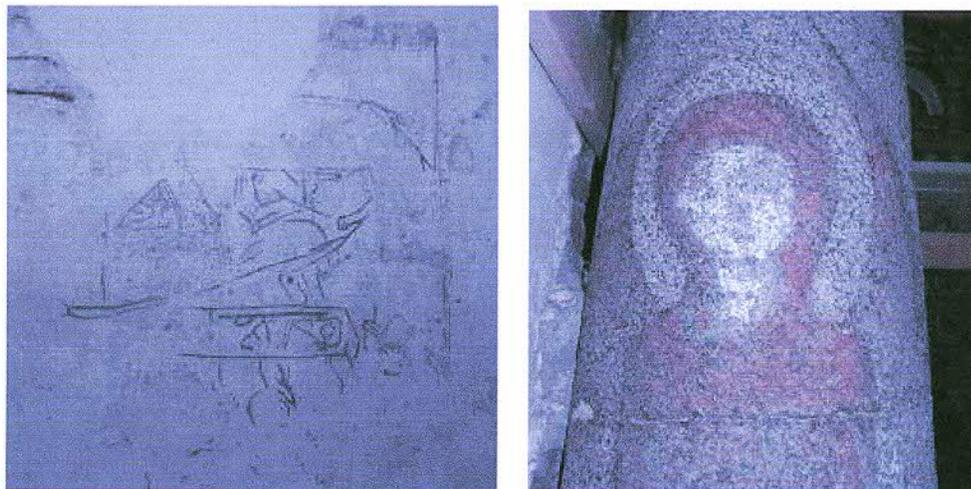
(Figures 24 and 25)

We have discovered a small and incomplete monochrome sketch on the plaster to the right of the horse's nose. The few lines visible suggest that it could depict a martyrdom (Figure 24). It is possible that the artist's original intention was to depict stories from the life and/or martyrdom of the saint in small paintings on the right-hand side; an intention that was subsequently never realized.

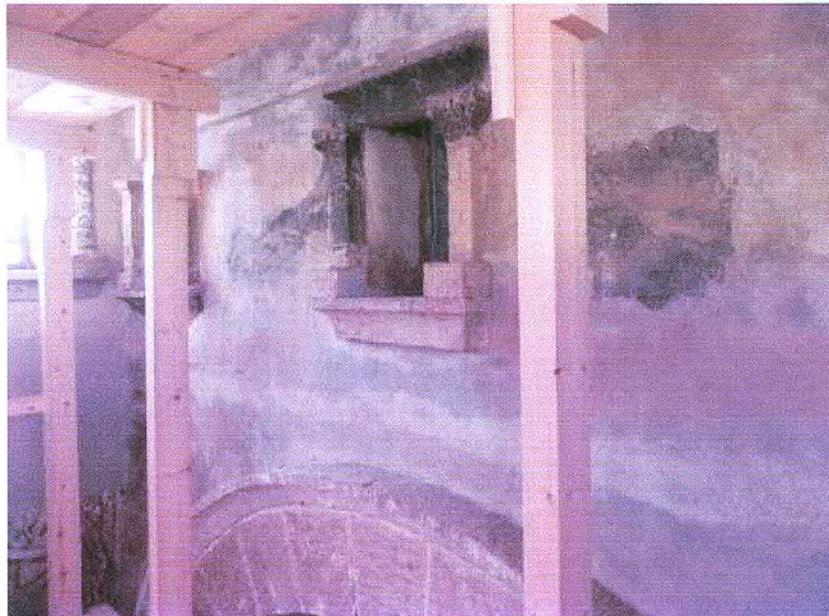
(Figure 31)

The west side of the clerestory was affected by an extensive deposit of dust and loose and partially consolidated particulate matter. The painted surface was damaged by the effects of rain water and wind erosion associated with the prolonged exposure of this part of the building in the absence of windows and roof. Most of the fourth-phase whitewash has fallen off, especially on the right, revealing the figure of a third-phase saint almost in its entirety and, lower down, the two peacocks. The extensive plaster loss was caused by the poor adhesion of the whitewash to the third-phase wax-painted surface (especially the jarosite backgrounds painted using the encaustic method). Areas where the plaster fell away in antiquity have been repaired using unsuitable mortar types that often encroach on the paint layer (Figures 31, 32 and 33).

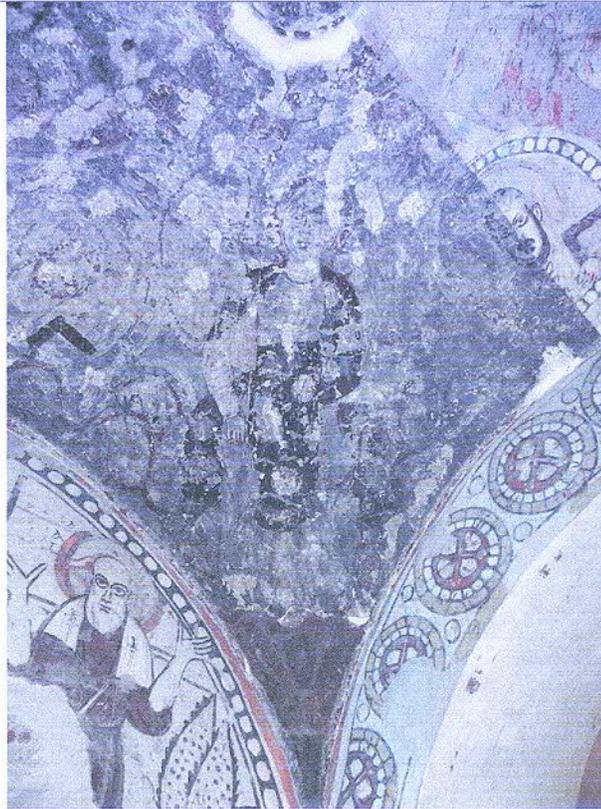
(Figure 37)

In the prothesis, the two phases of painting that can be seen (the first and the fourth) present differing states of preservation (Figure 37). The yellow pigment used to paint the forms of the eagles is well preserved but only faint traces of the details painted using the encaustic technique remain. The blue background visible between the wings and plant tendrils is quite patchy, presumably as a result of the pigment's natural fragility. The painted surface has been heavily blackened by unconsolidated deposits and soot produced by the burning of oil lamps and candles.
