## FINAL REPORT

Spring Mission: March 4, 2010 – April 28, 2010

Luigi De Cesaris & Alberto Sucato, Restorers

“Conservation and Documentation of the Wall Paintings at the Red Monastery, Sohag”

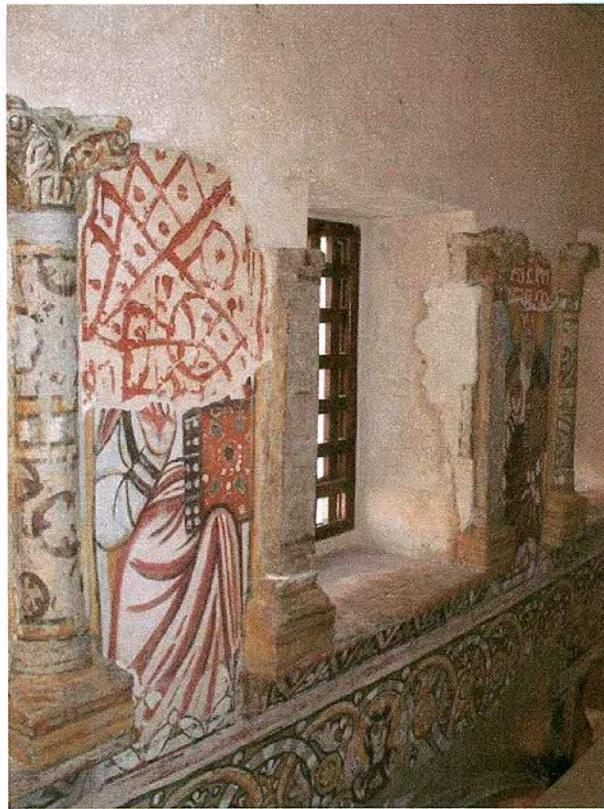
**Figure 2**

the flat panels. In the clerestory work was completed on the whole east wall, the three windows, the painted areas between them (Figure 2) and the area above up to the base of the dome.

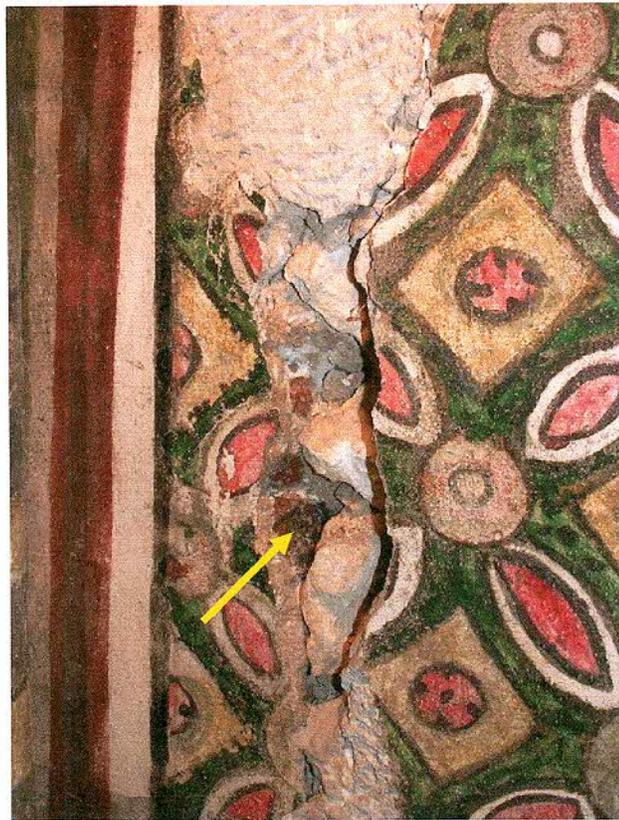
Figure 3

The triconch is built of blocks of limestone from local quarries, infilled with fired bricks (Figure 3).

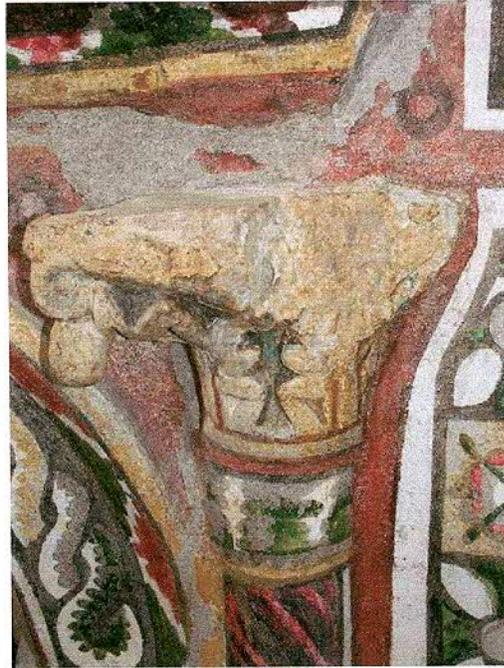
Figure 4

The apse and niches are built of fired bricks measuring approximately 19 x 9 x 11 cm, mostly arranged lengthways. The moldings and semi-capitals are made of limestone (Figure 4).

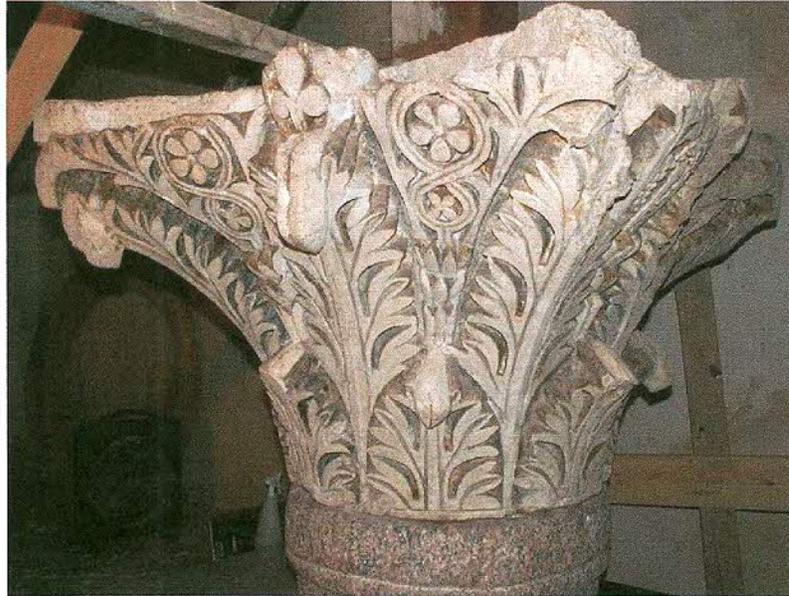
Figure 5

The bases of the columns supporting the triumphal arch are made up of two parts, one on top of the other: a rectangular limestone block that sits on the ground topped by a larger tapering piece of granite on which the shaft rests. The late antique capitals (Figures 5 and 6) are made of local soft white chalky limestone (Figure 5). Fossilized organisms can be seen in the stone with the naked eye.

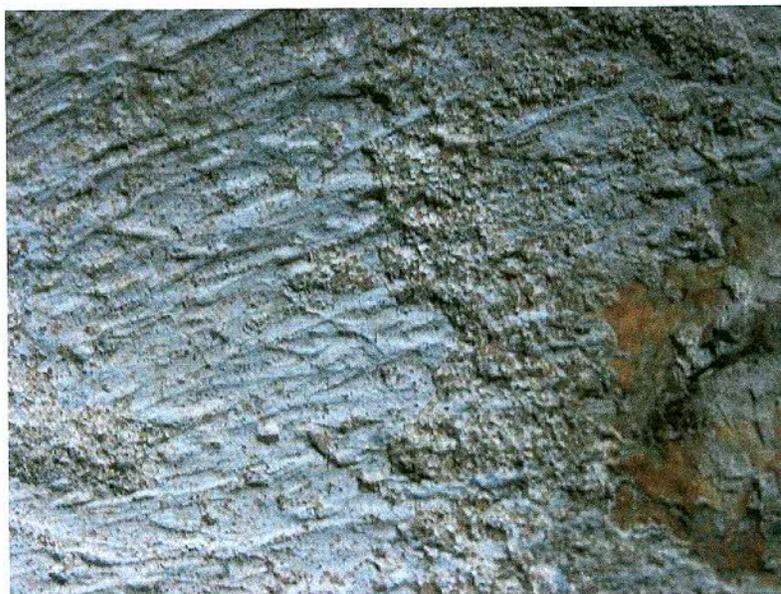
**Figure 7**

[...] This is a lime-based preparation comparable to that on the stone arch giving access to the north corridor, decorated with geometric motifs in a checkered design. This very thin preparation adapts itself well to the typical working of the limestone whilst leaving visible signs of the various stages in the process (Figure 7).

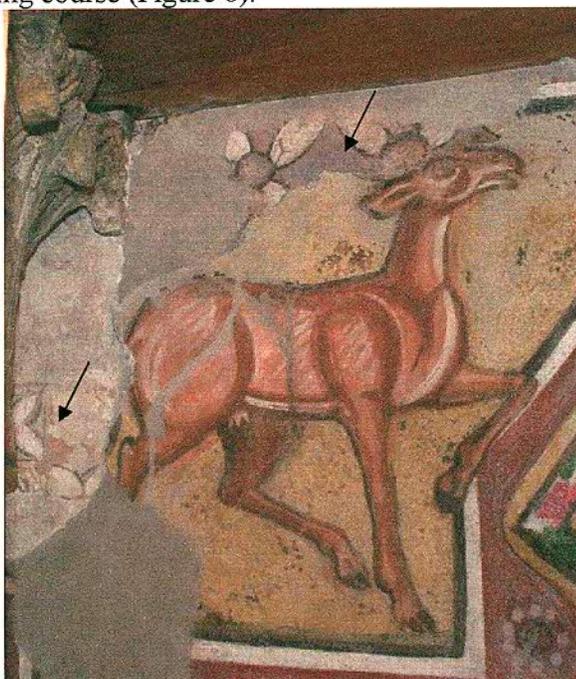
**Figure 8**

Some of these signs can be seen in the areas at the base of the niches, near the capitals and under the wooden string course (Figure 8).

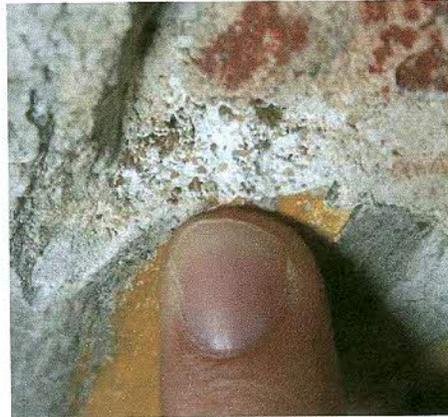
Figure 9

This first thin layer of plaster is overlaid by plaster from the third phase (the two photographs show the third-phase plaster in section in the clerestory and apse respectively (Figures 9 and 10). The plaster, applied in a layer varying from approximately 0.5 to 1 cm in thickness (it gets thinner on the moldings and column shafts) is lime-based and contains large, smooth, round grains of quartz sand<sup>2</sup> (Figure 11). It has a white surface finish.

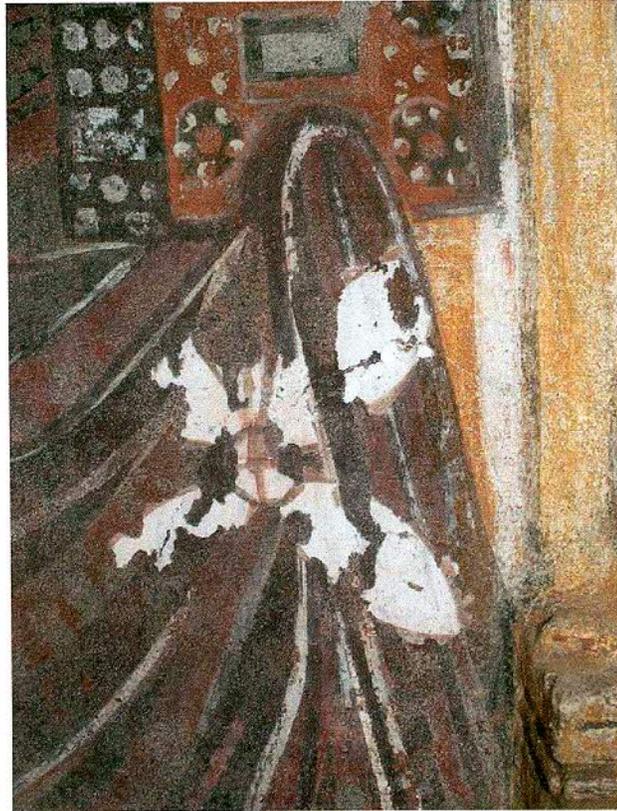
Figure 12

On the triumphal arch, the stone arch and the flat panels of the clerestory (Figure 12), this phase is overlaid by the characteristic white wash of the painter of the late antique fourth phase.

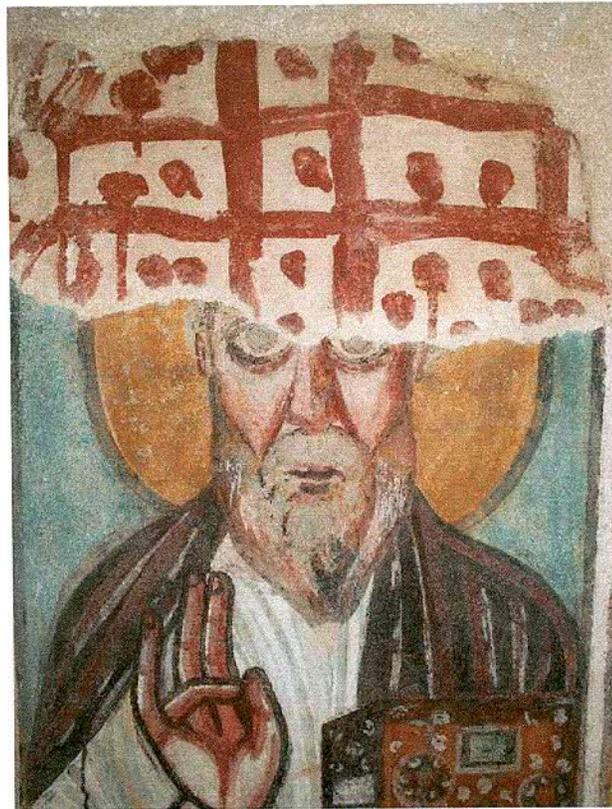
**Figure 13**

In the clerestory, the top part of the flat panels between the windows are both missing. These areas are infilled with a lime- and straw-based plaster that covers the third-phase plaster. The infilled areas, distinguished by a crude red geometric design, are thought to be medieval and presumably date from the time the original late antique dome first suffered from serious structural instability (Figure 13).

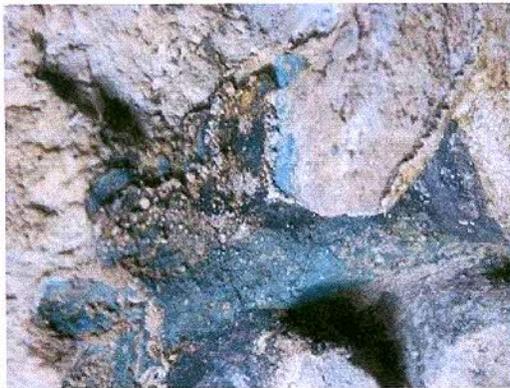
Figure 14

In the second tier the oldest decorated layer known as the first phase can be seen in places where the preparatory layers of the third phase have fallen away. This first painted layer (see Figures 8, 14, 15, 16 and 18) of which bits of blue (Egyptian blue) (Figure 14), yellow and orange can be seen, confirms that even at that time the architecture was brightly painted in a wide palette of colors.

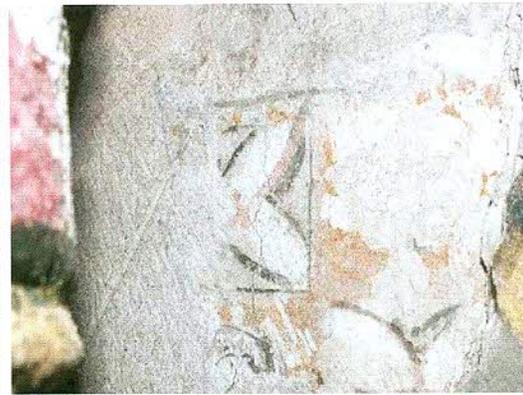
Figure 15

A band of stylized floral motifs (Figure 16) very similar to that running the length of the south corridor (Figure 17) extends along the area beneath the string course. The areas behind the columns are decorated with a checkered pattern whose squares contain alternating floral and circular motifs<sup>3</sup> (Figure 15).

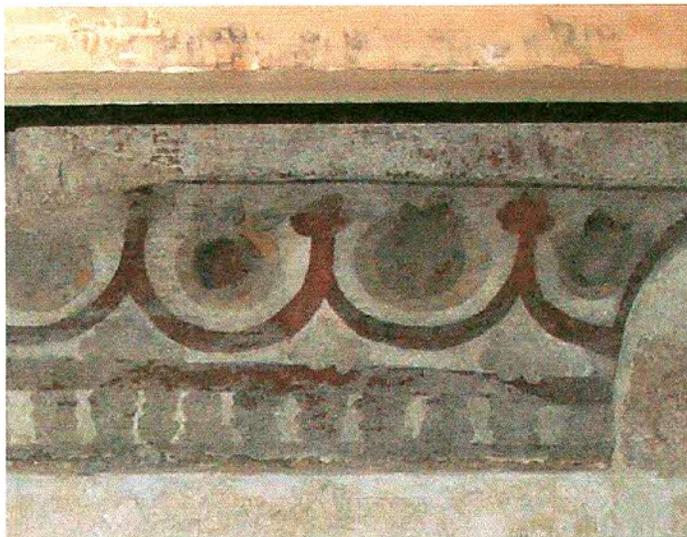
**Figure 19**

The external backgrounds of the north and south lateral niches were however decorated with a red geometric design on a white background. We had thought that the niches were decorated with *velaria* similar to the one visible in the niche above the doorway to the north corridor. However, when the semi-circular design possibly imitating the upper edge of a curtain or hanging on the string course above the doorway to the north corridor (Figure

19) is compared to the pattern now visible on the molding of the central niche<sup>4</sup> (Figure 18), the similarity is striking.

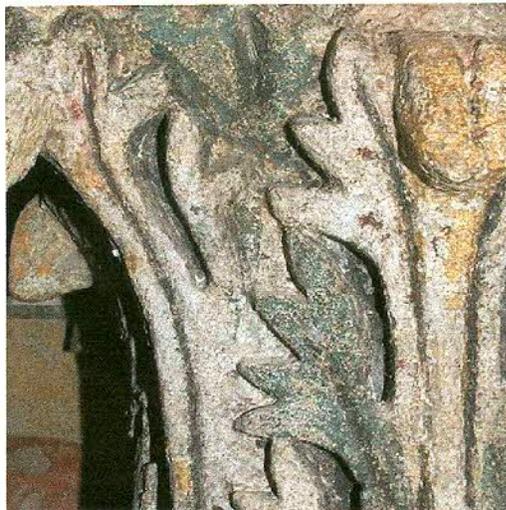
Figure 25

On the capitals of the second tier, Egyptian blue can be made out amongst the colors used by the artist of the third phase (Figure 25).

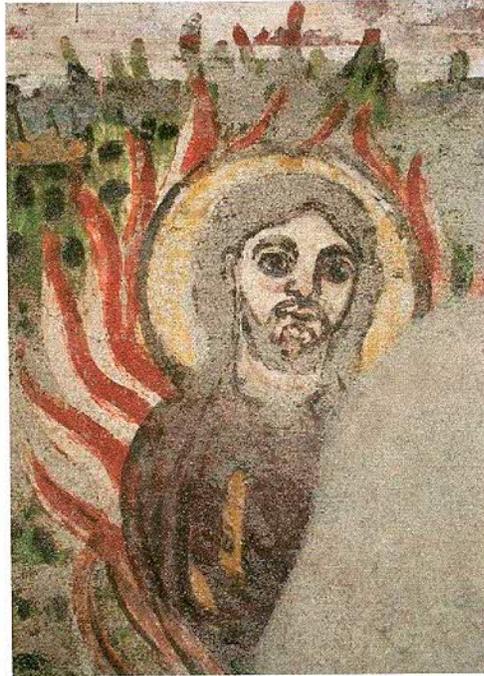
**Figure 27**

The right-hand flat panel (south) depicts the story of Moses taking off his sandals before the burning bush. Within the bush, God is represented in human form giving orders to Moses (Figure 27). Unfortunately the figure of the prophet in the upper part is extremely patchy: all that remains is the lower part of the figure showing Moses' bare feet and, adjacent to them, his discarded sandals. Once again, the upper edge of the frame bears a Coptic inscription relating to the scene.

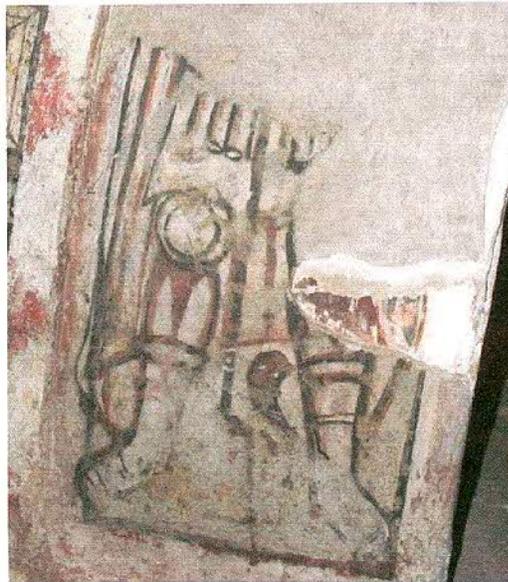
**Figure 28**

The front of the stone archway has third-phase decoration reworked by the artist of the fourth phase with his characteristic whitewash, in this case well preserved. The design is made up of a series of circles containing small floral patterns and pomegranates. The background of the arch is painted pink, a color produced by applying a transparent white glaze over the existing coat of deep red (probably hematite and minium). On the left side of the arch more surviving paintings from the fourth phase can be seen in the form of the lower half of a warrior saint (Figure 28). The figure seems to be wearing armor and in the background there seem to be the vestiges of a lance, a serpent and the lower hem of a cloak.

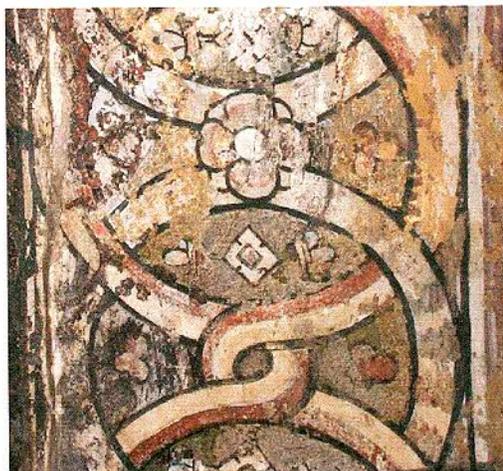
Figure 29

A test cleaning was carried out on the underside of the arch in the apse where the fourth-phase white wash is particularly well preserved (Figure 29). The pattern is made up of floral designs inscribed within repeating and interlocking circles.

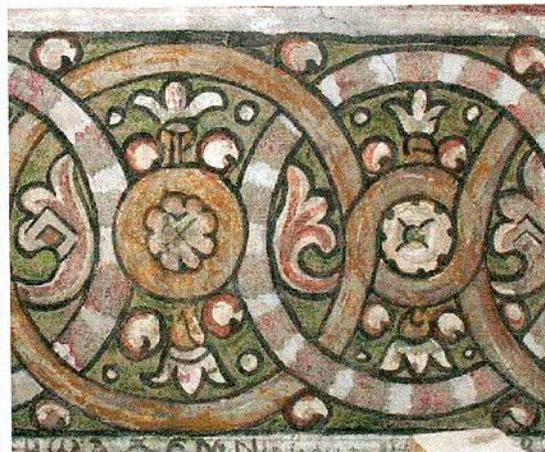
Figure 30

This pattern seems to have been inspired directly by the third-phase painting beneath the windows in the clerestory (Figure 30). It is interesting to note that on the underside of the arch in the east dome the painter's work is inspired by the third phase whilst on the underside of the arches in the north and south apses the decorative scheme is more classical in style and clearly belongs to the painter's repertoire, even if it is inspired by certain features of the Coptic geometric tradition. As a result of the test cleaning in this area, it was observed that the fourth-phase decoration completely alters the underlying layer by covering the figure of an archangel, possibly Gabriel.

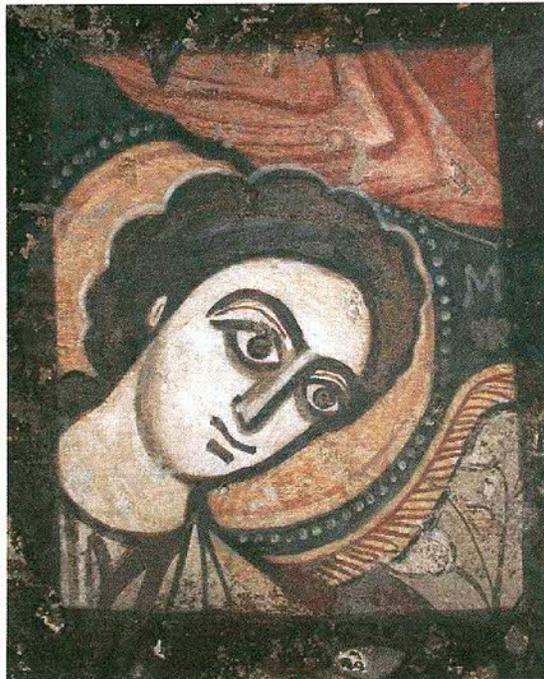
Figure 32

The second test cleaning carried out on the fourth-phase surface enabled us to recover the face of the Archangel Michael in a good state of preservation beneath a thick layer of lampblack (Figure 32). The working method is typical of the painter of the *Virgo Lactans*. The painter started with a preparatory design in yellow (ocher or giarosite) that set out the main lines of the painting; he then overlaid it with a more detailed design in red earth (hematite), using the same color to fill in the hair and those areas intended to be finished off with dark tones and then painted the halo and the flesh tones. At a later stage, he completed the painting by adding the bolder details in black (lampblack). Right at the end, the painter highlighted the flesh tones and outlined the hair in white (*bianco sangioivanni*). He also added the white dots around the halo and other decorative details using the same pigment.

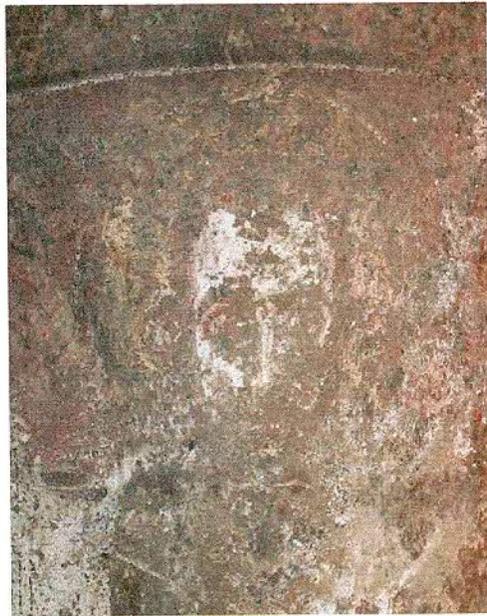
**Figure 39**

On both columns, careful cleaning has revealed fragments of the figures of two saints. On the northernmost column the saint (Figure 39) is turning towards the north wall in the direction of the medieval mounted saint and on the southernmost one the saint (Figure 40) is turning towards the nave. On the basis of the few fragments that allow us to guess at the working methods and iconographic features, we think that these paintings can be compared with the saints of the phase executed by the painter of the *Virgo Lactans*.

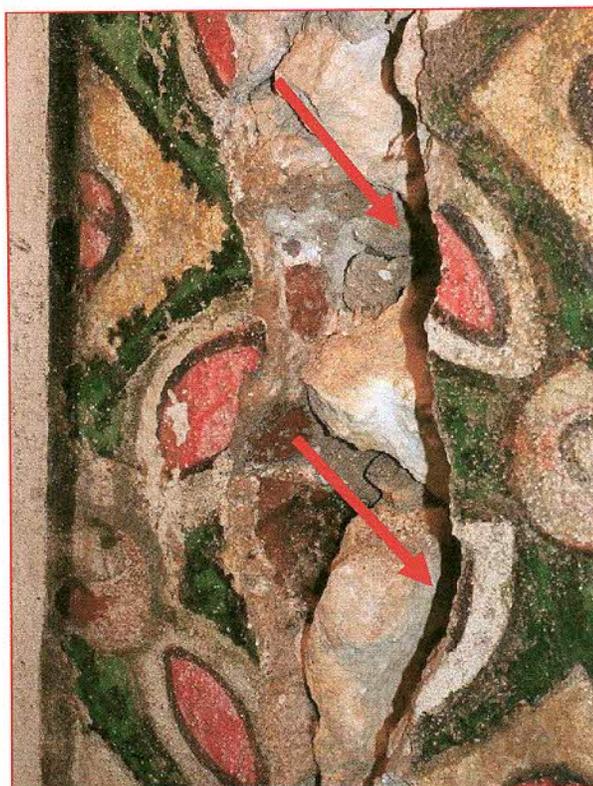
**Figure 42**

In antiquity, the masonry structure of the east lobe suffered from instability that caused widespread cracks and falling plaster. The causes of this instability and the settling of the masonry were specifically examined in the report on the spring 2007 mission<sup>13</sup>. Instances of damage caused by this instability are evident in the masonry, plaster and painting of the east lobe that were restored during this mission. In the second tier a wide crack runs to the left of the south niche and extends down as far as the first tier.

Here it is very clear that the two planes were moved apart and forced out of alignment when the surface of the wall on the south side of the conch sank some 7-12 cm (Figure 42). Other cracks with some degree of misalignment between the planes can be seen inside the apse, between the apse and the underside of the arch, in the external arch and in the clerestory where one particularly deep example affects the corbel of the central window.

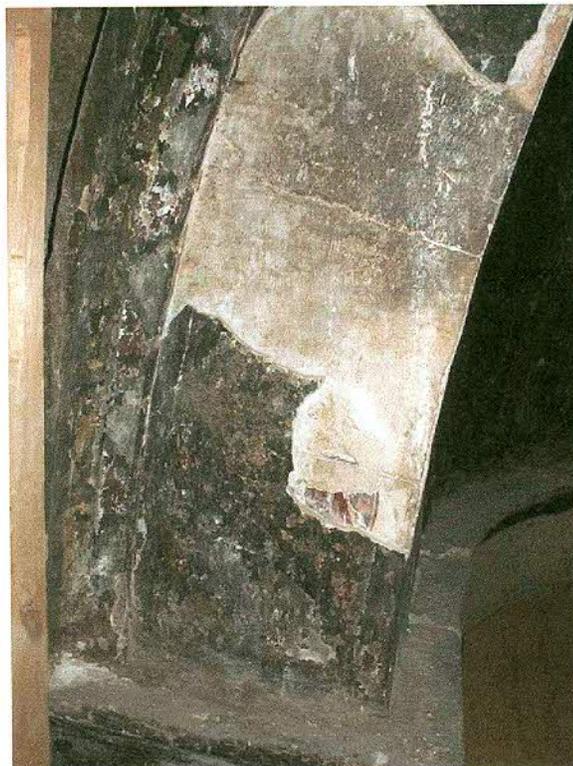
**Figure 44**

In the east lobe, the plaster is cracked and patchy, particularly in those areas where there is structural instability.

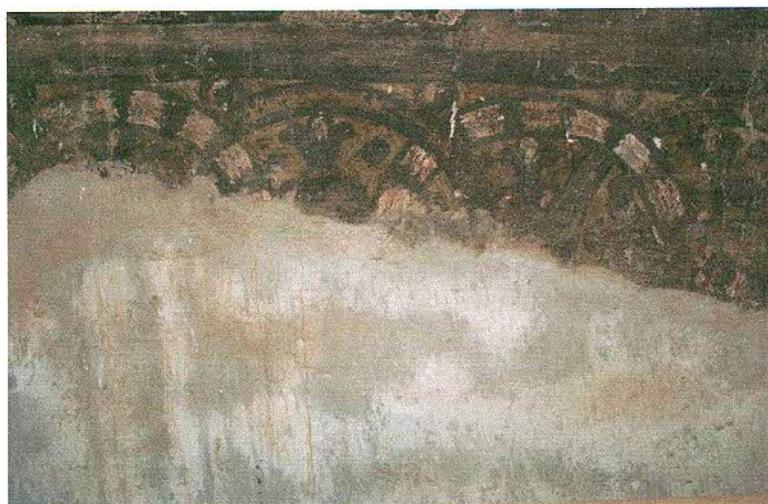
**Figure 45**

In addition to the work of the Comité, there is also evidence of more modern restoration work in the east lobe, probably dating from the second half of the twentieth century. Pointing used in earlier restoration work was mostly removed and the gaps filled with unsuitable mortar which covered large areas of the original plaster (Figure 45).

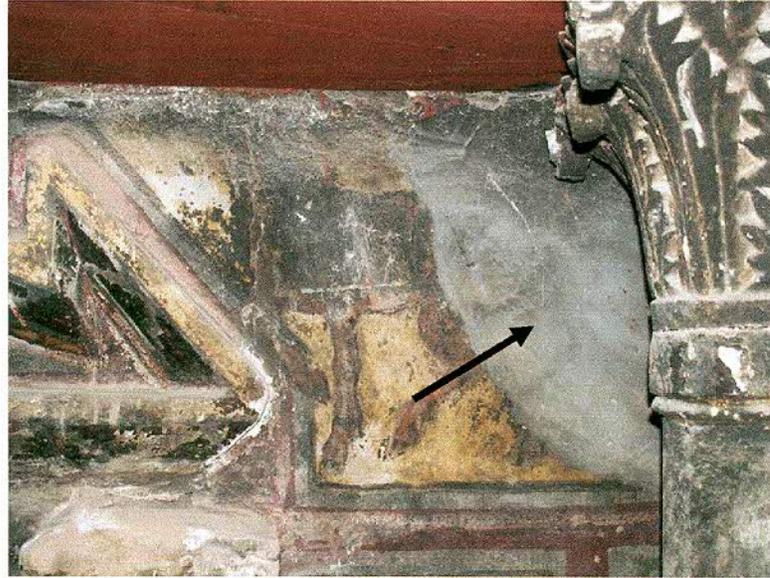
Figure 46

Plaster has fallen off in the vicinity of the wooden elements placed beneath the cornice and replaced at the time of the Comité's restoration work. This has caused a serious loss of plaster behind the capitals (Figure 46) and in the area where the gazelles are painted.

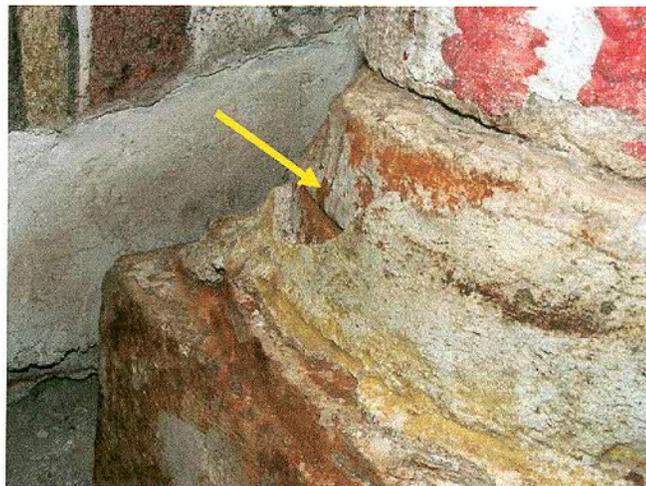
Figure 47

Pieces of plaster have also been lost from the column bases, particularly the two central ones. The plaster and decoration of the preceding phase can often be seen as a result (Figure 47).

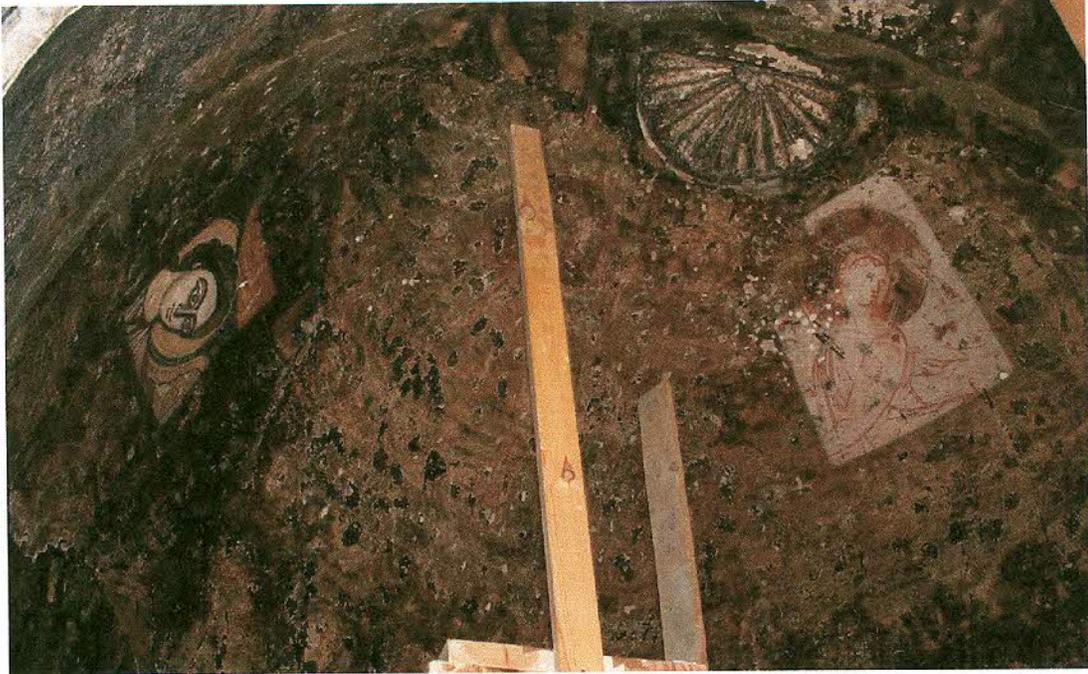
Figure 48

Plaster falling from the various phases of the palimpsest now reveals second-phase plaster covering approximately two thirds of the semi-dome of the apse (Figure 48).

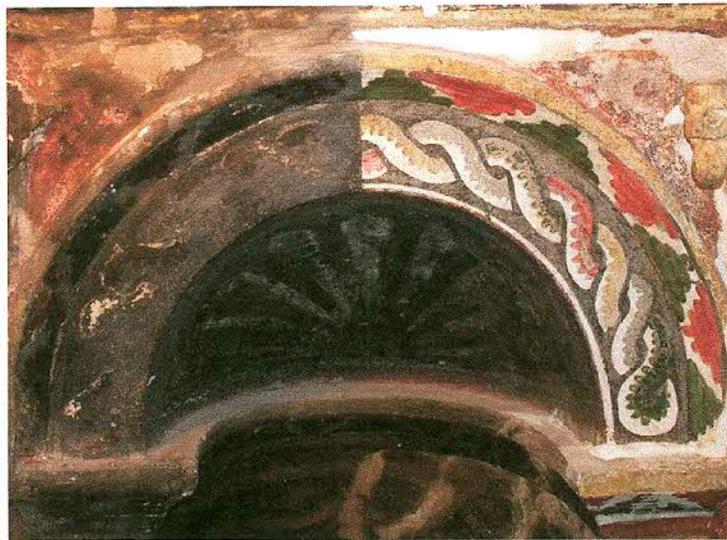
Figure 49

The decoration of the second tier is third-phase with the exception of limited areas where the fall of plaster has exposed the first-phase paint layer. The third-phase cycle of painting is generally in a good state of preservation. The layer of dirt formed a natural deposit composed of atmospheric particulate matter and carbon residue produced by the burning of lamps, candles and incense. The paintings were heavily blackened (Figure 49) because the altar was moved to this particular area and the consequent increase in the use of candles and incense was concentrated in this lobe.

As a result, the painted surface was impossible to make out. The pigments applied using the encaustic technique are generally well preserved. On the other hand, the virgin wax-

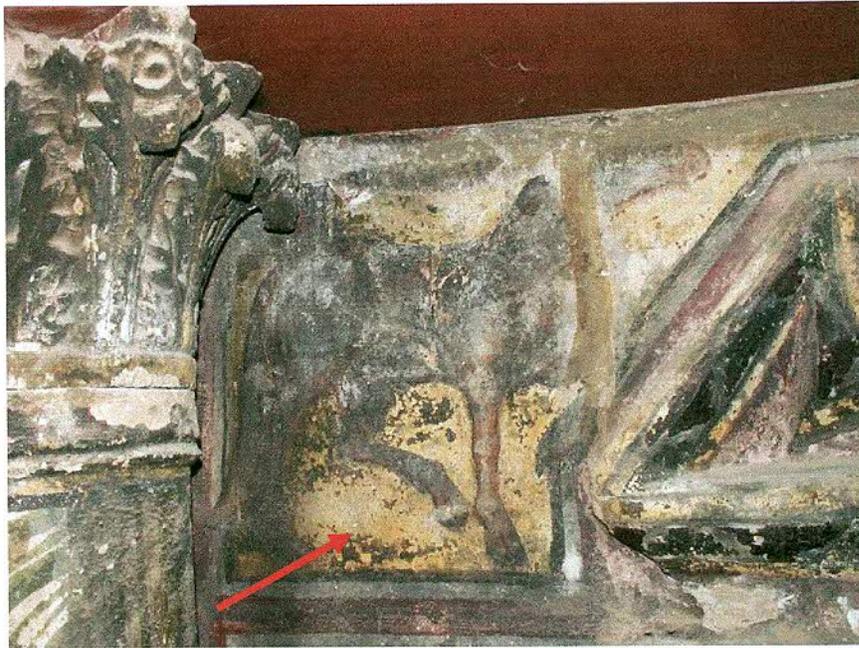
Figure 50

based varnish used to treat the yellow (giarosite) areas forming a background to the figures of the quadrupeds has been almost completely lost (Figure 50).

The background of the squares containing animals was also decorated with sprays of vegetation painted in wax, now almost entirely gone. This confirms that the giarosite background color proved incompatible with the encaustic technique<sup>14</sup>.

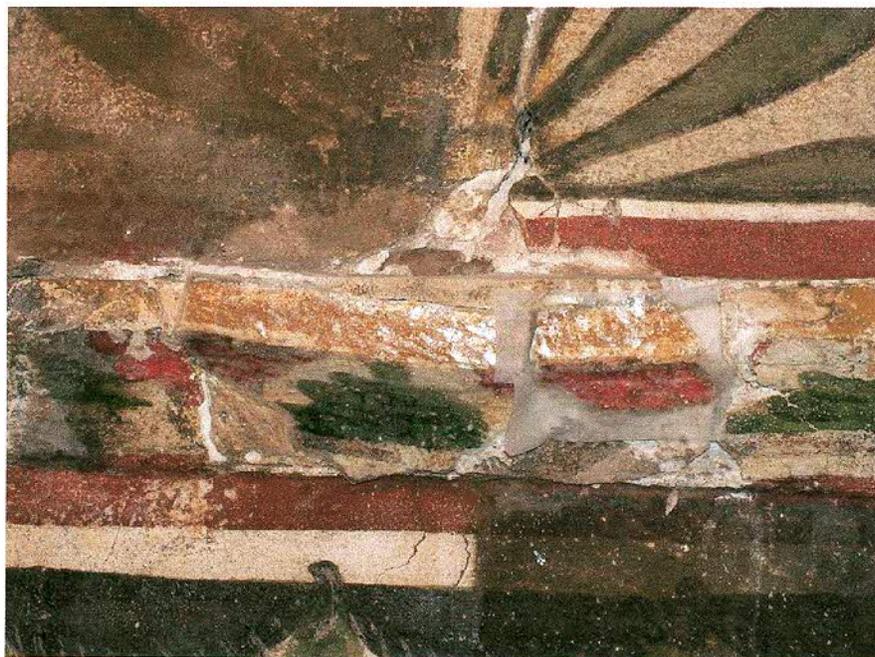
**Figure 53**

This technique was employed on areas of plaster in danger of falling on the south external side of the triumphal arch, on the cornice of the central niche in the second tier (where it was used to reposition a fragment – Figures 53, 54 and 55) and on both the semi-capitals of the left-hand niche (north).

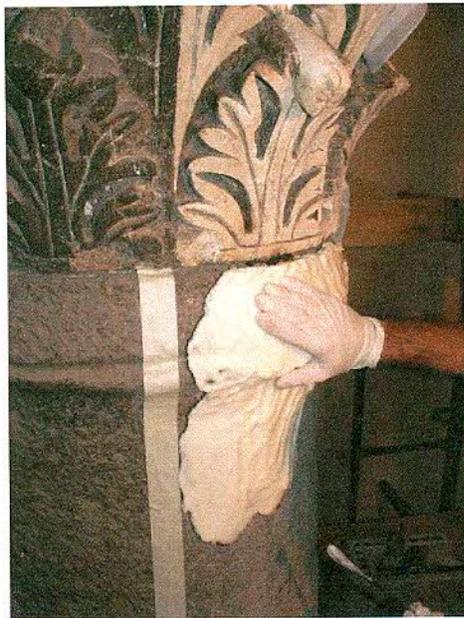
Figure 60

The cleaning of the stonework required a system different to that used for the plaster. Owing to the nature of the local limestone, the sooty residues and particulate matter were particularly ingrained in the pores of the stone, creating consolidated deposits over wide areas. To clean them we decided to use the same solvent mixture used for the plaster types but applied in a different way. Wood pulp was used as the medium, with the addition of a moisture-retaining substance (water-soluble methylhydroxyethylcellulose) (Figure 60). This compress allowed longer application times but did not soak the stone unduly.

Application times varied from 5 to 15 minutes depending on the thickness and resistance of the layers of dirt and incrustation to be removed. The same system was used to clean the shafts of the granite monumental columns, extending the application times to 30 minutes. Once the compress was removed, the stone was dabbed with sponges and soft-bristled brushes.
