FINAL REPORT

Fall Mission: October 28, 2009 – December 20, 2009

Luigi De Cesaris & Alberto Sucato, Restorers

“Conservation and Documentation of the Wall Paintings at the Red Monastery, Sohag”

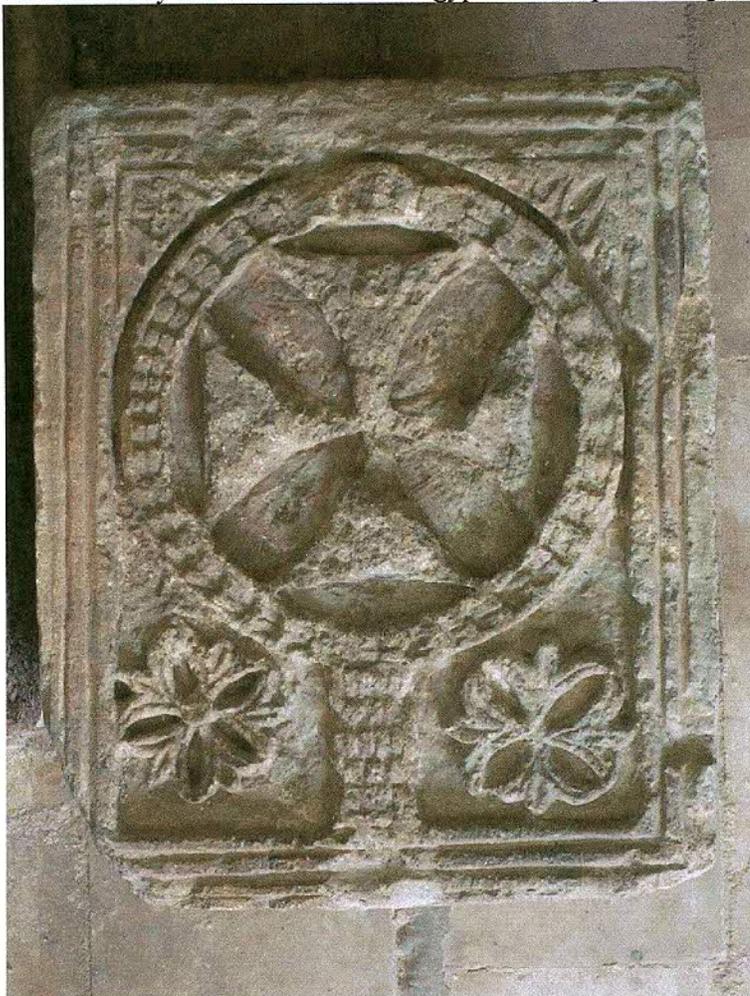
Fig. 1

Two major test cleanings have been carried out under the right niche (south) on the ground floor of the east lobe in preparation for the work of forthcoming missions. These test cleanings have revealed a typical *velaria* painting of considerable size. In the same lobe the altar has been removed, revealing a concealed limestone stele² (Fig. 1).

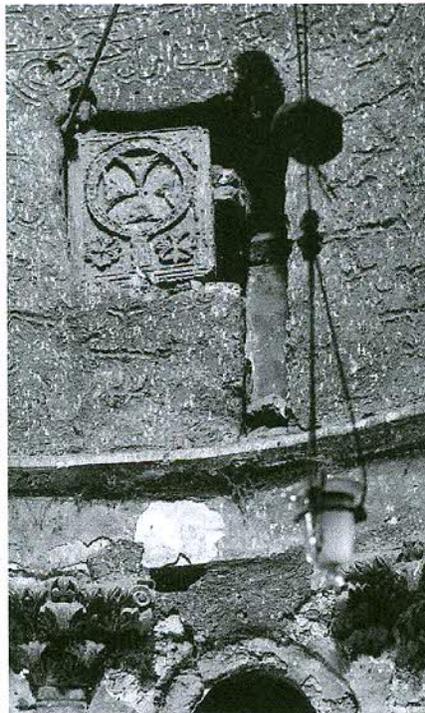
Fig. 2

² During the mission Father Maximus El Anthony and Dr. M. Johns removed the altar installed in the east lobe subsequent to the work of the Comité. The altar was made of bricks bedded in a mud-based mortar with an external cement plaster. During the dismantling process a late antique limestone stele set into the brick structure and wrapped in a piece of green acrylic material came to light. It is decorated with a carved cross inscribed within a circle and surrounded by plant motifs. This stele appears in a photograph taken by the Comité, set into the wall of unfired brick dating from the medieval period at the height of the second tier in the north lobe (Fig. 2).

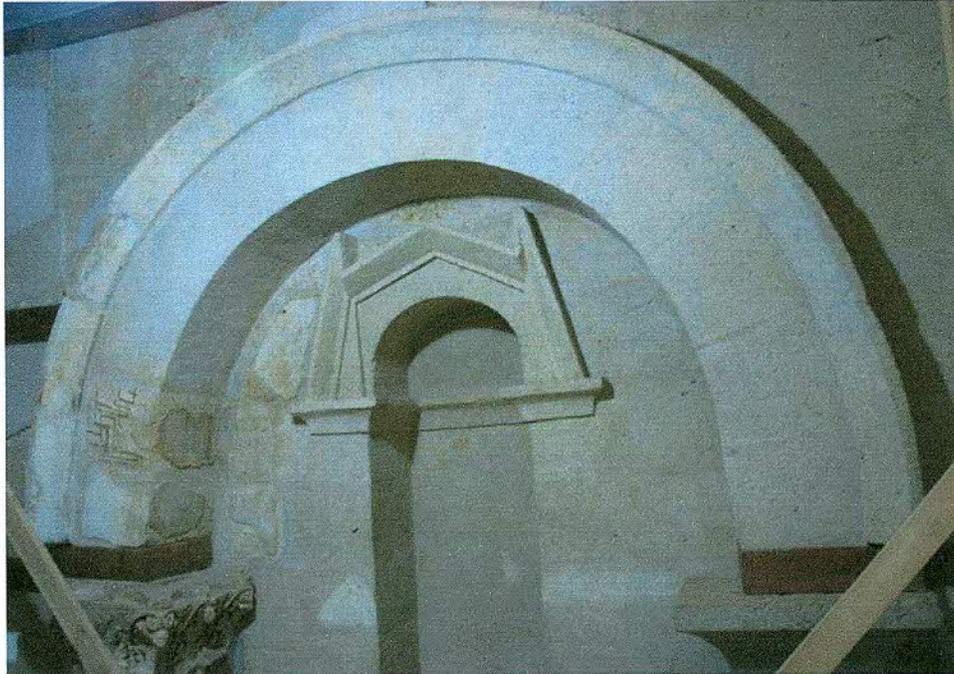
Fig. 3

On the south side, the blocks comprising the corner and portion of the original facade to the right of the triumphal arch appear to have been tampered with. The south corner, from the stone arch providing access to the south corridor (SEB) up to the highest tier was almost entirely rebuilt by the Comité. The arch was almost entirely rebuilt using new stone blocks (Fig. 3).

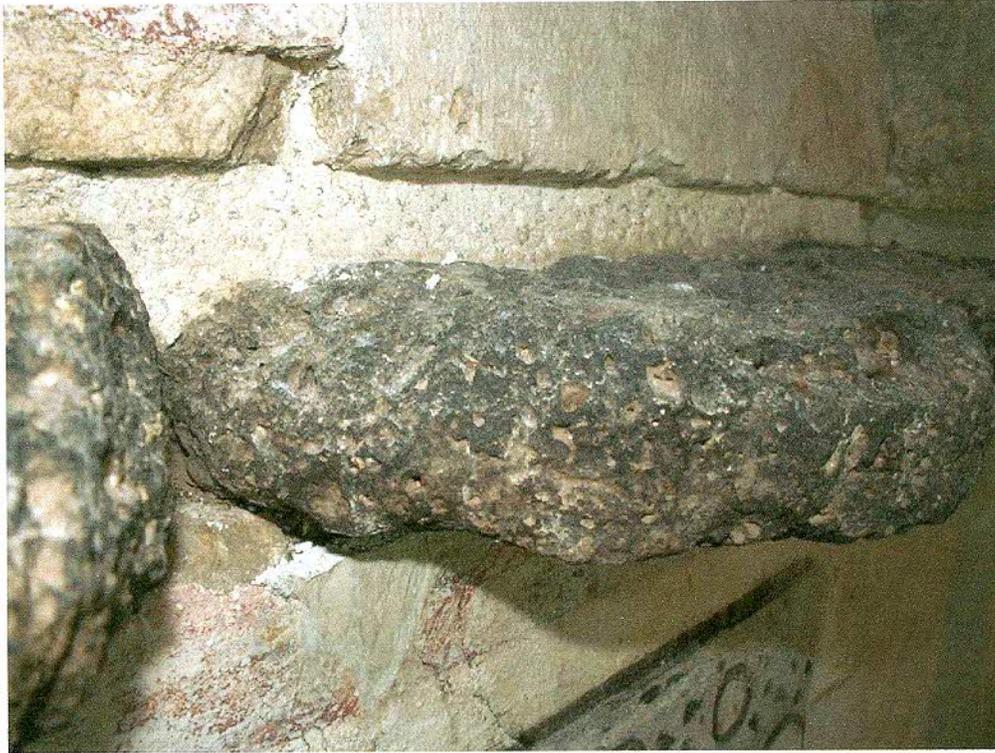
Fig. 4

The uppermost tier was completely rebuilt in brick. In the area between the second and third tiers there is a ledge of dark stones which appear to be volcanic in origin. The architectural role played by this ledge and the reason for its presence require further exploration. The ledge could be associated with the construction of a wooden floor connected to the balcony or a women's gallery (Fig. 4).

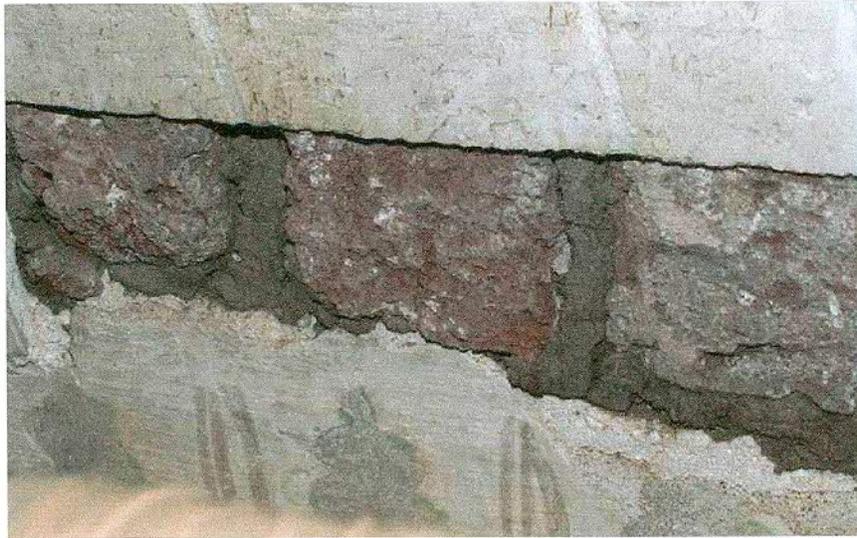
Fig. 5

The removal of non-original plaster from the vault of the corridor (NEB) has confirmed that the masonry structure does not predate the construction of the triconch. Here too the masonry comprises fired bricks bedded in a mortar of mud and straw (Fig. 5).

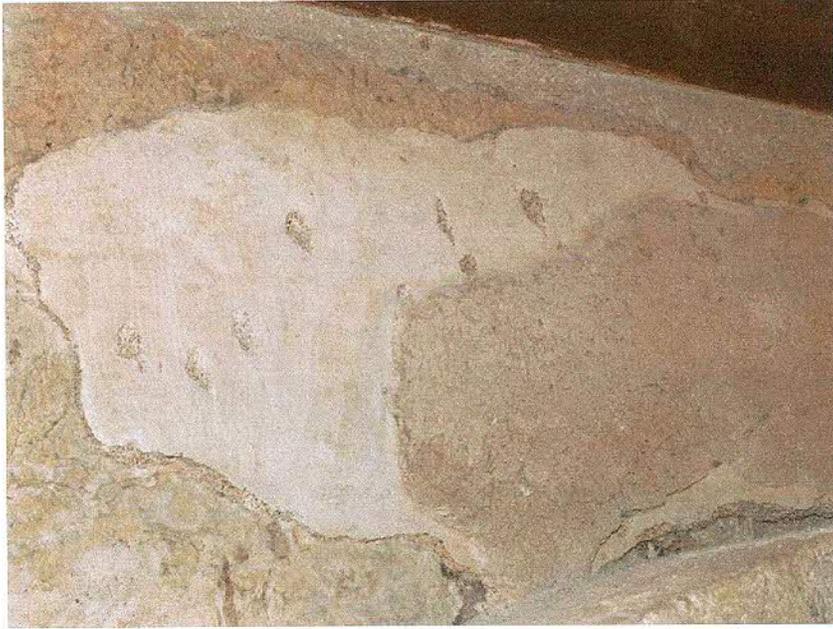
Fig. 6

The work has allowed the recovery of a considerable amount of third-phase plaster including the flat panels, the interiors of the niches, the molded elements of the pilasters, the semi-columns, the semi-capitals and the area to the right of the uppermost window. Portions of whitewash from the fourth phase are present on the top part of the facade inside the niche in the third tier and on the capital of the south monumental column. The medieval plaster based on lime, powdered limestone and straw is only present in the second tier where a large undecorated fragment is extant (Fig. 6).

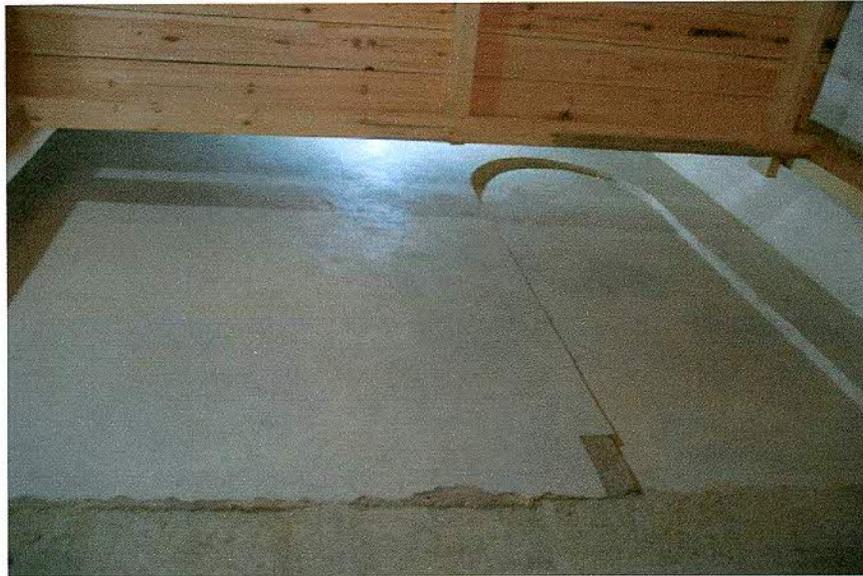
Fig. 7

In the third tier, the wall on the right side (south) was strengthened by the Comité. The restoration work was covered by a layer of white gesso-based plaster (Fig. 7) of relatively recent date that shows the outline of the blocked-up window (Fig. 7).

The triumphal arch in its entirety, the arch giving access to the south corridor and the area above it were all subject to wholesale repositioning and replacement of blocks by the Comité. The Comité was also responsible for rebuilding in fired brick the upper right-hand part of the two pilasters from the level of the impost of the triumphal arch and the area to the right of the uppermost window¹⁵ (see Fig. 7).

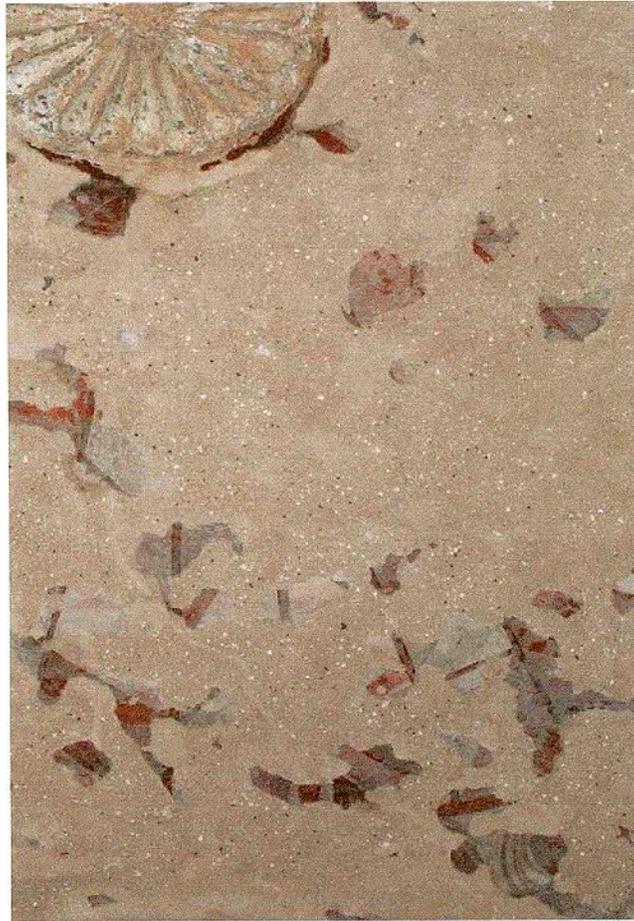
Fig. 9

On the vault the new plaster has covered the preexisting fragments. Owing to the removal of the modern plaster, a large painted area in a very patchy condition has been recovered (Fig. 9). The characteristics of the late antique plaster in some respects (Figs. 30-31) resemble those of the plaster in the adjacent corridor (SEB) and even in the north corridor (NEB)⁶.

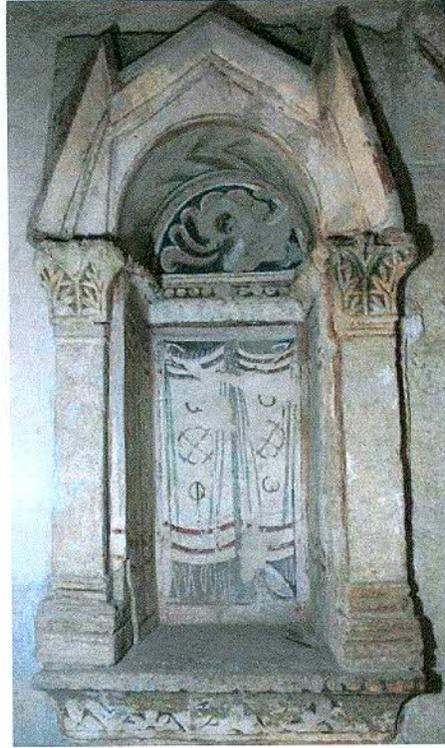
Fig. 10

Starting from the upper tiers, in the third tier there is a small niche (Fig. 12) decorated with *velaria*. This niche is similar in architectural structure and decoration to the one on the north side (Figs. 10-11).

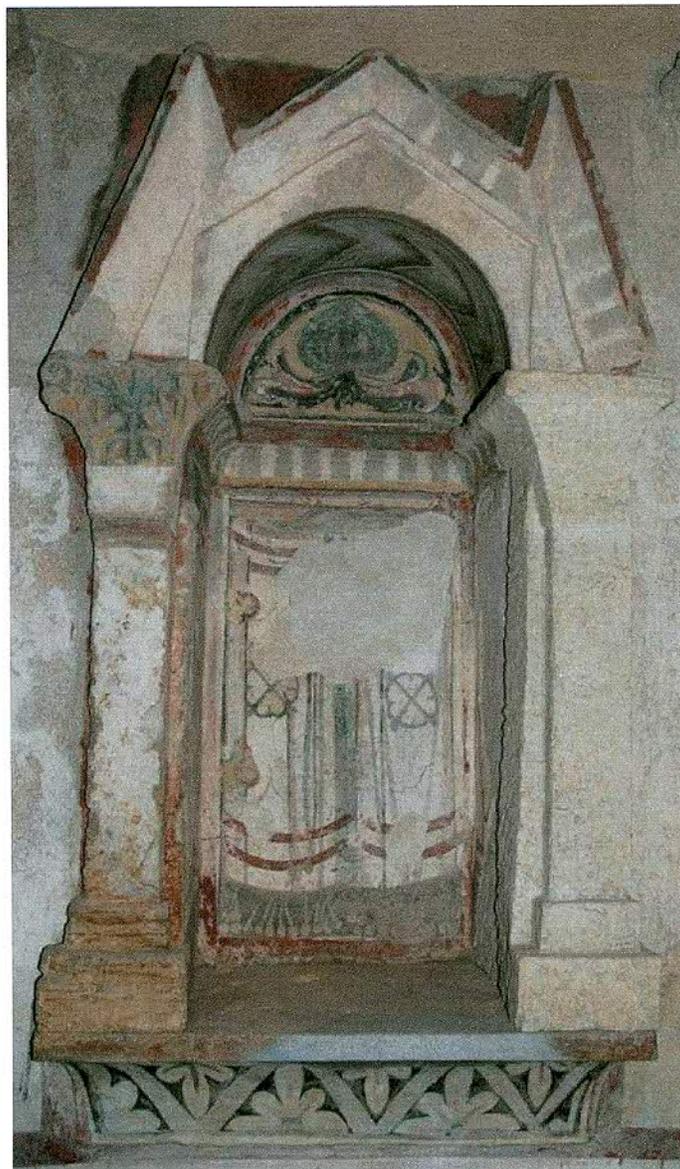
Fig. 12

On the painted surface of the niche there are a few fragments of white wash from the period of the *Virgo Lactans*. During the fourth phase, the decoration was completely redone, and the preexisting paintings were completely covered by geometric designs and circular and lanceolate motifs. On the right-hand side of the lunette, a particularly well-conserved pink pigment forms the background to the decorative elements⁷ (Fig. 13).

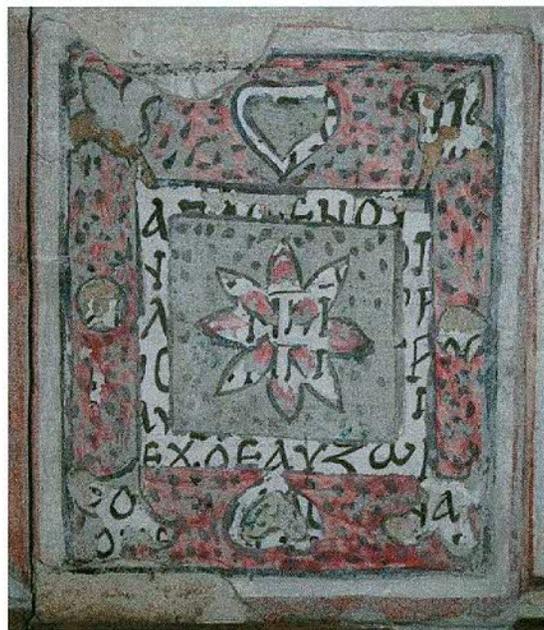
Fig. 14

In the lower register there is a rectangular panel decorated with a geometric motif against a background of encaustic green⁸ and pink pigments.

The painter of the *Virgo Lactans* subsequently covered this panel with the usual white wash and inscribed it in Coptic. The white wash did not adhere properly to the surface owing to the use of encaustic pigments. Much of it has fallen off, leaving only the remains of the inscription (Fig. 14).

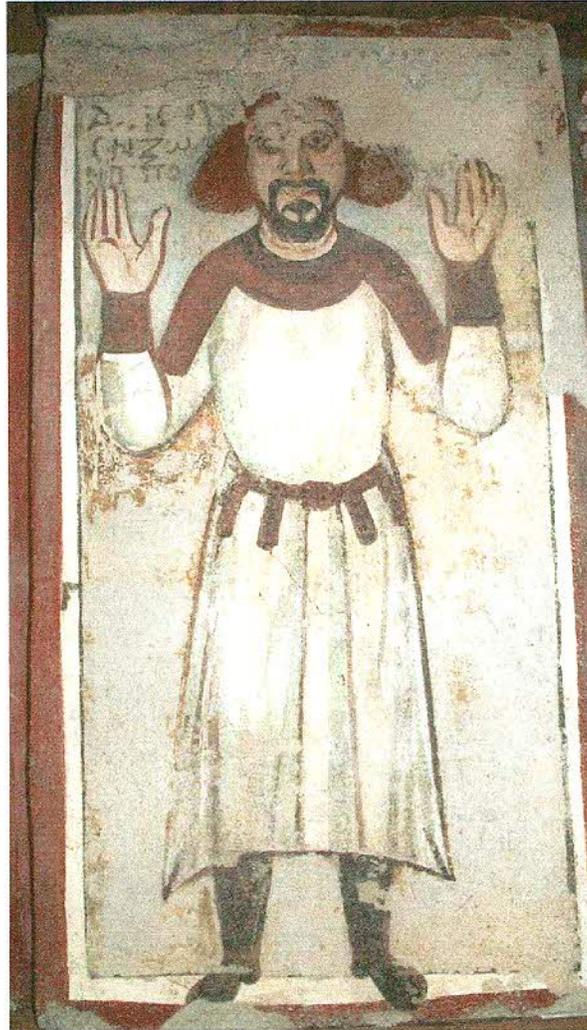
Fig. 15

Still in the second tier, the figure of a person praying (Fig. 15) is depicted to the left of the niche just described. This particular painting is the only one of its type in the facade. The figure is wearing a close-fitting cap and a white robe. The background is light and hazy, leaving visible many of the green lines of the preparatory design. The belt and trimmings on the gown are painted in red and brown and decorated with a series of small circles.

The top of the background to the figure is painted a light blue obtained by mixing blue pigment with a lot of white. At the top left there is a very patchy Coptic inscription, probably the name of the individual.

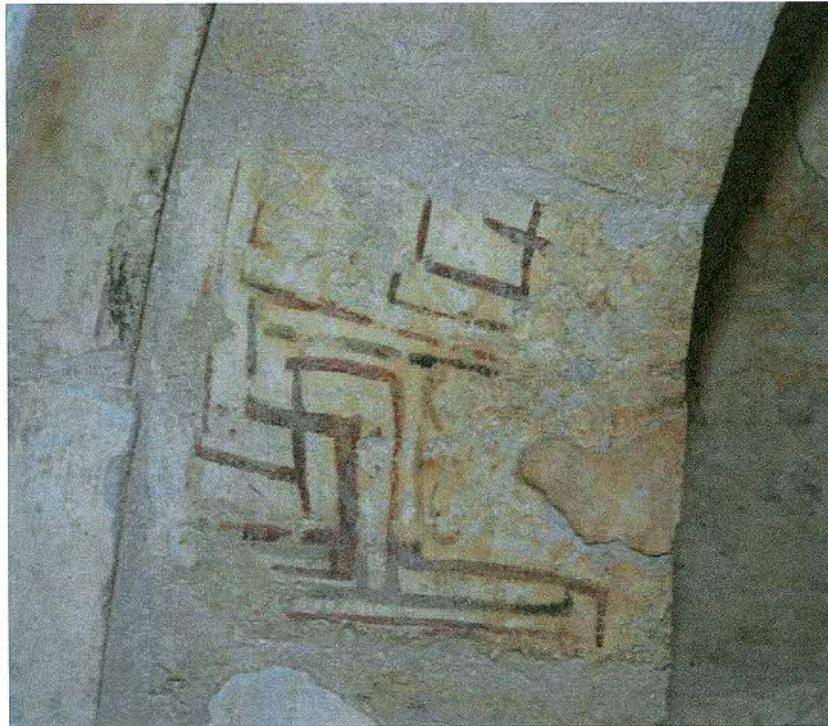
Fig. 16

On one of the few original blocks remaining in the arch above the doorway giving access to the south corridor (SEB) a typical first-phase painting has been preserved on top of a thin coat of white wash applied to prime the stone. This painting comprises a geometric motif with orthogonal lines overlying each other in the Greek manner, painted using a simple and limited palette (Fig. 16).

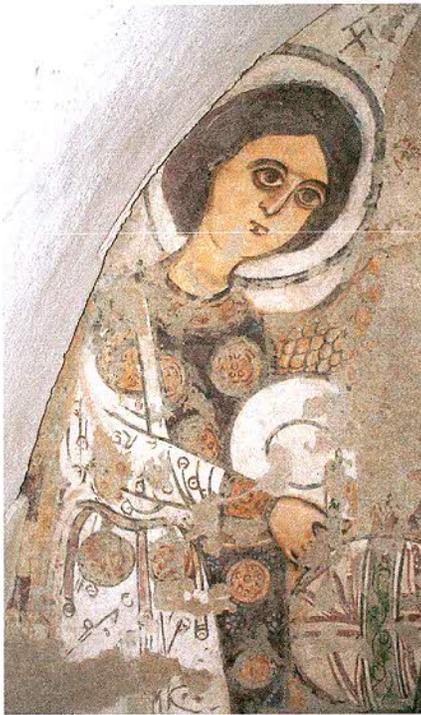
Fig. 18

left of the Madonna (Fig. 19). Also on the left of the enthroned Virgin is an archangel facing the center of the composition and holding in his right hand the holy bread (Fig. 18). On the underside of the arched passage between the prothesis and the corridor occasional fragments of the surviving paint layer can now be seen. Two different phases, one partially overlying the other, can be distinguished. Of the earlier phase, probably the first, all that remain are a few stylized floral motifs that originally had an encaustic finishing. The overlying painting presumably belongs to the fourth phase. The few remaining fragments suggest that two figures with halos were depicted there⁹.

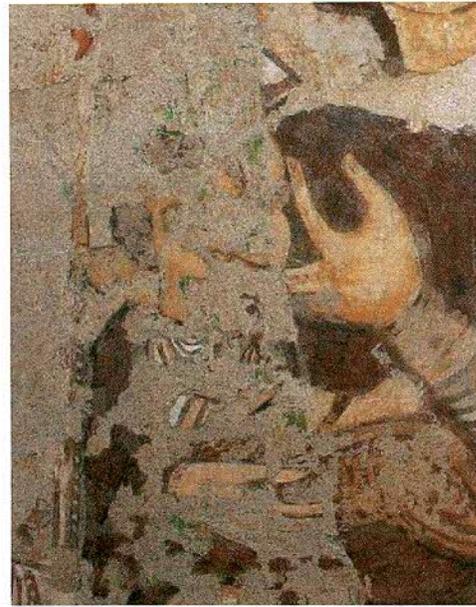
Fig. 19

On the basis of technical similarities and stylistic comparisons, we can say with some certainty that this painting belongs to the fourth phase of painting. Its close relation to the *Virgo Lactans* in the north lobe is clear even though in this case the Christ child is on the

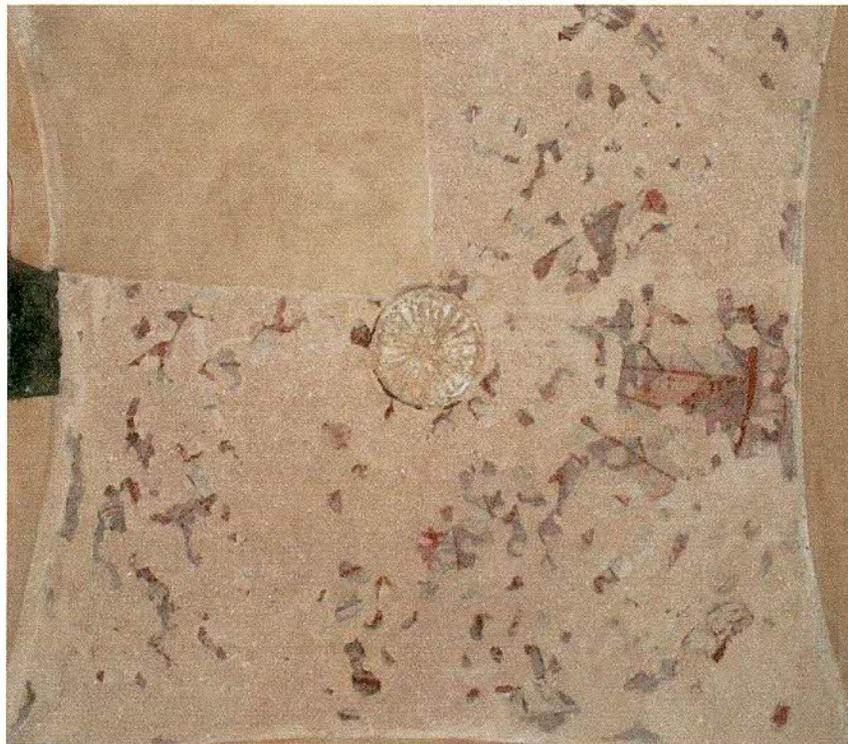
Fig. 20

We worked in the southern half of the diaconicon (SEC), revealing a great many fragments that greatly assist our understanding of the decorative scheme¹⁰ (Fig. 20).

The decorative scheme, already described in the Spring 2009 report, comprises a classical-type cornice that runs the length of the external perimeter of the vault and encloses a large roundel painted with geometric motifs. The internal space of the roundel is divided up by radii and concentric rings. The keystone is a piece of carved limestone positioned at the geometric center of the painting. In a limited area it has been possible to observe, under a raking light, that the design of the large circle was laid out by incising the plaster.

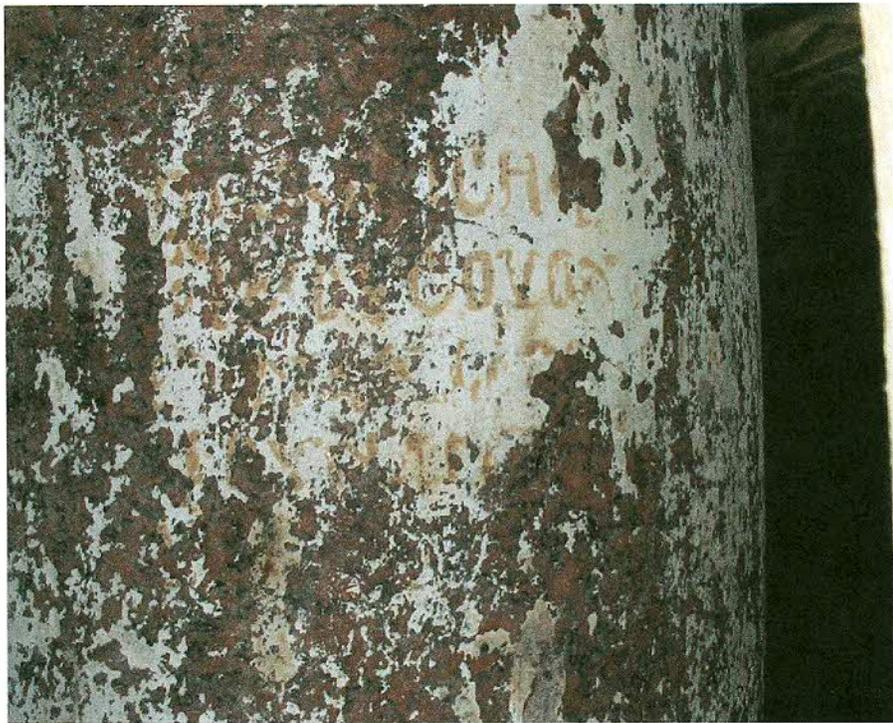
Fig. 22

The restoration work also involved both the monumental columns of the triumphal arch. In the center of the shaft of the north column, there is a patchy area of white wash where fragments of a Coptic inscription¹² written in ochre can be made out (Fig. 22).

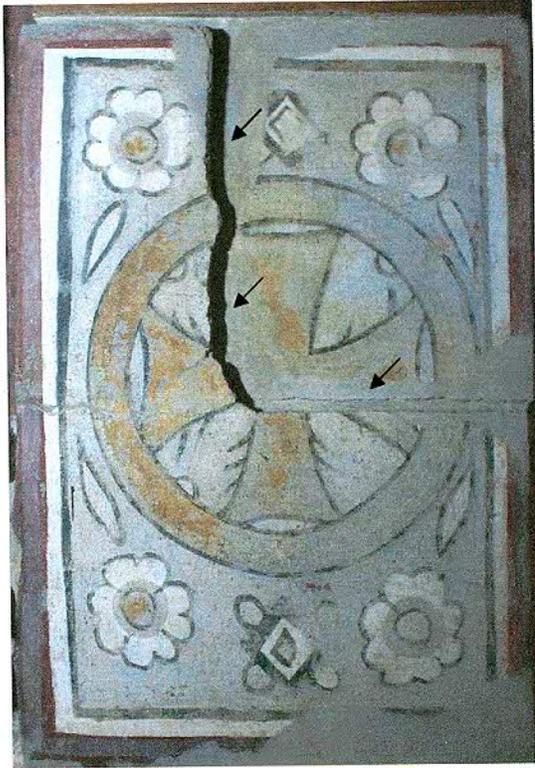
Fig. 23

In this area the break is particularly clear between two plastered blocks that were both part of the same design featuring a painted panel with a cross inscribed within a circle and geometric and floral motifs (Fig. 23).

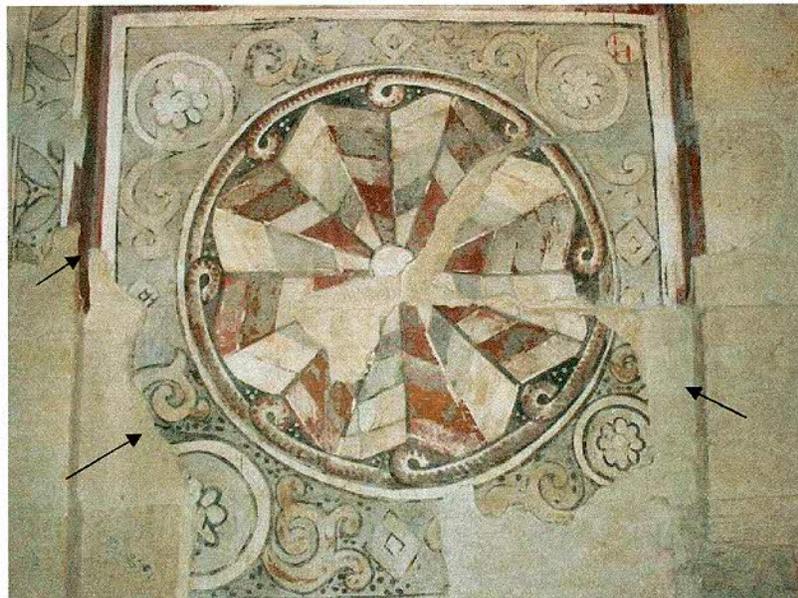
Fig. 24

The plaster on the right-hand side (south) has been less exposed than the rest of the facade to harmful natural phenomena such as atmospheric agents and the rays of the sun. Consequently the impact of these agents, particularly on the paint layer, has been less harmful. The process of dismantling and repositioning many of the blocks, in some cases incorrectly, has had a negative impact on the plaster. In fact, almost all the most exposed areas such as the corners of the pilasters, points close to joints where the woodwork has been repositioned and areas adjacent to wooden elements have lost a great deal of plaster (Fig. 24).

The various forms of plaster loss described above were repaired during the 20th century by the Comité and subsequently by the Egyptian Antiquities Organization, using mortars of different kinds.

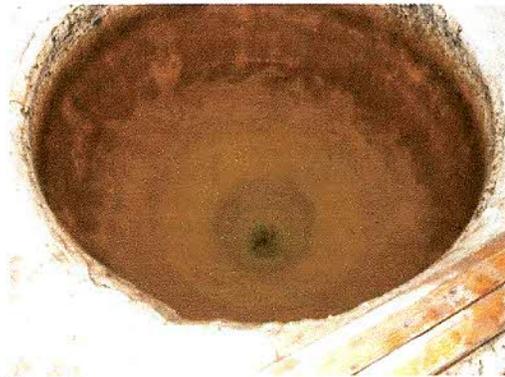
Fig. 26

As already observed in the Spring 2009 report, the modern plaster is well preserved and has few gaps. However, we noticed that the plaster was bulging strangely below the niche on the east wall. Upon carrying out a close examination of the area we found that the masonry was very damp because the baptismal font (Fig. 26) in the niche above was draining directly into the wall. We have removed a portion of masonry in this area in order to assist the drying out process and to prepare for the installation of a suitable means of drainage during the next mission (Fig.27).

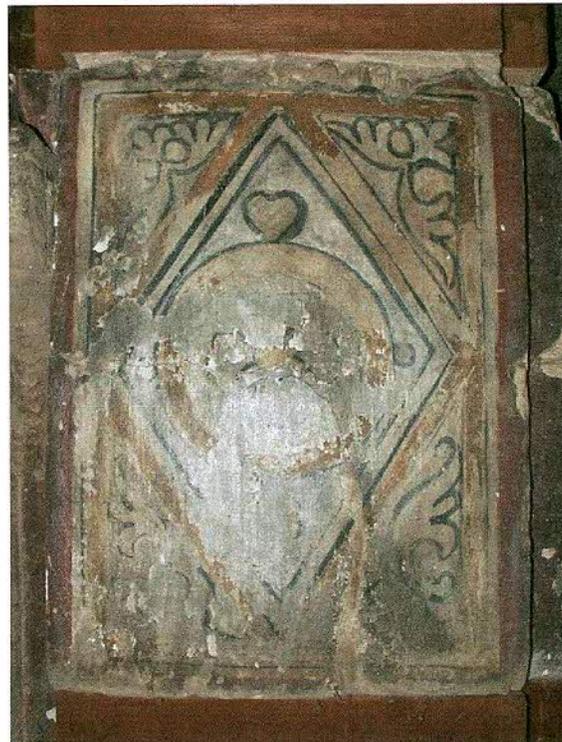
Fig. 29

Damage connected with alterations to the masonry has naturally resulted in the loss of the painted surface (Fig. 29).

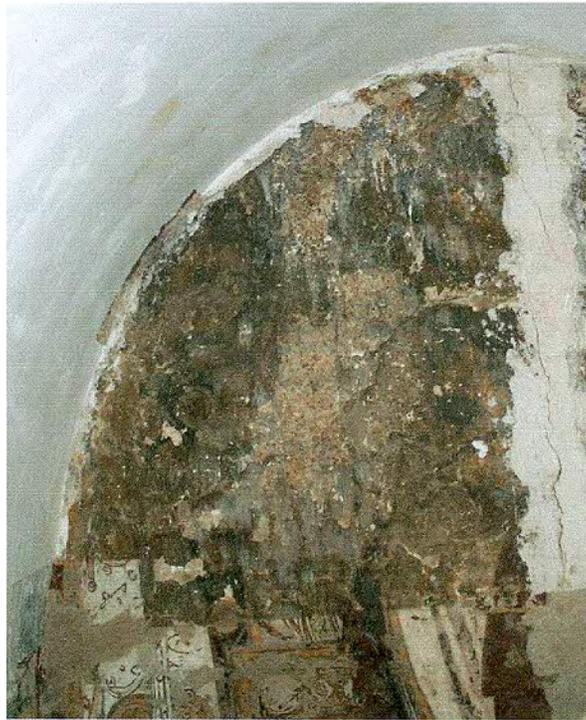
Fig. 30

In the west lunette of the north corridor (NEB) the archangel and the Virgin with the infant Christ at her breast were concealed beneath a thick and consolidated layer of deposited material (Fig. 30).

The right-hand part of the late antique painting was lost as a result of the rebuilding of the external wall. This area was then repaired with Fatimid plaster (with the large crosses). The exposure of the facade to atmospheric agents, the infiltration of rainwater through the window over the archway to the corridor and repairs to the masonry and plaster on the west wall of the corridor have all contributed to the seriously patchy condition of the painted surface and the formation of a thick, consolidated and partially carbonated layer of deposited material.

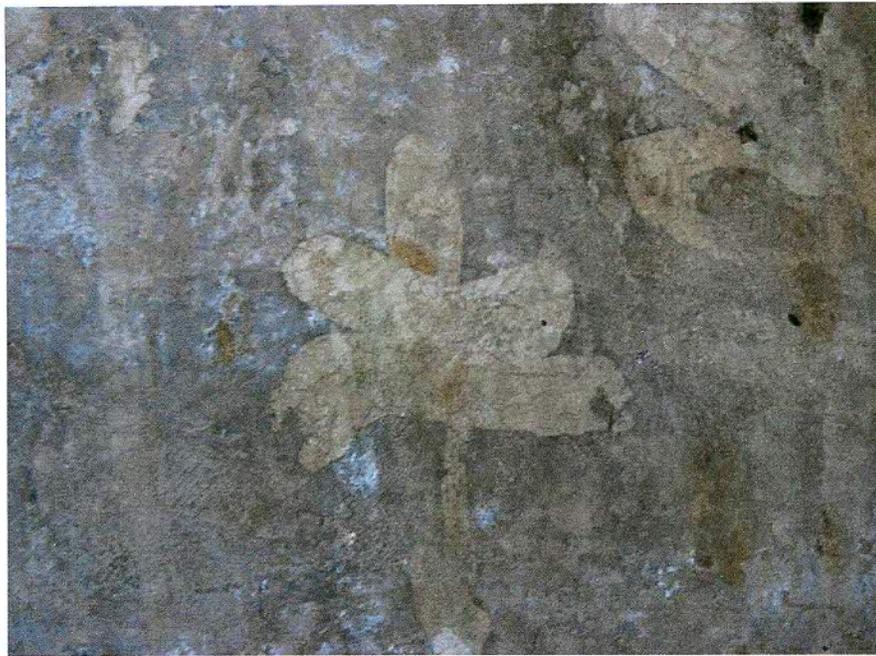
Fig. 33

In the first tier of the east lobe two test surveys were carried out under the south niche. The paintings seem to be almost entirely covered by a thick layer of carbon-based particulate matter resulting from the number of religious activities conducted in this area (Figs. 31-32). There are numerous drips of candle wax under the ledge of the niche and many details of the painted decoration are obscured by residue from cement-based pointing. The outlines of plant motifs painted using encaustic pigments and now lost are clearly visible (Fig. 33).

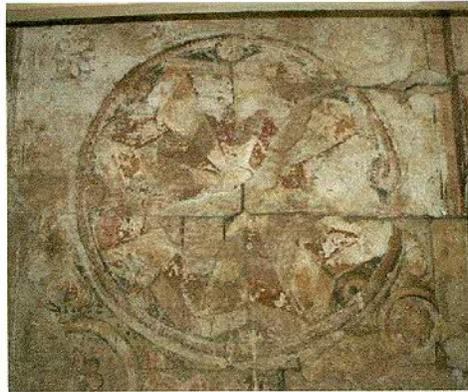
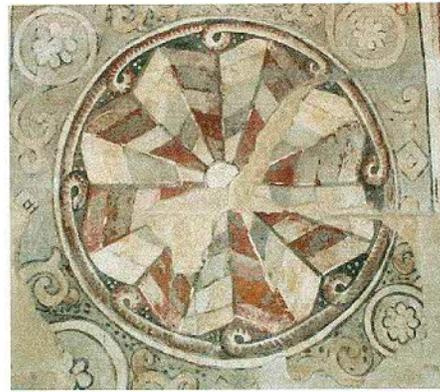
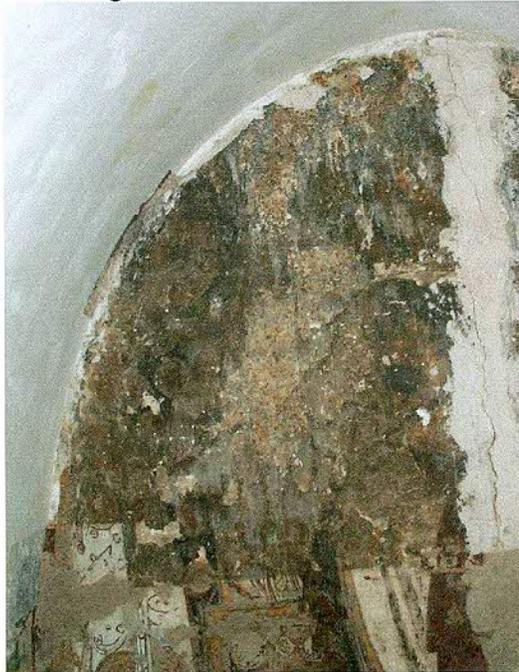
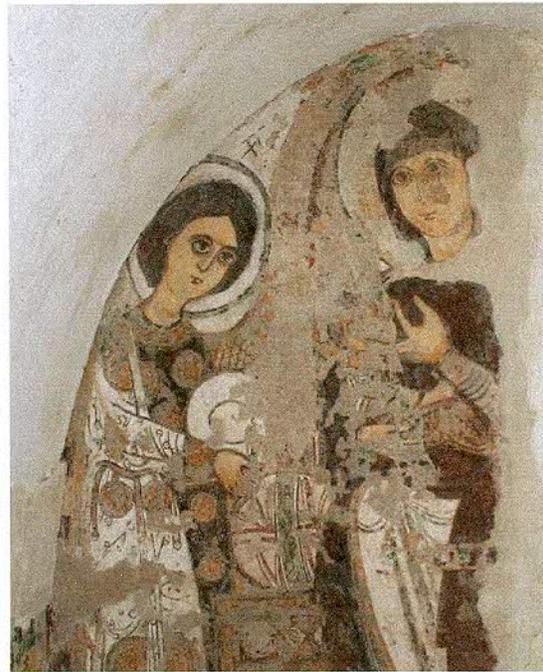
Next, sooty deposits, oily residues and thin layers of saline efflorescence are removed using a slightly basic solution of inorganic salts applied on several thicknesses of paper tissue or Japanese paper and working in small areas at a time (Figs. 38, 39, 40 and 41).

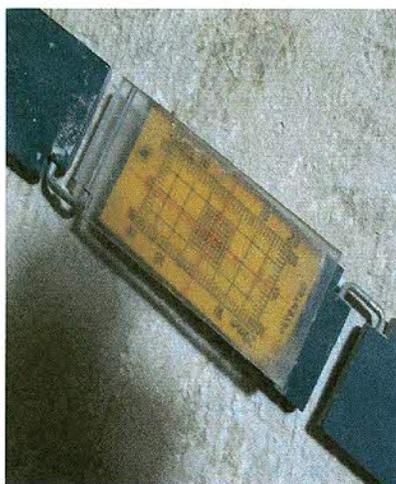
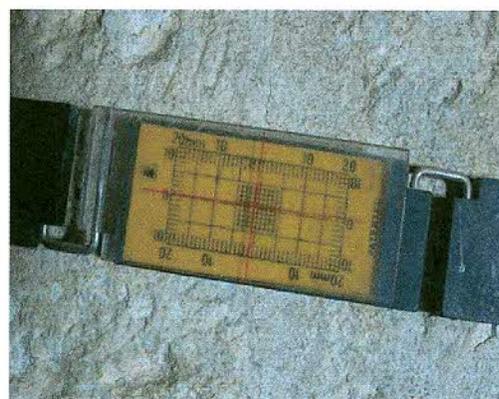
Finally, the latest readings from the crack monitors installed on the access archway to the triconch were compared with those taken during the Spring 2008 campaign (Figs. 47 and 48). No variations caused by possible settling of the building were recorded²².

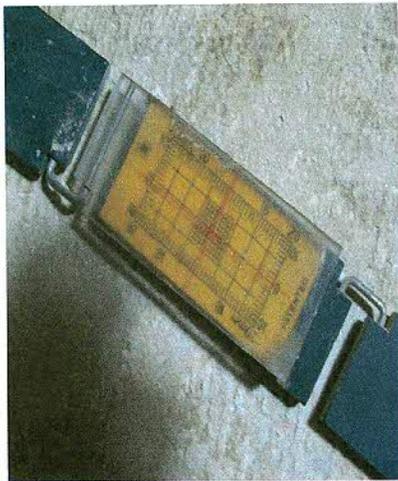
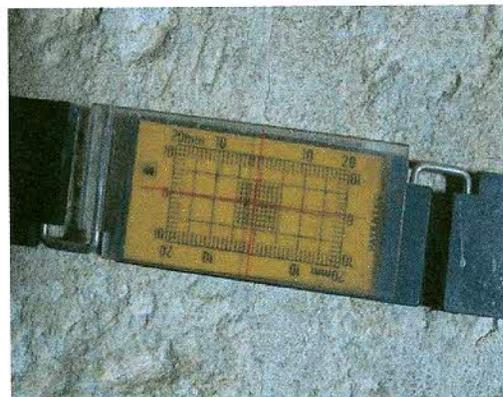
Finally, the latest readings from the crack monitors installed on the access archway to the triconch were compared with those taken during the Spring 2008 campaign (Figs. 47 and 48). No variations caused by possible settling of the building were recorded²².
