FINAL REPORT

Fall Mission: October 26, 2007 – December 21, 2007

Luigi De Cesaris & Alberto Sucato, Restorers

“Conservation and Documentation of the Wall Paintings at the Red Monastery, Sohag”

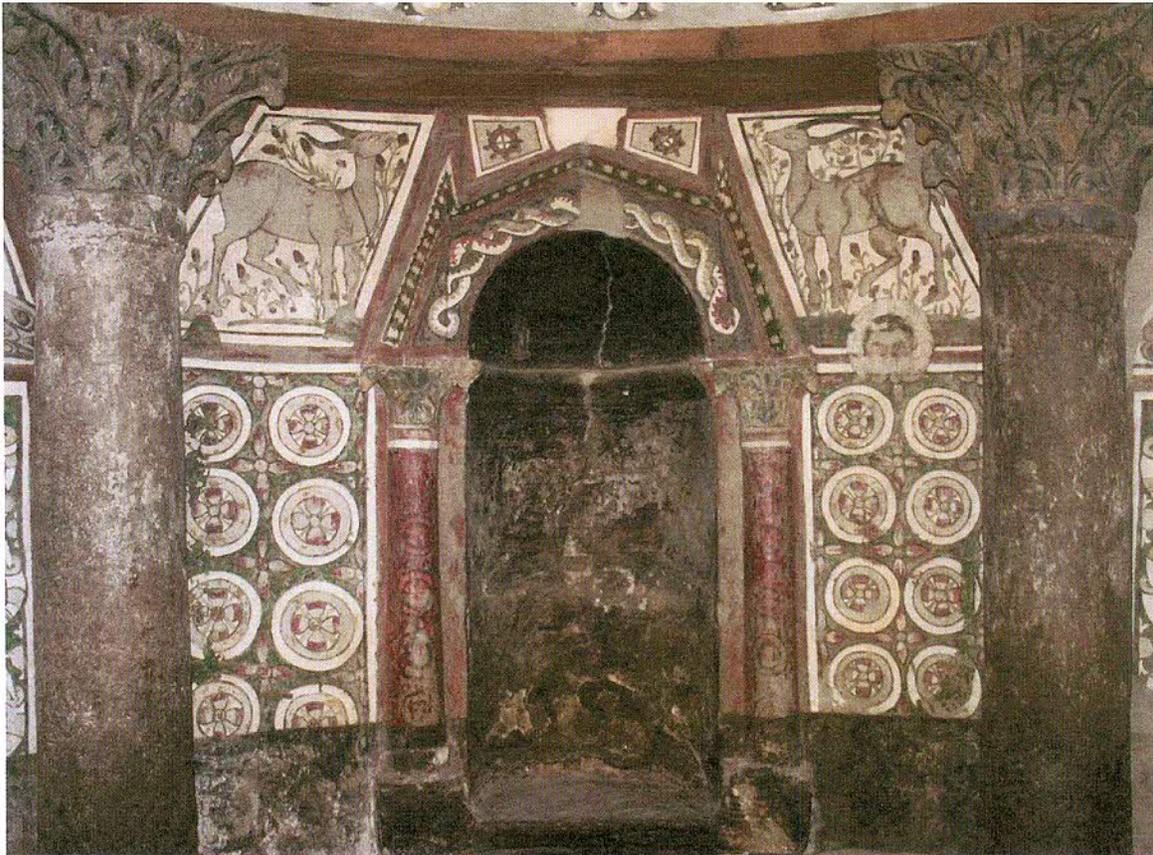
Fig. 1

In the east conch, our decision to tackle a large band had a very positive outcome: approximately half the surface area of the first tier was completed, with the exception of the interiors of the niches which will be restored during future campaigns (Fig. 1, east conch, central niche).

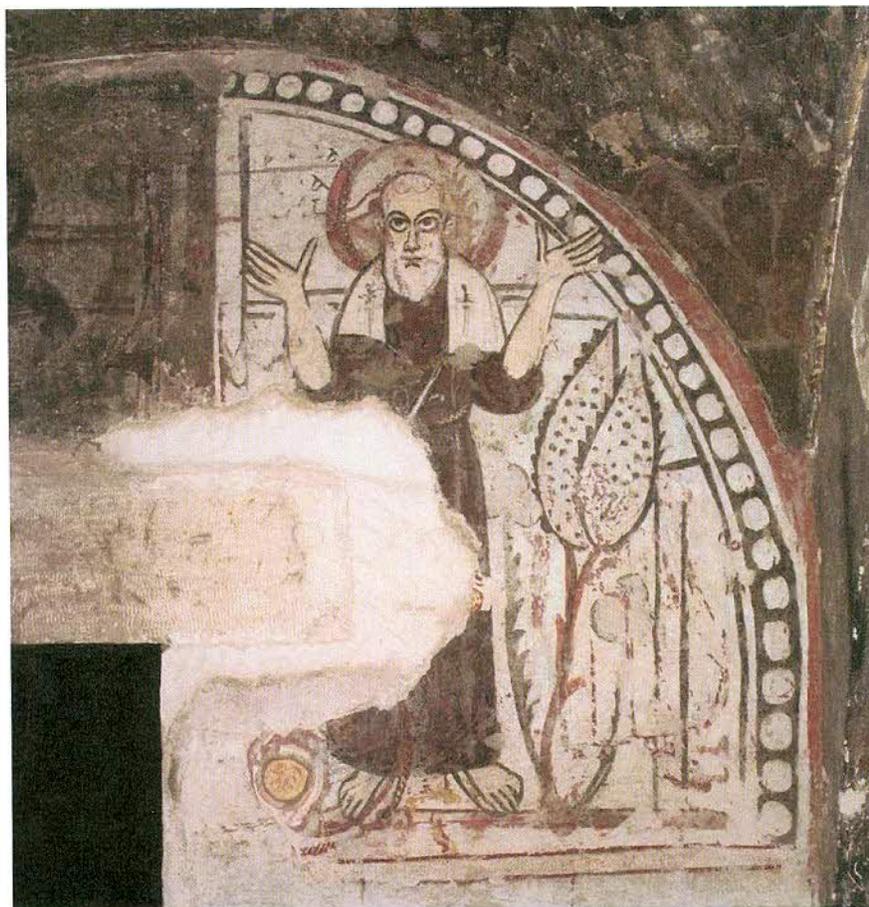
Fig. 2

We completed approximately half of the west (Fig. 2) and south lunettes in the *prothesis*. In the unfinished section of the west lunette (left side) a test cleaning measuring approximately 30 x 30 cm was carried out on the face of the Virgin.

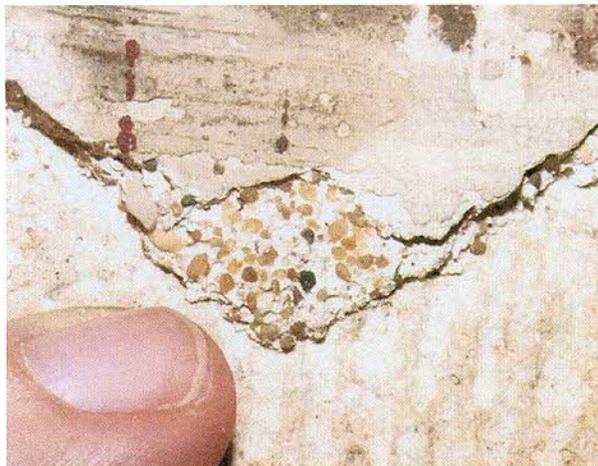
Fig. 3

We can state with certainty that the plaster types most widely visible in both lobes all share the same characteristics. They are lime-based with inclusions of quartz sand with large round grains⁶. This plaster, which varies from approximately 0.5 to 1 cm in thickness (the thickness diminishes on the moldings and shafts of the columns) can be linked to the plaster we define as the third phase of application⁷ (also known, by reference to the related phase of painting, as *encaustic* decoration plaster) (Fig. 3). The composition and surface treatment of this plaster are slightly different at ground level although it does belong to the same third phase.

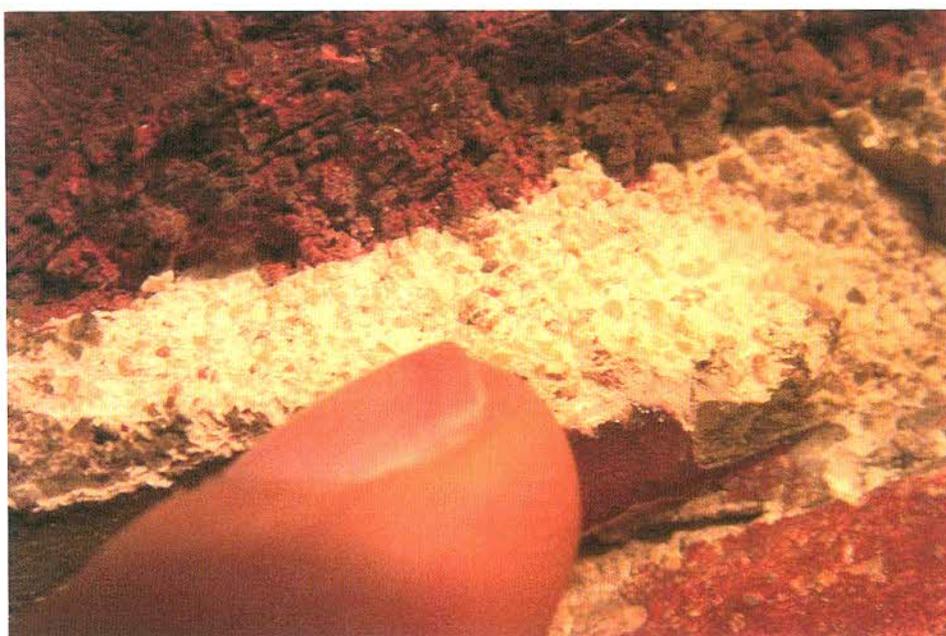
Fig. 4

Extensive work was carried out in the west and south lunettes and almost half the surfaces were restored. Even bearing in mind the considerations set out in the mission report for Spring 2007⁹, it seems less certain that the oldest application of plaster belongs to the third phase. Some elements¹⁰ suggest that we are dealing with an application that preceded the third phase¹¹ (Fig. 4).

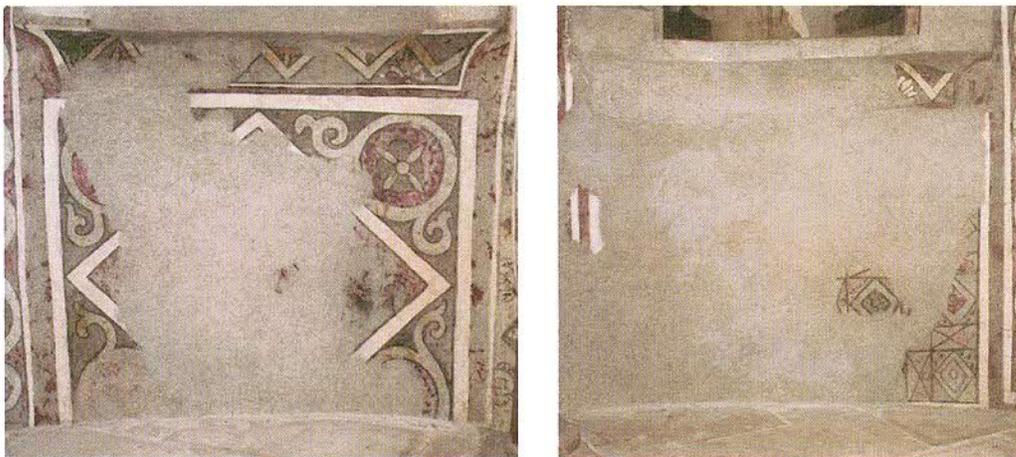
Figs.5 & 6

The restoration work in the south lobe has enabled us to observe and further clarify the decorated backgrounds between the niches and the paintings in the two sections flanking the access door to the façade and the *diaconicon*. The geometric motif of the two decorated panels below the two niches (Figs. 5 & 6) is discernible once again, although a great deal of the plaster is missing. All these decorations belong to the third phase of painting.

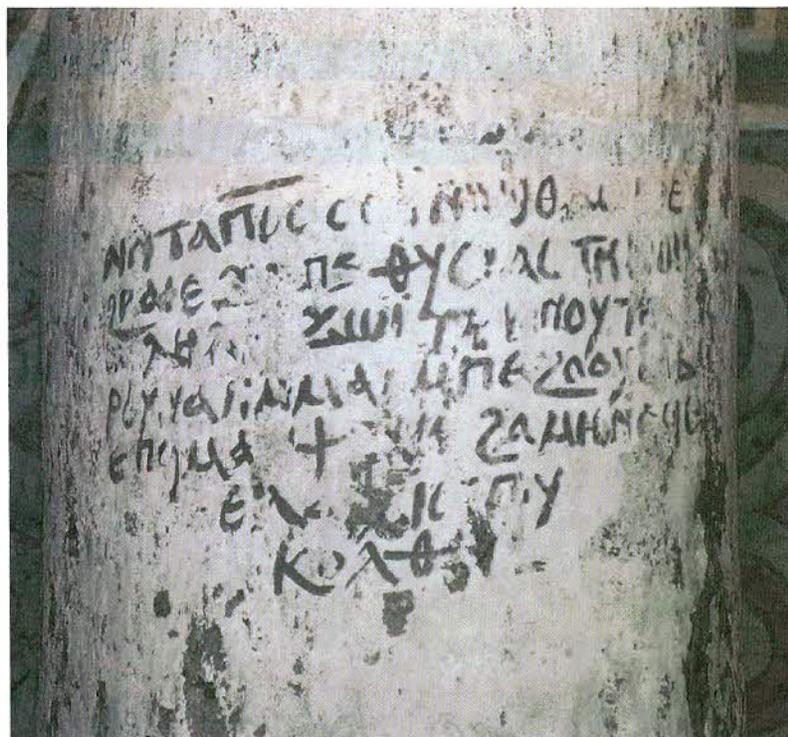
Fig. 6

The granite surface of the columns has been recovered as a result of cleaning. Some portions, applied directly to the stone, appear to show traces of a hematite finish. At some as yet undefined point in the past a white finish (white wash) was applied to the column shafts. This whitewash is better conserved at the tops of the columns. On the middle

column, the restoration work has enabled us to recover a partially preserved Coptic inscription in red¹³ (Fig. 6).

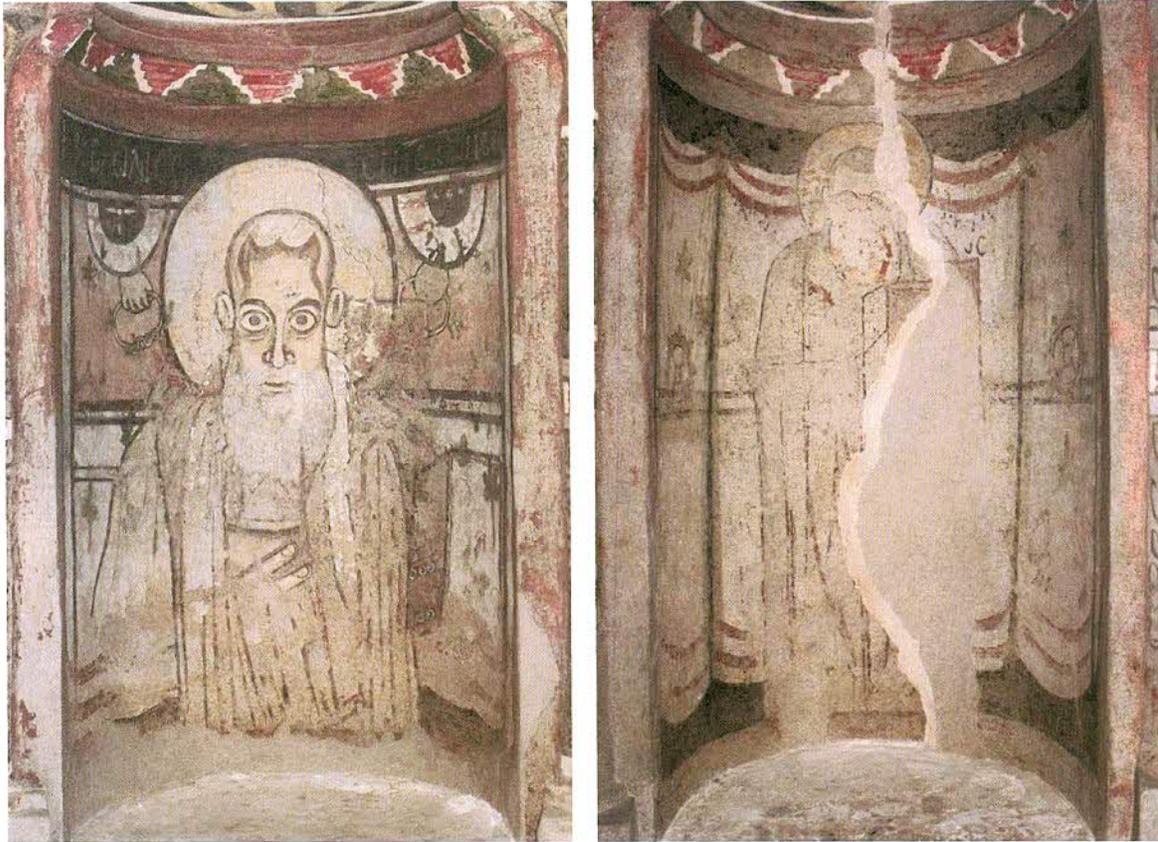
Figs.7 and 8

Also in the south lobe, the restoration of the two niches in the first tier has made it possible to discern the fourth phase of painting and the typical palimpsest encountered in all the painted niches in the church. St. Basil is represented in the left niche whilst the state of preservation of the right niche has made it impossible to identify the saint depicted there (Figs. 7 and 8).

The work of the painter of the *Virgo Lactans* (fourth phase) in the left niche is only partially preserved whilst in the center the typical palimpsest is visible through the gaps in the whitewash. In this case it reveals the underlying third phase application.

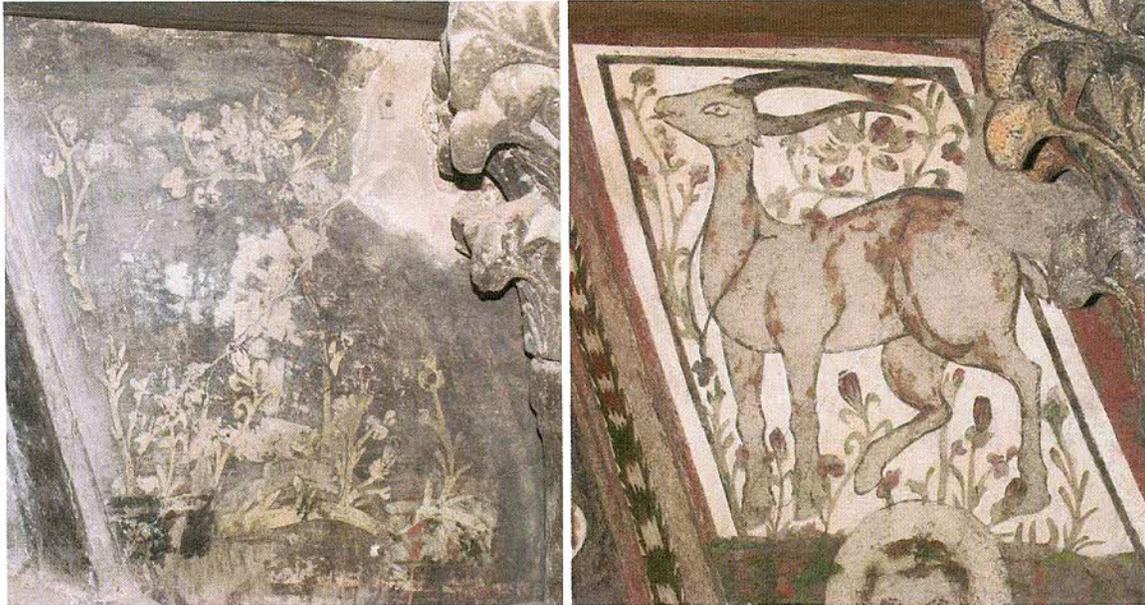
Figs. 9 and 10

The beautiful decorations on the panels in the first tier of the east lobe have been restored and are once again clearly visible. The paintings were concealed beneath a thick layer of dirt and partially obscured by an old layer of wash without any decorative element¹⁶ (Figs 9 and 10).

¹⁶ This wash was applied over the paint layer but particulate matter produced by burning (lampblack) was trapped between the paint layer and the wash.

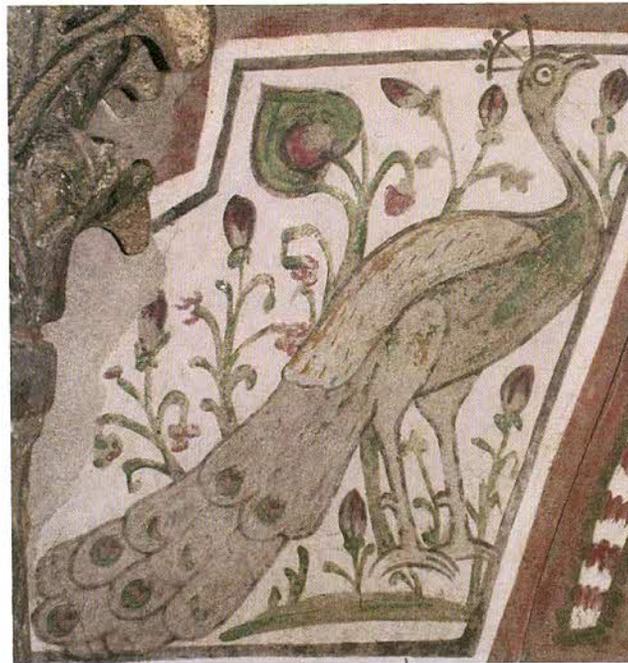
Fig. 11

The restoration of the decorations on the panels between the niches and the engaged columns has enabled us to recover new elements of the decorative repertoire typical of the Coptic figurative tradition during the late antique period. Additionally, in the upper area with the six flat panels below the cornice, animal motifs of particular interest were revealed. On the panels flanking the right and left niches, two pairs of symmetrically opposed peacocks are depicted (Fig. 11).

The shape of the peacocks is outlined in black and filled in with an application of green (encaustic) color and yellow. Flanking the central niche however, are two gazelles, also symmetrically opposed (Fig. 10) depicted with one back hoof raised and in the act of stripping leaves off flowering bushes. The paintings of all these animals use the white surface of the plaster as a background, across which elegant plants with flowers and leaves extend in the middle distance. The plants are painted in green and pink, using the encaustic or wax technique. Buds and pomegranates are outlined in black (Fig. 12).

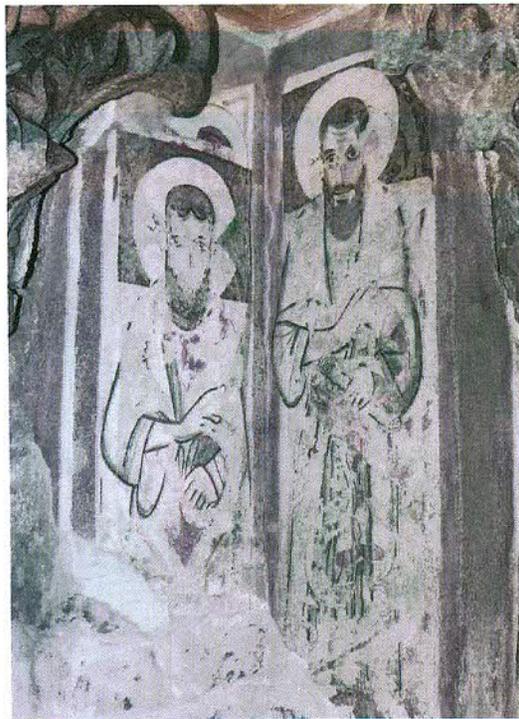
Fig.13

These fragments include the small figures of two saints (Fig. 13) painted on the engaged columns in the corner high up between the north and east lobes and in a relatively good state of preservation. The style of painting together with the black background framing the haloes of the saints links them unequivocally with two discoveries made during the Autumn 2006 mission at the foot of the external arch of the south apse (Figs. 14 and 15).

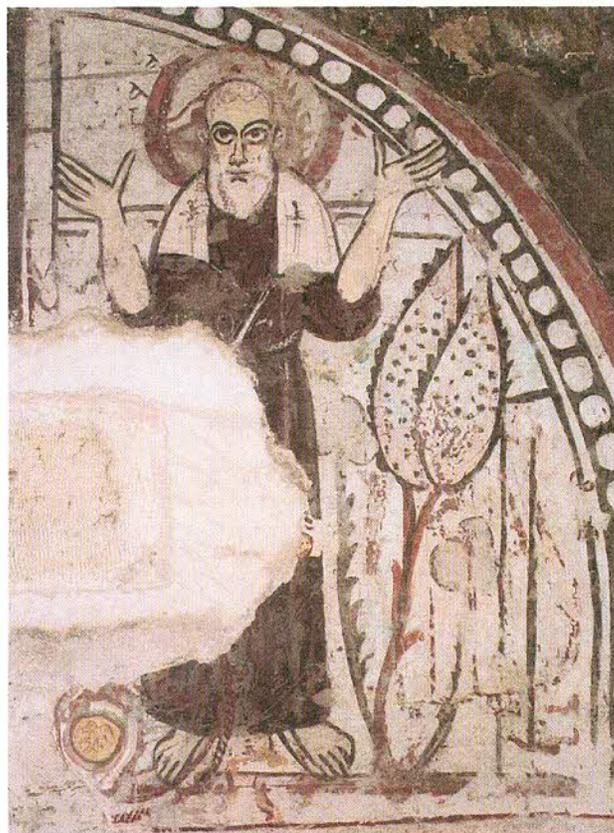
Fig. 17

The fourth phase, by the painter of the *Virgo Lactans*, prevails owing to the fine state of preservation evidenced by its iconographic features. On the right side of the west lunette the full-length figure of a praying saint is depicted (Fig. 17). A number of plants, standing out against the background, are painted growing out of the earth. At the top, around the halo, the fragments of several letters are visible. These were probably part of an inscription bearing the name of the saint and are no longer legible.

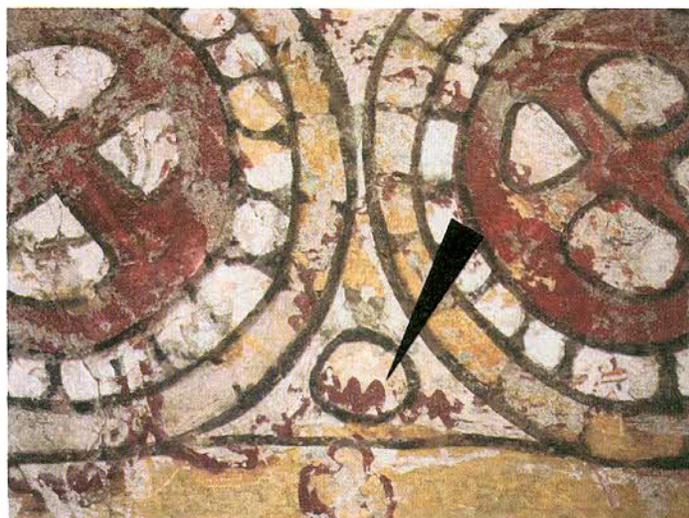
Fig. 22

Given the particularly poor state of preservation of the whitewash and seeing that it bore no graffiti or incisions, it was decided to recover the decorative elements underlying it. As a result of this decision, we were able to recover an elegant design comprising a motif of intersecting and interwoven concentric circles (measuring approximately 70 cm in diameter) repeated in a horizontal direction and executed with great precision, using a compass (Fig. 21). The design is enclosed between two horizontal red bands. Above the motif, this decorative band is surmounted by a horizontal braid. A braid with similar characteristics is thought to be present beneath the fourth phase composition recovered during restoration of the south lunette and beneath the decoration of the arch of the *prothesis* (Fig. 22).

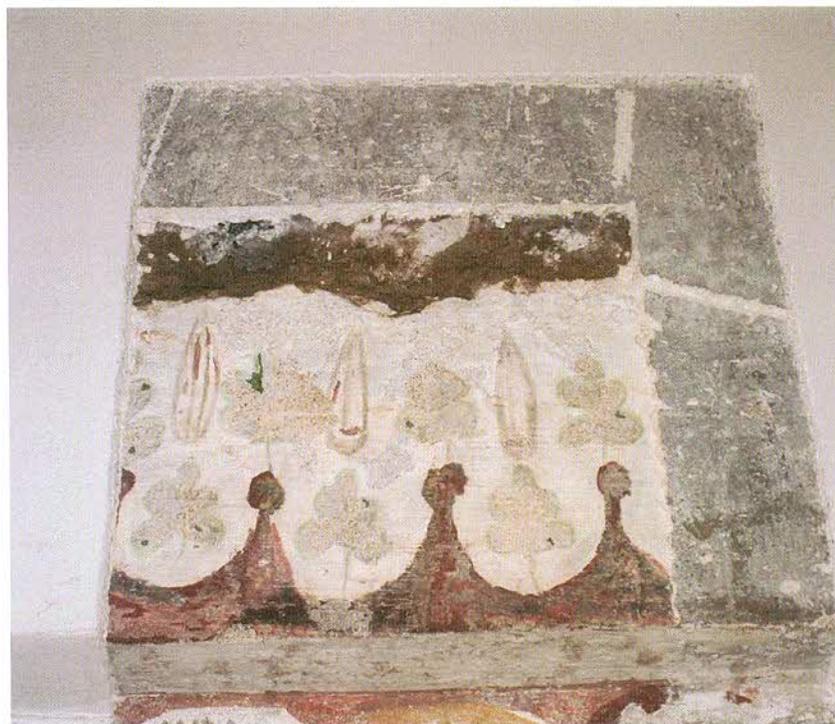
Fig. 23

Within each scallop there is a plant motif, of which the imprint alone is visible today (Fig. 23). The pattern of concentric circles stops near the entrance to the *prothesis* area leaving space around the arch for unstructured decoration based on an animal theme.

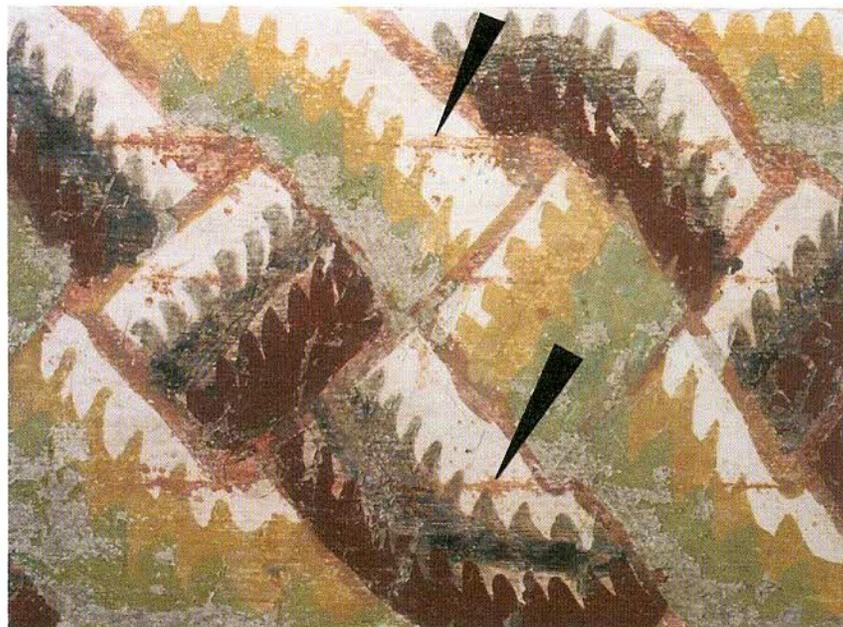
Fig. 25

The systematic manner in which the preparatory design and painter's line (Fig. 25) are employed and the use of the compass (Fig. 26) in the circle design suggest that these decorative elements belong to an earlier phase.

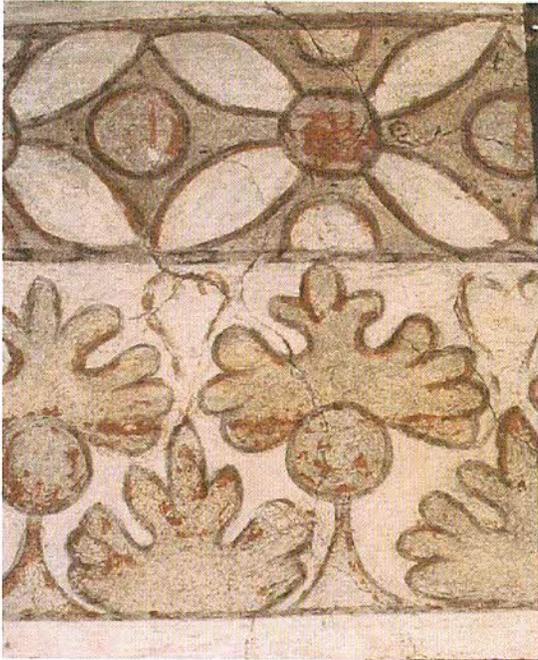
Fig. 27

Two test cleanings carried out in the south corridor enabled us to investigate the single area of plaster that currently seems ascribable to the oldest decorative phase of the building. The test cleanings revealed a decorative scheme that is repeated along the corridor and runs under the impost of the vault. The design consists of a plant motif with trilobate leaves emerging from a circle supported by a pedestal. These elements recall the shape of the Eucharistic chalice. Above runs a horizontal band decorated with repeated circular and oval shapes (Fig. 27). Only two colors appear to have been used: ochre and brown.

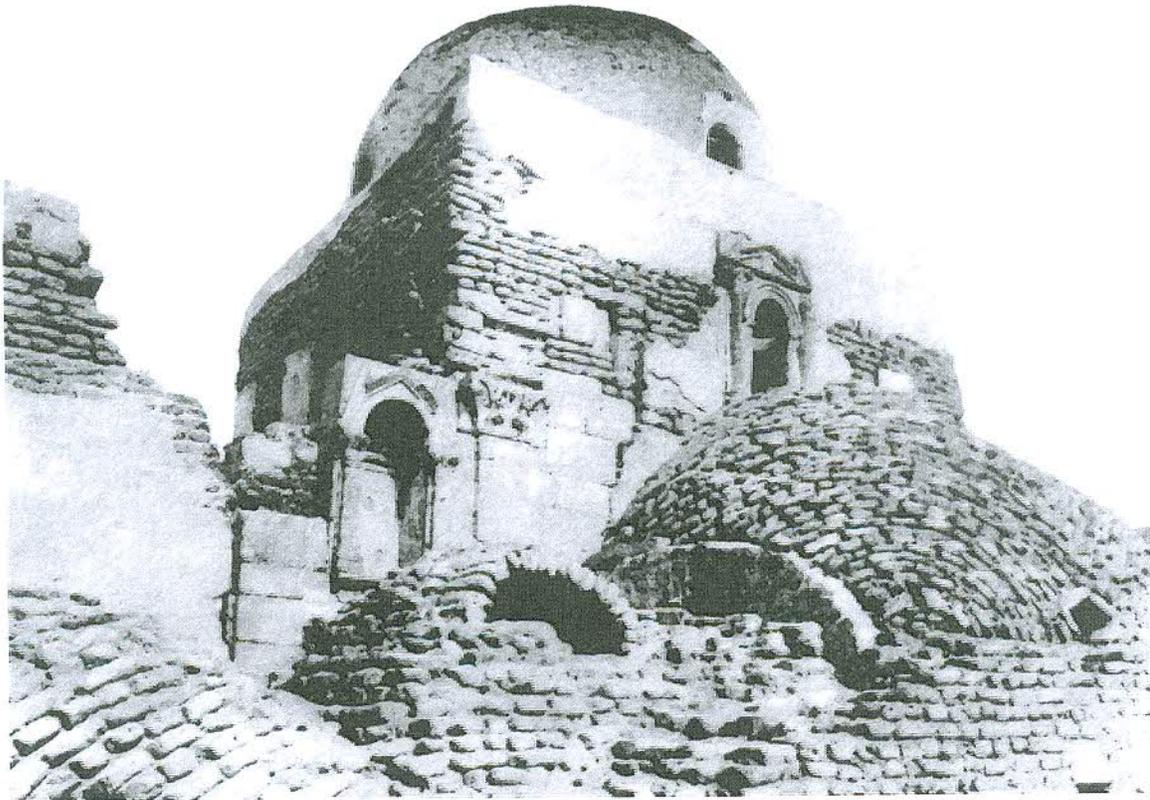
Fig. 28

The architectural structure of the south lobe suffered serious structural disruption in antiquity. Considering the area in which we have worked, it is possible to evaluate and precisely catalogue the structural problems and their consequent impact on the surfaces. Naturally, a simple comparison of the current state with the photos documenting the state of the façade at the beginning of the twentieth century (Fig. 28 taken from: C.Meurice, *Redécouvertes et premiers travaux sur les monastères de Sohag*, 2004) shows the scale of the structural problems and the work connected with them.

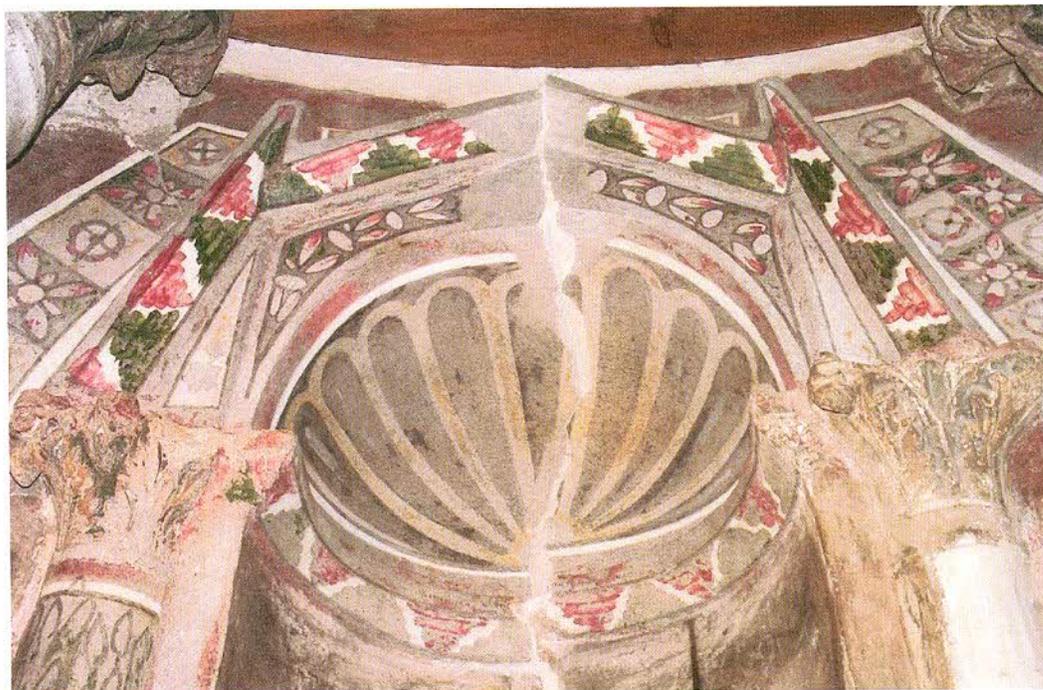
Fig. 29

which start in the second tier from the area above the extreme right-hand niche and descend to the first tier where the stone blocks composing the right-hand niche are also fractured. The tympanum is cracked exactly at its apex and there is marked slippage between the two sides (Fig. 29). The crack descends the entire length of the niche resulting in the loss of a considerable section of plaster from the center.

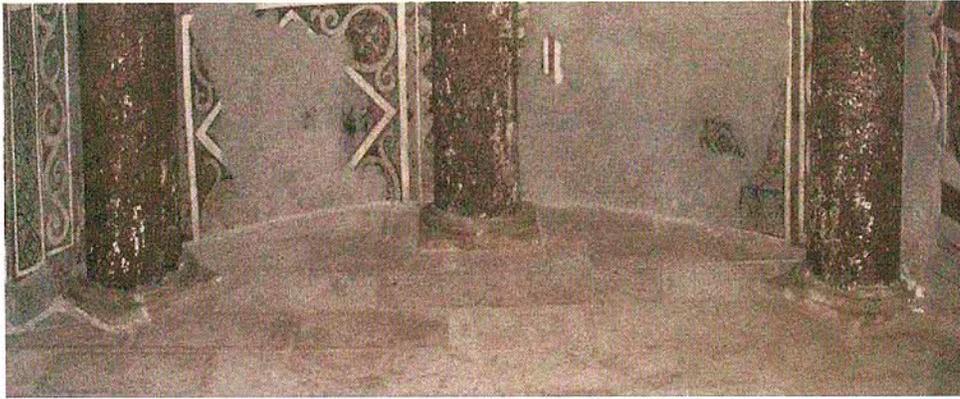
Fig. 30

The difference in floor level between the part of the south lobe adjacent to the *diaconicon* (the east side) and the opposite side, facing west, is probably also a consequence of this instability. This is because, when the floor was re-laid in modern times, the architectural structure had become stabilized with the east lobe sunk some 15-20 cm (Fig. 30).

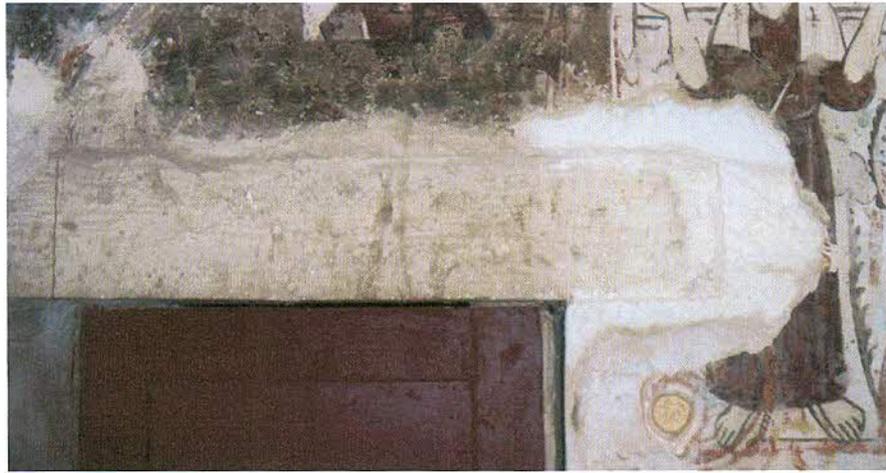
Fig. 32

In the *protesis* and the cornice of the east lobe portions of plaster have been lost as a result of human intervention. As already indicated, there are many gaps in the plaster in the west lunette of the *protesis* where the architrave was replaced (Fig. 32).

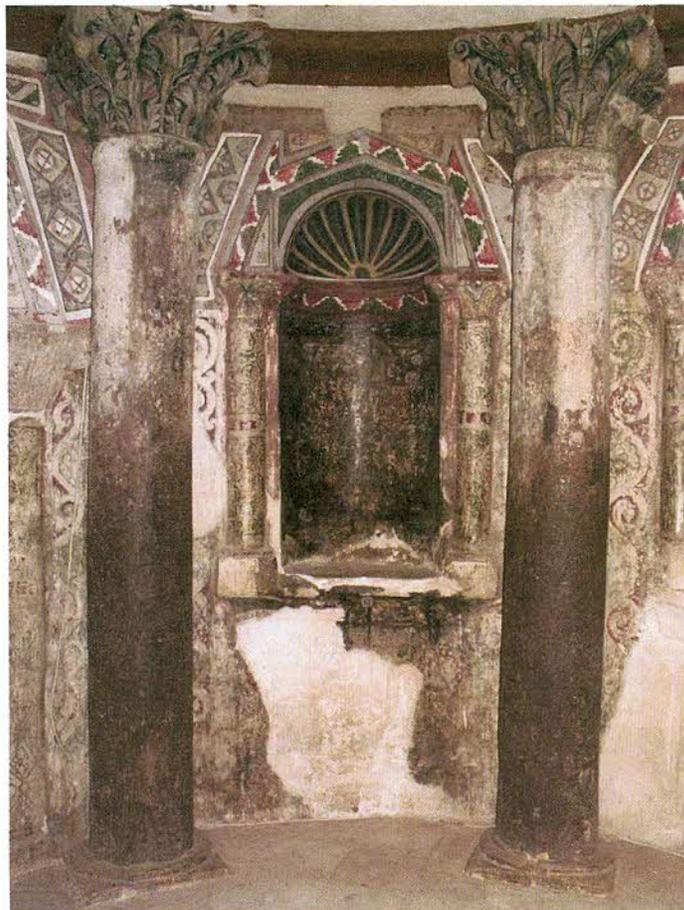
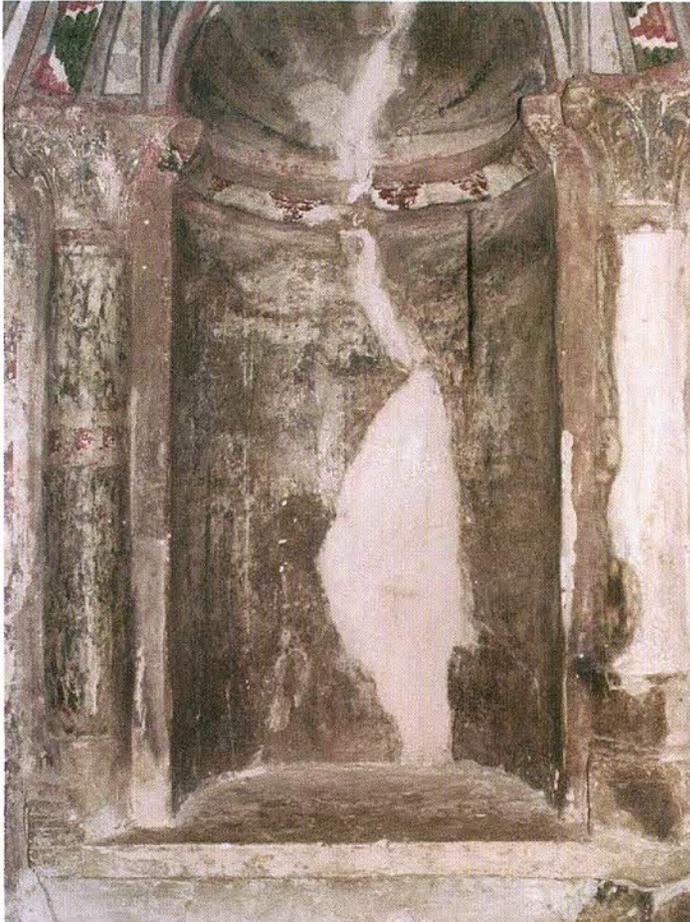
At this time, earlier repairs were redone and gaps filled using unsuitable mortar that encroached heavily on the original painted plaster (Figs. 33 and 34).

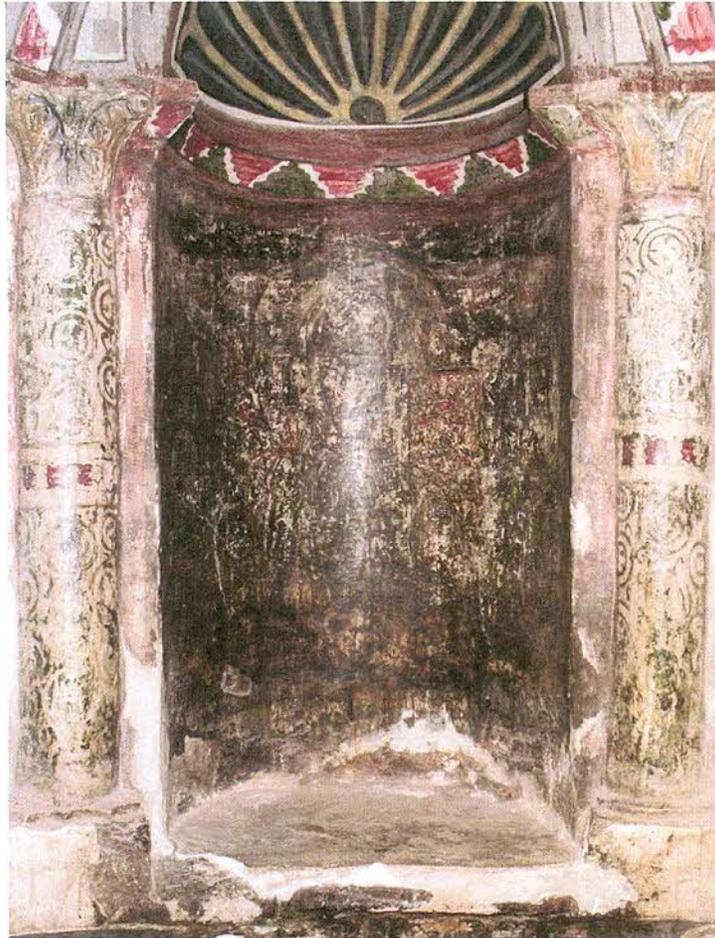
Fig. 35

prothesis and the niches of the south lobe, are generally well preserved. Paintings tend not to adhere in places where they are executed over an earlier paint layer with a thick covering of dirt and where the earlier paintings were executed using the encaustic or wax technique. In analyzing the causes of deterioration triggered by human intervention, it is interesting to note the similarities and chronologically group a number of operations identified in different areas and carried out during previous restoration work on the paintings. The paintings in the niches in the first tier were subject to restoration work that cannot be dated accurately but was probably carried out after the work of the Comité. These areas were covered with a thick layer of heavily oxidized oil and resin-based varnish²⁴ (Fig. 35).

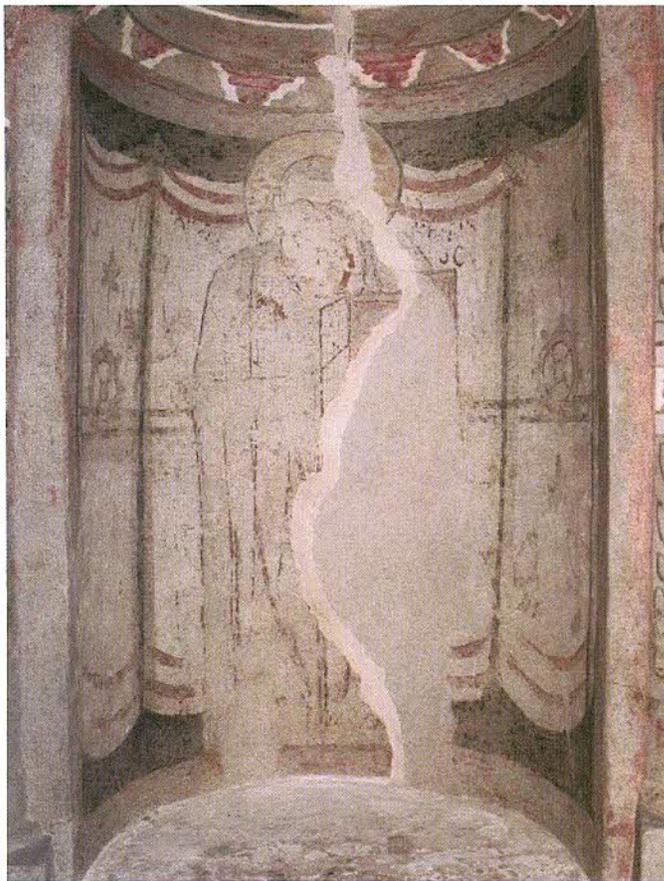
Fig. 36

To date, the full-length figure of the saint belonging to the third level of painting is almost impossible to make out (Fig. 36). This is the result of the mechanical cleaning carried out in order to reveal the figure coupled with its exposure and proximity to the faithful during religious services. It was common practice to place candles and oil lamps in the ground floor niches during religious ceremonies. In addition to this, the Coptic community's habit of touching the images of the saints in order to receive their blessing has worsened the state of preservation of the paint layer.

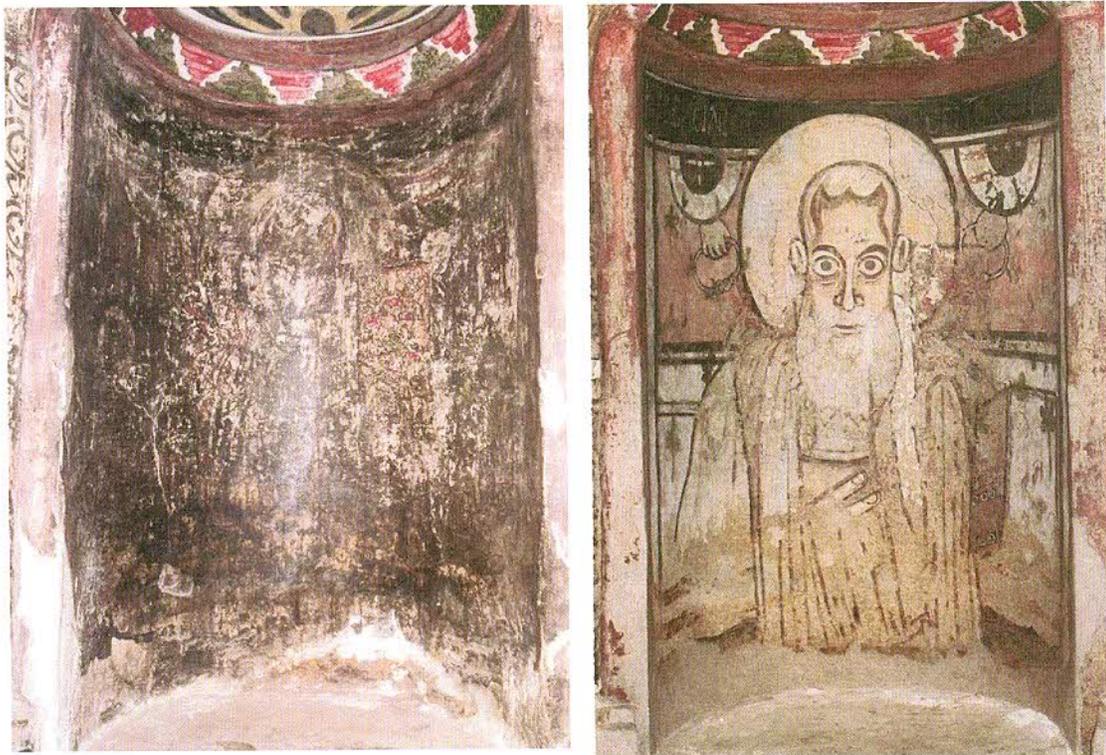
Figs. 37 and 38

Fortunately for us however, the white wash was not mechanically removed in the left-hand niche in order to investigate the painted palimpsest. Our restoration work revealed it to be partially preserved beneath a layer of dirt and sooty deposits from candles and oil lamps (Figs. 37 and 38, before and after restoration). The areas in which the white wash has fallen away can be attributed to differing powers of adhesion to different applications of color in the underlying paintings and the mechanical action of the touch of the hands of the faithful. On all the remaining surfaces of the niches the layer of dirt appeared to be a natural deposit composed of atmospheric particulate matter and sooty residues produced by the burning of

candles, lamps and incense. Now the Coptic script at the top of the icon is legible again and the saint can be identified (BASILIO).

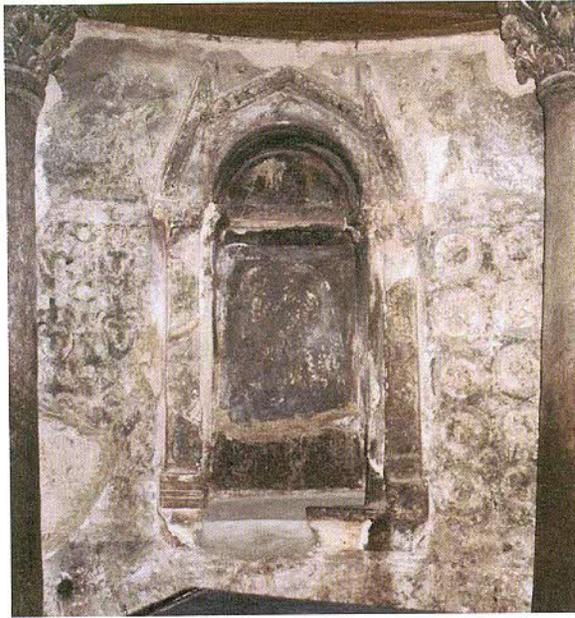
Fig. 39

The decoration of the first tier of the east lobe, home of the *santa sanctorum*, was heavily blackened, as can be seen from the state of the lower section down to ground level which we have not restored. The blackening can be explained by the fact that this is the current location of the altar, illuminated by a great number of lighted candles, and where the priest usually stands with the censer. As a result, the whole surface was much more greatly obscured than the other areas of the triconch (Figs. 39 and 40).

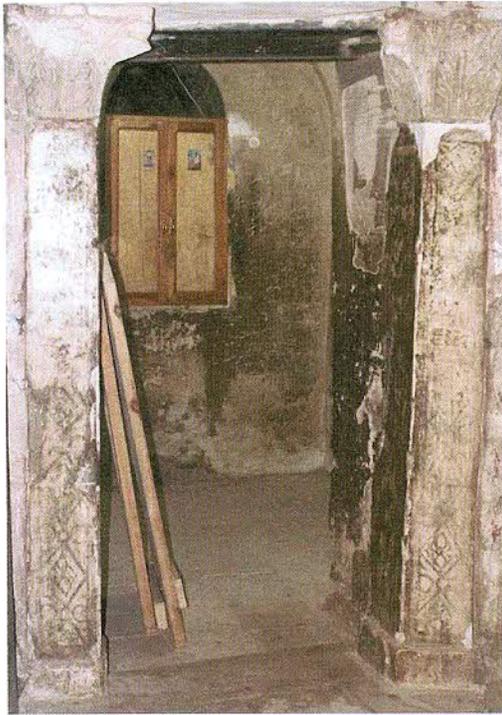
Fig. 41

Before restoration, the task of deciphering part of the decoration was rendered even harder by the presence of a relatively modern wash, without decoration and with many gaps. However, the pigments applied using the encaustic technique seem to have been preserved better in this area than in others. This demonstrates that, as is often the case, the dirt and sooty particulate matter deposited on the surface have directly or indirectly protected the paint layer. On the other hand, where mechanical action on the walls and the passage of pilgrims associated with the religious activities of the building had a greater impact, the paint layer and decoration have almost entirely disappeared, leaving only the imprint of the design to be seen. This kind of problem has been encountered particularly on the uprights of the two passageways connecting the south lobe to the facade area and the south lobe to the *diaconicon* (Fig. 41).

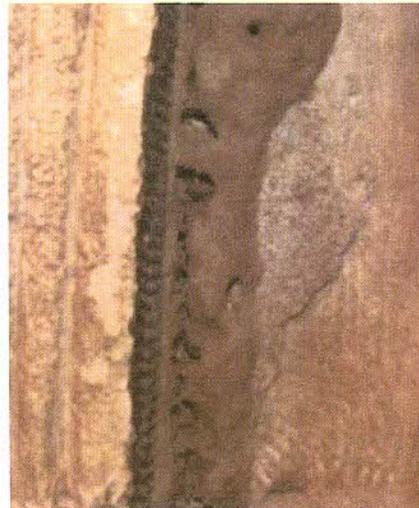
Fig. 45

In some places, insect nests have been found (Fig. 45).

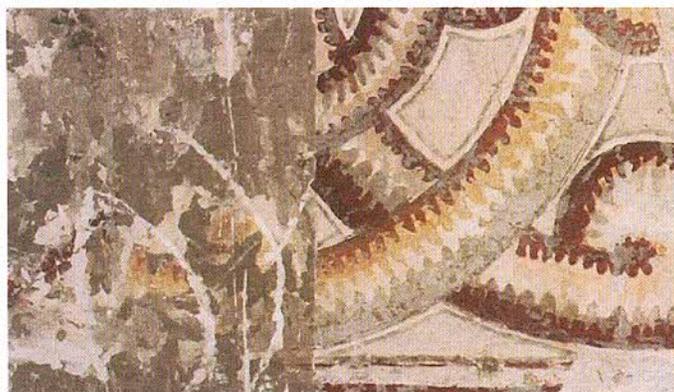
Fig. 46

The extensive tests carried out in the adjacent corridor brought to light a paint layer affected by generalized abrasion that has not however compromised the reading of the paintings. The technical aspects of the paintings, namely a thin application of paint on well-smoothed plaster, have favored their preservation. The fact that these paintings remained hidden beneath a layer of wash has proved to be their ultimate salvation (Fig. 46).
