FINAL REPORT

Spring Mission: March 2, 2007 – May 2, 2007

Luigi De Cesaris & Alberto Sucato, Restorers

“Conservation and Documentation of the Wall Paintings at the Red Monastery, Sohag”

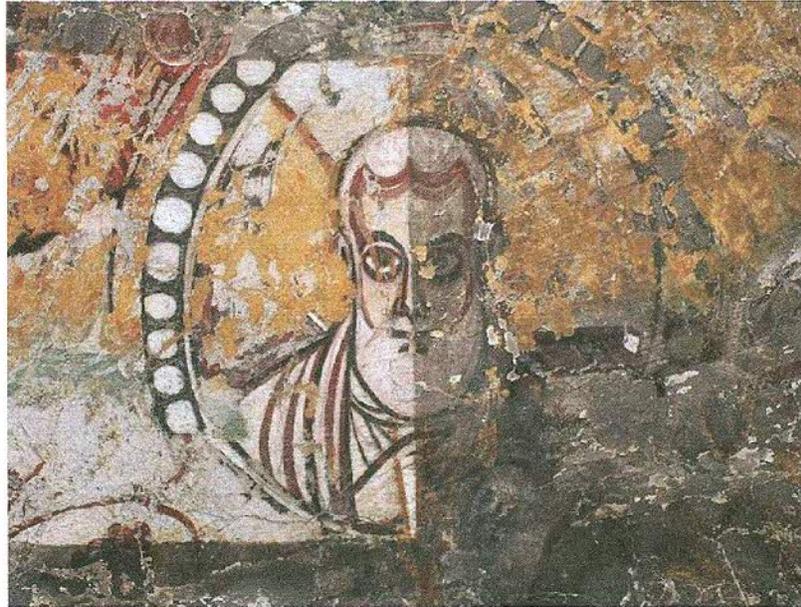
Fig. 4

In the *protesis*, efforts were concentrated on the vault, completing half of the surface (Fig. 4) and two test cleanings were carried out on the archway to the north corridor (Fig. 5) and the upper part of the south wall (cf. Fig. 39) respectively.

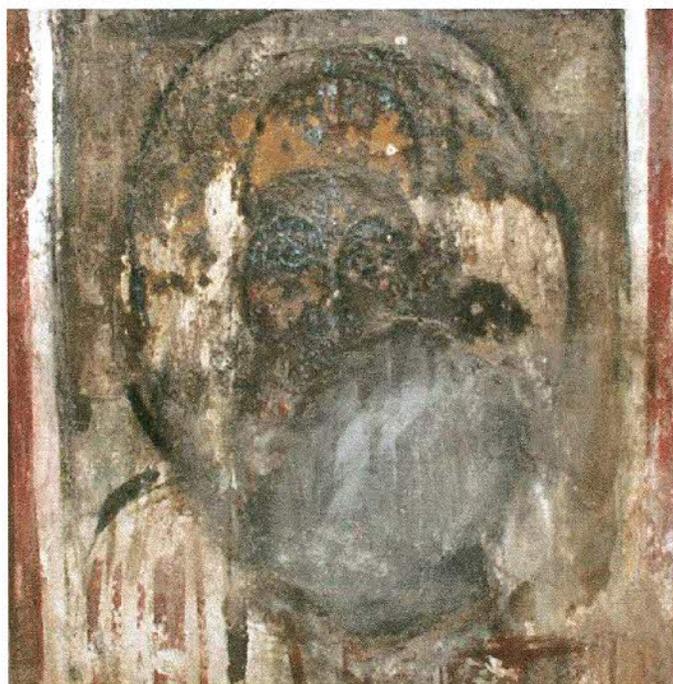
Fig. 6

During the first phase of work we tackled the delicate issue of removing old repairs carried out using mortar that was not compatible with the original mortar² (Fig. 6).

² These are deep repairs with the following stratigraphy: vegetable fiber with animal glue, gypsum, cement, gypsum.

- recovery of painted areas covered by old pointing (in the south lobe numerous repairs to cracks, large gaps and hairline cracks had been carried out over the entire surface);
- recovery of mortar used in restoration where this did not have a negative impact on the constituent materials of the original; bringing this mortar up to aesthetic parity with our restoration work;
- consolidation of fractured or detached stonework and repairing of gaps in the cornices and moldings to make the architectural features easier to read;

- repairing of gaps using appropriate mortar in the areas where the removal of the old mortar used in restoration proved unavoidable.

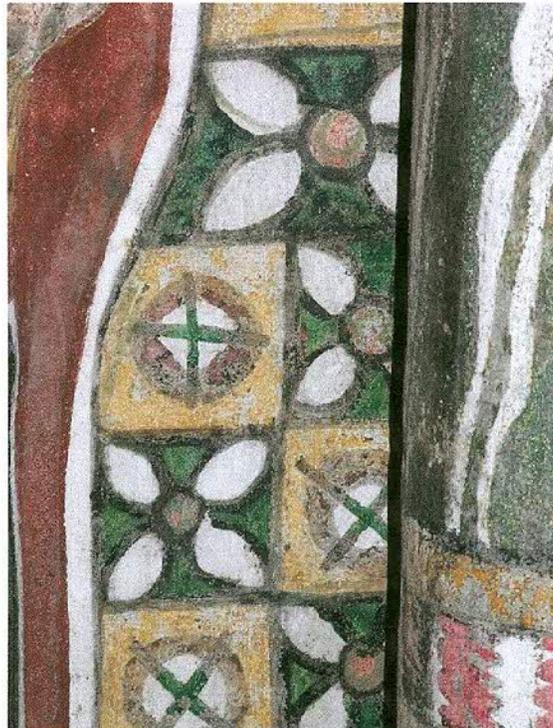
Fig. 9

We can be quite certain that the most visible types of plaster all share the same characteristics. They are lime-based with inclusions of quartz sand with very rounded, spherical grains⁴. This plaster is approximately 0.5 -1 cm thick (it is thinner on the moldings and the shafts of the columns) and can be linked with the third (or wax decoration) phase of decoration⁵ (Fig. 9).

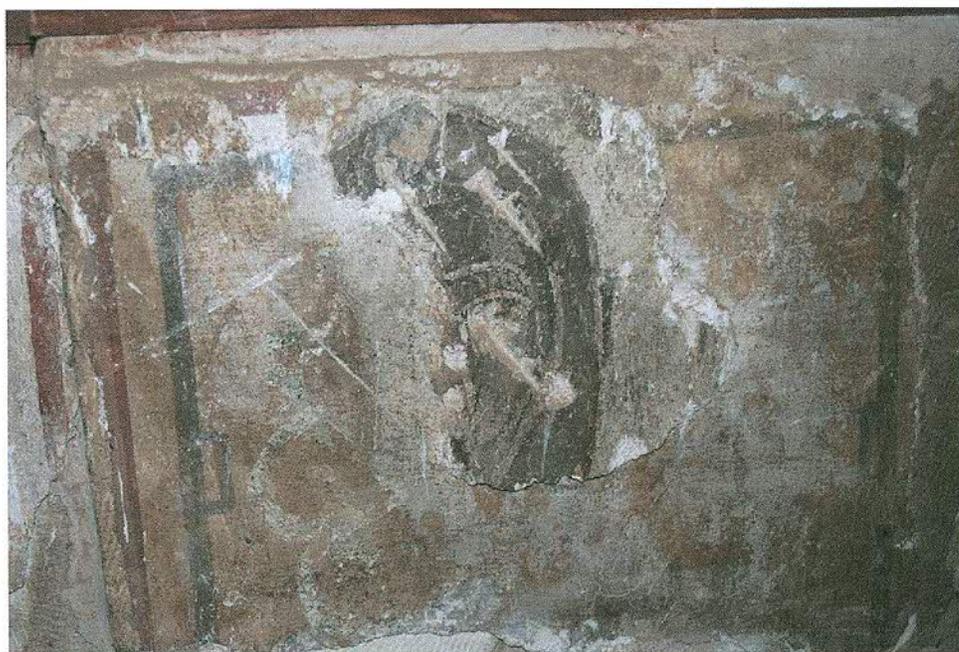
Fig. 10

Most of the plaster visible on the façade is from the third phase; however it can be linked more specifically to the wax decoration period. In the areas where the plaster has fallen away, underlying portions of painting from the first phase of decoration of the church can be seen. We have observed that the surface of the stone blocks, where exposed, is coated with very fine (1-2 mm thick) plaster/pointing (cf. south lobe⁶) comparable to that present on the stone arches of the apses and painted with decorative geometrical designs on a white background.

10). This plaster, which has an average thickness of 8-10 mm, is fine and white with a low percentage of sand and a considerable amount of straw in the mix.

The two remaining fragments between the first and second tiers, where the head of a saintly monk in the Coptic tradition (cf. Figs 10 and 11) can be made out, may be associated with this period.

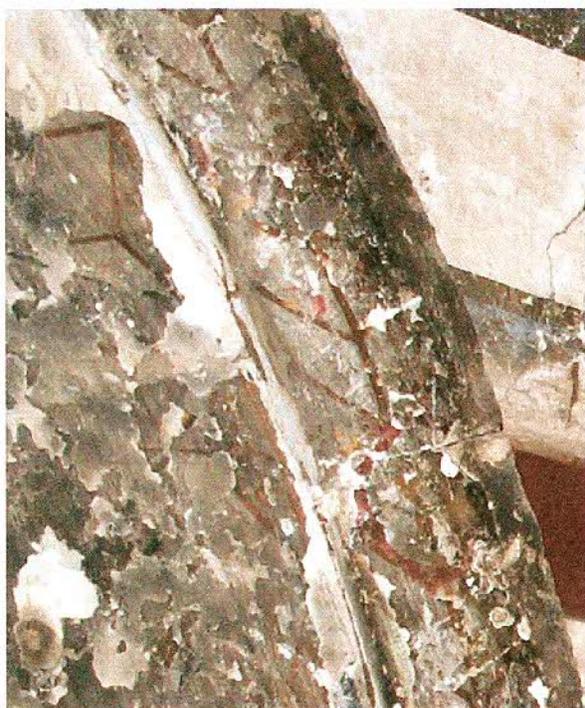
Fig. 11

This plaster is comparable to that on the adjacent north wall where the saint on horseback is depicted. An initial visual analysis suggests that the plaster covering the curtain walls of the courtyard/nave has the same composition. Furthermore, in the arch surmounting the access door to the north corridor, we have observed that during the application of this plaster over the third phase decoration, the molded parts were primed with a thin (1.5 mm thick) coat of fine plaster with a similar composition (Fig. 11).

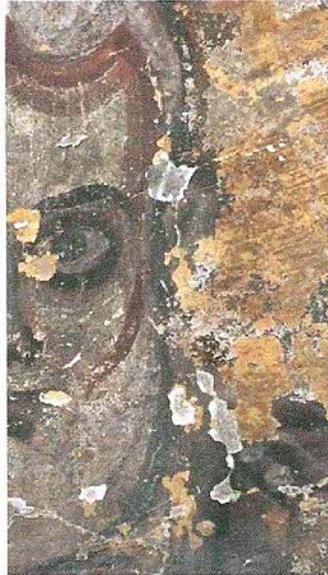
Fig. 12

As described previously, the painter of the fourth phase did not deem it necessary to apply new plaster, counting instead on the properties of *white wash* used as a covering preparation applied directly over the existing paint layer. This layer, with its characteristically chalky texture, was applied to the entire surface and varies from 0.5 mm to 1.5 mm in thickness (Fig. 12).

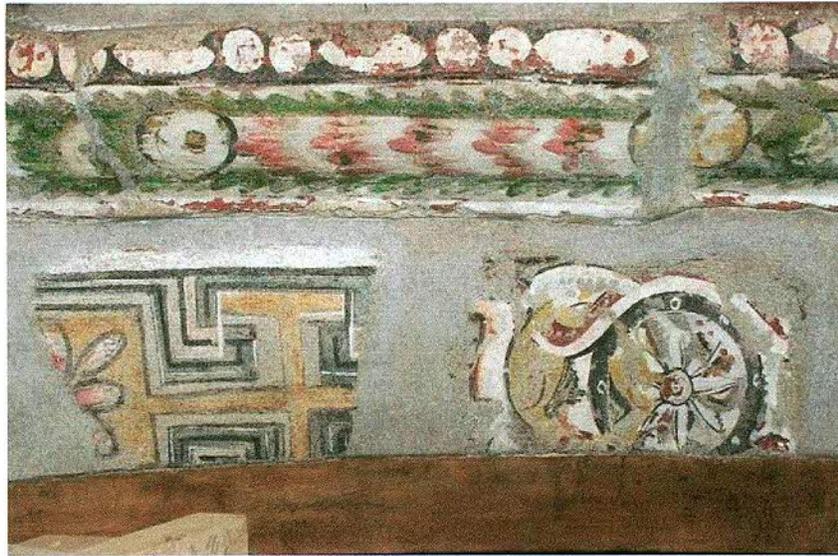
Fig. 13

Starting our analysis of the south lobe, we were able to read the geometric decoration of the cornice dividing the apse from the second tier in a new light. We observed that several blocks in the cornice had been removed and replaced in the wrong position during the work of the Comité. This suggests that, during the Comité's radical intervention, no account was taken of the original position of the stones when replacing them (Fig. 13). It is likely that enormous deposits of dust and the remains of mortar from old repairs made it difficult to reposition the stones in their original order.

The cornice is made up of two elements, an upper projecting one and a lower vertical one. The upper one is decorated with a pink and green garland interspersed with medallions, the upper edge of which is marked by a motif of circles and ovals. The latter design was painted during the fourth phase over an existing red band. The same artist selectively painted over the backgrounds and medallions in white. The green and pink pigments, applied using the wax technique, link this painting to the third phase. The curvilinear bands and circles with floral motifs on the lower vertical part can be attributed to the *white wash* period (fourth phase of painting) but probably cover an older similar motif. The geometric design with meanders and floral motifs (Fig. 14) only partially present on the cornice is from blocks belonging to the lower cornice which were wrongly replaced here (Fig. 13).

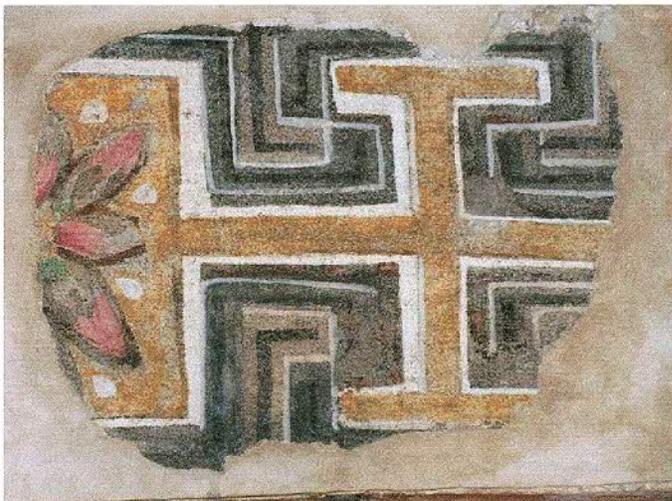
Fig. 14

The lower cornice is also made up of two elements, an upper projecting one and a lower vertical one. The upper one is decorated in a manner similar to that already described. The vertical one has a geometric pattern with meanders and floral motifs (third phase).

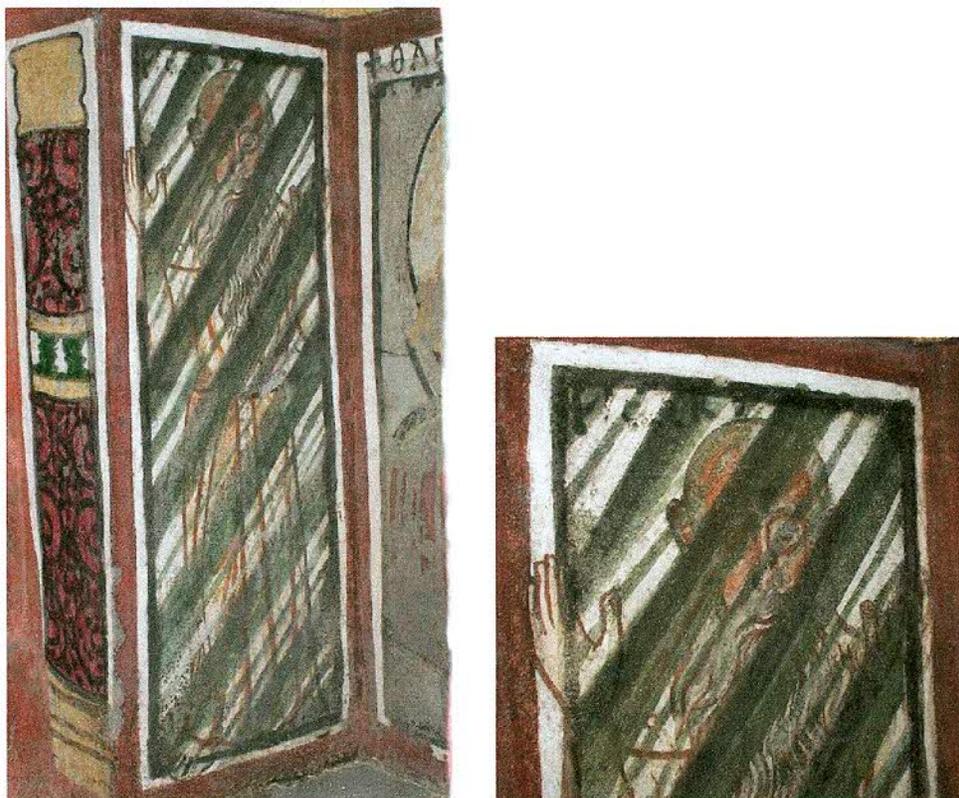
Figs. 19 and 20

The niche depicting St Mark has a peculiar characteristic. On the two lateral panels there are two small full-length images of saints (Figs. 19, 20, 21 and 22) that have been covered by the same artist with an imitation marble pattern of diagonal green bands. Their obliteration was the result of a change in the iconic program. These images of saints could only be seen from a lateral viewpoint owing to their small size and position; it was hard to distinguish them from below and their presence may possibly have disrupted the rhythm of the composition. Such a volte-face, halfway through the work and seen only in this tier, adds weight to the previously advanced theory that the south lobe was decorated before the north. As in the north lobe, it is evident here that the painter of the fourth phase primed the surface with *white wash* and only repainted the saints² inside the niches (Figs. 15, 16, 17 and 18). In this area it has been possible to clarify and recover important information as a result of cleaning work. The two external niches depict saints who were difficult to identify before they were cleaned. The text that once named them runs along the upper cornice and probably dates to the third phase. It was damaged during earlier attempts at restoration and is not easy to decipher. Fortunately, the cleaning of the surface has made the fourth phase text legible again, enabling us to rediscover the inscriptions and original names of Saints Stephen and Theon. In the two central niches, drastic early attempts at restoration have wrought particular damage on the lower part depicting the hand holding up a book. The fourth phase plaster, a great deal of which is missing, reveals the book and fragments of the hand from the preceding phase³. Much of the lower part of the two saints is missing and it has

not been possible to recover the fourth phase inscriptions, however, the recovery of the names on the upper cornice, even though they are not particularly clear, has led us to identify Mark and Annaeus⁴.

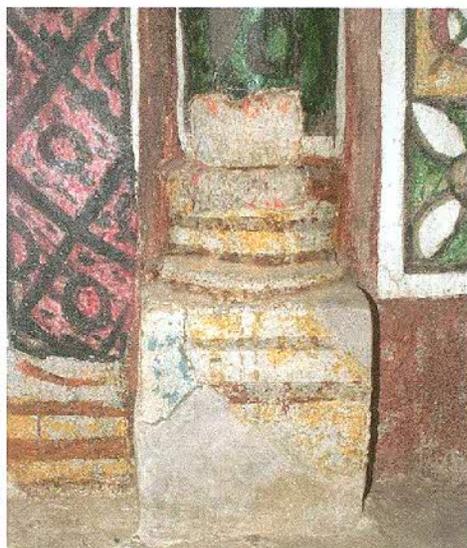
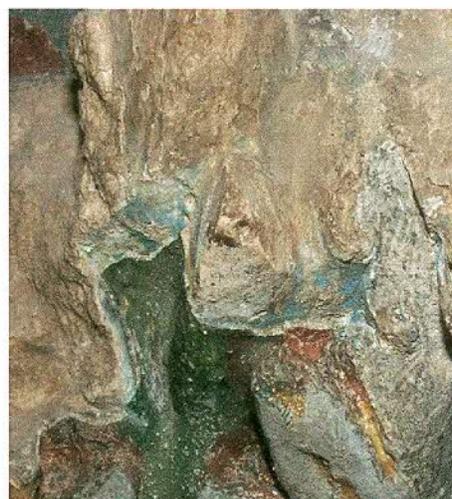
Figs. 23 and 24

This early decoration (Figs. 23 and 24), of which portions of blue (Egyptian blue), pink and red can be seen, confirms that the architecture was already painted extensively in polychrome at that time.

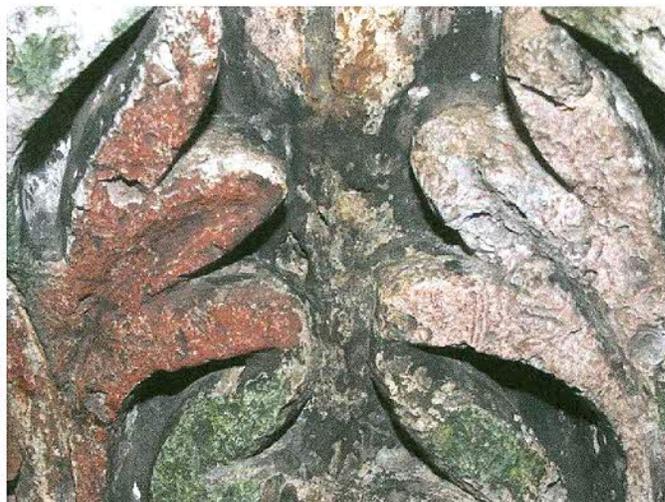
Fig. 25

The five capitals surmounting the granite columns are polychrome and paint was applied directly to the surface of the limestone. The absence of preparation leads us to believe that the capitals must have been polychrome from earliest times; during successive phases they were simply cleaned and touched up (Fig. 25). The decoration of the capitals highlights their sculptural nature: the background and areas of low relief are black, contrasting with the areas of high relief which are painted green, yellow and red. The painted palimpsest echoes that of the north lobe in this tier too. The lunette over the access door to the *diaconicon* was repainted during the fourth phase and our work has enabled us to recover part of the background, the halo and the face of the saint as well as fragments of the Coptic inscription. It is likely that this repainting also involved the interior of the two niches where we have not yet worked.

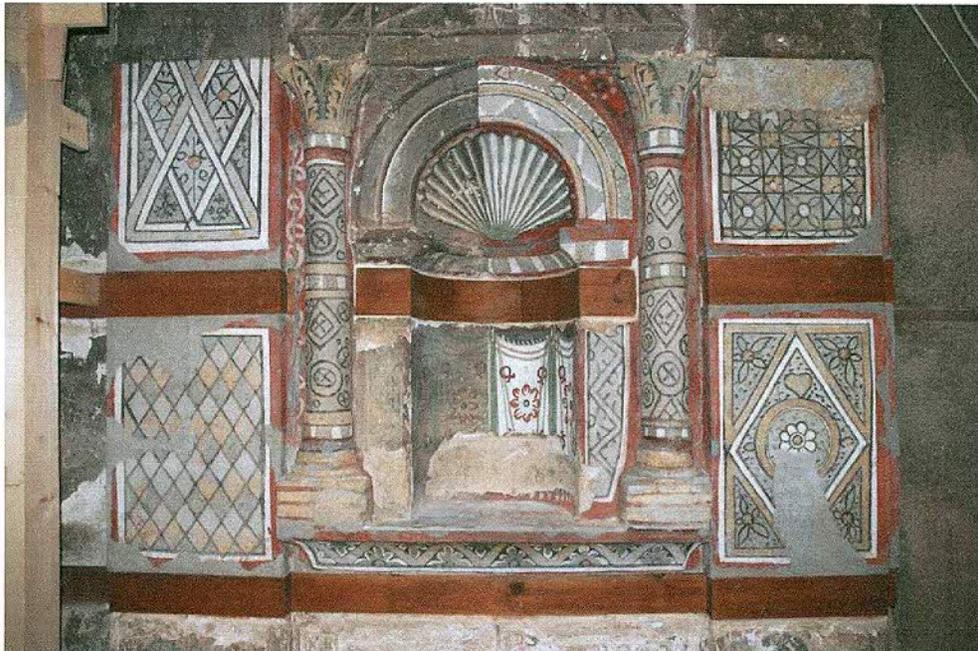
Fig. 28

Three test cleanings were carried out in the second tier of the north side of the facade. A first large test cleaning was carried out between the two engaged columns (Fig. 28) and the others on the background close to the cornice of the arch containing the niche over the door to the corridor and on the apex of the same cornice (Fig. 33) respectively. These test cleanings enabled us to understand the painted palimpsest of the facade. The first and third phases are present although the fourth phase has not been encountered to date⁵. However, we now understand that there is a further phase to the decorative scheme known to date. This can be attributed to the period of the painted crosses present on the facade above the arch and to the left of the saint on horseback. The crosses can certainly be linked with those painted on the plaster of the courtyard/nave. During the work we were able to observe an area where the first phase of painting is clearly visible. Its state of preservation enabled us to understand some of the techniques used in its execution. The painting was laid out on a thin preparatory layer approximately 2 mm thick which leveled the irregular surface of the limestone blocks. By observing it under a raking light, we were able to see that the design was divided up using the builder's line technique (Fig. 26). It is decorated with a geometric checkerboard pattern with tondi and floral elements. It is interesting to note that the third phase painter subsequently used this pattern.

The decorative scheme of the facade is on plaster from the third phase. The painter followed a scheme of geometric modules, limiting the use of curvilinear designs and inscribing floral elements in large rectangles and rhombi (Figs. 27 and 28).

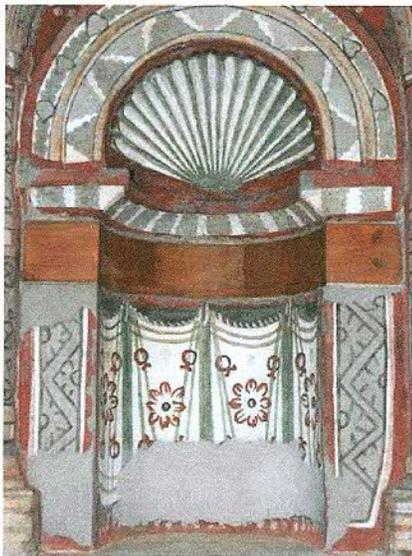
Fig. 31

A comparison of the decoration of the niche with the others in the triconch shows that the former is somewhat simplified. The veins of the shell are highlighted with green lines, leaving the white background with its preparatory layer visible. The *velarium* or curtain is also painted using a limited palette, given the size of the niche, and in a less elaborate fashion⁶ (Figs. 31 and 32).

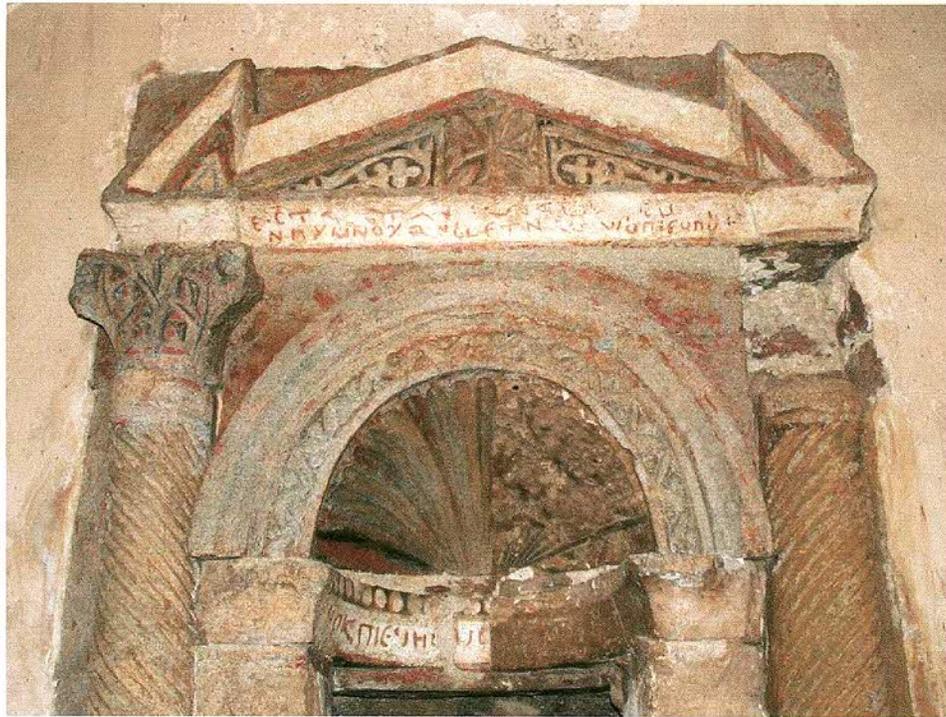
Fig. 34

Without scientific backup it is currently difficult to decide whether the decoration of the window belongs to the first phase of decoration of the church or, as seems more likely, the third (Fig. 34).

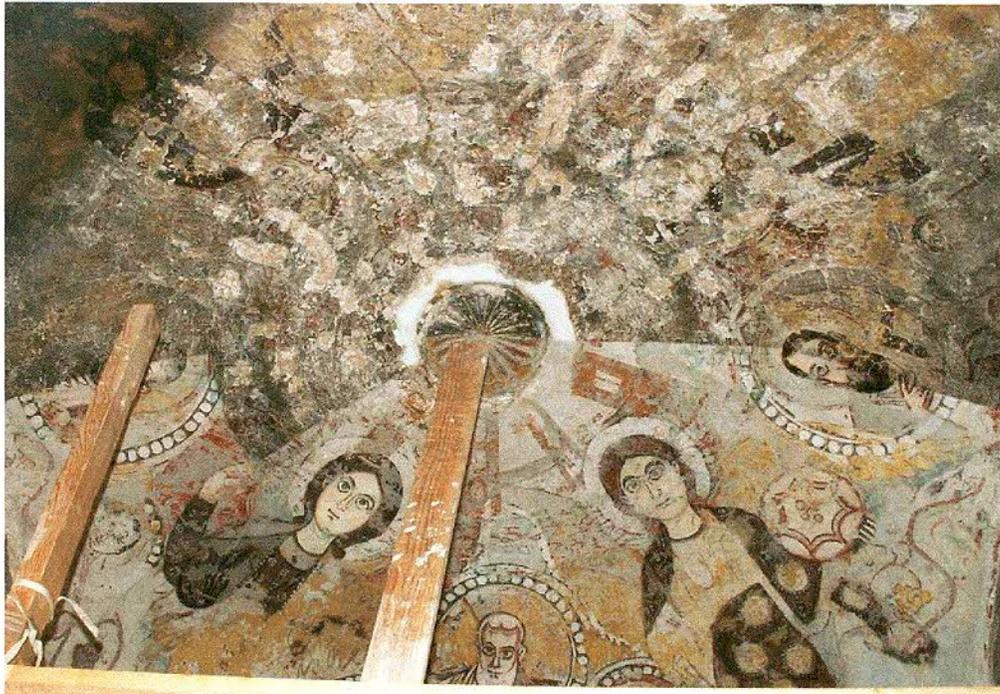
Fig. 38

The artist of the *Virgo Lactans* painted a layer of *white wash* over this phase in order to execute a new design. He painted four large archangels on the two diagonals of the vault and inserted four tondi containing half-length figures of the evangelists in the spaces between them. Between these he painted smaller tondi containing small figures, also half-length (Fig. 38).

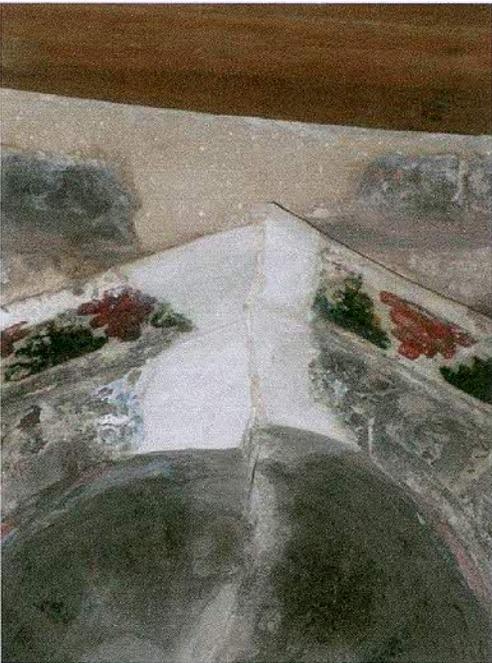
Fig. 40

Our report of autumn 2006 has already described the characteristics of the damage evident between the windows of the drum, on the triumphal arch and on the curved face of the apse in the south conch. The consequences of this instability on the paintings and architectural surfaces can also be seen in the second tier. The lesions in this area (niche of St Stephen) extend down to the first tier where the single stone architrave surmounting the access door to the *diaconicon* is fractured and the contact surfaces have slipped slightly. Even more accentuated is the line of cracks beginning in the area above the niche of St Theon in the second tier and running as far as the first tier where even the stone blocks of which the right-hand niche is built are fractured (Figs. 41 and 42). The tympanum is cracked precisely at its apex and there is marked slippage between the contact surfaces (Fig. 40).

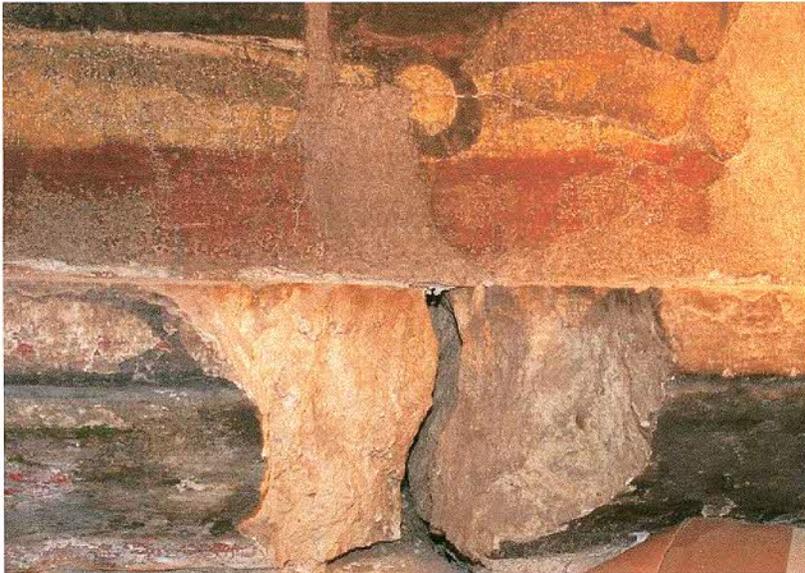
Fig. 43

Human intervention in the form of the movement, replacement and substitution of stone blocks and columns has also impacted negatively on the stonework, causing the structural instability described above (Fig. 43).

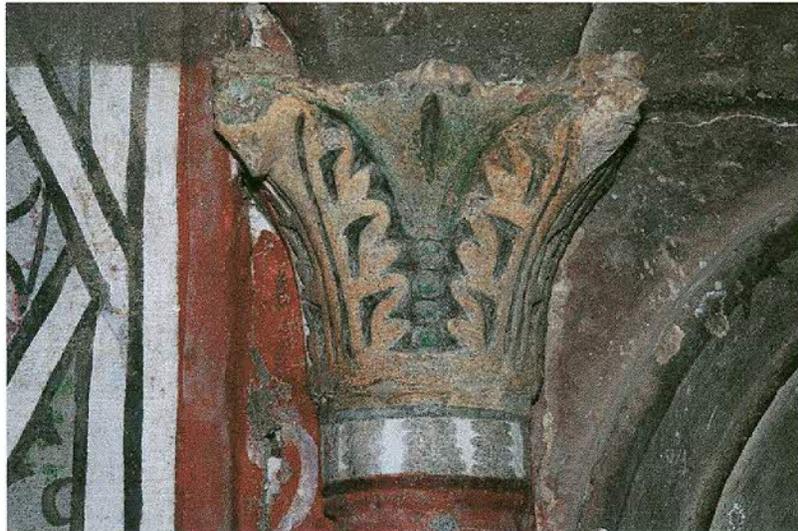
Fig. 45

In the south lobe the plaster is cracked in the areas where there is structural instability. The cracks correspond to sizeable gaps between the plaster layers and the wall. Portions of plaster have been lost from the lunette of the access door to the *diaconicon* in the façade area (Figs. 44 and 45) and from the two cornices.

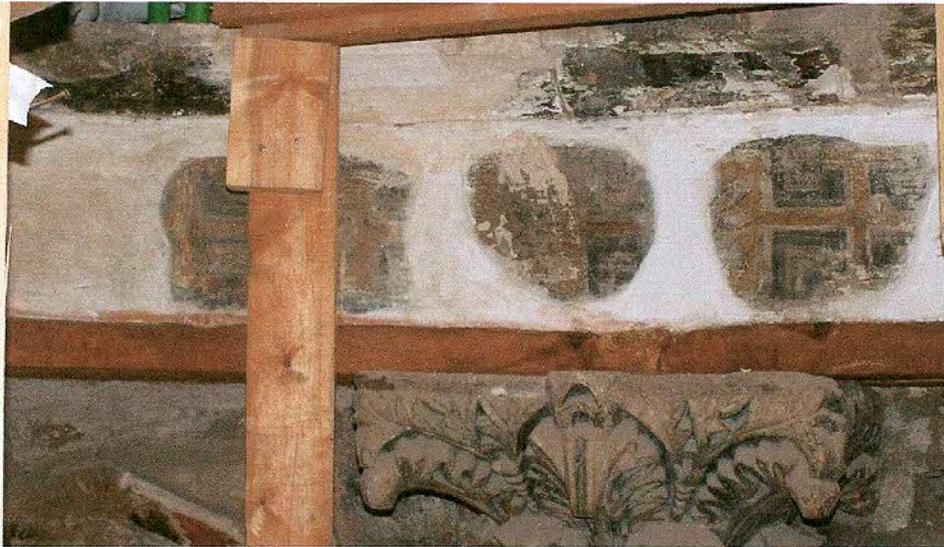
Fig. 51

Much of the restored pointing was replaced and gaps were filled; the inappropriate mortar used for both these tasks encroached heavily on the original painted plaster (Fig. 51, cf. Fig. 6).

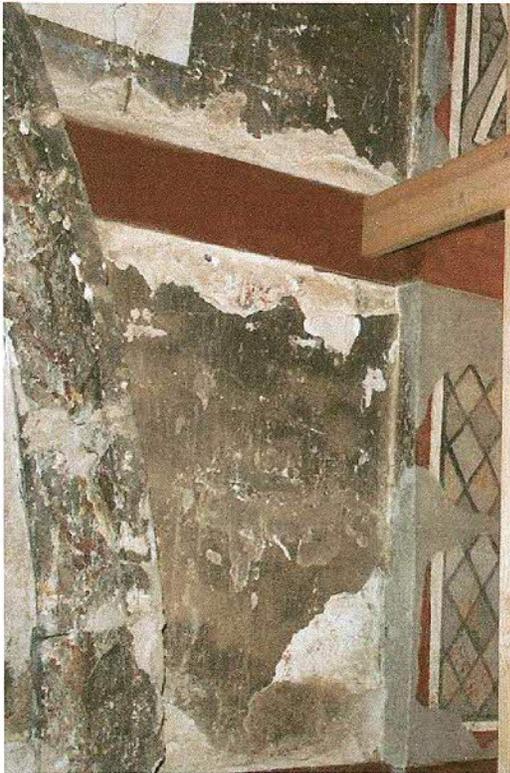
Fig. 52

Part of the plaster has fallen off at the edges of the stone blocks removed and replaced at the time of the Comité's work (Fig. 52).

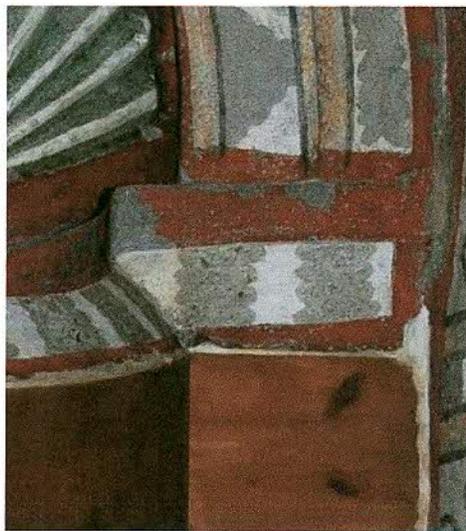
Fig. 53

It is interesting to observe that in some cases the angles of the plaster panels painted with fake marble inlays are well conserved (Fig.53). This supports our theory that the sockets now housing wooden elements replaced by the Comité did not originally hold pieces of stone. In fact, considerable mechanical force would have been required to replace pieces of limestone and extensive cracks would have been caused in the neighboring plaster.

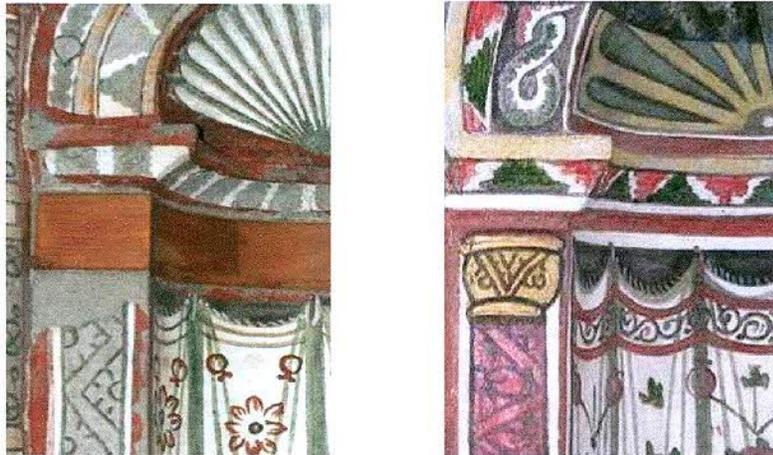
Figs. 57 and 58

All the wax technique applications from the third phase have virtually disappeared today and, for this reason, it would be worth comparing the state of preservation of paintings in the triconch with those on the facade (Figs. 57 and 58).

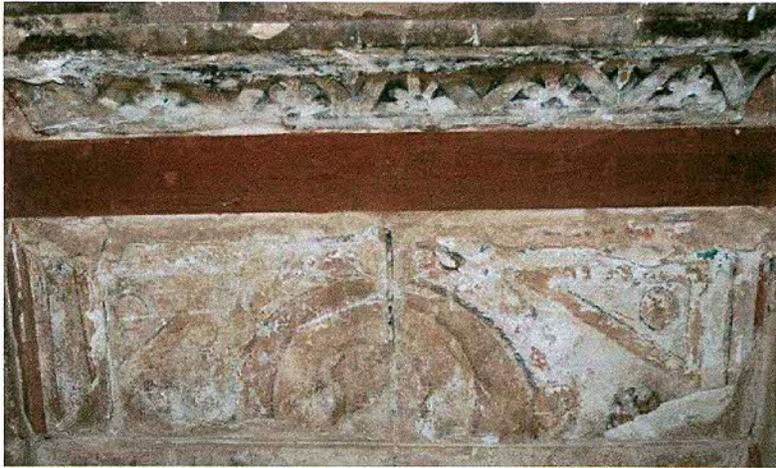
Fig. 60

The window with the tympanum and small columns surmounting the triumphal arch retains a considerable amount of its polychrome decorative scheme even though it was exposed to the open air for a long time.

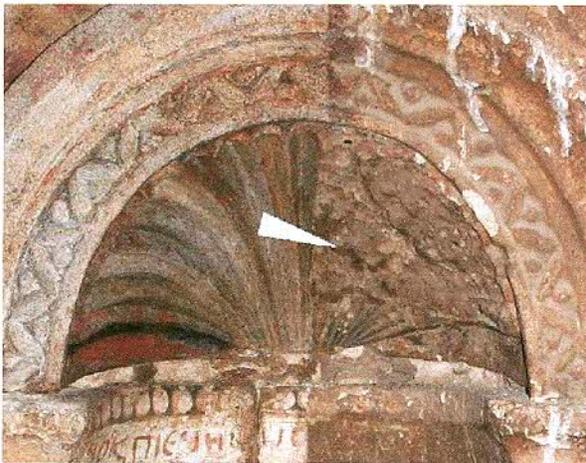
Fig. 61

All the projecting parts were covered with a thick layer of bird droppings, in some places 1.5-2 cm thick. The surface of the sculpted shell was covered with insect nests (presumably *Imenotteri* from the *Vespidi* family), made up of a layer of organic material and mud several centimeters thick (Fig. 61)⁸.

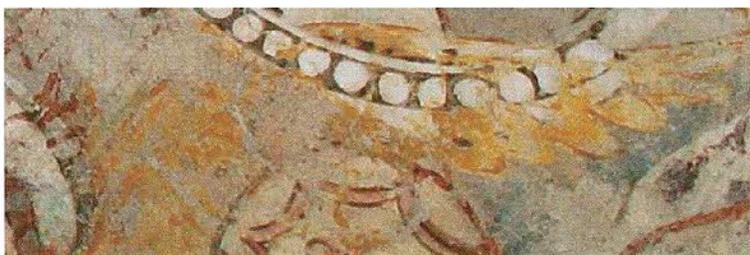
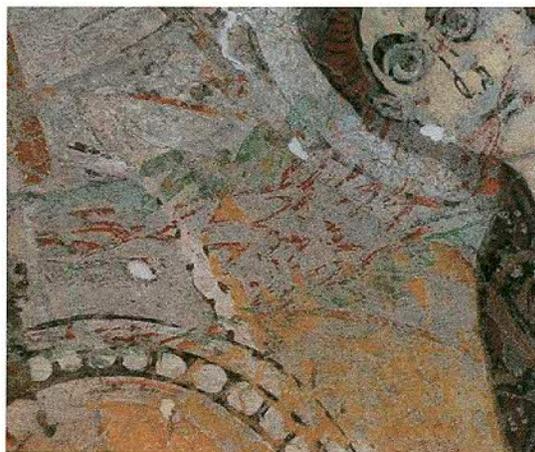
Fig. 62

In the *protesis* it would be helpful to analyze the state of preservation of the paint layer as two separate layers: the third phase and the fourth phase on white wash. The fact that the white wash layer has fallen off so extensively renders the underlying decoration easily visible. The yellow used to color the eagles is well preserved even though the wax finish that was presumably applied has completely disappeared now. However, the blue background visible between the wings and the racemes has many gaps in it presumably owing to the natural fragility of the pigment. The paint of the crown, applied using the wax technique, is very thin. This leads us to believe that the painter of the *Virgo lactans* rubbed it down to some extent to facilitate the adhesion of the *white wash* (Figs. 62 and 63).

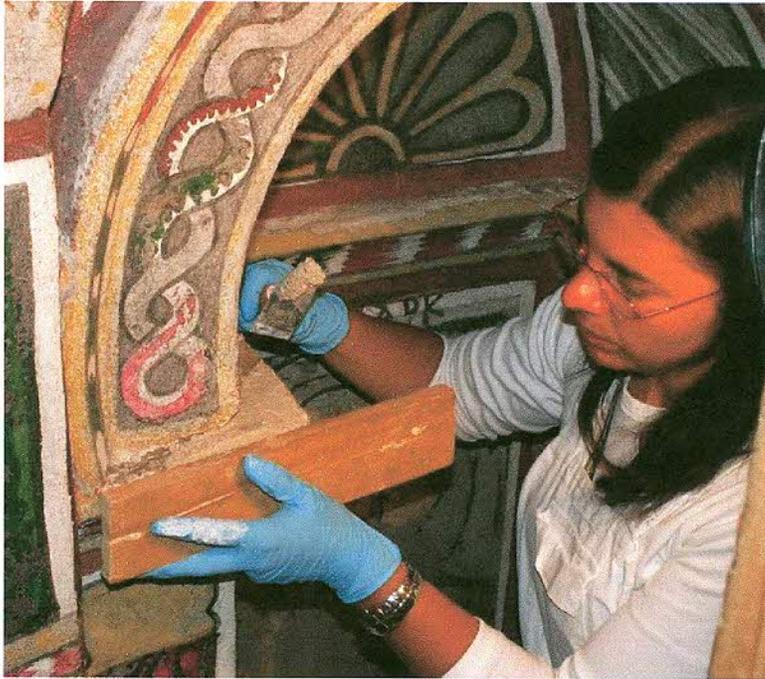
Fig. 66

The rods were needed to provide a supporting framework and lasting anchorage for the mortar. The mortar was applied in levels, using mortar with medium-sized grains first and finer grains on the surface (Fig. 66). The composition of the mortar used for repairs is similar in appearance and composition to the plaster of the third phase. Hydrated lime, local sand and a small percentage of local finely powdered limestone were used (1.5 parts lime, 2 parts sand and 1 part powdered limestone). The mortar has less mechanical resistance than the original plaster. Repairs were never carried out where they would cover an older paint layer, in order to preserve the immediate legibility of each decorative element in the different layers.
