# FINAL REPORT

ARCE Groundwater Lowering Response Project, Luxor

“Talatat Project”

**AMERICAN RESEARCH CENTER IN EGYPT****TALATAT PROJECT, KARNAK****Final Report, December 2012****Introduction**

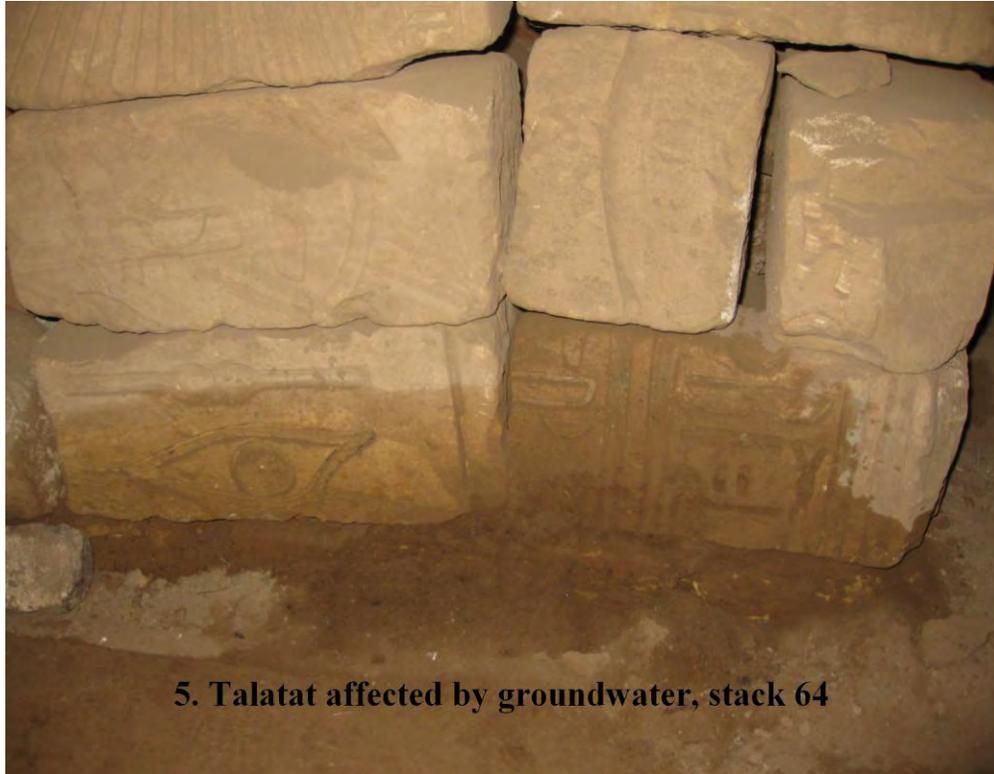
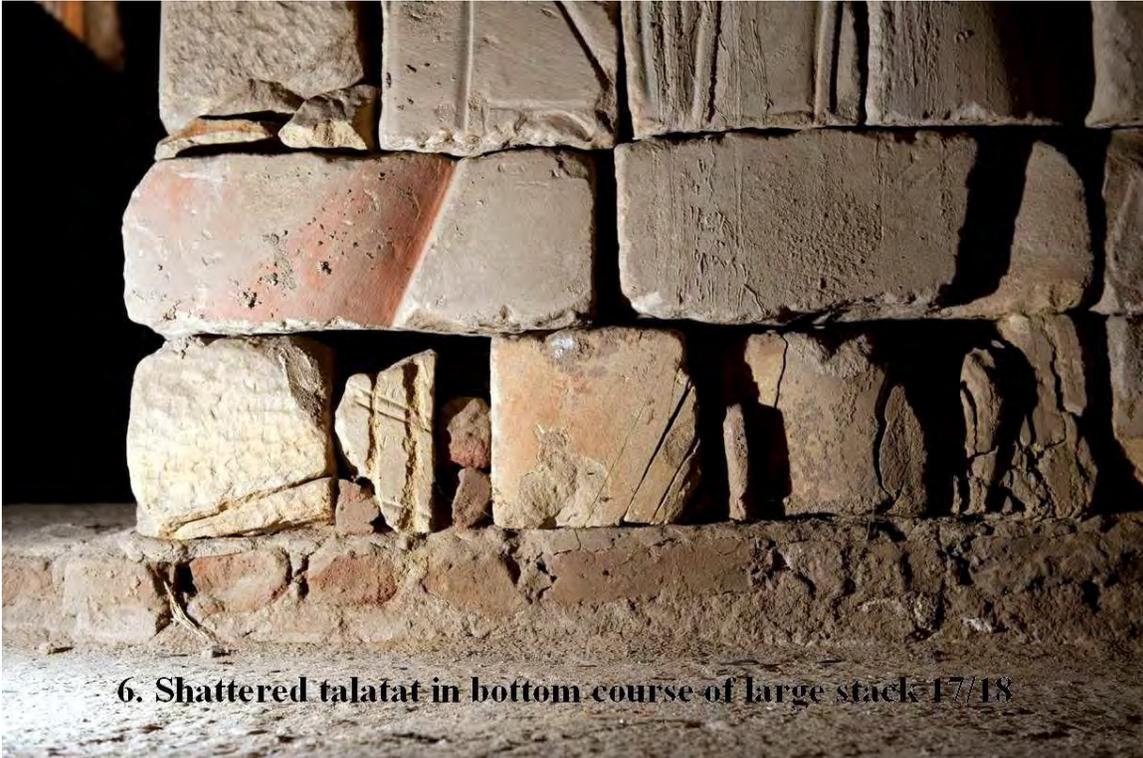
in order to plan for the next stage of the project, which would involve removing the talatat from the magazine, cleaning, conservation, digital photography, database recording, and re-storage of the talatat. The survey was carried out by the Project Director Jocelyn Gohary, and Assistant Director Rawya Ismail, and a digital photographic record was made by Matjaz Kačičnik. Results of the survey recorded that the talatat were stacked on low brick mastabas, but the ground level was irregular, and in several places burrowing by foxes, or other animals, had piled up large mounds of earth against the lowest course of talatat. This factor, as well as groundwater

and the passage of time, had resulted in damage to the lowest course of blocks in each stack, causing some blocks to crumble on the underside, or even split or shatter under the weight of 7-8 layers of blocks above them.

Rain water had come through gaps in the roof in some places, and left streaks of mud down several courses of talatat in most stacks.

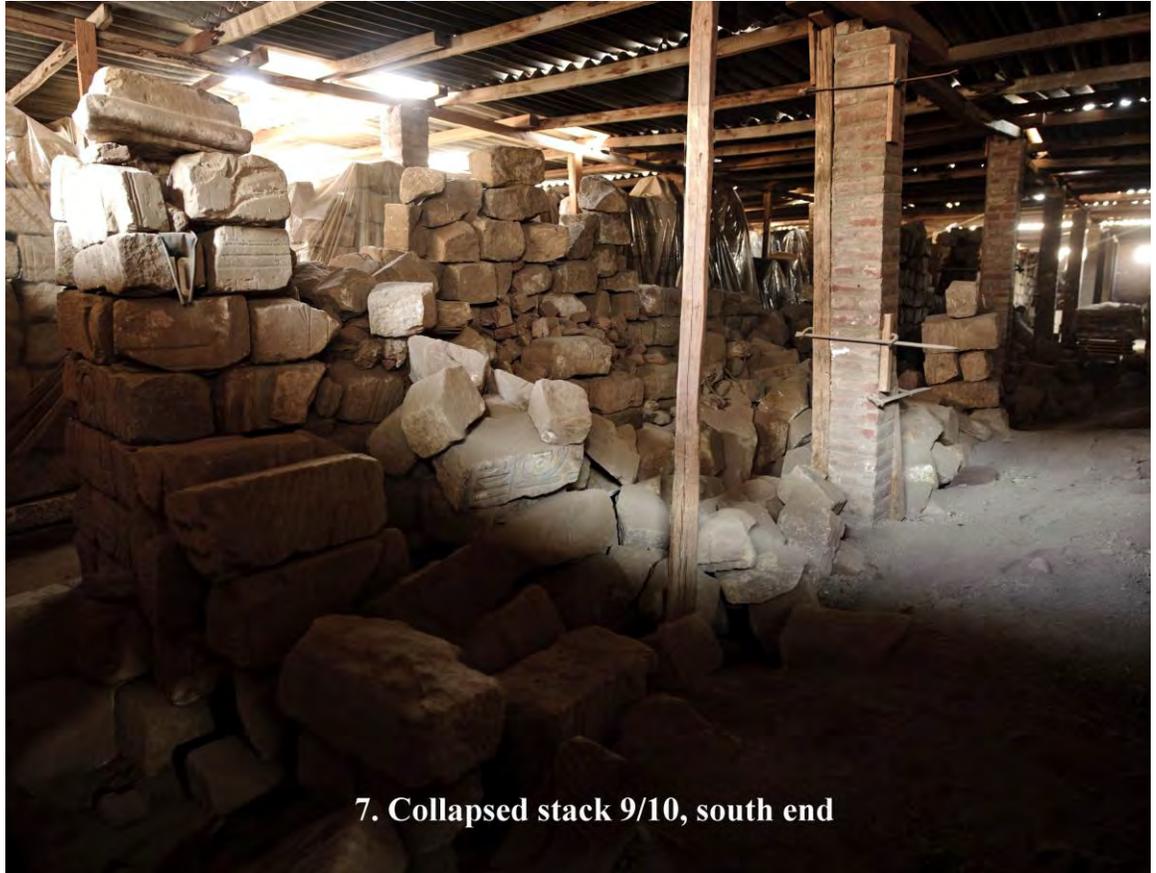
7. Collapsed stack 9/10, south end

This was due to extensive burrowing by foxes in areas where the original thin cement floor had not been completed for some reason. About 75% of the talatat in the magazine retained most of their original paint, but they were all covered with a thick layer of dust, those in the stacks against the wall of the Khonsu Temple even more so, because the gap in the roof was wider at this end.

During the second season, the remaining seven main stacks of blocks were documented, including Stacks 9 and 11, which had collapsed eastwards because of extensive burrowing underneath them by foxes. Several sizeable fox holes were discovered, where the animals had been able to burrow because of gaps in the cement floor. These two mastabas were extensively repaired; the southern half of the one under Stack 9 was completely rebuilt, and the whole of the mastaba under Stack 11 was reconstructed. Two brick pillars which had cracked when these two stacks collapsed, one beside Stack 9 and the other beside Stack 11, were considered unsafe. They were dismantled and replaced by a number of wooden uprights and roof supports. The large gaps in the floor were also cemented over.

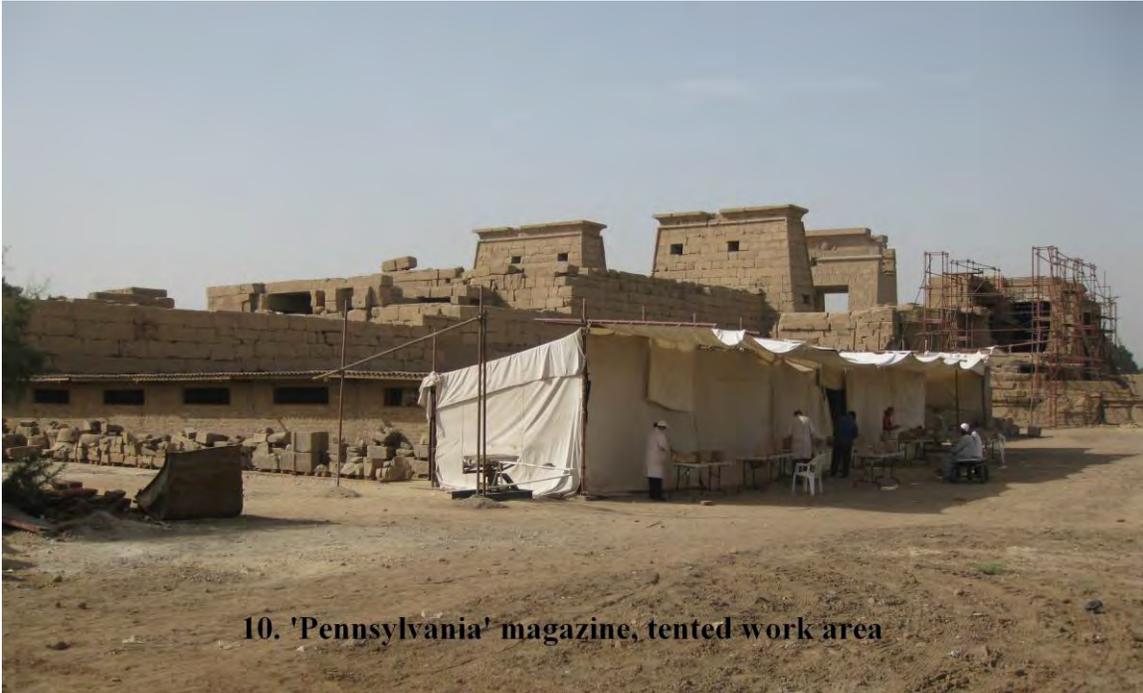
**10. 'Pennsylvania' magazine, tented work area**

and a tented work area created around this cement floor, extending for a length of approximately 20 meters.

The canvas canopy was later extended outwards in February 2009 to make a larger working space for the conservators outside the covered area, because of the considerable amount of dust brushed off the talatat as they were being cleaned, and the strong smell of some of the conservation materials. A survey was made of the condition of the major stacks in the magazine, and three of them which were leaning outwards dangerously in parts were supported with wooden planks covered in sponge in order to protect the decorated surfaces of the talatat.

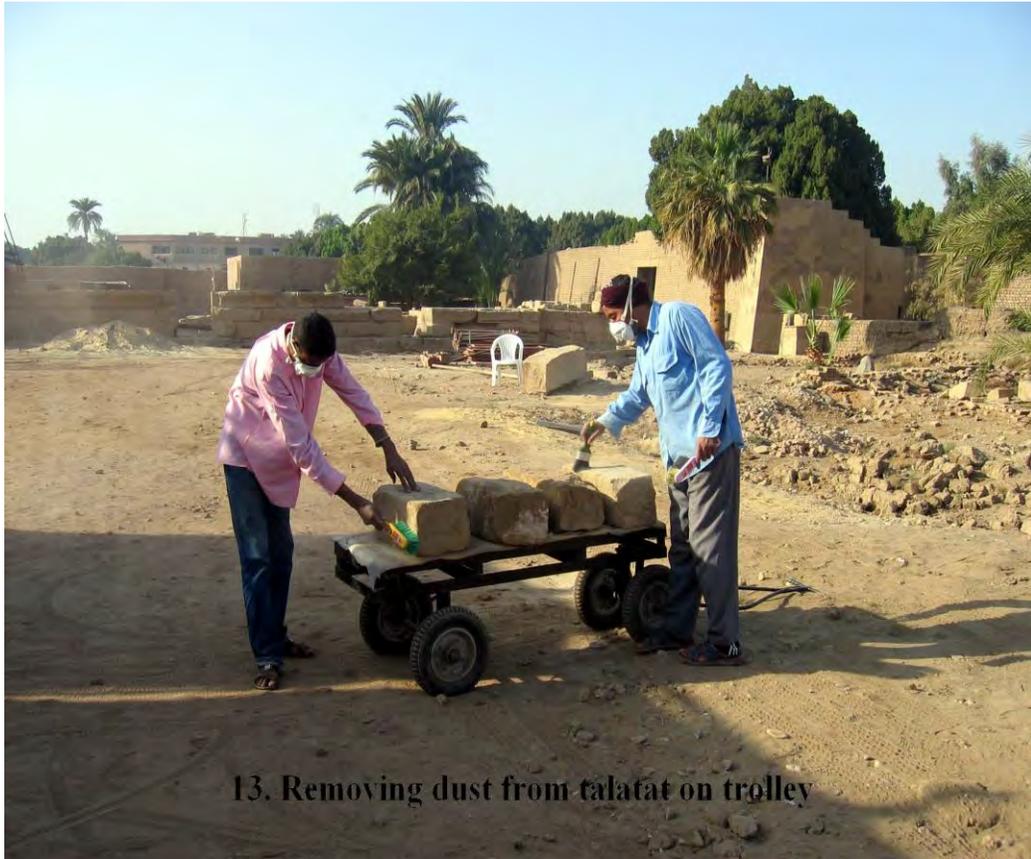
**13. Removing dust from talatat on trolley**

x 26 cms, and weighs about 60 kgs. First, the dust was brushed off the talatat,

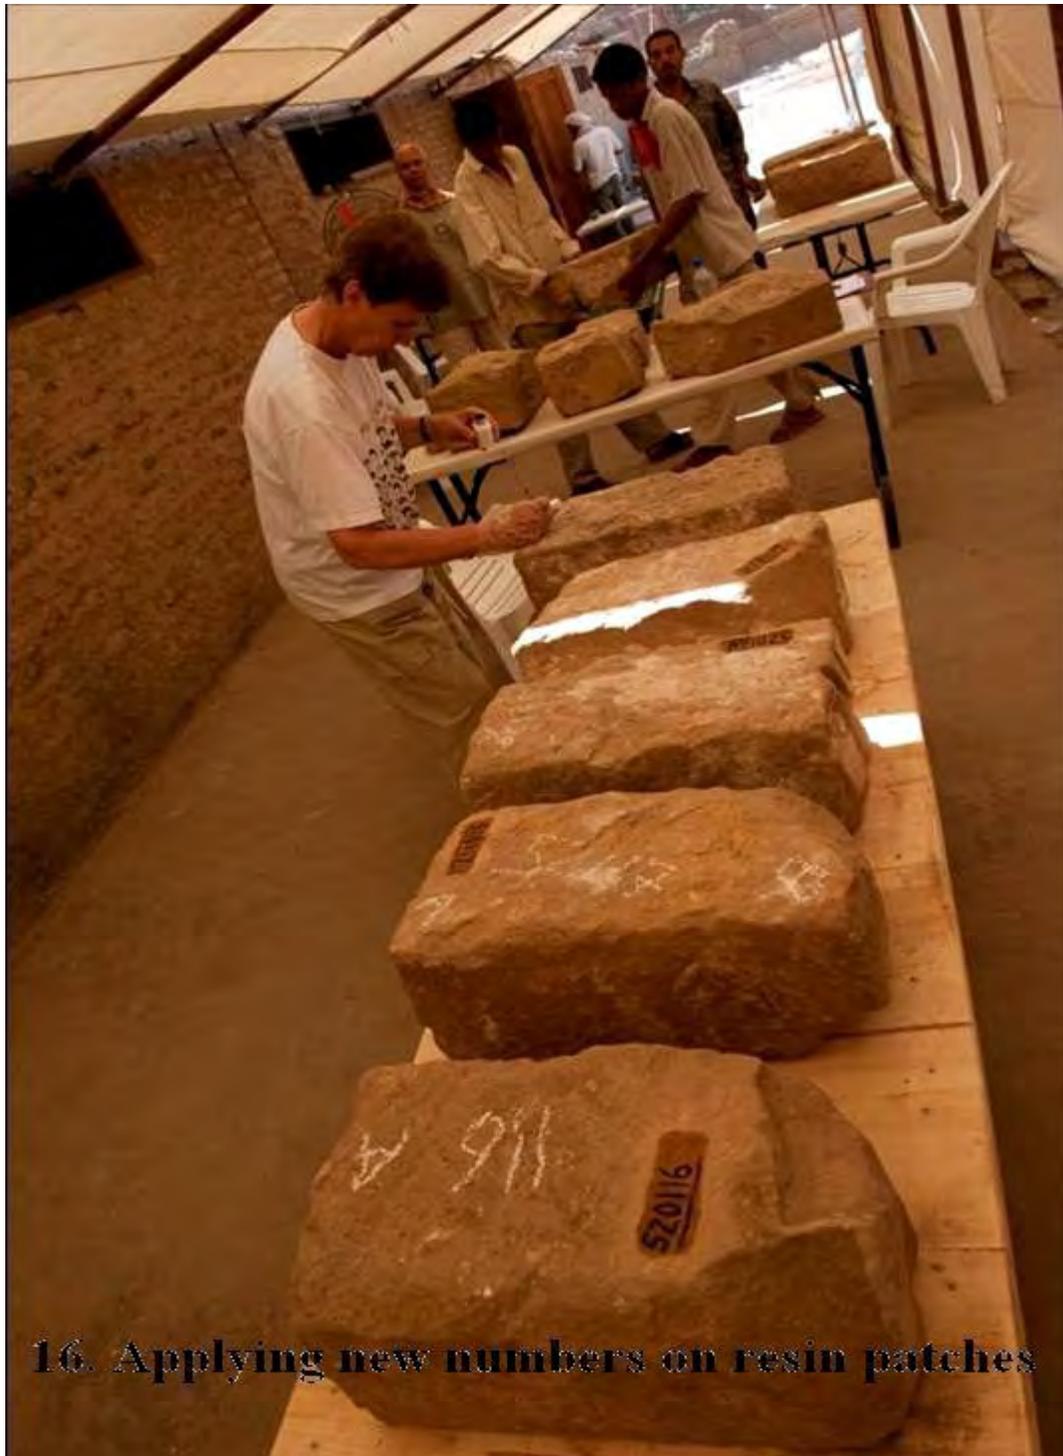
**16. Applying new numbers on resin patches**

on the assumption that blocks in the same stack may have been located close to each other when they were discovered in modern times, and so may have come from the same part of the Aten Temple when it was dismantled by the ancient Egyptians. The stack numbers assigned by ATP were retained as far as possible, but as it would be impossible to restack the talatat in the original order after documentation, only the odd number for a double-sided stack was incorporated into the new ID number. Therefore, original stack 1/2 is now all 01, 3/4 is now 03, and so on. The numbers were written with permanent marker on a resin base, and were painted over with another resin layer when dry.

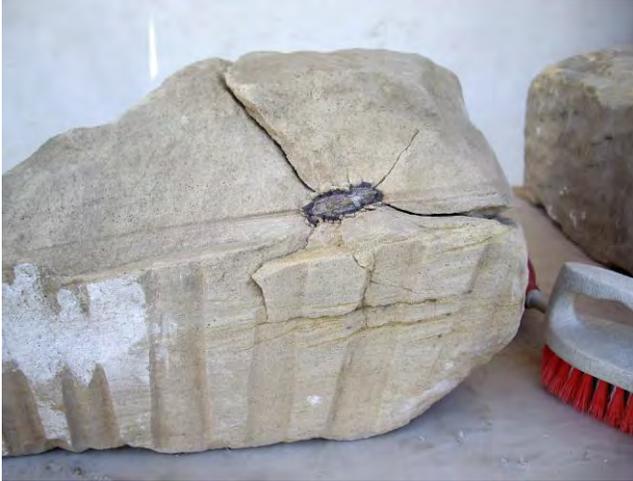
Block 250794  
Iron inclusions with stone cracks.

Regarding the state of preservation of the stone, two types of degradation were noted. The first was linked to the constitution of the stone, where in some cases tension points had developed around iron nodules, causing cracks and sometimes shattering of

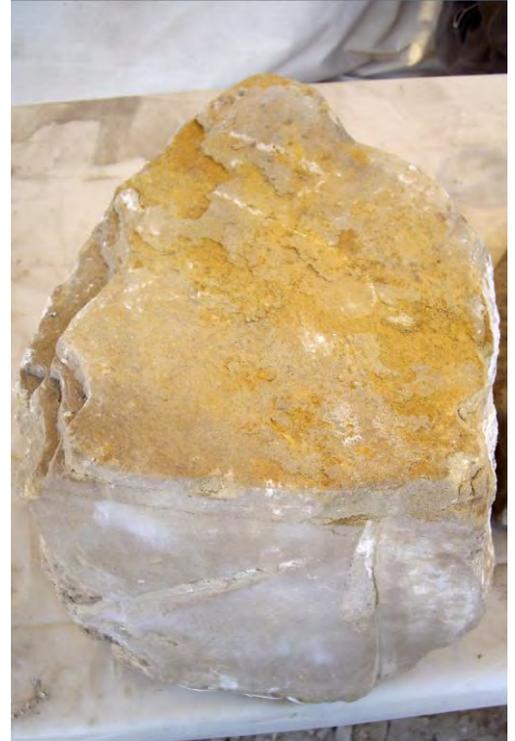
Block 250816  
Strong  
concentration of  
iron at bedding  
planes

the block. The concentration of iron at some bedding planes caused lower resistance in the layer, with sanding and delaminating.

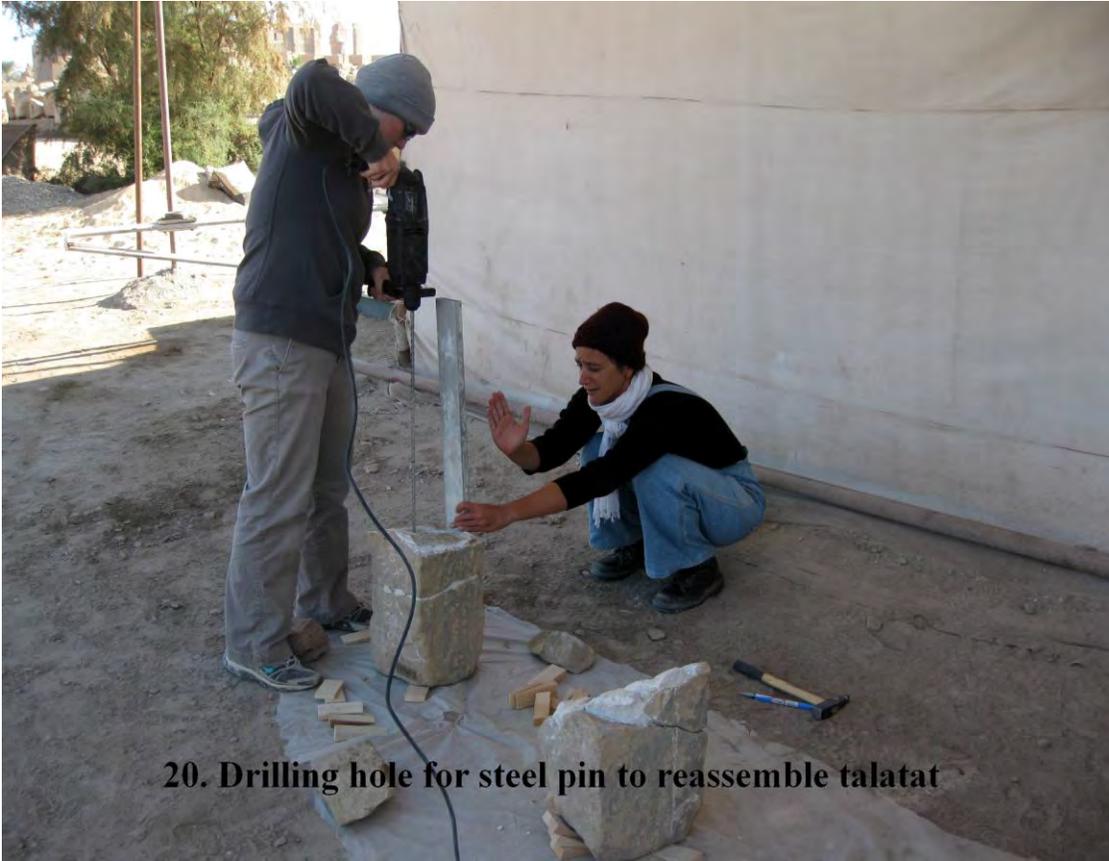
**20. Drilling hole for steel pin to reassemble talatat**

Ten talatat had broken into two or three pieces with almost no contact between faces, and so needed to be pinned together. The pinning method depended on the state of fragmentation: when the block was in two pieces, and there was still some contact between faces, the pieces were first joined with araldite and the gaps were filled with lime mortar. A hole was then drilled through both fragments,

a stainless steel pin, 8-10 cm in diameter, was inserted, and araldite was poured into the hole around it. When the block was in three fragments, the pinning was carried out in two stages. First the fragments were joined with lime mortar, then one fragment was removed, keeping its mortar at the contact point. A hole was drilled through the other two fragments and a pin inserted. The third fragment was then reattached; a hole was drilled through all three fragments, a pin inserted and araldite poured into the hole.

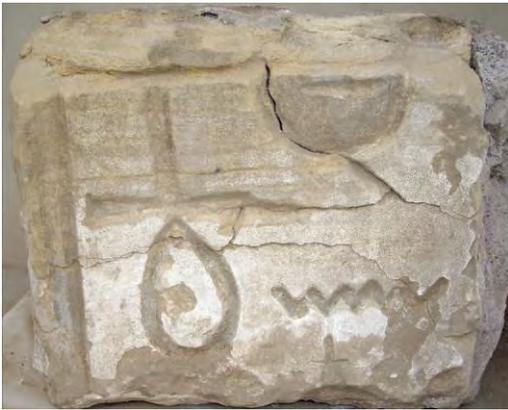
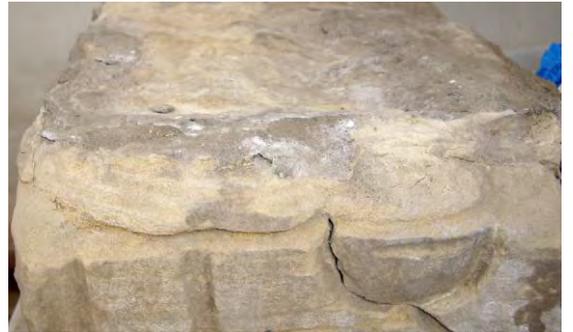
Block 230952

Degradation was also caused by salt efflorescence, which, along with salt crusts, formed on surfaces or inside blocks, resulting in sanding and often cracks, leading to fragmentation of the surface of the block. As there was no time to treat blocks affected in this way, where possible gauze strips were applied to the cracked faces to ensure the cohesion of the assembly, and the blocks were stored on the conservation shelves.

Salt crust covers part of bottom side causing cracks, delamination and sanding.

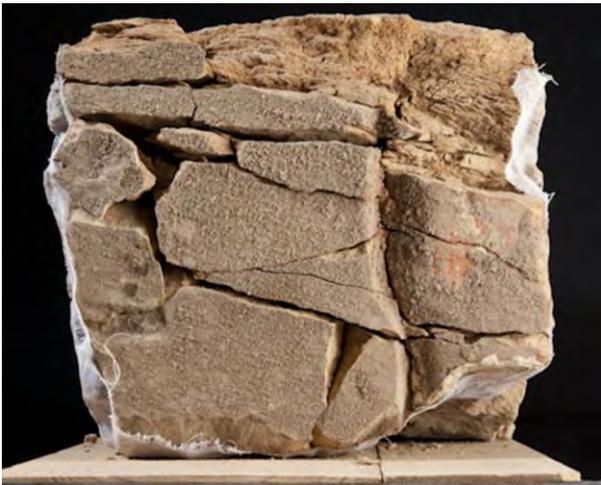
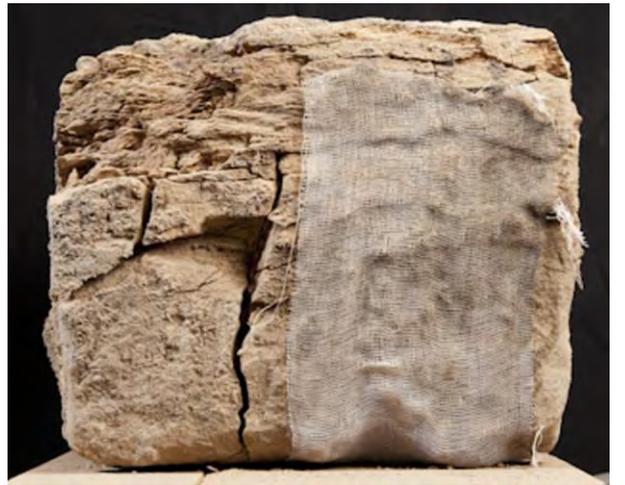
Block 190236

From lowest course with salt efflorescence throughout causing multiple cracks. Gauze strips applied to surfaces to maintain cohesion.

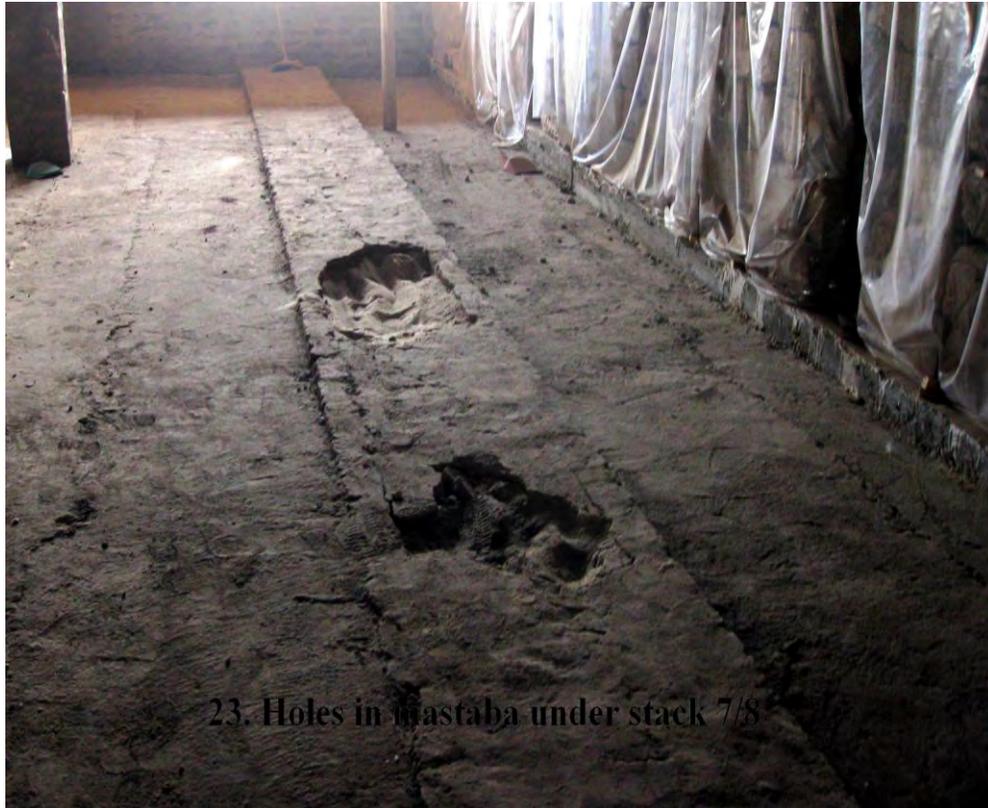
Dismantling and processing the large main stacks of talatat, each containing approximately 900 talatat, began on 12 February 2009. As some of the original mastabas were no longer effective protection against rising groundwater, many of the blocks in the lowest course of the major stacks were visibly damp, and had cracked under the weight of the talatat stacked above them. However, the majority of the blocks in the main stacks were in reasonably good condition, and as anticipated, the work proceeded at a faster rate.

Because the original mastabas were only two or three bricks high, in poor condition and no longer water resistant,

as each mastaba became vacant and before talatat were restacked on it, it was built up, then resurfaced with burlap, cement and lime mortar, in order to protect the restacked blocks from the effects of groundwater, and make the stacks more stable.

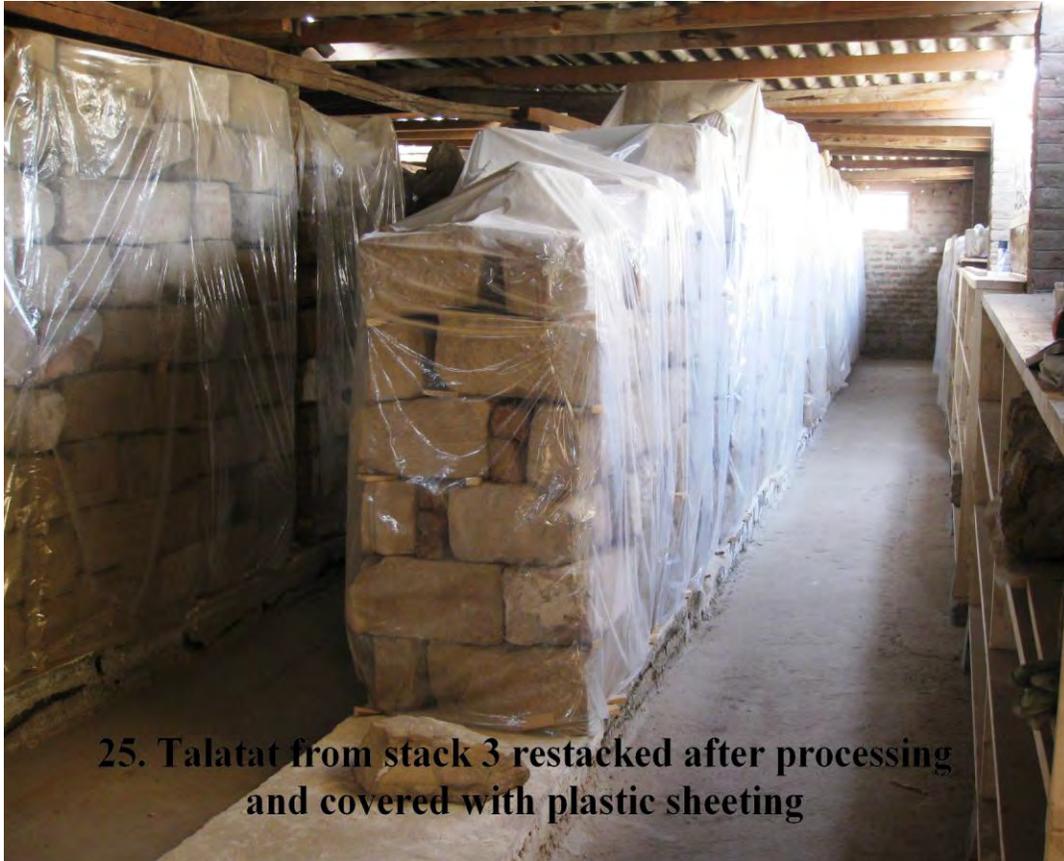
**25. Talatat from stack 3 restacked after processing and covered with plastic sheeting**

After restacking, each stack was loosely covered with plastic sheeting to try and reduce the accumulation of dust on the decorated surfaces of the talatat. Careful monitoring of the humidity in the magazine during each season, and over the summer break from July to September 2009, revealed that there was no build-up of condensation.

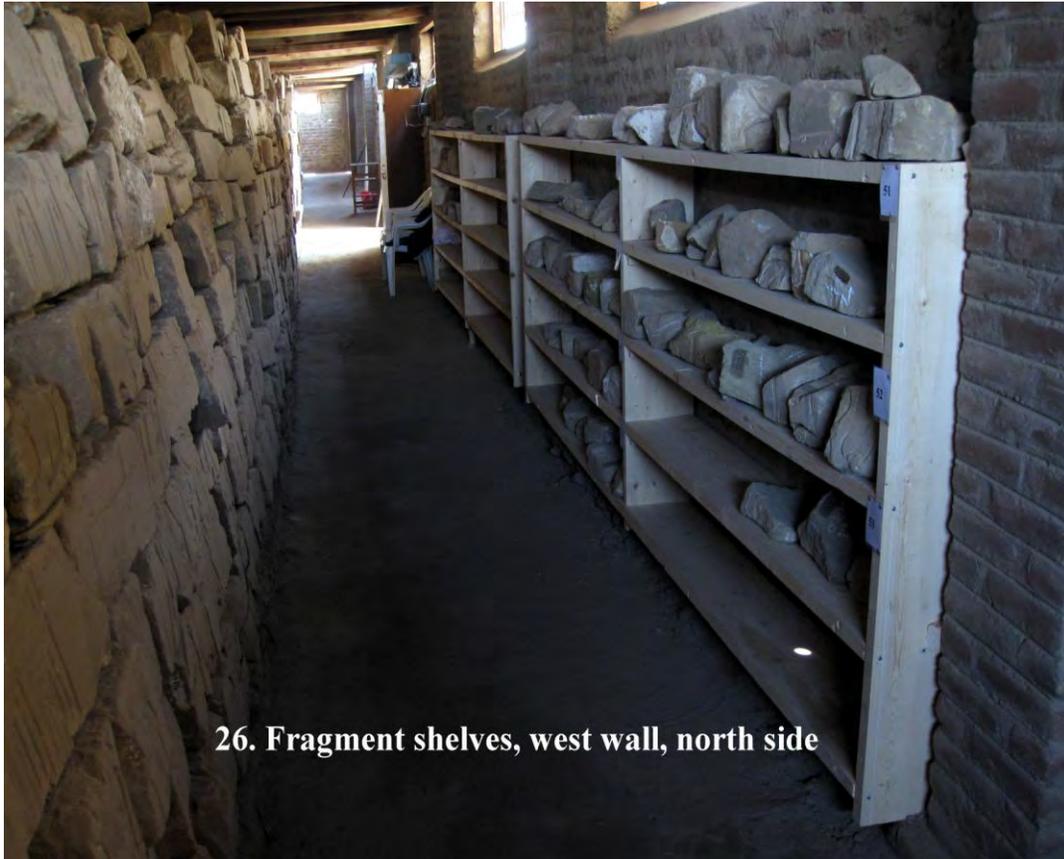
**26. Fragment shelves, west wall, north side**

Wooden shelving was erected inside the magazine to the left of the door for storing talatat

fragments,

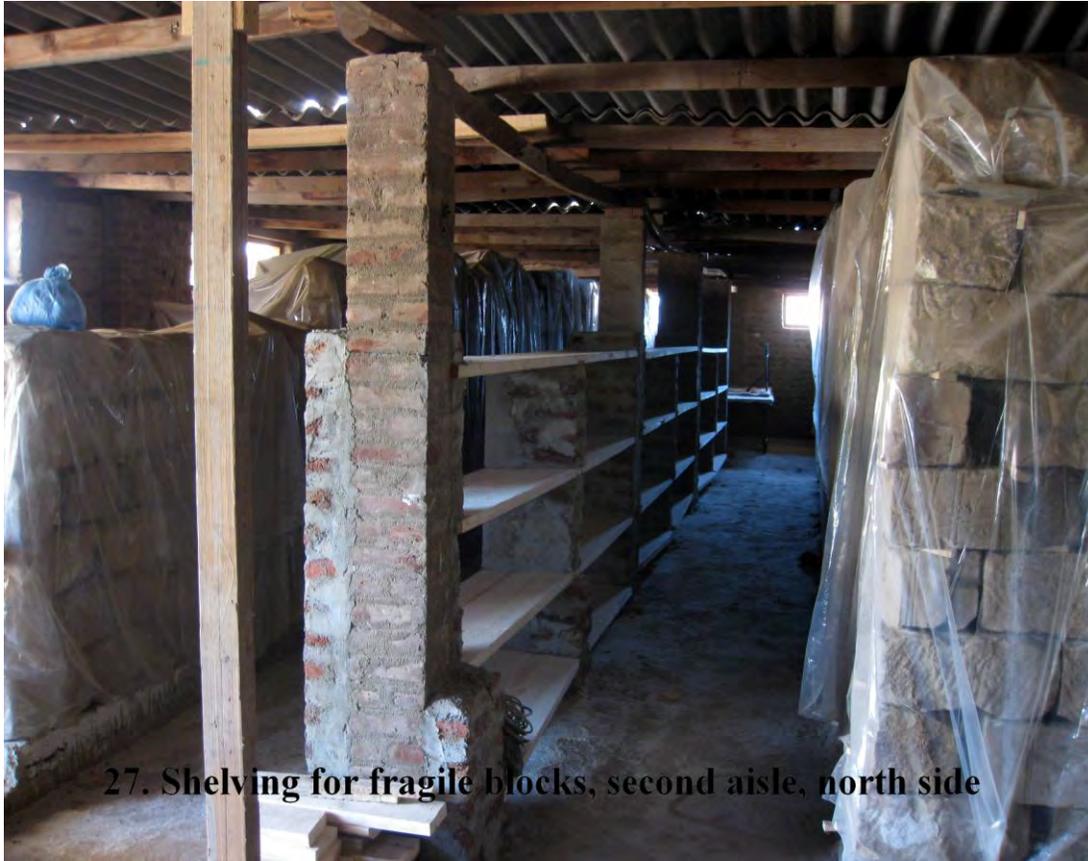
**27. Shelving for fragile blocks, second aisle, north side**

and more shelving was installed to the right of the door for the badly damaged talatat which could not be restacked, and required further treatment . Some of the most fragile blocks were stored on the shelves on wooden trays, which had been used for moving severely damaged talatat during the documentation process, to avoid handling them any more than necessary. Towards the end of the first season, additional shelving for fragile blocks was erected on brick supports in the second aisle to the left (north side) of the magazine.

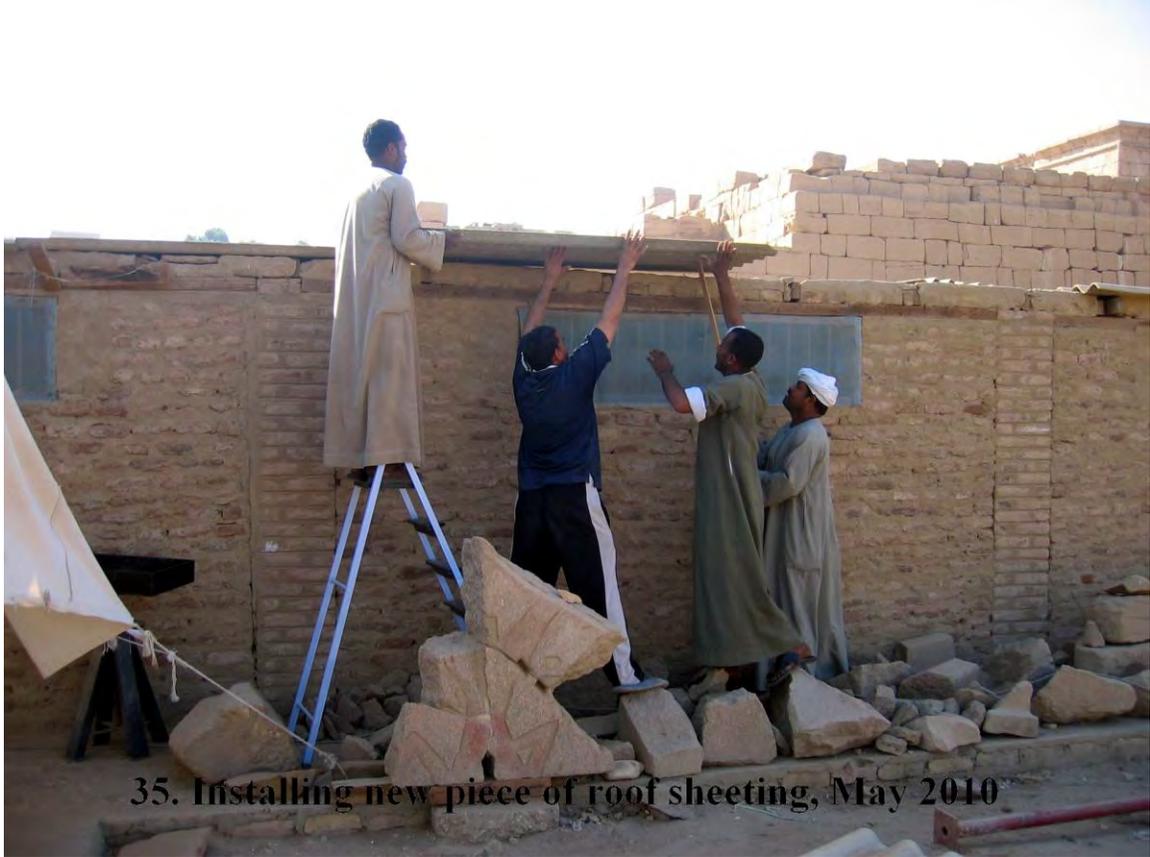
**35. Installing new piece of roof sheeting, May 2010**

installing a new piece of sheeting over a large gap in the roof near the magazine entrance,

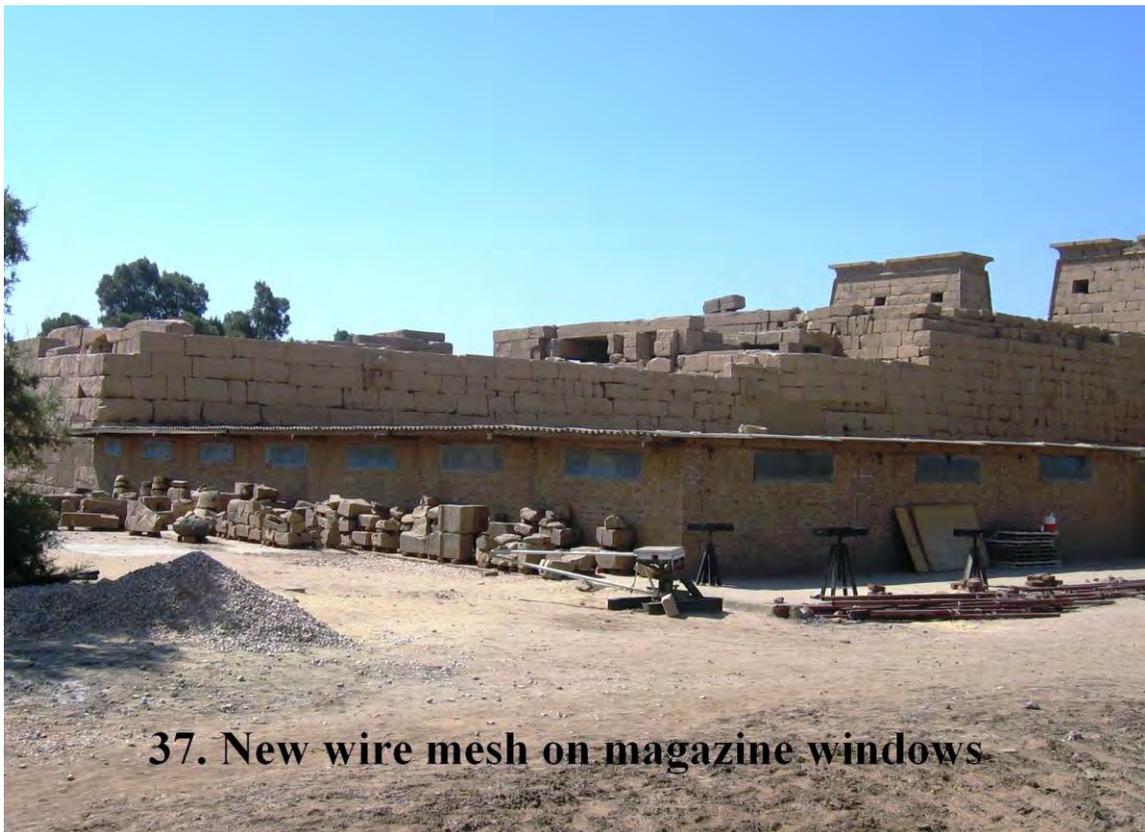
**37. New wire mesh on magazine windows**

covering smaller gaps in the roof with wire netting to prevent birds and foxes from entering, putting stronger fine wire mesh on the windows to prevent insects, particularly hornets,

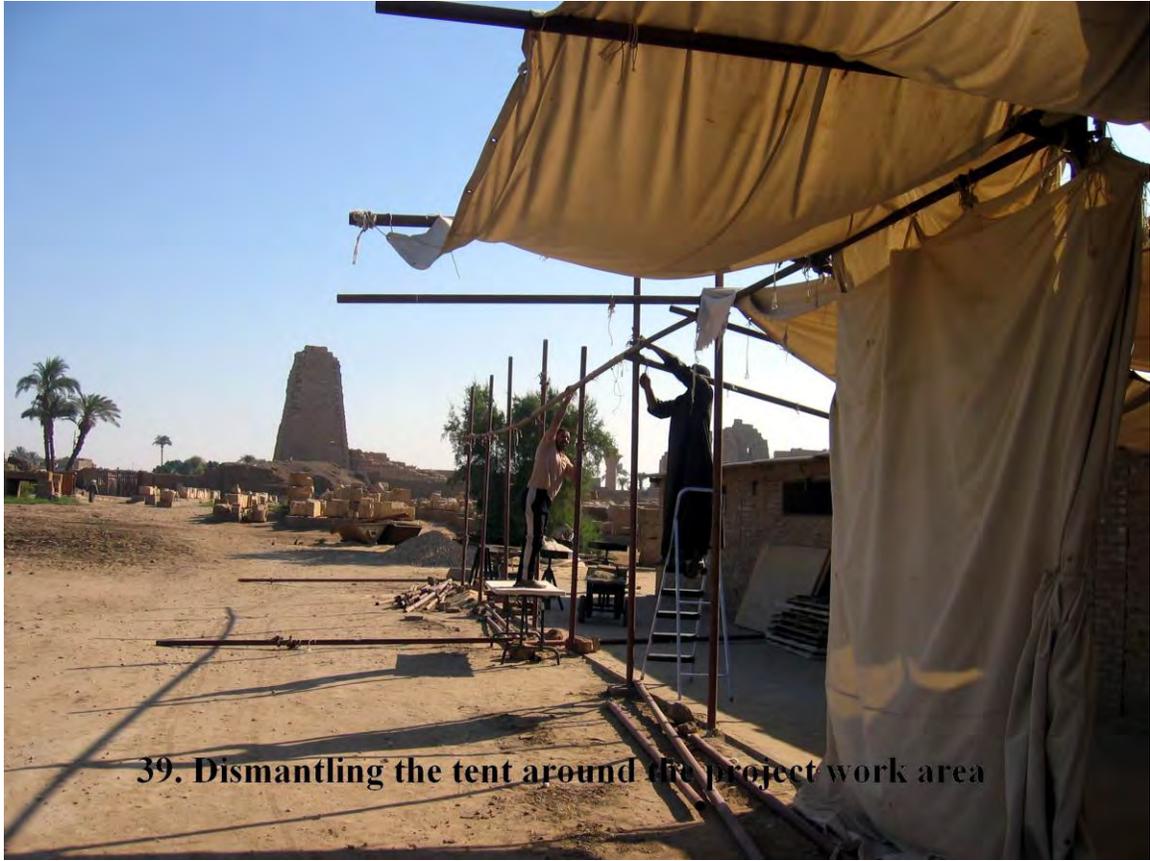
**39. Dismantling the tent around the project work area**

to prevent burrowing by foxes, as well as general cleaning. The large tent, which had covered the project work area in front of the magazine, was dismantled.

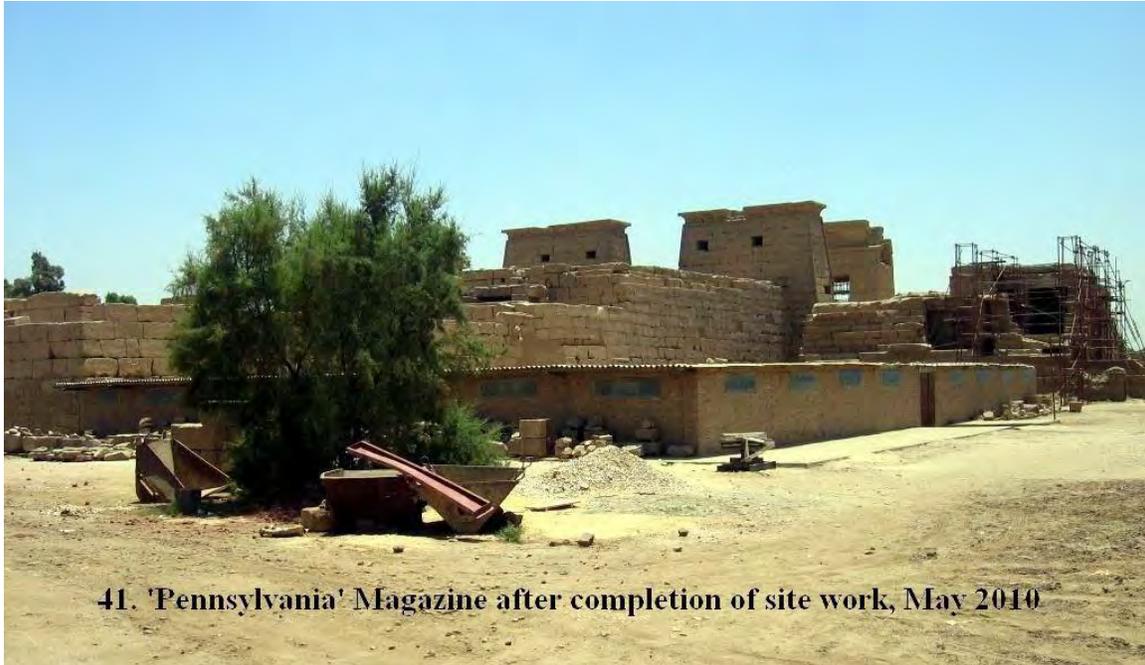
41. 'Pennsylvania' Magazine after completion of site work, May 2010

With the completion of the documentation of the talatat and the repairs, the magazine was finally closed on 6 May 2010.

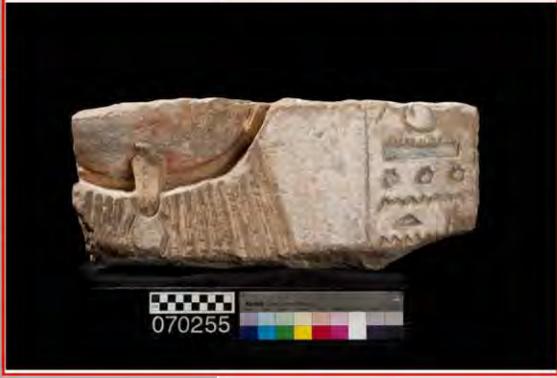
Insert Picture

Pigment and preparatory layer are flaking
